# Inspection/Audit Photos

Location Name: QB ENERGY OPERATING LLC HMU 10-1D (A10W) Pad

Location #: 334924

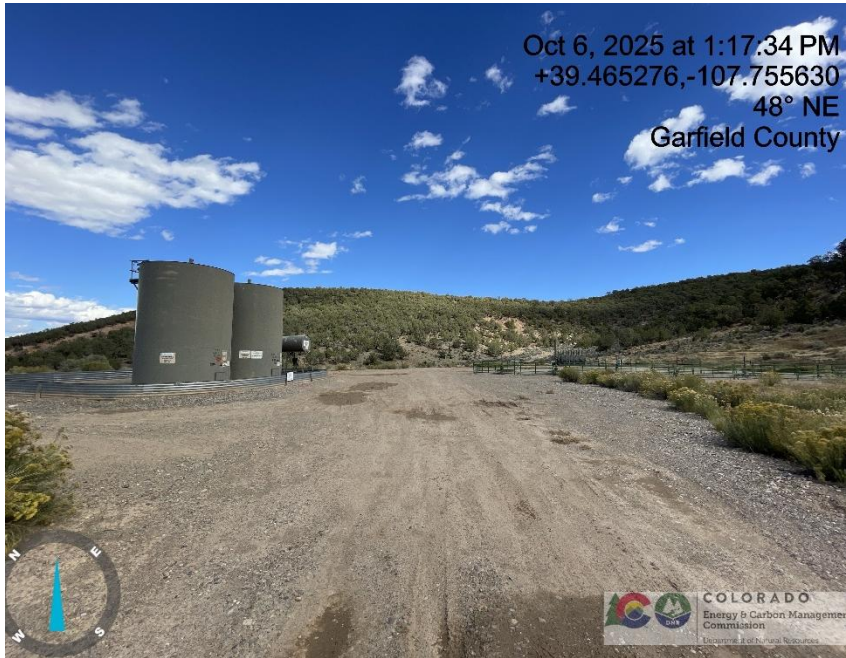
Photo # 4238 From entrance to location

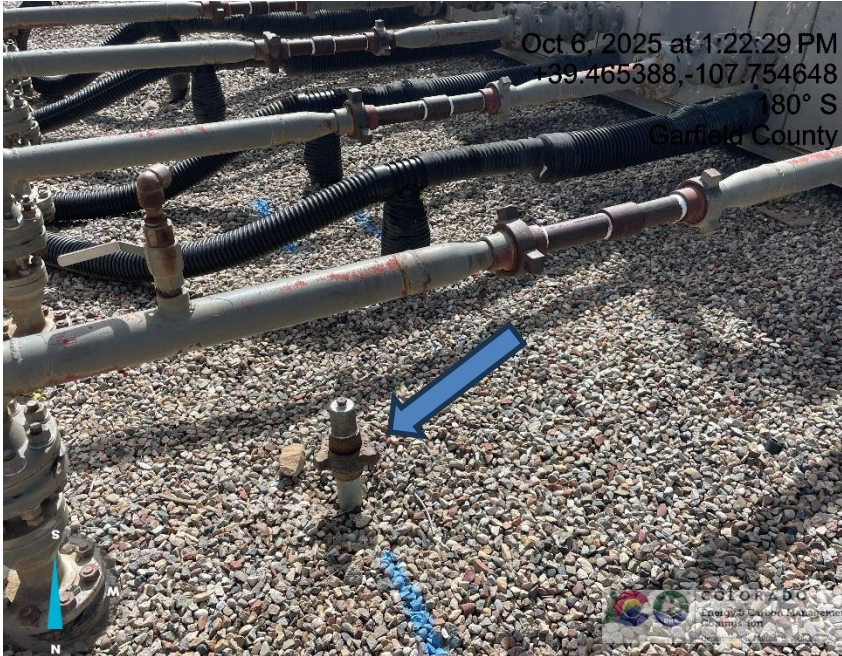
Photo # 4244 Unused flowline lacks lockout tagout (OOSLAT)

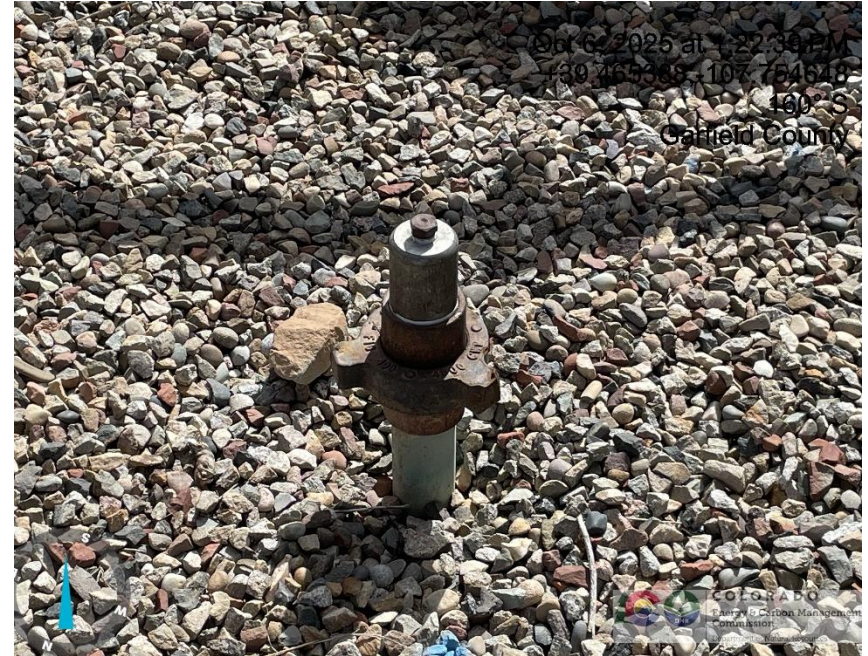
Photo # 4245 Unused flowline lacks lockout tagout (OOSLAT)

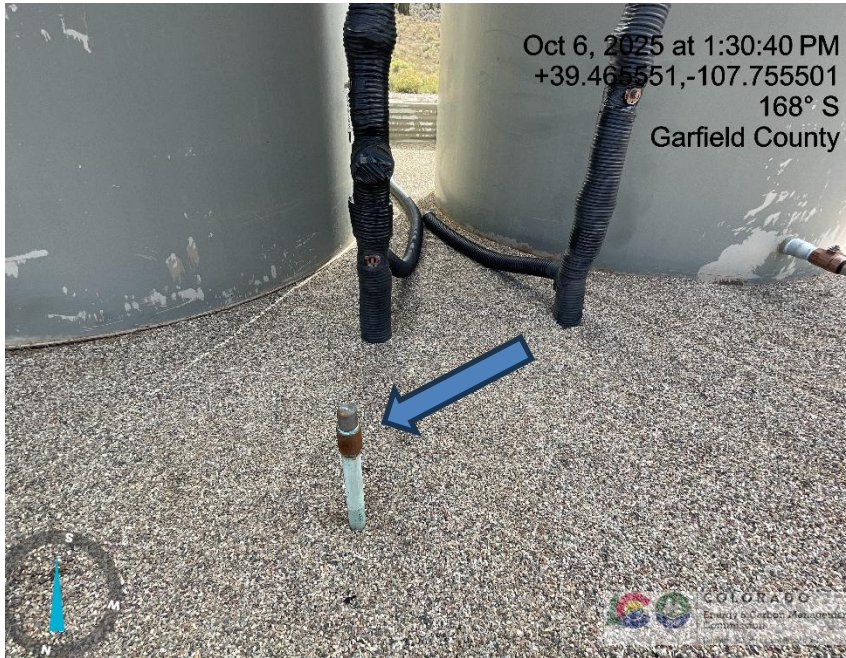
Photo # 4246 Unused flowline lacks lockout tagout (OOSLAT)

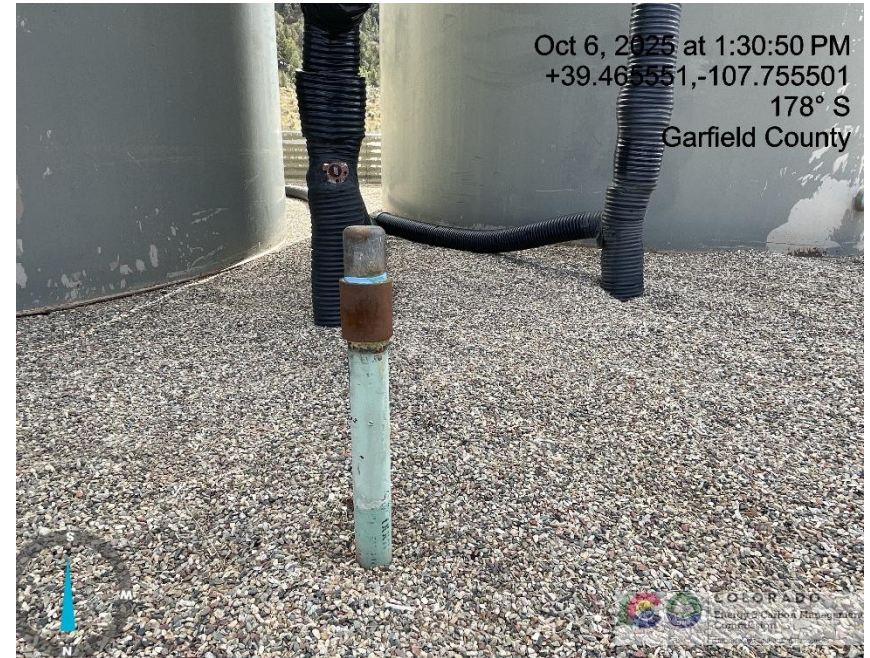
Photo # 4247 Unused flowline lacks lockout tagout (OOSLAT)

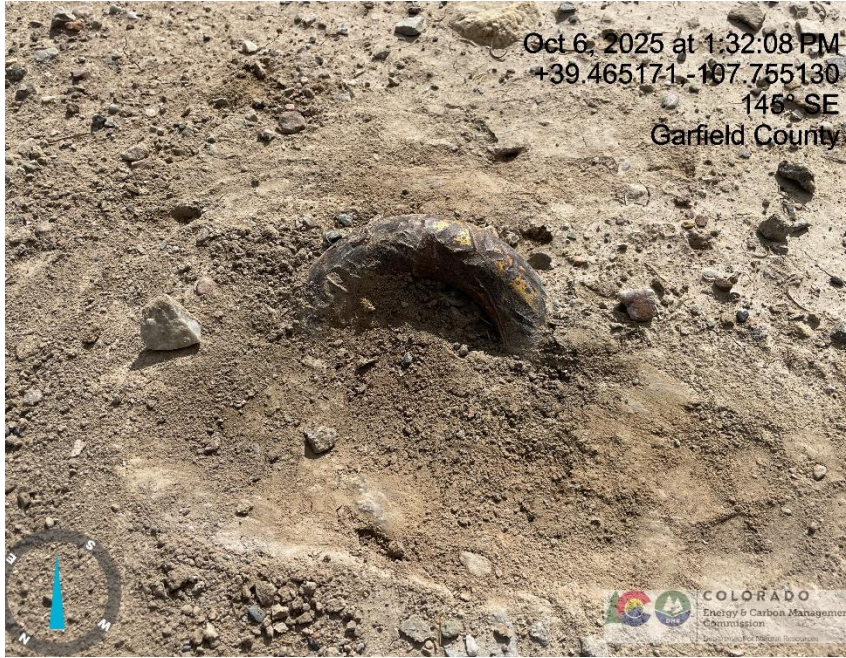
Photo # 4248 Unmarked deadman

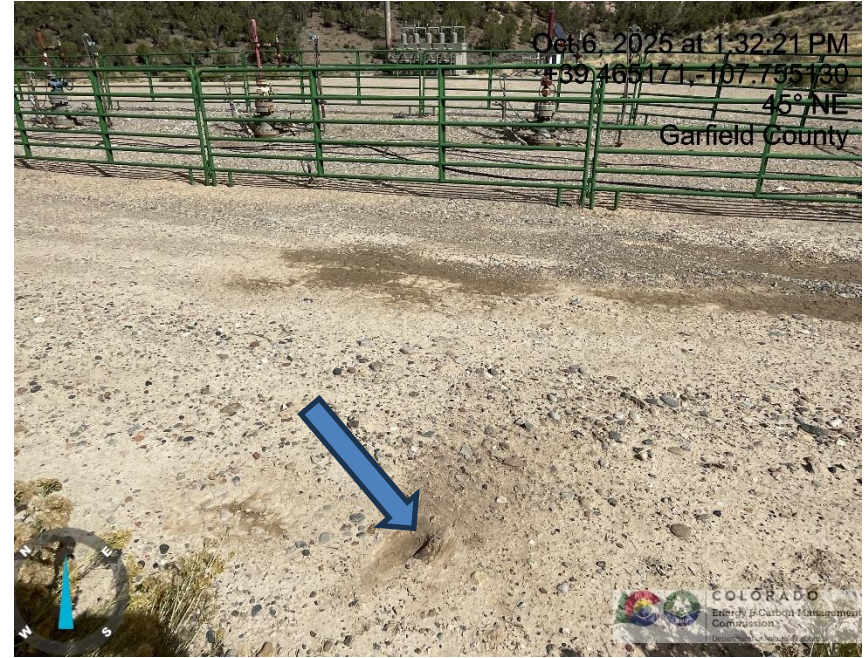
Photo # 4249 Same unmarked deadman

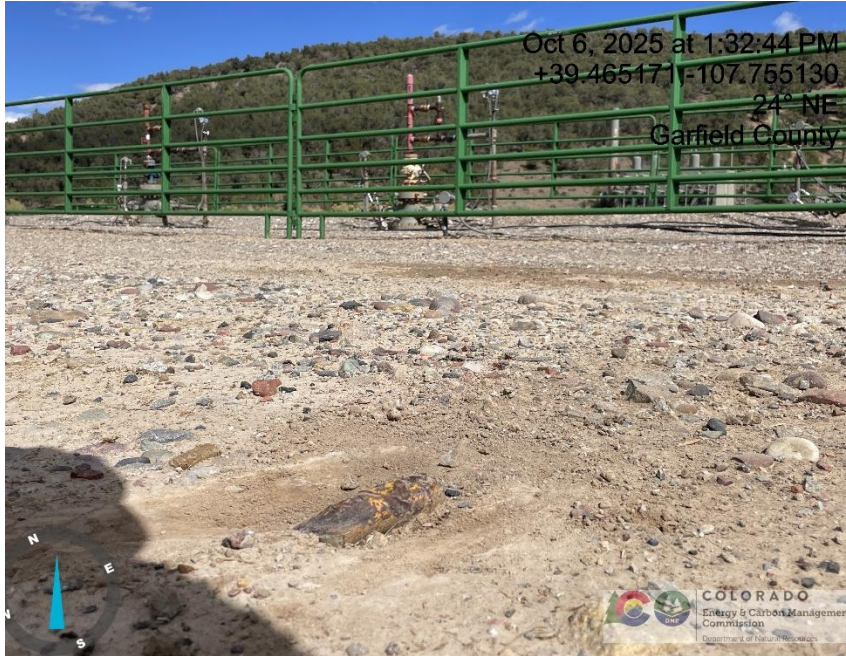
Photo # 4250 Same unmarked deadman

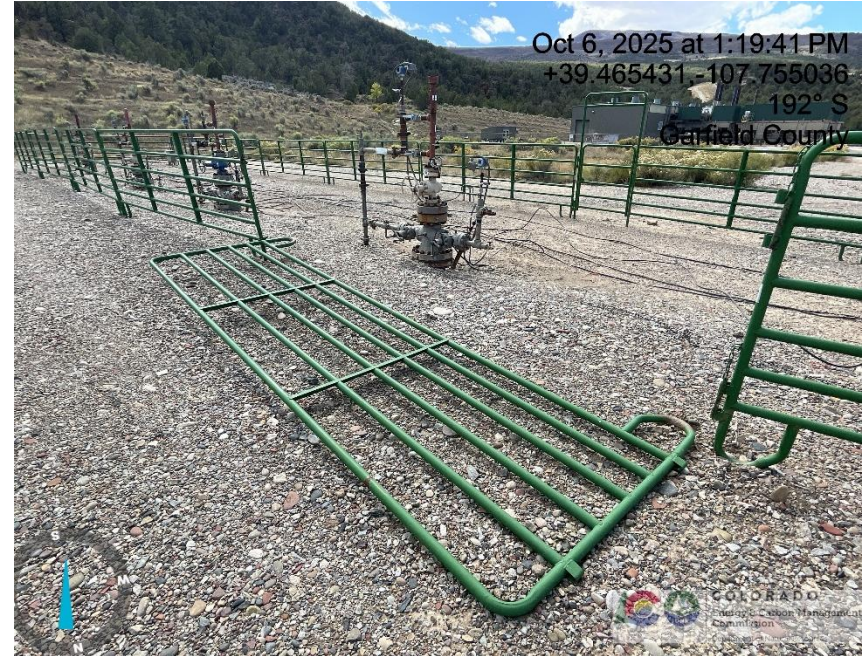
Photo # 4251 Cattle panel laying on ground
