Inspection Photos

Loc: 321940

Operator: CITATION OIL & GAS CORP

Inspection Date: 9/24/2025

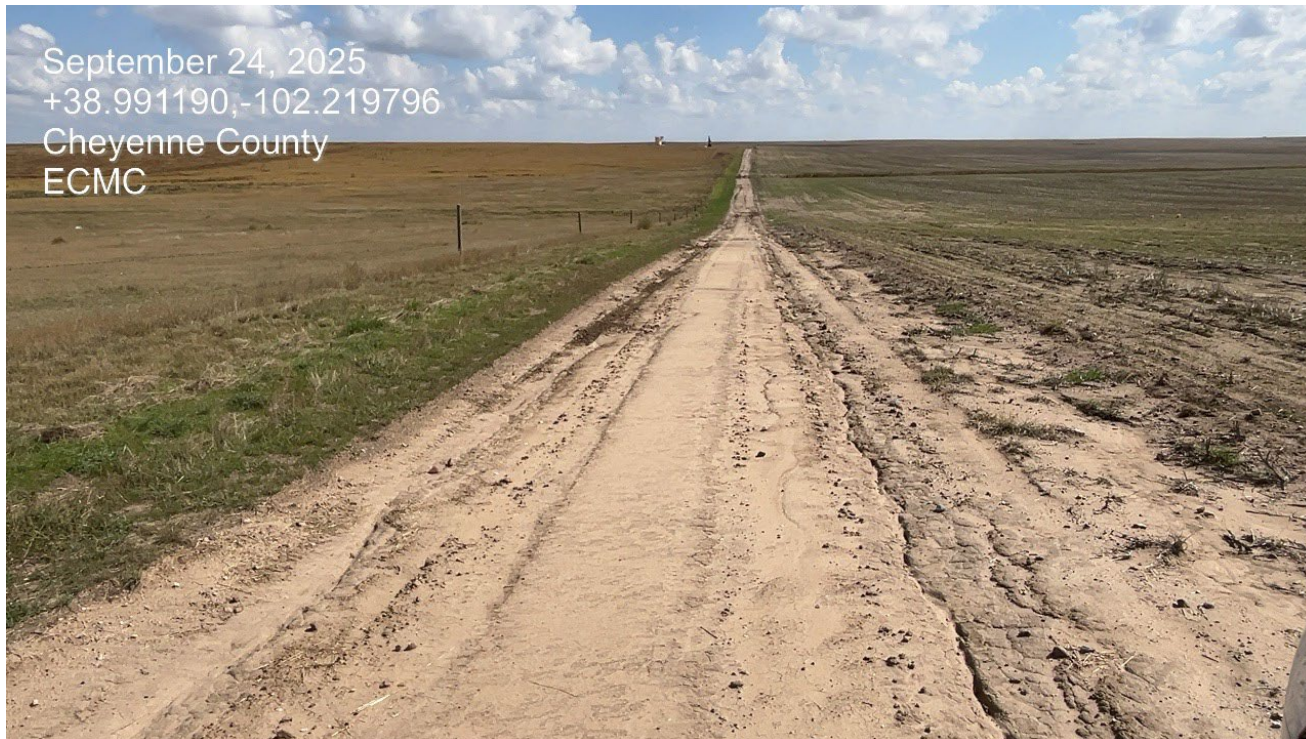
Photo 1. Facing east along the access road. Stormwater is eroding the road and is not properly diverted off the road with BMP's.

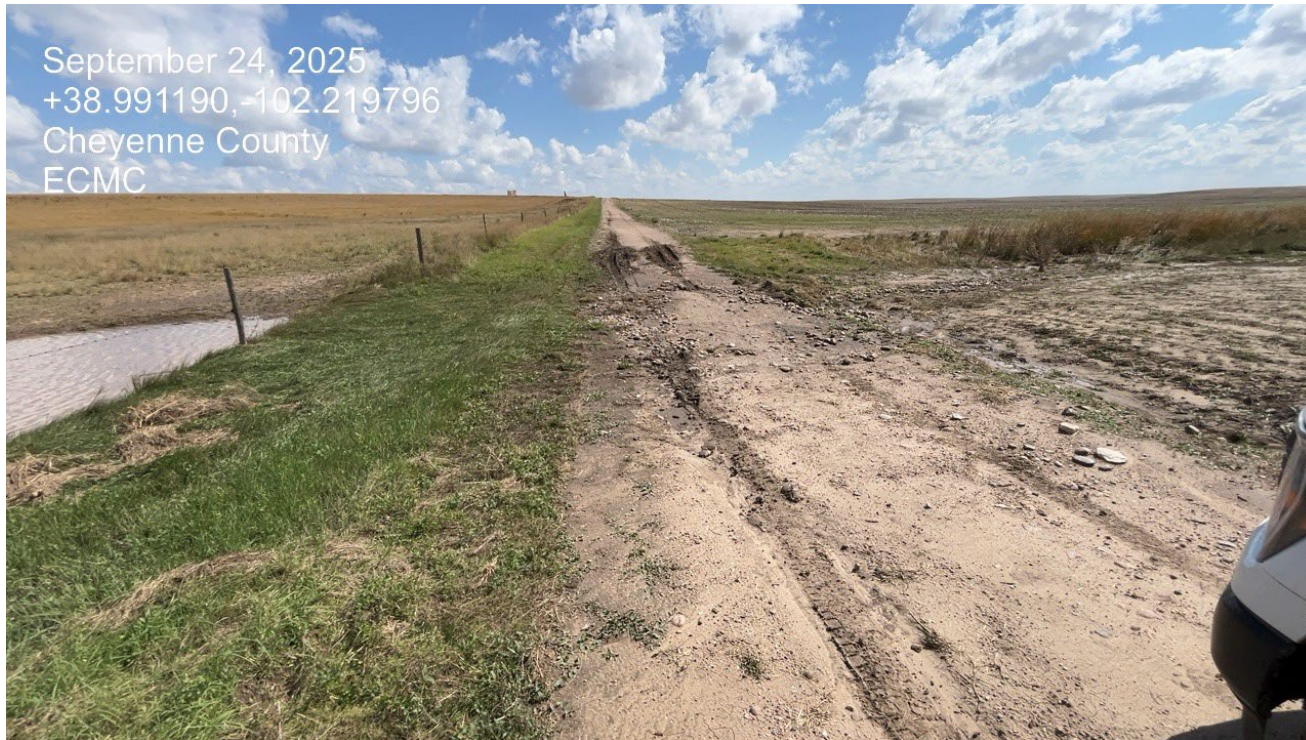
Photo 2. Facing east along the access road. The road has eroded in this area. It appears a culvert needs to be installed in this area.

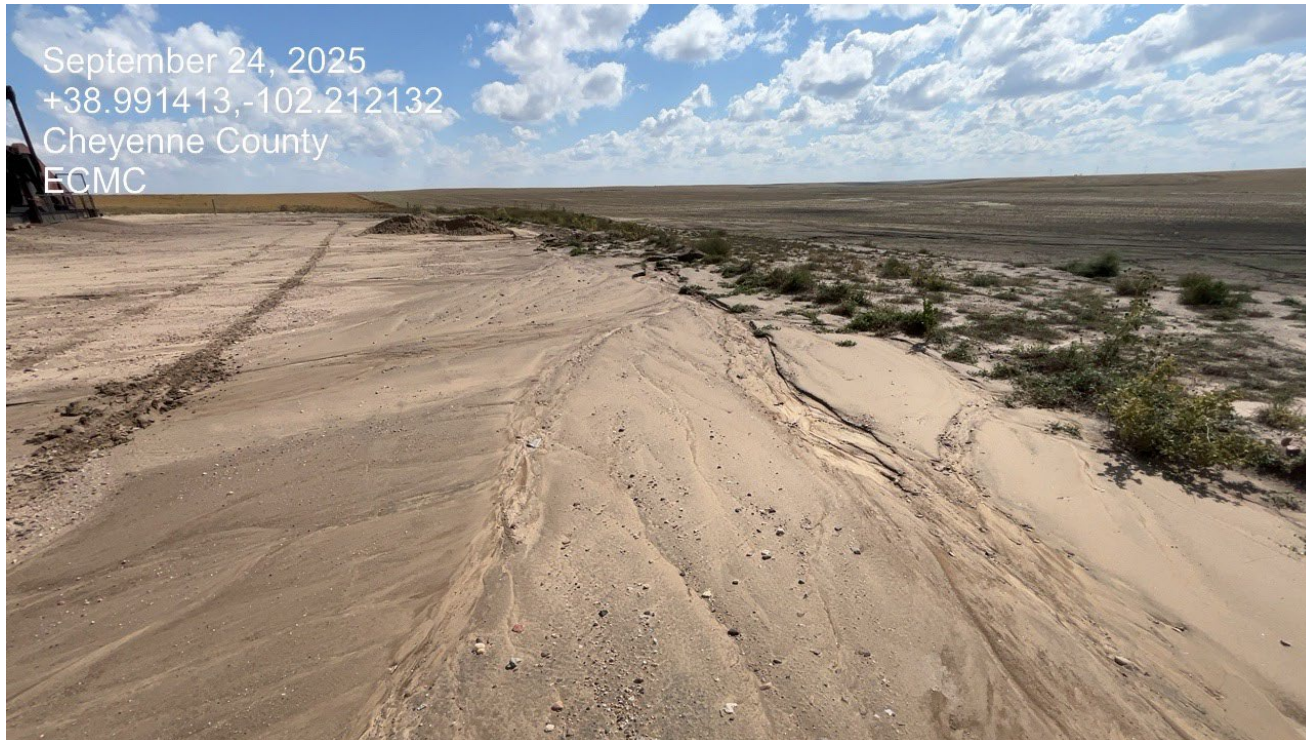
Photo 4. Facing east at the south side of the location. This area is not reclaimed or stabilized. The perimeter berm has filled in with sediment and has eroded.

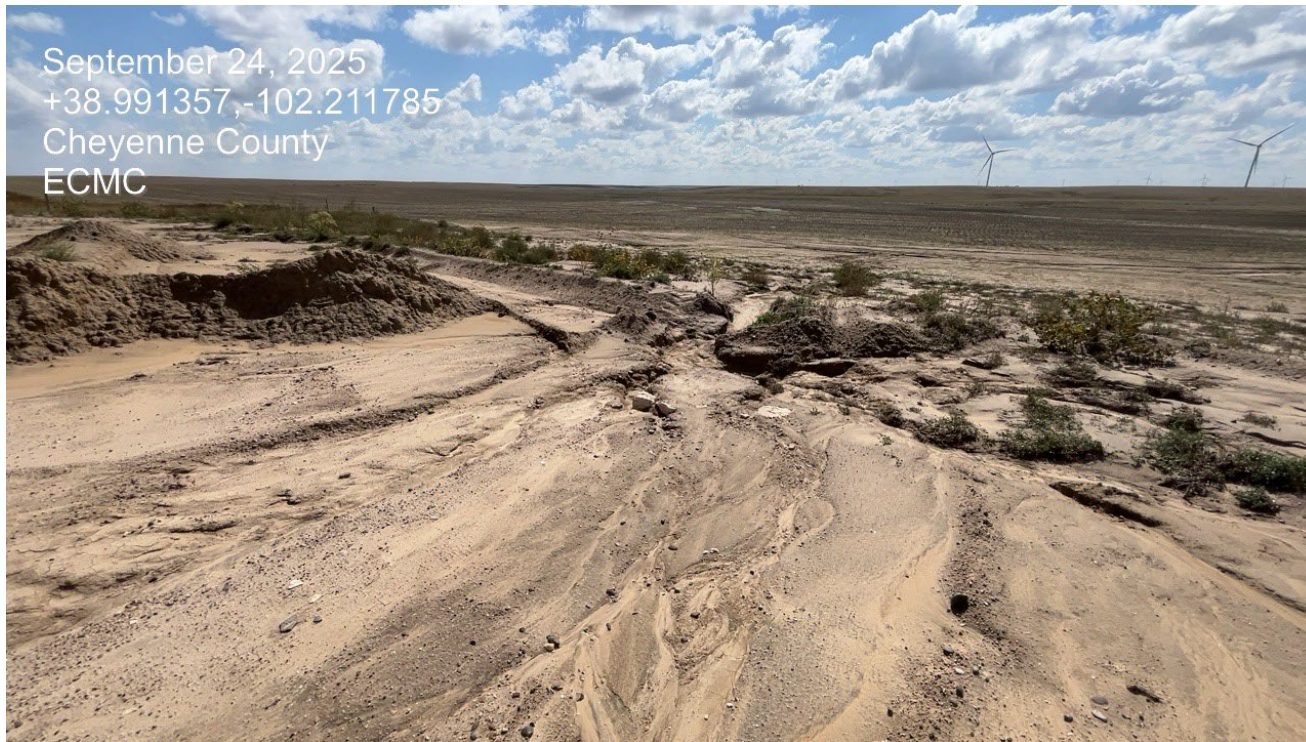
Photo 5. Stormwater has eroded the berm along the south side of the location which was not properly constructed with armored outlets/ sediment traps/ ect.

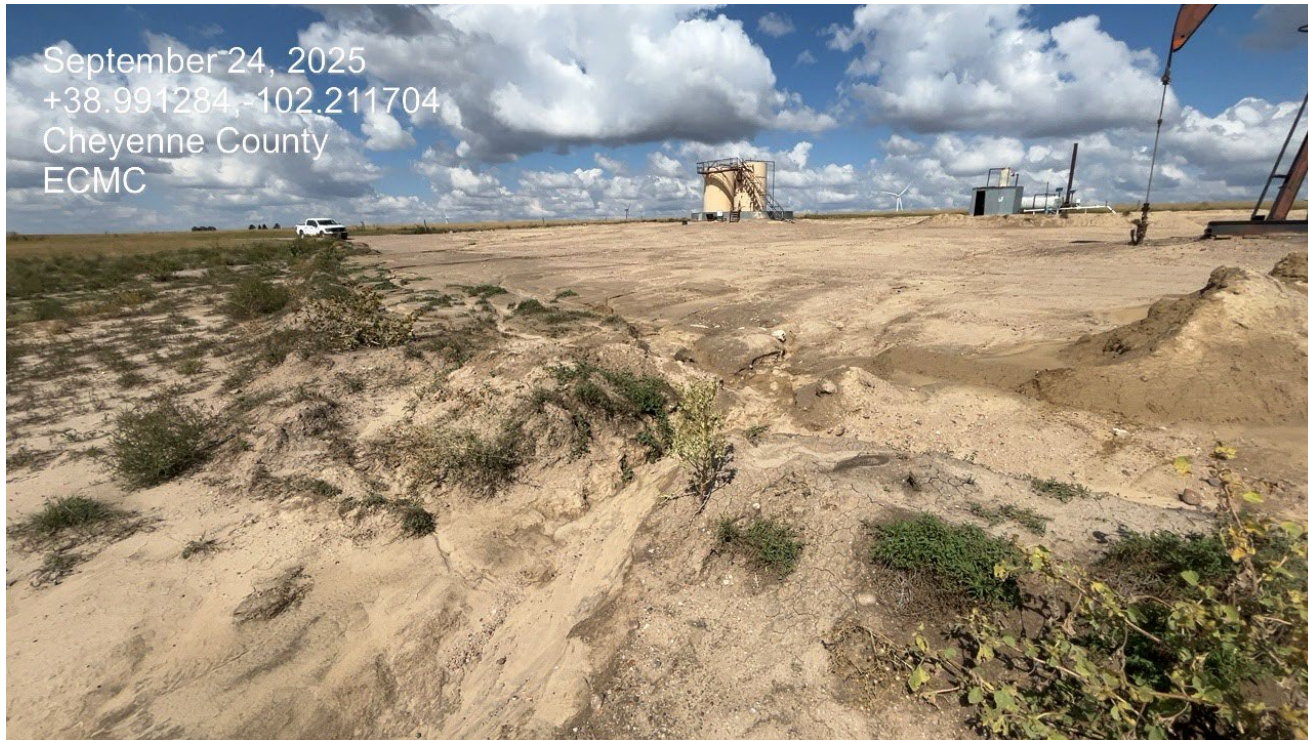
Photo 6. Stormwater has eroded the berm along the south side of the location which was not properly constructed with armored outlets/ sediment traps/ ect.

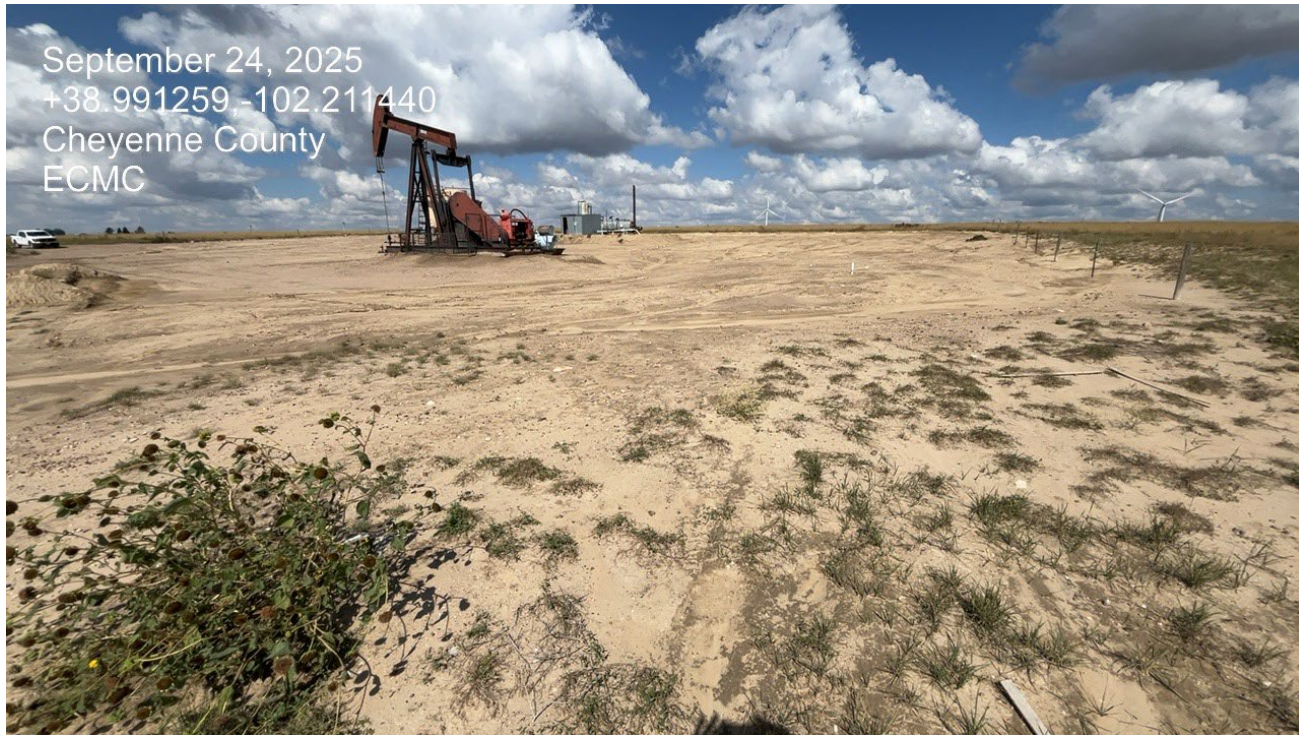
Photo 7. Facing north at the east side of the location. There are used areas of the location that need to be reclaimed which will help stabilize the location to prevent erosion.

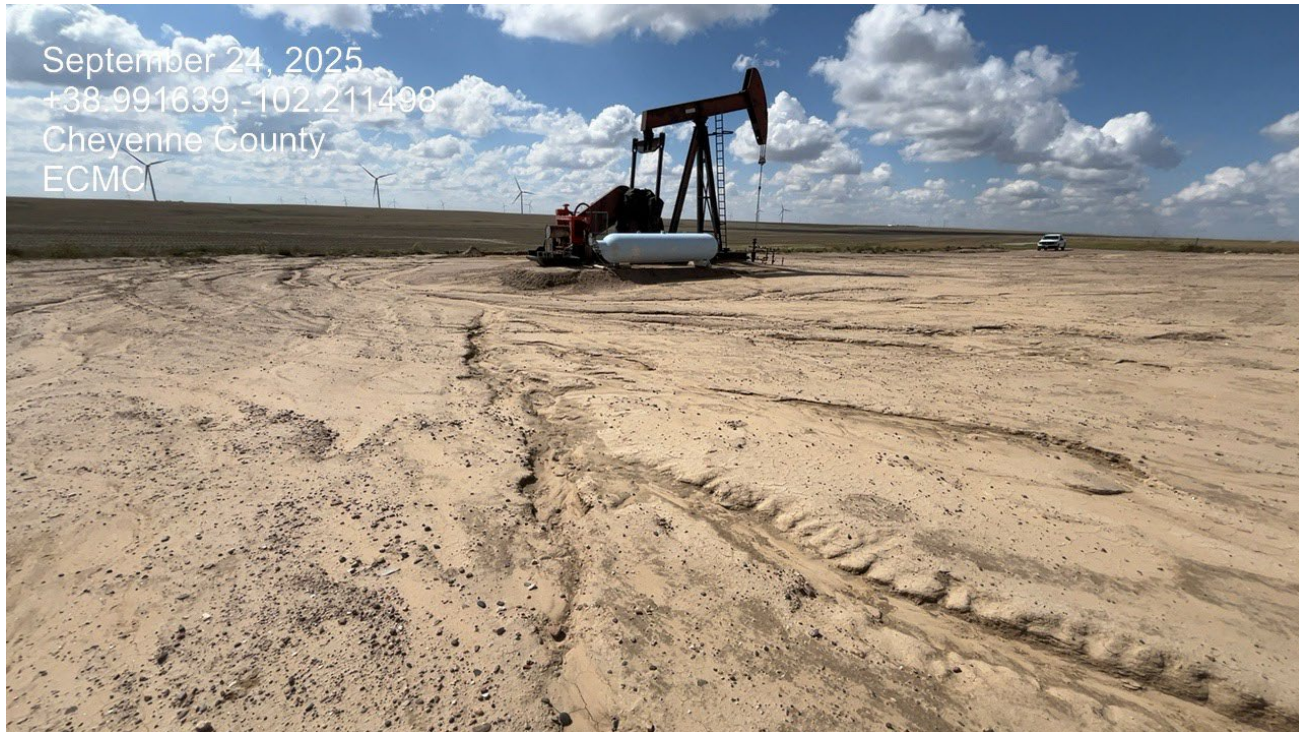
Photo 8. Facing southwest at the location showing stormwater erosion across the location. This unused area of the location needs to be reclaimed.

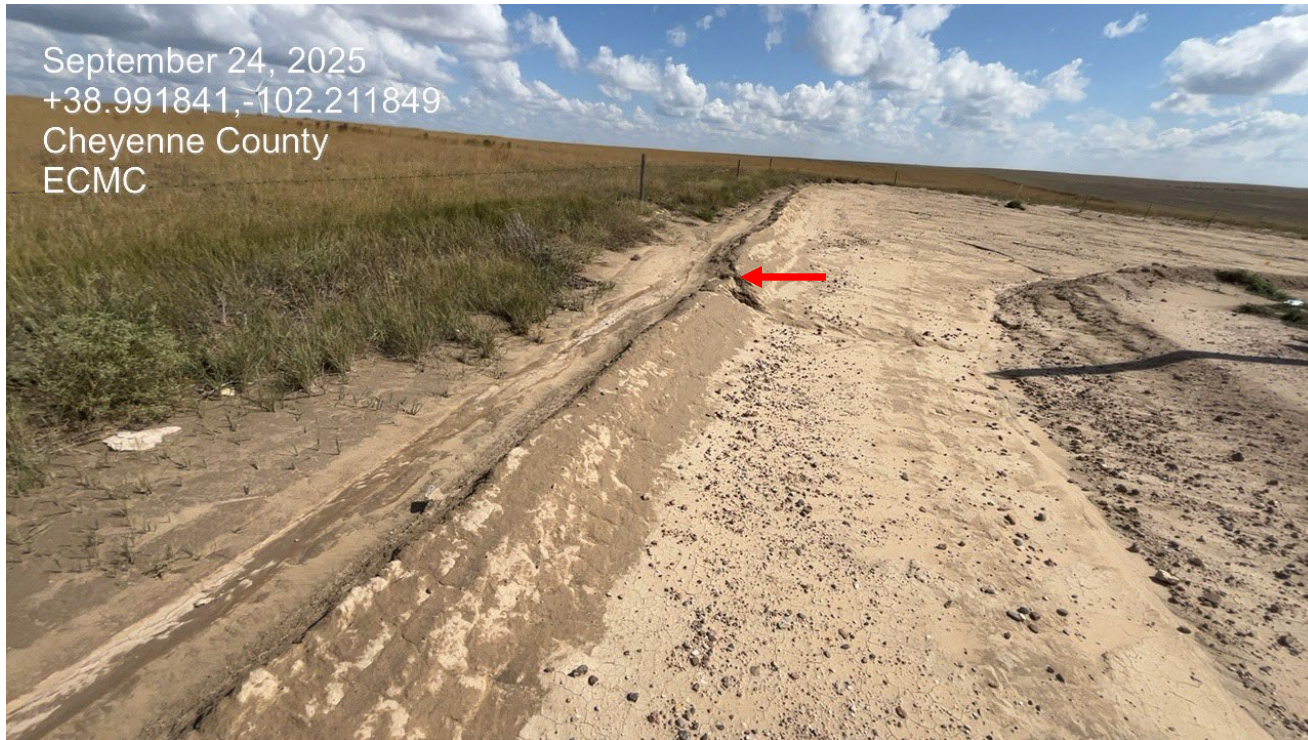
Photo 9. Facing east at the north side of the location. The diversion ditch has eroded at red arrow.

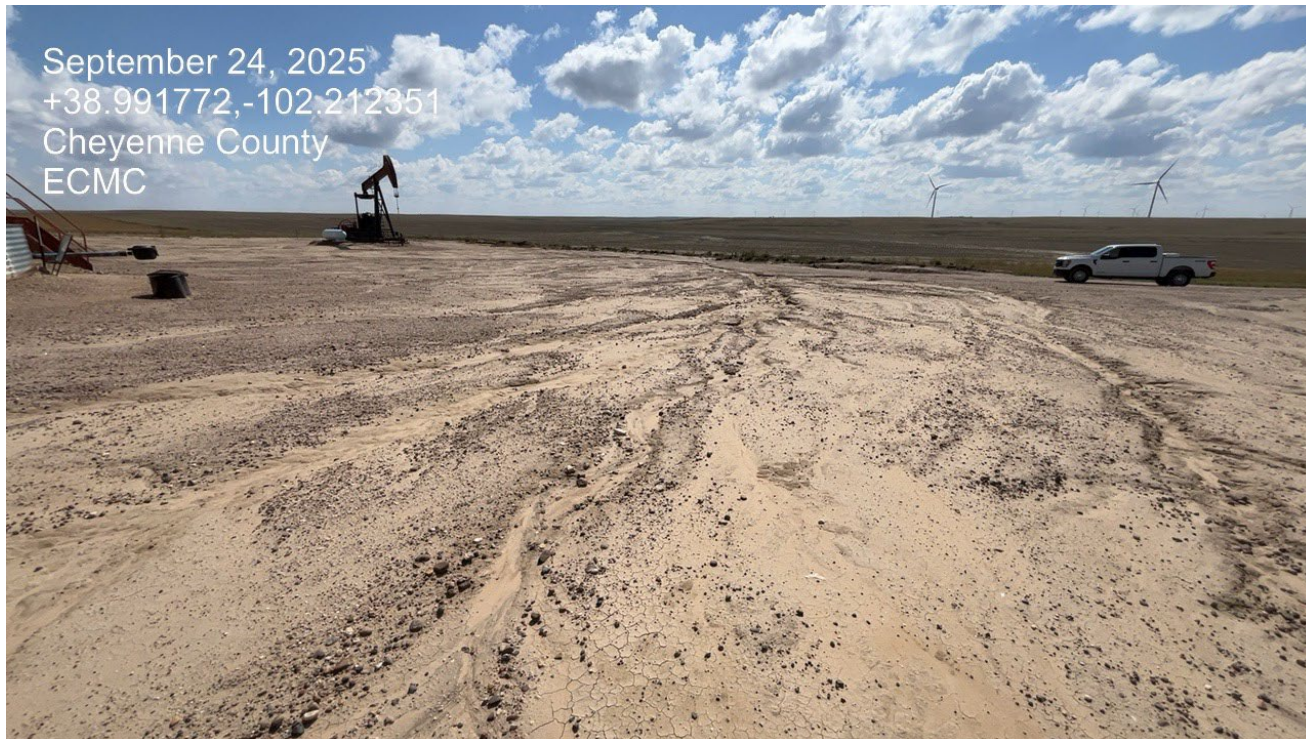
Photo 10 Facing southeast at the location showing erosion channels across the location.

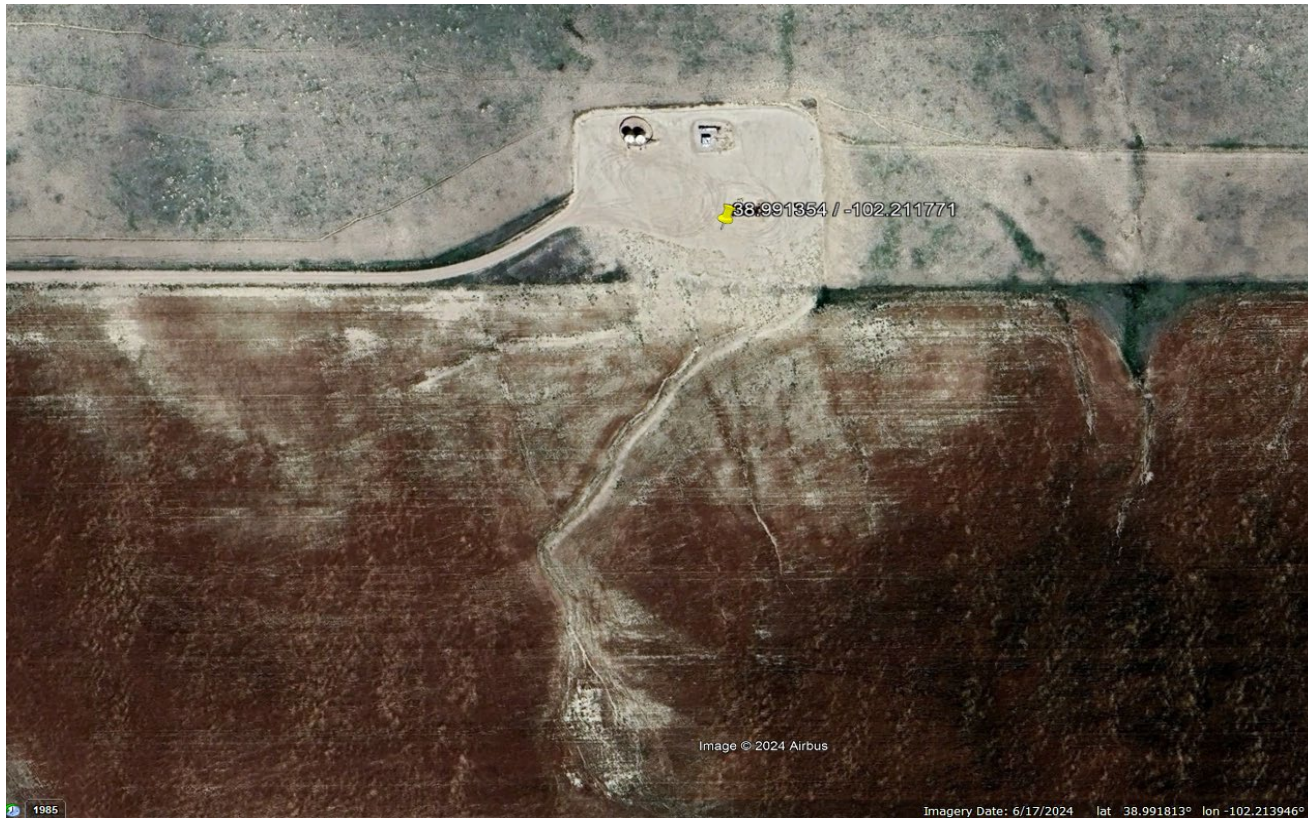
Photo 12. 2024 aerial view of the location shows unused areas of the location are not reclaimed and stormwater erosion is transporting sediment offsite.
