# Inspection Photos

**Operator:** TEP Rocky Mountain LLC #96850

**Location ID:** 324099

**Inspection Doc:** 719200274

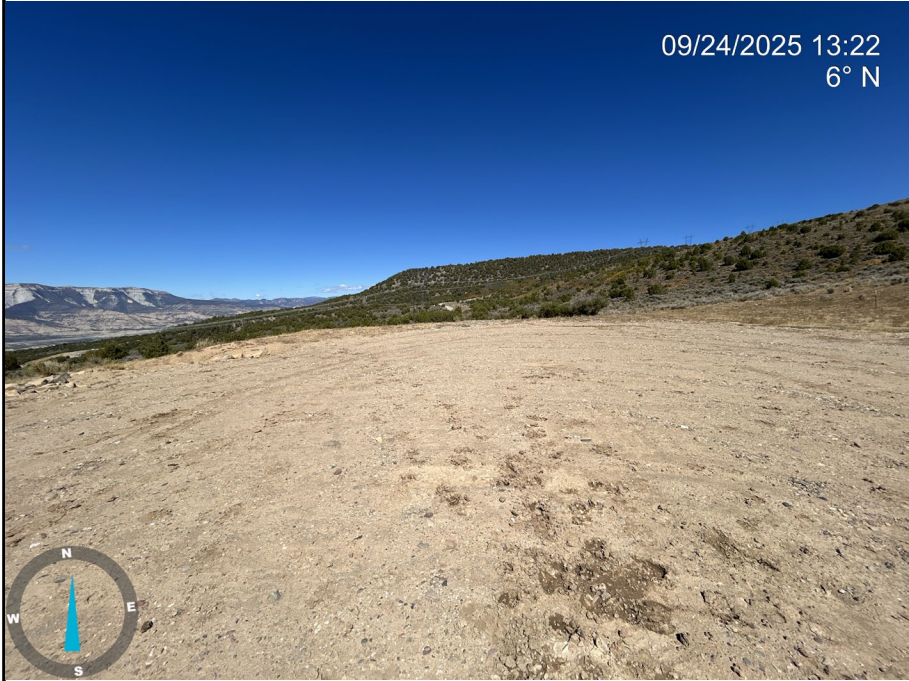
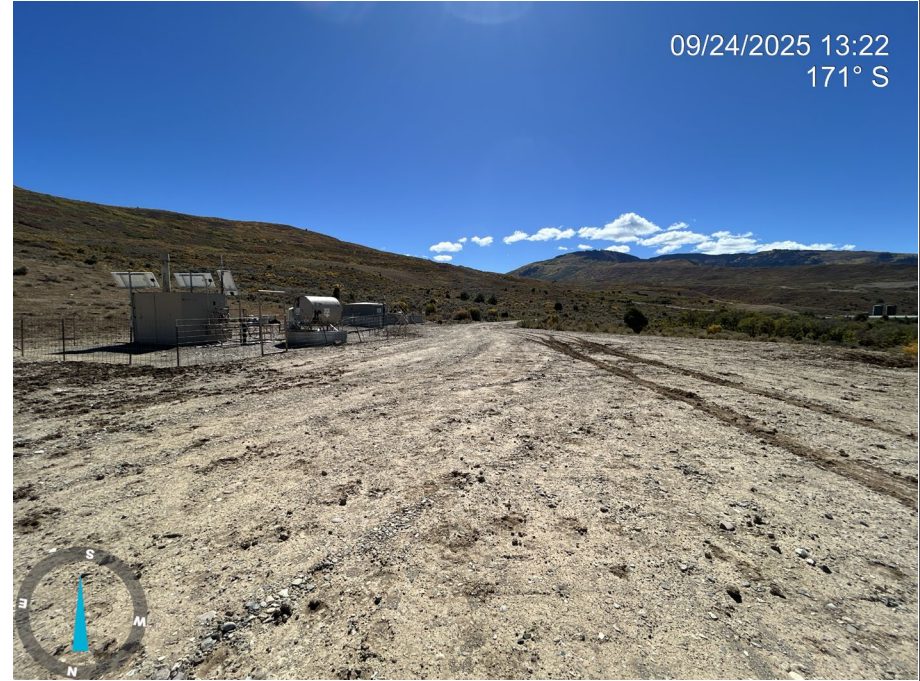
**Photo 1:** Photos showing an overview of the location looking north and south, respectively.

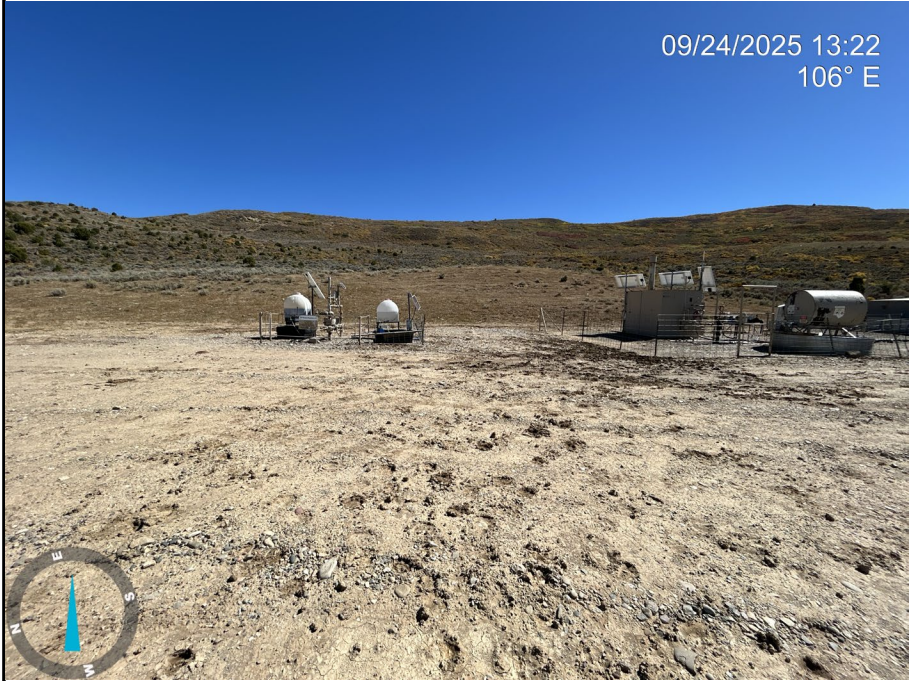
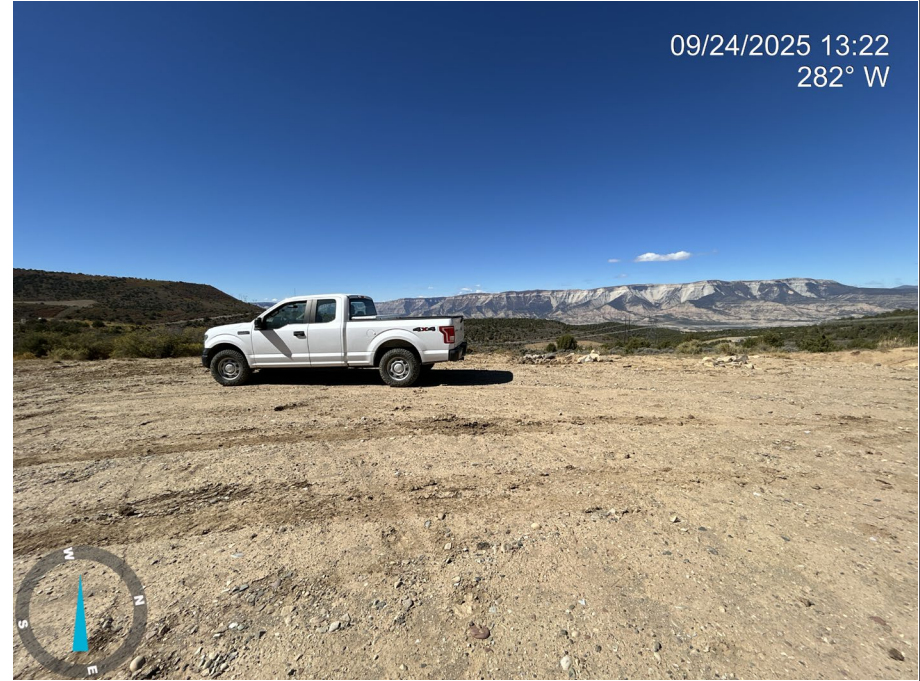
**Photo 2:** Photos showing an overview of the location looking east and west, respectively.

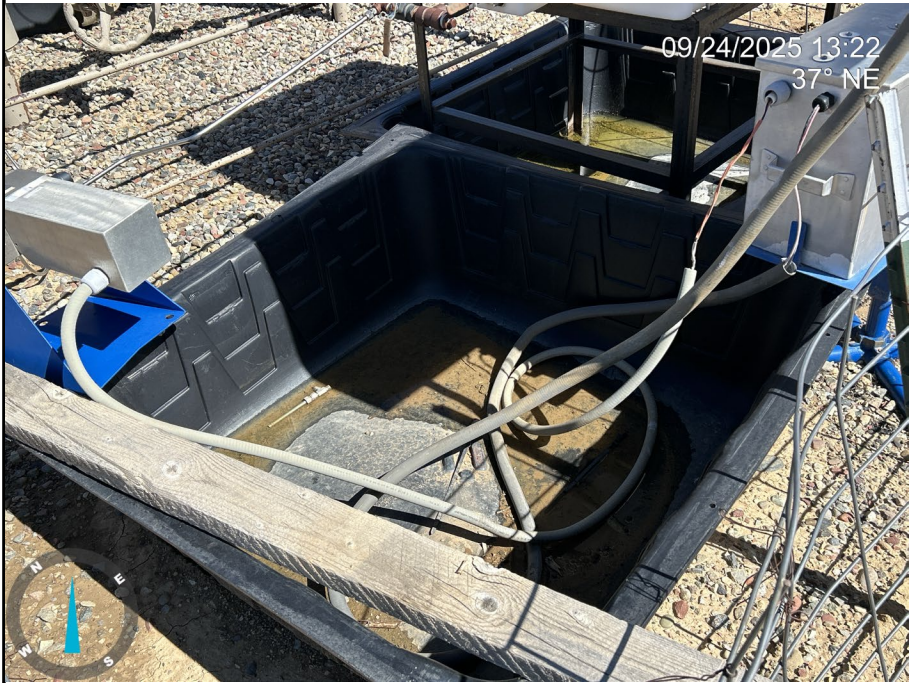
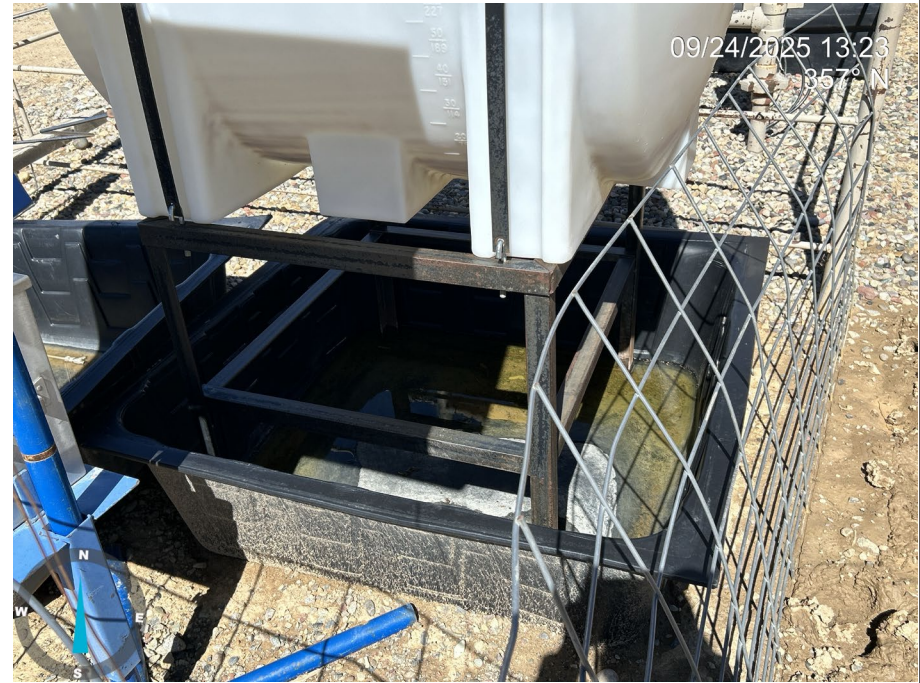
**Photo 3:** Photos showing that secondary containment at methanol tanks at the location are not covered and do not possess adequate wildlife egress. Comply with Rule 902.b.

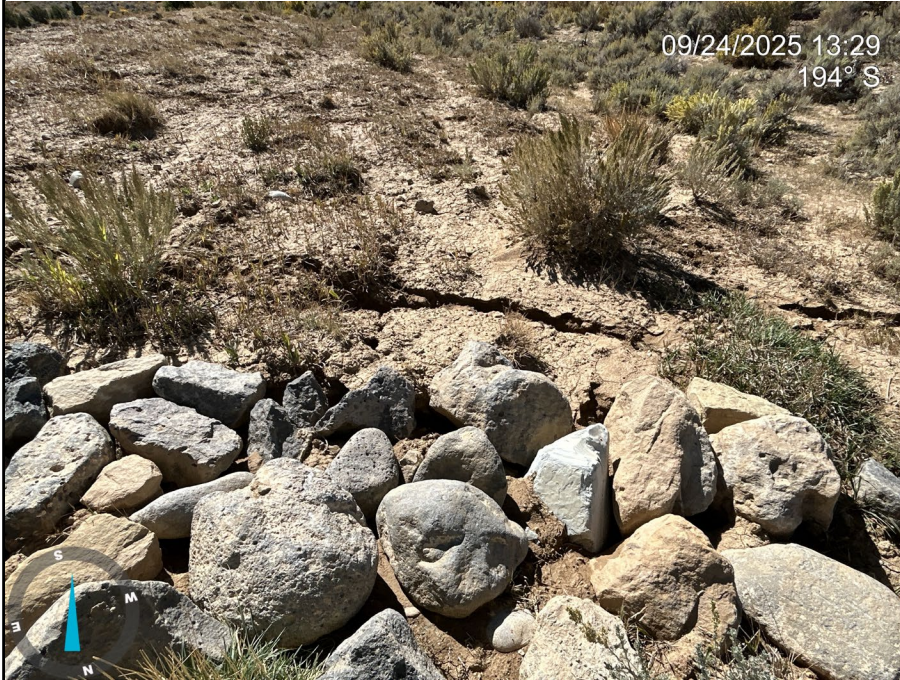
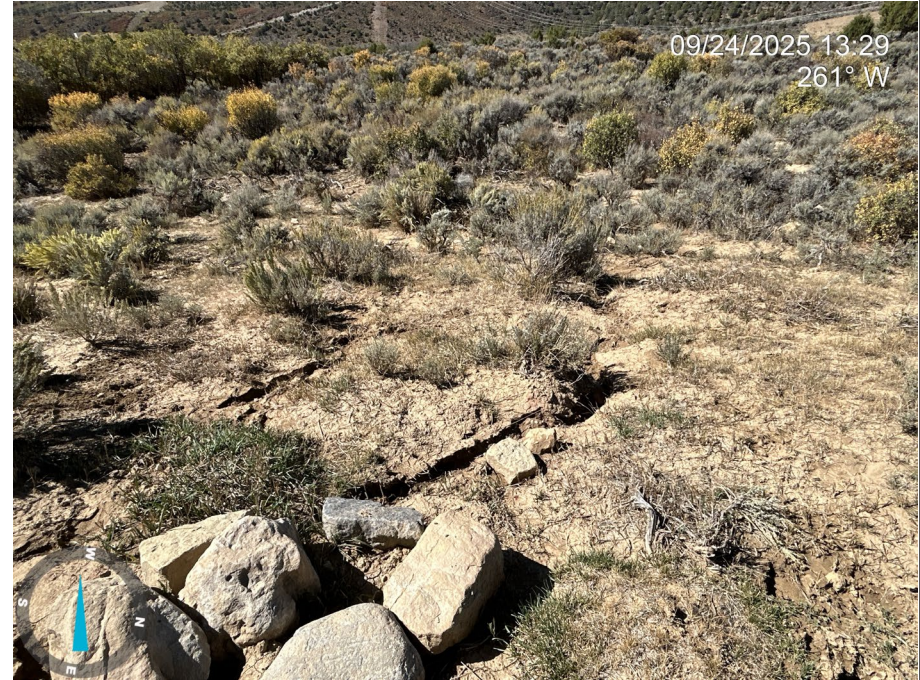
**Photo 4:** Photos showing erosion, rilling and sediment transportation is occurring near stormwater controls on the western portion of the location. Stormwater BMPs appear to be missing or insufficient. Comply with Rule 1002.f. and implement or maintain stormwater BMPs.

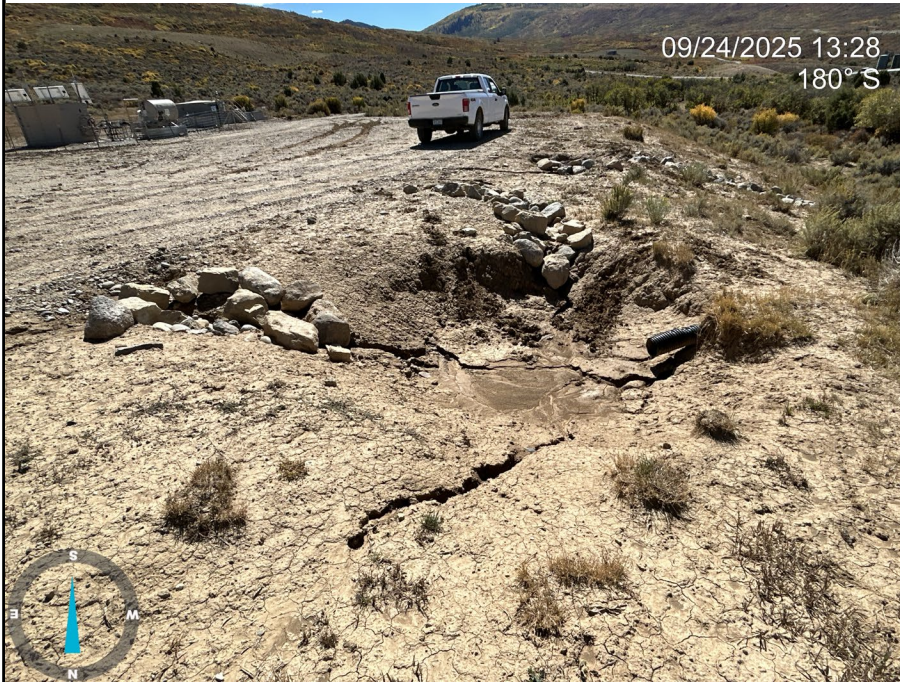
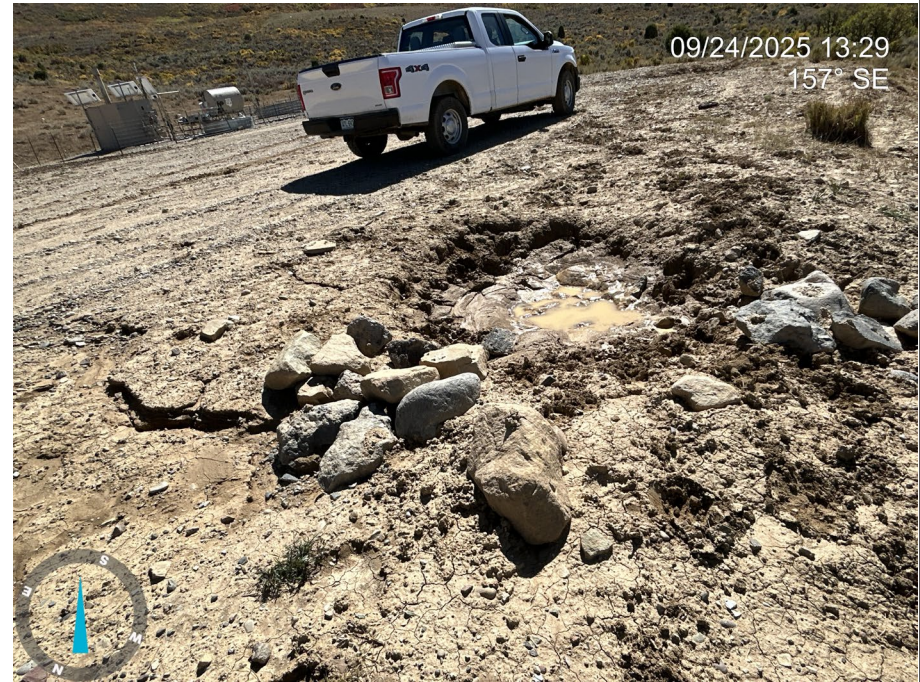
**Photo 5:** Photos showing examples of sediment traps on the western portion of the location. Sediment traps are used by cattle; rilling and erosion is occurring in some places. Comply with 1002.f. and maintain stormwater BMPs.

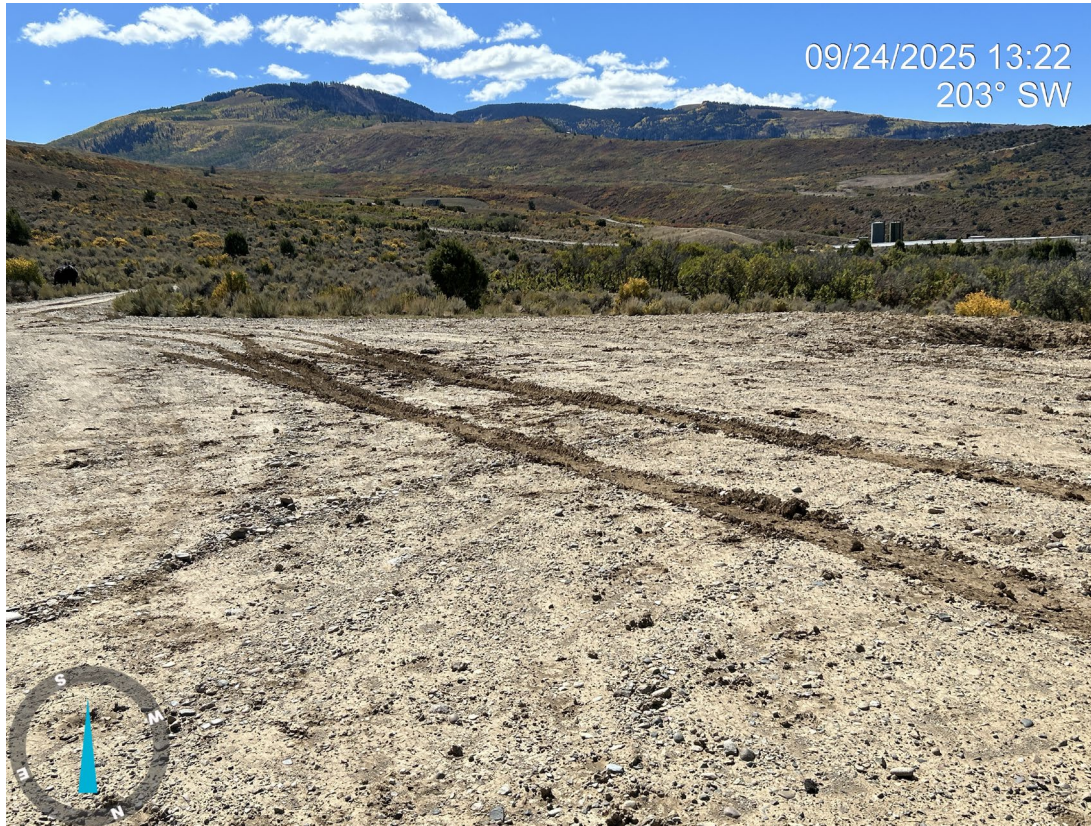
**Photo 6:** Photo showing an example of vehicle tracking occurring on the working pad surface. Gravel is sparse in some areas on the pad. Maintenance is required. Comply with Rule 1002.f. and implement or maintain stormwater BMP's.

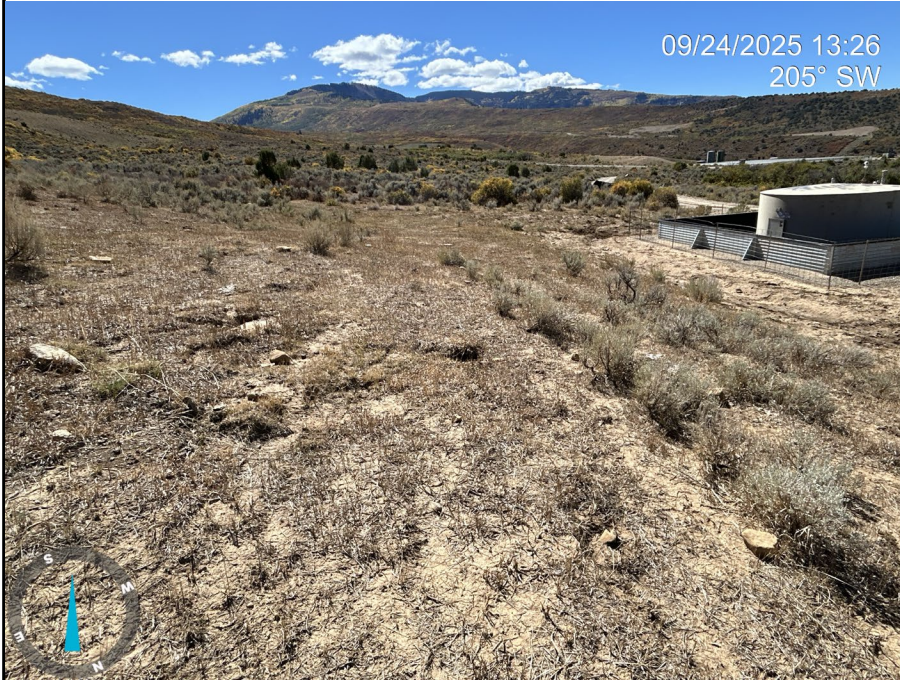
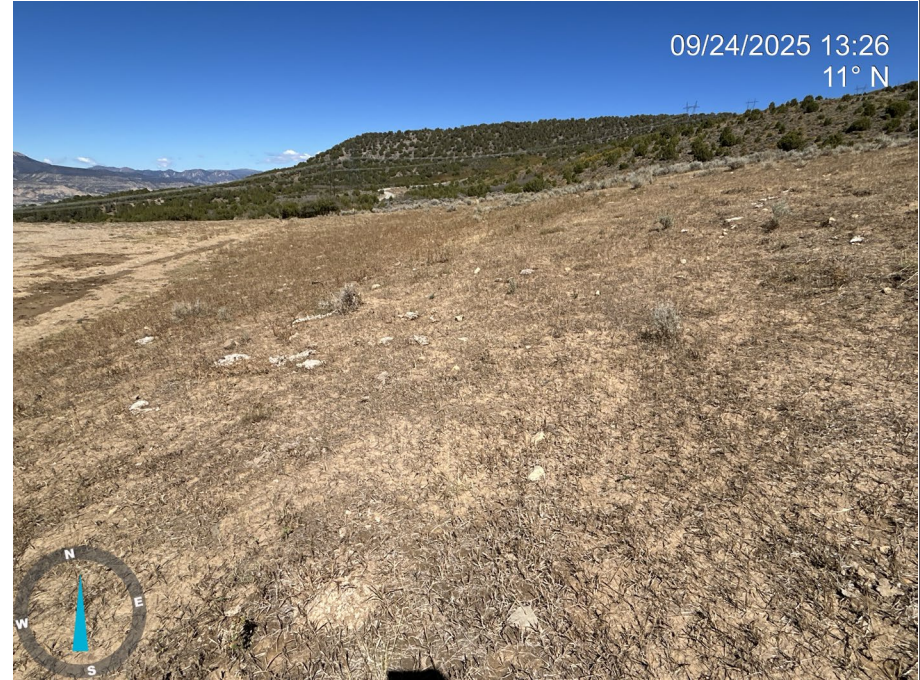
**Photo 7:** Photos showing the eastern interim area. Interim areas are composed of smooth brome and curlycup gumweed with trace amounts of rubber rabbitbrush and big sagebrush. Interim areas are used by cattle. Interim areas are progressing towards 1003 reclamation requirements.
