TEP
 Scott 24B
 Location ID: 335079

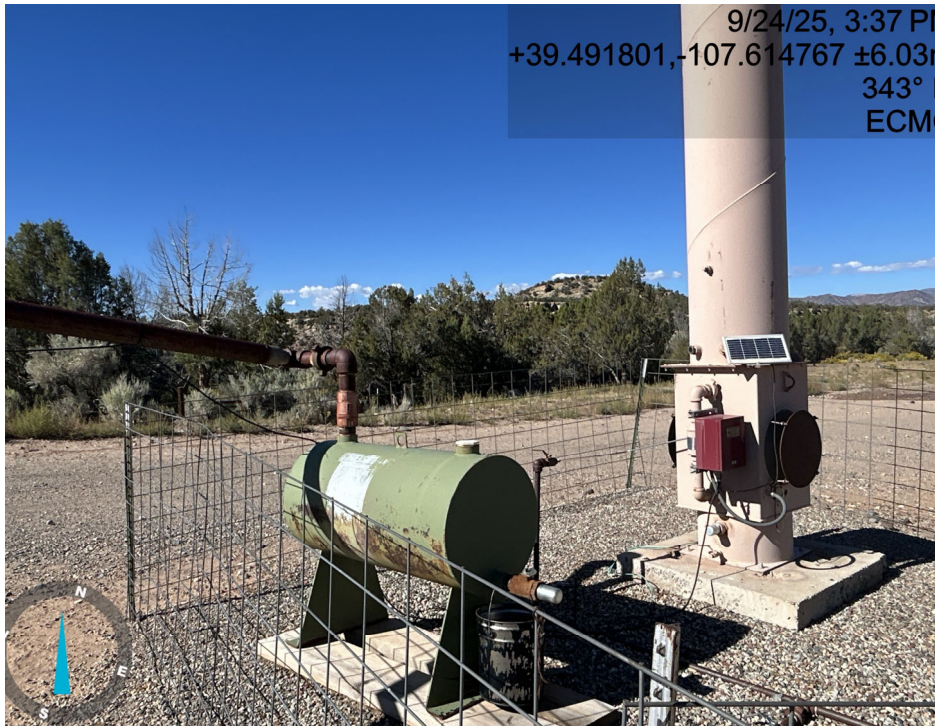
ECD is not running and not metered

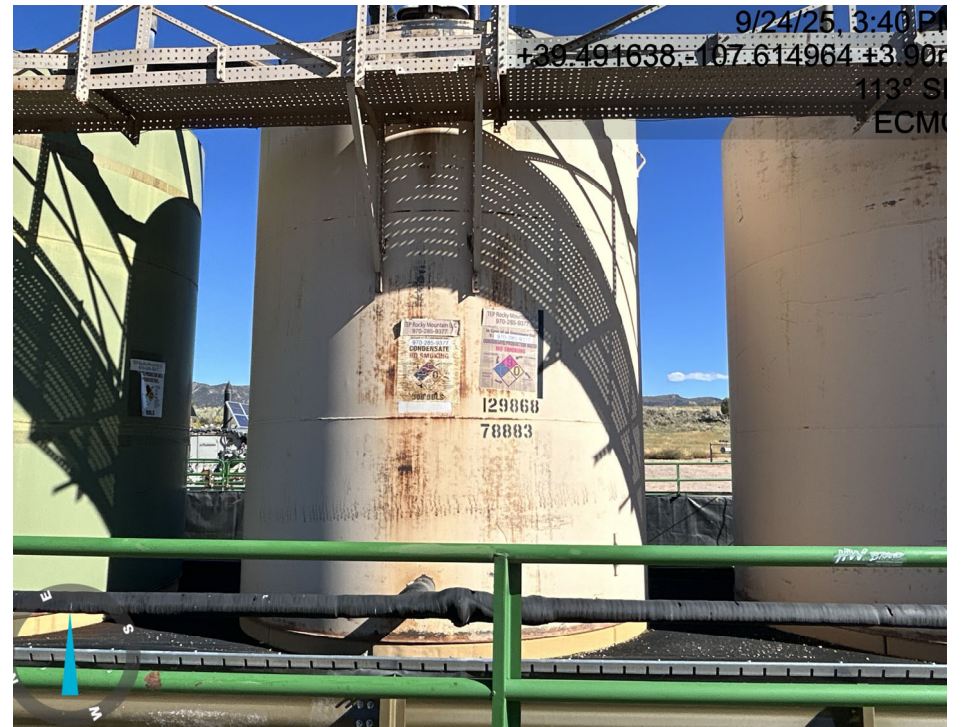
Tank label is illegible

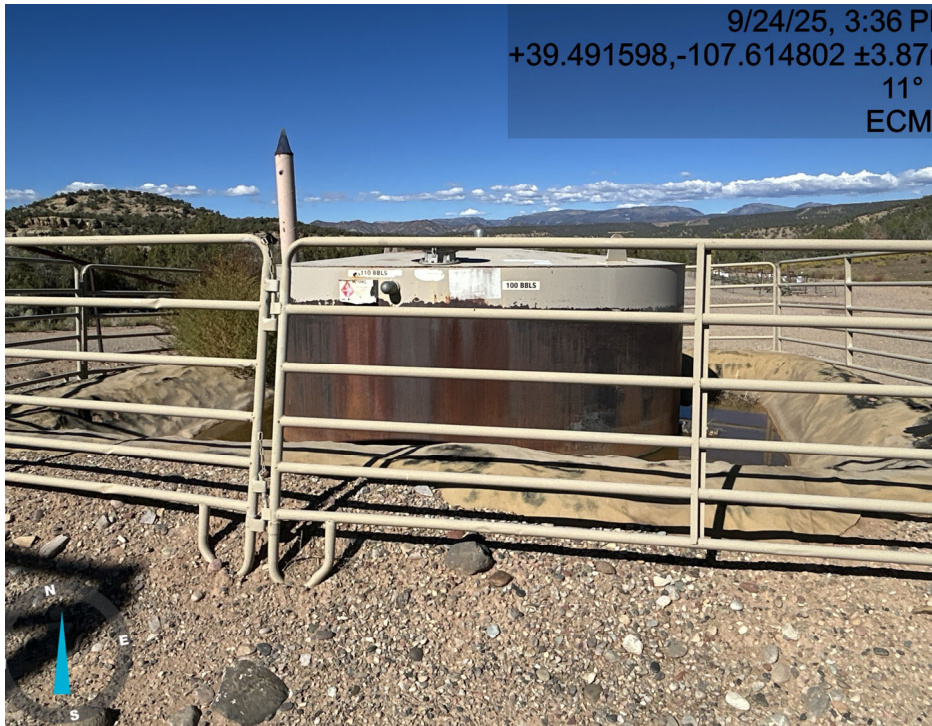
Tank liner has multiple areas with holes

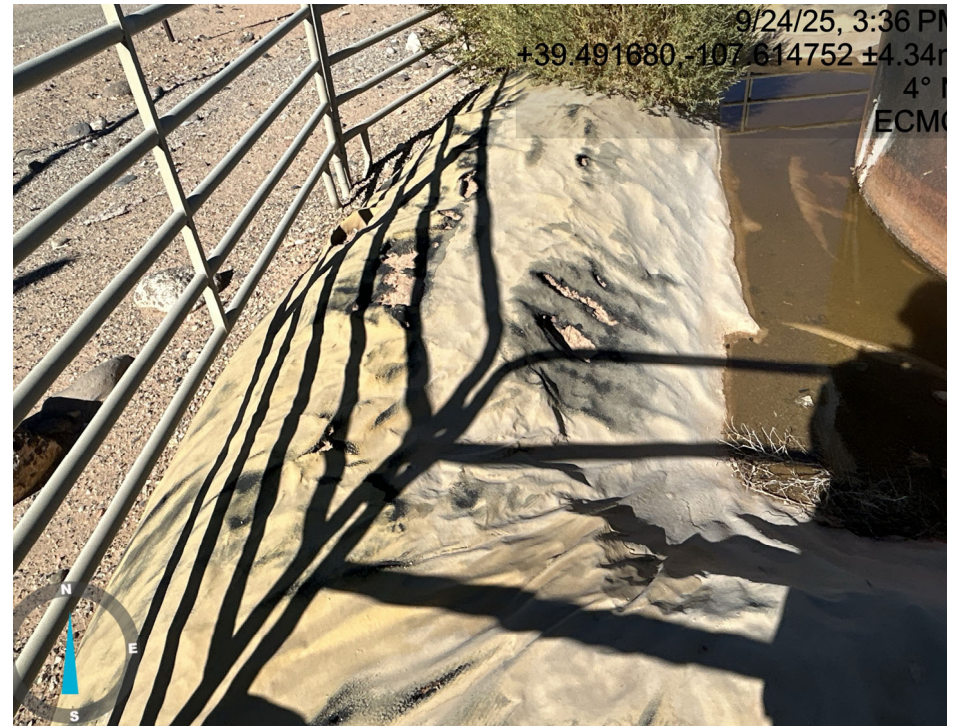
Tank liner has multiple areas with holes

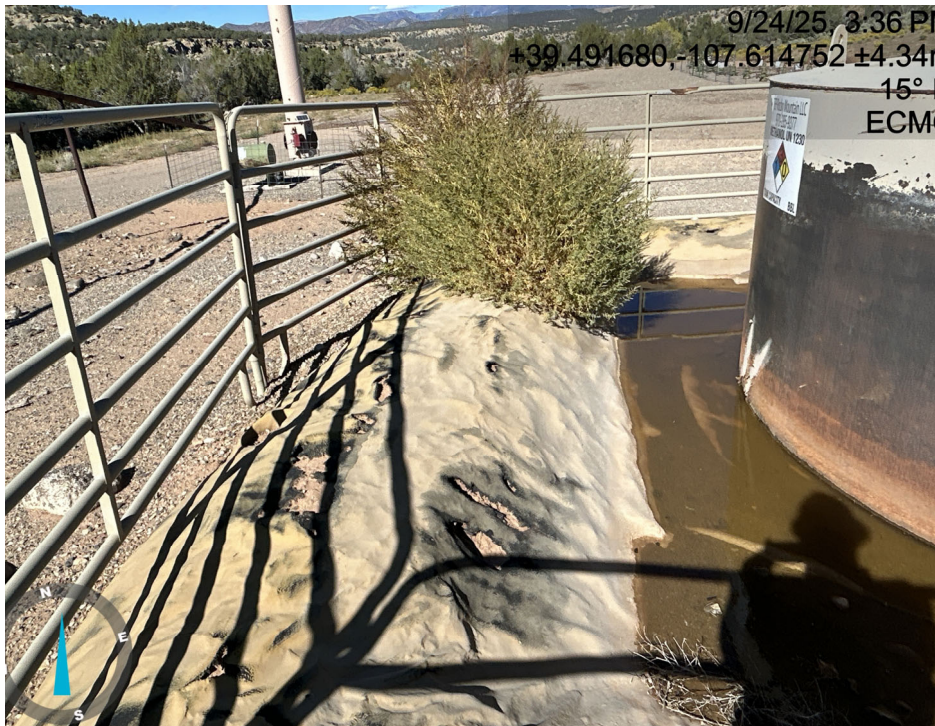
Tank liner has multiple areas with holes, weeds are growing through liner.

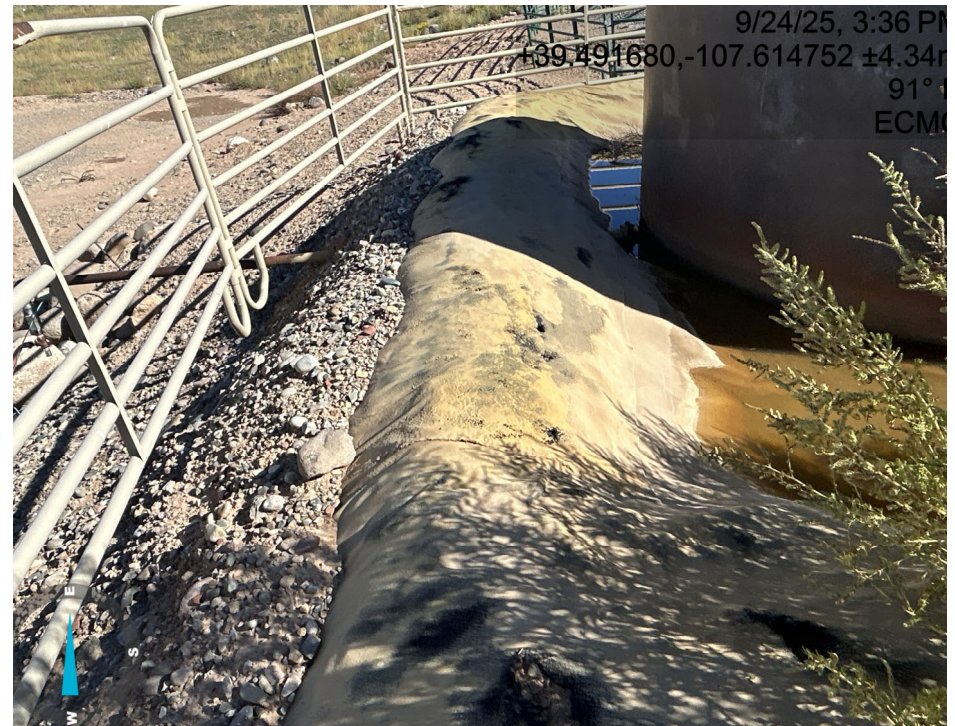
Tank liner has multiple areas with holes
