WELL NAME: RUTABAGA 23-11, API #: 071-09003, INSP. # 716301583

EVERGREEN
NATURAL RESOURCES LLC

RUTABAGA 23-11

API No. 05-071-09003

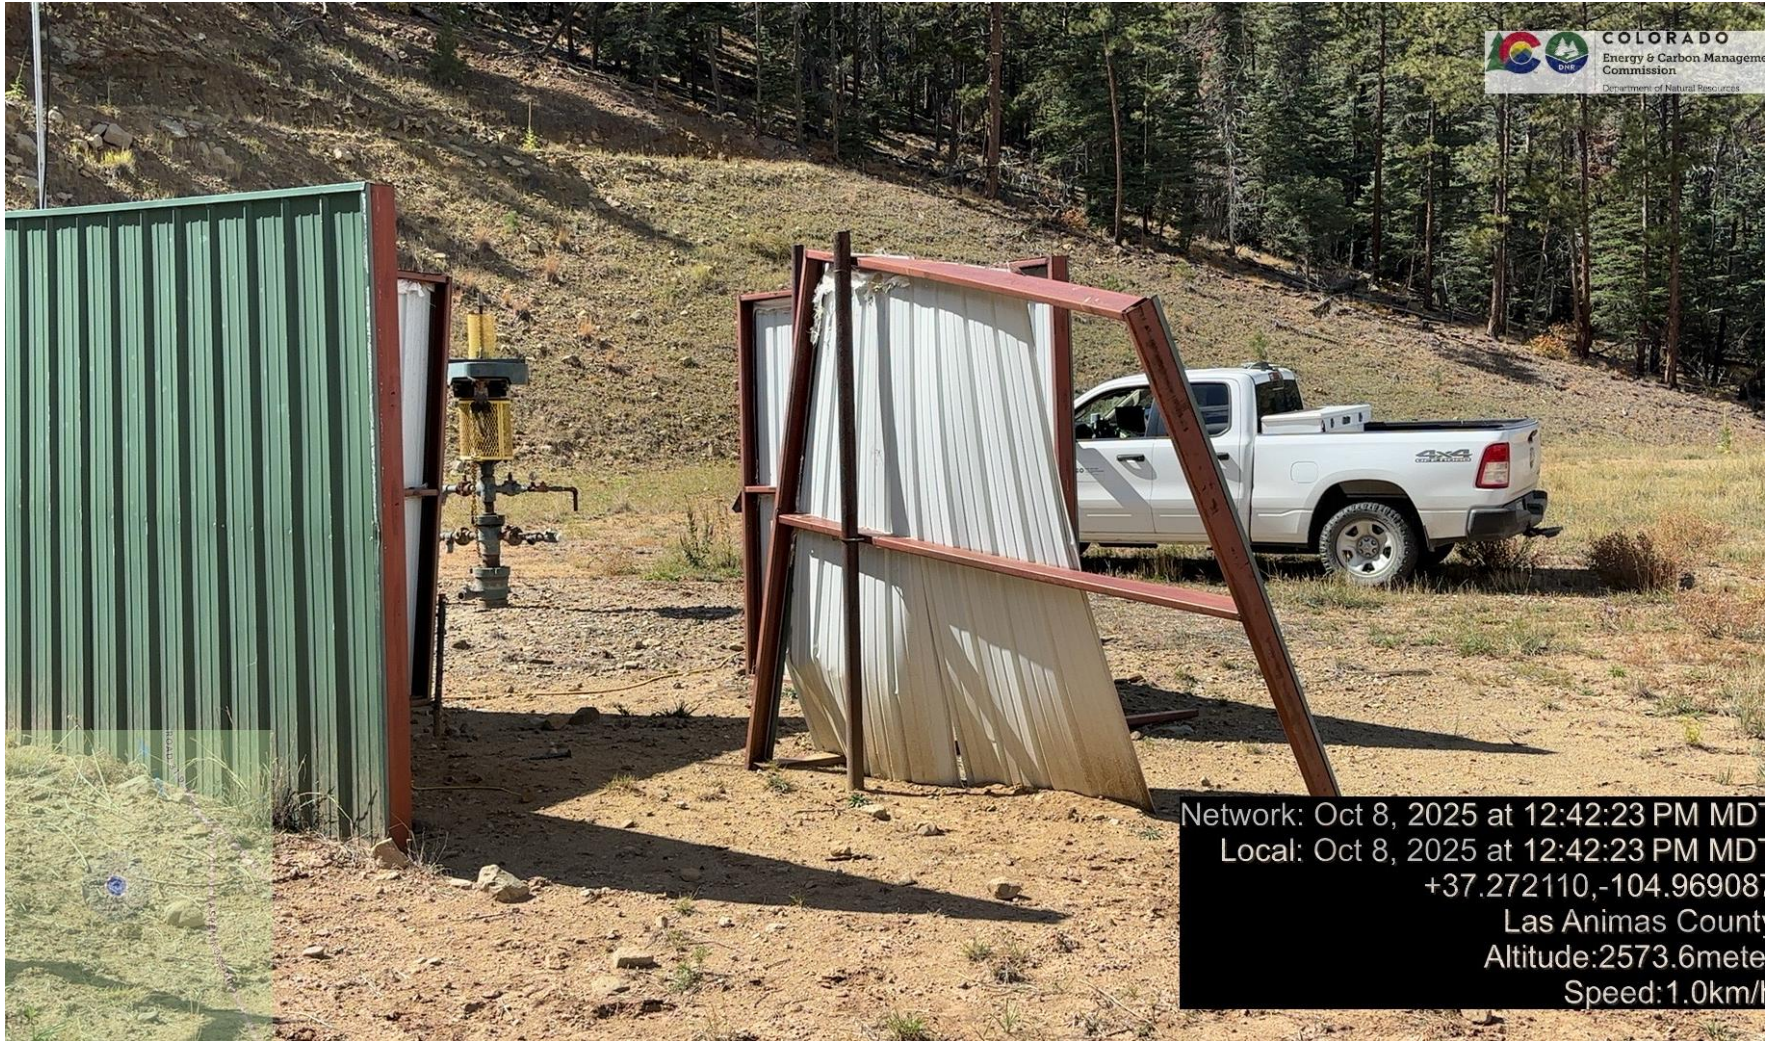
PHOTO 3: DEBREE FROM SOUND WALLS. REMOVE DEBREE PER RULE 606. CA DATE 11-8-2025.
