Inspection/Audit Photos

Location Name: QB ENERGY OPERATING LLC KRK 7-6 (C7E) Pad

Location #: 334560

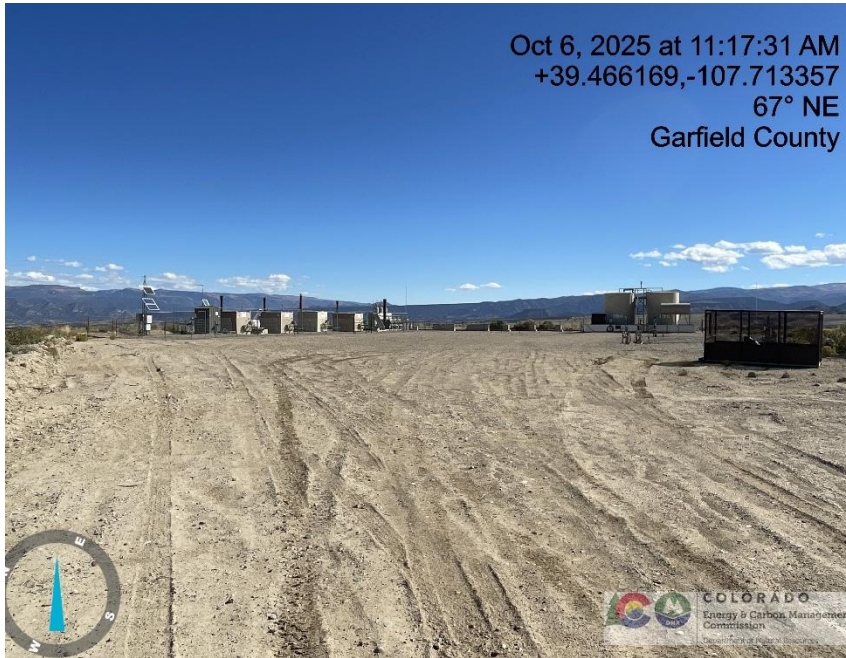
Photo # 3956 From entrance to location

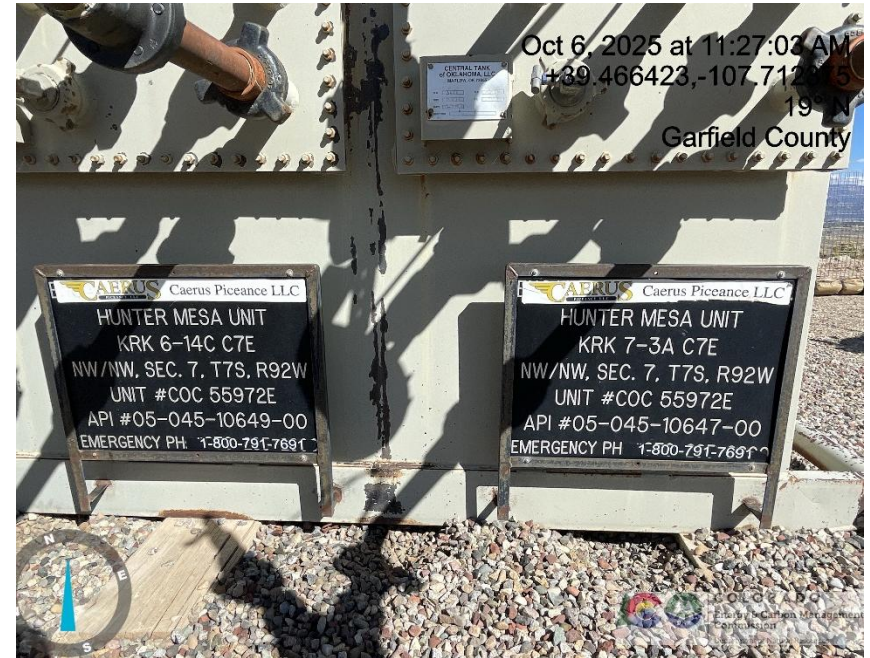
Photo # 3965 Signs at separators have previous operators name

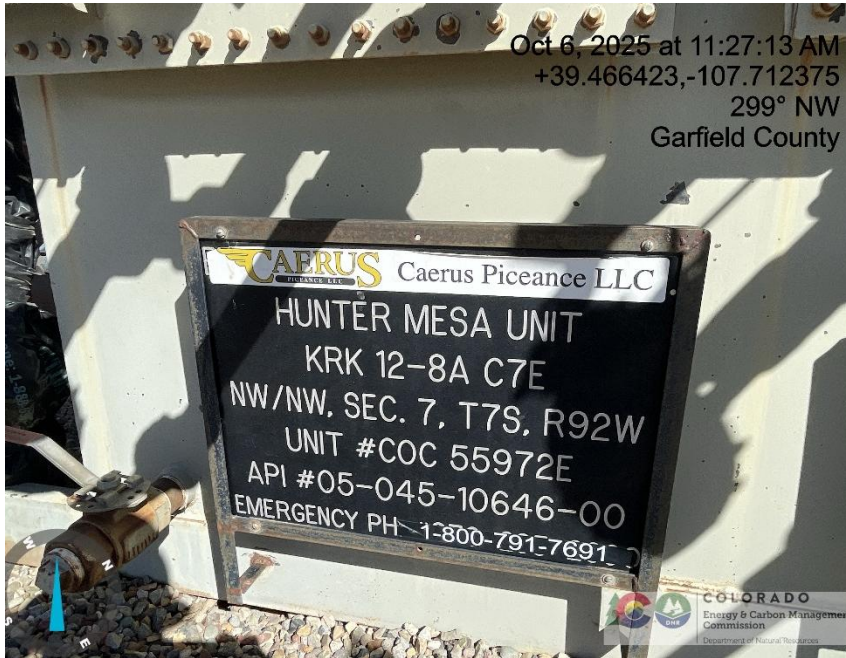
Photo # 3966 Sign at separator has previous operators name

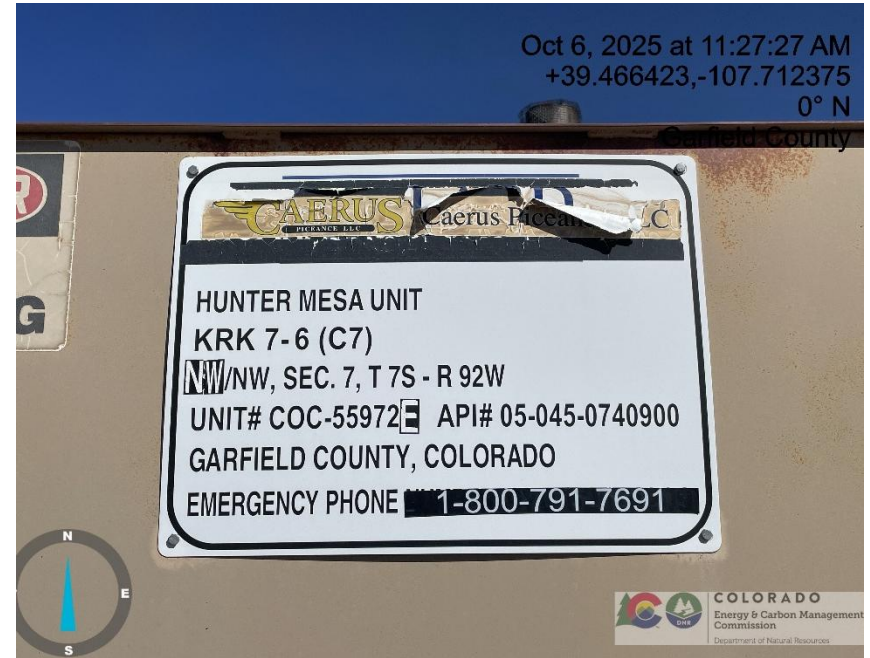
Photo # 3967 Sign at separator has previous operators name

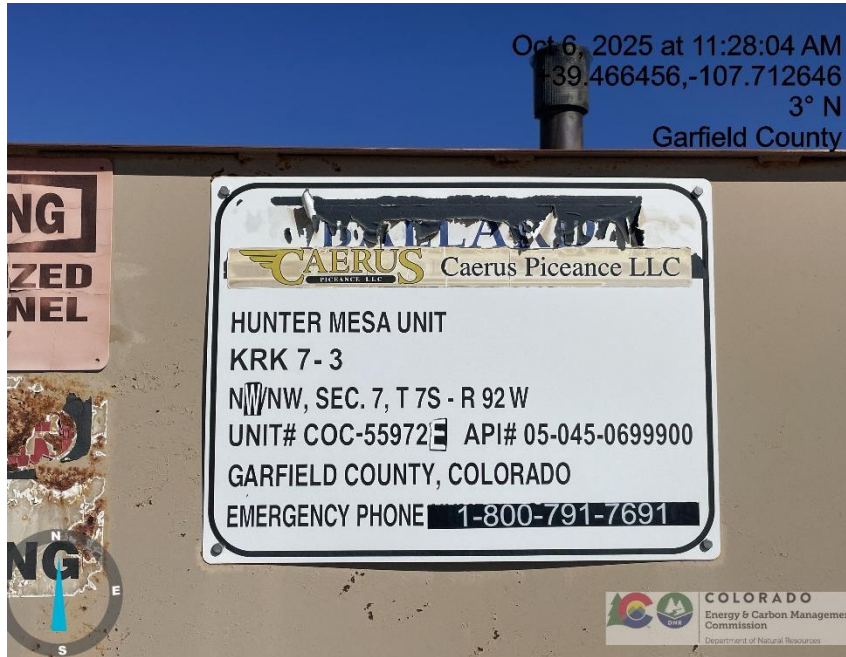
Photo # 3970 Sign at separator has previous operators name

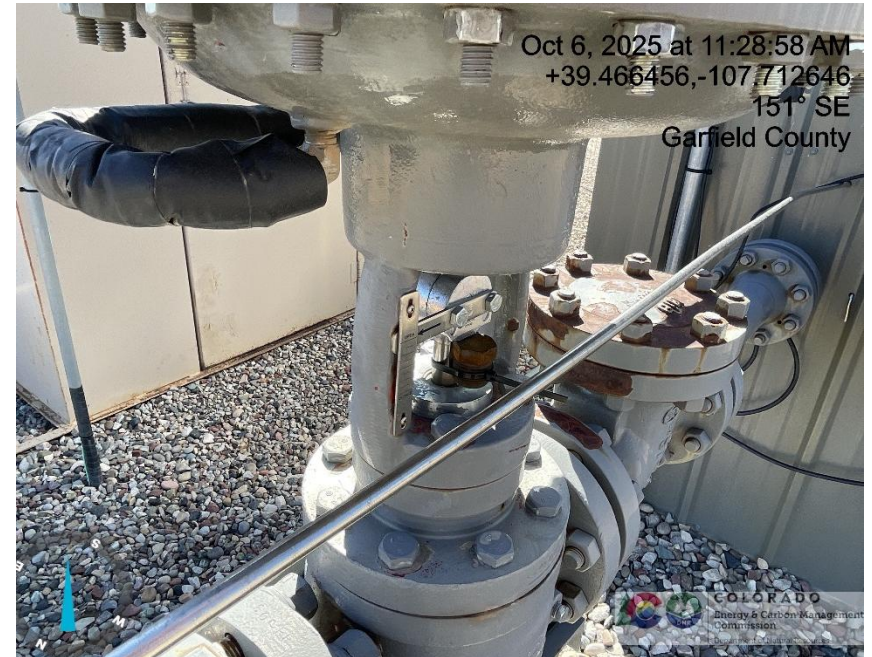
Photo # 3971 Pneumatic control valve on summit pipeline has been modified/valve no longer has the ability to close

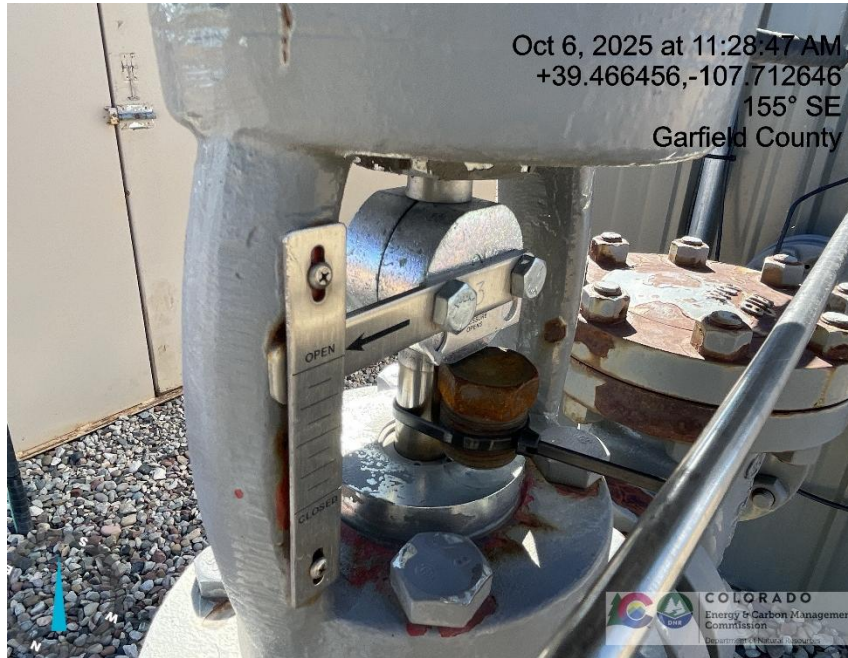
Photo # 3972 Pneumatic control valve on summit pipeline has been modified/valve no longer has the ability to close
