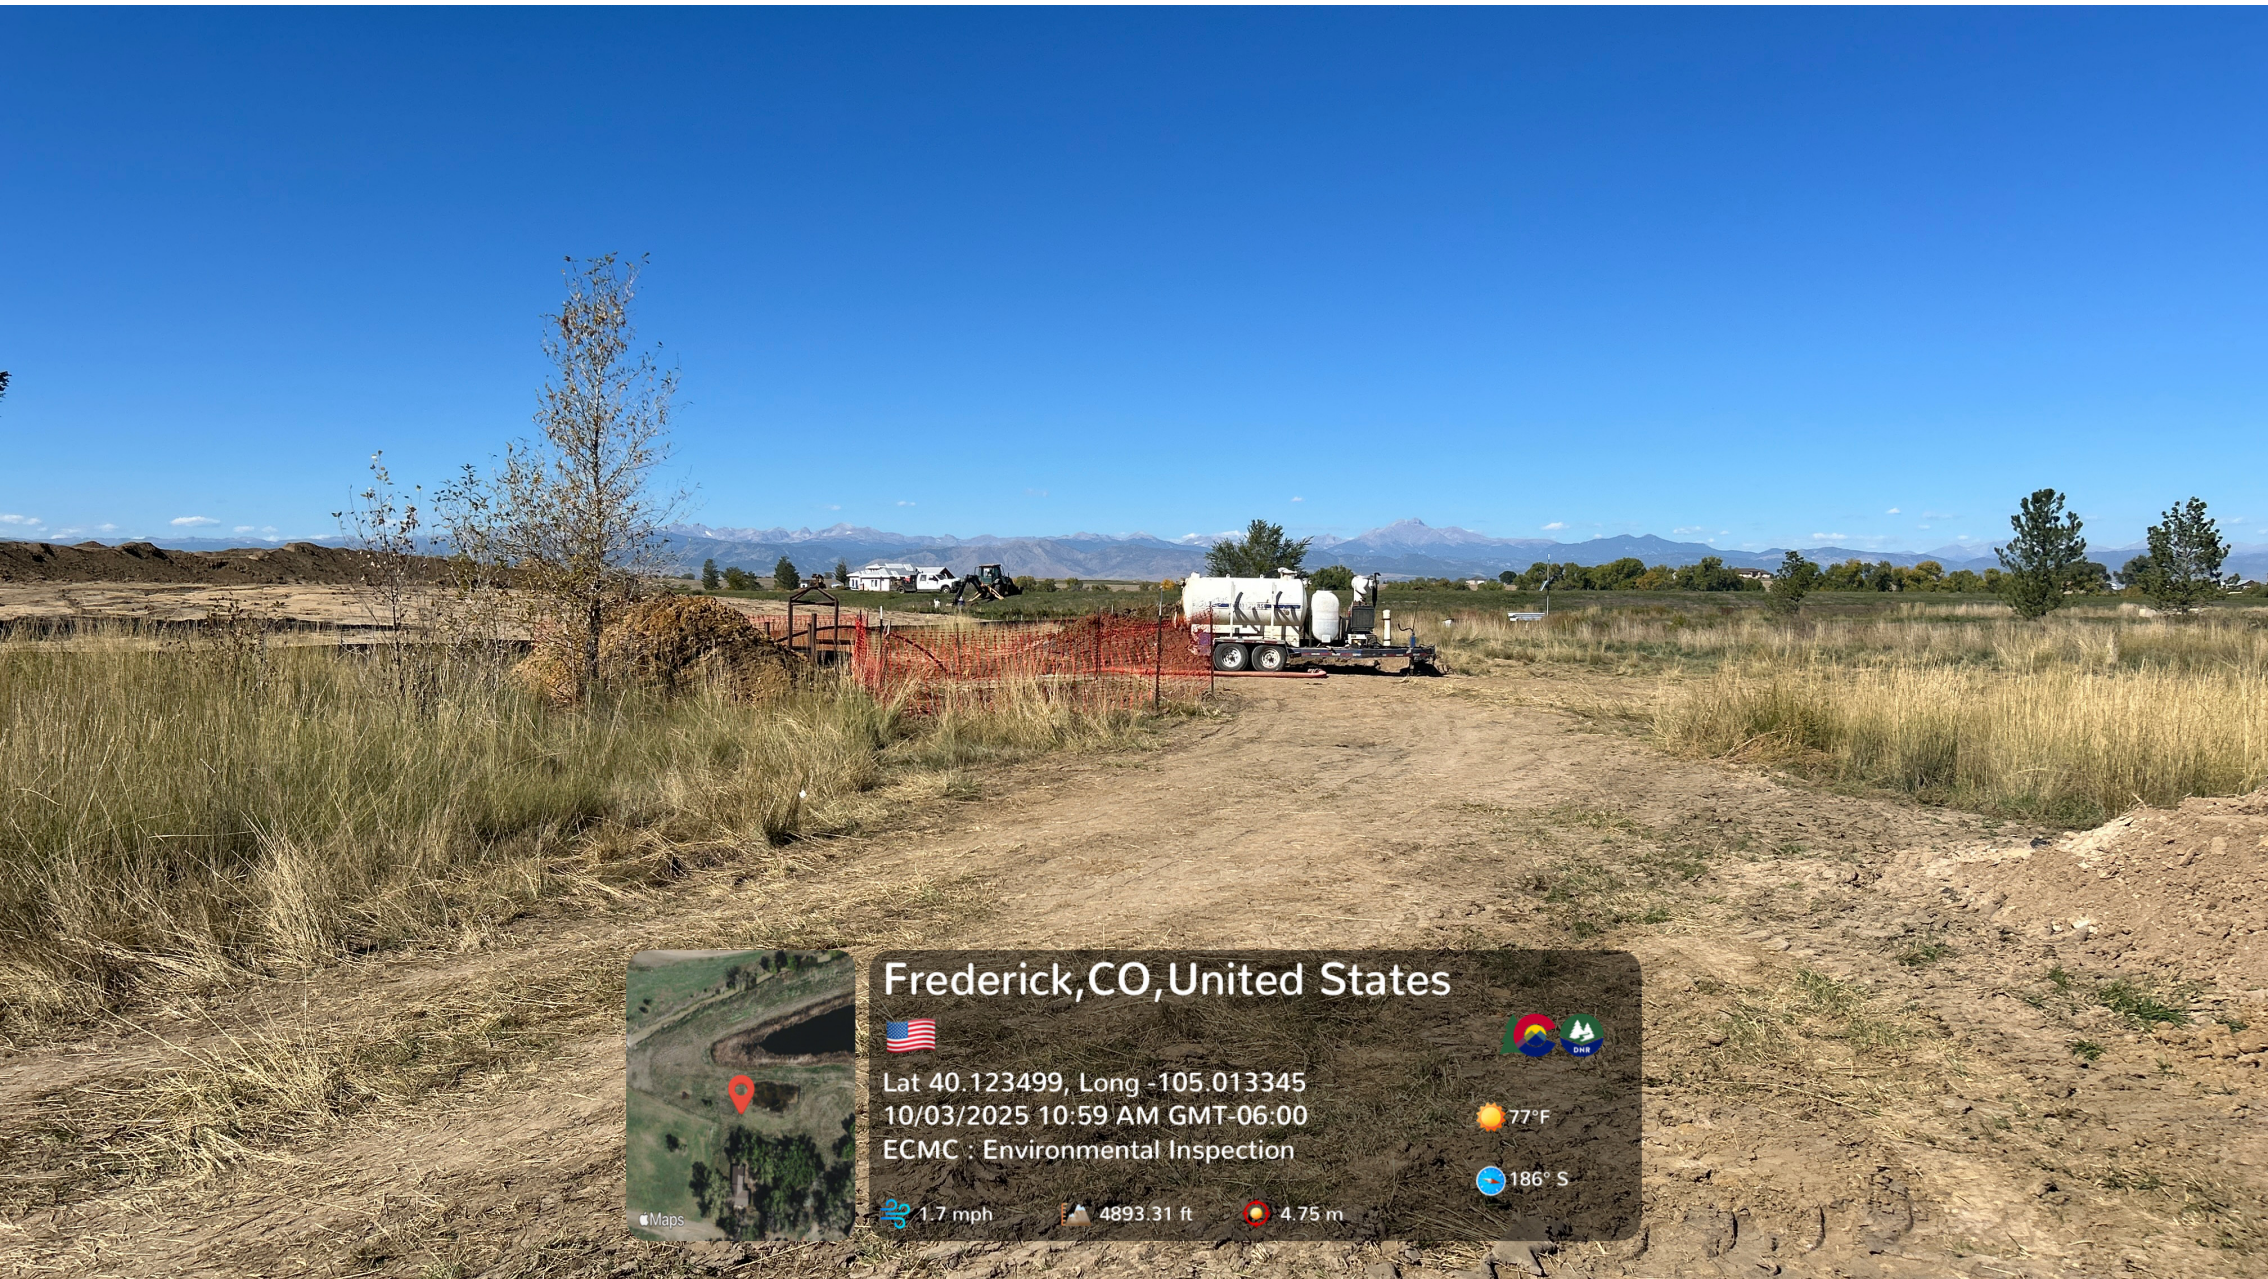
Looking at spill location and spill response area. Soil stockpiles remain on location. Operator equipment (vacuum trailer) is visible on location. Orange construction fencing partially surrounds the perimeters of the open excavations.

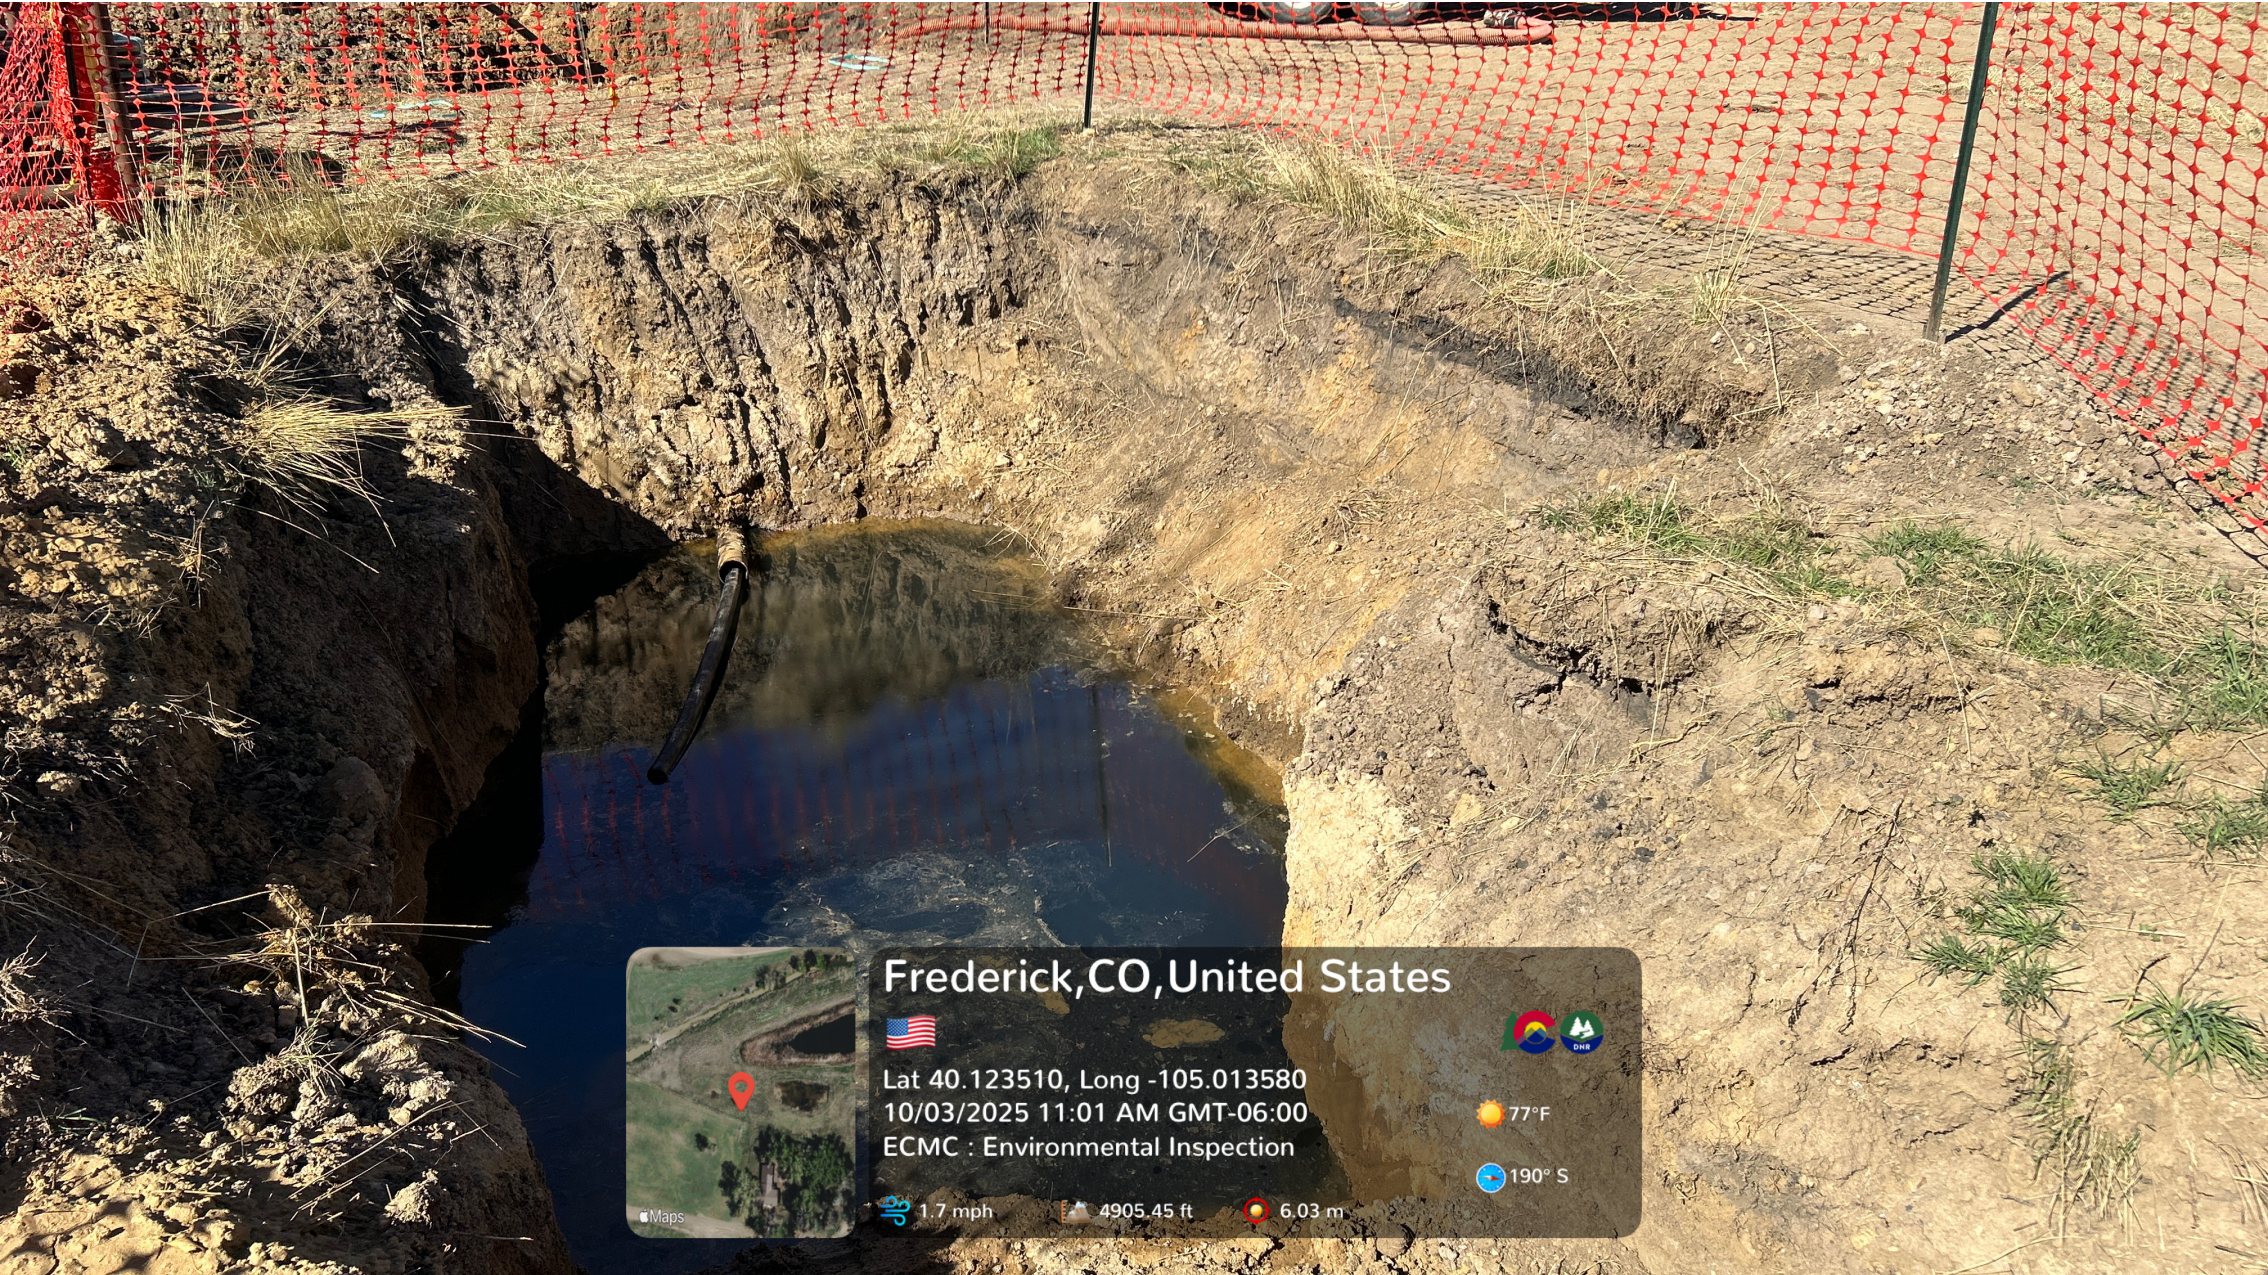
Looking at an excavation Operator personnel previously indicated was opened for flowline repairs. Free product is visible on groundwater within the excavation. Stained soil is visible on the excavation sidewalls.

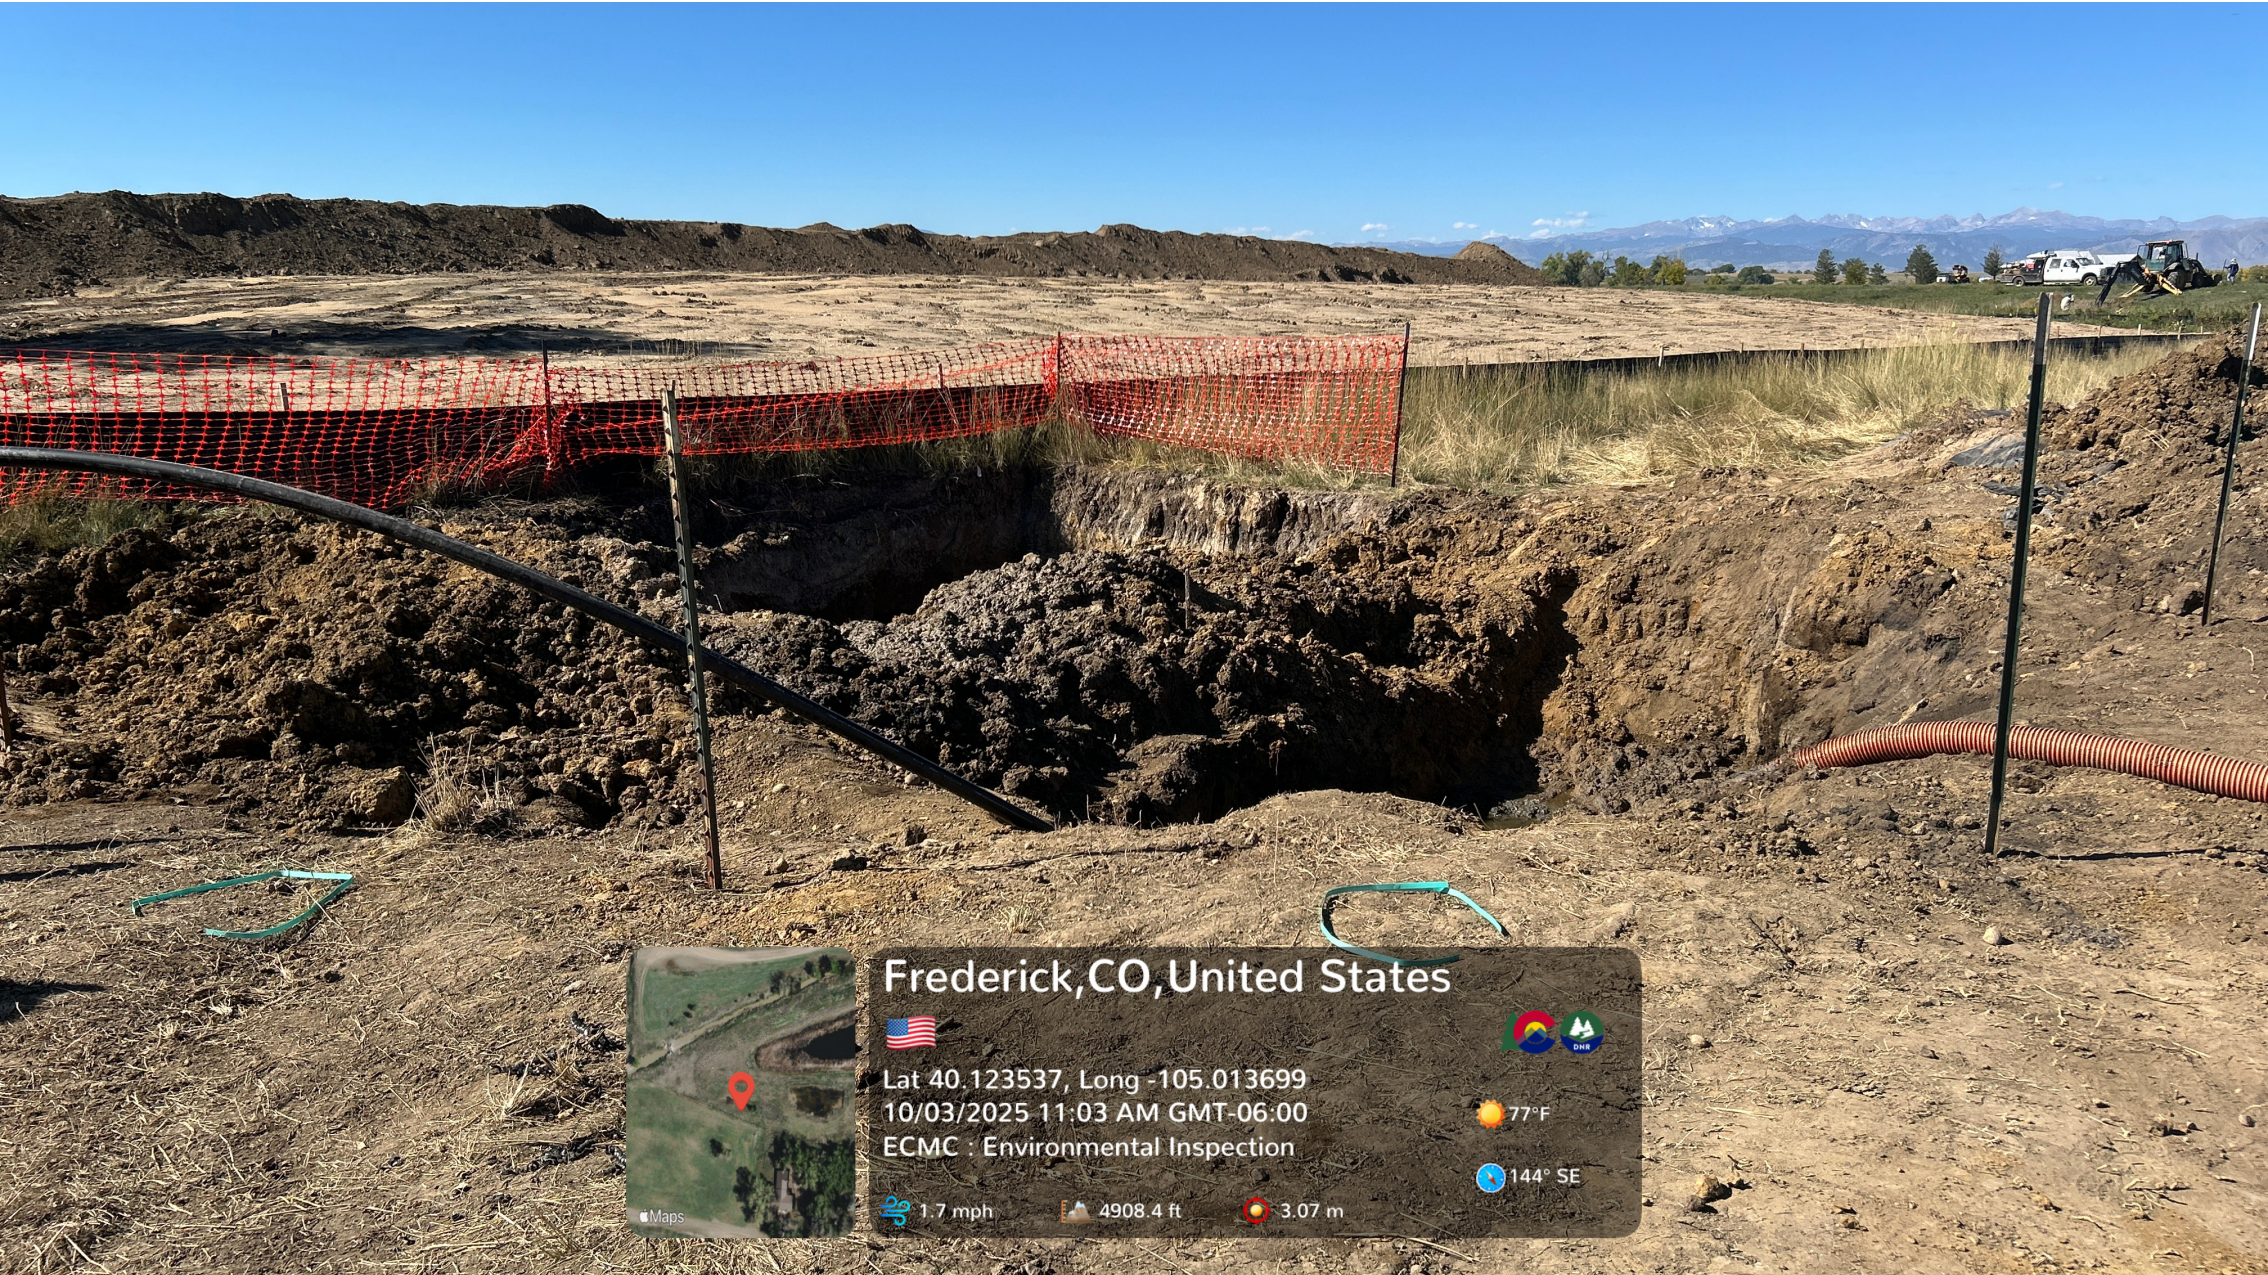
Looking at the spill location. The excavations remain open.

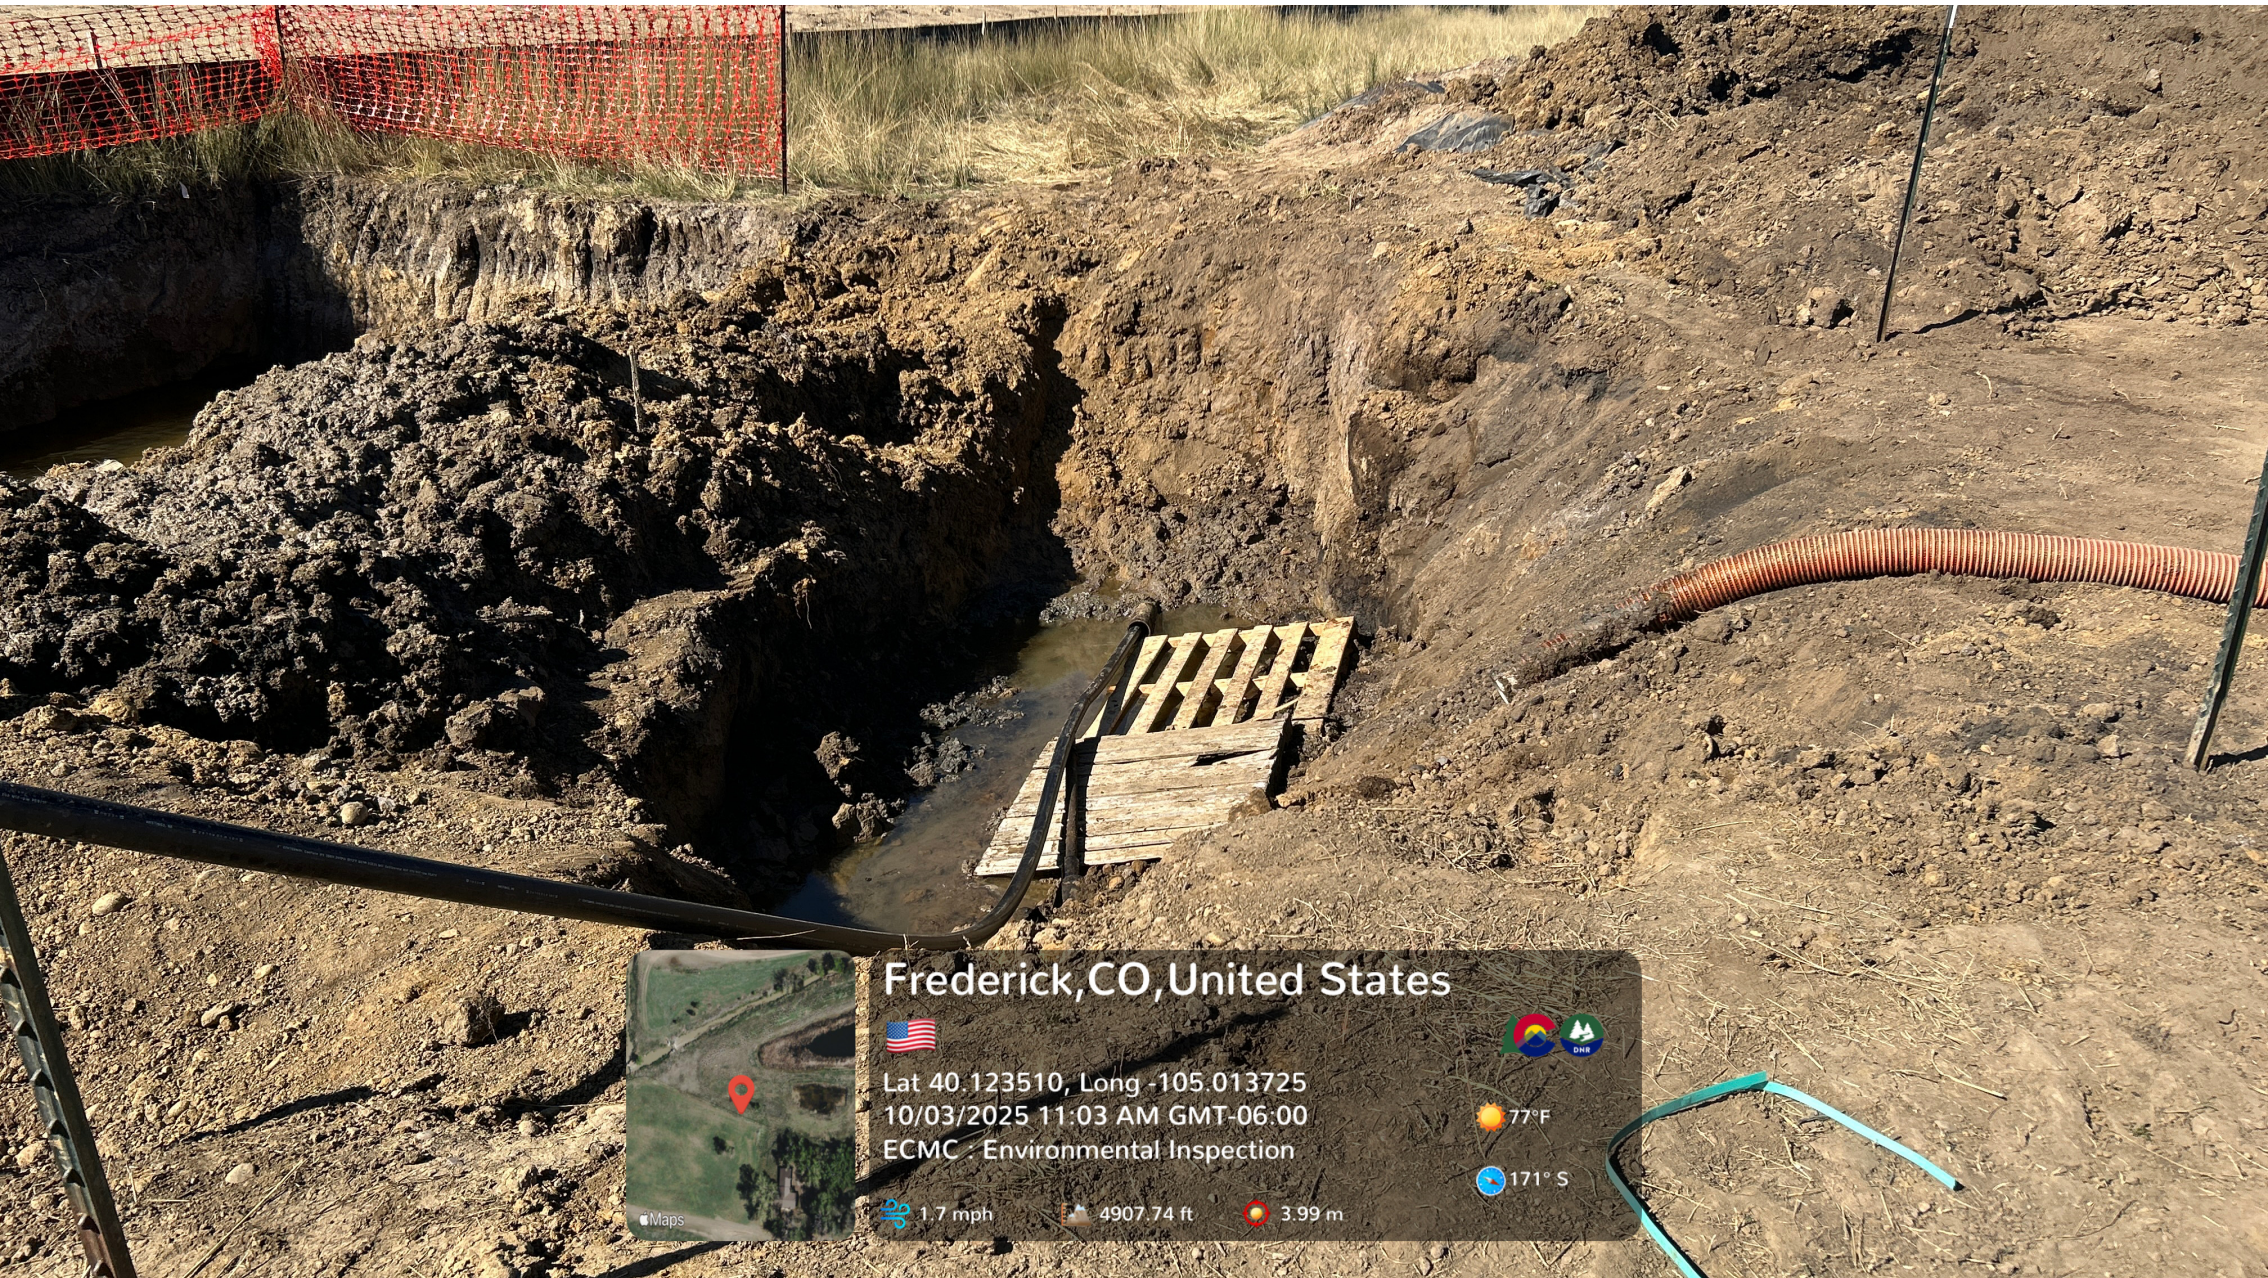
Free product is visible on groundwater within the excavation. Stained soil is visible on the excavation sidewalls. Flowline stinging/repair operations appear to be underway.

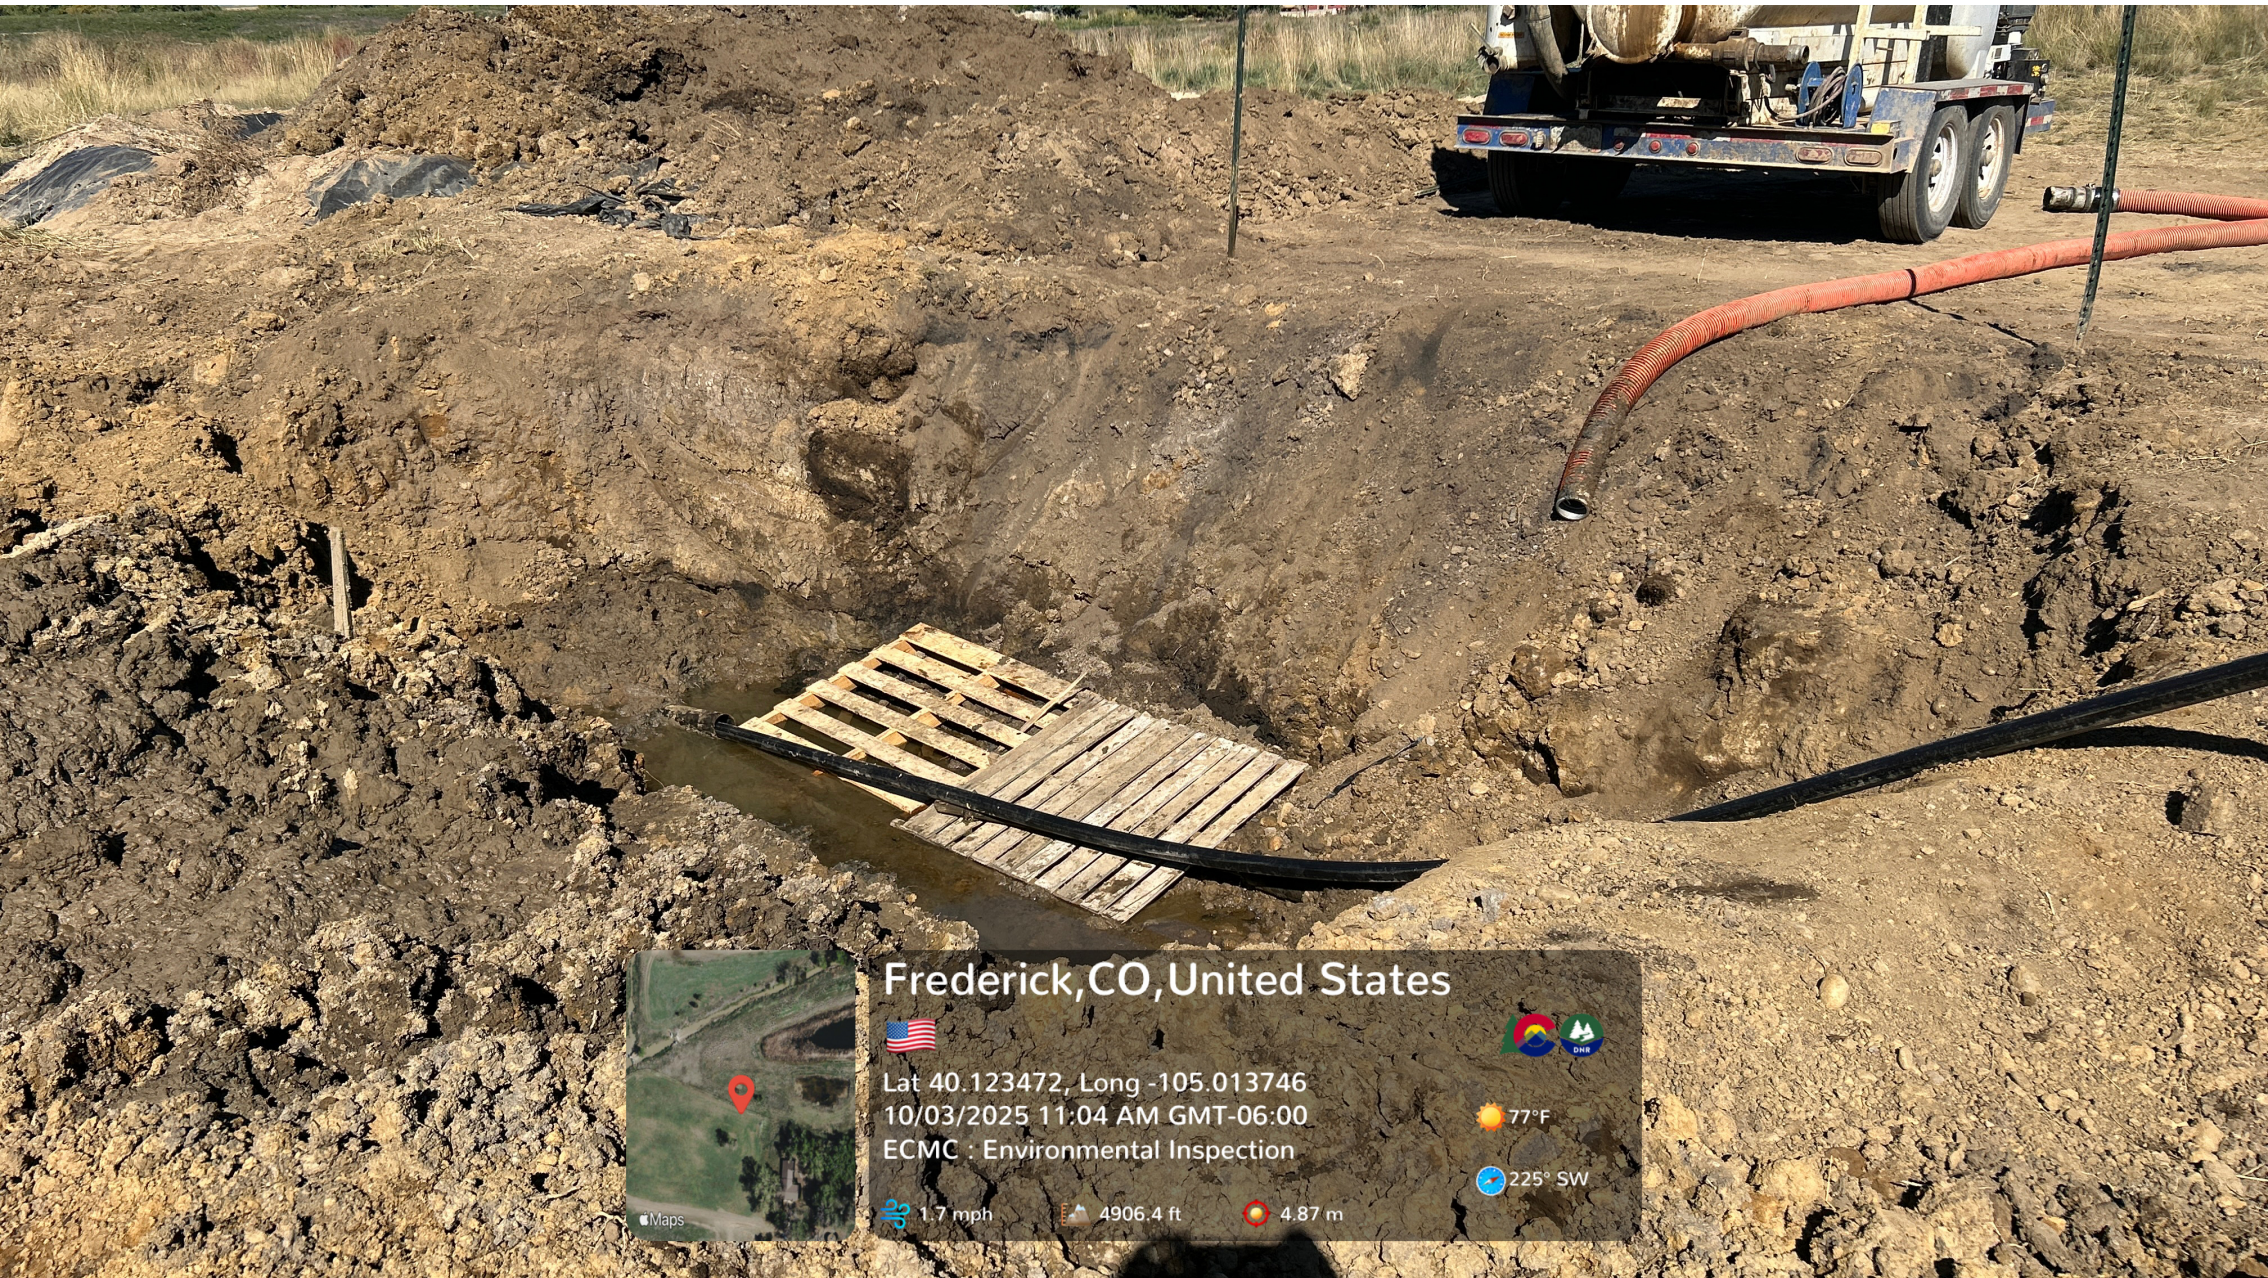
A hose is visible partially within the excavation and adjacent to the vacuum trailer.

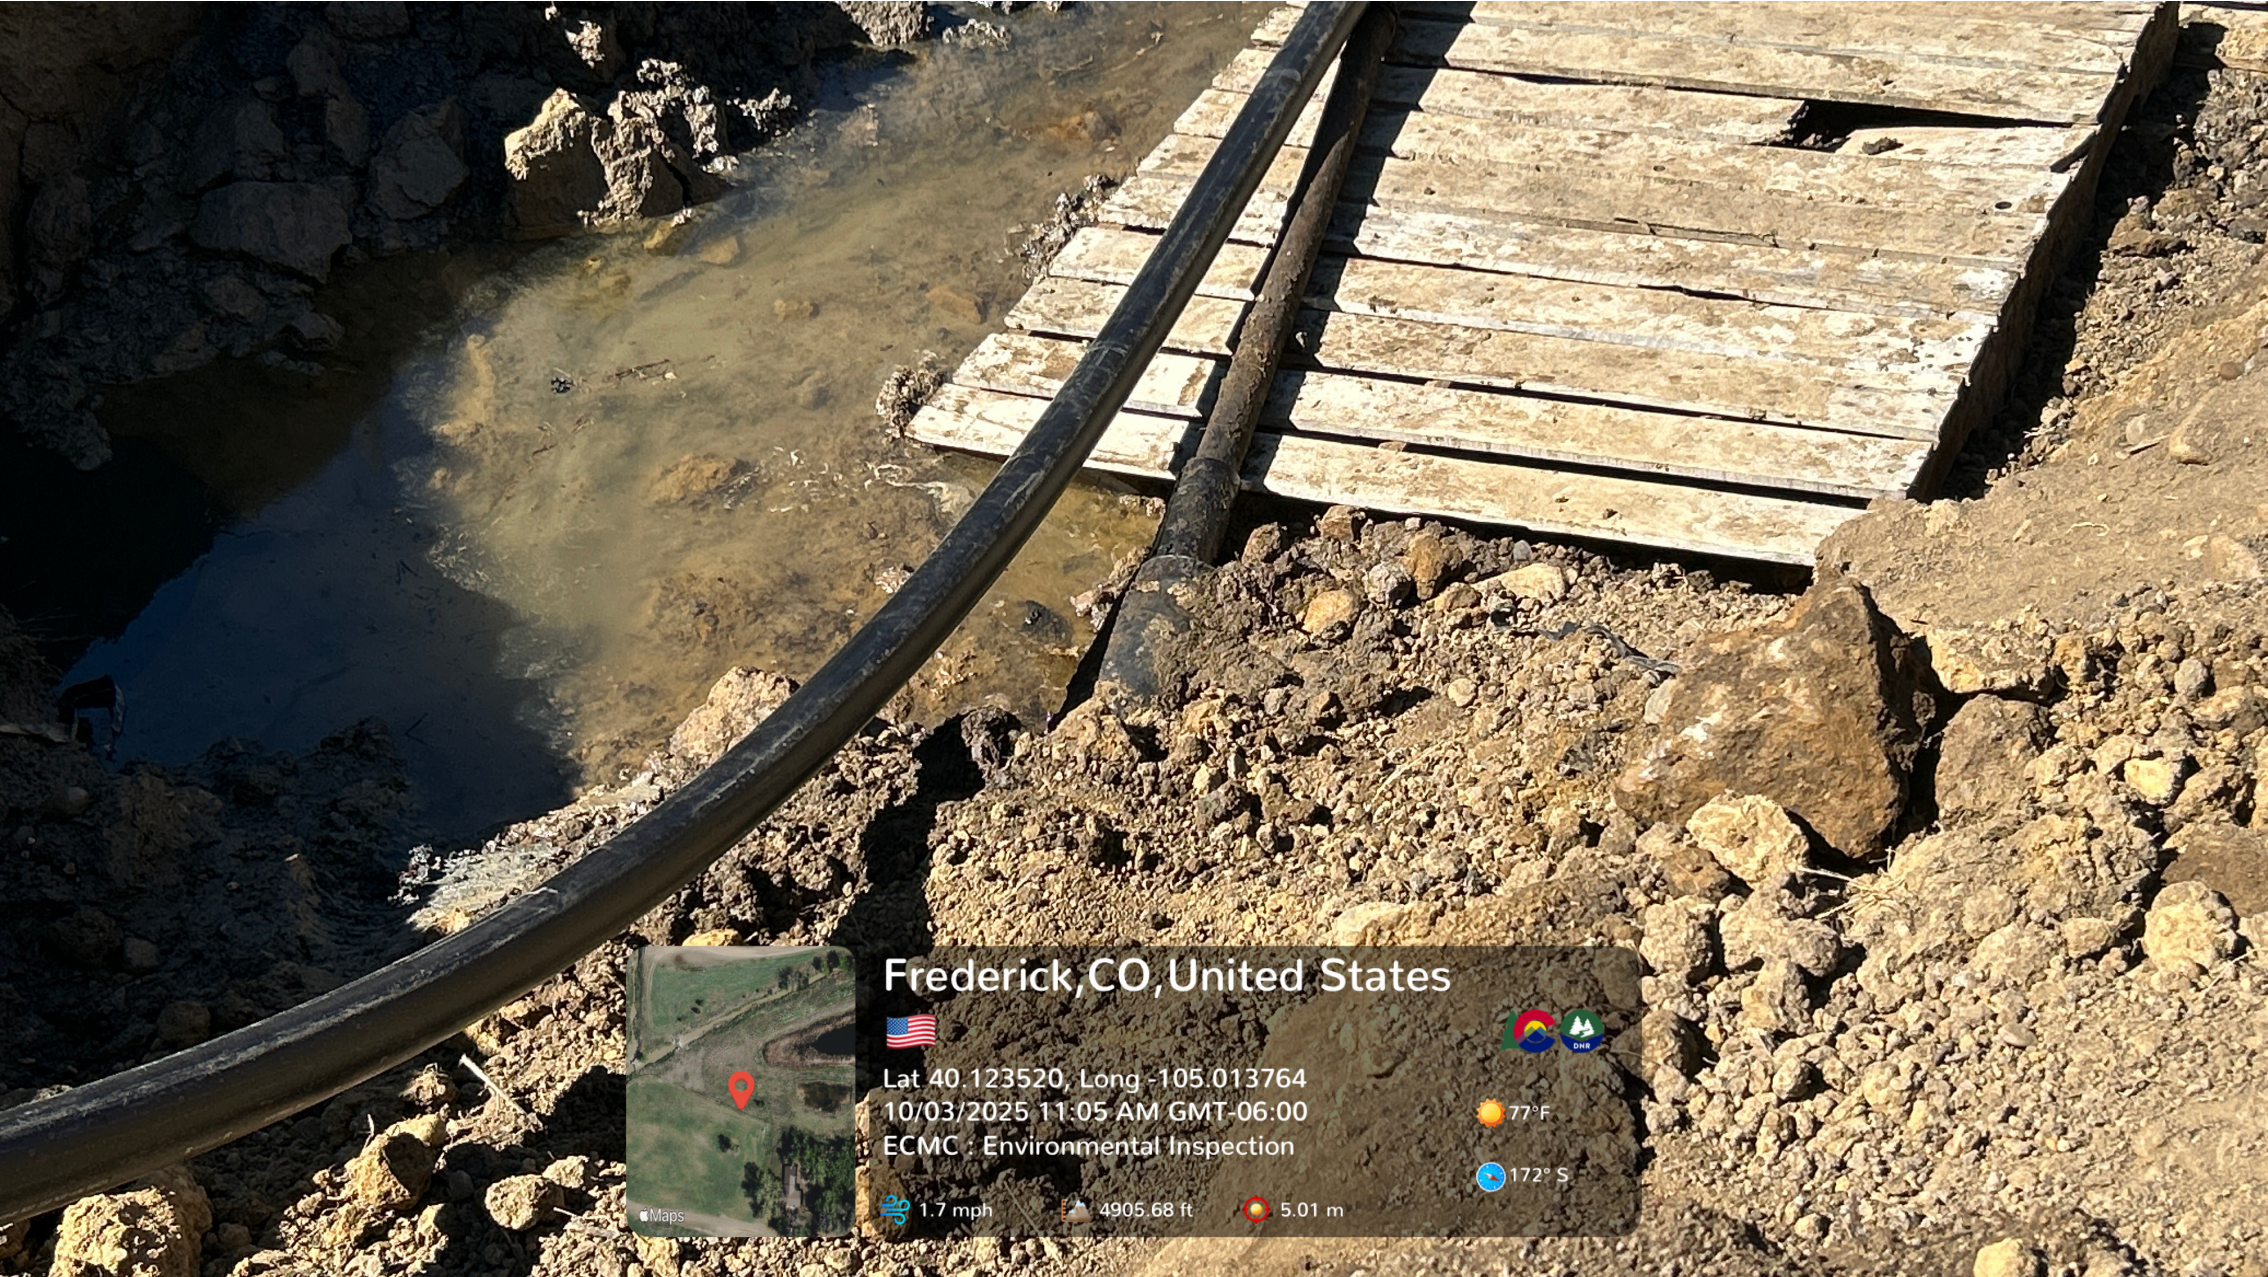
Looking at flowlines.

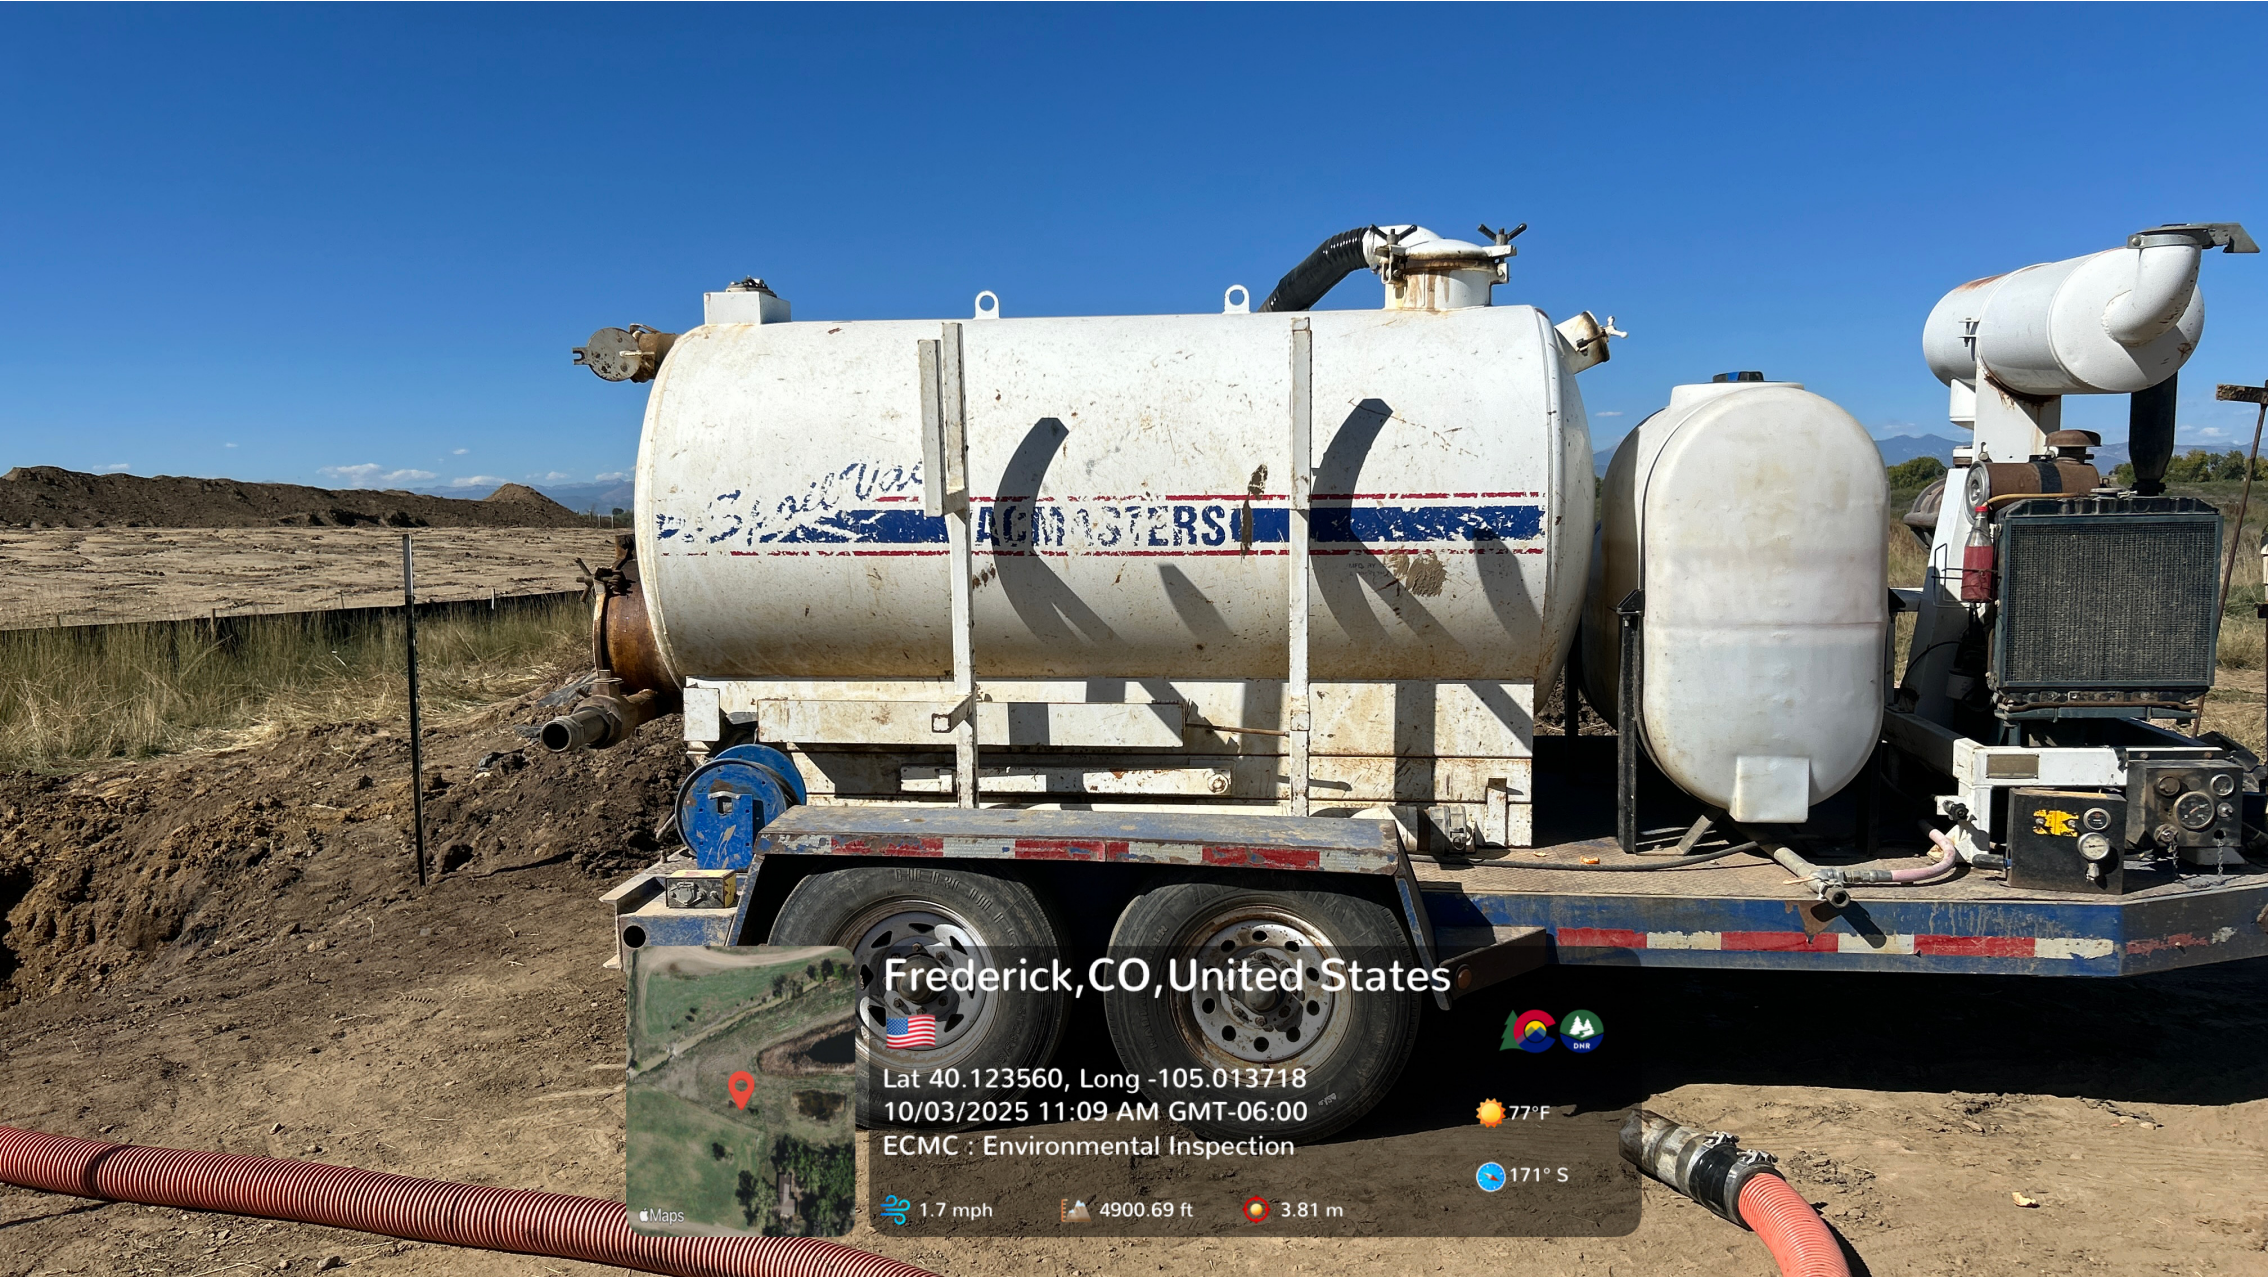
Looking at the vacuum trailer.

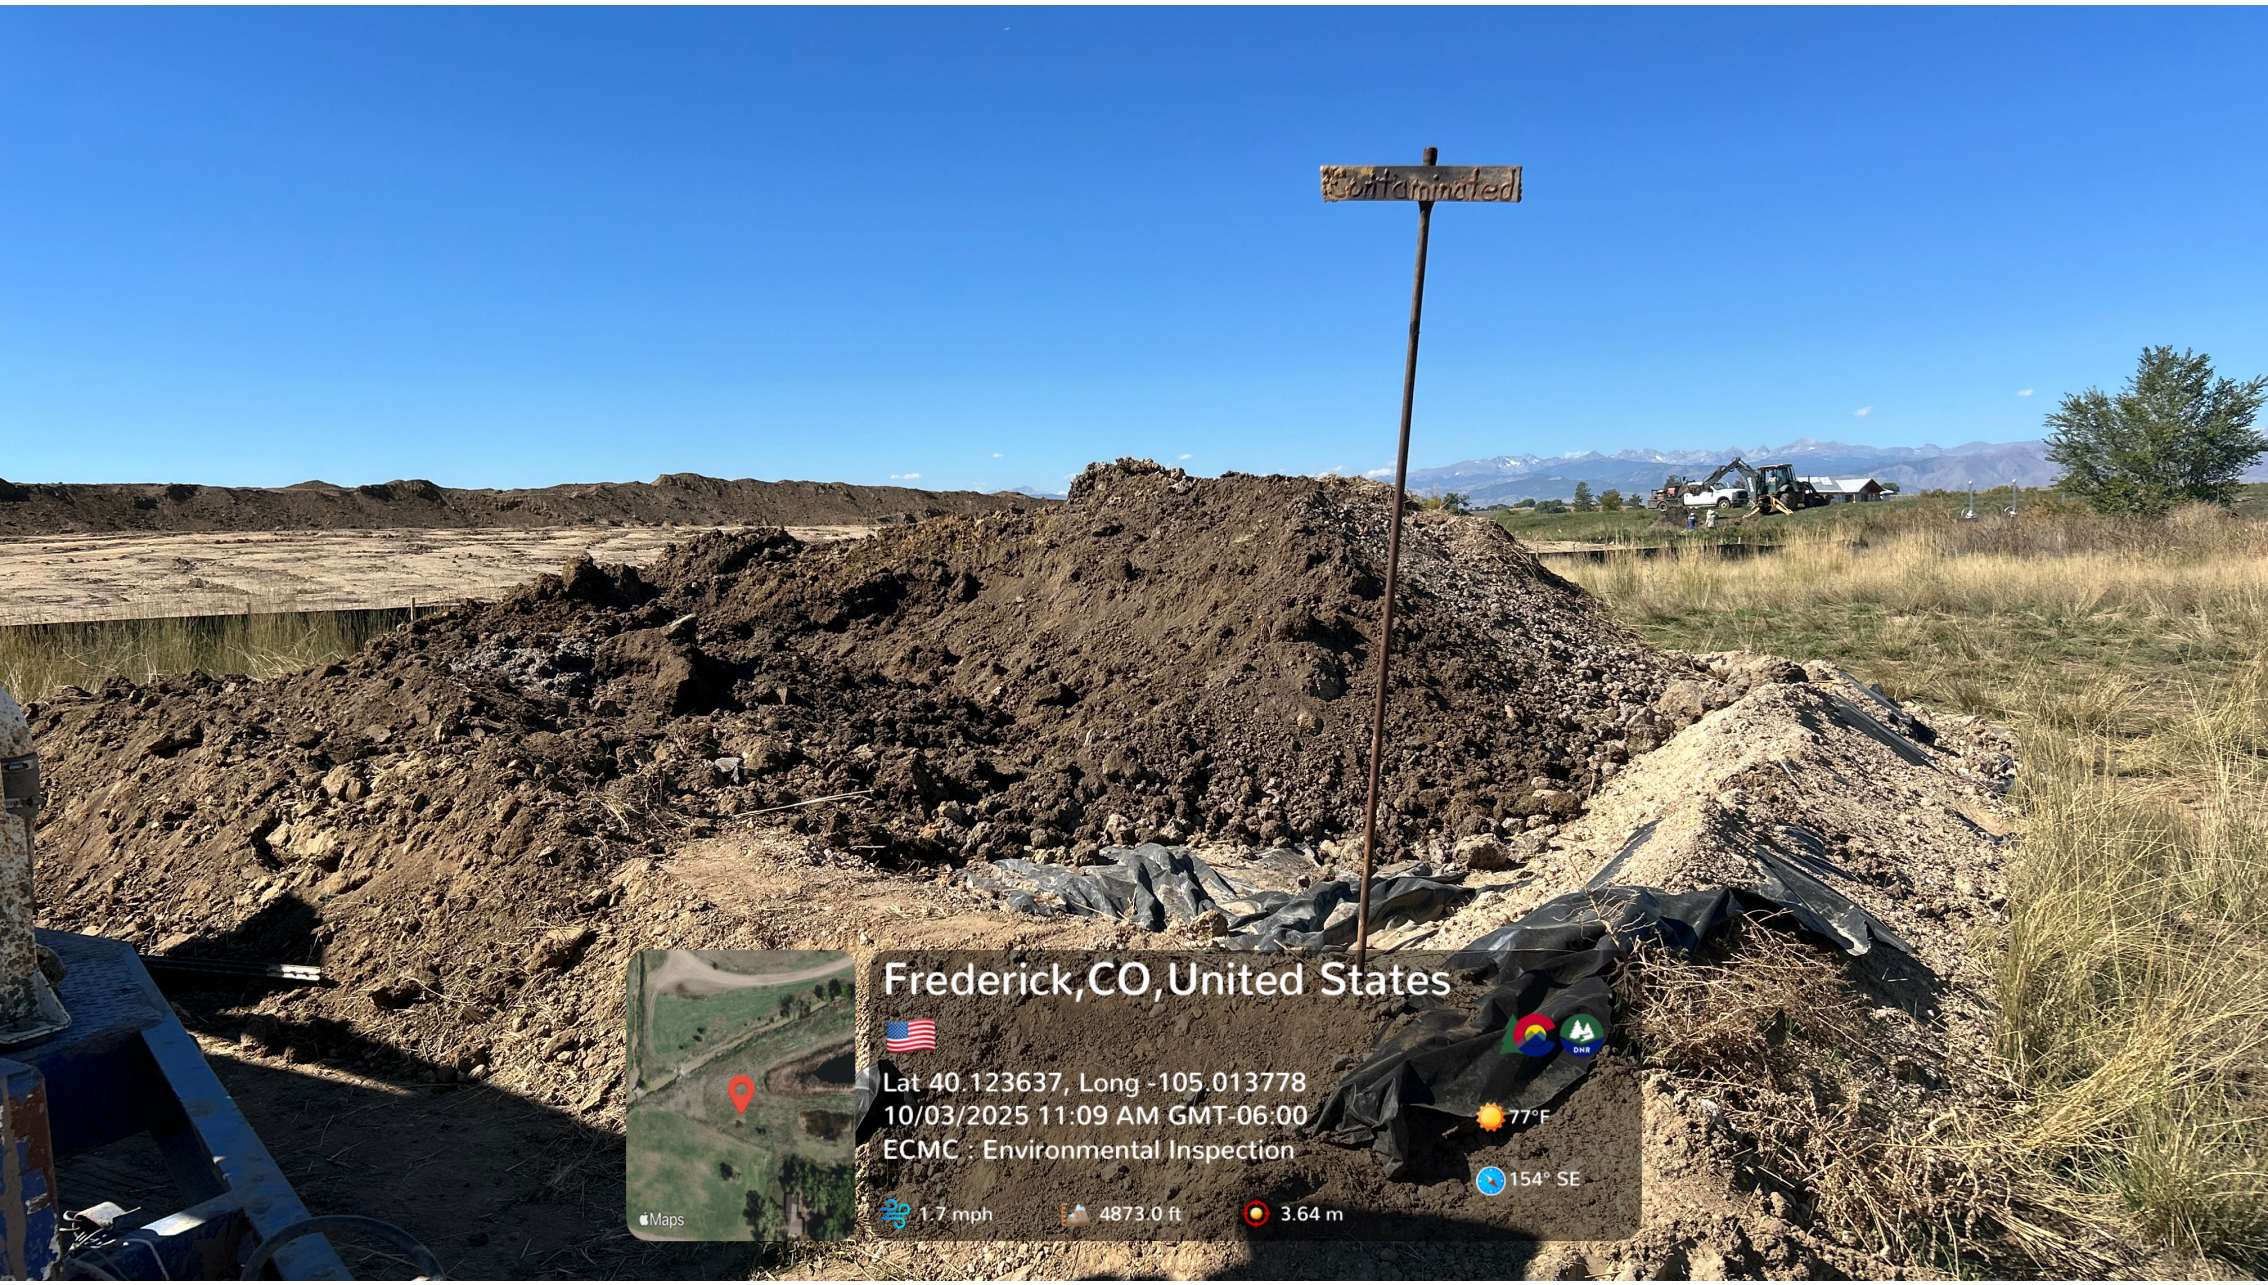
The stockpile marked "contaminated" remains on location. A liner is visible but has been compromised by holes/tears; soil has spilled outside of containment.
