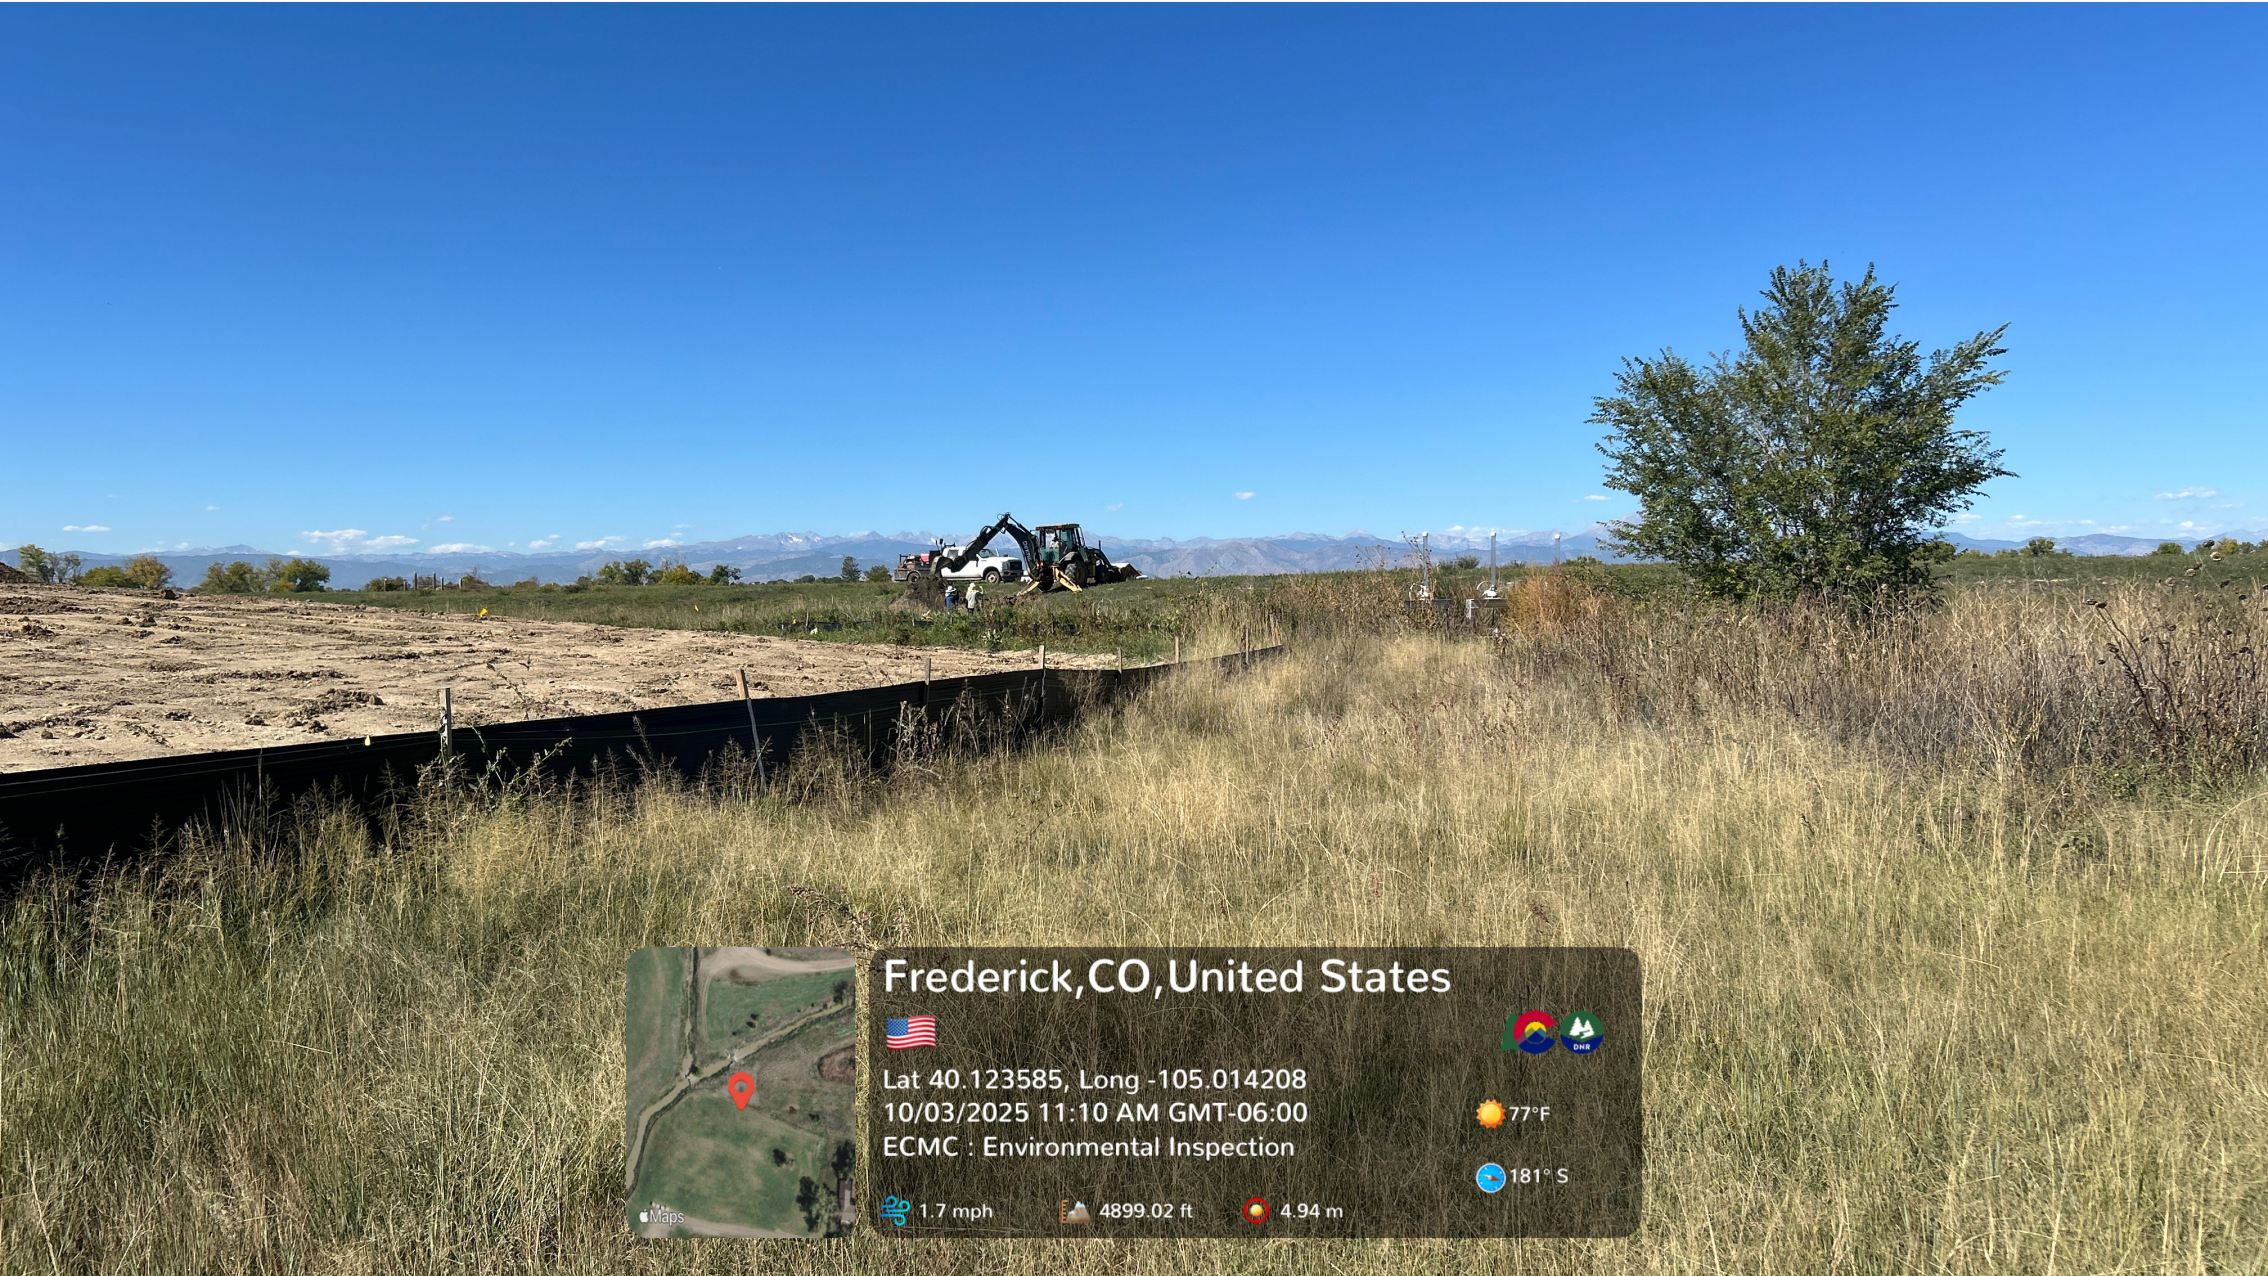
Underground utility flags which read "KP Kauffman" are visible west of the location. A backhoe and crew are visible on the hillside, on the west side of Idaho Creek.
