Inspection Photos

Operator: TEP Rocky Mountain LLC #96850

Location ID: 323944

Inspection Doc: 719200280

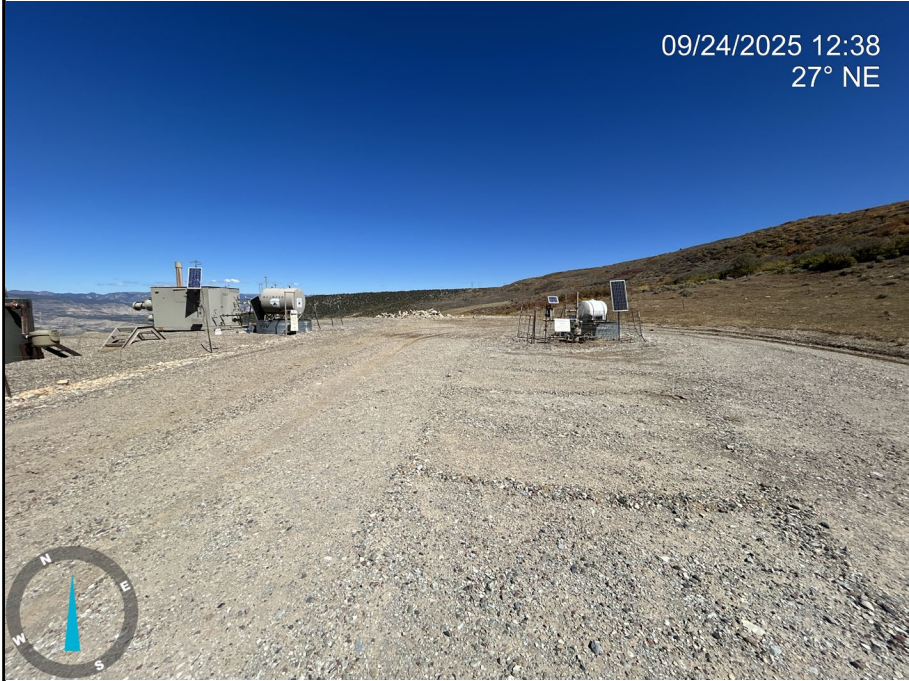
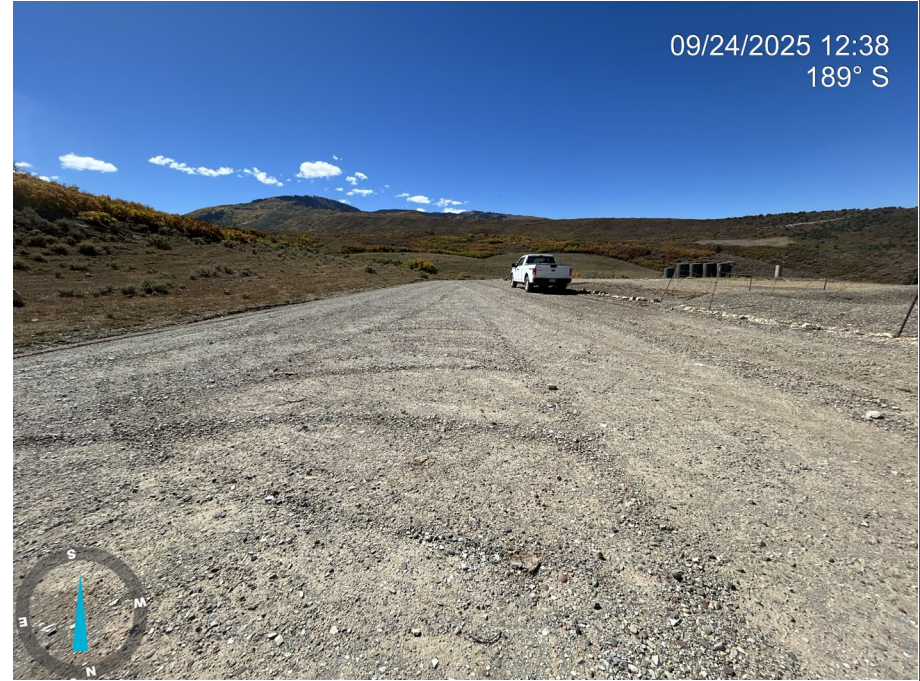
Photo 1: Photos showing an overview of the location looking northeast and south, respectively.

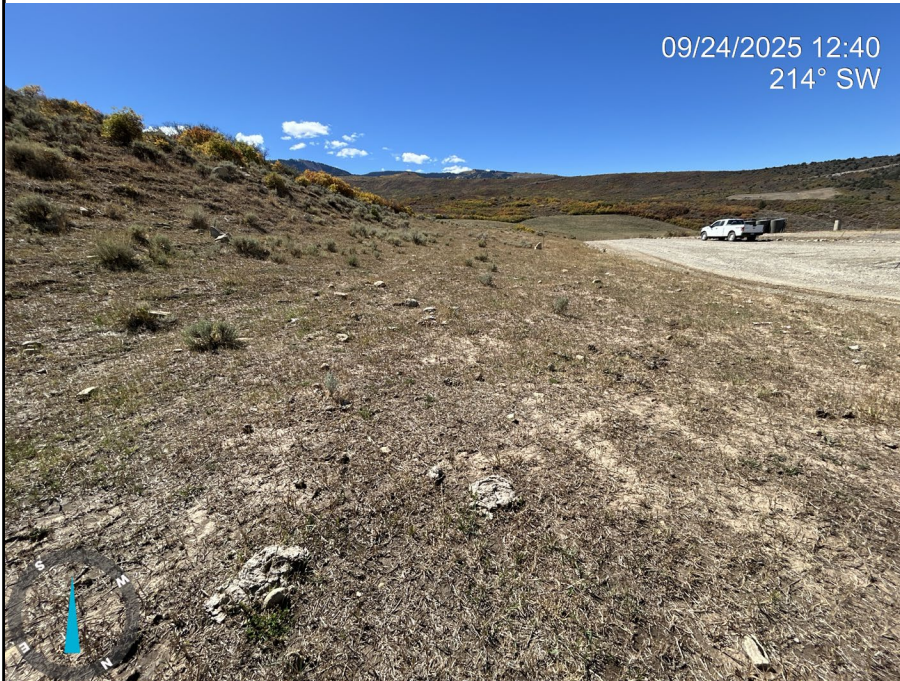
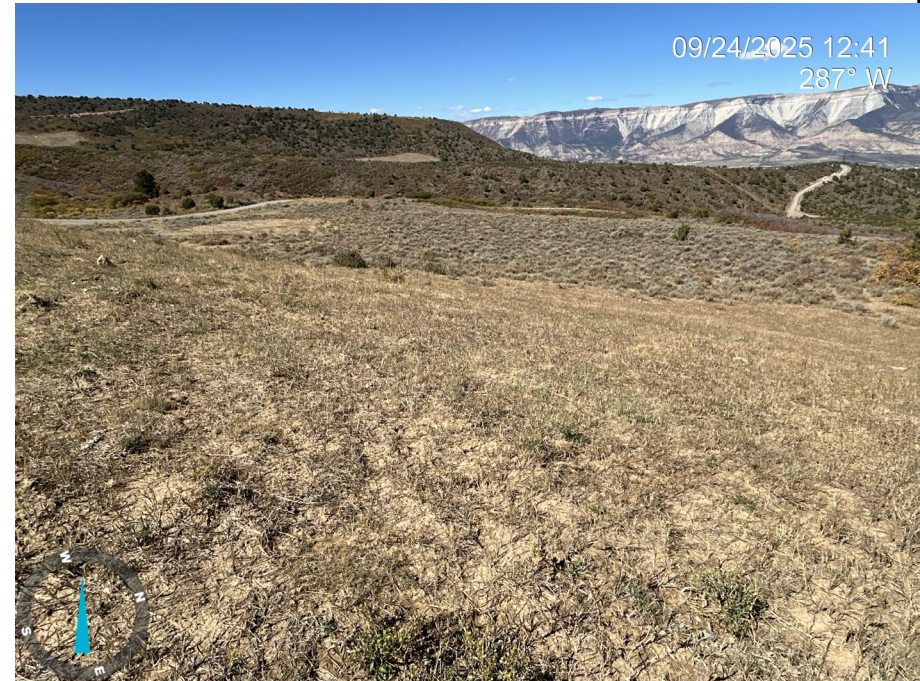
Photo 2: Photos showing interim areas at the location are composed of smooth brome and intermediate wheatgrass, with secondary amounts of curlycup gumweed and trace amounts of big sagebrush. Interim areas are progressing towards 1003 reclamation requirements.

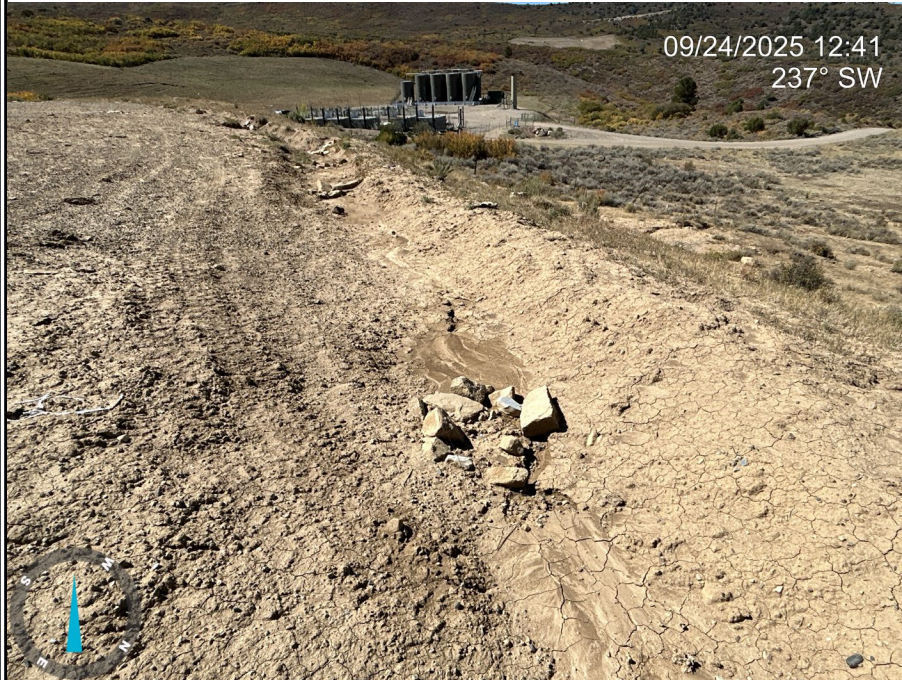
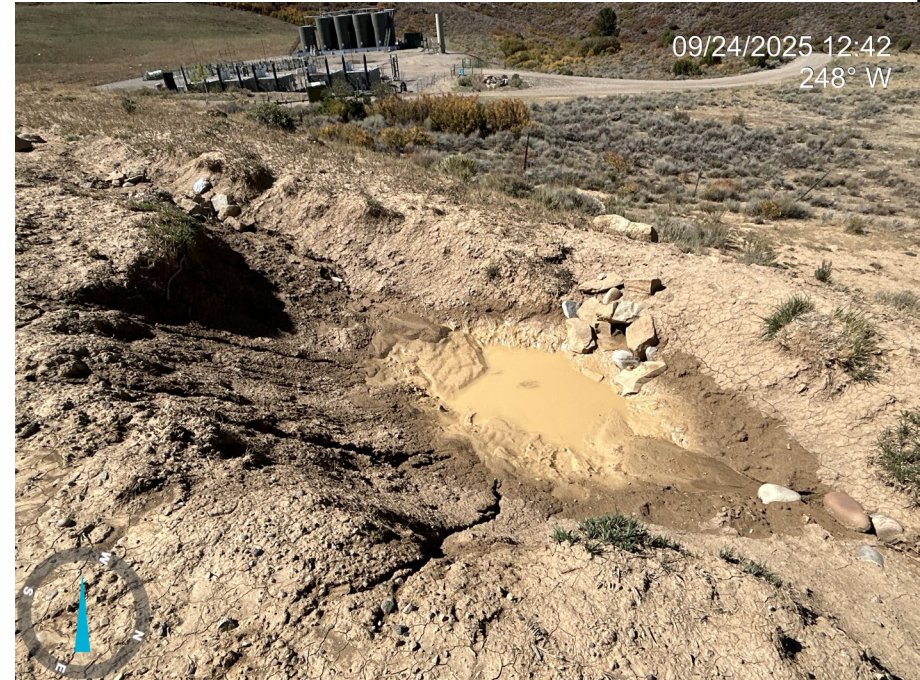
Photo 3: Photos showing stormwater controls on the northern portion of the location appear to be in disrepair. Sediment migration and rilling is evident. Stormwater BMPs do not appear to be constructed per good engineering practices. Comply with 1002.f. and implement and/or maintain stormwater BMPs.

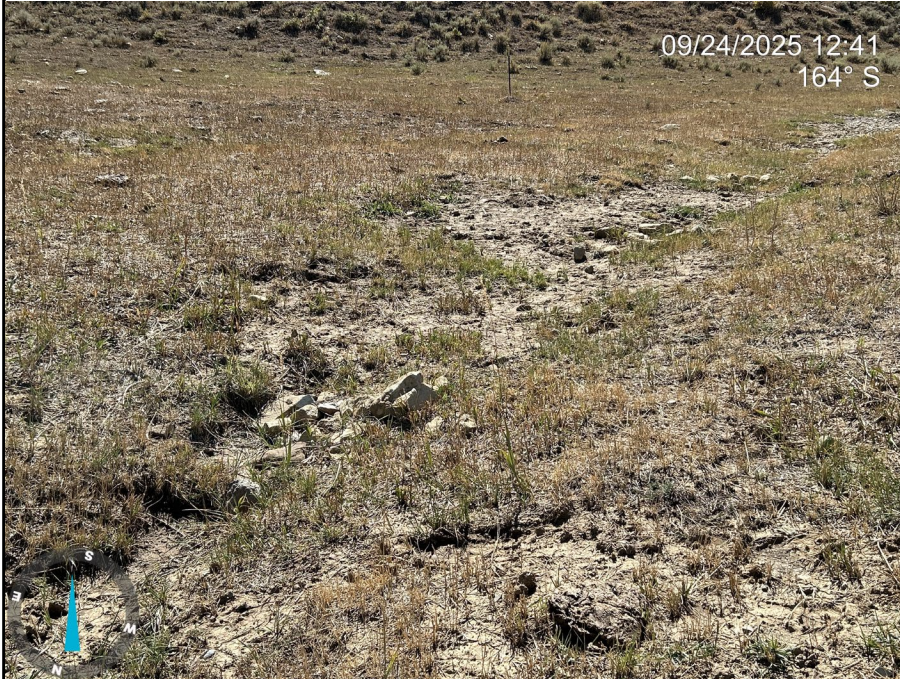
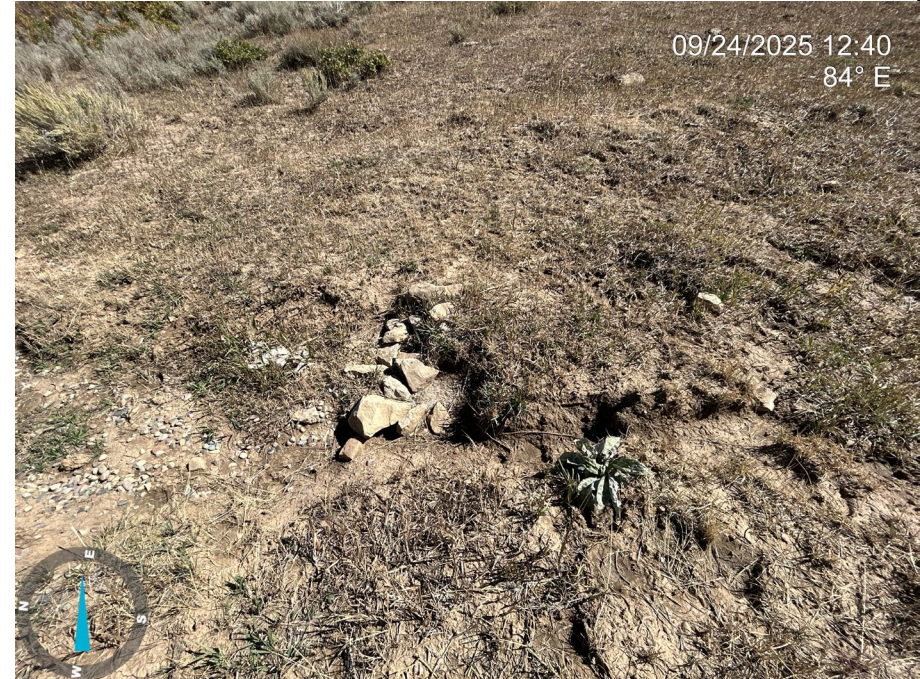
Photo 4: Photos showing stormwater controls on the northern portion of the location appear to be in disrepair. Sediment deposition and erosion is evident. Stormwater BMPs do not appear to be constructed per good engineering practices. Comply with 1002.f. and implement or maintain stormwater BMPs.

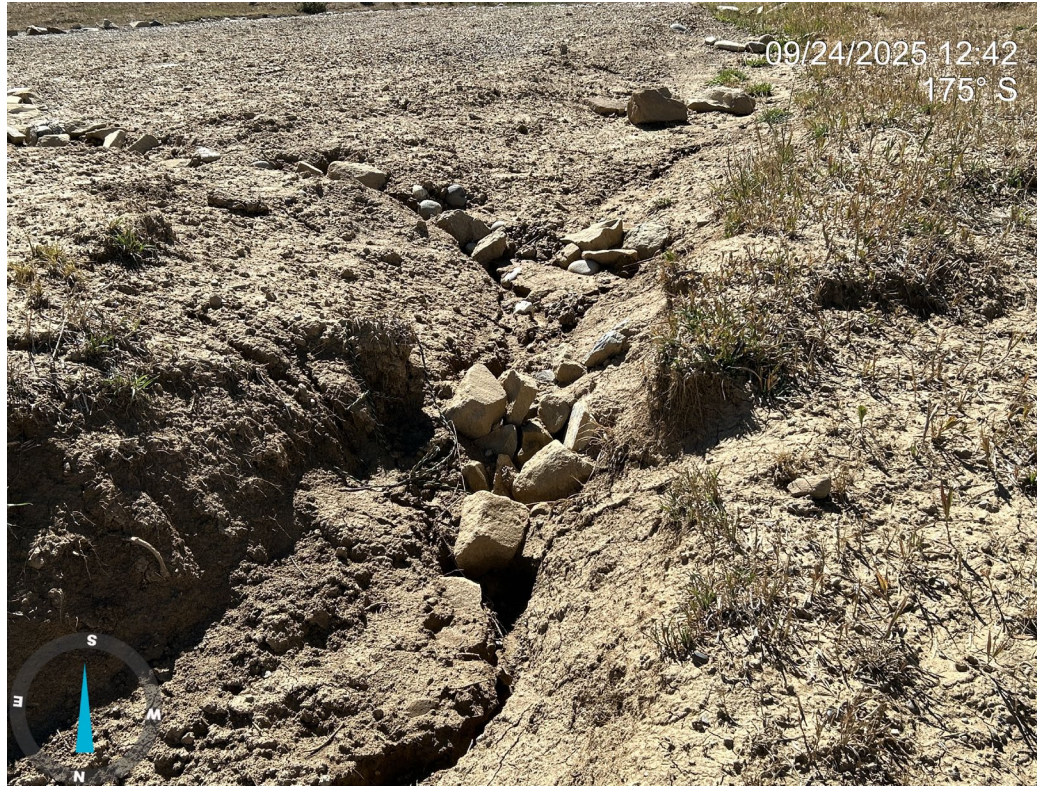
Photo 5: Photos showing stormwater controls on the northern portion of the location appear to be in disrepair. Sediment deposition and erosion is evident. Stormwater BMPs do not appear to be constructed per good engineering practices. Comply with 1002.f. and implement or maintain stormwater BMPs.
