# Inspection/Audit Photos

Location Name: TEP ROCKY MOUNTAIN LLC CRYSTAL CREEK MV 3-30

Location ID: 322532

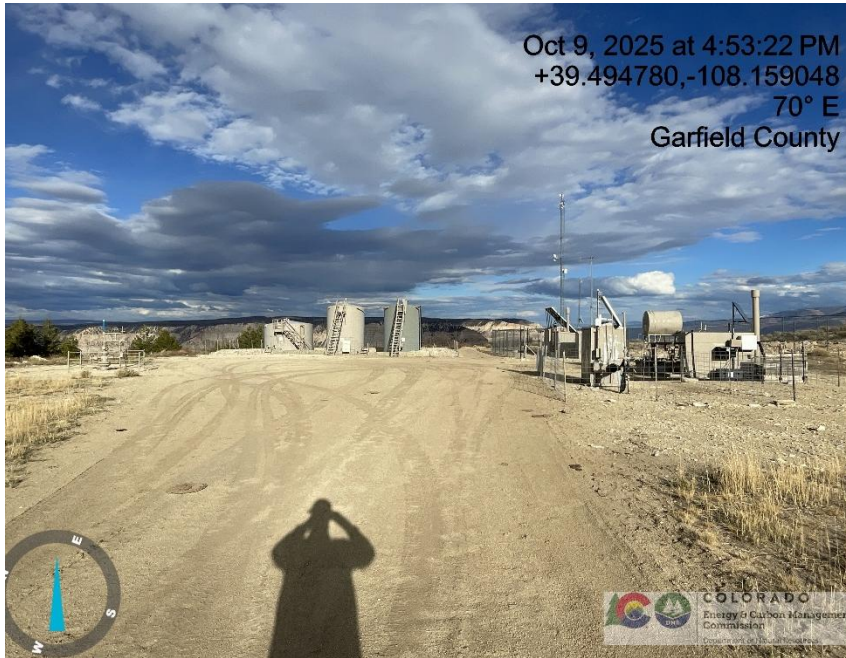
Photo # 6021 From entrance to location

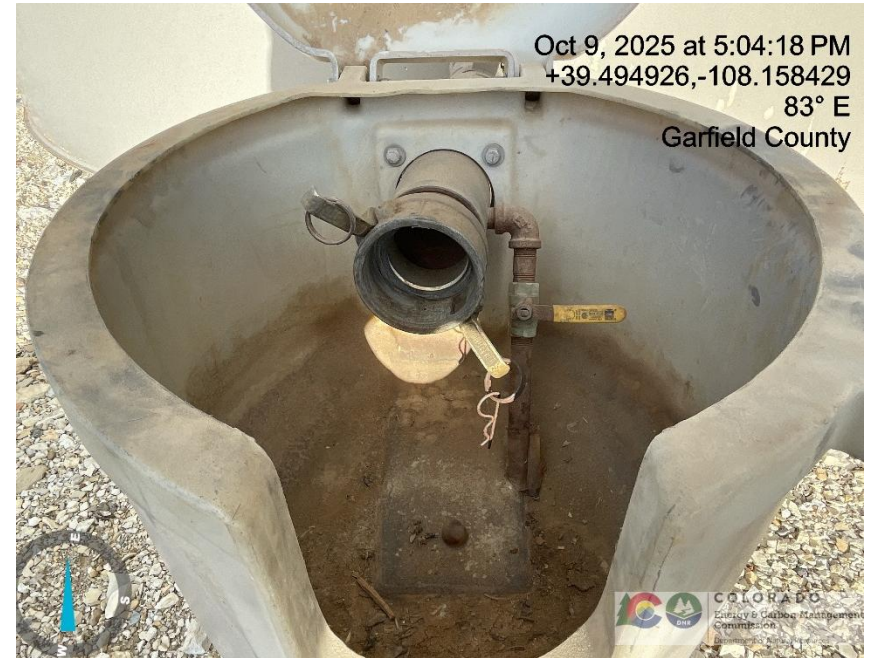
Photo # 6028 Open ended load line

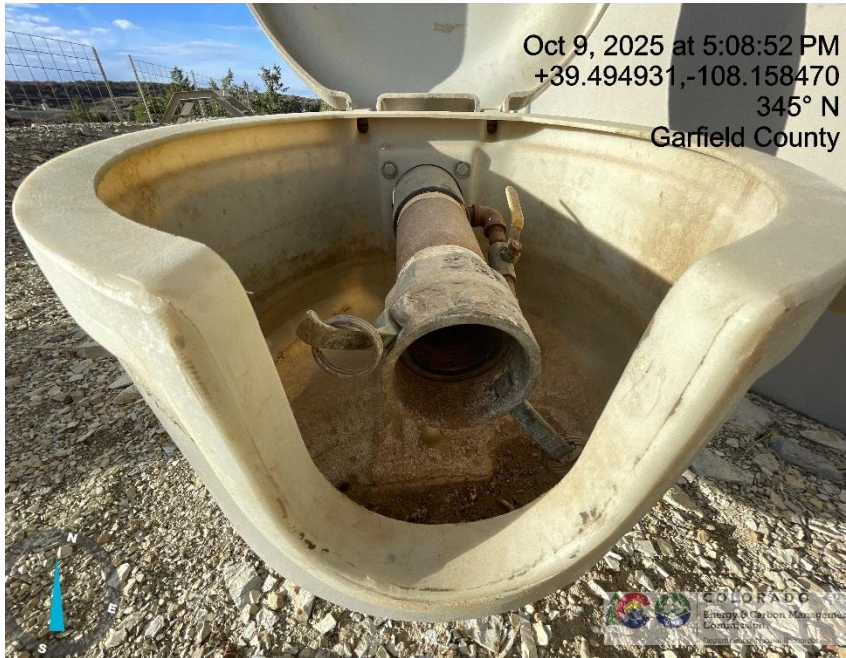
Photo # 6029 Open ended load line

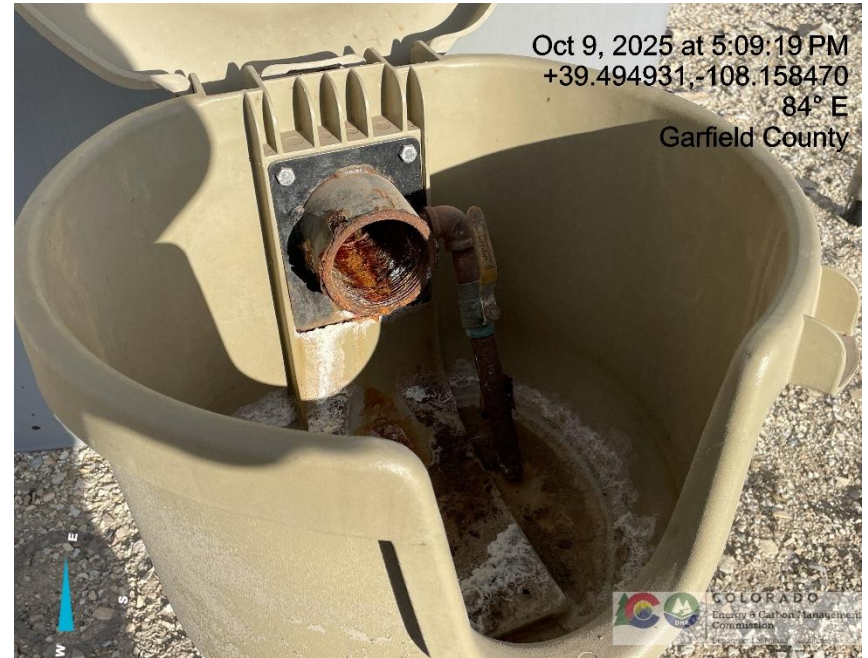
Photo # 6030 Open ended load line

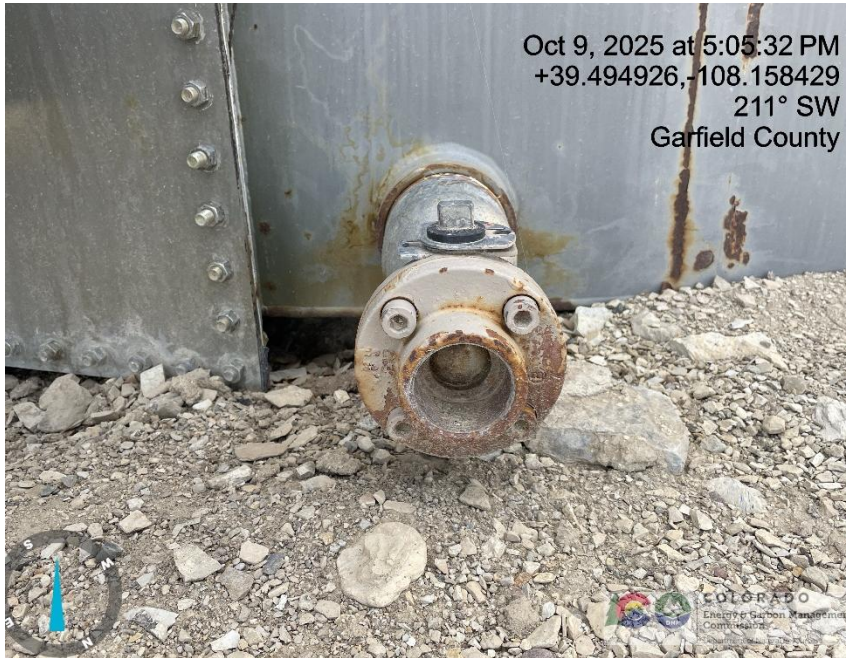
Photo # 6031 Open ended load line

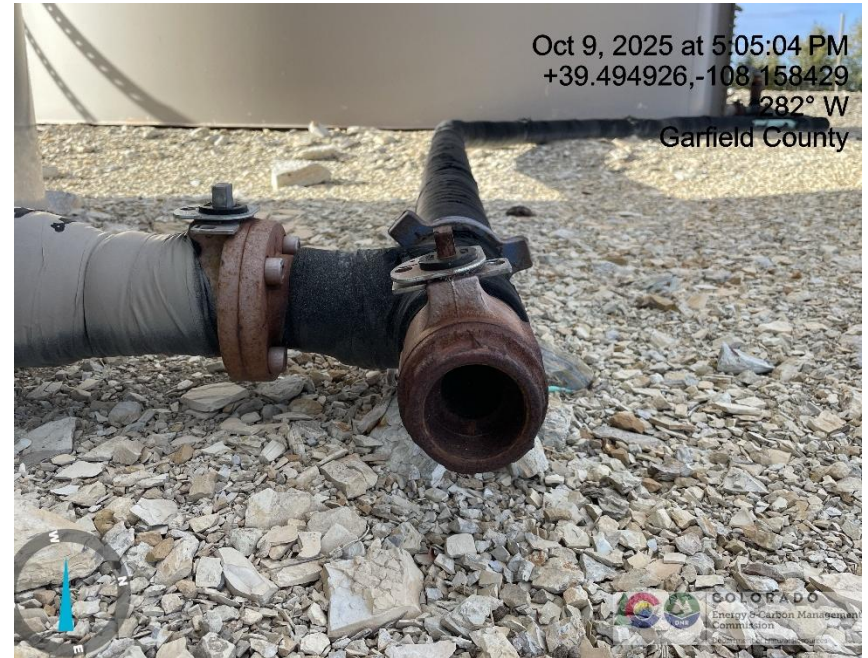
Photo # 6032 Open ended load line

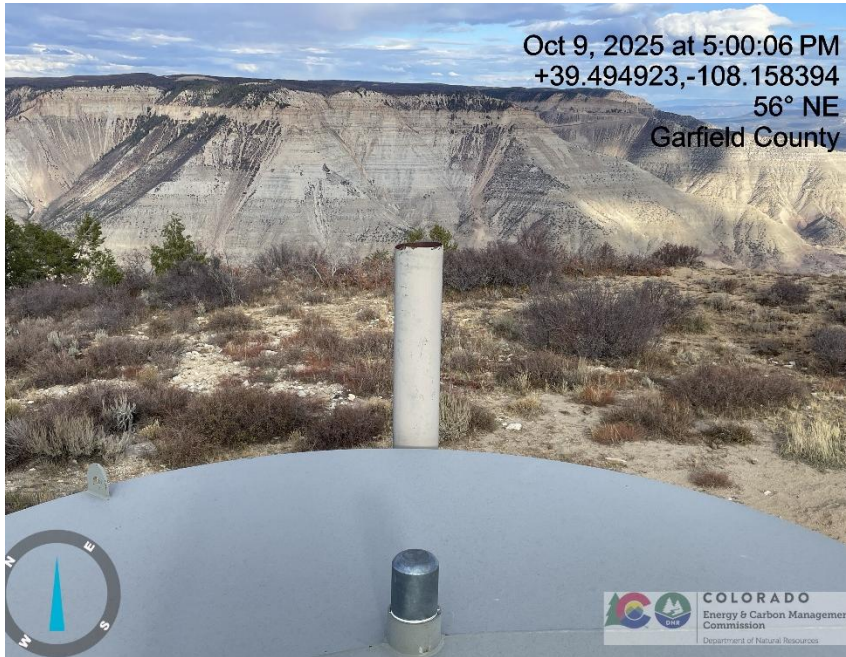
**Photo # 6033 Burner exhaust stack on tank heater lacks bird protection/available for entry by wildlife/wildlife hazard**

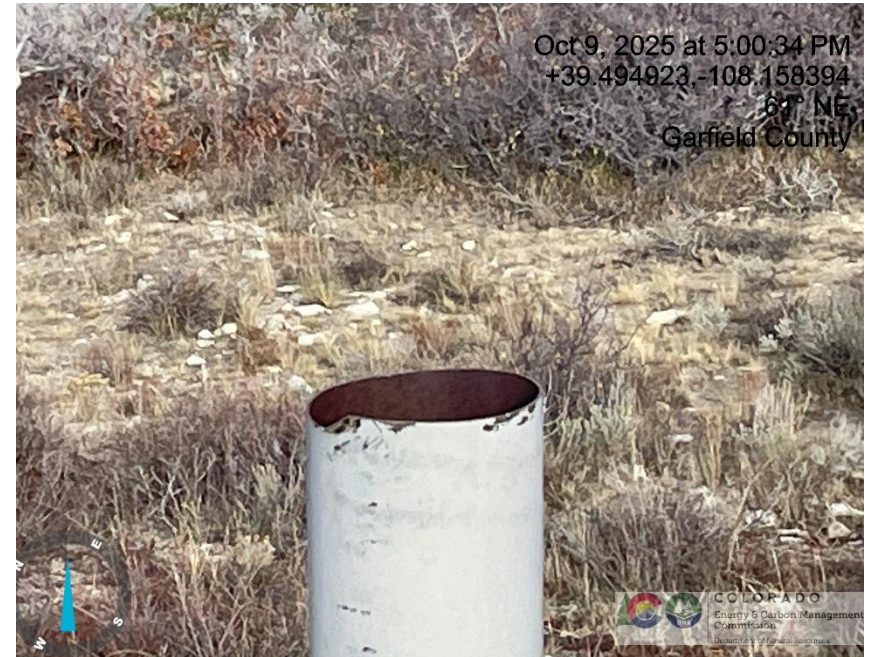
**Photo # 6034 Burner exhaust stack on tank heater lacks bird protection/available for entry by wildlife/wildlife hazard**

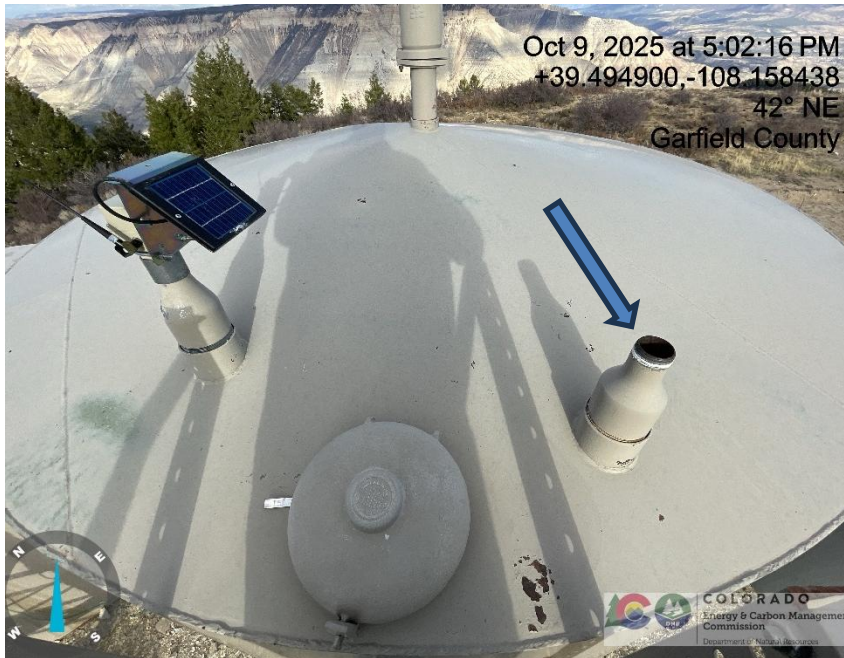
**Photo # 6035 Open ended pipe on production tank/available for entry by wildlife/wildlife hazard**

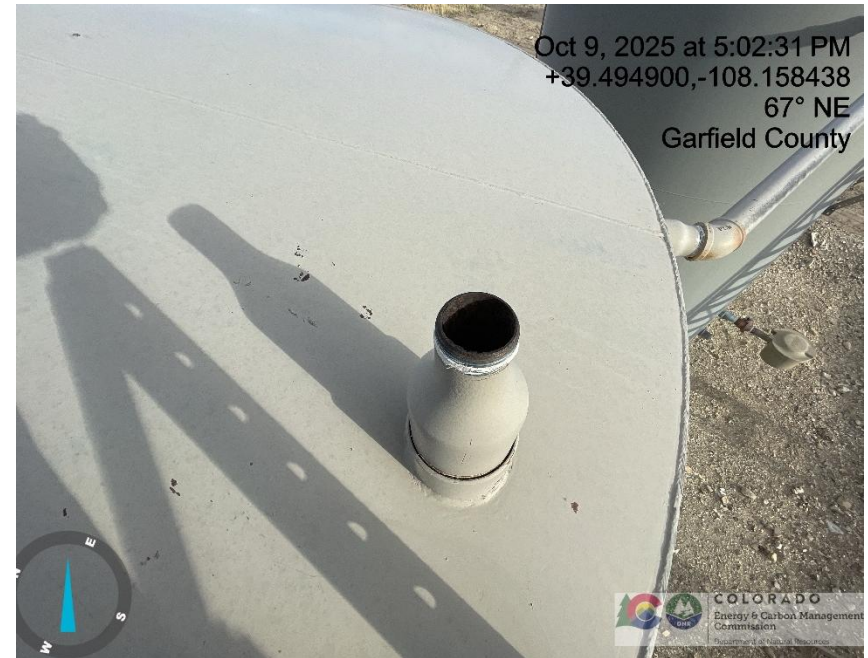
**Photo # 6036 Open ended pipe on production tank/available for entry by wildlife/wildlife hazard**

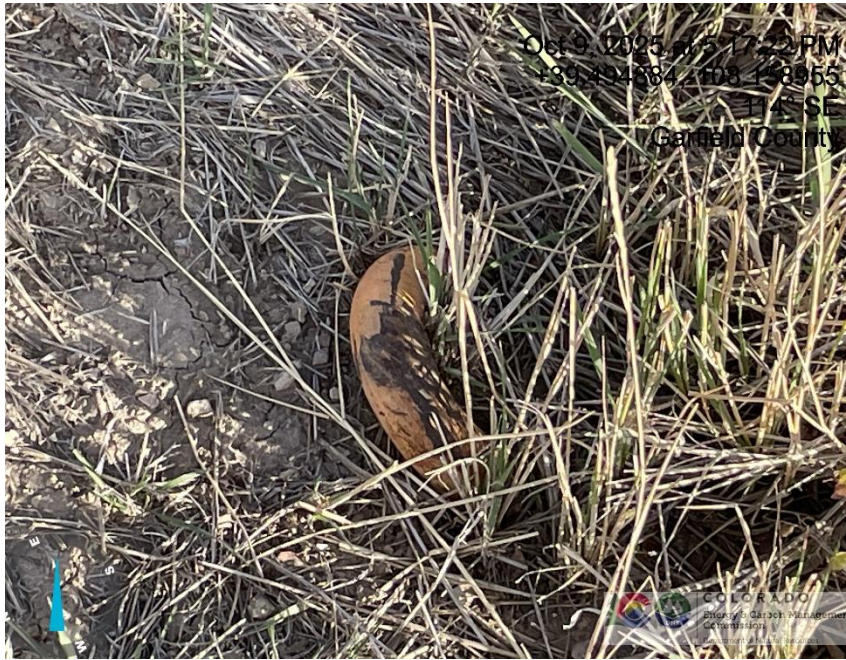
Photo # 6037 Unmarked deadman

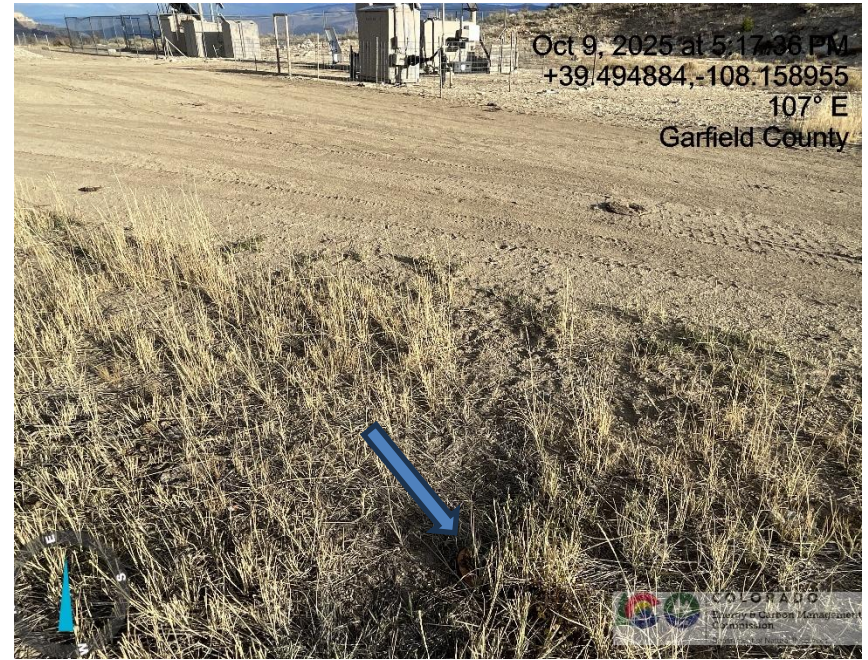
Photo # 6038 Same unmarked deadman

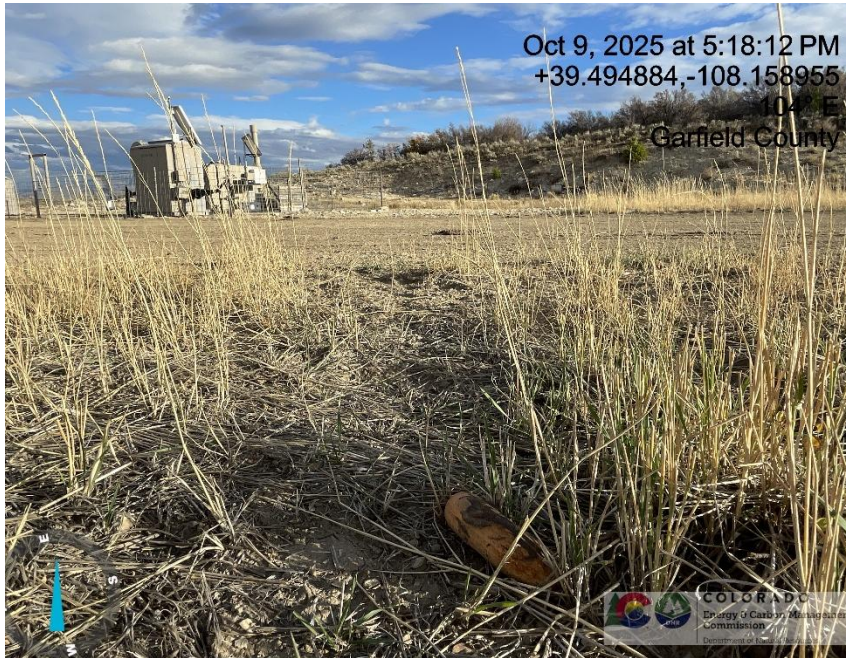
Photo # 6039 Same unmarked deadman

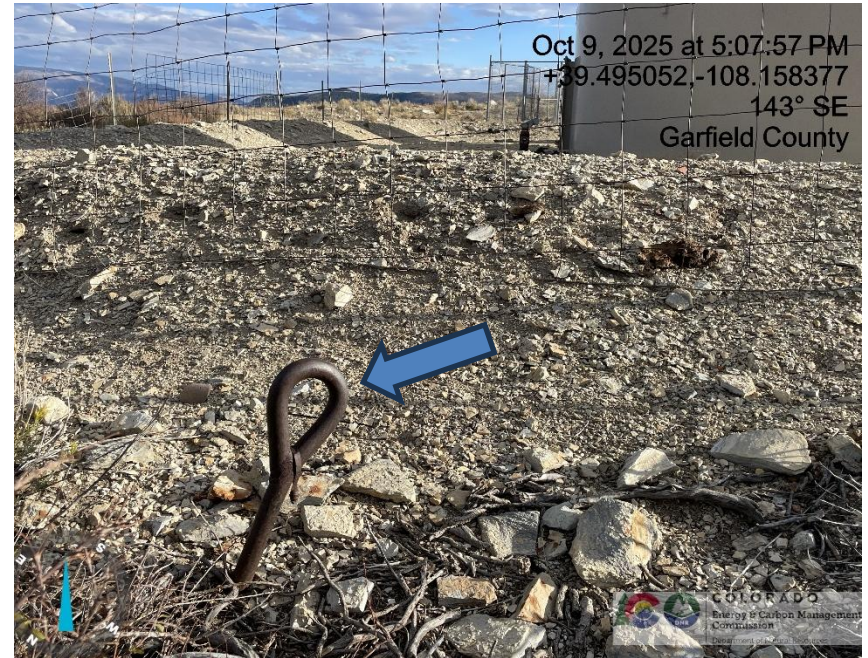
Photo # 6040 Unmarked deadman

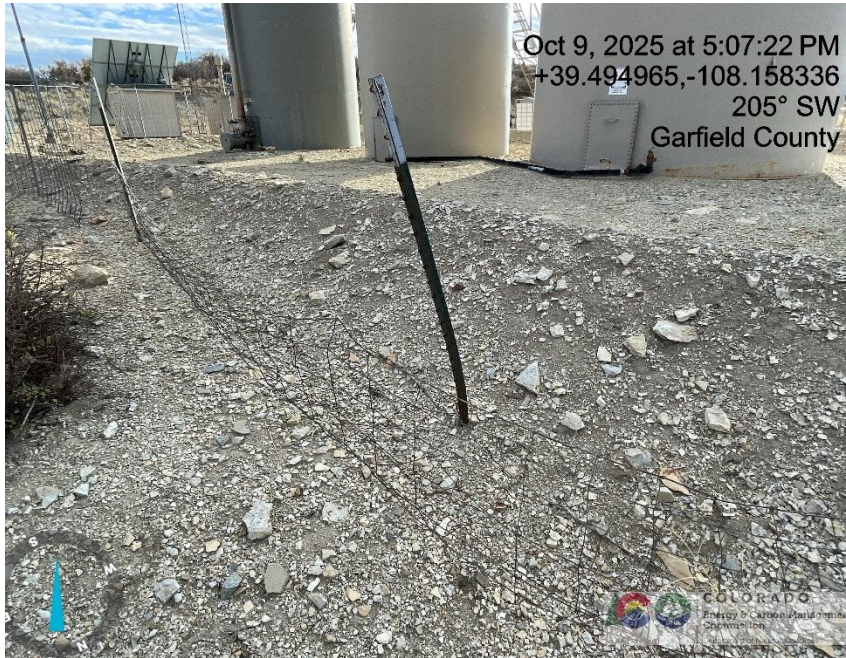
Photo # 6041 Fencing around tank battery needs maintenance

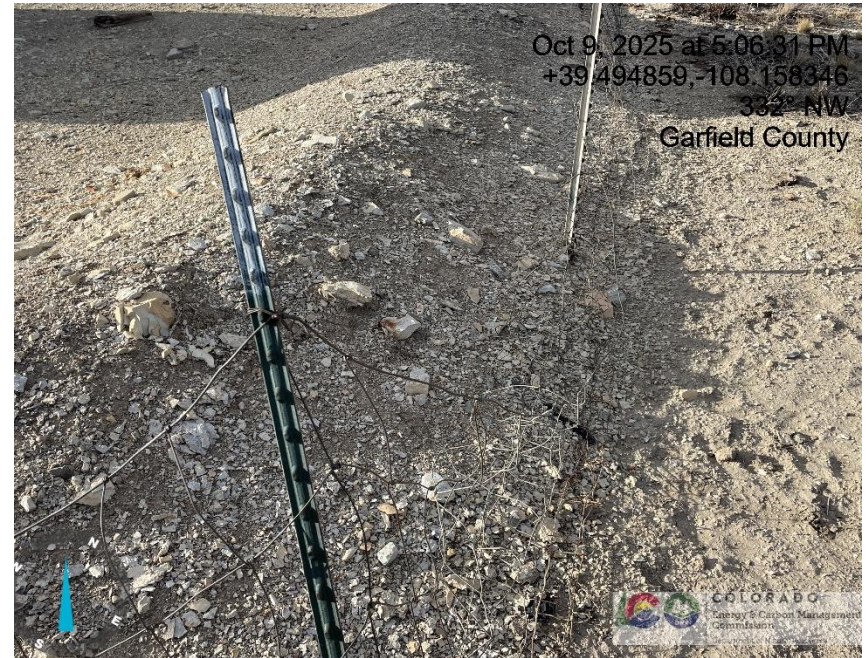
Photo # 6042 Fencing around tank battery needs maintenance

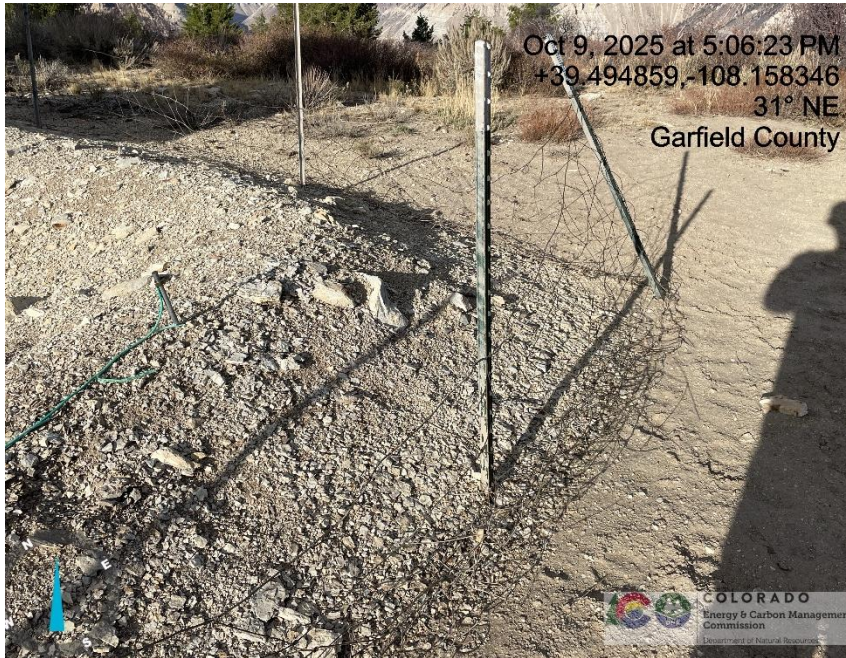
Photo # 6043 Fencing around tank battery needs maintenance

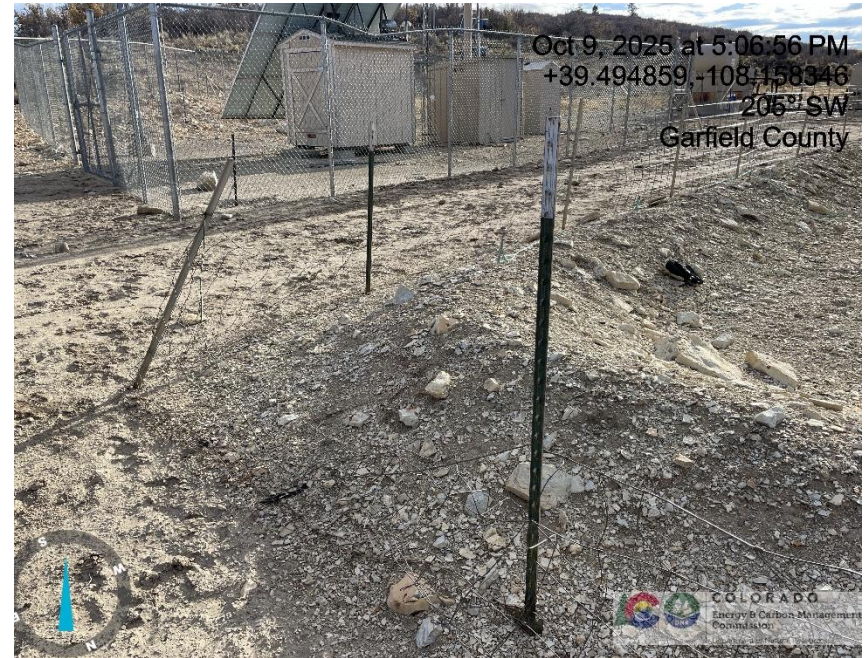
Photo # 6044 Fencing around tank battery needs maintenance
