Final Reclamation Inspection

Operator: PDC ENERGY INC - 69175

Location ID: 331556

Inspection Photos
Location Name: GADDIS #41-36
Location ID: 331556

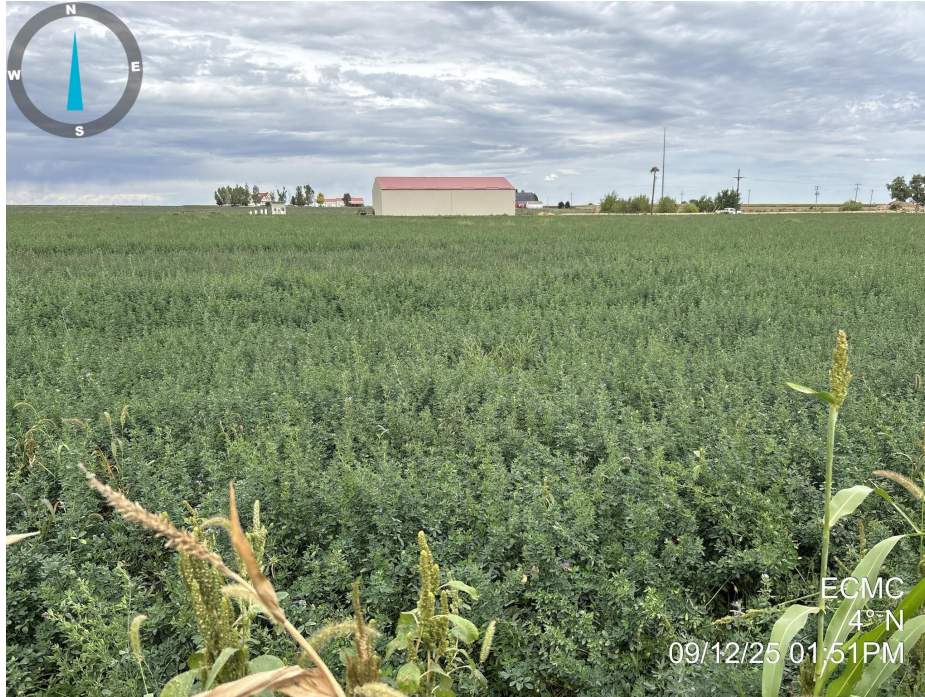
Photo 1. Photo taken of the well location, facing north. Photo illustrates that final reclamation activities have taken place, but vegetation establishment does not meet Rule 1004 standards as corn growth did not match that of reference areas.

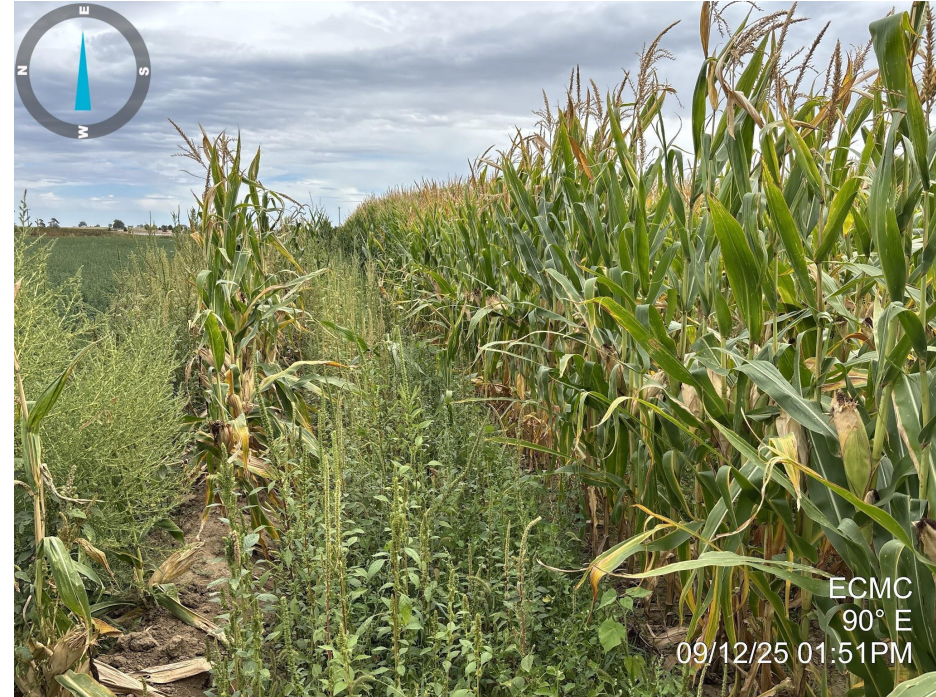
Photo 2. Photo taken of well location, facing east. See comments under Photo 1.

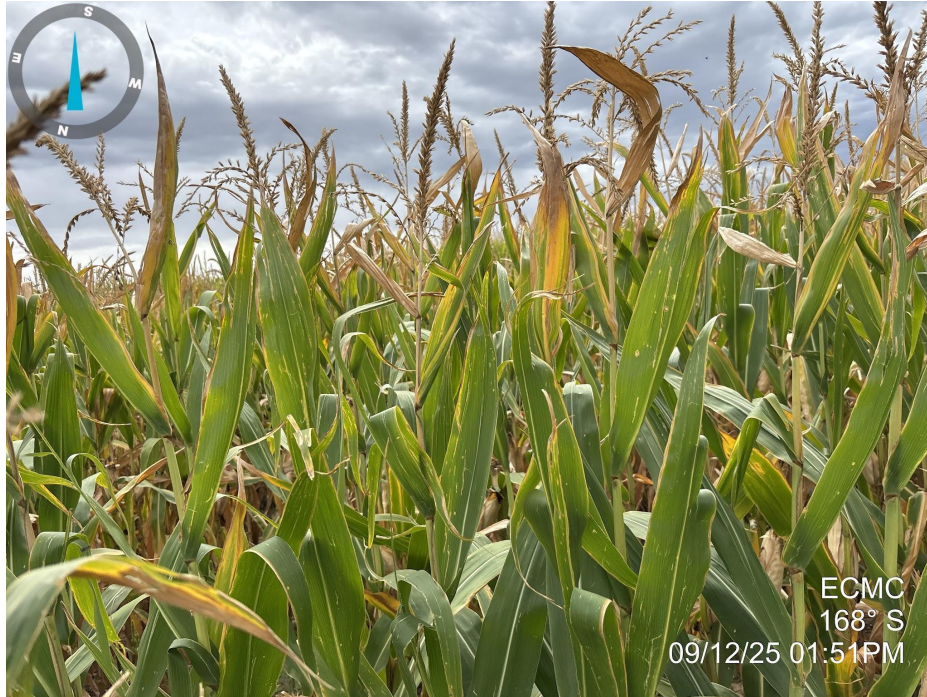
Photo 3. Photo taken of the well location, facing south. See comments under Photo 1.

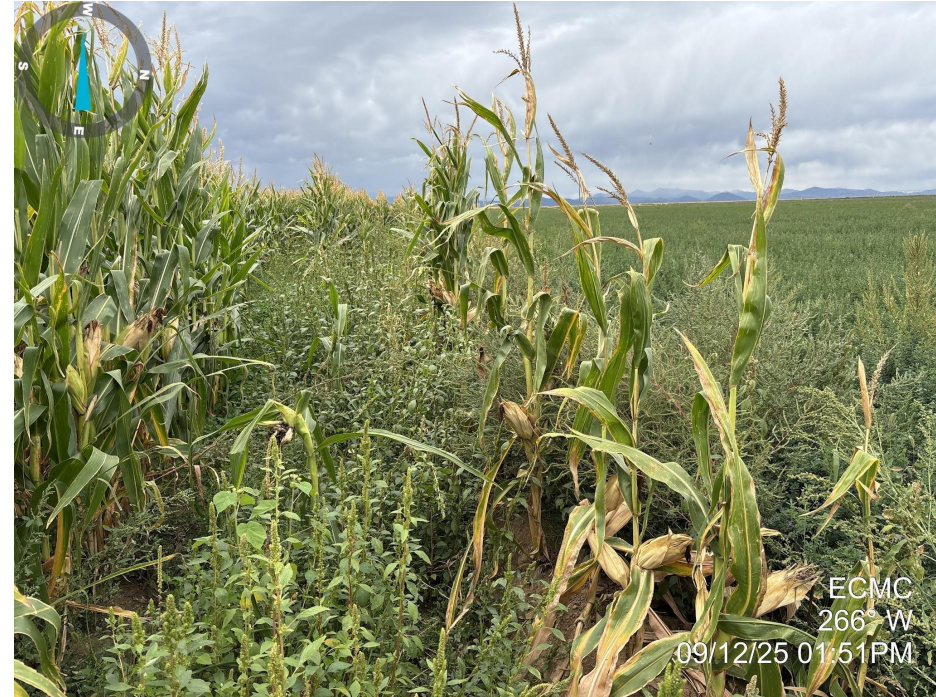
Photo 4. Photo taken of the well location, facing west. See comments under Photo 1.

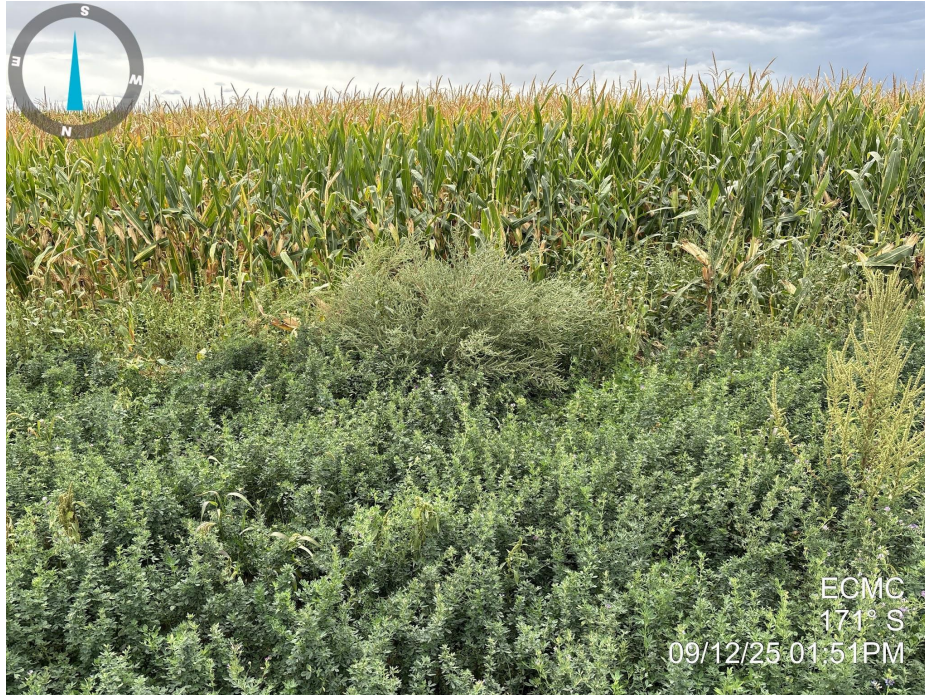
Photo 5. Photo taken of the well location, facing south. Photo illustrates that final reclamation activities have taken place, but weedy annual vegetation including kochia (*Bassia scoparia*) was observed at the location and corn growth did not match that of reference areas.

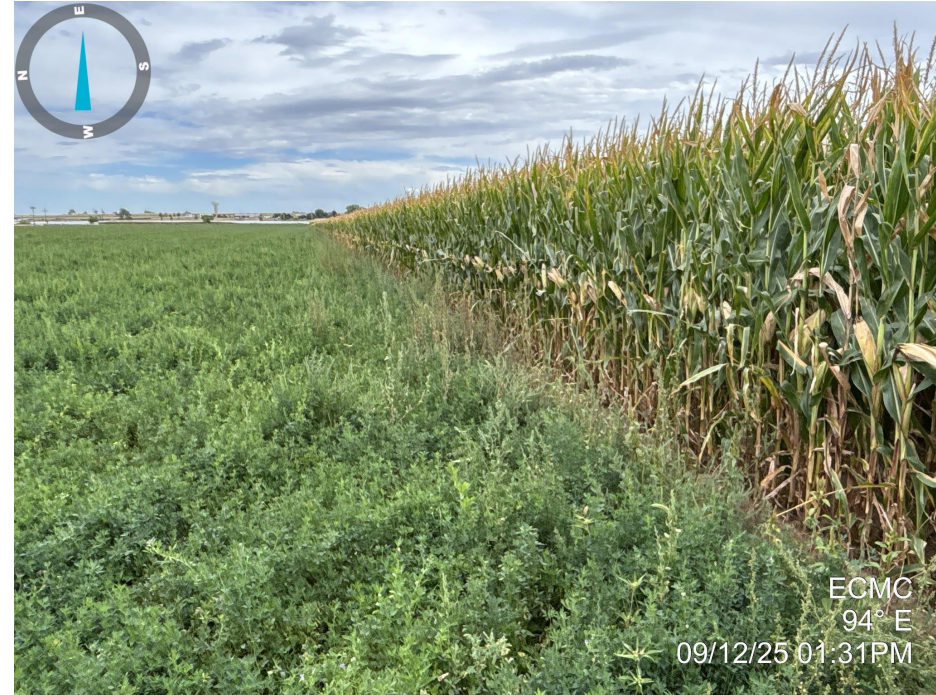
Photo 6. Photo taken of the reference area to the well location, west of the location, facing east. Photo illustrates alfalfa and corn cropland.

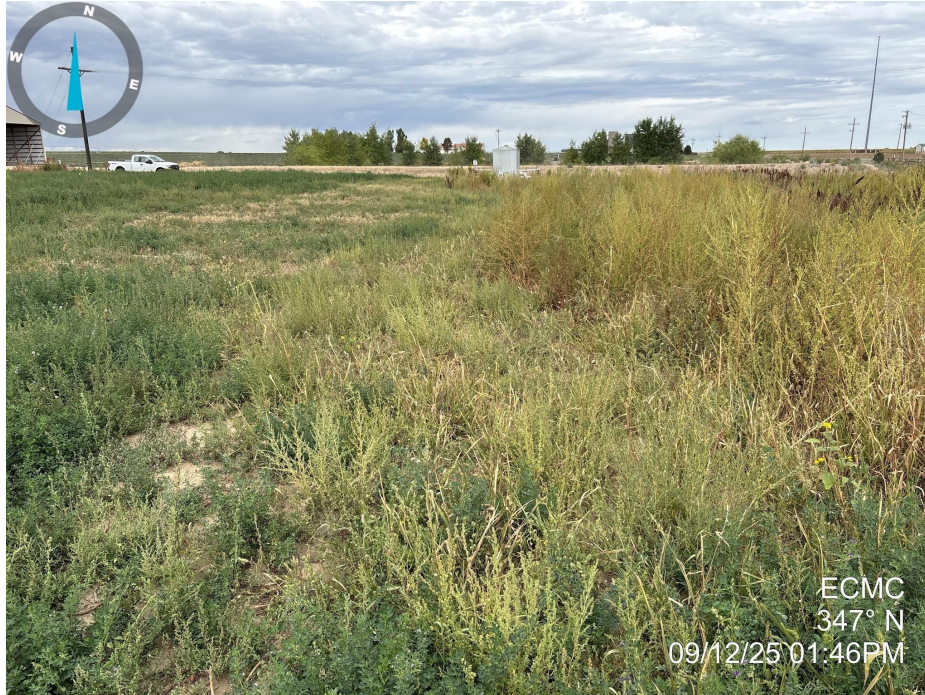
Photo 7. Photo taken of the tank battery location, facing north. Photo illustrates that final reclamation activities have taken place, but vegetation establishment does not meet Rule 1004 standards. Weed annual vegetation including kochia (*Bassia scoparia*) was observed across the location.

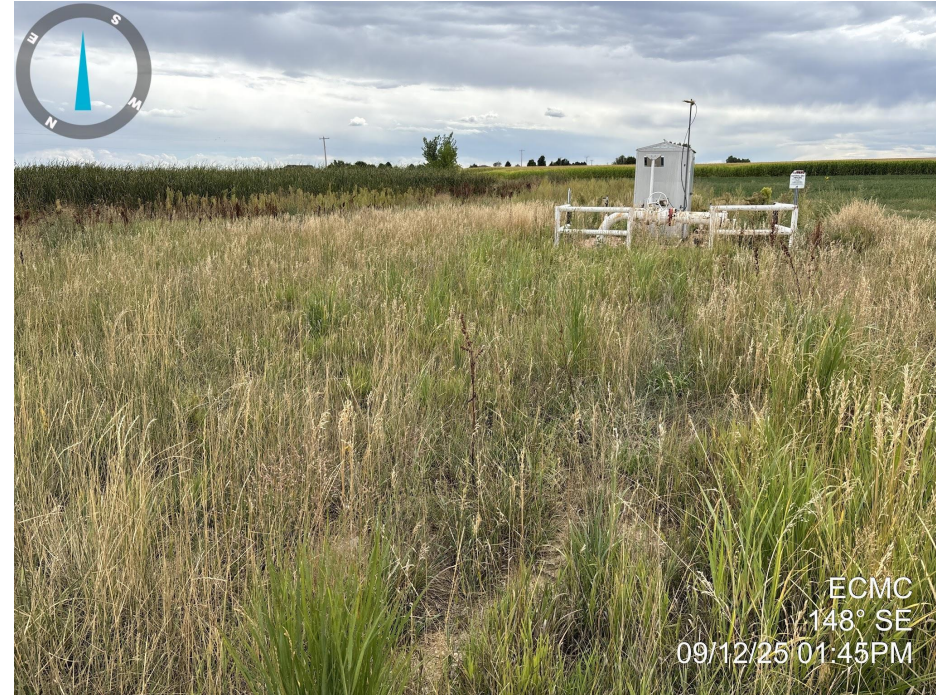
Photo 8. Photo taken of the tank battery location, facing southeast. Photo illustrates midstream equipment remains at the location.

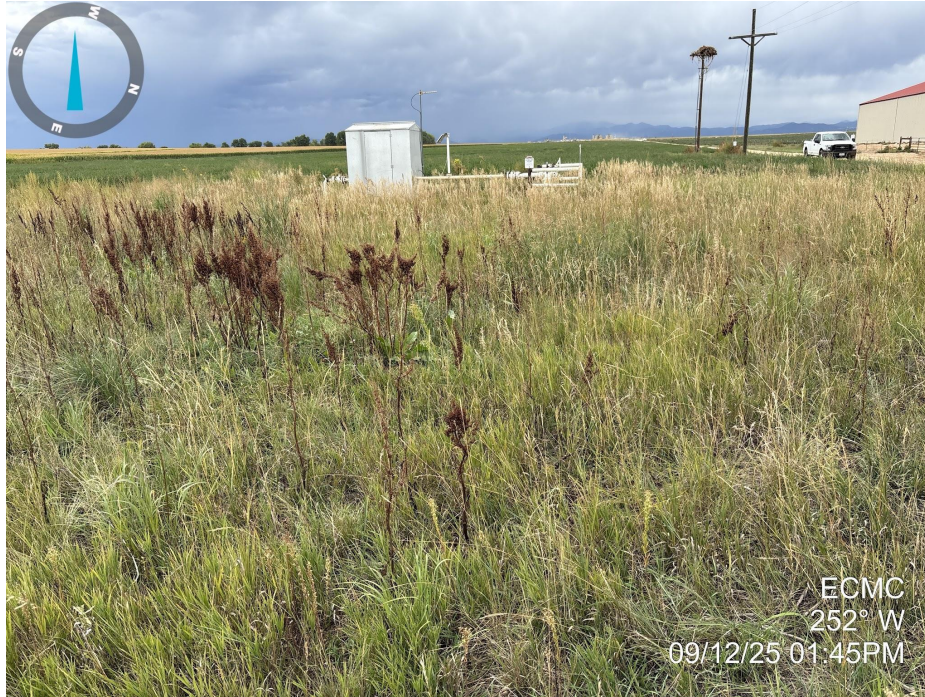
Photo 9. Photo taken of the tank battery location, facing west. See comments under Photo 7.

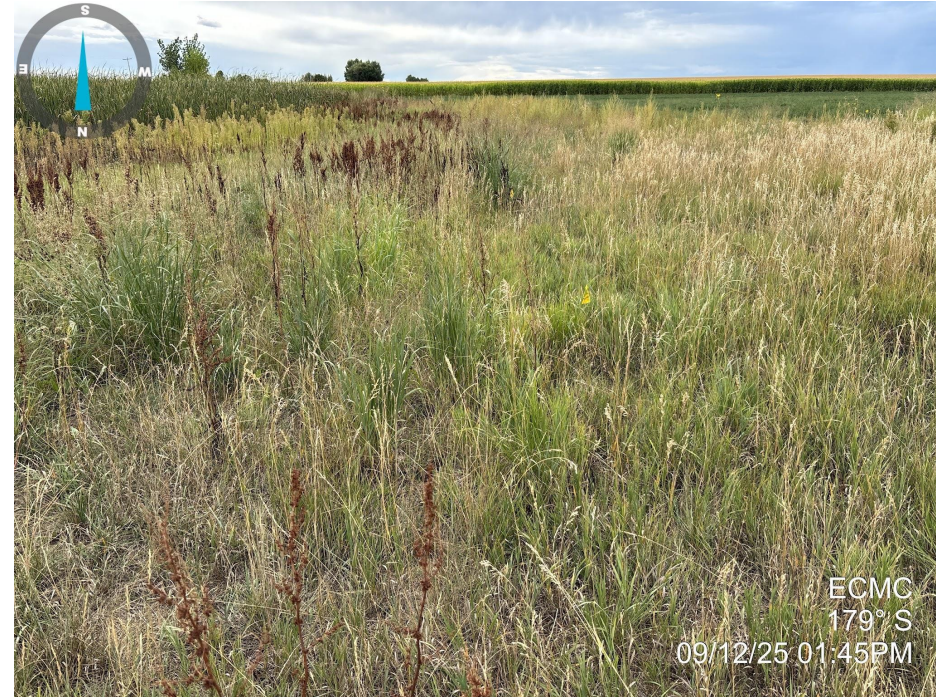
Photo 10. Photo taken of the tank battery location, facing south. See comments under Photo 7.

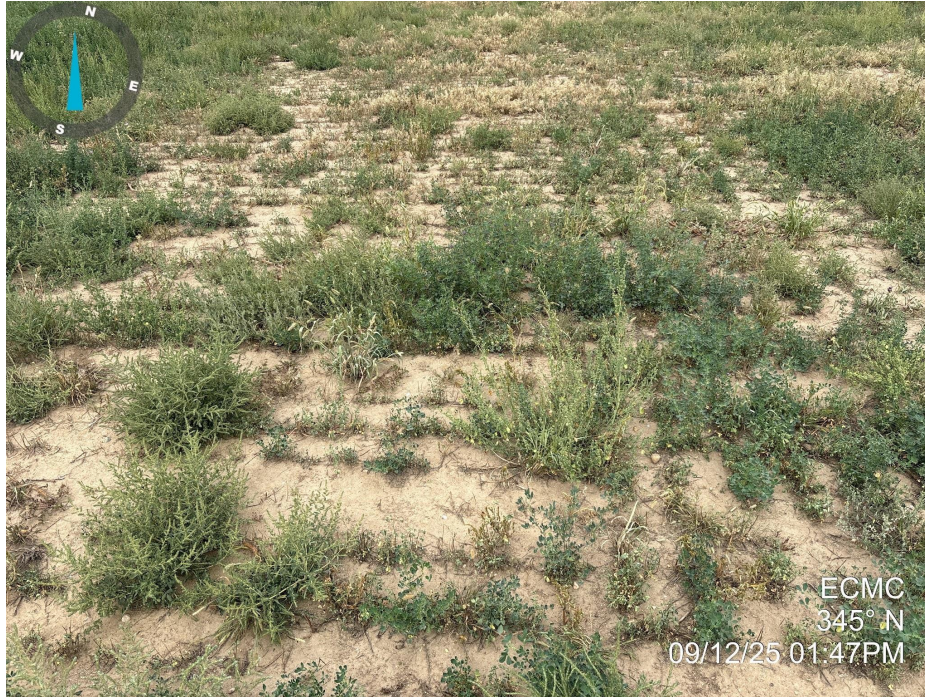
Photo 11. Photo taken ground cover at the tank battery location, facing north. Photo illustrates weedy annual vegetation including kochia (*Bassia scoparia*).

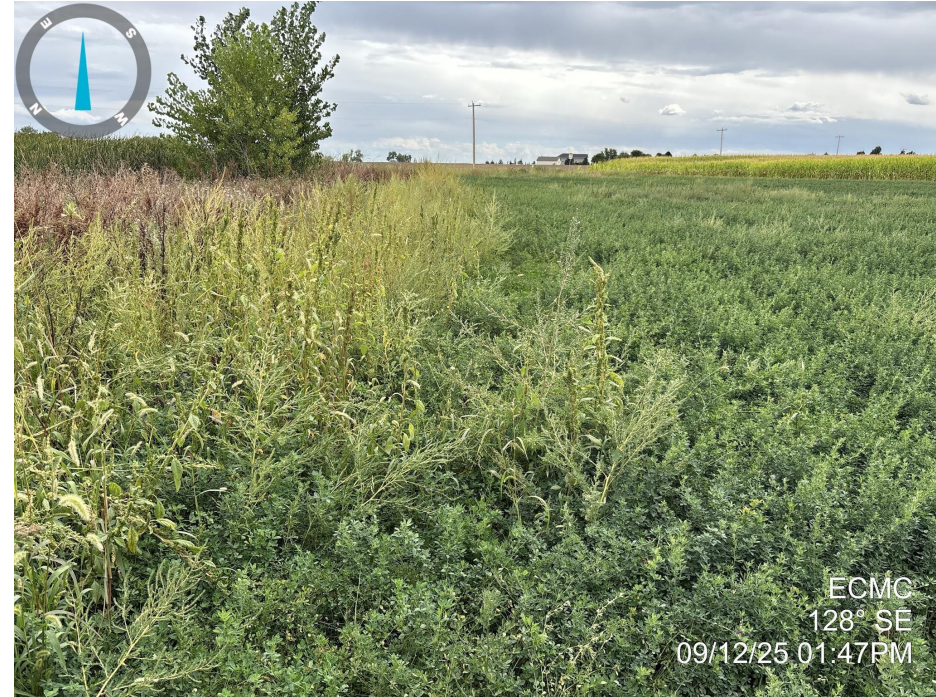
Photo 12. Photo taken of the reference area to the well location, south of the location, facing southeast. Photo illustrates alfalfa cropland bordering a wetland area with weedy annual vegetation.
