Inspection Photos  
Location Name: Rice 06-06 J I  
Location ID: 305815

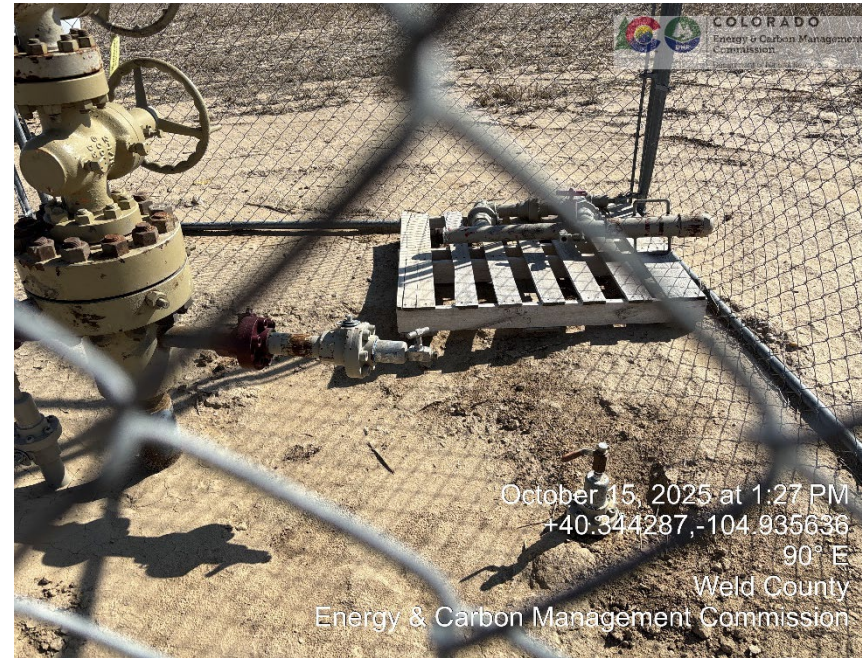
Disconnected flowline
