Inspection Photos

Location Name: Dillard USX AB/09-99HZ

Location #: 415940

**Energy & Carbon Management
Commission**

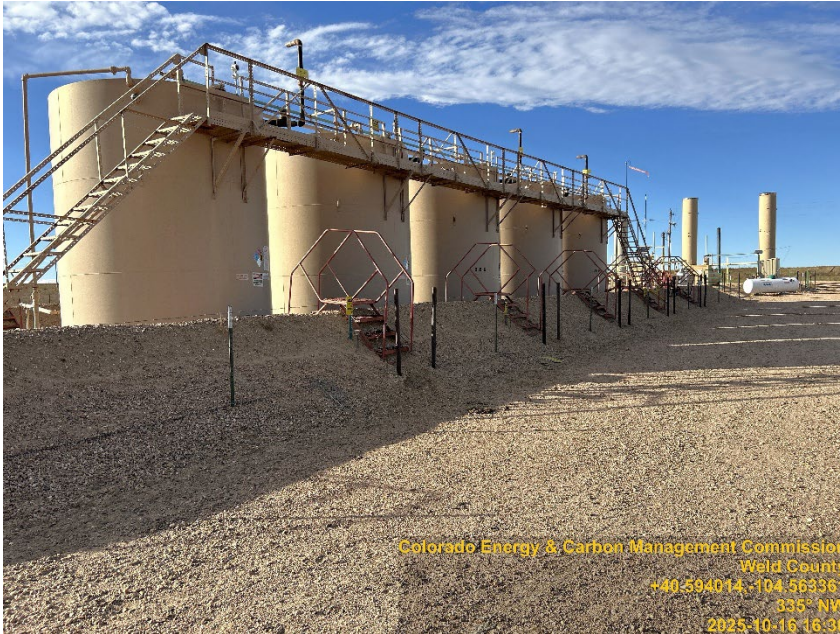
Photo #1

Inactive | Shut-down

Equipment documented: Loc. ID 415940

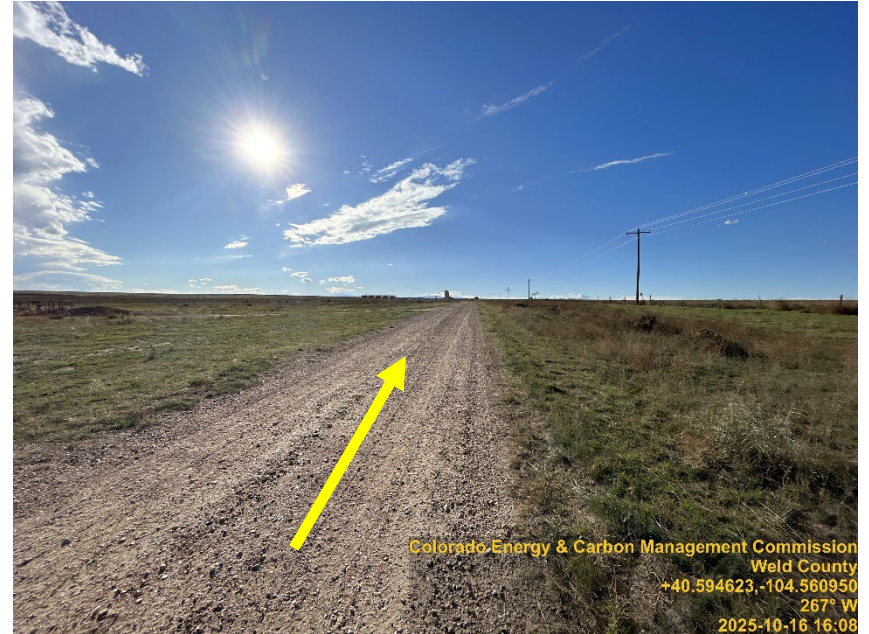
Photo #2

Inactive | Shut-down

Wellsite(s), Battery entrance

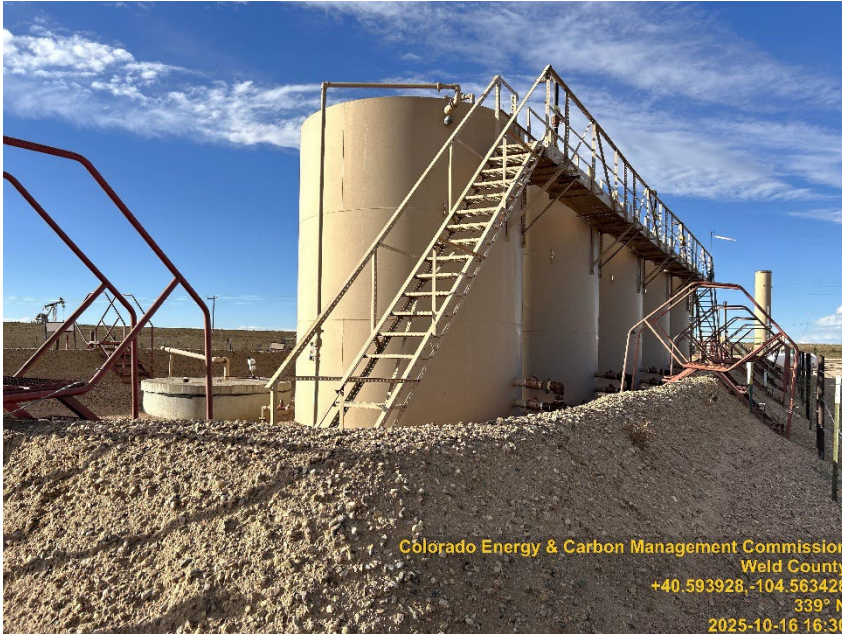
Photo #3

Inactive | Shut-down

Crude Oil tank(s), Produced H2O vault(s); SE corner

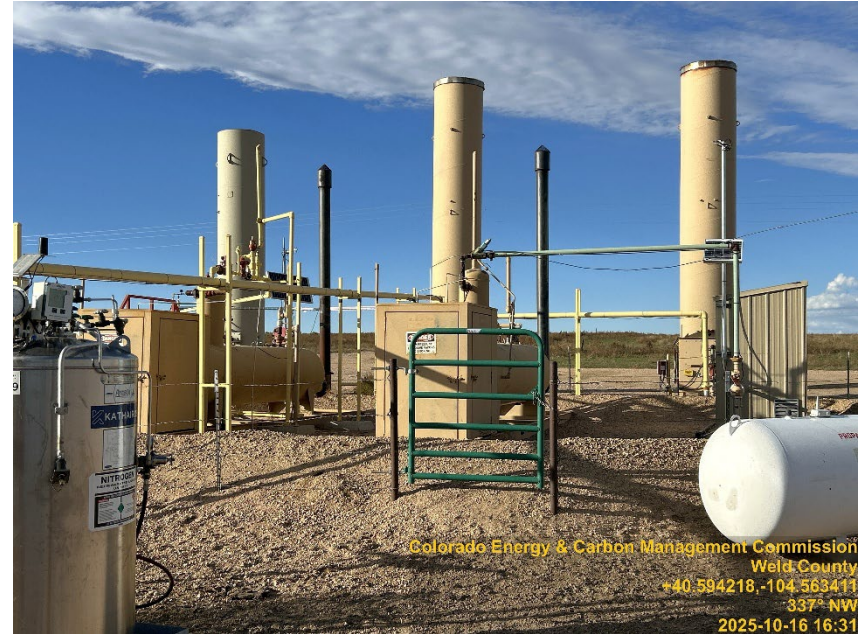
Photo #4

Inactive | Shut-down

Separator(s), ECD(s)

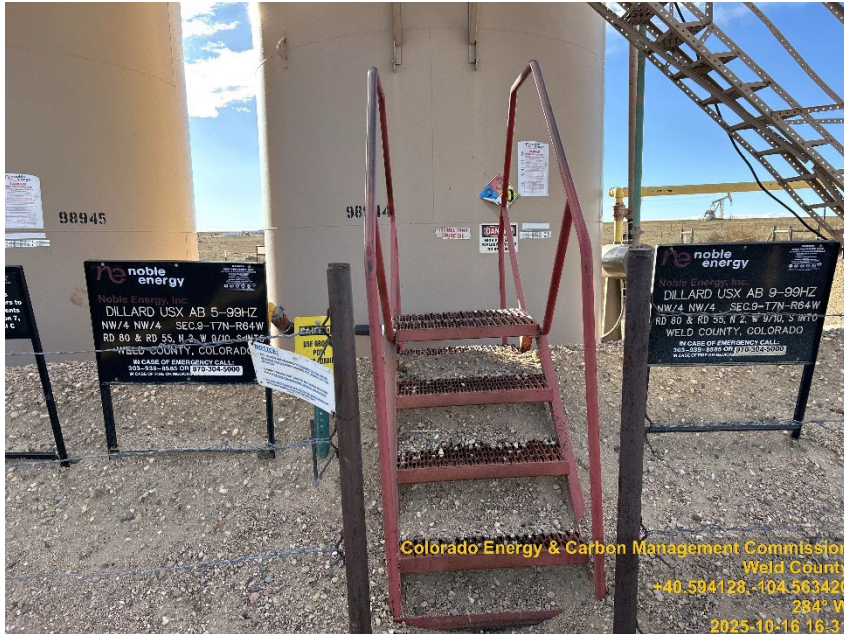
Photo #5

Inactive | Shut-down

Battery signage
