## Inspection Photos

Location: HORN SPRINGS GAS COM 3-32-33, 1-32

Location ID: 307268

API # 05-071-06101

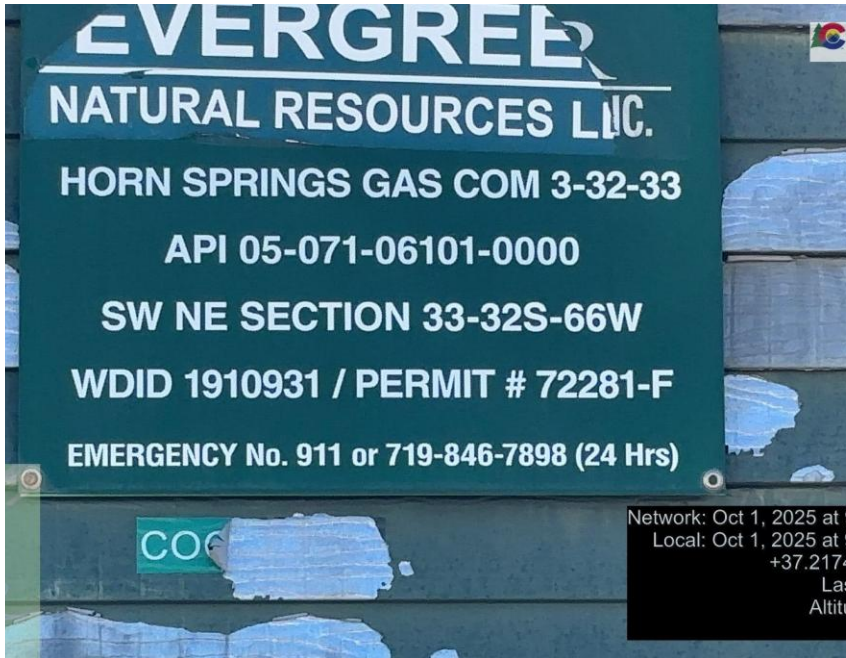
**Photo 1 – Adjacent well site Information**

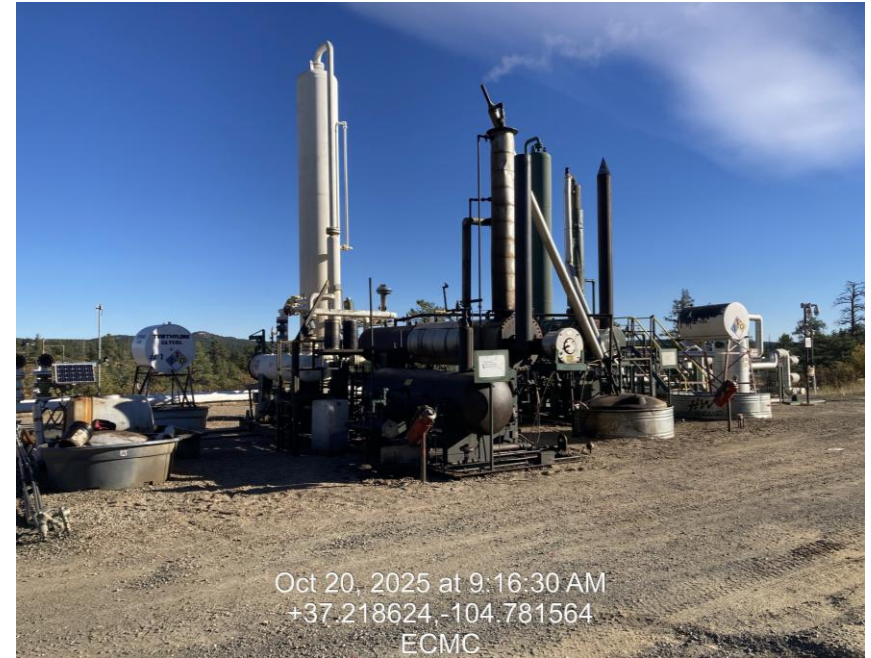
**Photo 2 – Location Overview**

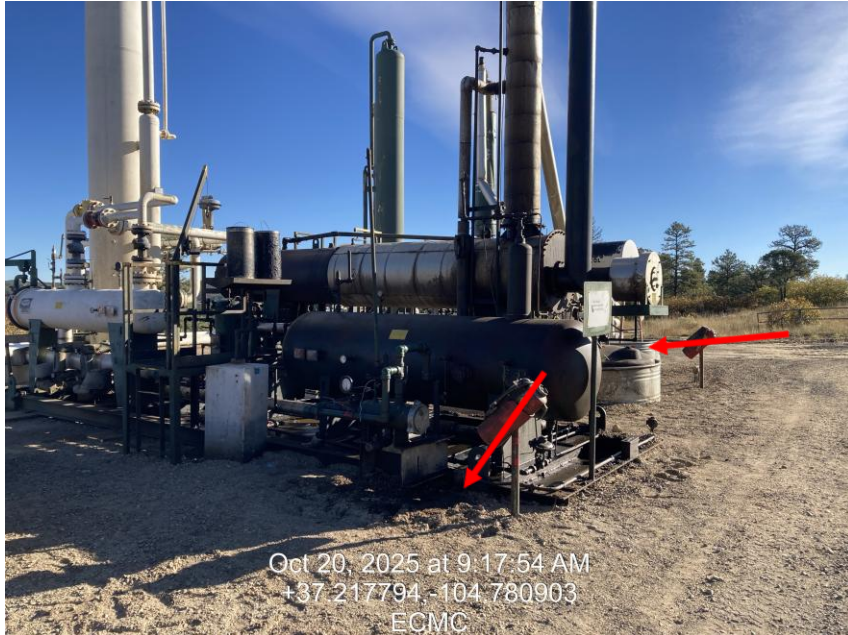
**Photo 3 – Impacted soils at arrow and between Dehydration Units**

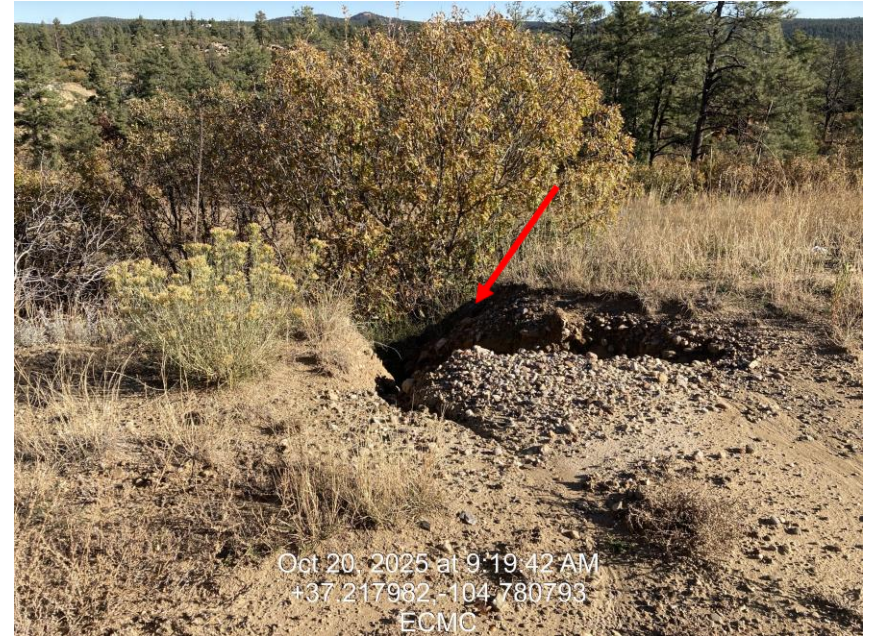
**Photo 4 – Erosion**

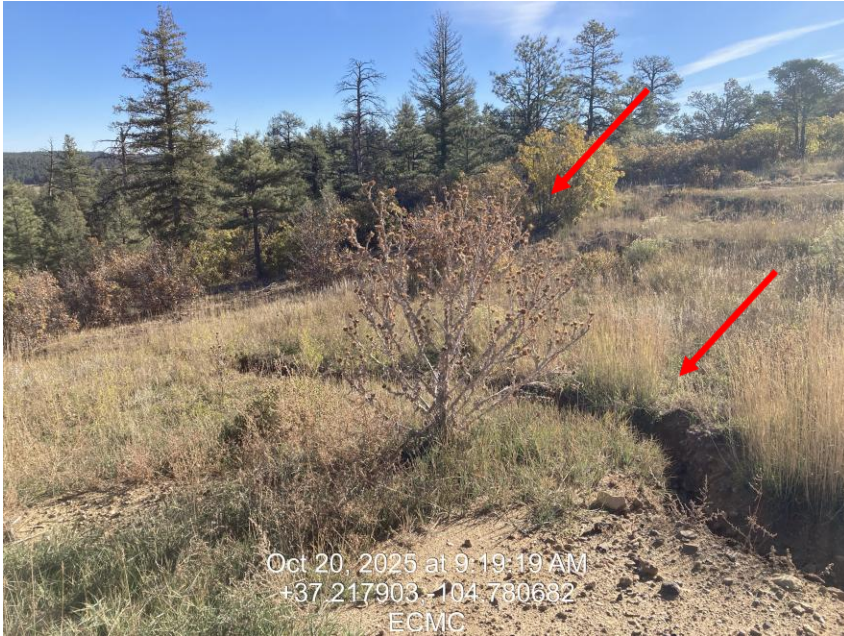
**Photo 5 – Erosion and Noxious Weeds**

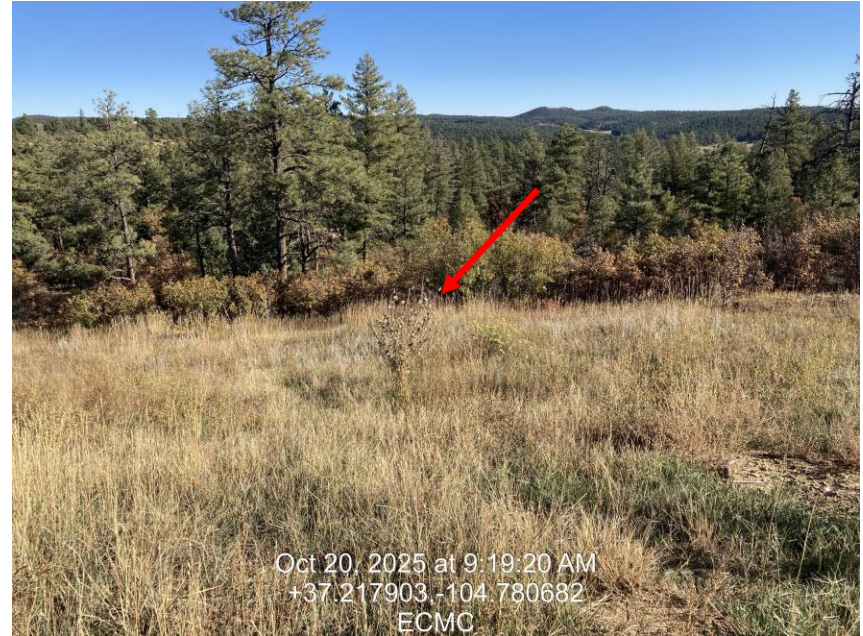
**Photo 6 – Noxious weeds**

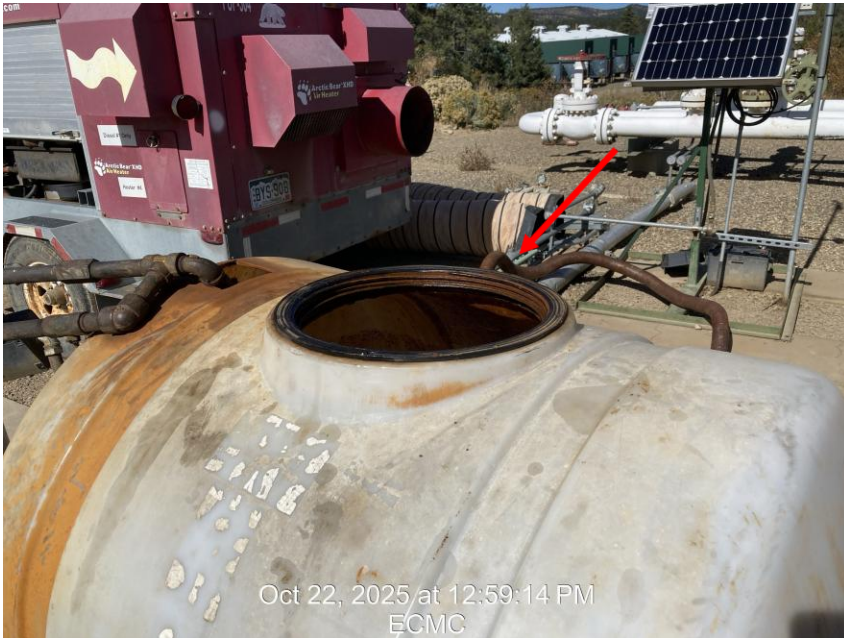
**Photo 7 – Missing cap, wildlife protection**

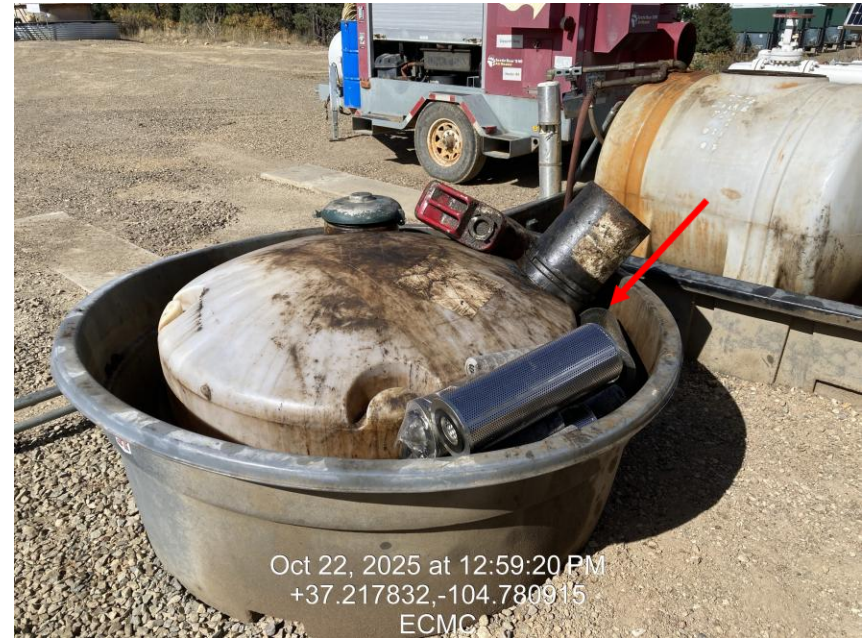
**Photo 8 – Dehydration Filters Improperly Stored**

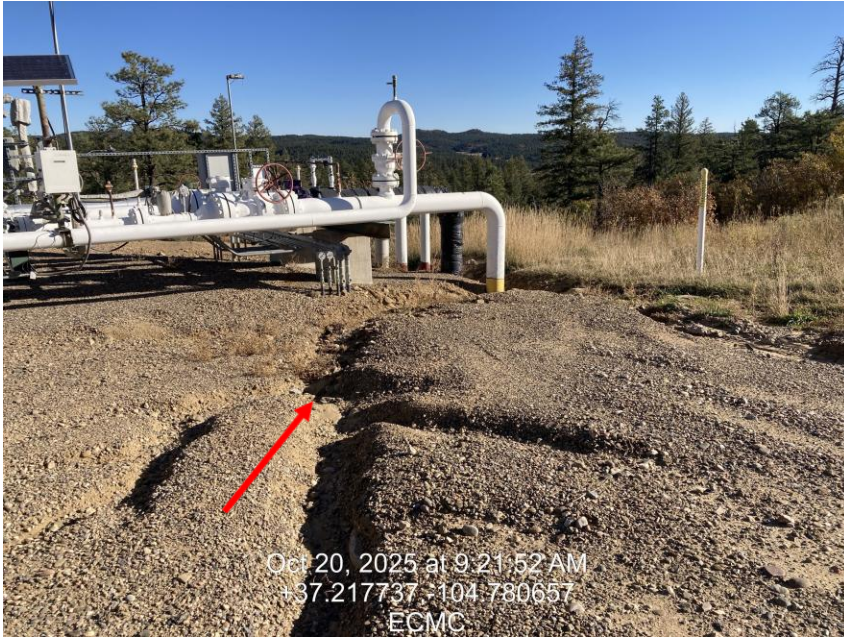
**Photo 9 – Erosion**

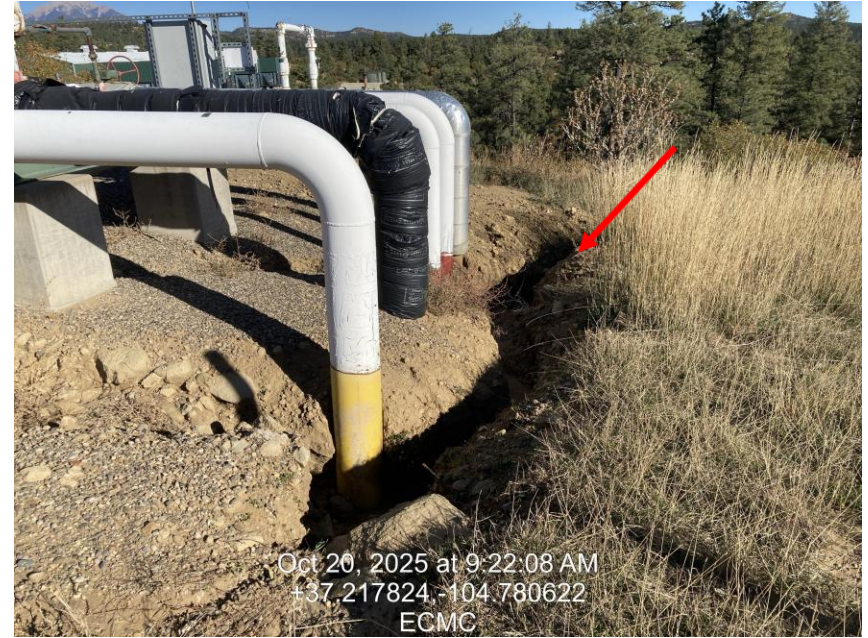
**Photo 10 – Erosion**

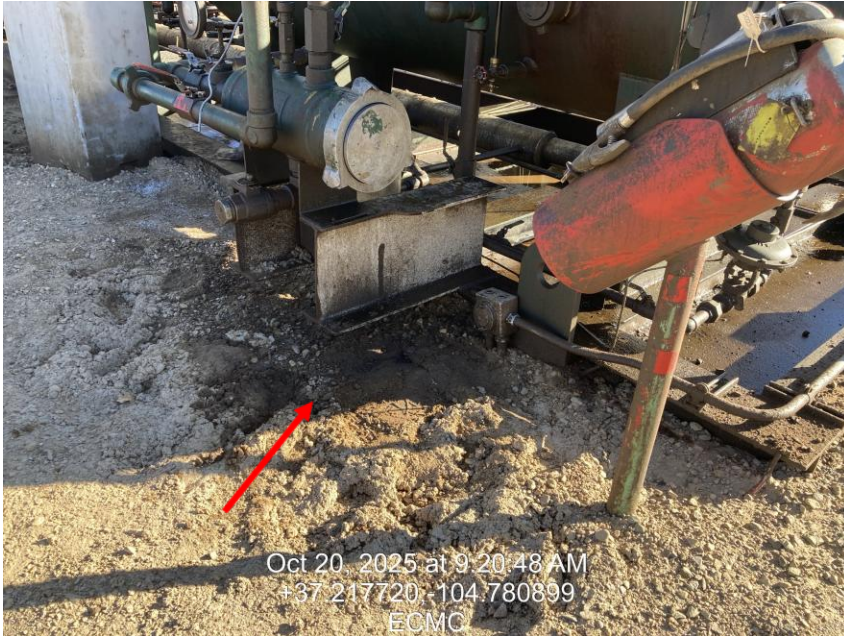
**Photo 11 – Impacted soils**
