WELL NAME: HORN SPRINGS GAS COM 3-32-33, API #: 071-06101, INSP. # 716301577

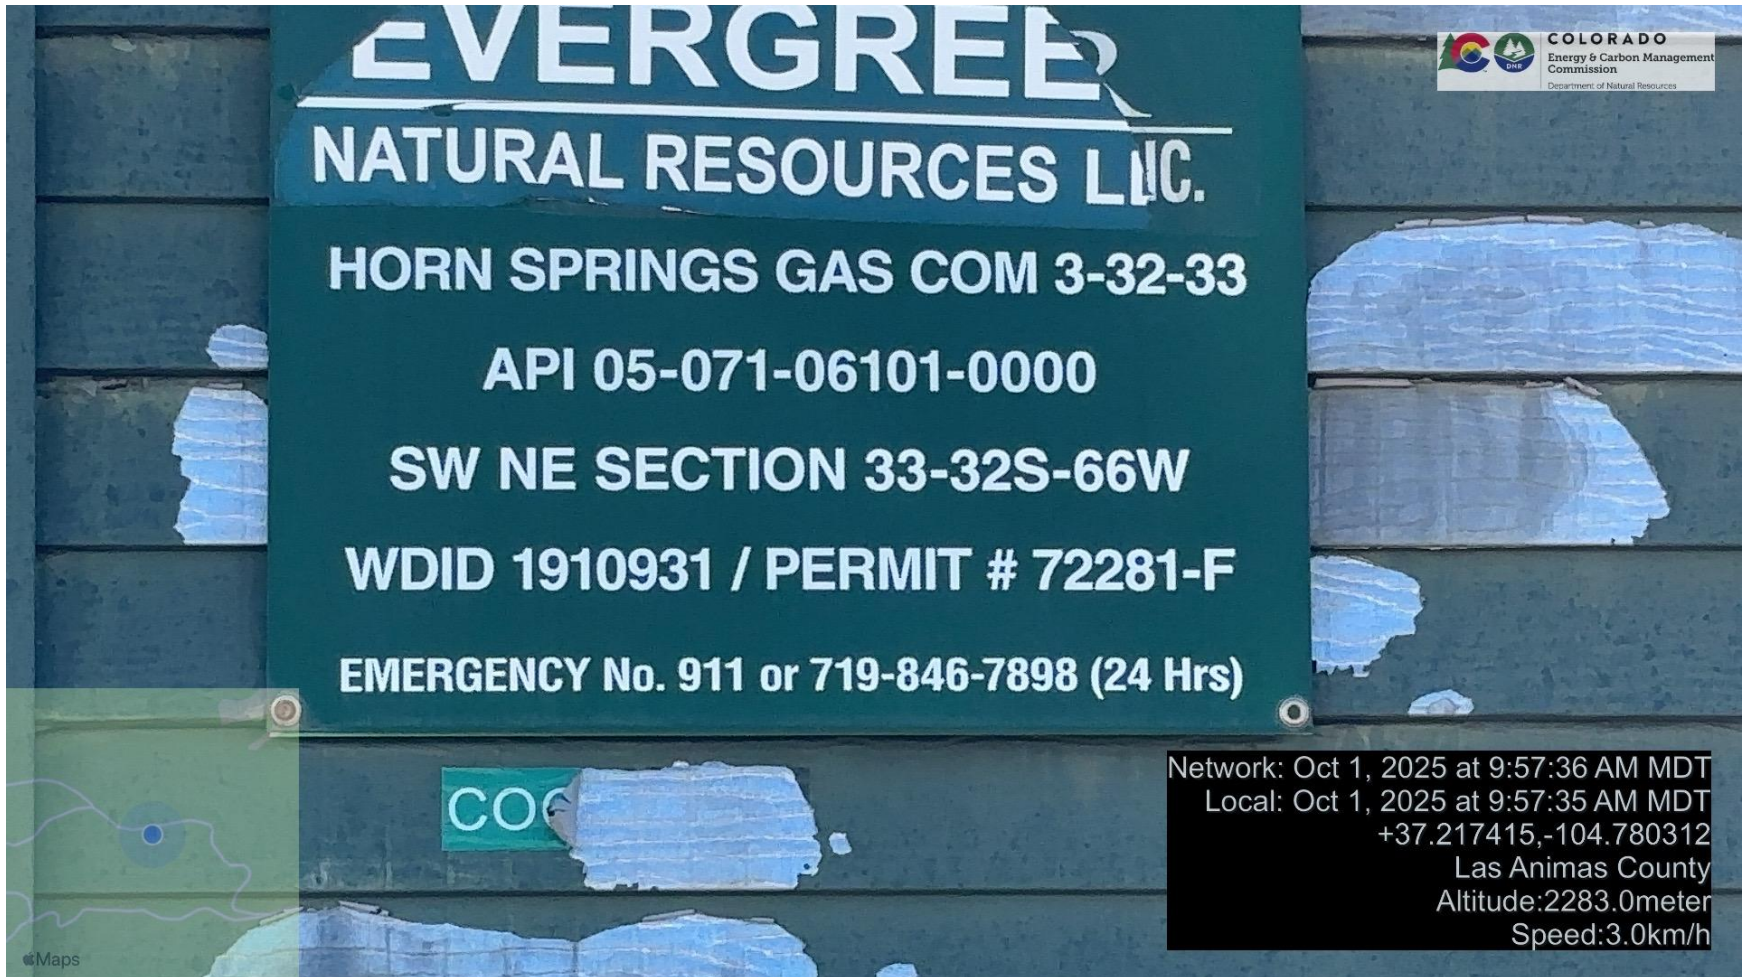
PHOTO 1: WELL SIGN

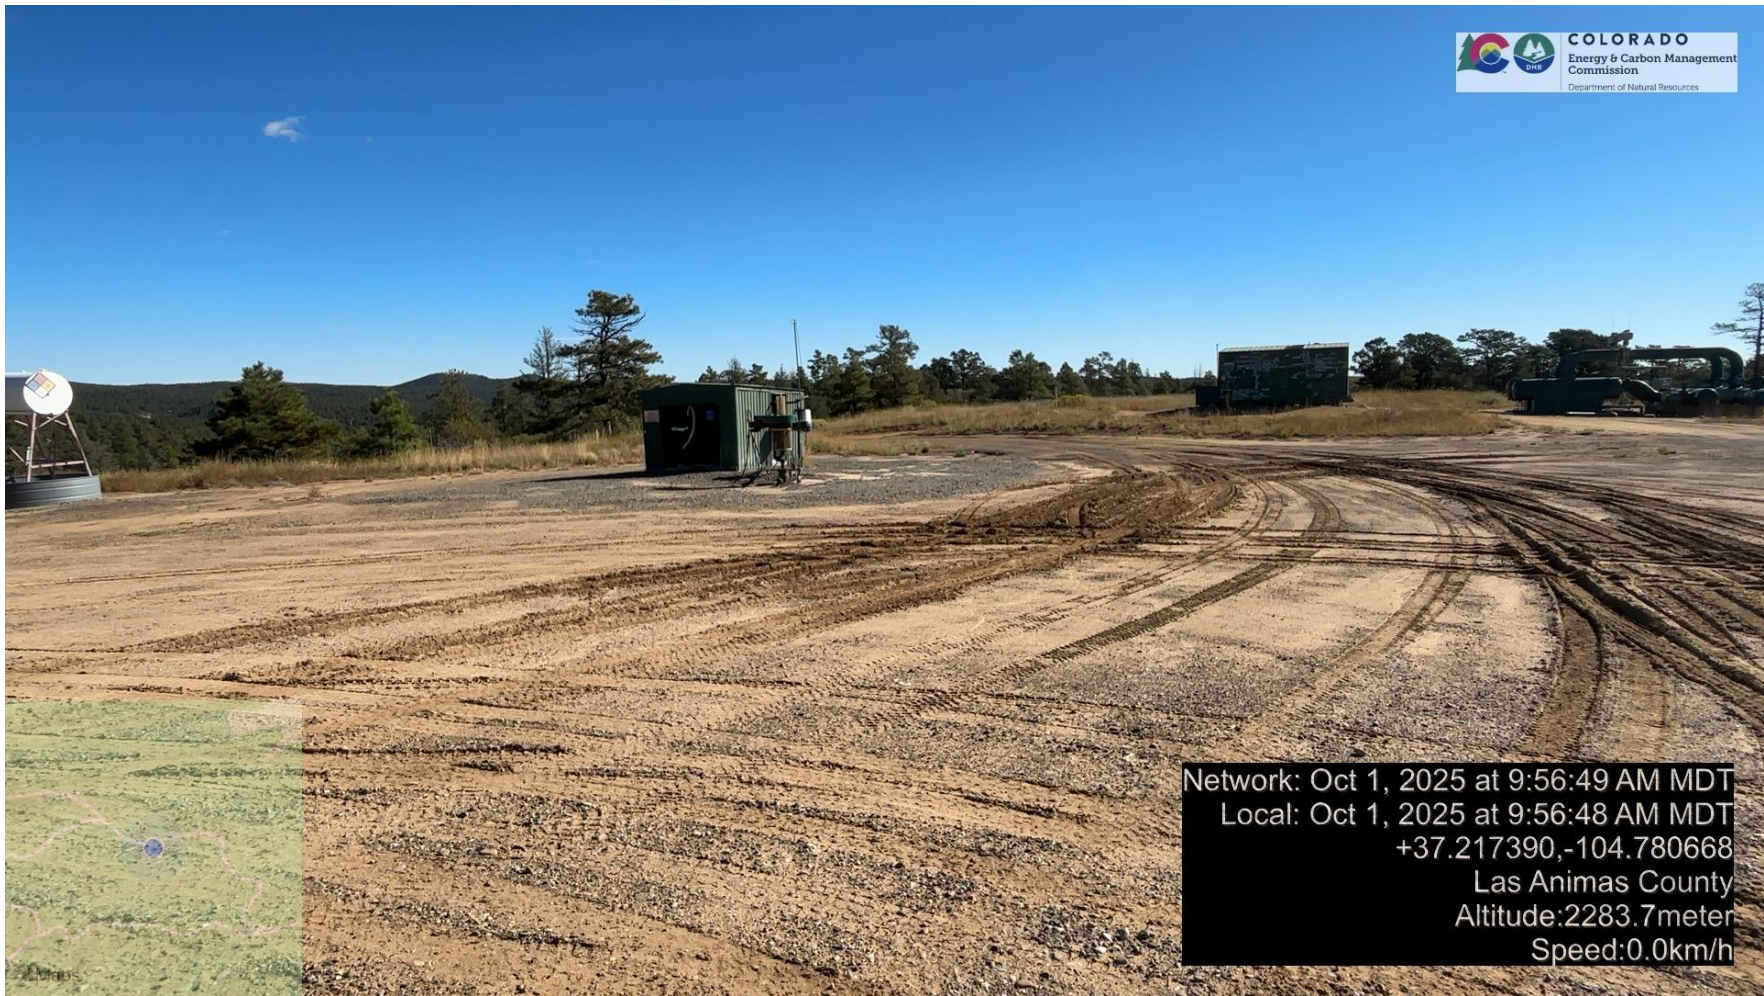
PHOTO 2: LOCATION.

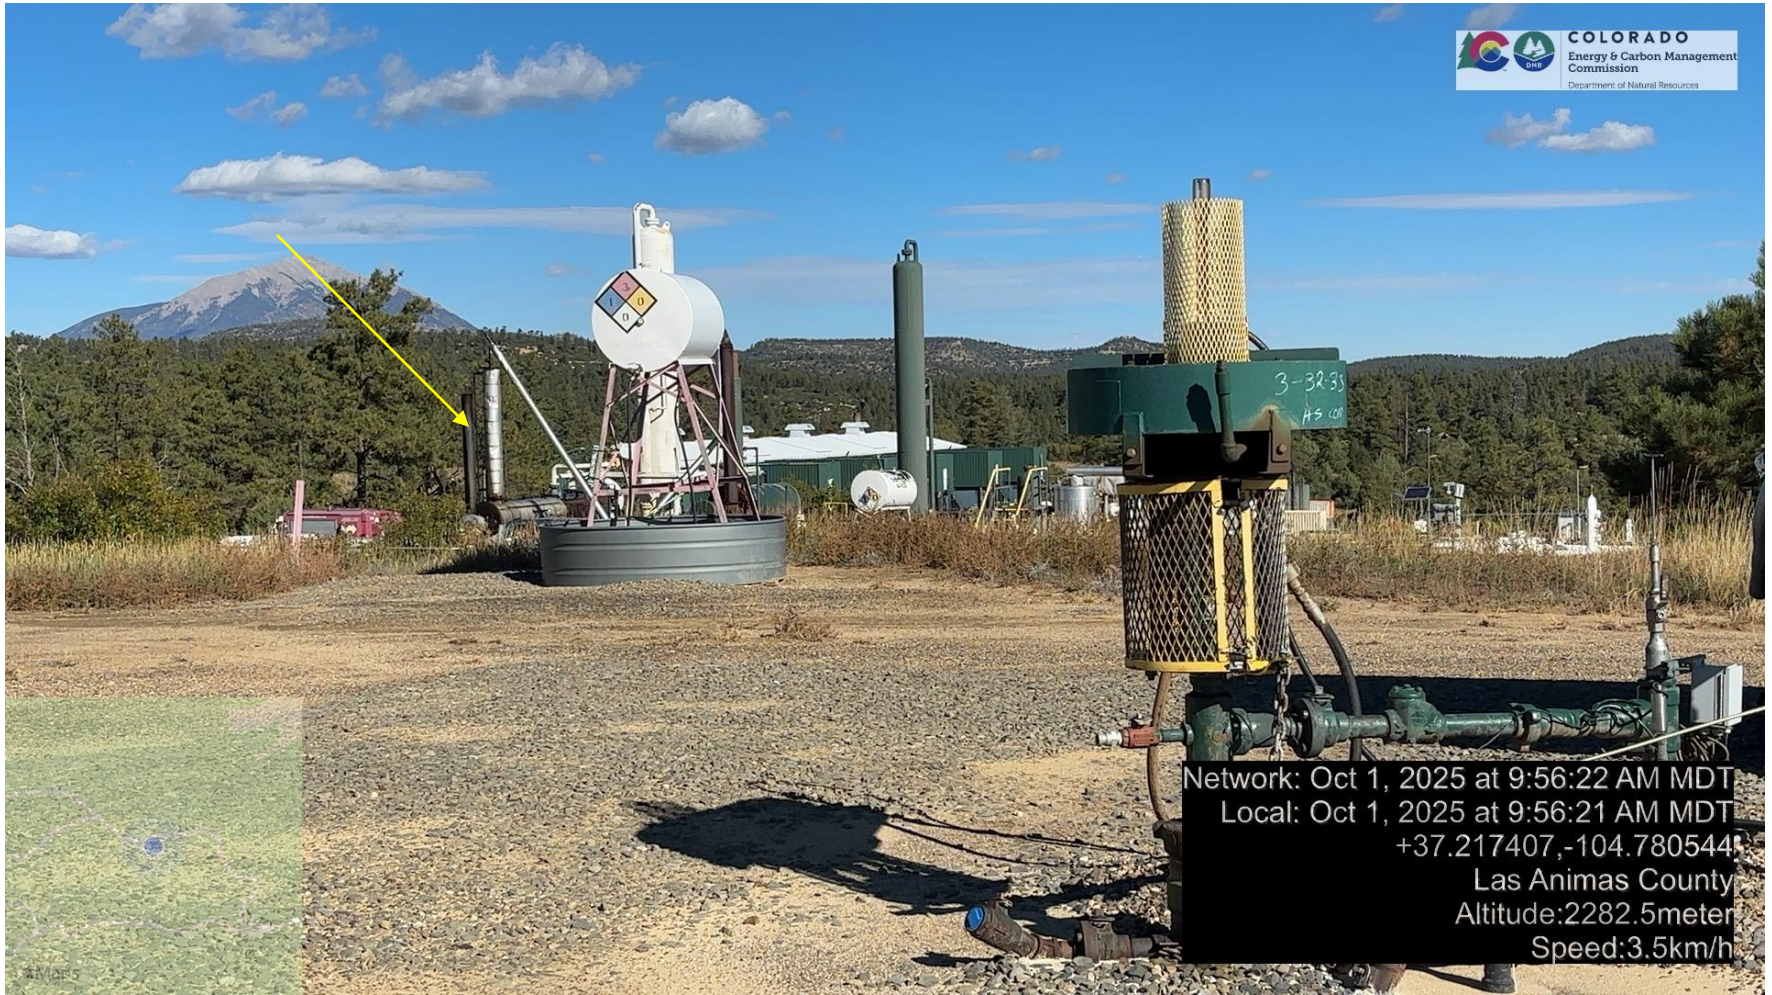
PHOTO 3: AROW SHOWING THE EQUIPMENT WITH THE FAILURE APP. 120' TO THE NORTH OF THE EDGE OF LOCATION, THERE IS A ROW BETWEEN THE METHANOL TANK AND THE DEHYDRATOR EQUIPMENT THAT IS NOT SHOWN IN PHOTO.

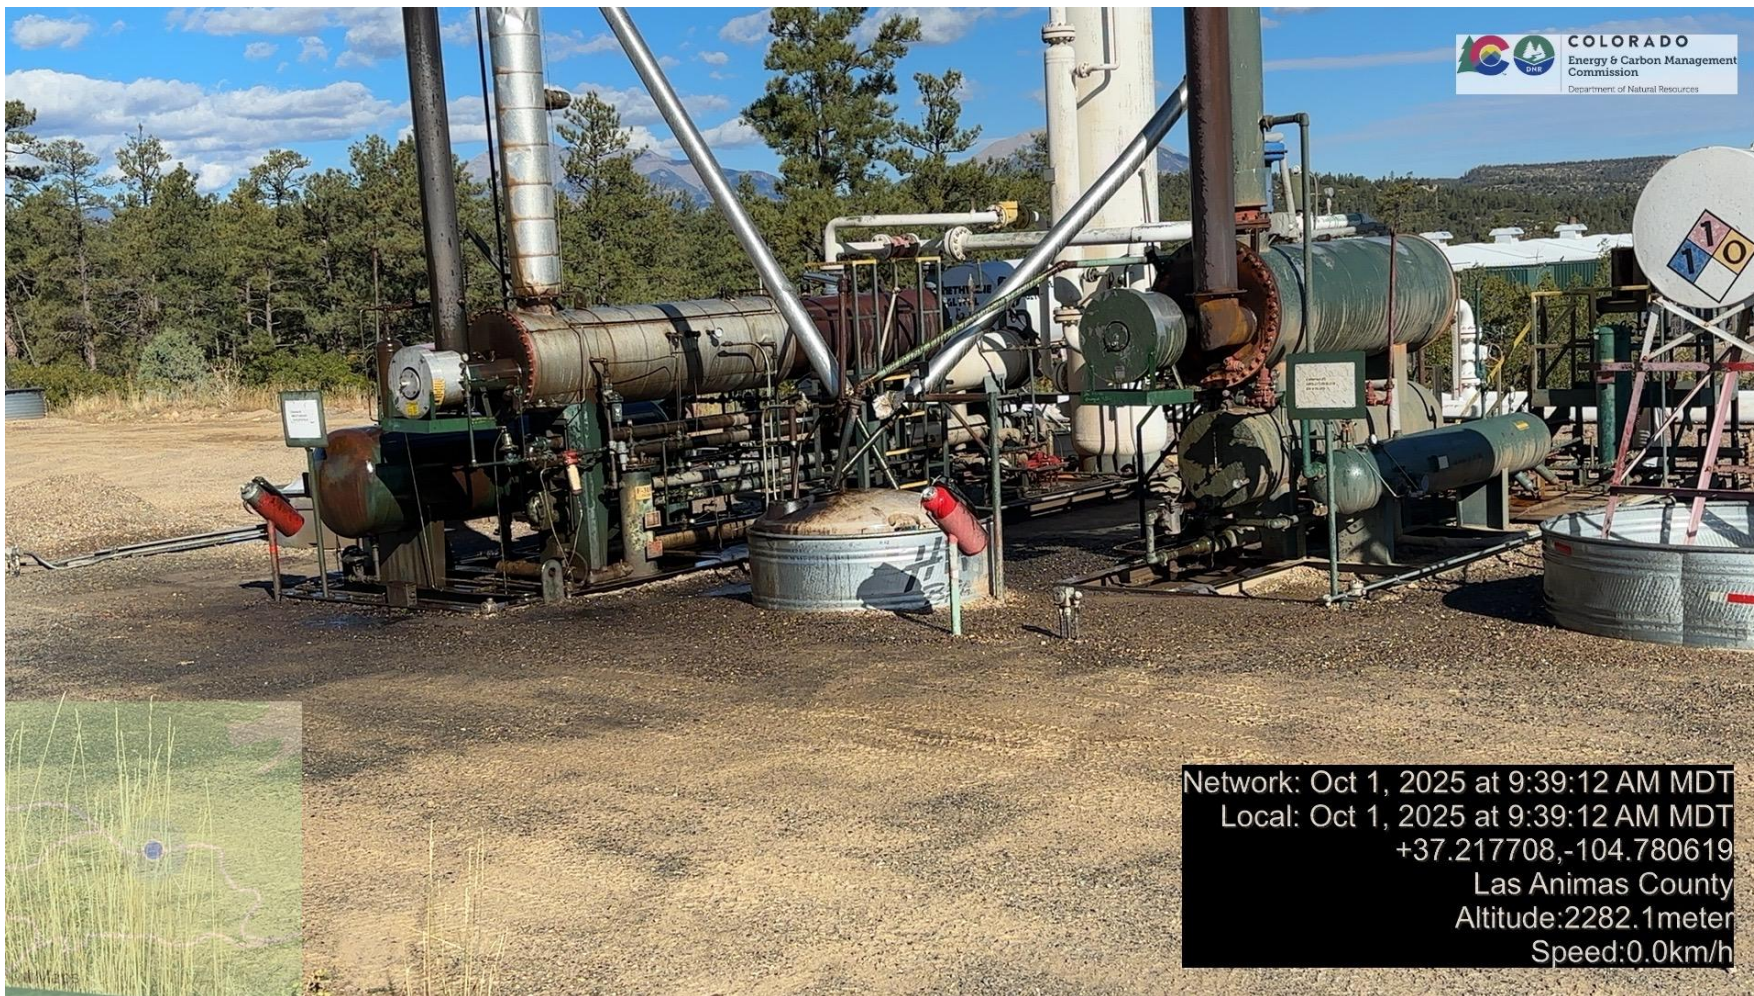
PHOTO 4: IMAGE SHOWING THE SPILL AREA. THE BULK OF THE SPILL FLUID IS APP. 35' AROUND THE EQUIPMENT WITH SOME SPRAY REACHING OUT TO THE EAST AND SOUTH APP. 50'.

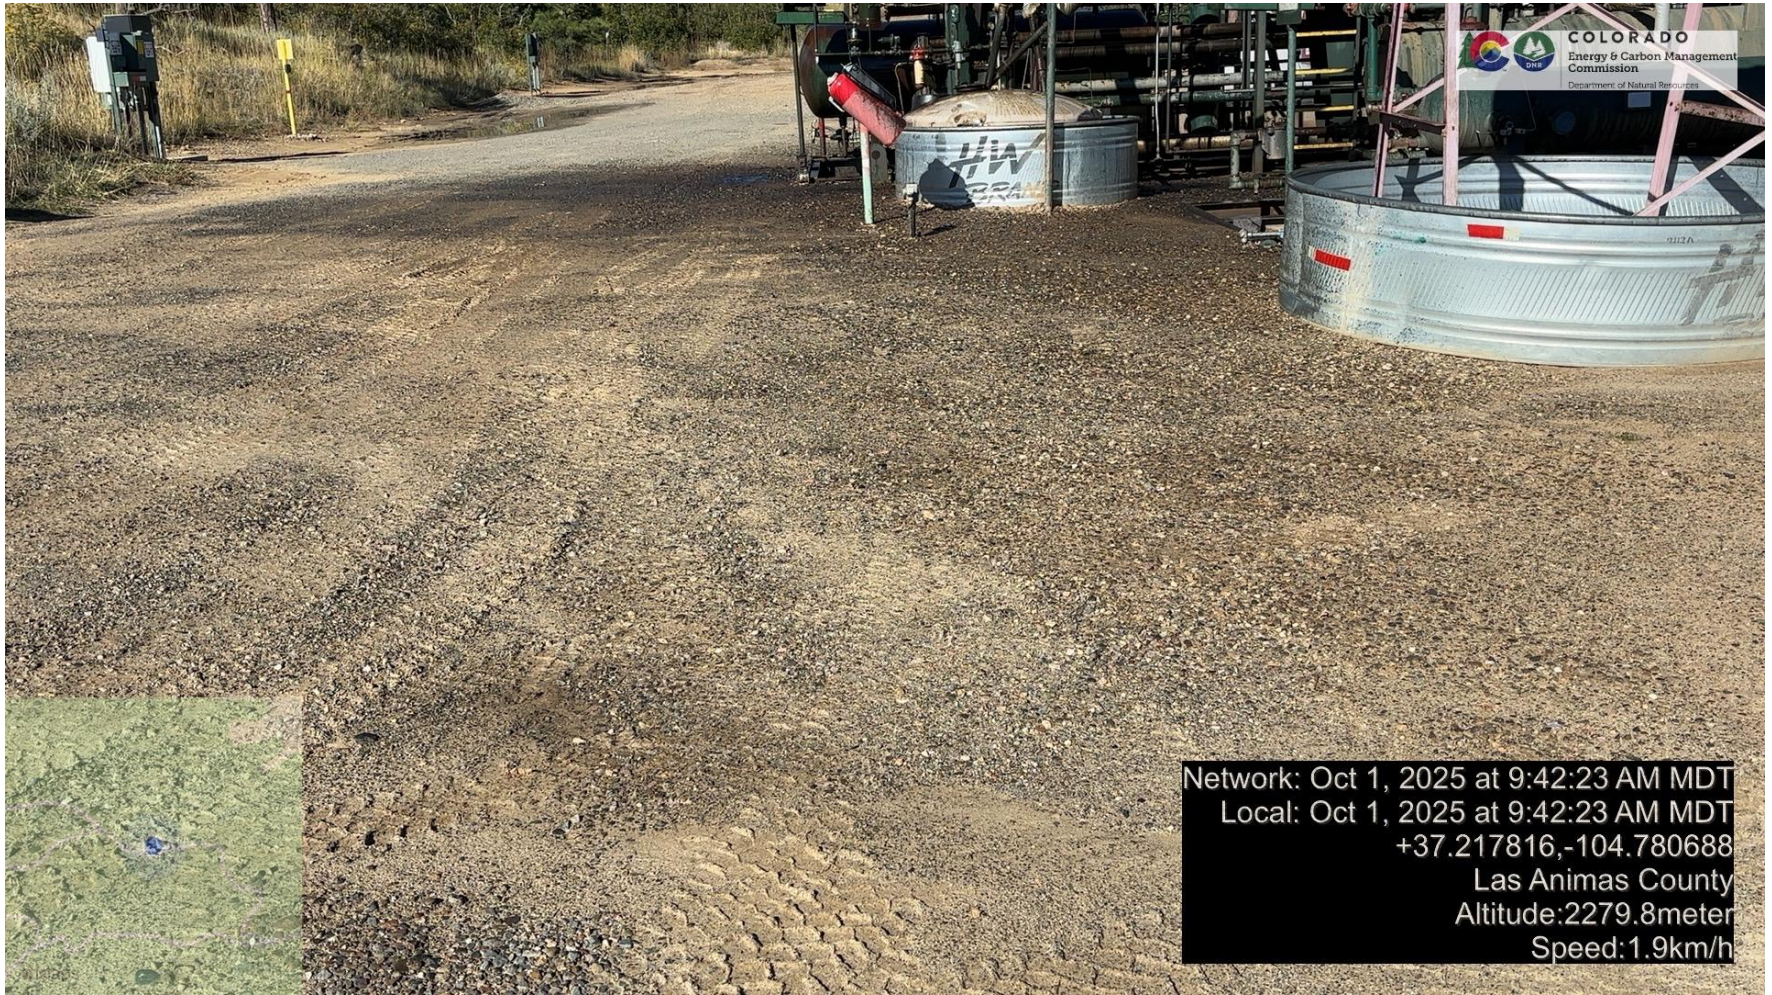
PHOTO 5: ANOTHER IMAGE SHOWING THE SPILL AREA. THE BULK OF THE SPILL FLUID IS APP. 35' AROUND THE EQUIPMENT WITH SOME SPRAY REACHING OUT TO THE EAST AND SOUTH APP. 50'.

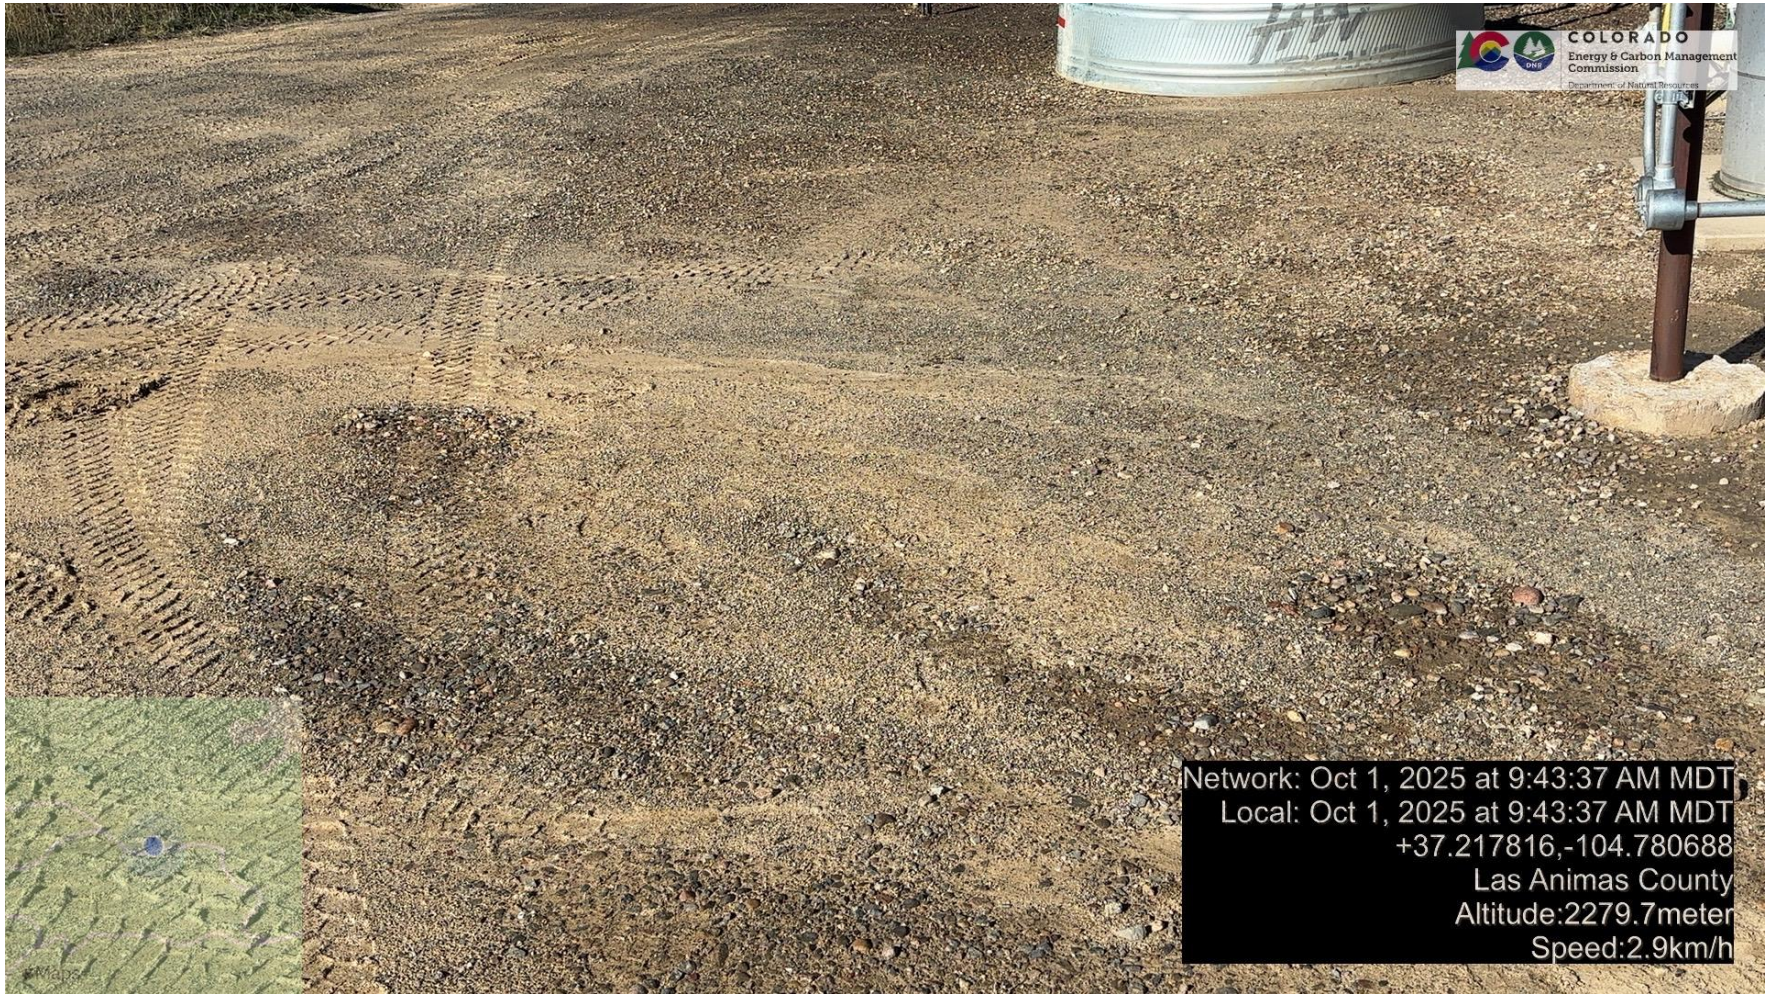
PHOTO 6: ANOTHER IMAGE SHOWING THE SPILL AREA. THE BULK OF THE SPILL FLUID IS APP. 35' AROUND THE EQUIPMENT WITH SOME SPRAY REACHING OUT TO THE EAST AND SOUTH APP. 50'.

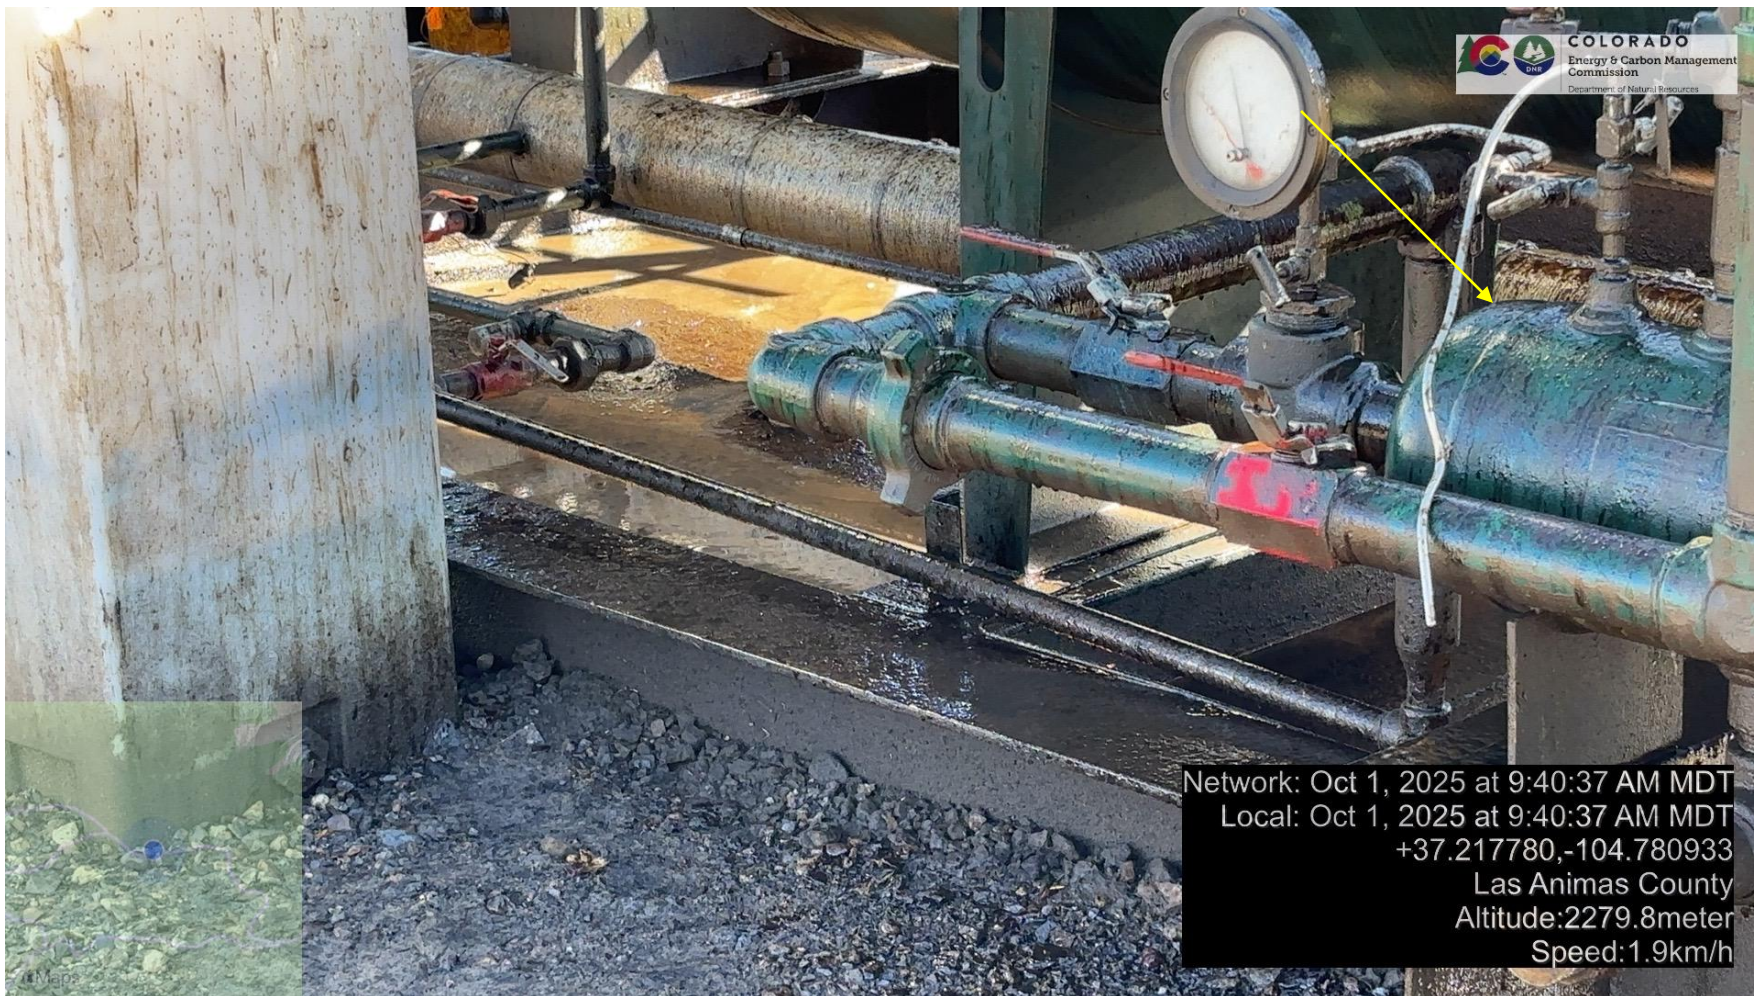
PHOTO 7: CLOSER IMAGE OF THE EQUIPMENT WITH THE MECHANICAL FAILURE. OPERATOR INFORMED ECMC STAFF THAT THE FILTER MARKED BY THE ARROW PLUGGED AND CAUSED THE FAILURE.
