# Inspection Photos

**Operator:** TEP Rocky Mountain LLC #96850

**Location ID:** 335069

**Inspection Doc:** 719200339

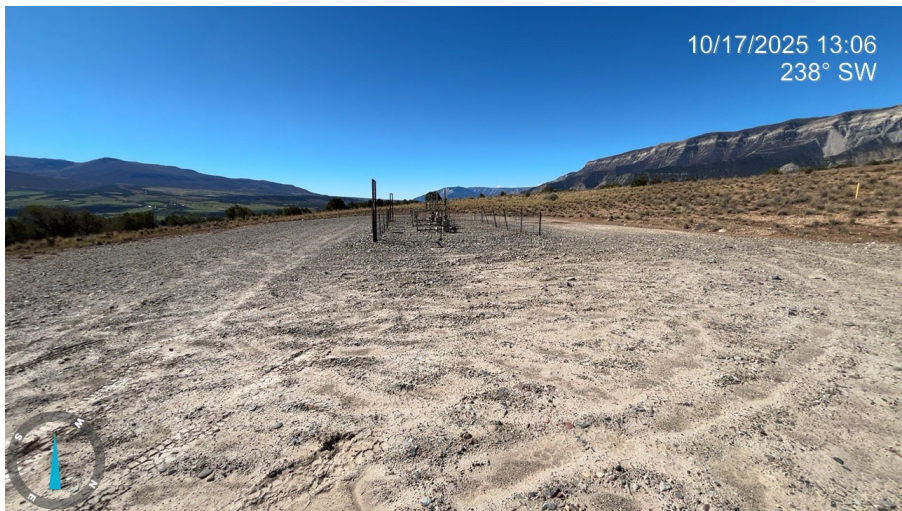
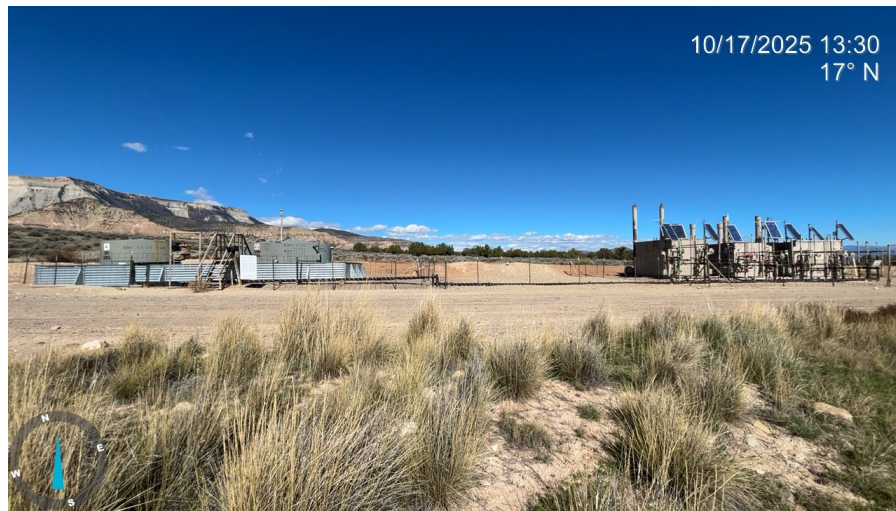
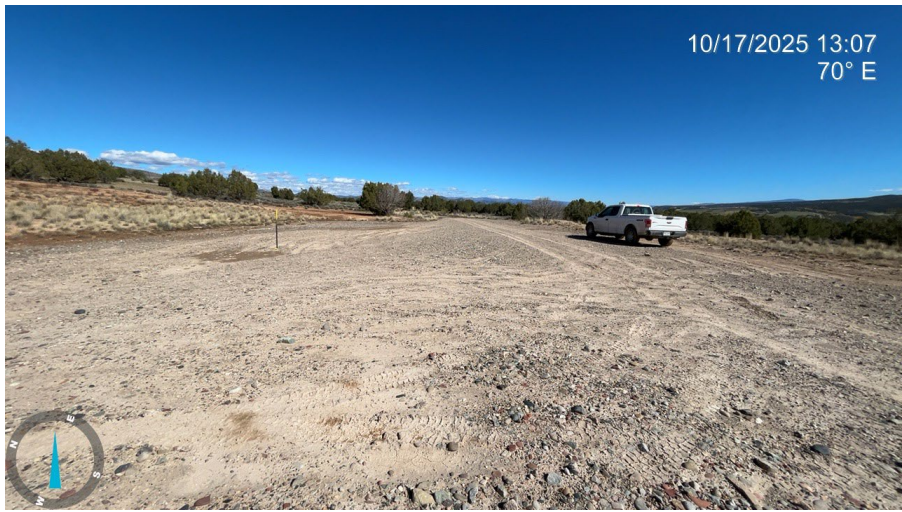
**Photo 1:** Photos showing an overview of the location looking southwest and east (left top and bottom, respectively) and the production equipment shared with location #335175 looking north (top right).

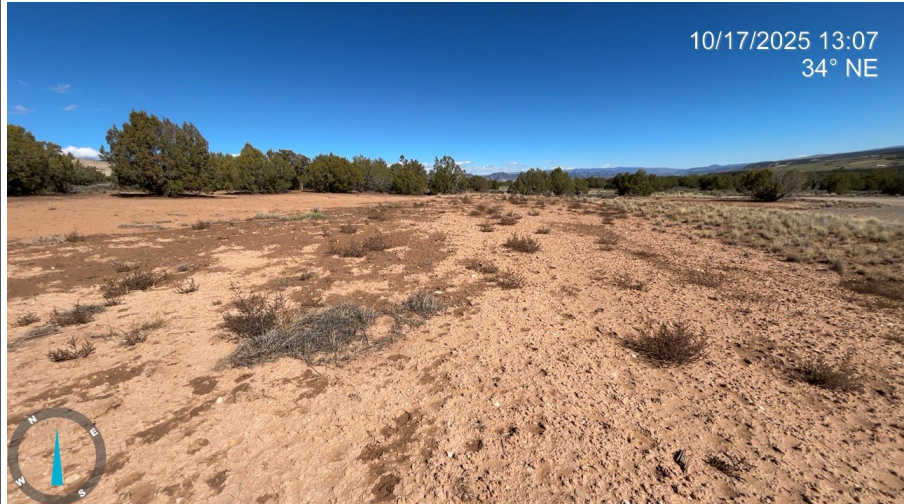
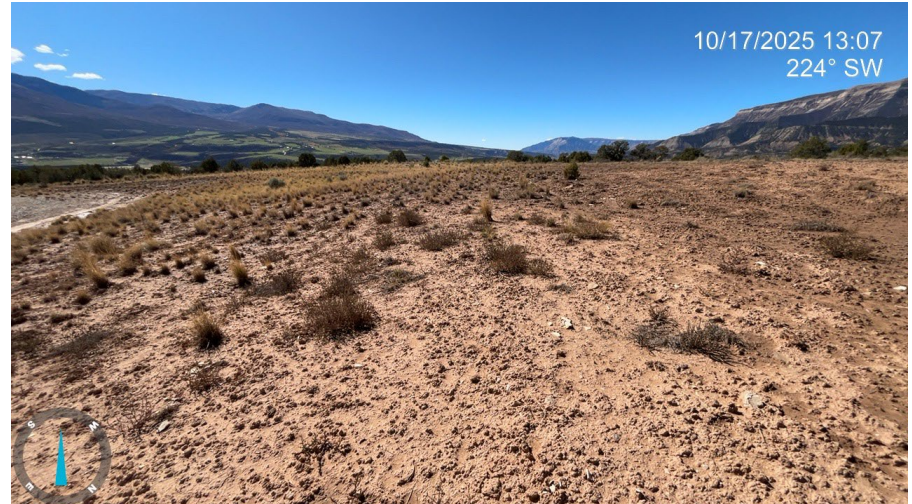
**Photo 2:** Photos showing an overview of the northeastern and northwestern interim areas, respectively. Northern interim areas are not progressing towards 1003 reclamation requirements; areas are predominantly bare with prickly Russian thistle present. Additional reclamation efforts are required.

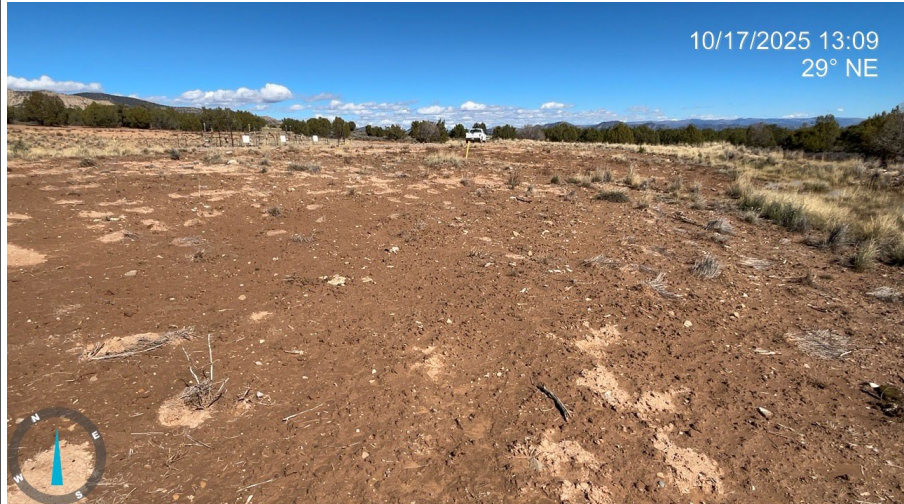
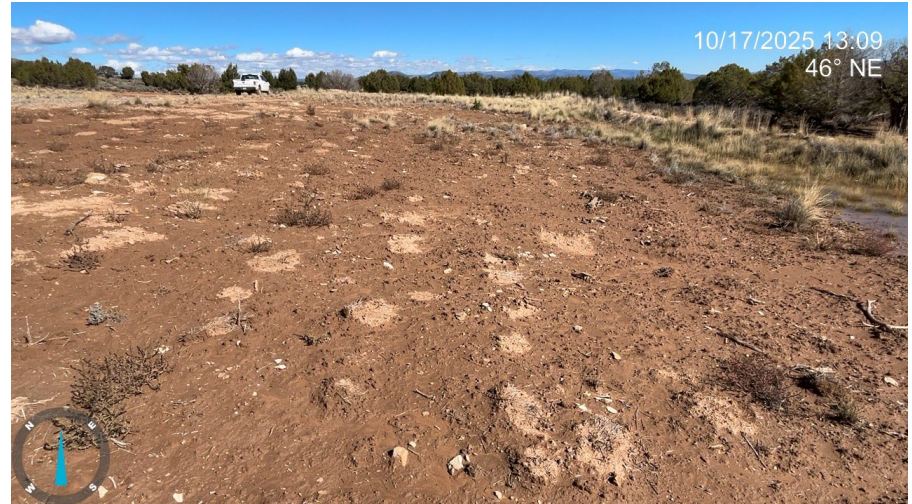
**Photo 3:** Photos showing an overview of the southern interim area. The interim area is not progressing towards 1003 reclamation requirements; areas are predominantly bare with prickly Russian thistle present. Additional reclamation efforts are required.

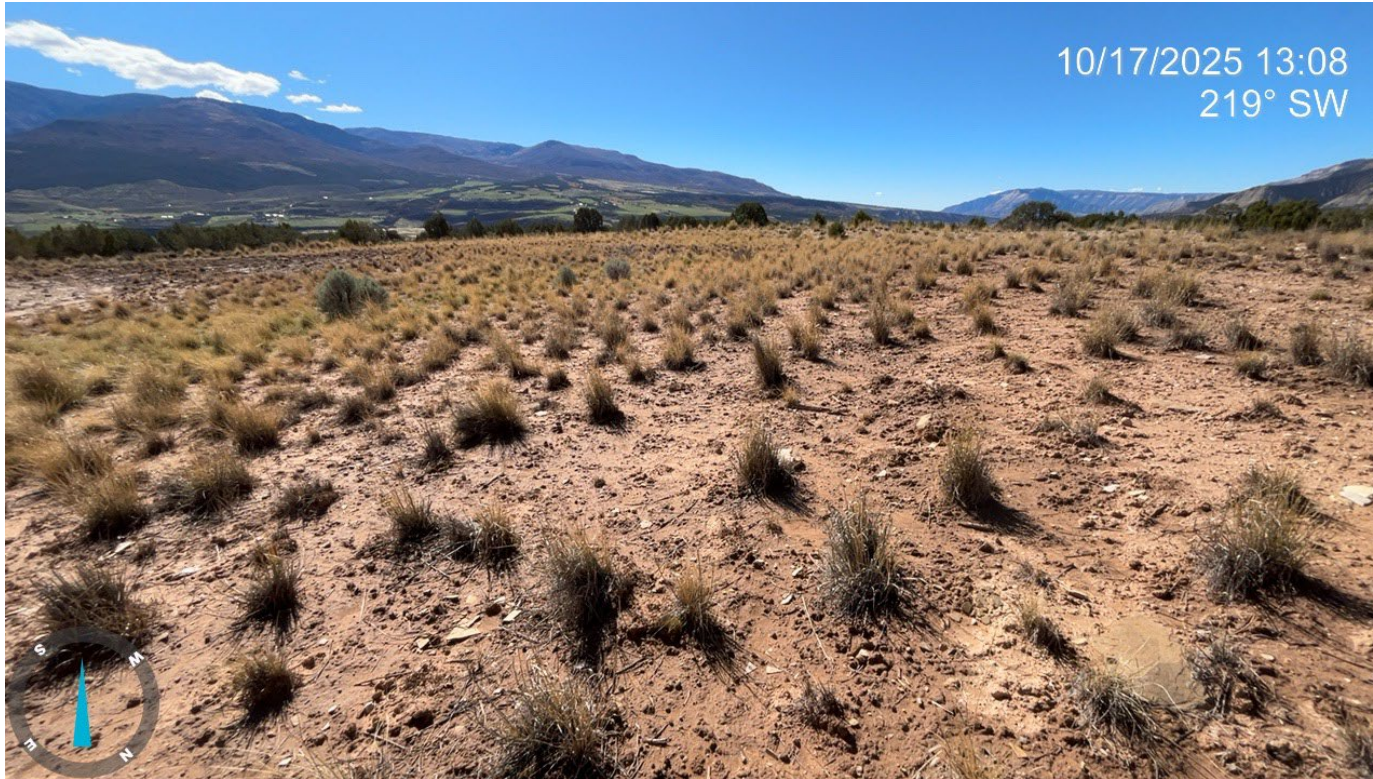
**Photo 4:** Photos showing an overview of the western interim area. Intermediate wheatgrass has established. This portions of the location is progressing towards 1003 reclamation requirements.

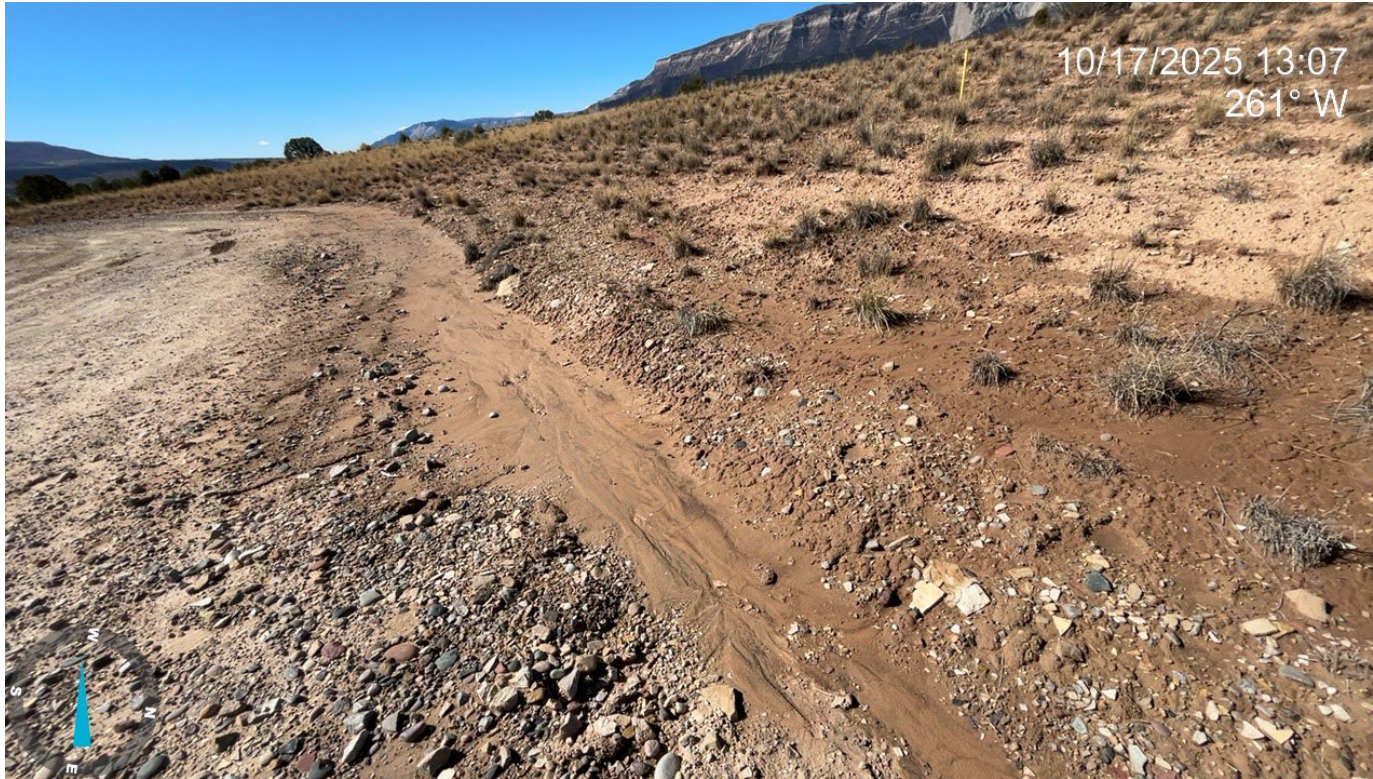
**Photo 5:** Photos showing an example of stormwater controls on the northern edge of the working pad surface. The drainage channel appears to be laden with sediment, reducing capacity. Comply with 1002.f.

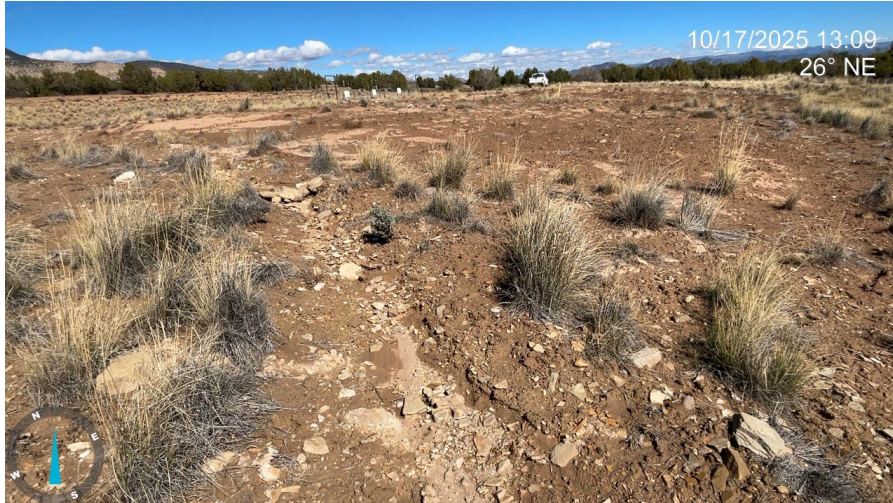
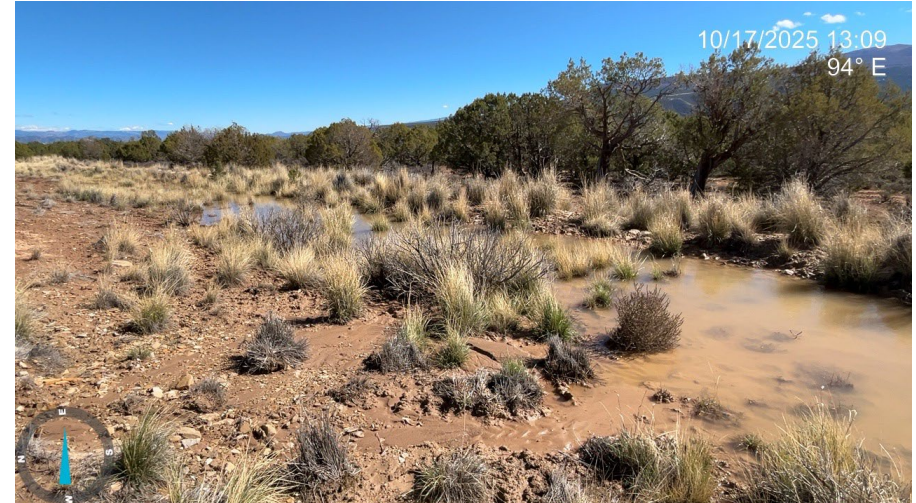
**Photo 6:** Photos showing an example of a stormwater control on the southwestern edge of the interim area. Stormwater controls appear to be missing or insufficient; check dams are in disrepair, sediment transport is evident, and the stormwater control appears to have reduced capacity, resulting in standing water in the interim area. Comply with 1002.f.

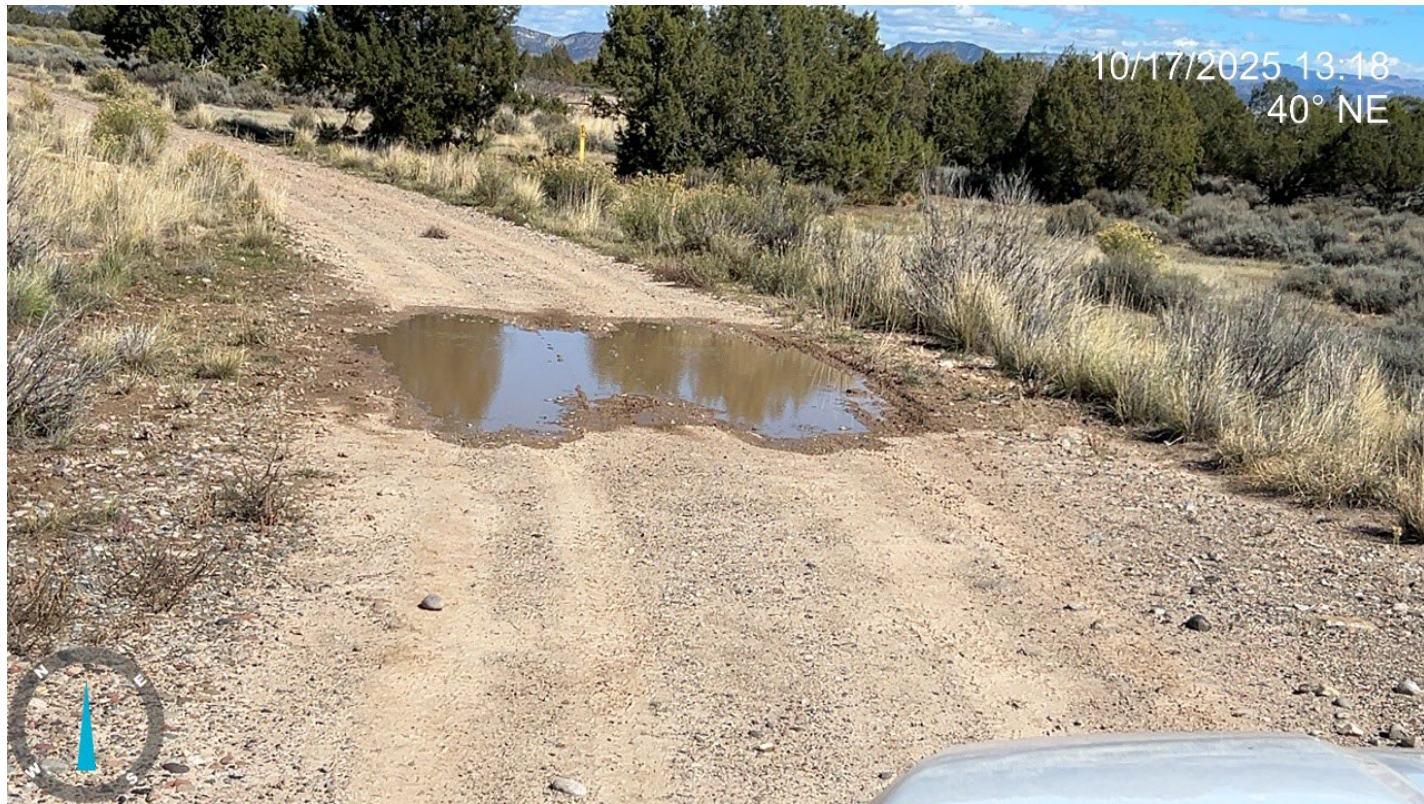
**Photo 7:** Photos showing ponded water on the access road where gravel appears to be sparse. Comply with 1002.f.
