Final Reclamation and Stormwater Inspection

October 20, 2025

Location ID: 336442

Well Name: MURATA #23-19

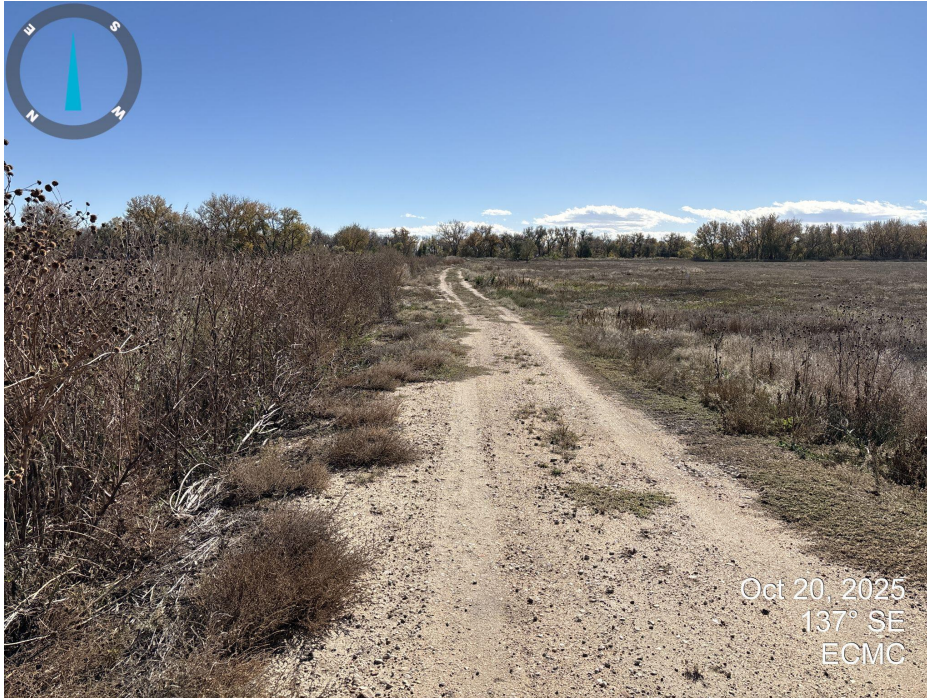
Photo 1. Looking southeast down the main access road. This road appears to be the only access to the eastern field and preexisting to oil and gas.

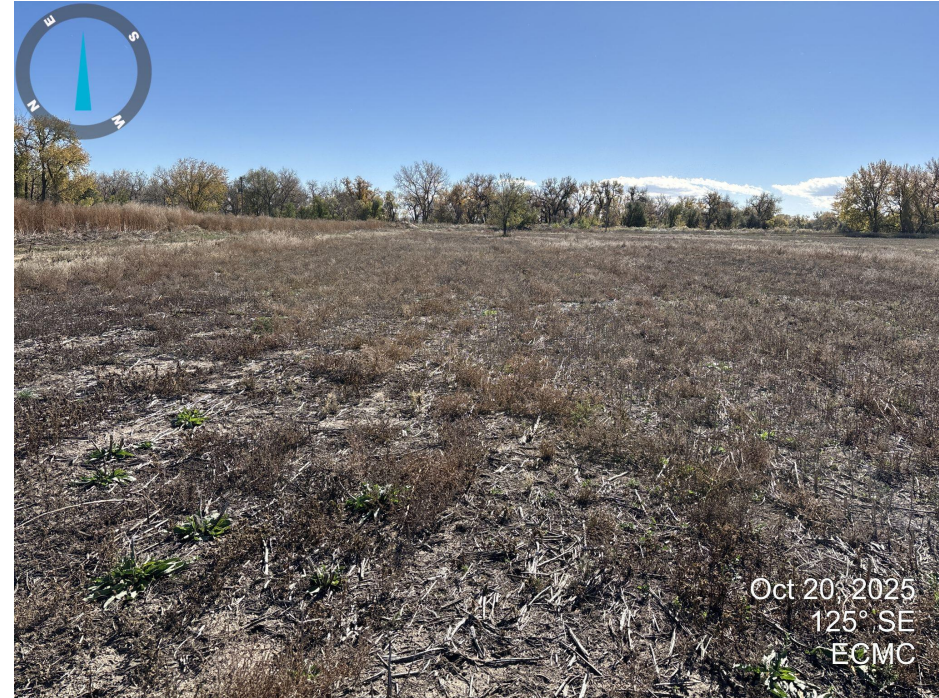
Photo 2. Looking east across the well location. No oil and gas equipment remains. The northern side of this field including the well area consists of undesirable weedy species such as kochia and russian thistle. There is little to no establishment of desirable vegetation at the time of inspection.

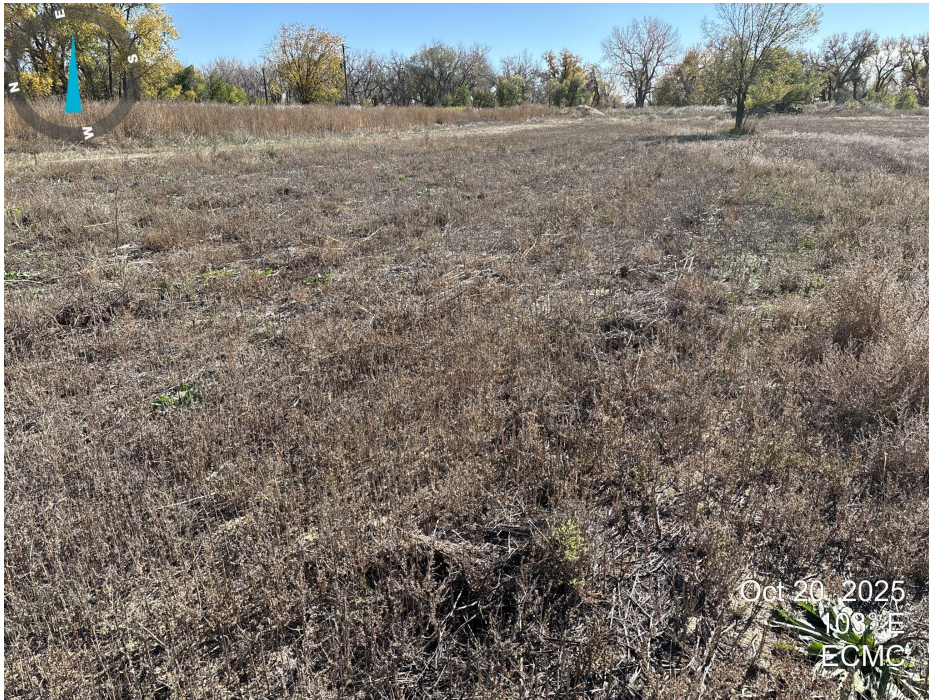
Photo 3. Looking east from the wellbore. Vegetation consists of undesirable weeds such as kochia and russian thistle. Little to no desirable vegetation is present. The location is mowed.

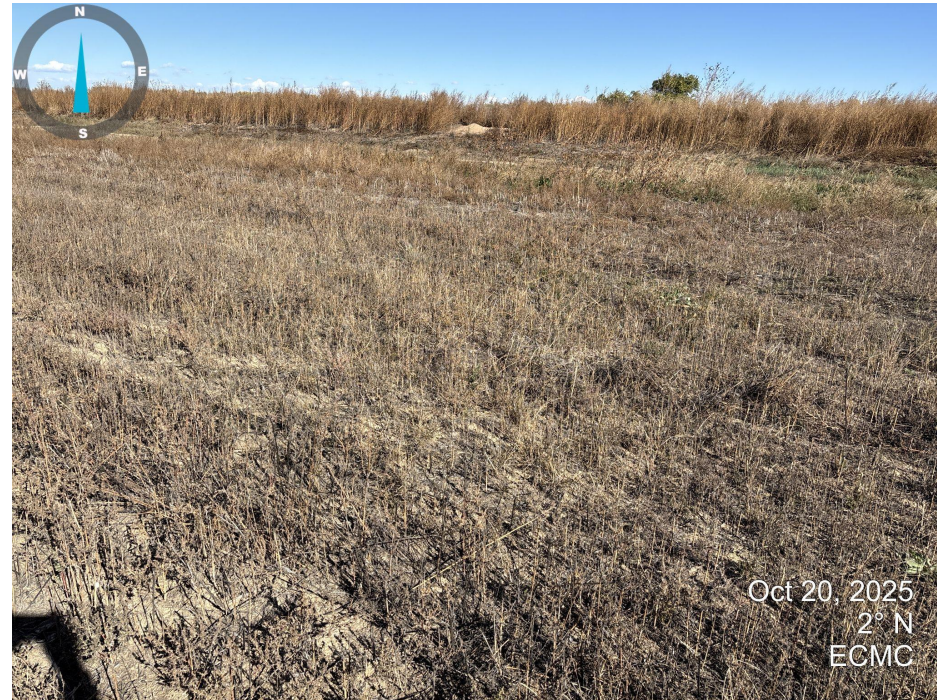
Photo 4. Looking north from the wellbore area. See photo 3 comments.

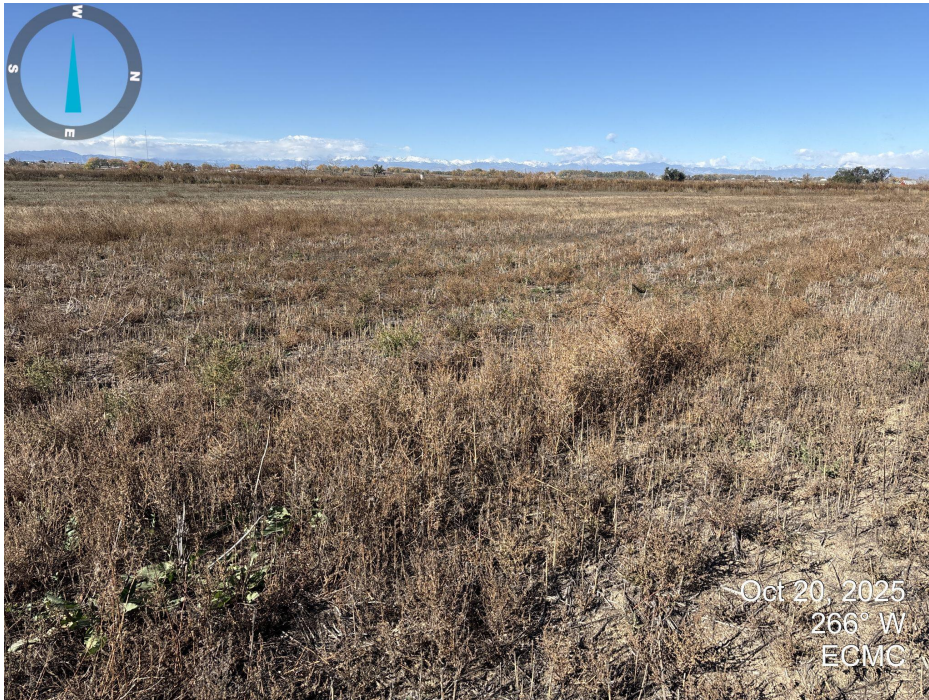
Photo 5. Looking west from the wellbore area. See photo 3 comments.

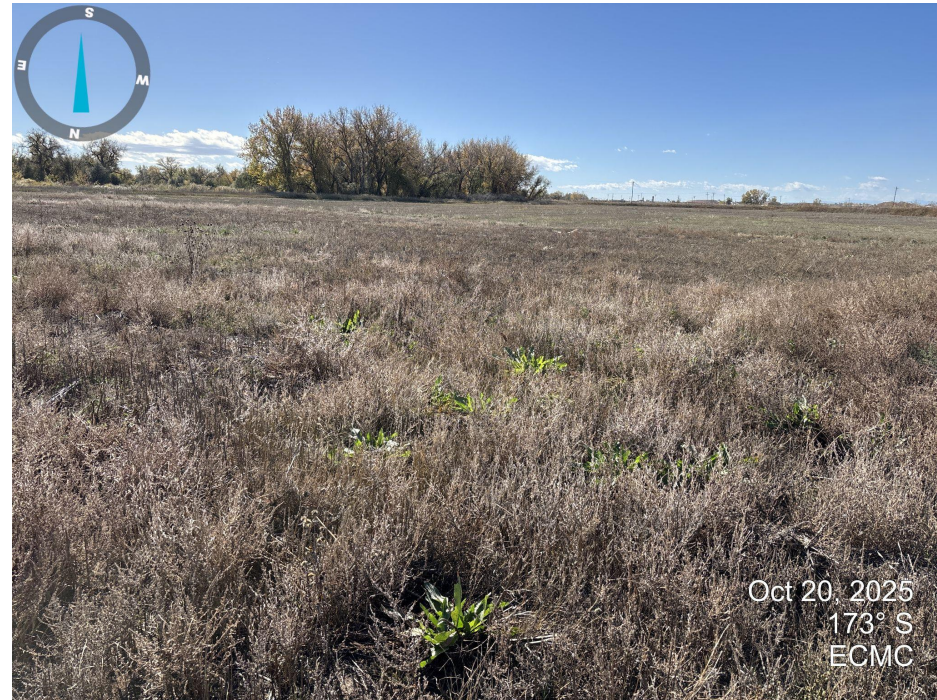
Photo 6. Looking south from the wellbore area. See photo 3 comments.

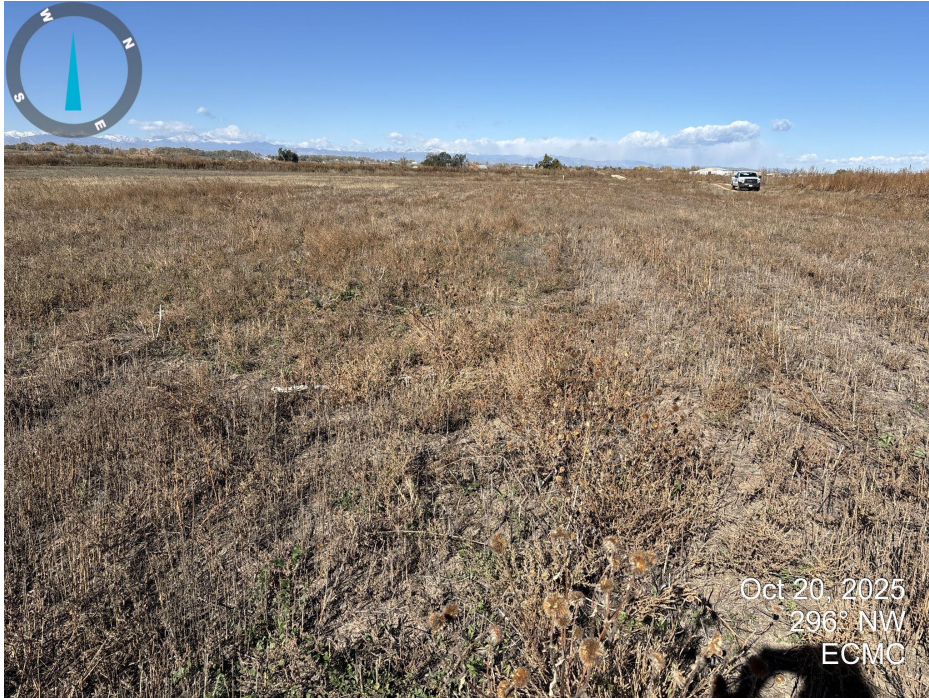
Photo 7. Looking west across the location.

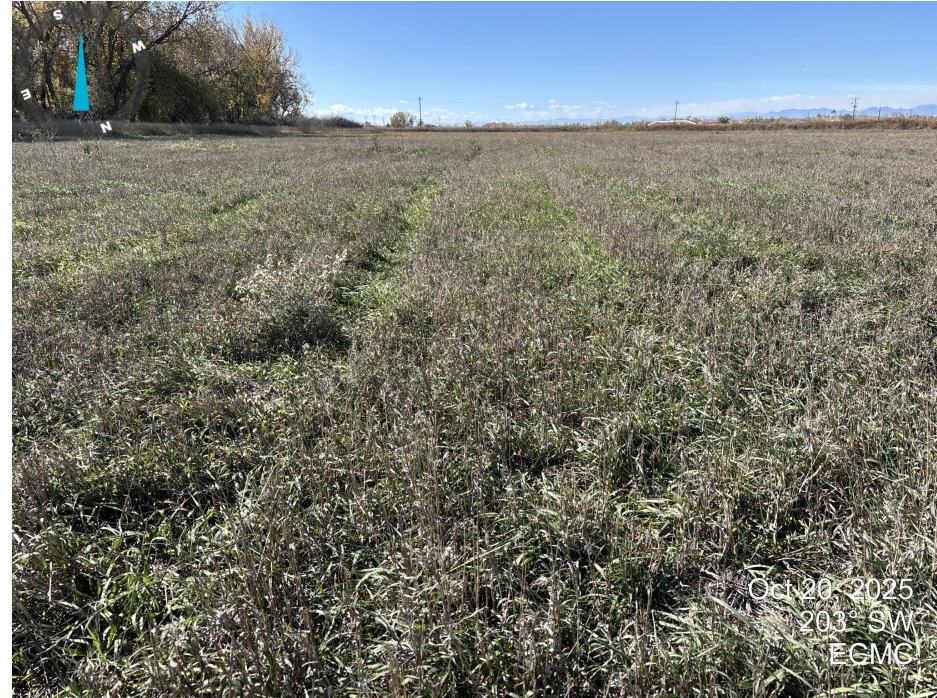
Photo 8. Reference vegetation to the south of the well location. Brome pasture or hay field.

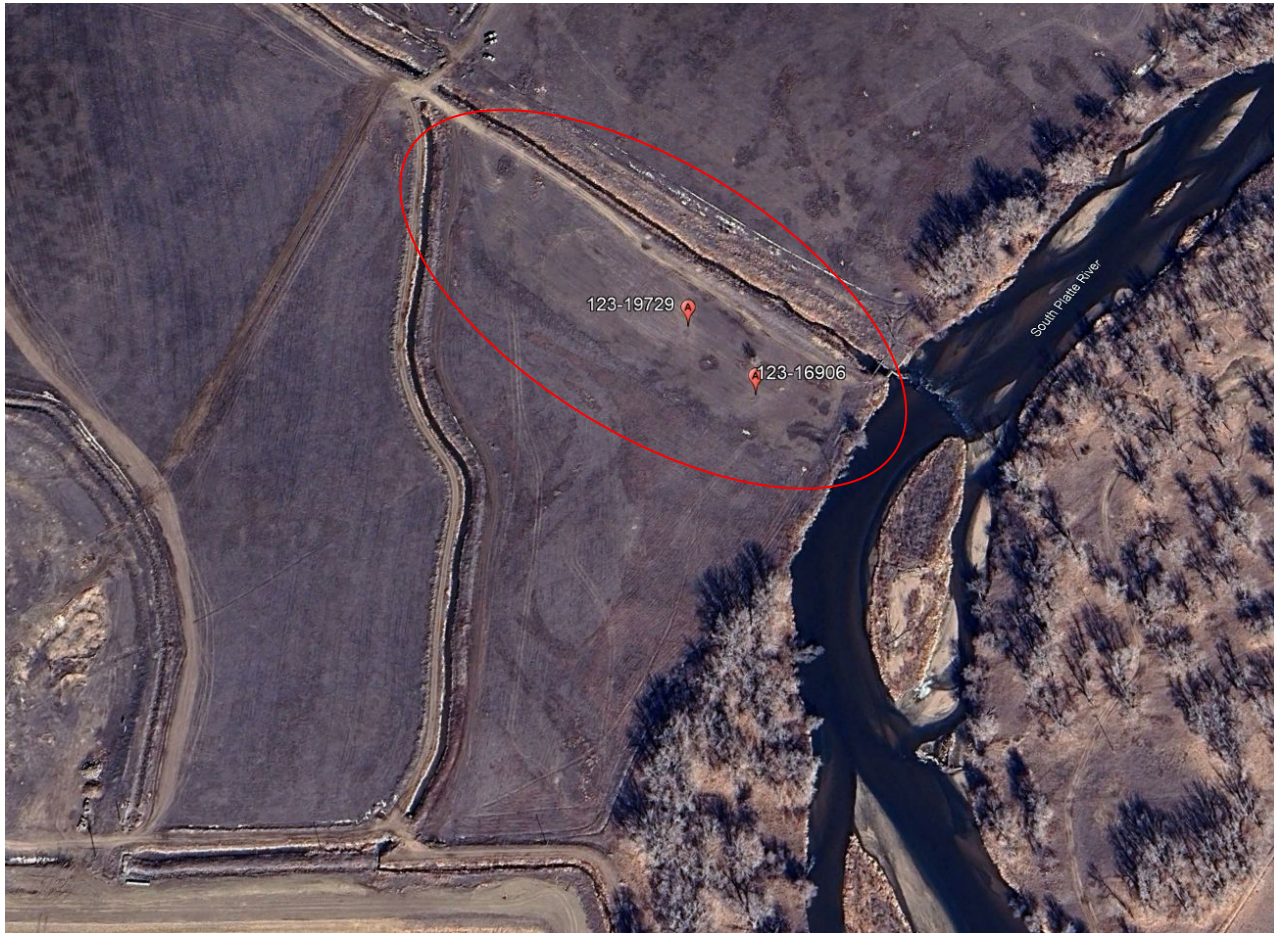
Photo 9. Google earth aerial imagery taken 2/4/2025. The northern part of the field (red circle) has primarily weedy vegetation compared to the the surrounding field.
