Inspection/Audit Photos

Location Name: TEP ROCKY MOUNTAIN LLC CHEVRON GR 41-20 Pad

Location #: 335223

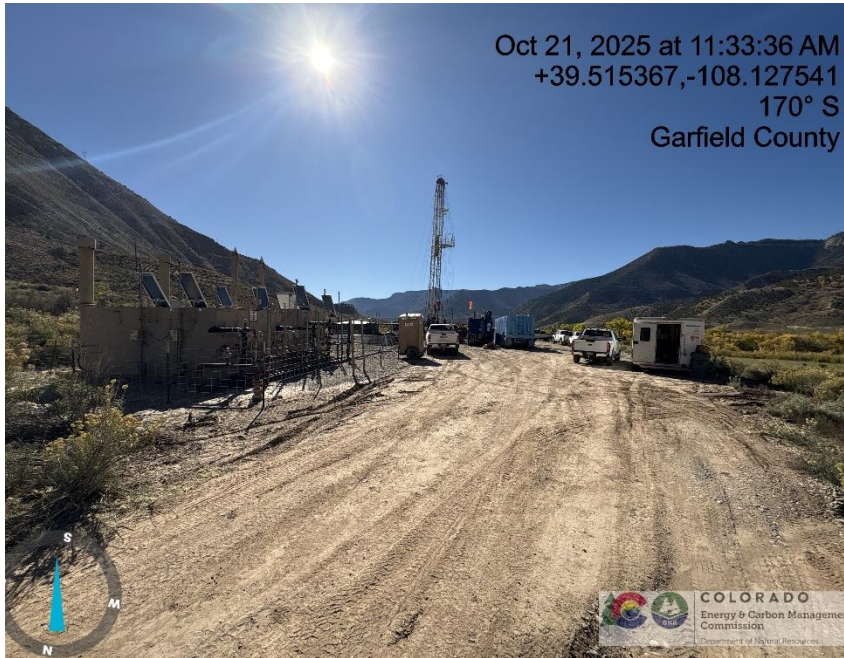
Photo # 914 From entrance to location

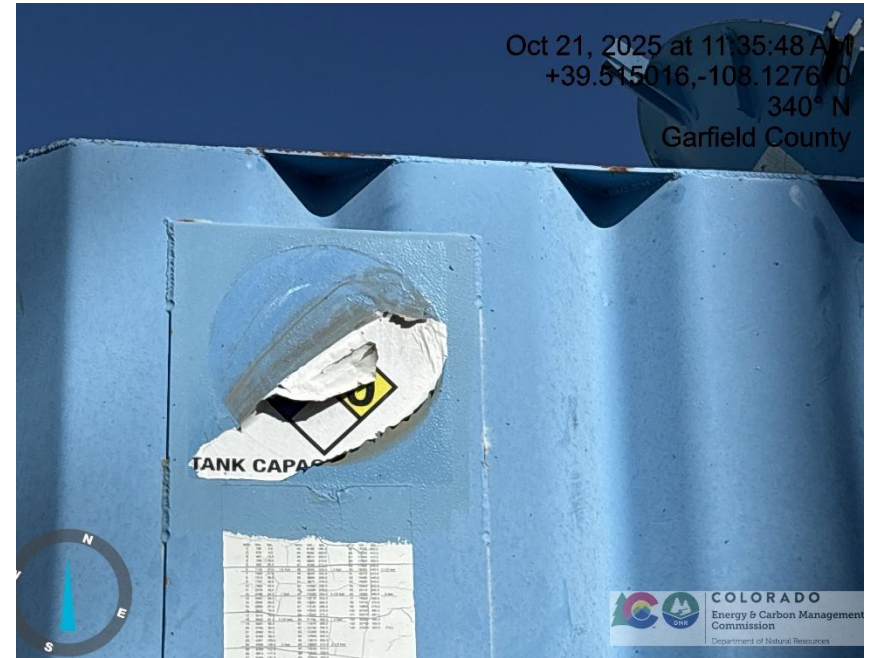
Photo # 927 Tank label on frac tank damaged & illegible
