Inspection/Audit Photos

Location Name: QB ENERGY OPERATING LLC PUCKETT 21C-25 (MESA 10) Pad

Location #: 335105

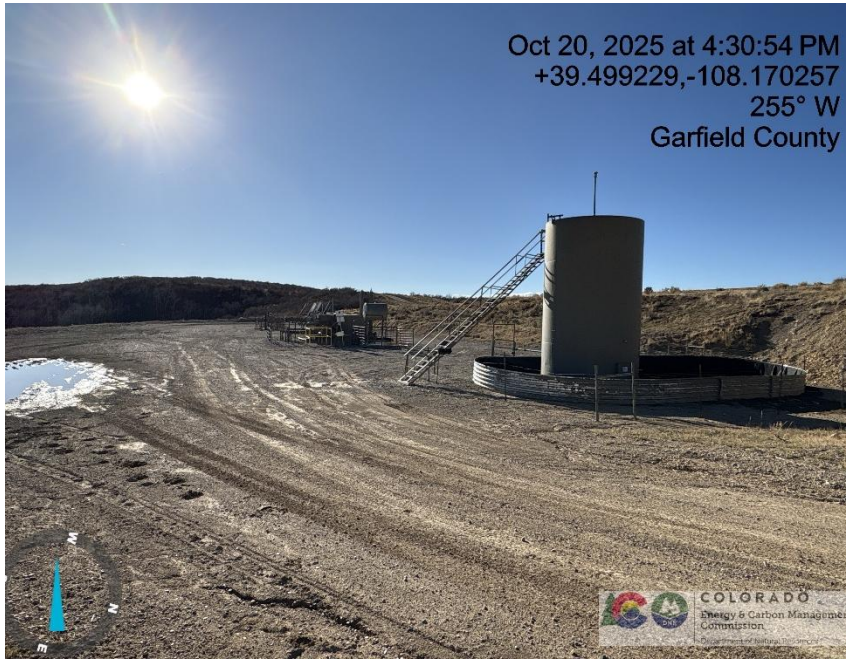
Photo # 572 From entrance to location

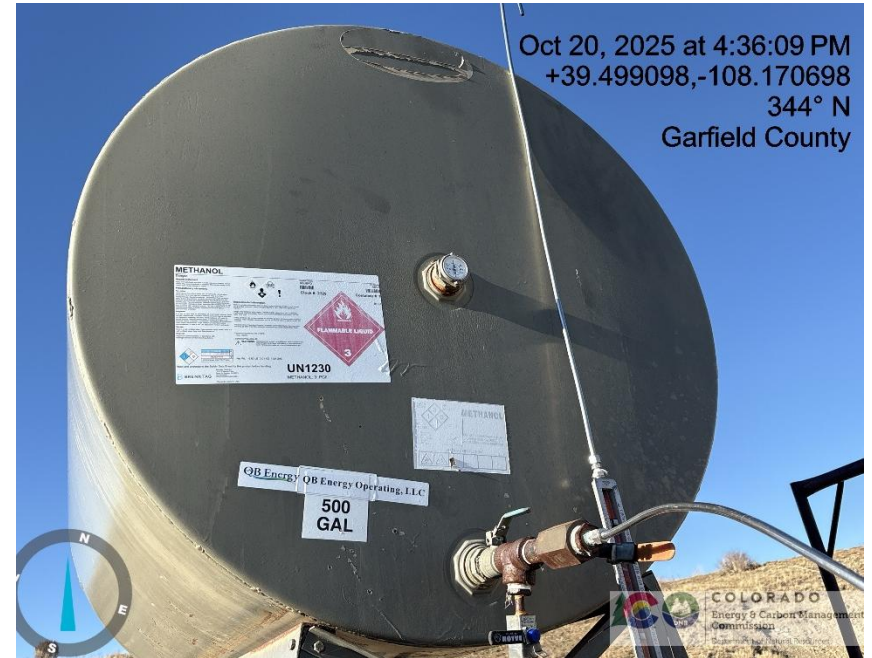
Photo # 579 Methanol tank lacks operator emergency #

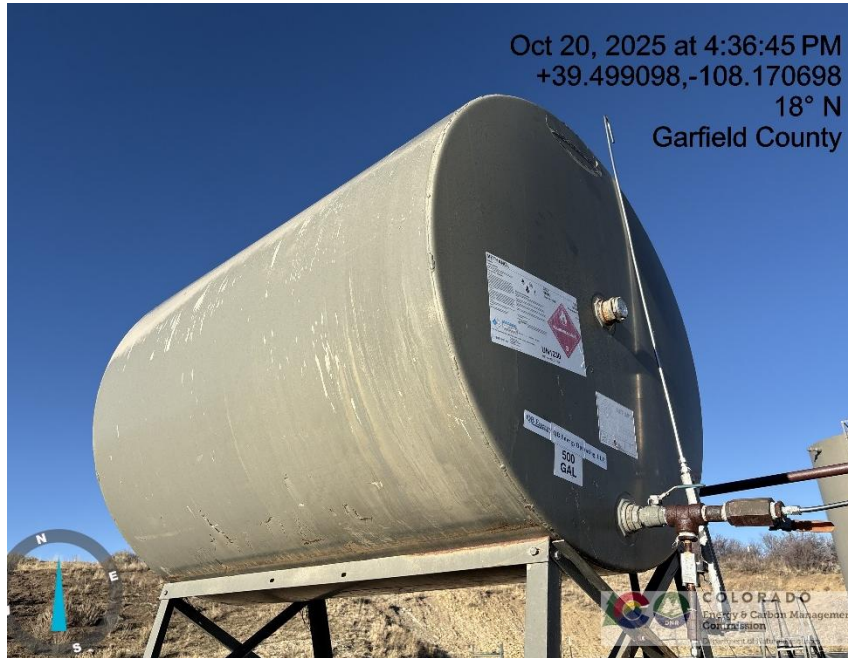
Photo # 580 Methanol tank lacks operator emergency #

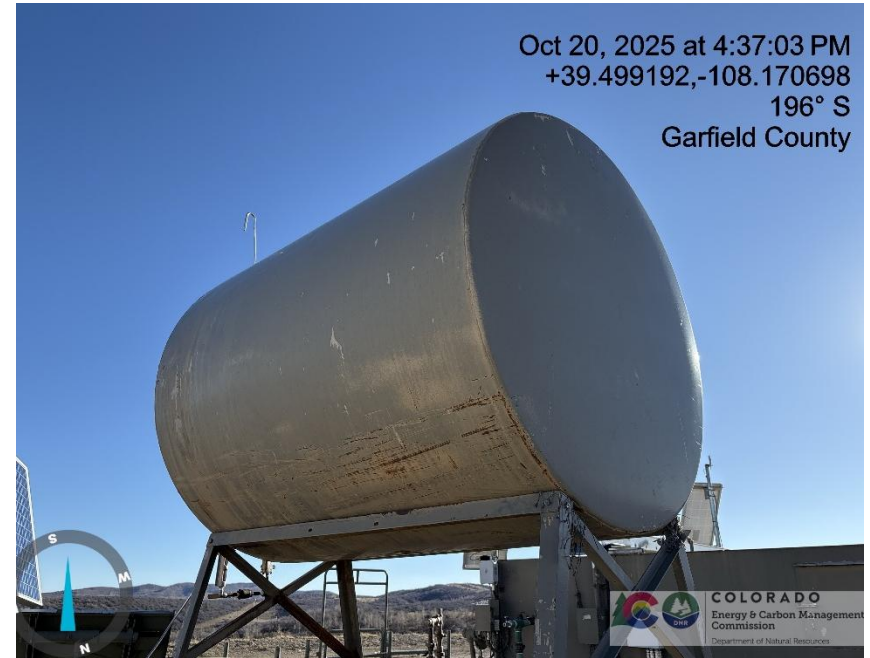
Photo # 581 Methanol tank

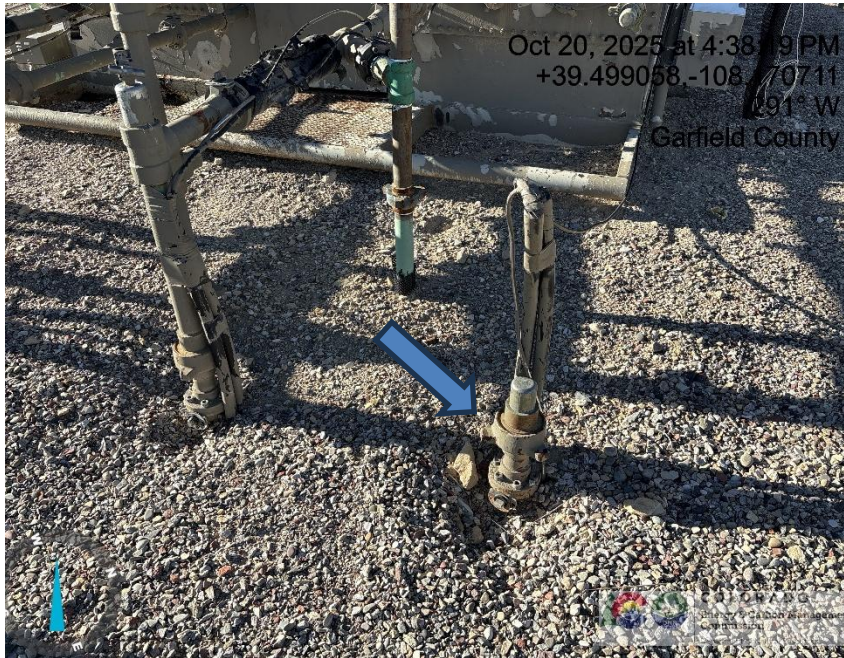
Photo # 582 Unused flowline lacks lockout tagout (OOSLAT)

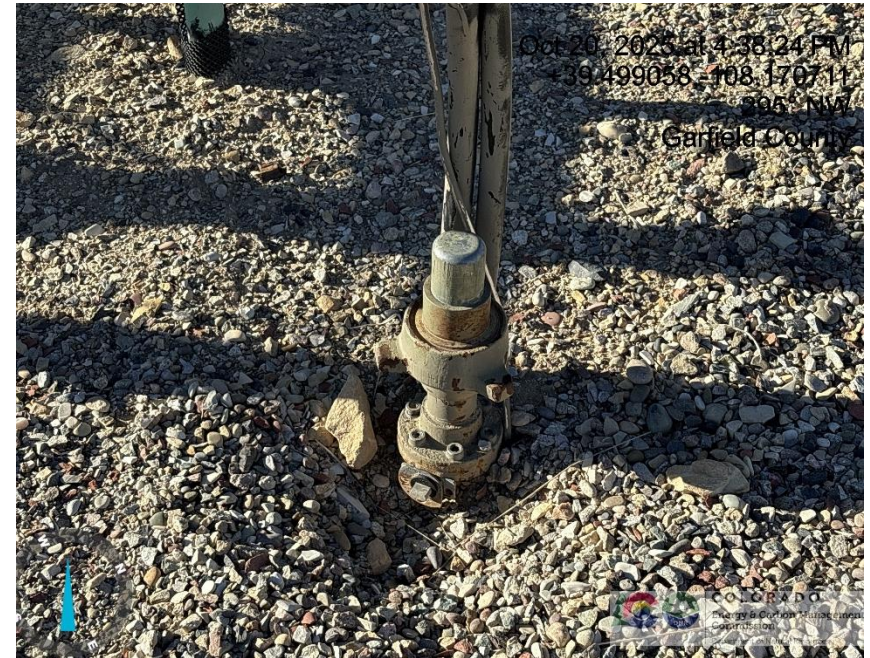
Photo # 583 Unused flowline lacks lockout tagout (OOSLAT)

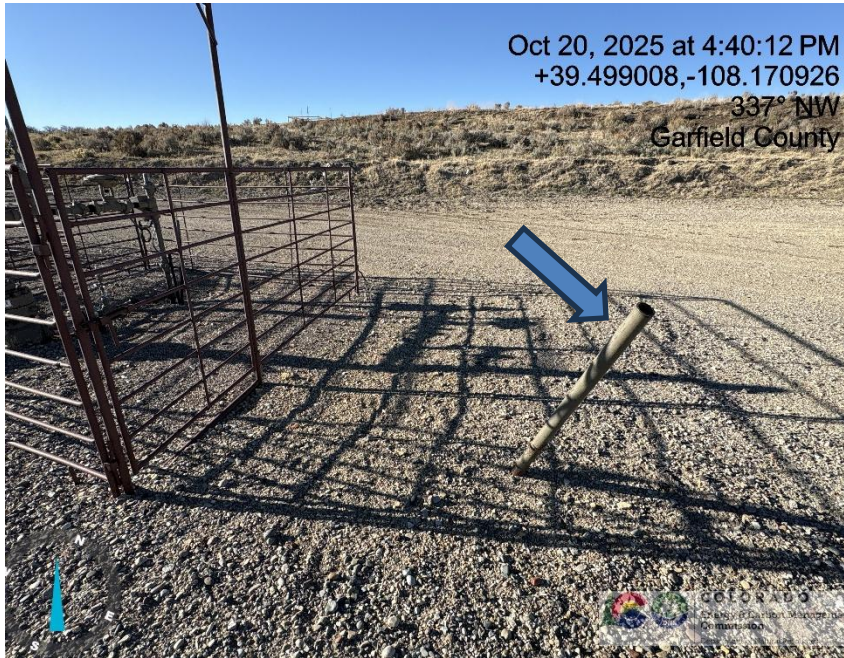
Photo # 584 Unused flowline lacks lockout tagout (OOSLAT)

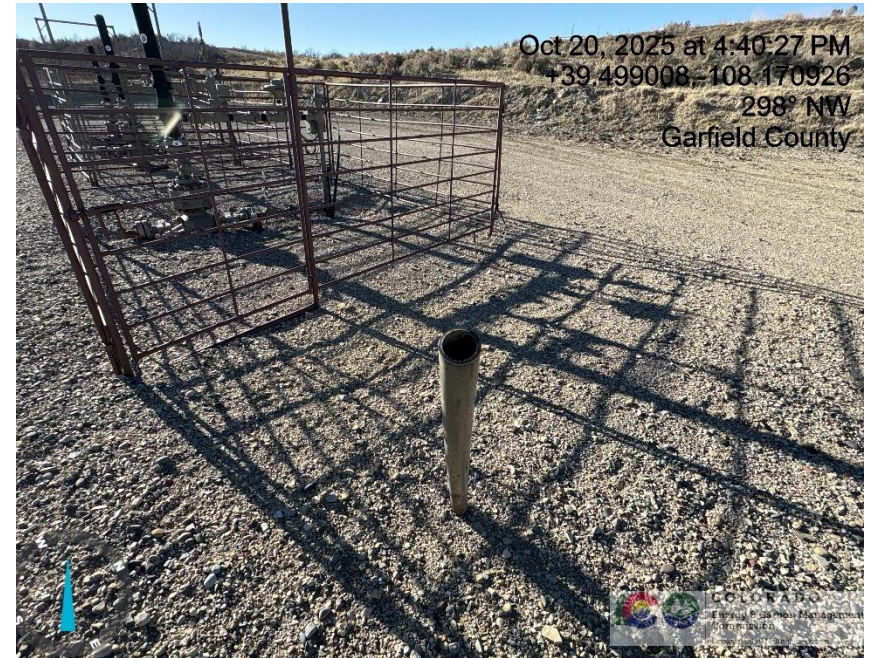
Photo # 585 Unused flowline lacks lockout tagout (OOSLAT)

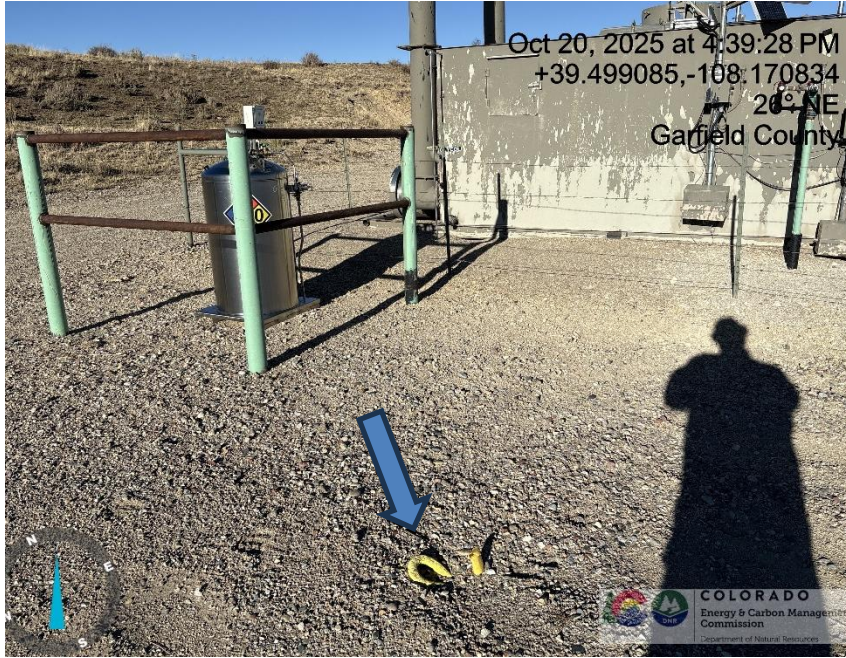
Photo # 586 Unmarked deadman

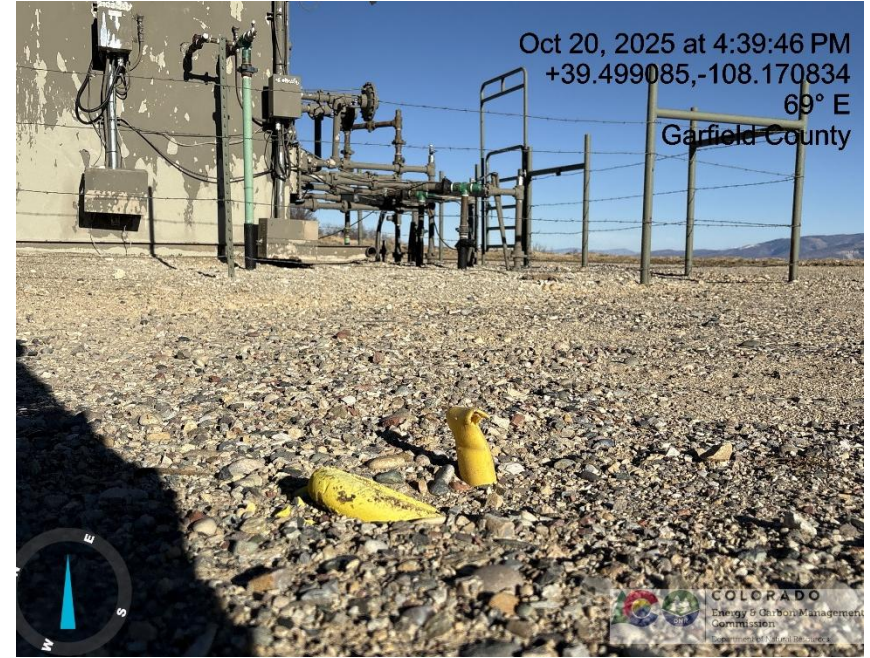
Photo # 587 Same unmarked deadman
