# Inspection/Audit Photos

Location Name: QB ENERGY OPERATING LLC MESA P24-697 Pad

Location ID: 445862

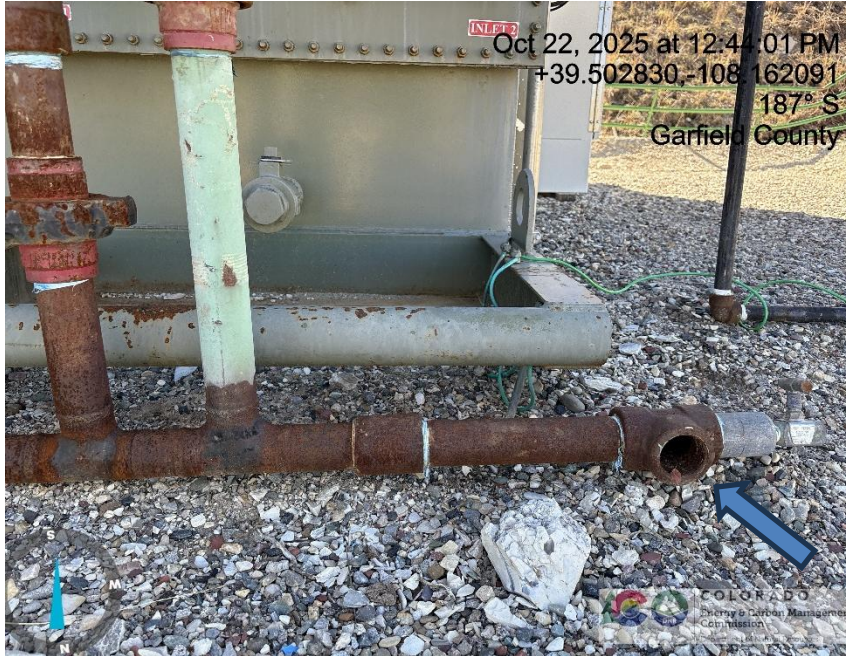
**Photo # 1197 Open ended pipe near separators/wildlife hazard/available for entry by wildlife**

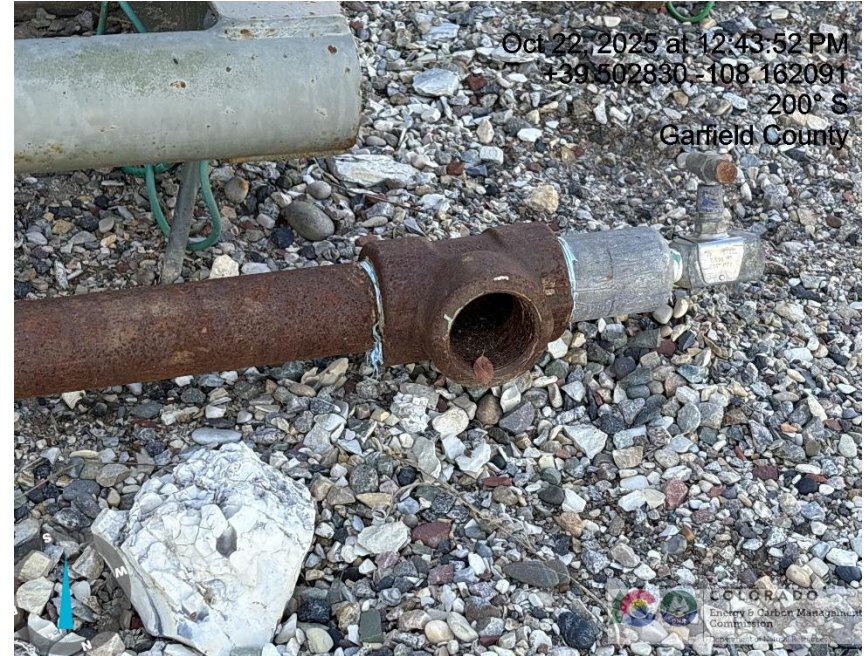
**Photo # 1198 Open ended pipe near separators/wildlife hazard/available for entry by wildlife**

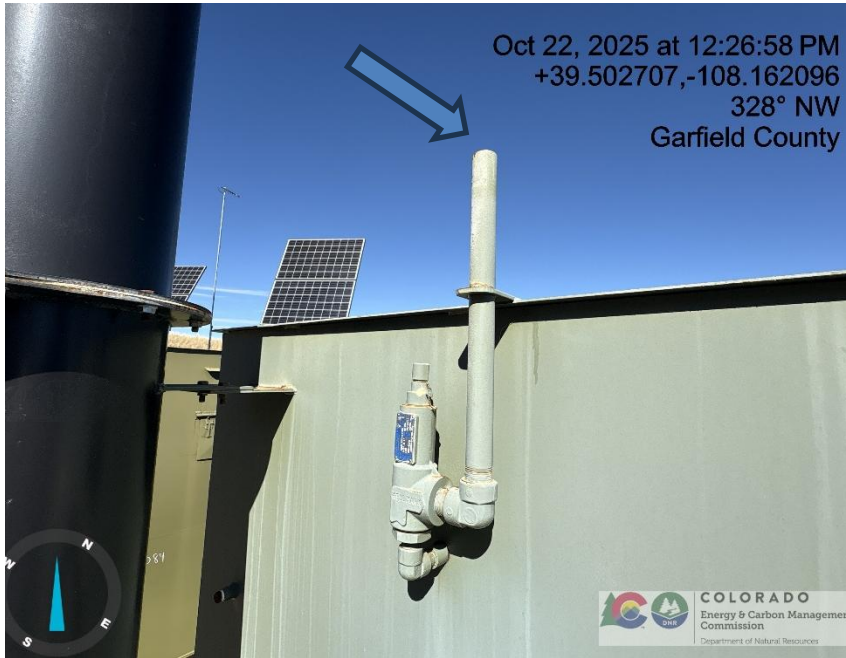
**Photo # 1199 PRV vent line does not comply with CECMC pressure safety device rules**

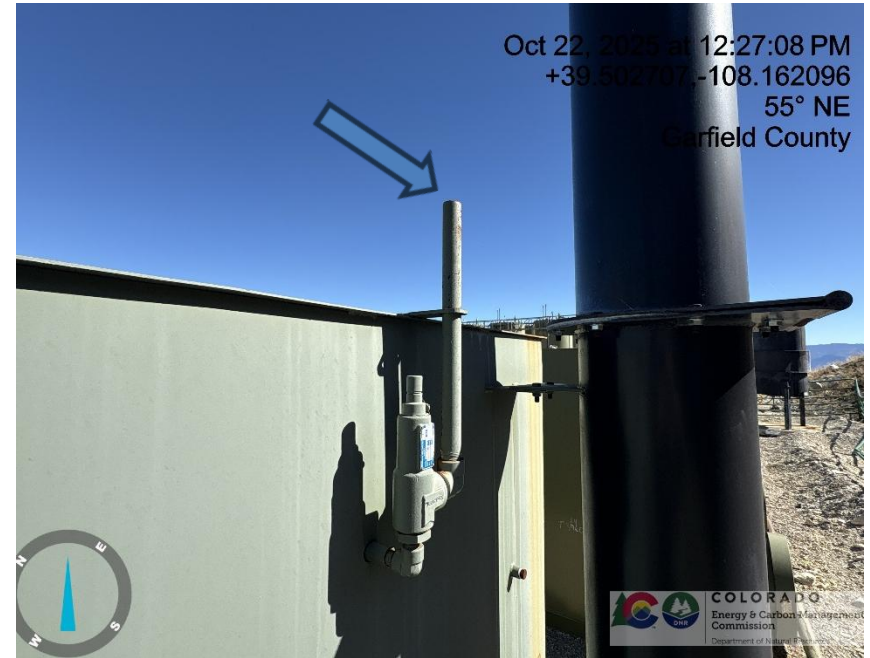
**Photo # 1200 PRV vent line does not comply with CECMC pressure safety device rules**

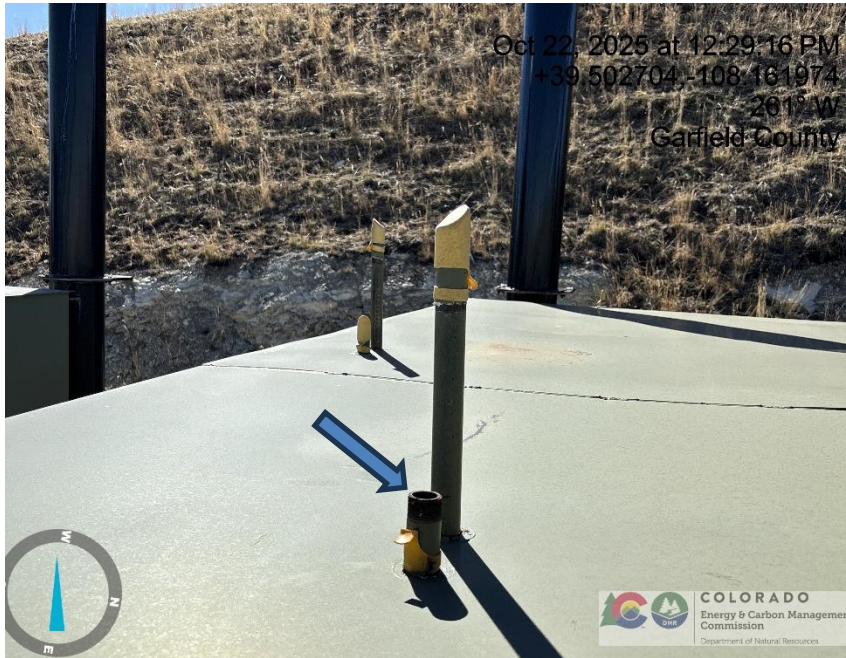
**Photo # 1201 Rupture disc vent line does not comply with CECMC pressure safety device rules**

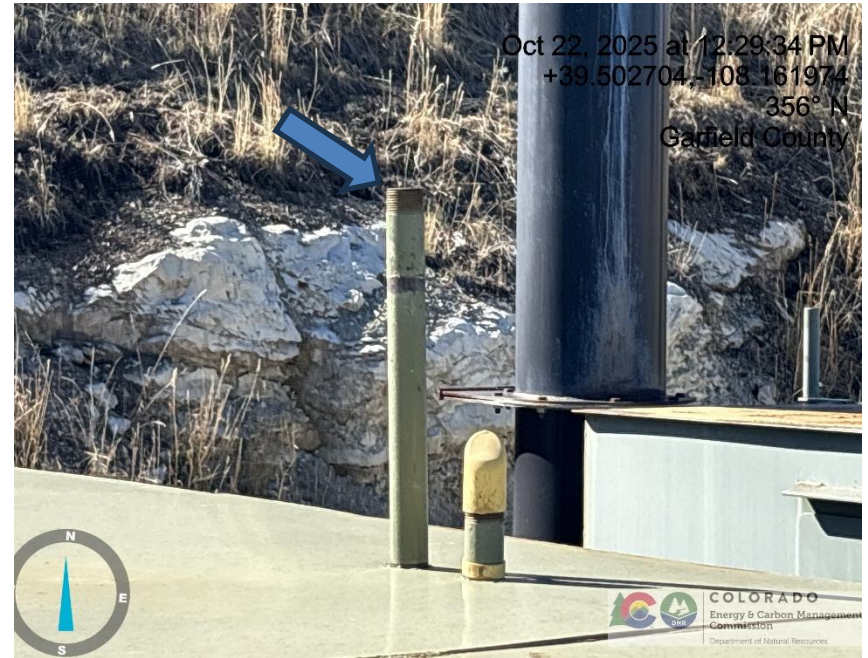
**Photo # 1202 PRV vent line does not comply with CECMC pressure safety device rules**

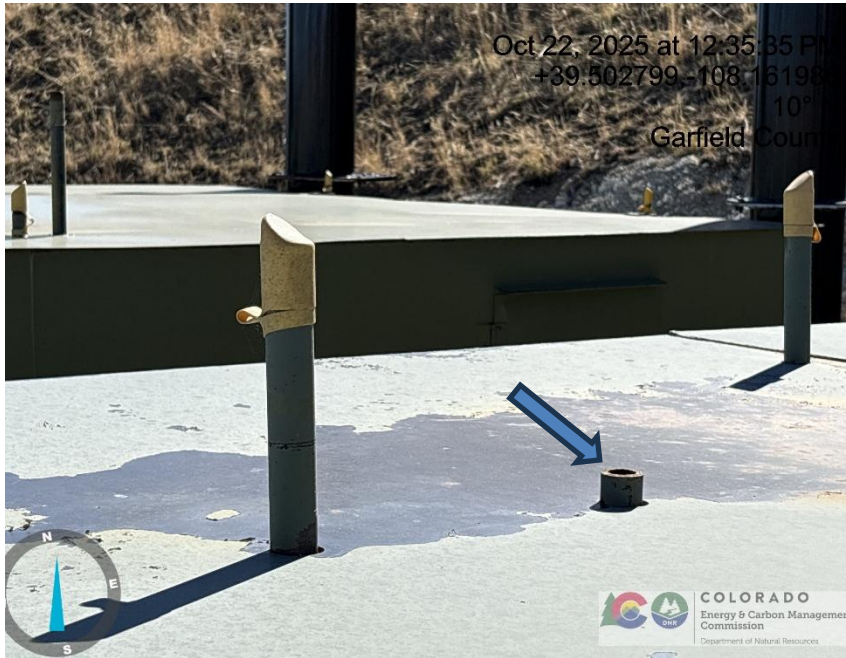
**Photo # 1203 Rupture disc vent line does not comply with CECMC pressure safety device rules**

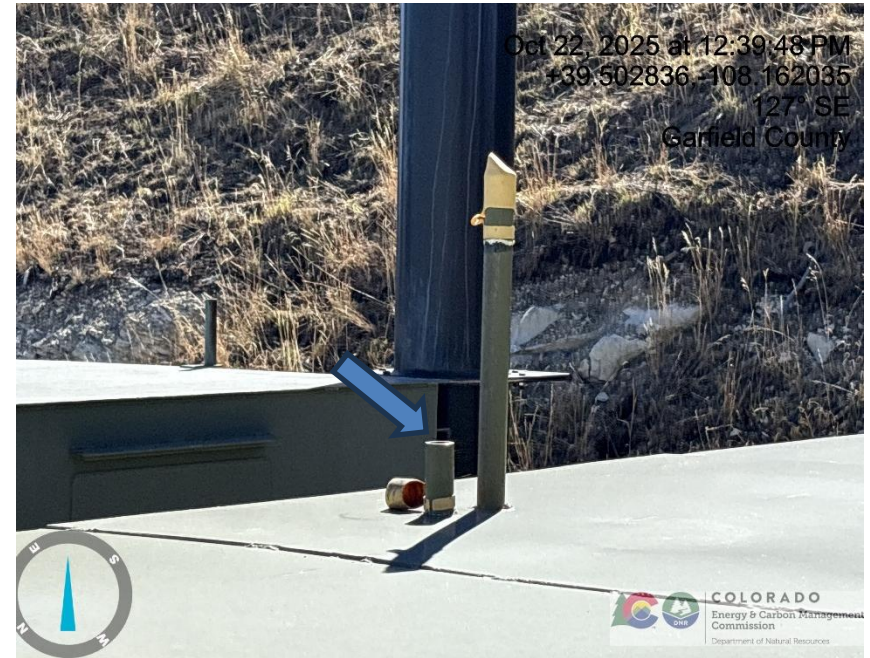
**Photo # 1204 Rupture disc vent line does not comply with CECMC pressure safety device rules**

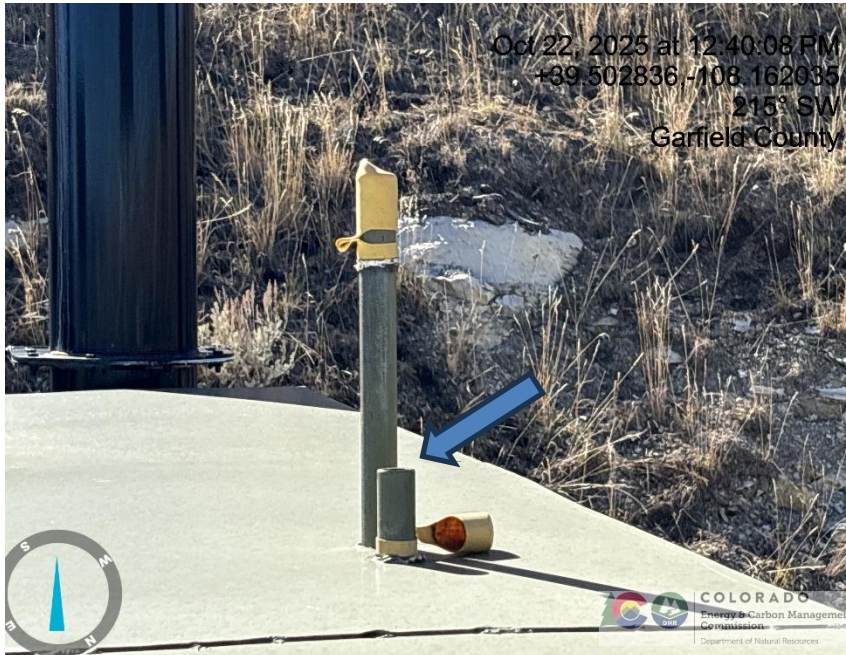
**Photo # 1205 Rupture disc vent line does not comply with CECMC pressure safety device rules**

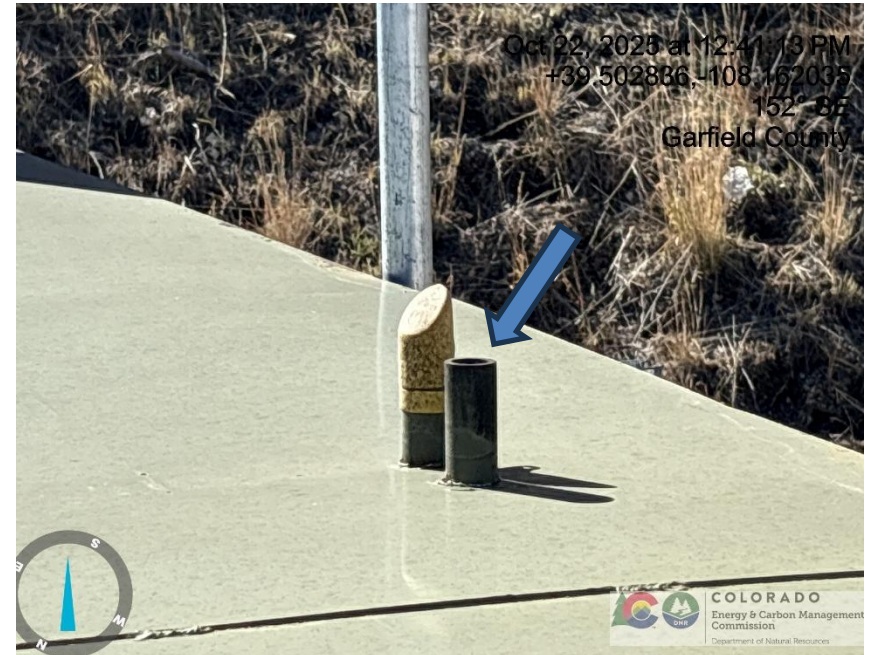
**Photo # 1206 Rupture disc vent line does not comply with CECMC pressure safety device rules**

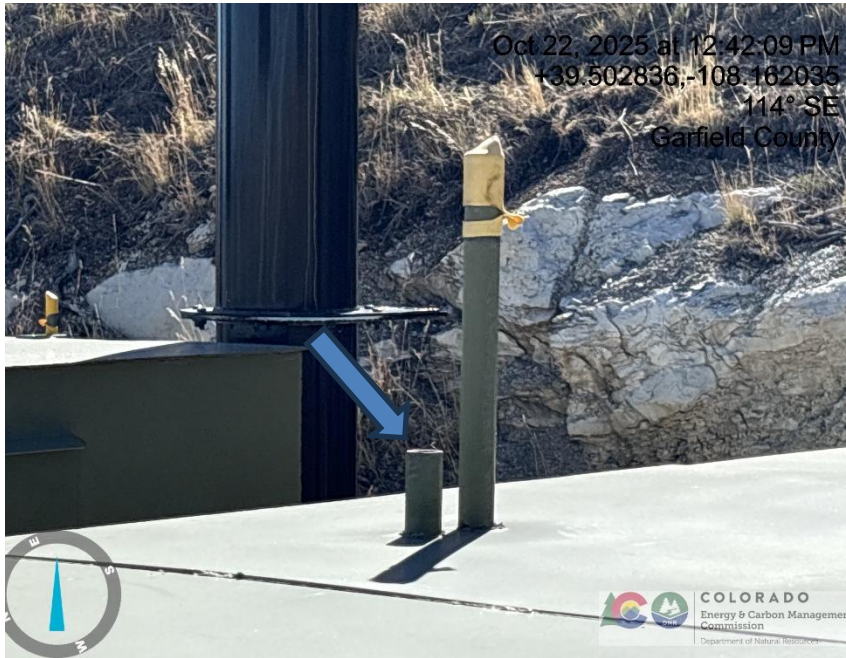
**Photo # 1207 Rupture disc vent line does not comply with CECMC pressure safety device rules**

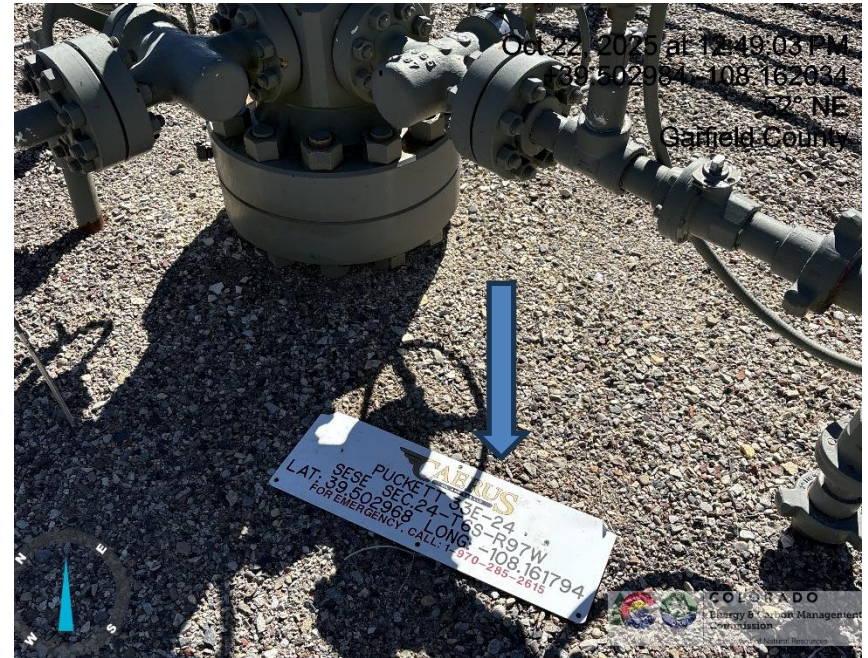
**Photo # 1208 Debris**

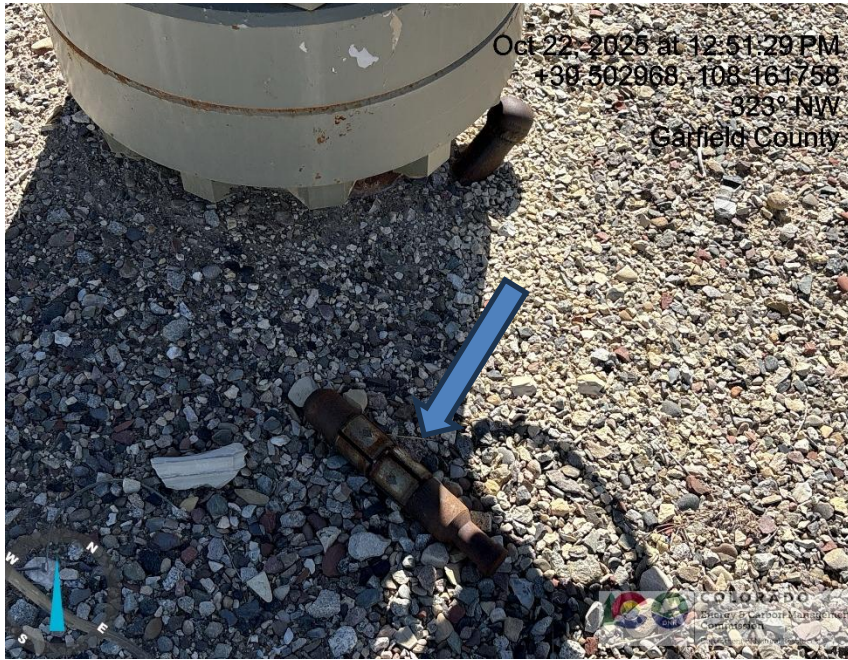
Photo # 1209 Debris

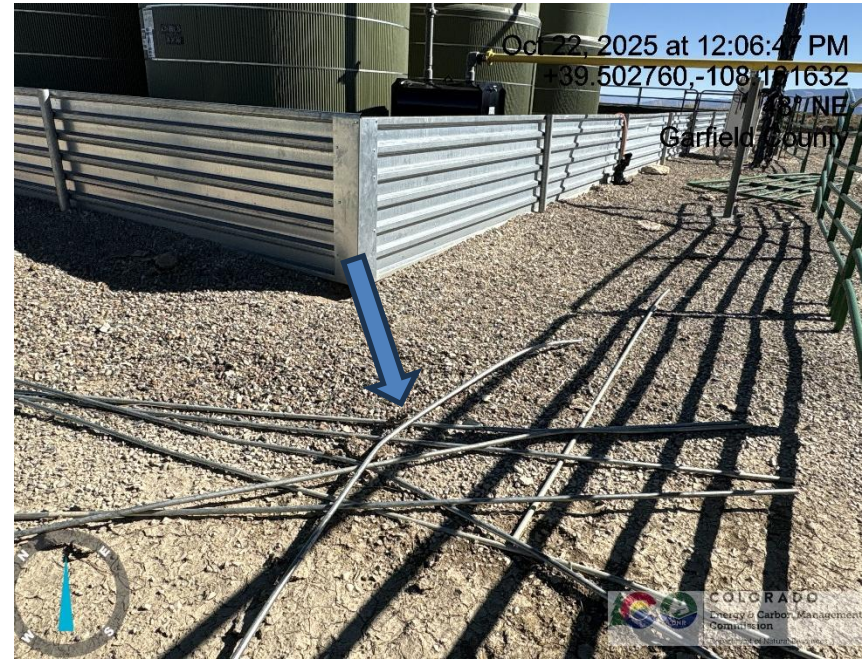
Photo # 1210 Debris

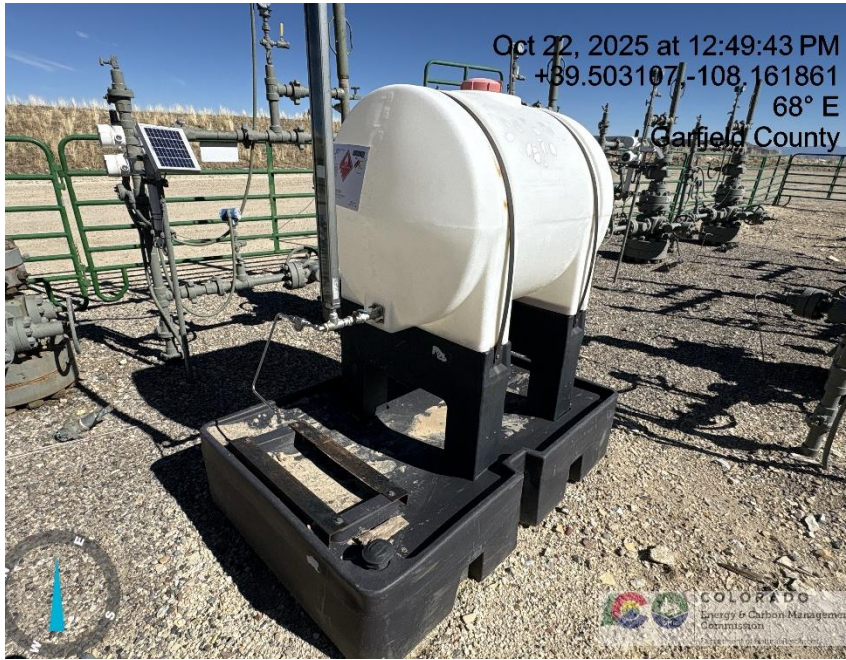
Photo # 1211 Unused equipment

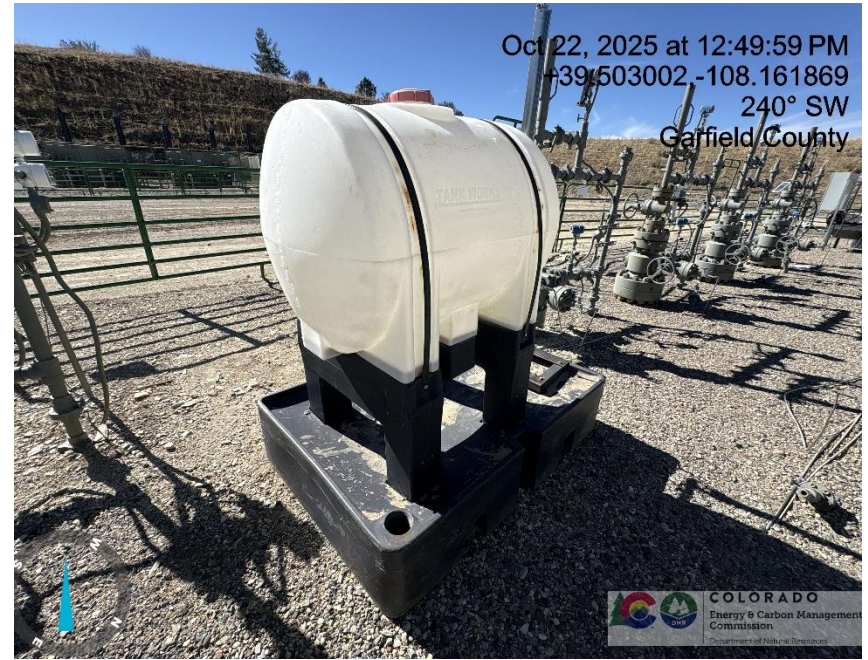
Photo # 1212 Unused equipment

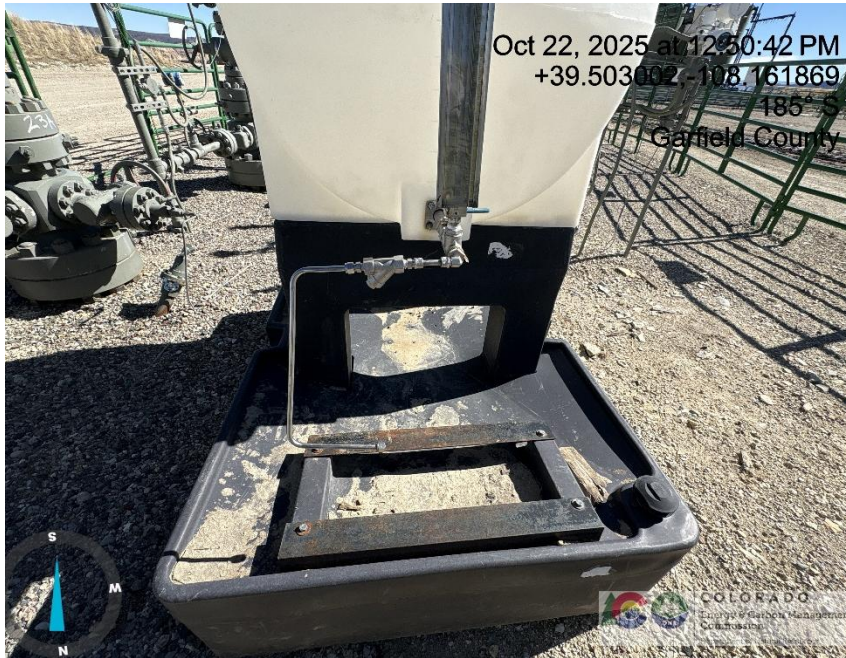
Photo # 1213 Unused equipment

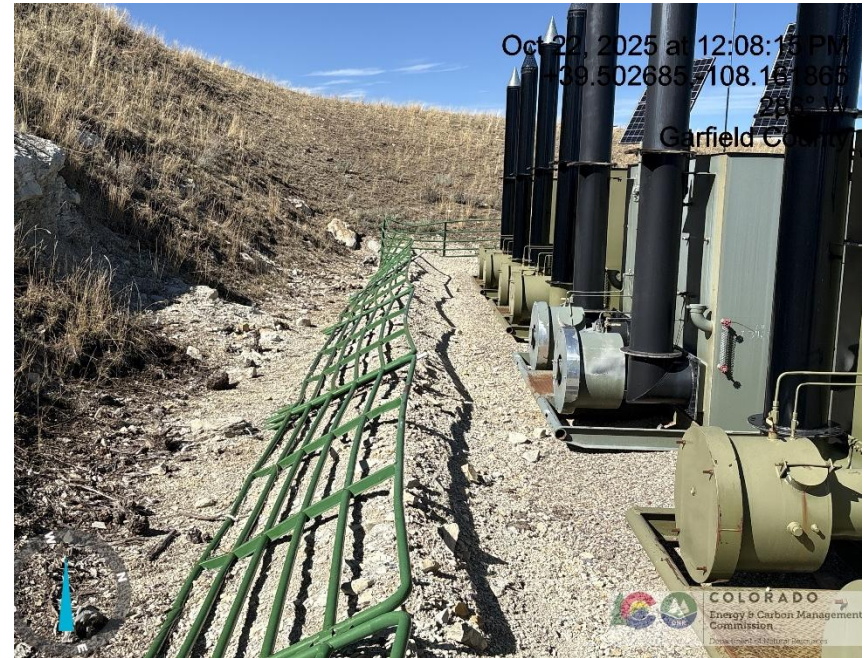
Photo # 1214 Cattle panels behind separator units laying on the ground

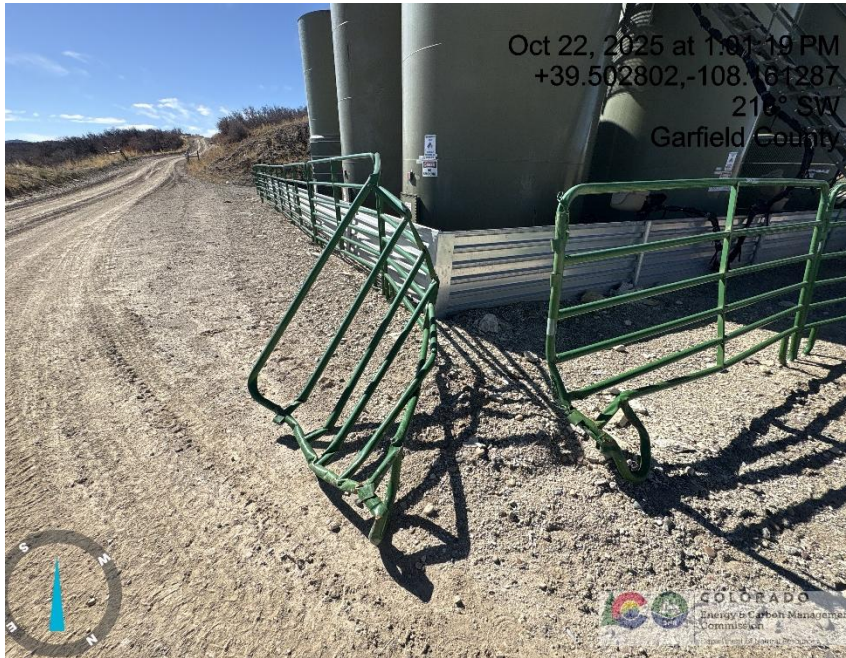
Photo # 1215 Cattle panel around tank battery damaged

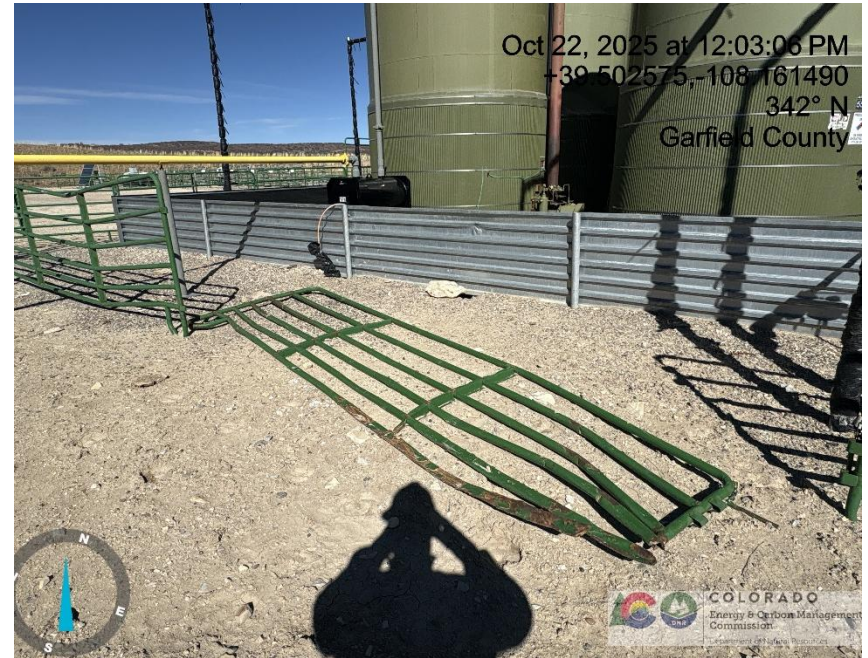
Photo # 1216 Cattle panel around tank battery damaged & laying on the ground
