Cosslet A9
© 21-Oct-25 13:42:57
ECMC Environmental Inspection

ECMC
Environmental
Field Inspection

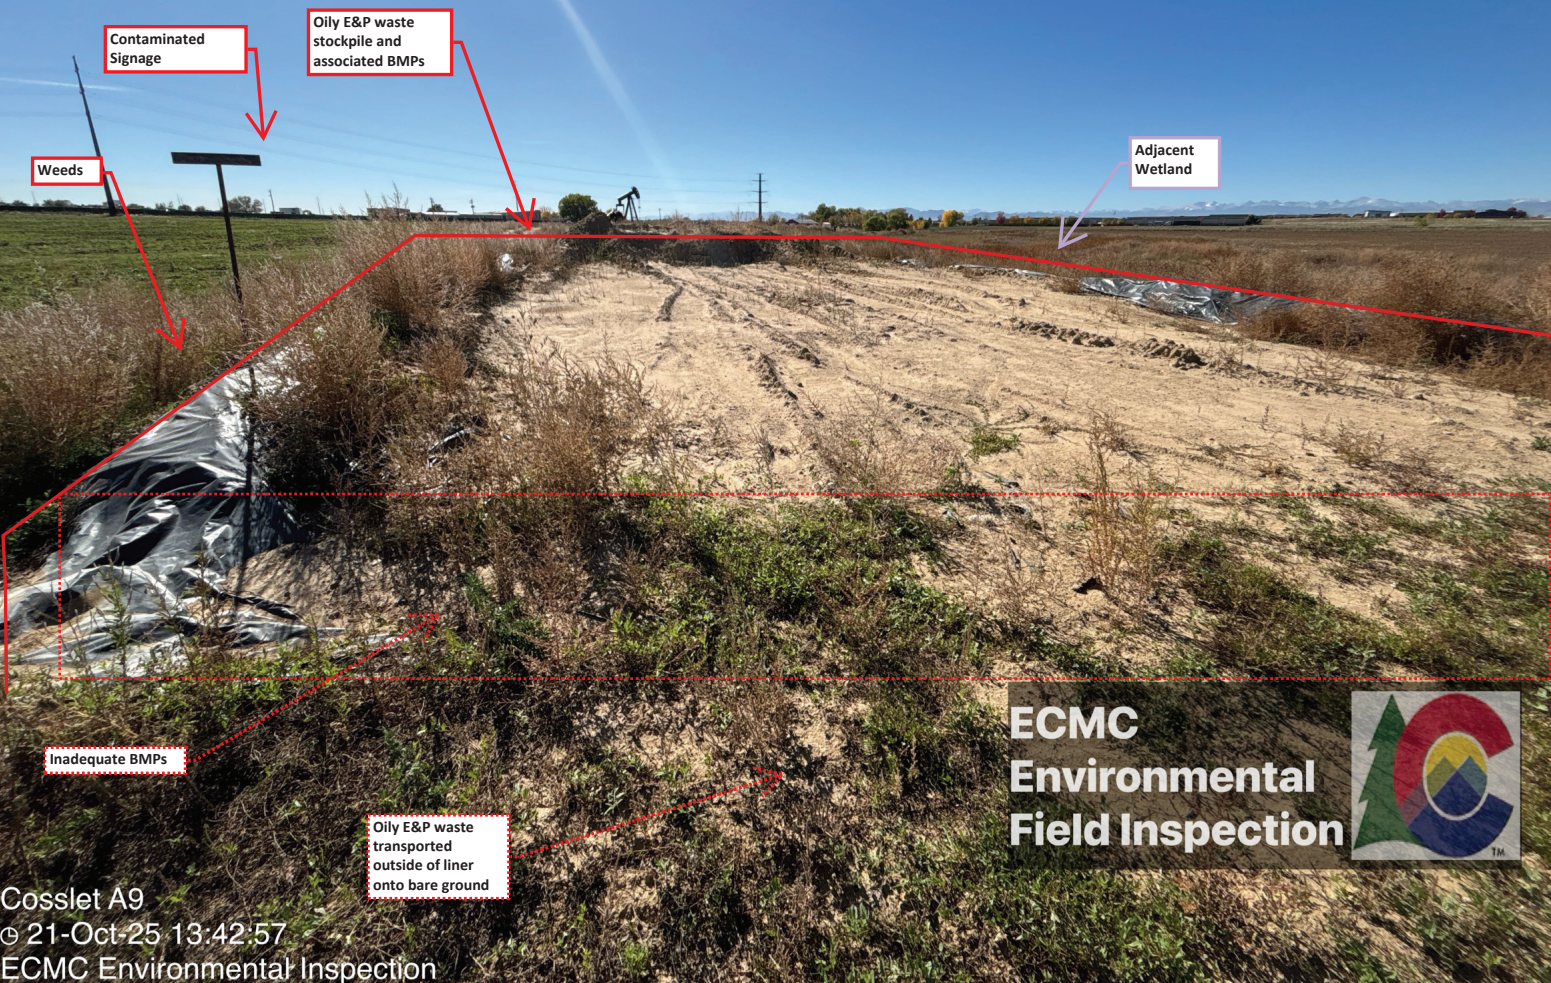
Weeds
Erosion - Transport of Oily E&P waste from stockpile off/outside liner onto bare ground adjacent to wetland.
Inadequate BMPs - E&P waste stockpile liner has torn in multiple locations and the earthen berm surrounding the stockpile is discontinuous.

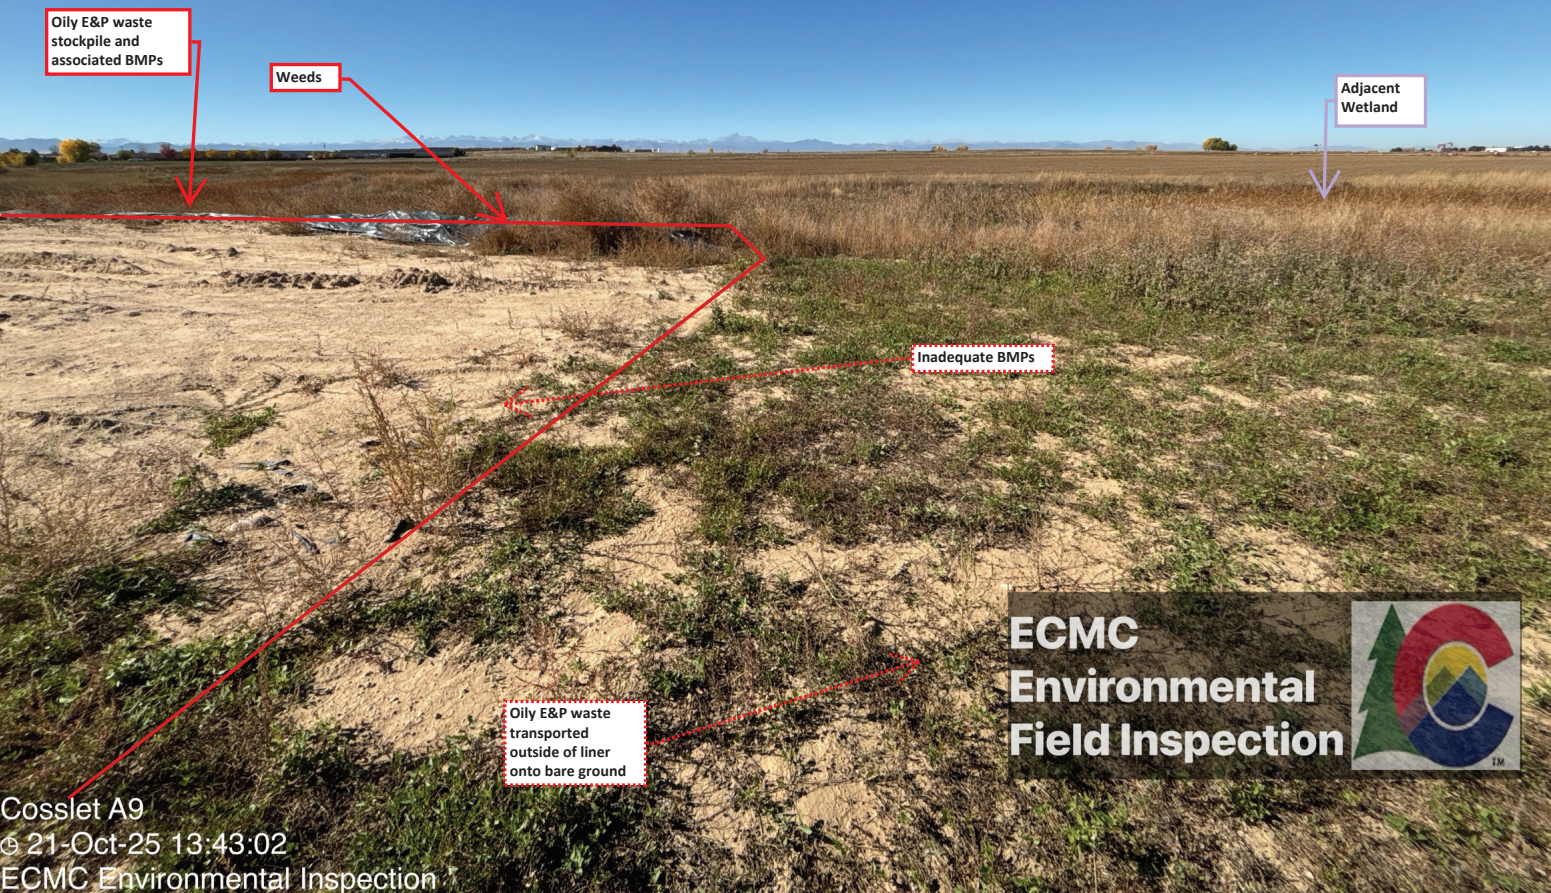
Oily E&P waste stockpile and associated BMPs

Inadequate BMPs

Oily E&P waste transported outside of liner onto bare ground

Weeds
Erosion - Transport of Oily E&P waste from stockpile off/outside liner onto bare ground adjacent to wetland.
Inadequate BMPs - E&P waste stockpile liner has torn in multiple locations and the earthen berm surrounding the stockpile is discontinuous.

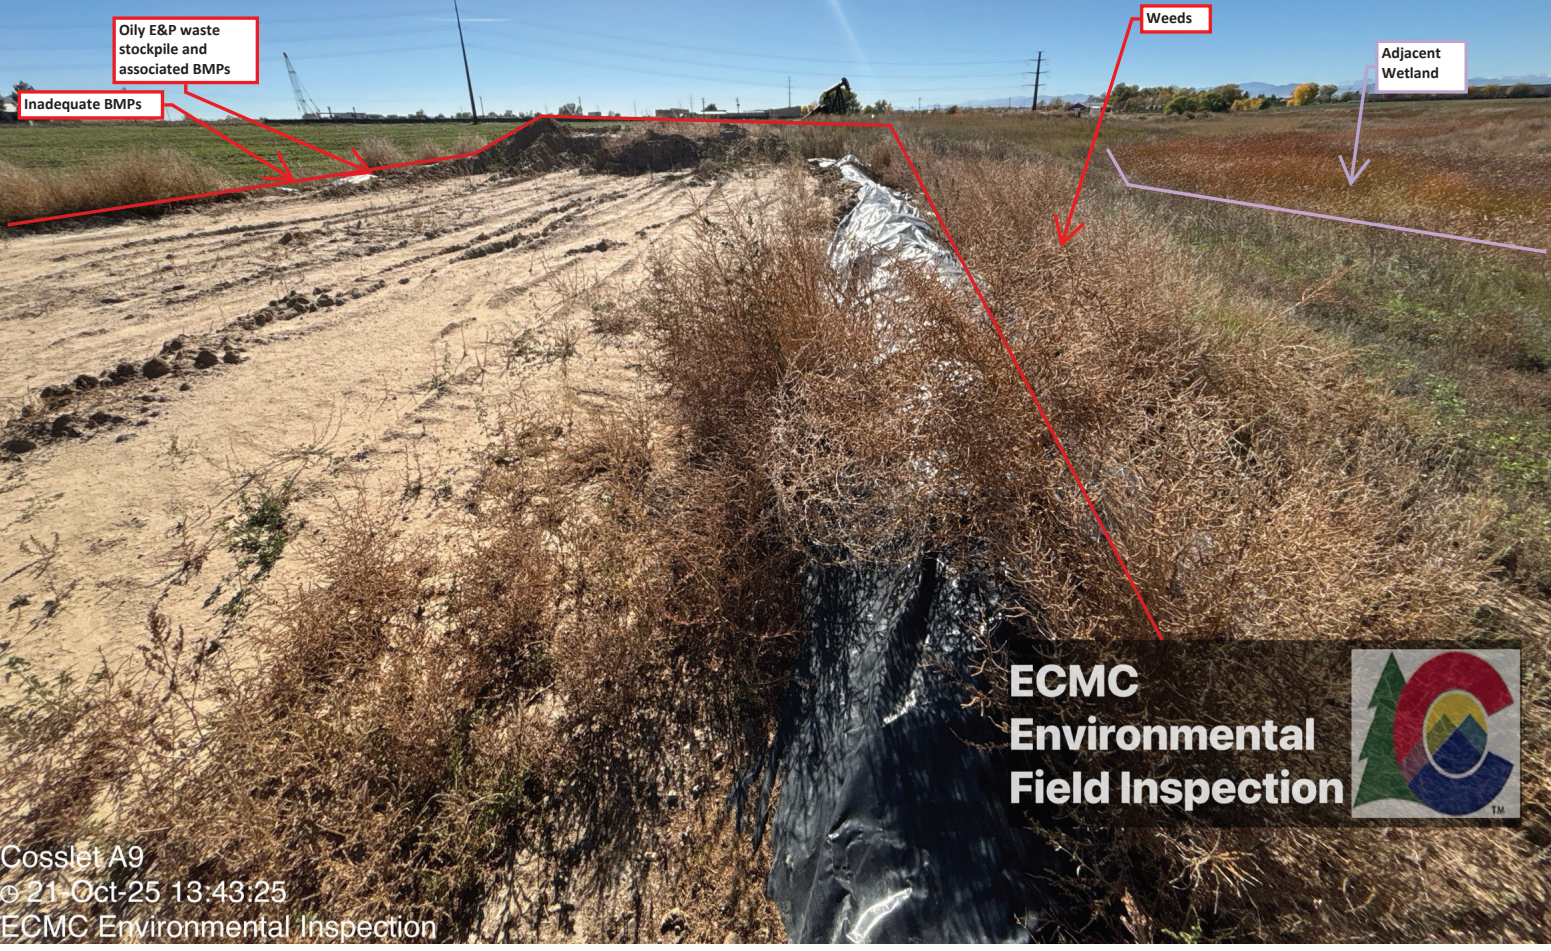
Oily E&P waste
stockpile and
associated BMPs

Inadequate BMPs

Weeds
Erosion - Transport of Oily E&P waste from stockpile off/outside liner onto bare ground adjacent to wetland.
Inadequate BMPs - E&P waste stockpile liner has torn in multiple locations and the earthen berm surrounding the stockpile is discontinuous.

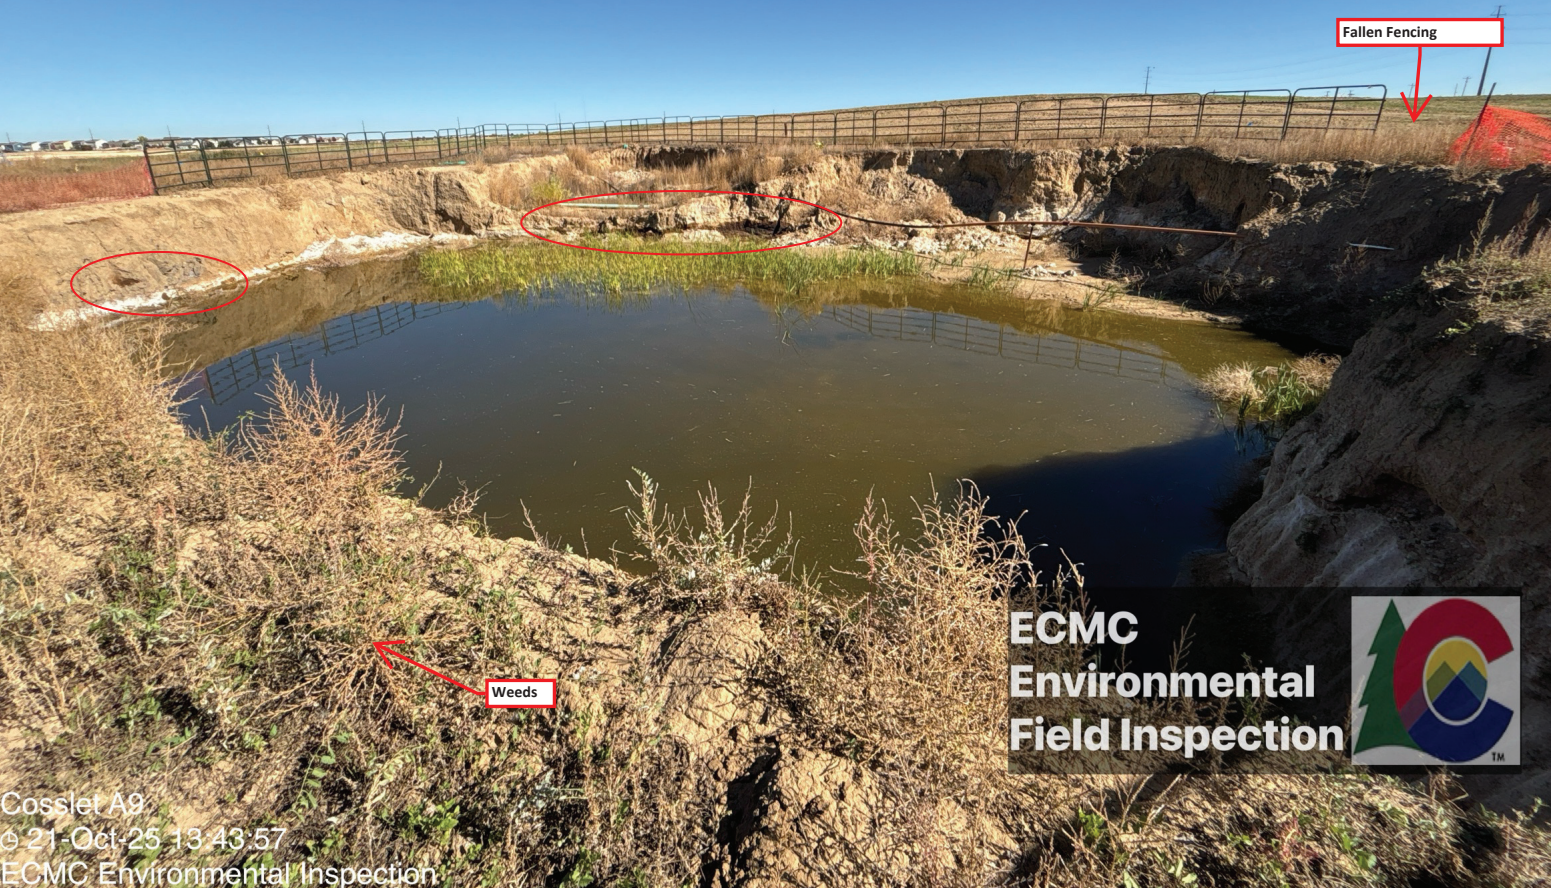
Fallen Fencing

Inadequate fencing around open excavation within City of Dacono Limits
Weeds
Oil stained soil remains in situ within the open excavation.

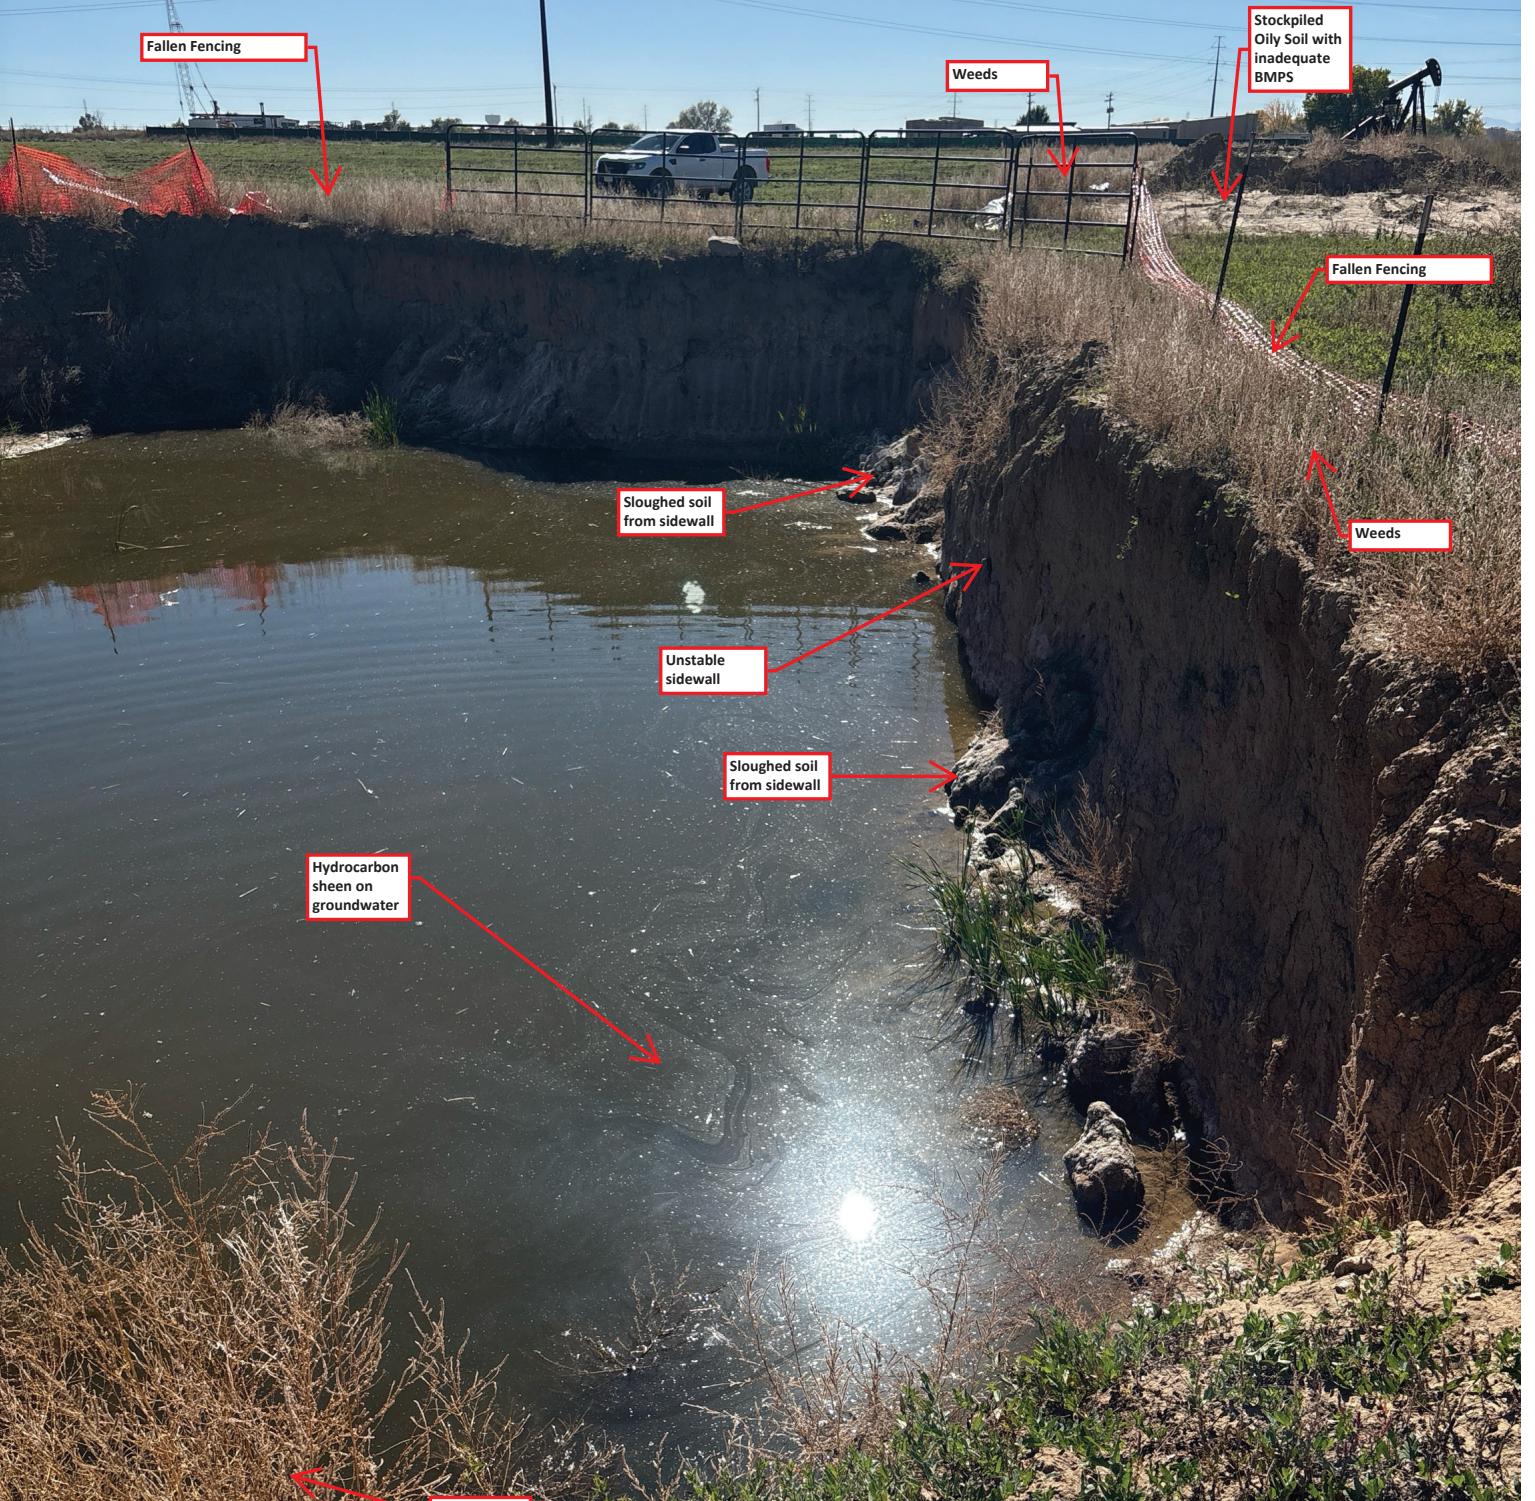
Stockpiled Oily Soil with inadequate BMPs

Sloughed soil from sidewall

Unstable sidewall

Hydrocarbon sheen on groundwater

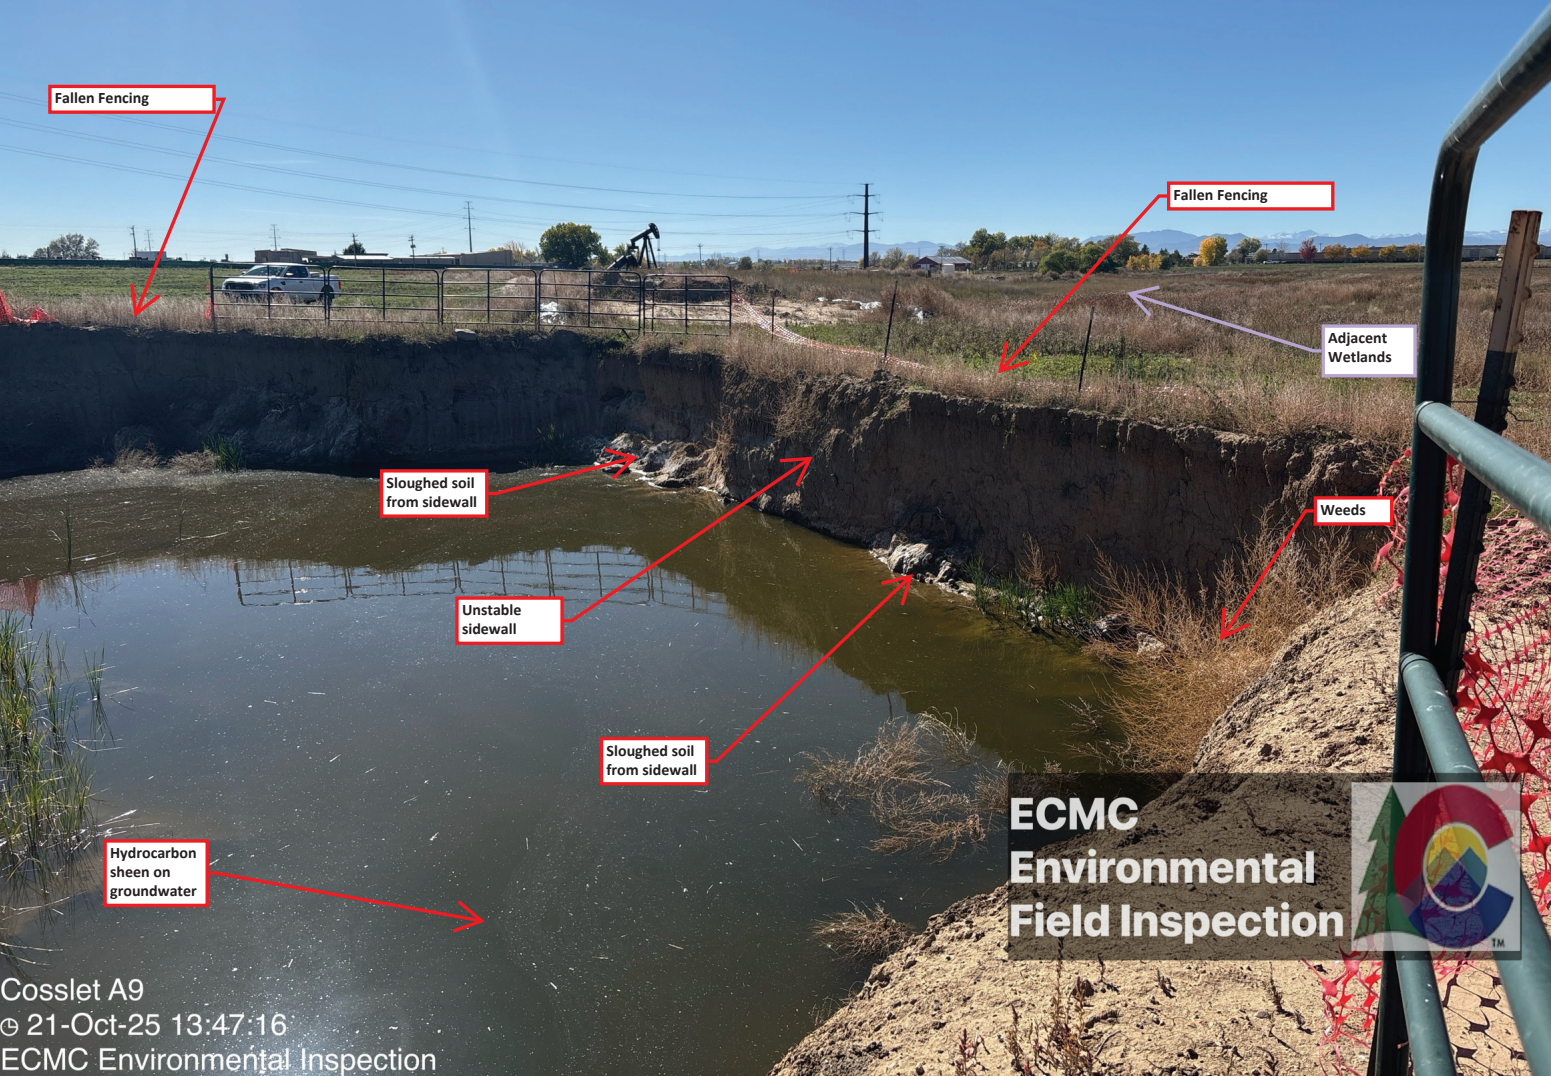
Inadequate fencing around open excavation within City of Dacono Limits

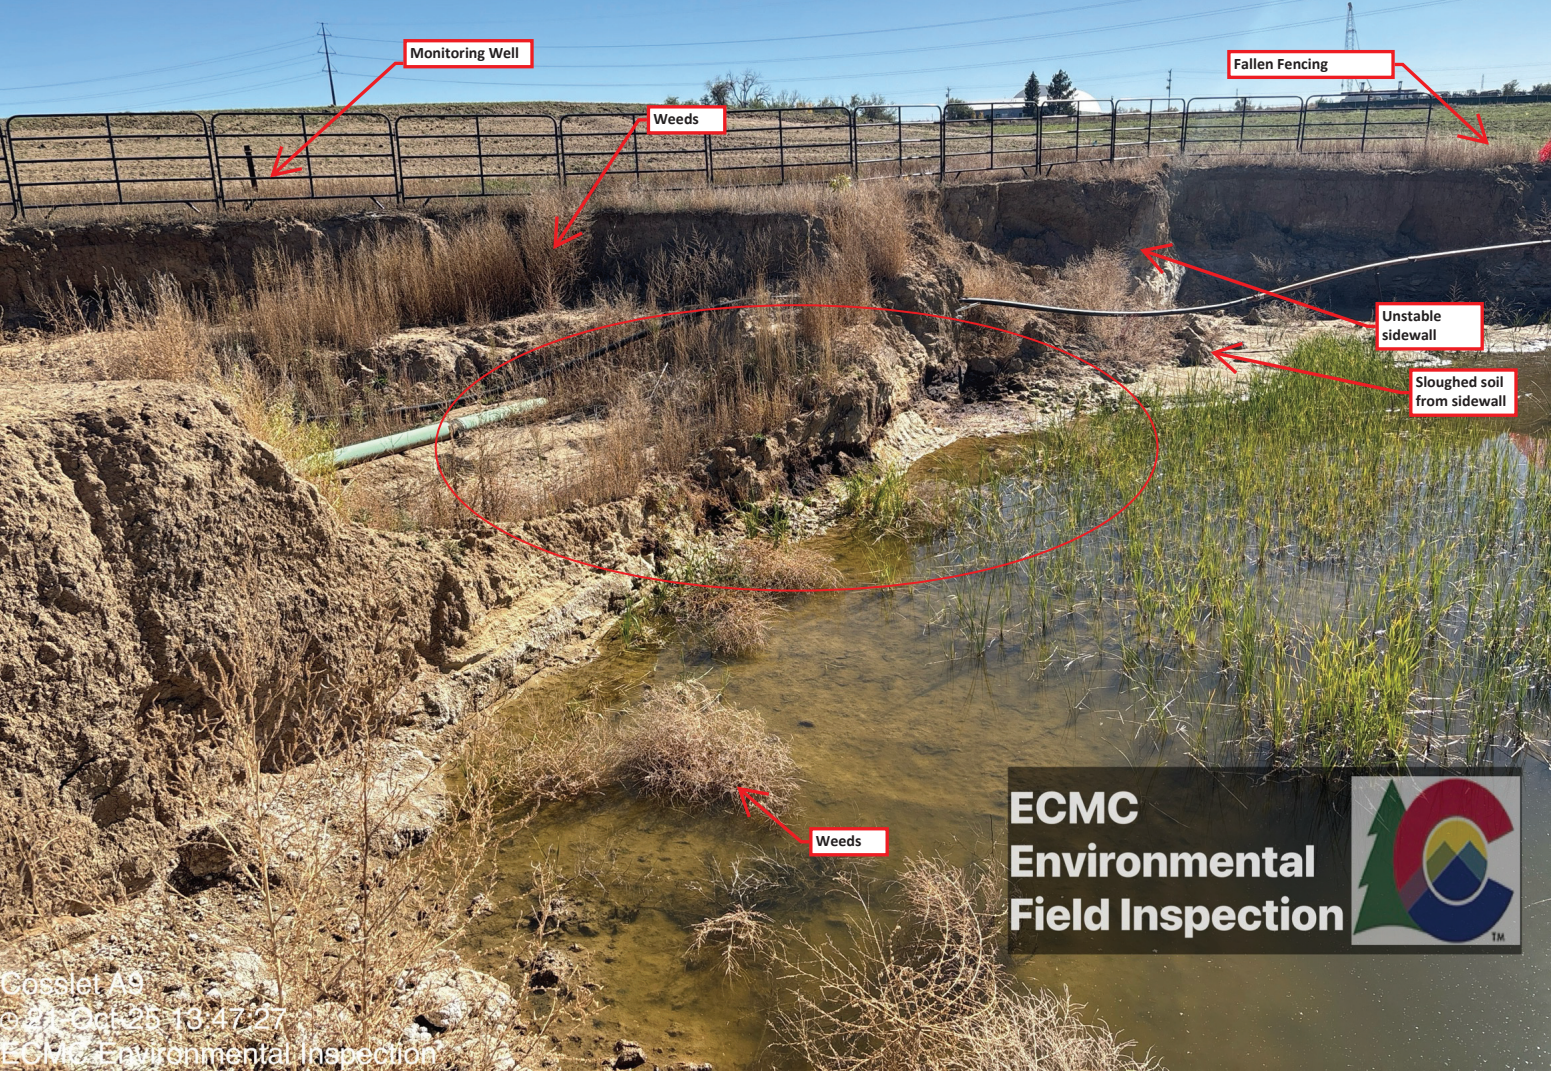
Missing J-Plug on
Monitoring Well

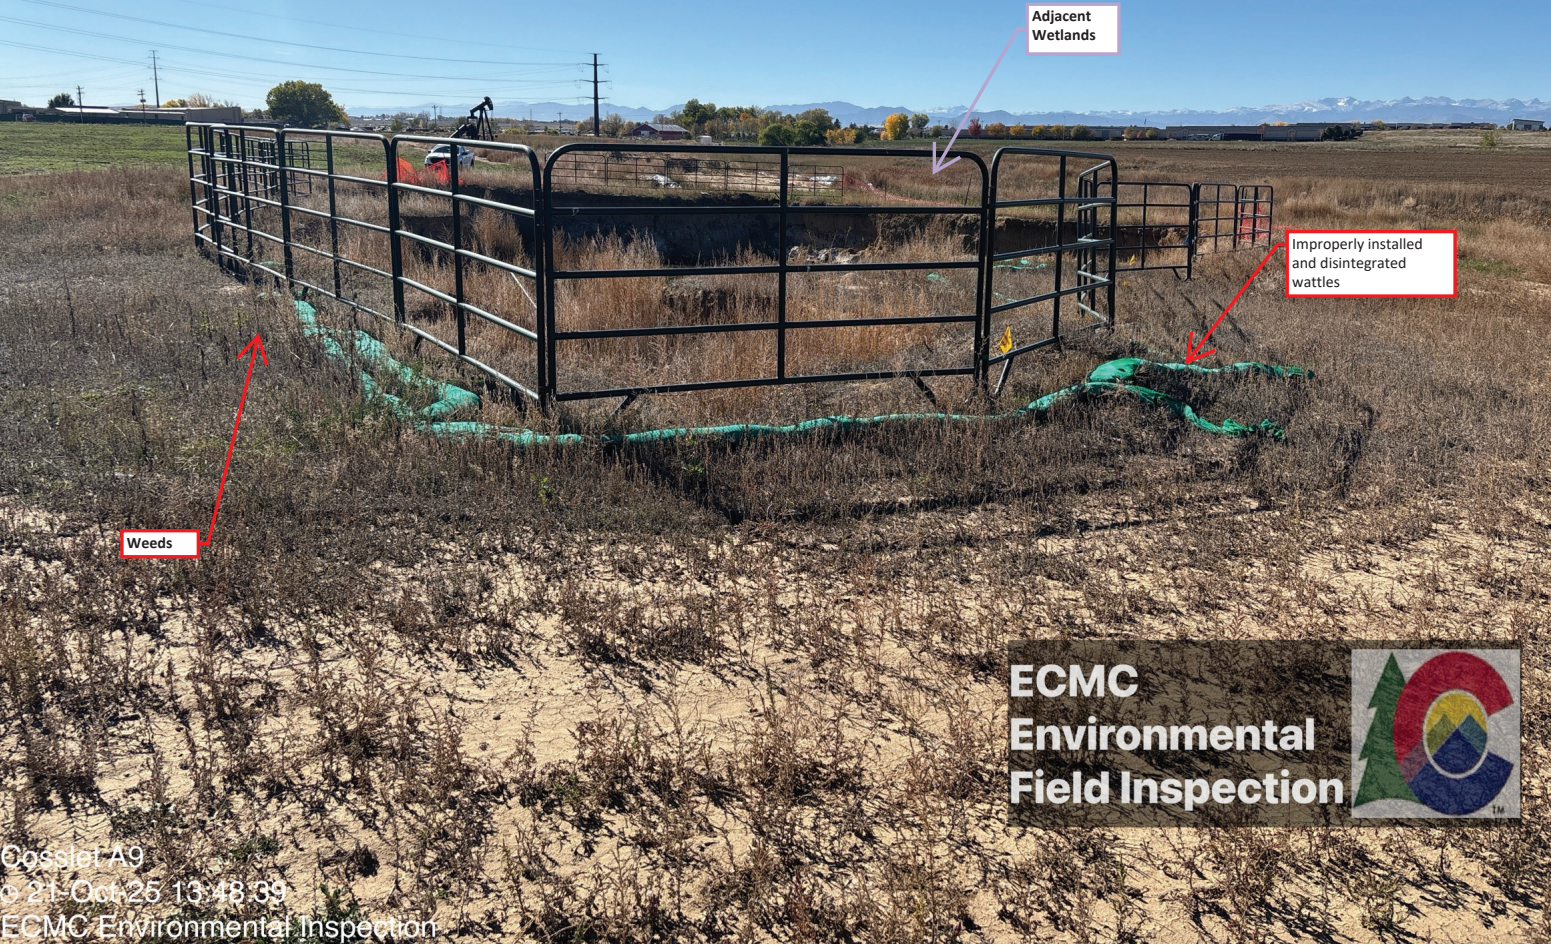
Improperly installed
and disintegrated
wattles

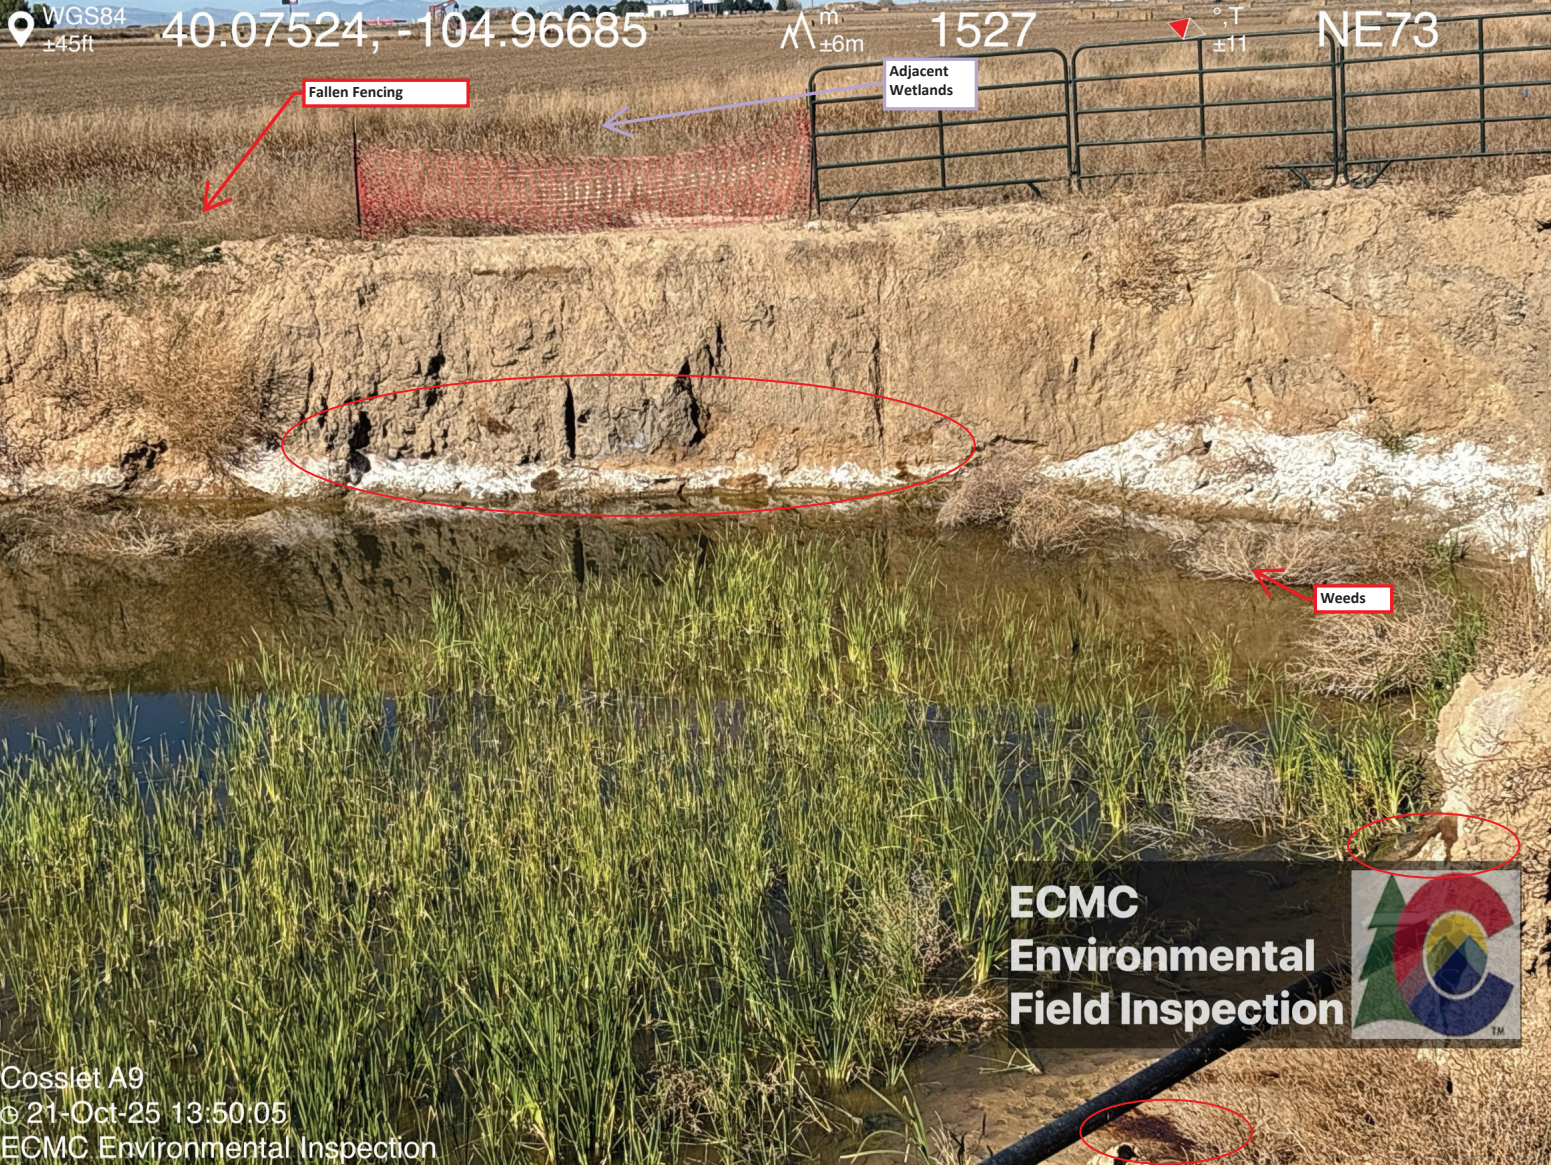
Fallen Fencing

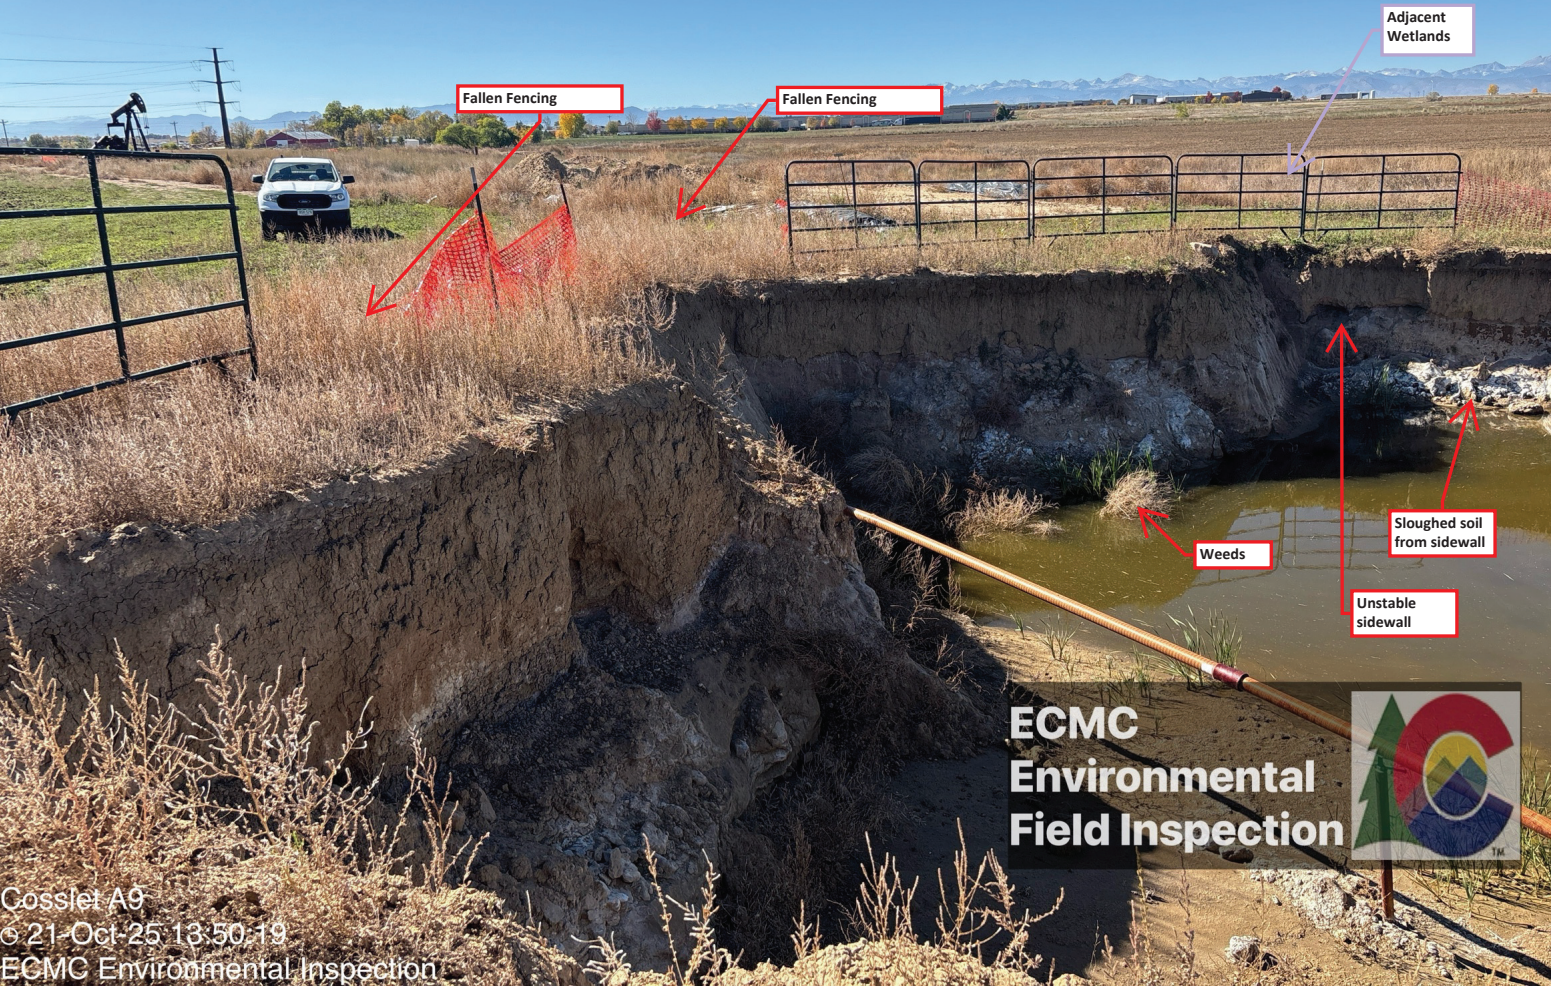
Fallen Fencing

Sloughed soil
from sidewall

Unstable
sidewall

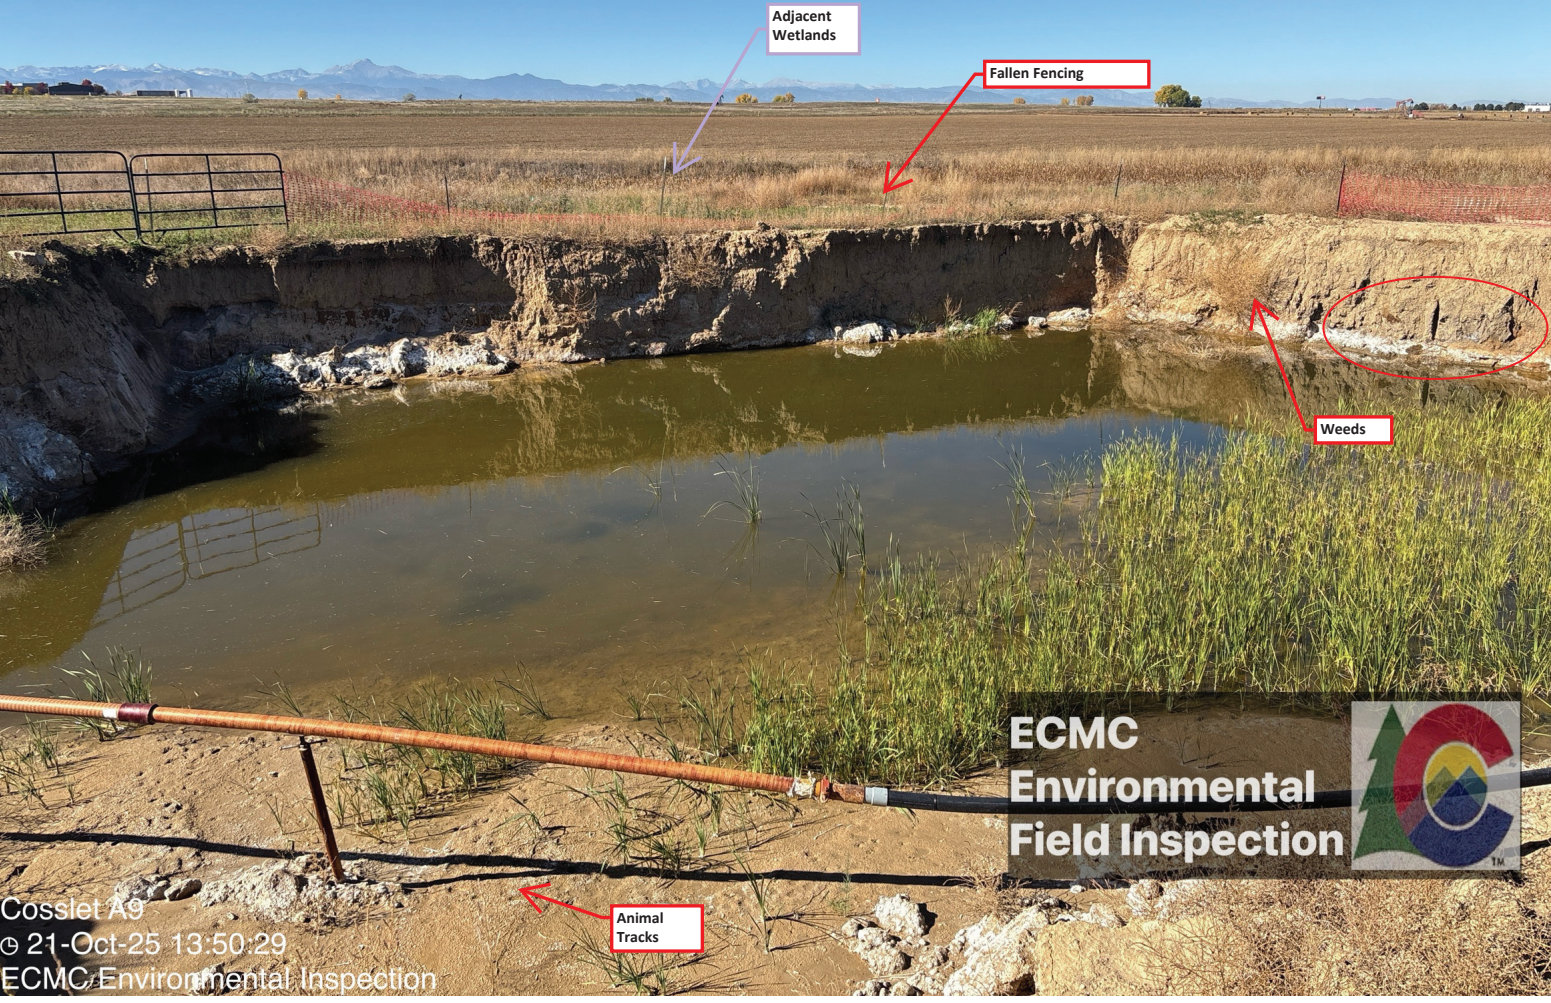
Fallen Fencing

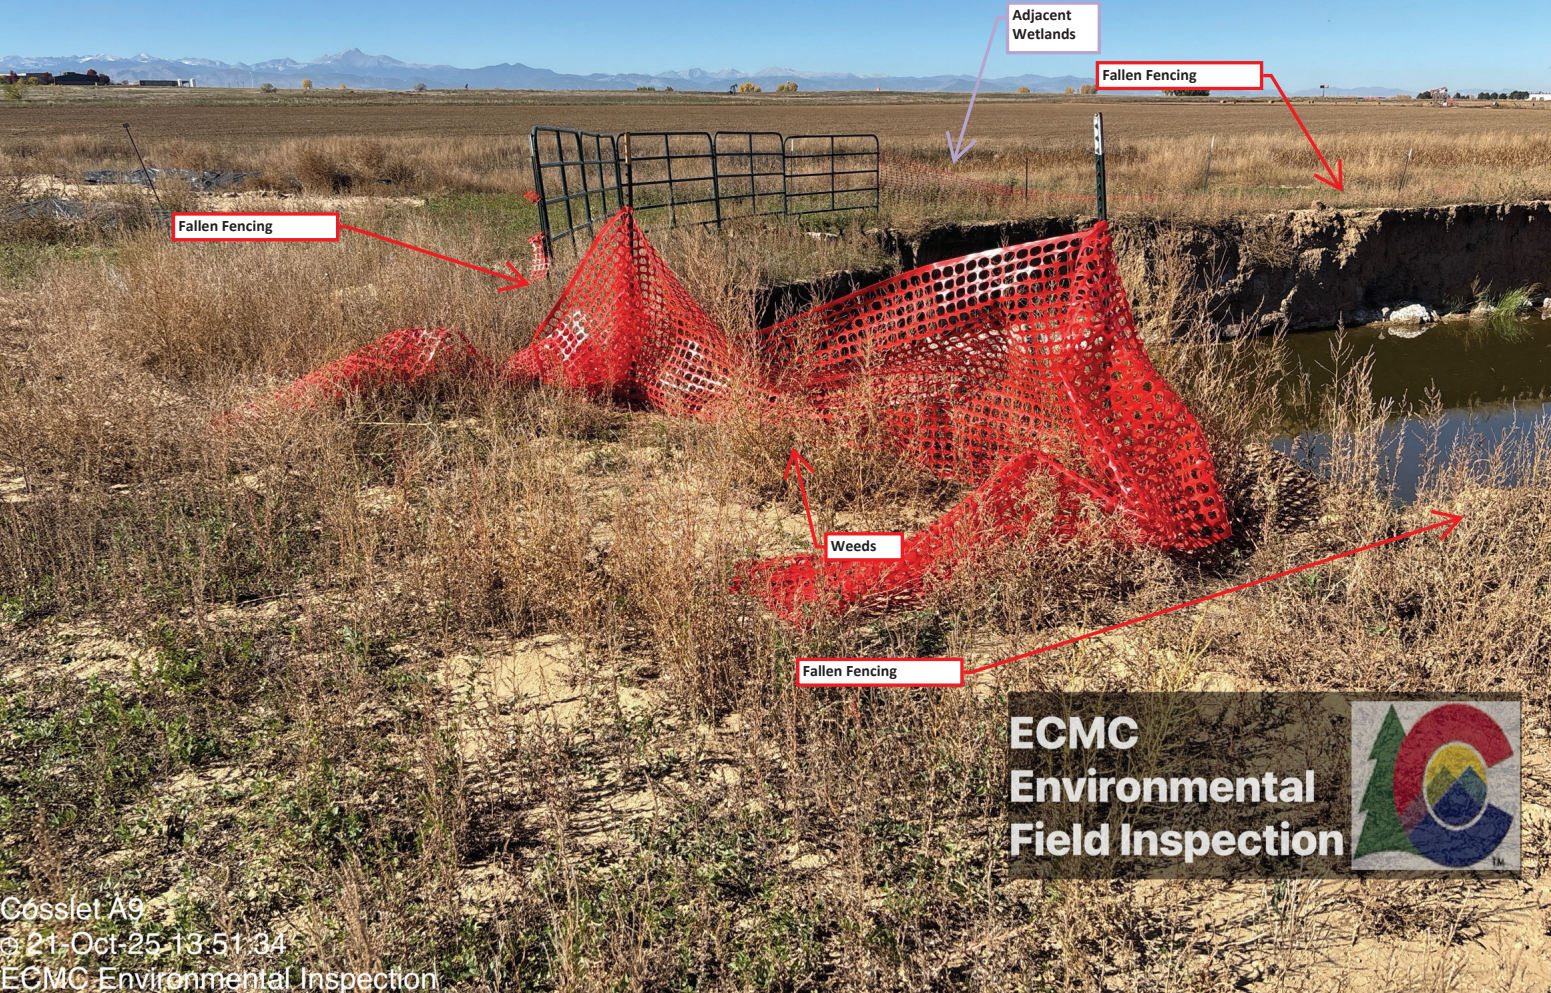
Fallen Fencing

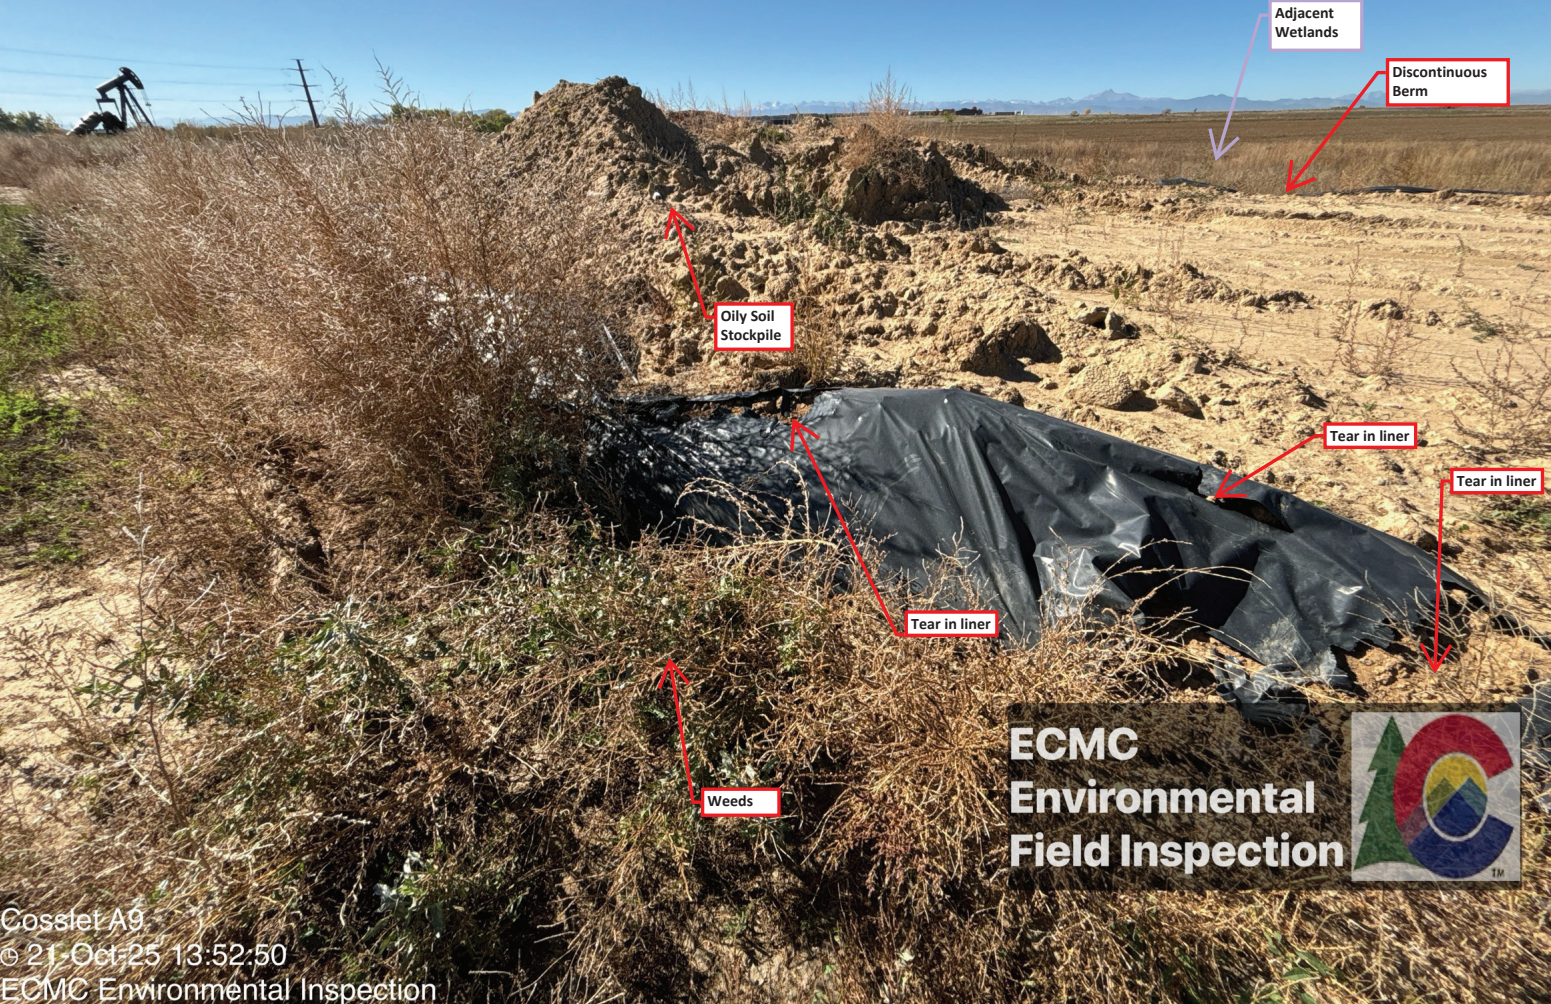
Discontinuous
Berm

Tear in liner

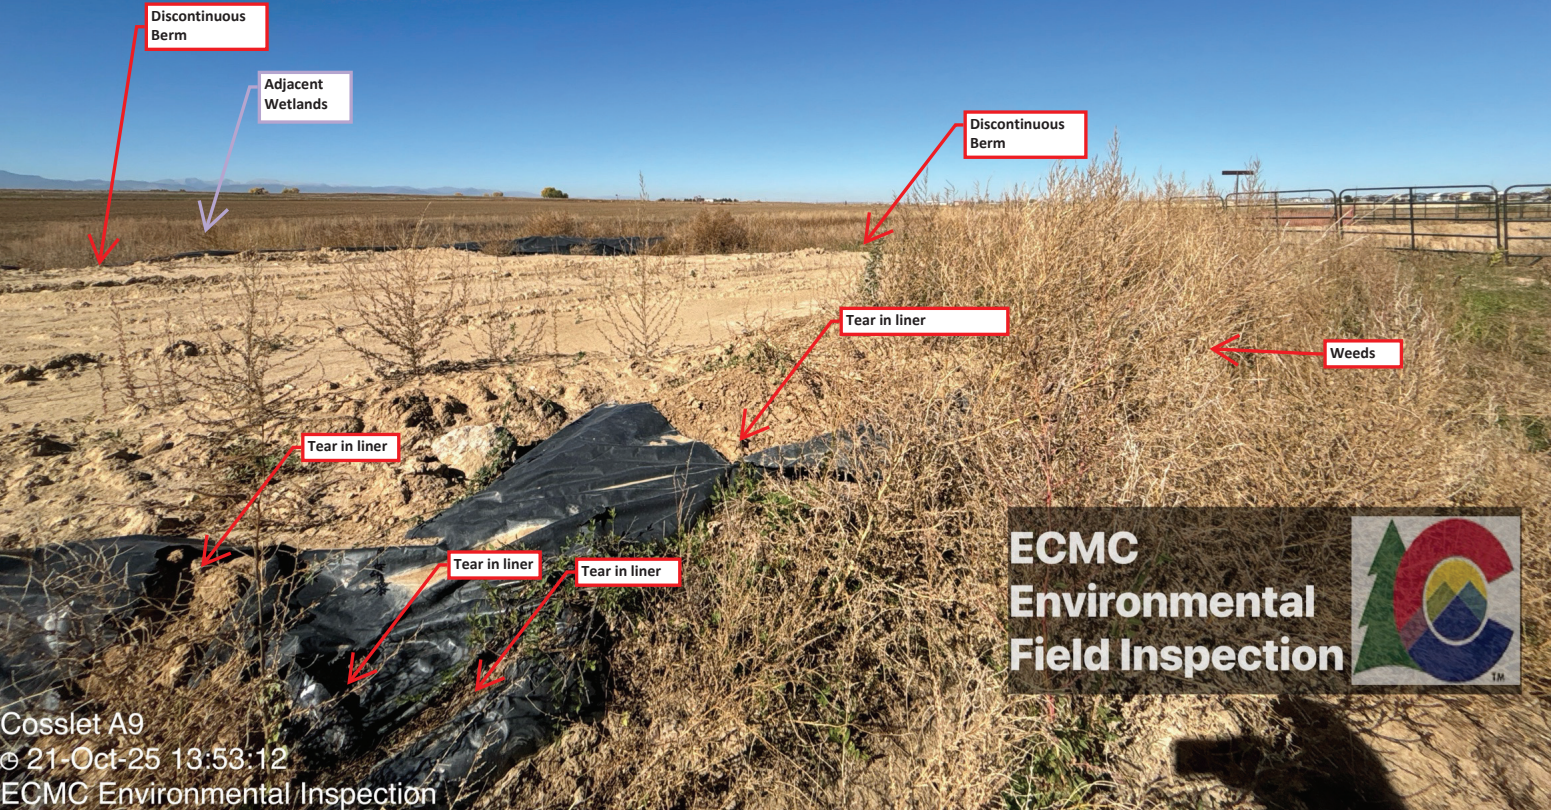
Oily soil spilling
outside
containment

Torn liner
