Cosslet A9
© 21-Oct-25 13:42:57
ECMC Environmental Inspection

ECMC
Environmental
Field Inspection

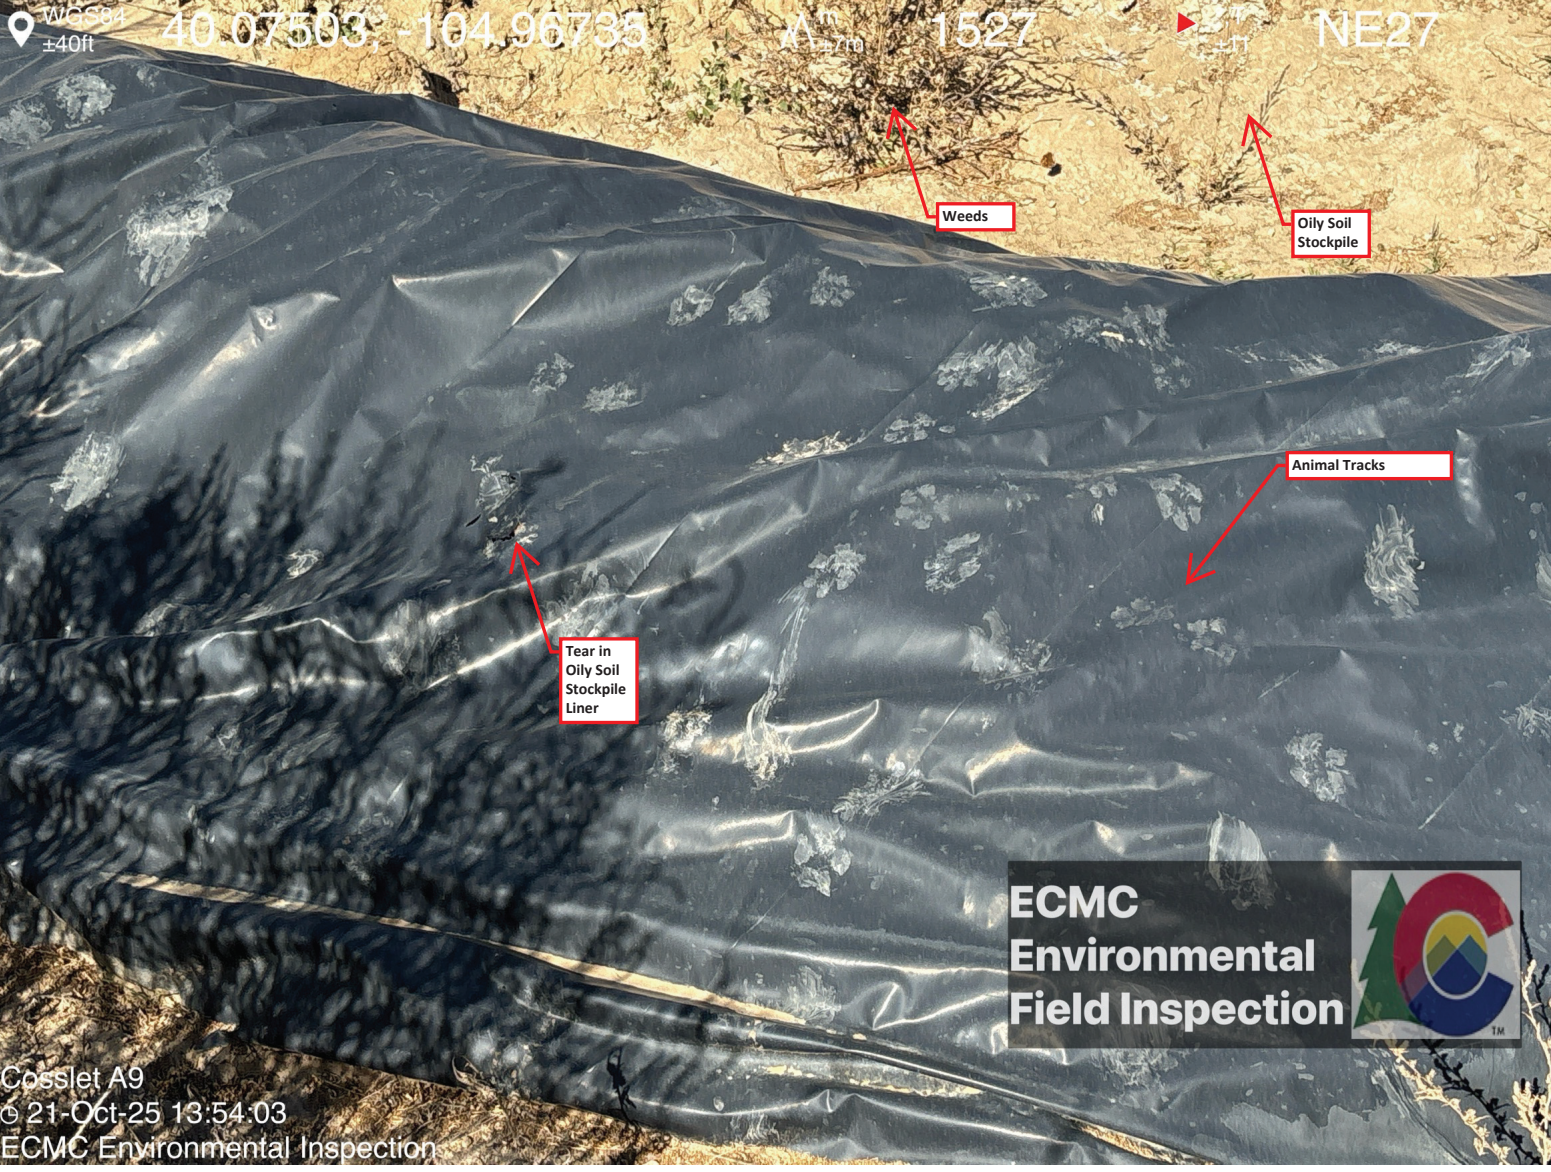
Tear in
Oily Soil
Stockpile
Liner

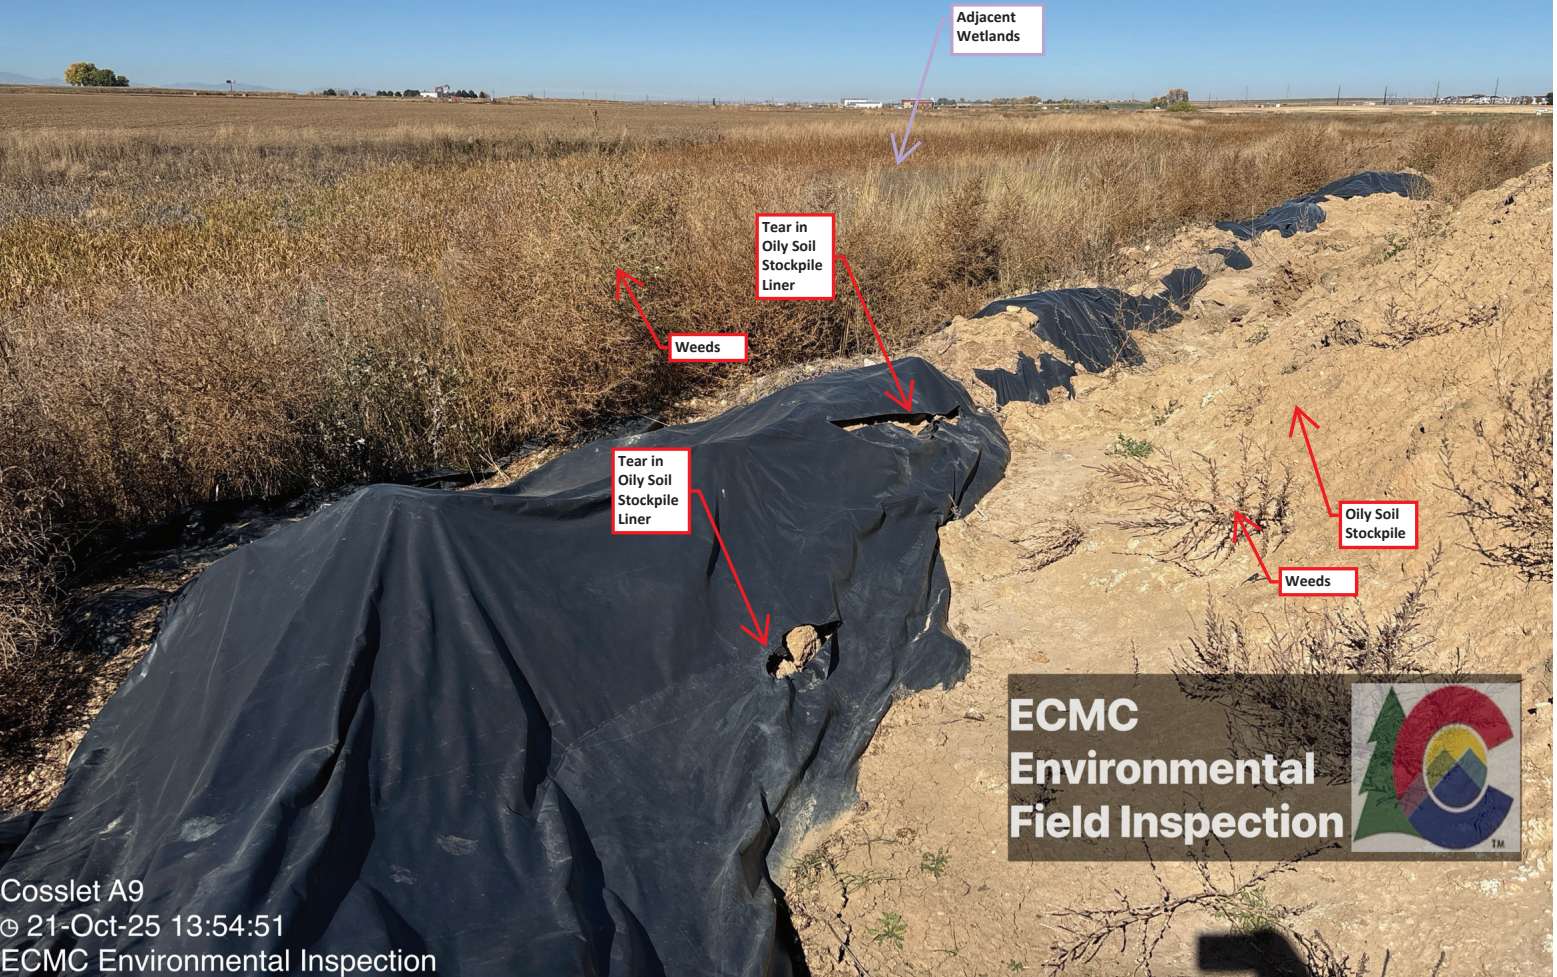
Tear in
Oily Soil
Stockpile
Liner

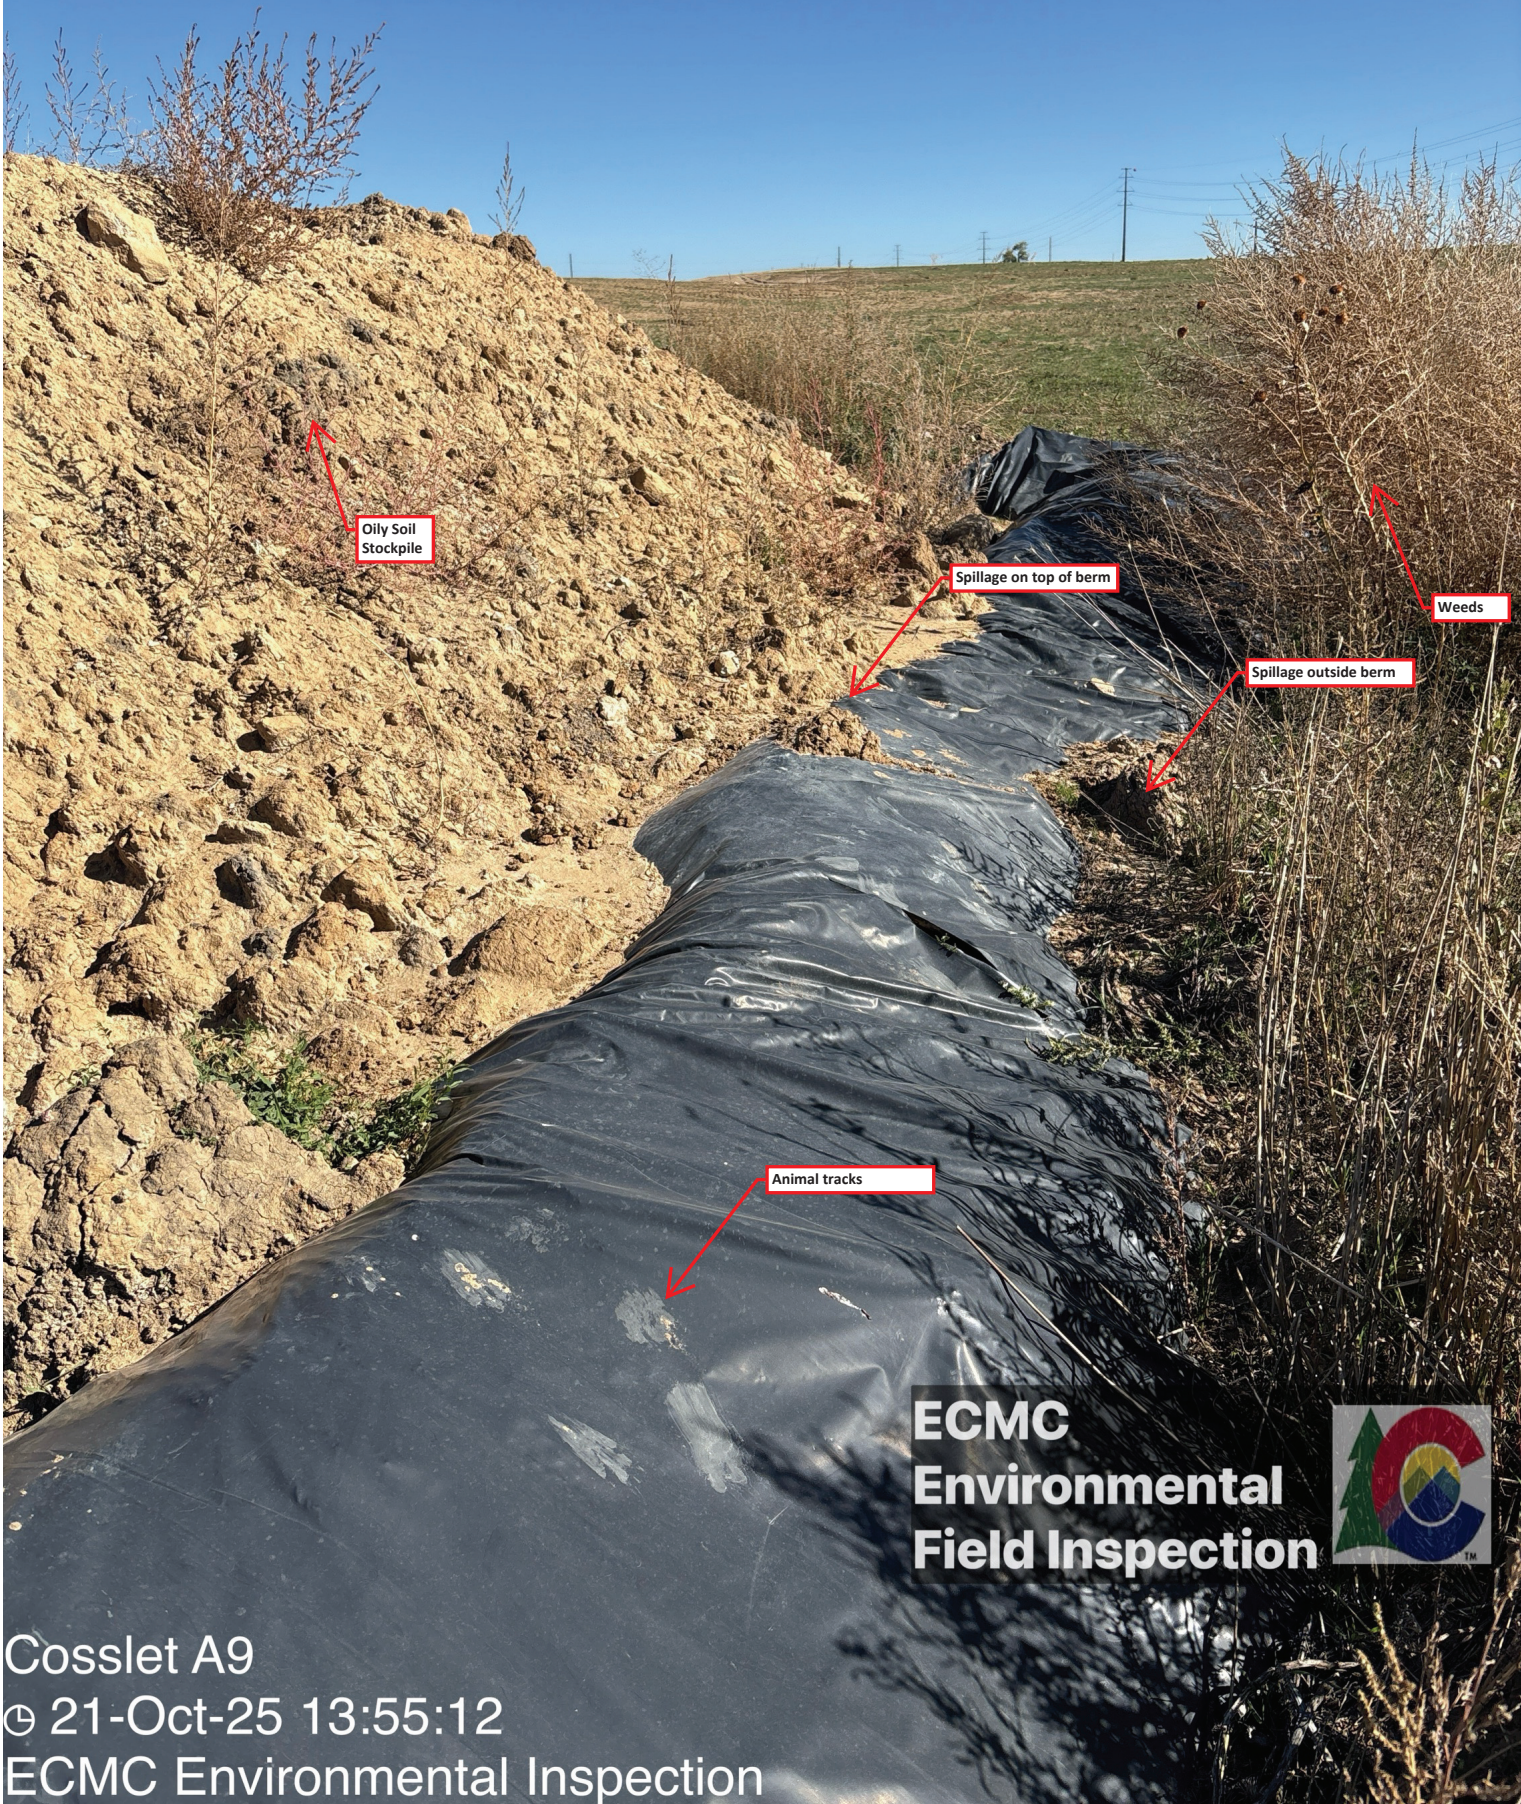
Spillage on top of berm

Spillage outside berm
