Inspection Photos
Facility 9 Flowline
Facility ID 478843

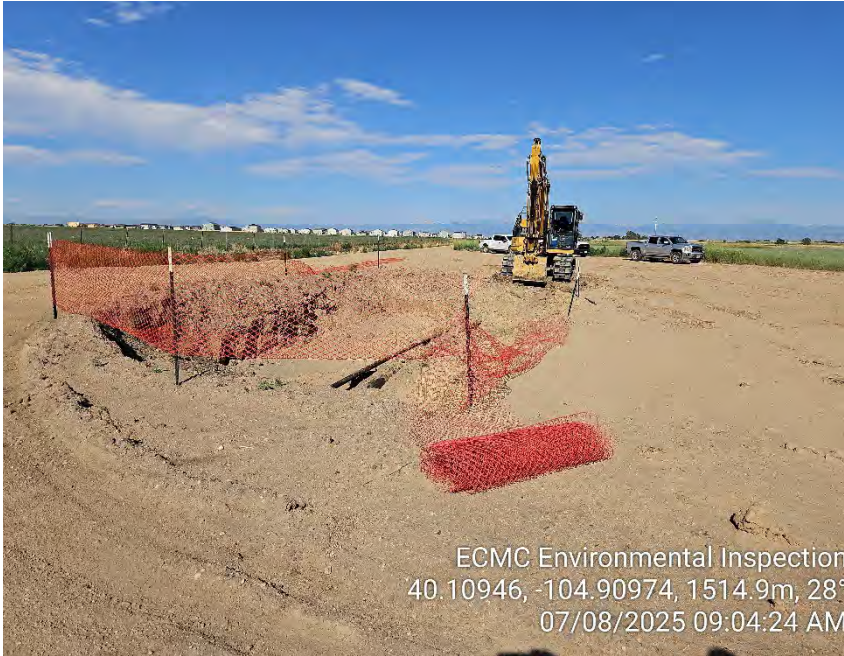
**Photo 1 – Spill excavation with pipelines/flowlines.
Fence down for active work**

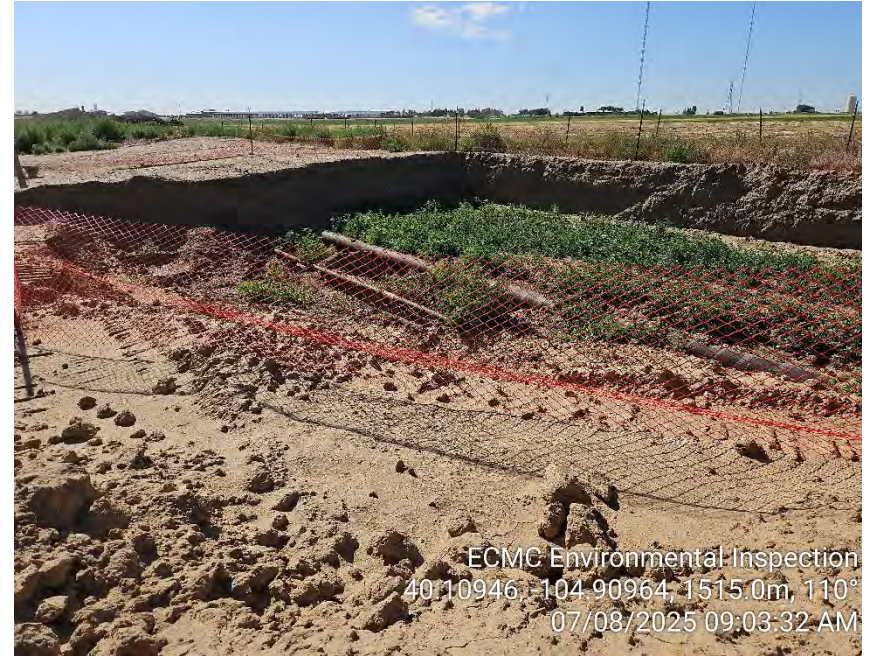
Photo 2 - Spill excavation with pipelines/flowlines

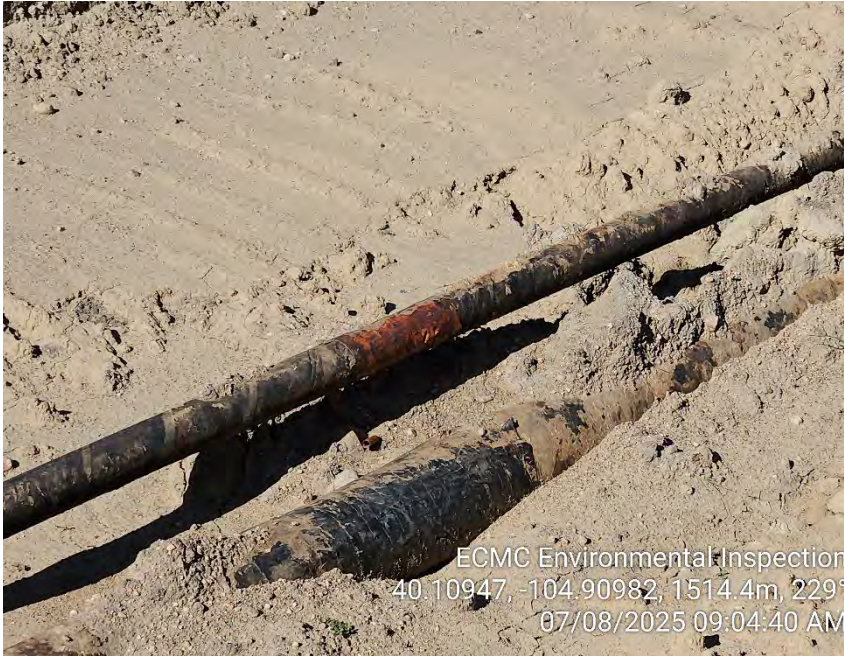
Photo 3 – Pipelines/flowlines in open excavation

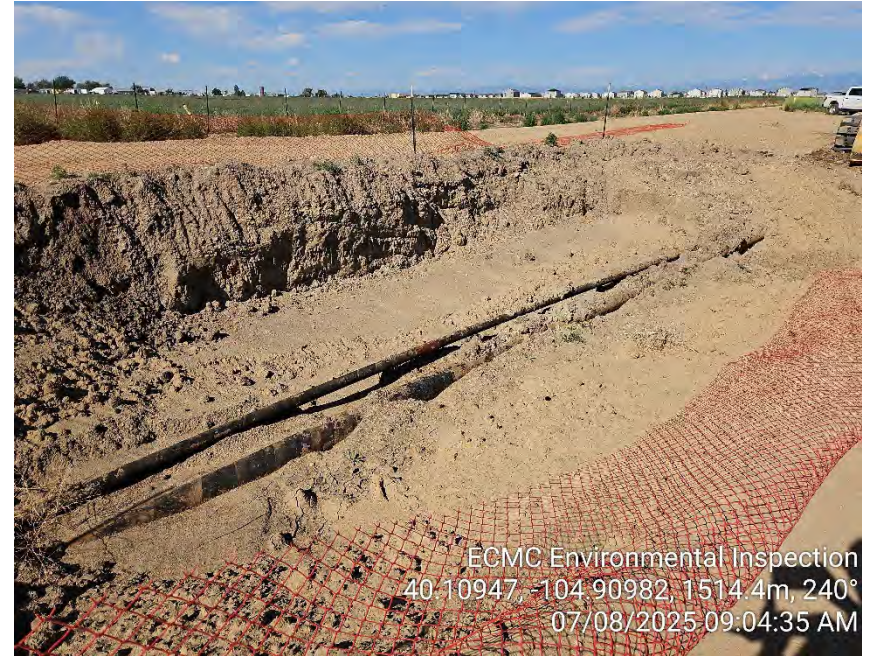
**Photo 4 - Spill excavation with pipelines/flowlines.
Fence down for active work**

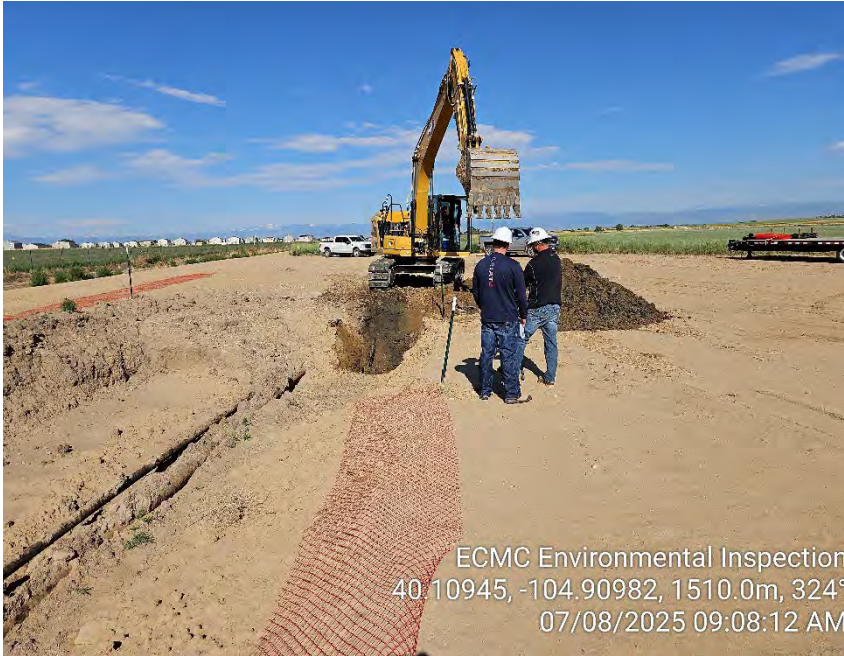
Photo 5 – Pothole adjacent to flowline shows impacted soil. Fence down for active work.

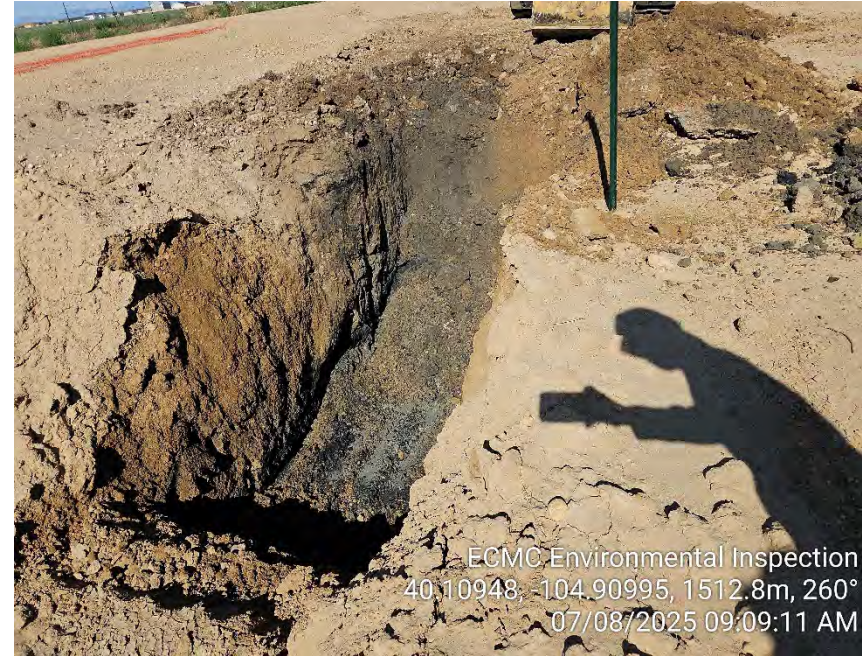
Photo 6 - Pothole adjacent to flowline shows impacted soil. Fence down for active work.

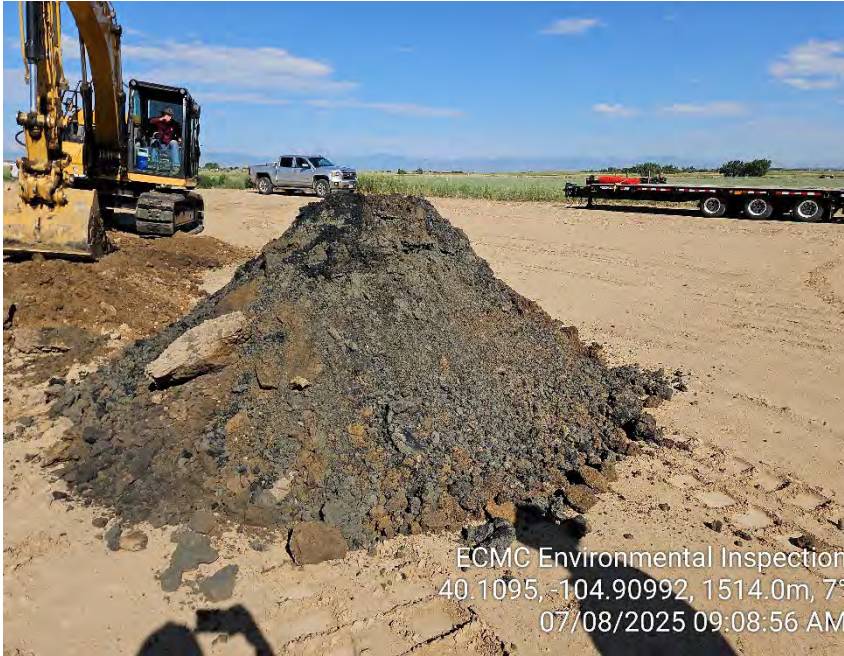
Photo 7 – Impacted soil excavated from pothole adjacent to pipelines/flowlines. Fence down for active work

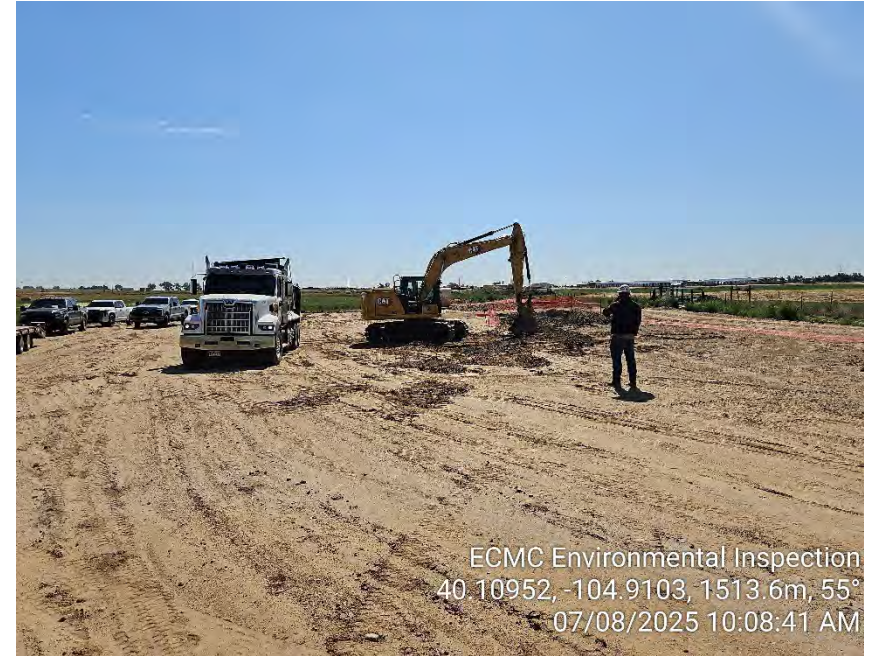
Photo 8 - Impacted soil being loaded on truck to be disposed of off location. Fence down for active work

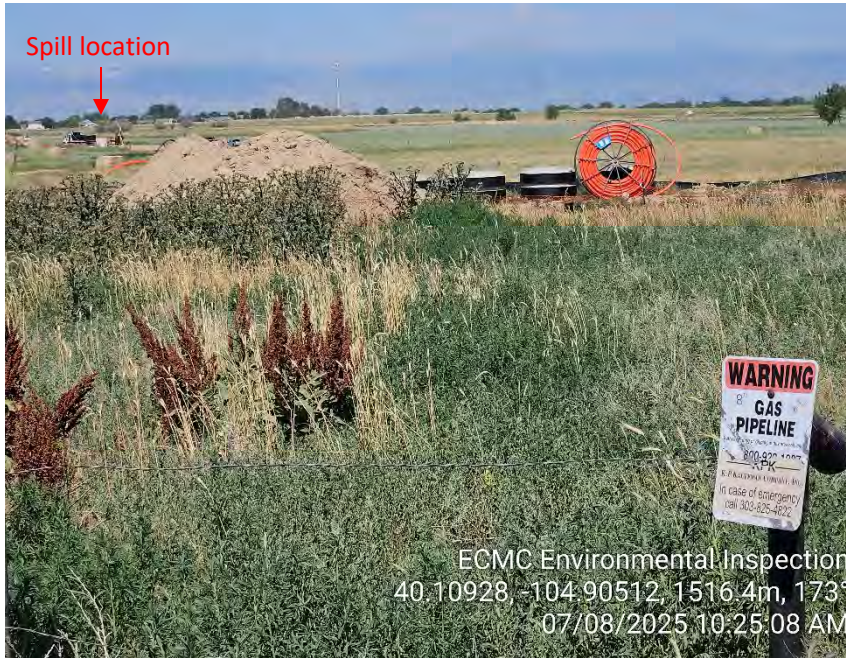
Photo 9 – 8” KPK pipeline marker east of spill location

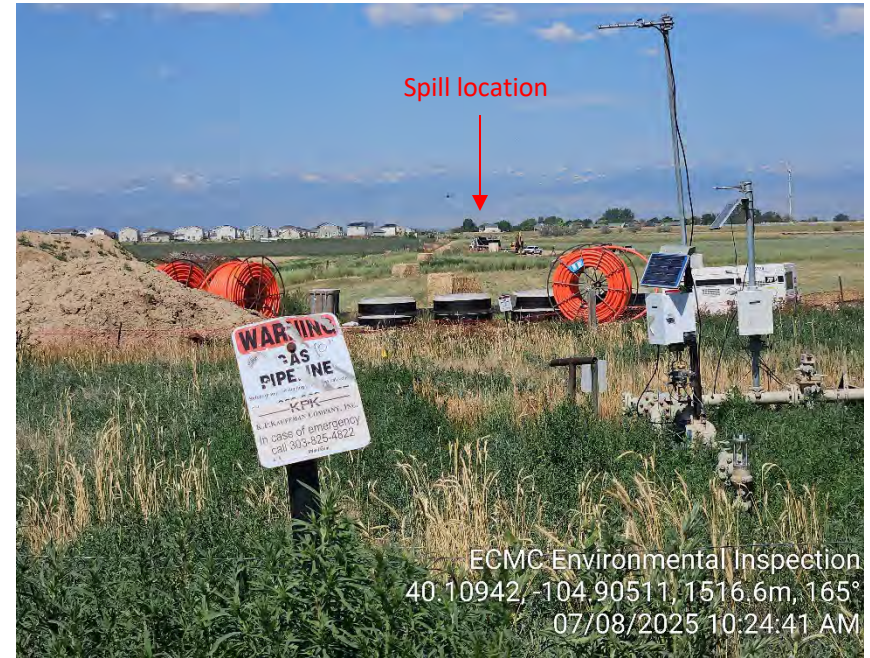
Photo 10 - 10” KPK pipeline marker east of spill location
