Inspection/Audit Photos

Location Name: QB ENERGY OPERATING LLC PUCKETT 12A-24D (MESA 11) Pad

Location ID: 335455

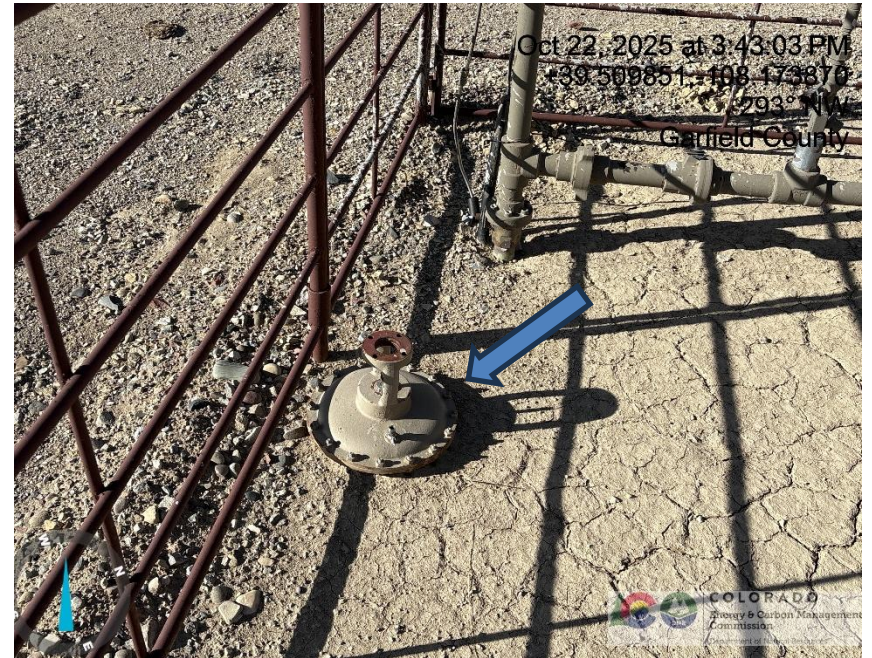
Photo # 1776 Debris

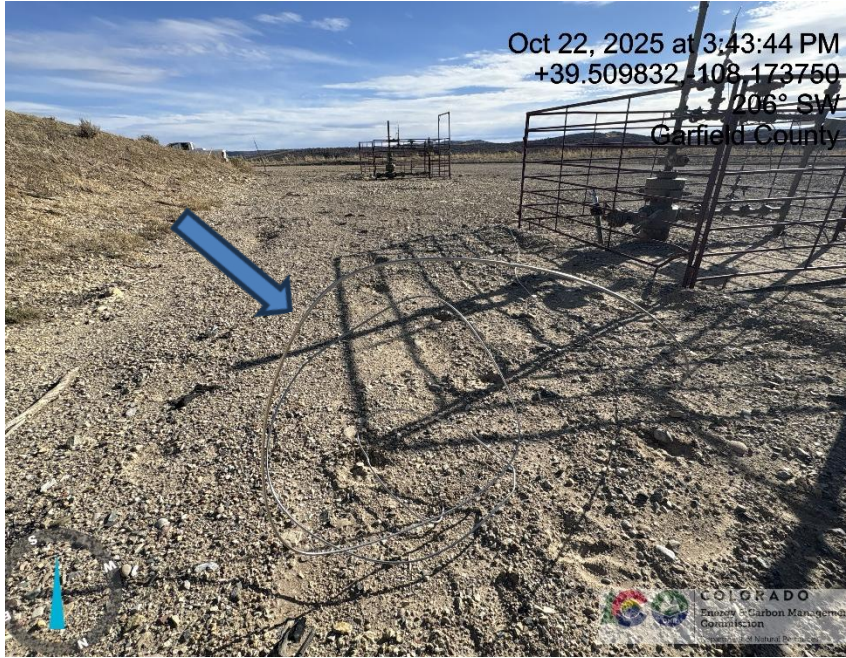
Photo # 1777 Debris

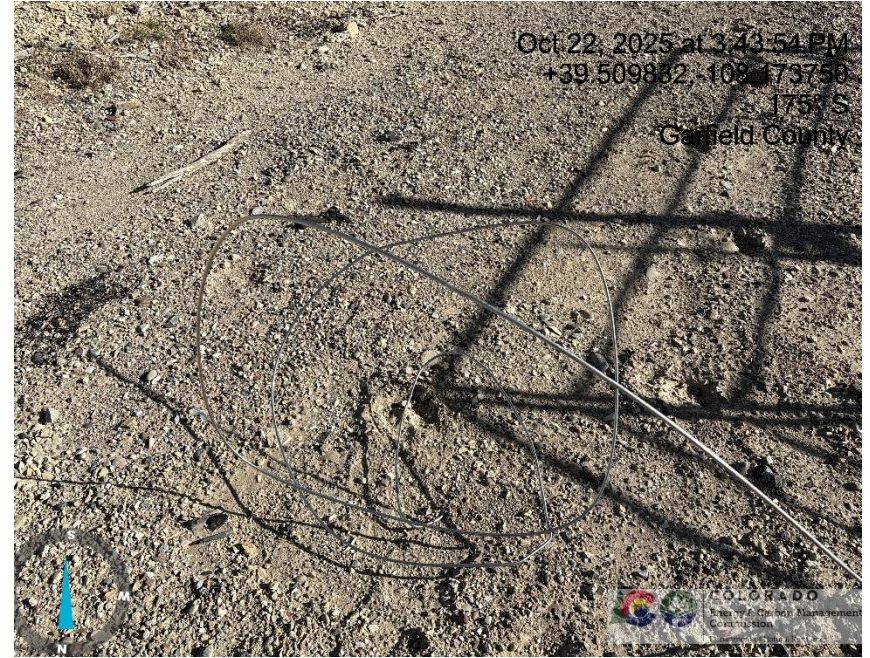
Photo # 1778 Debris

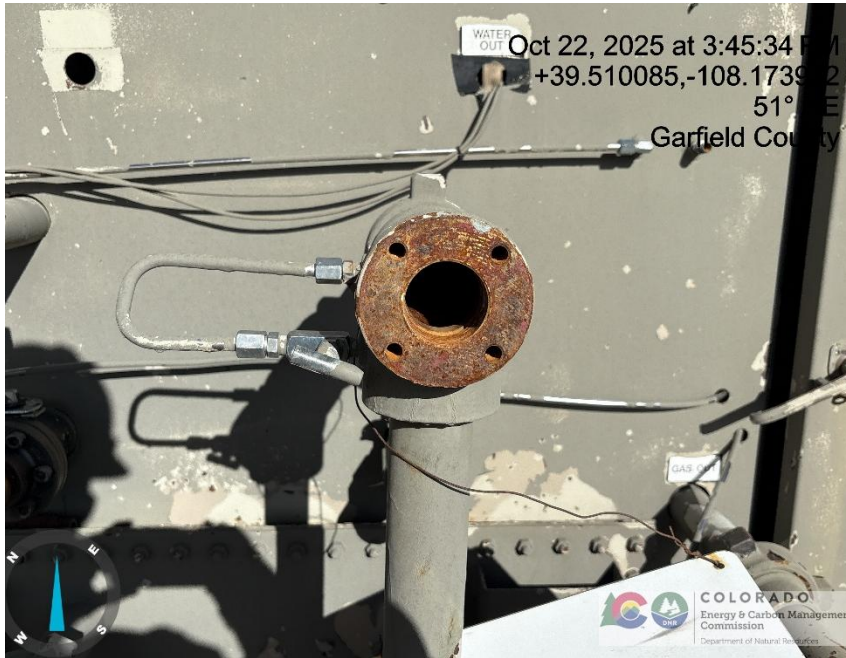
Photo # 1779 Open ended piping on separator/wildlife hazard/available for entry by wildlife

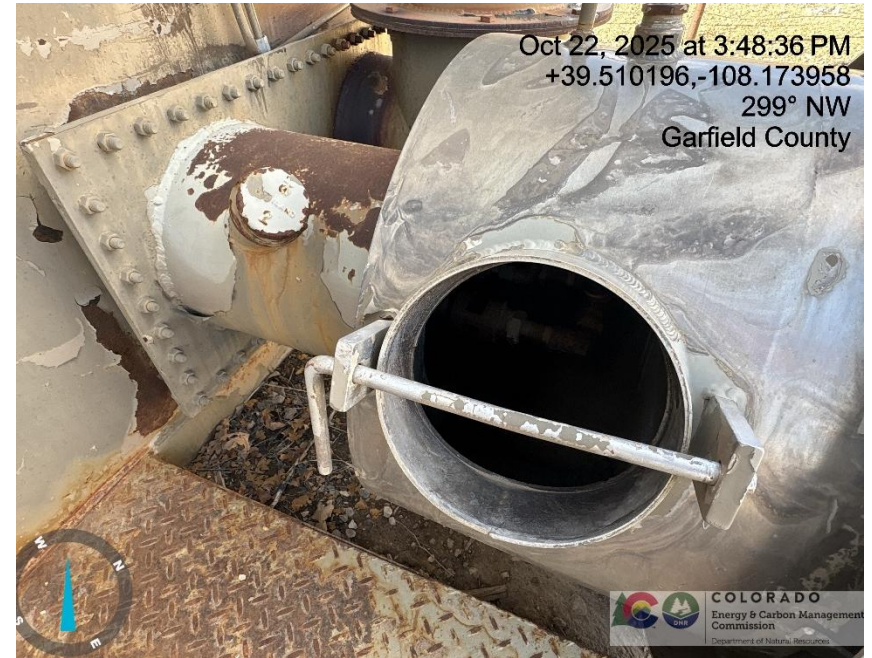
Photo # 1780 Flame arrester housing missing cover/wildlife hazard/available for entry by wildlife

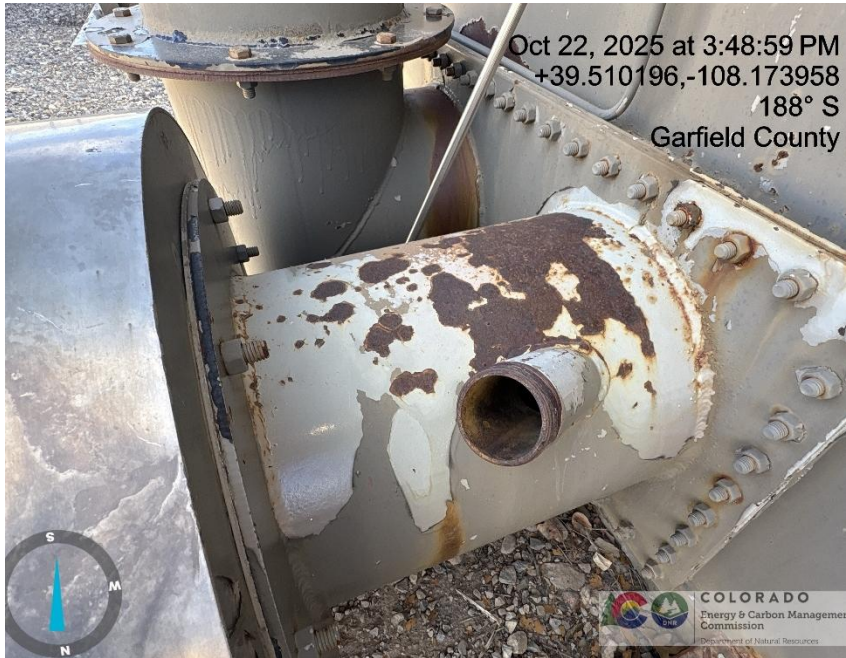
**Photo # 1781 Open ended pipe on fire tube/wildlife hazard
/available for entry by wildlife**

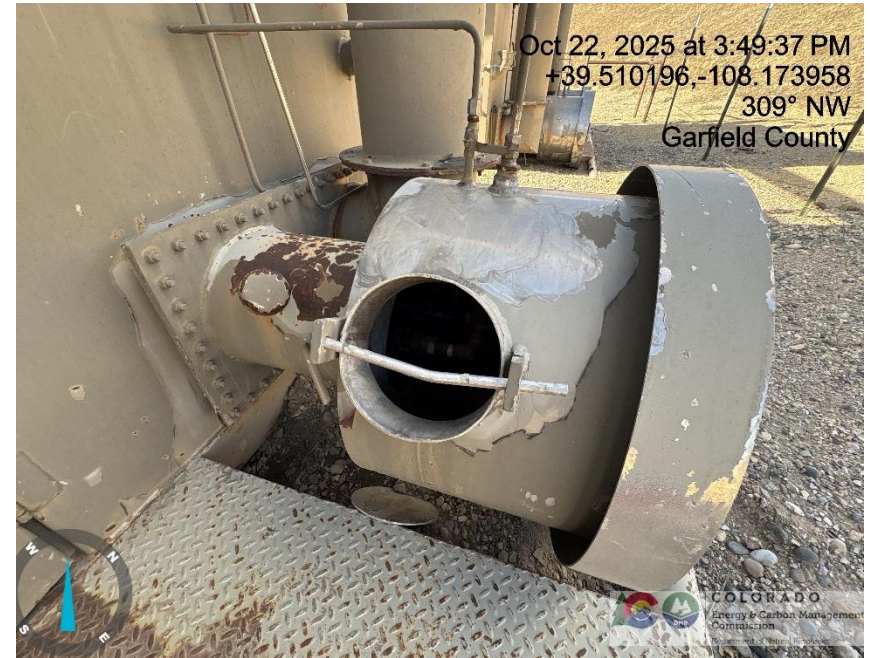
**Photo # 1782 Flame arrester housing missing cover/wildlife
hazard/available for entry by wildlife**

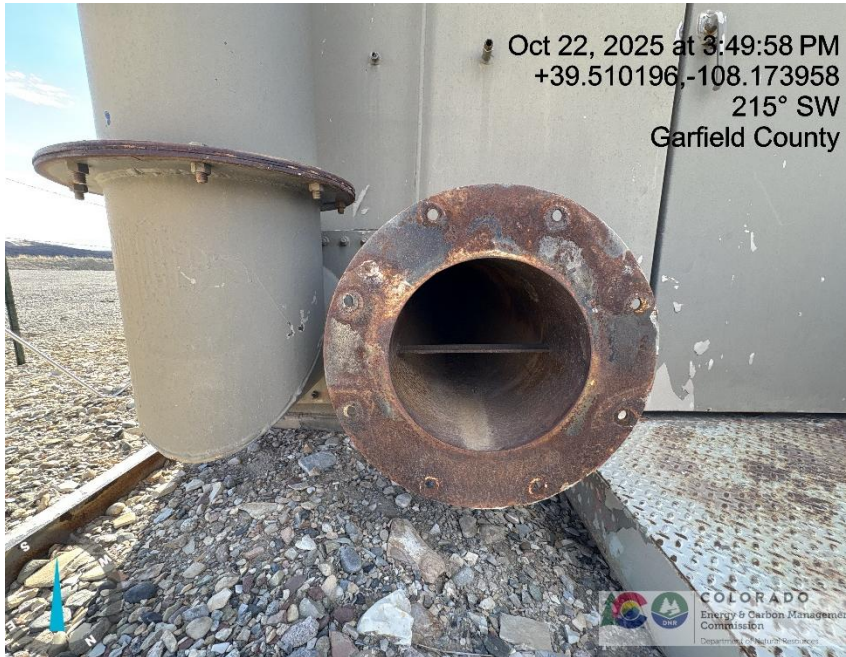
**Photo # 1783 Fire tube open ended/wildlife hazard
/available for entry by wildlife**
