Inspection Photos
Location Name: Pan Am B 4,6,10,12
Spill ID: 485939

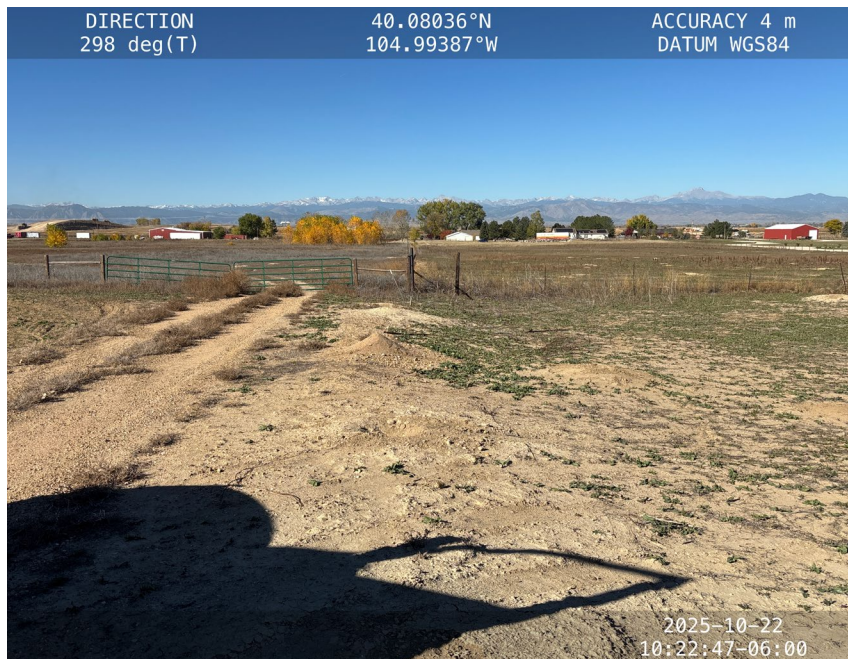
Locations where Landowner's fencing was torn down

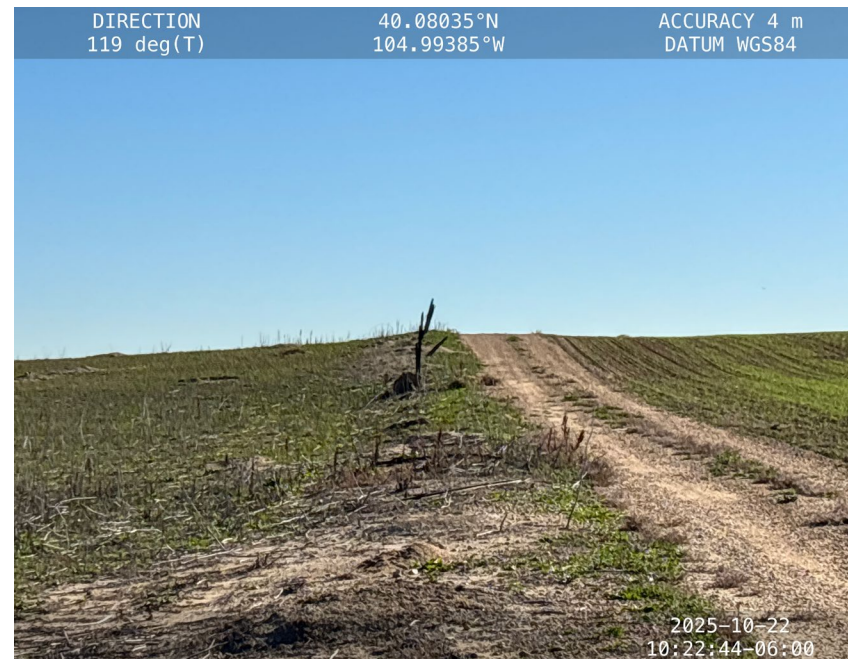
Locations where Landowner's fencing was torn down

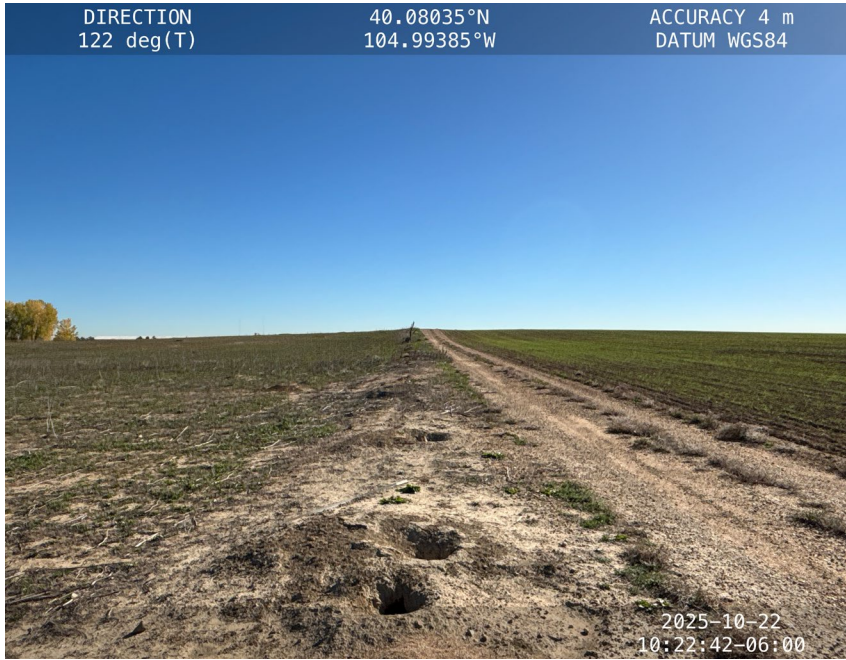
Locations where Landowner's fencing was torn down

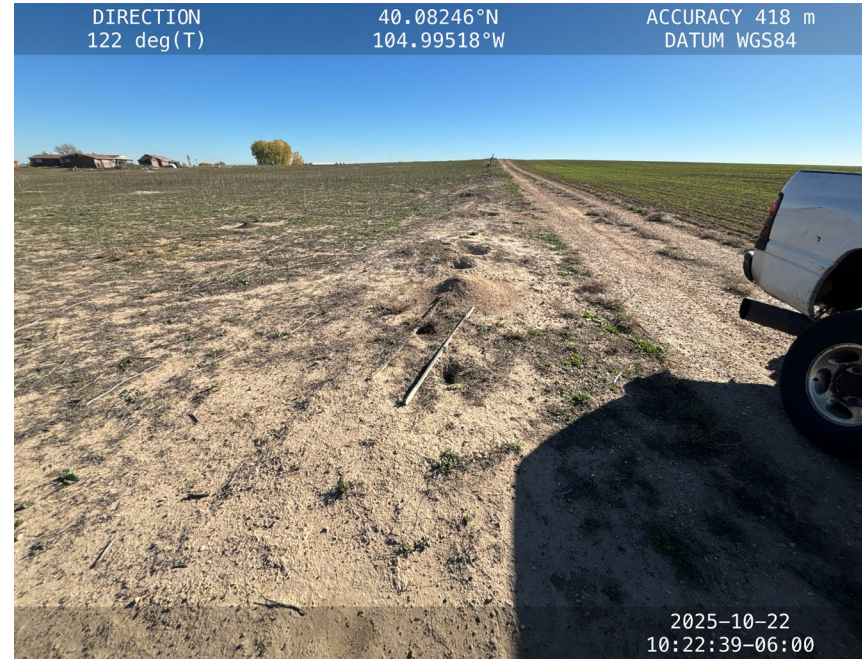
Locations where Landowner's fencing was torn down

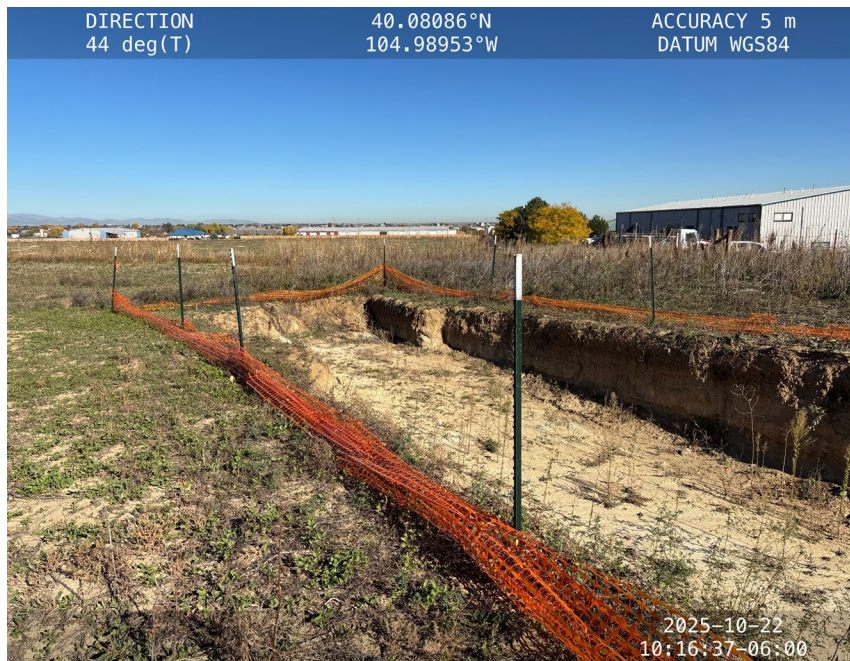
Open excavation and fallen fencing

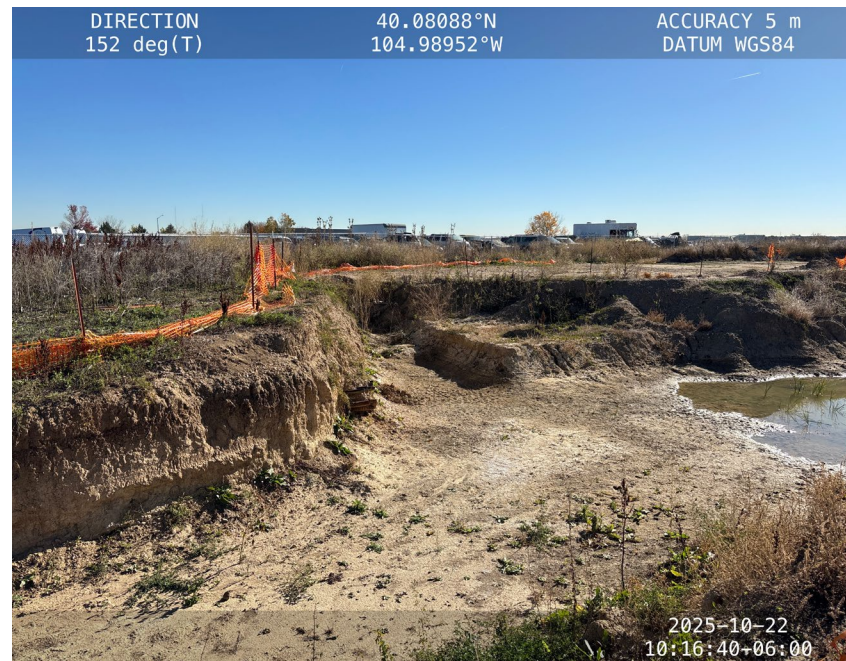
Open excavation and fallen fencing

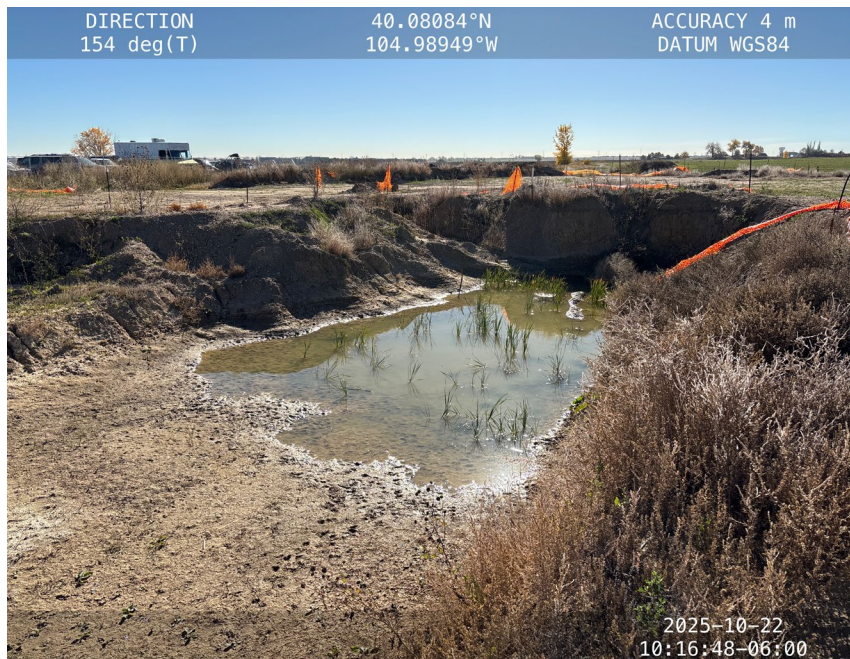
Open excavation and fallen fencing

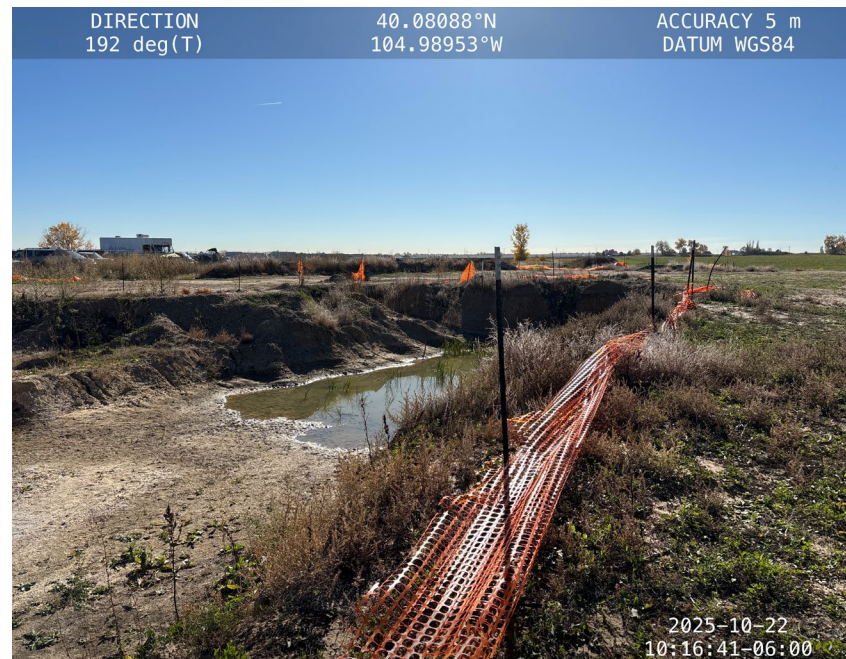
Open excavation and fallen fencing

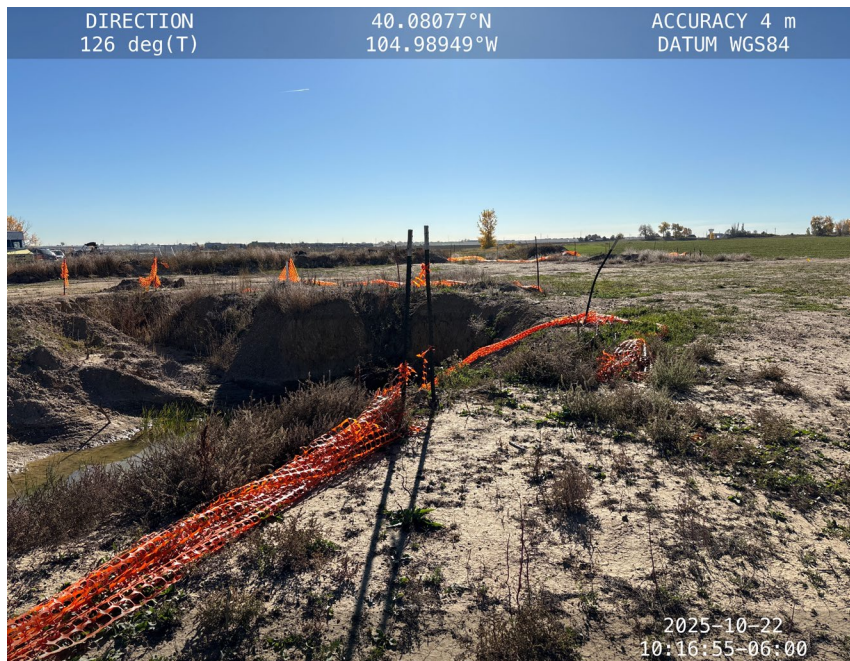
Open excavation and fallen fencing

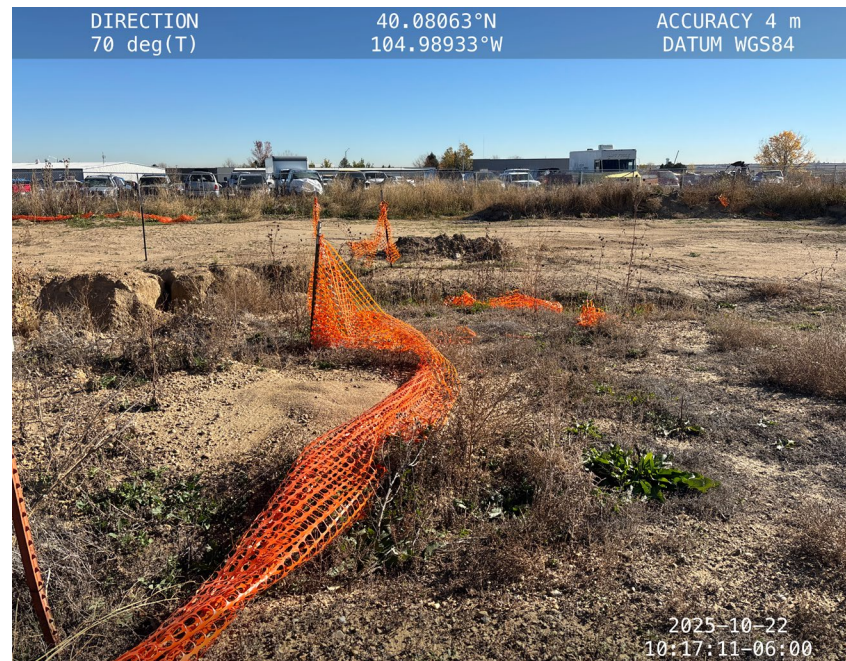
Open excavation and fallen fencing

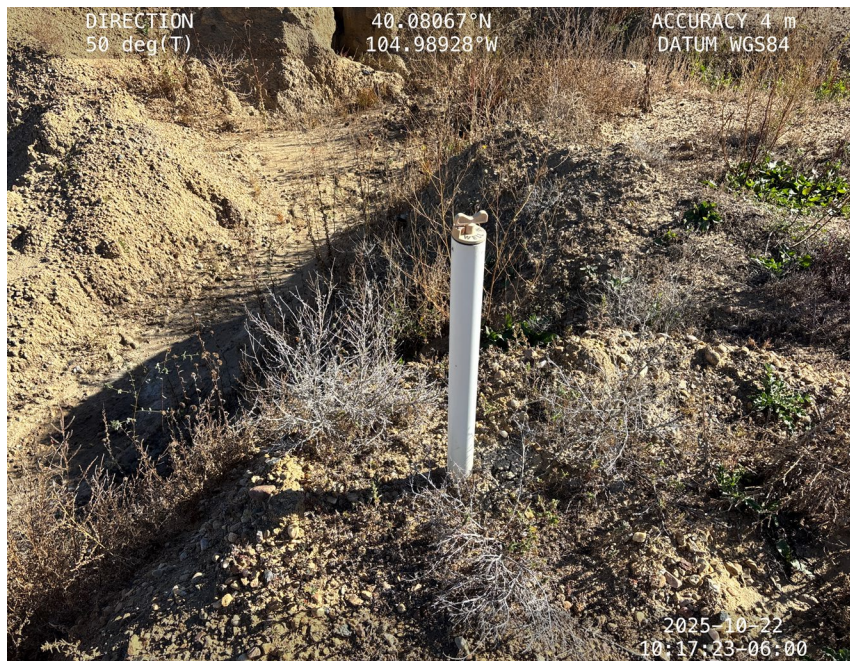
Monitoring well

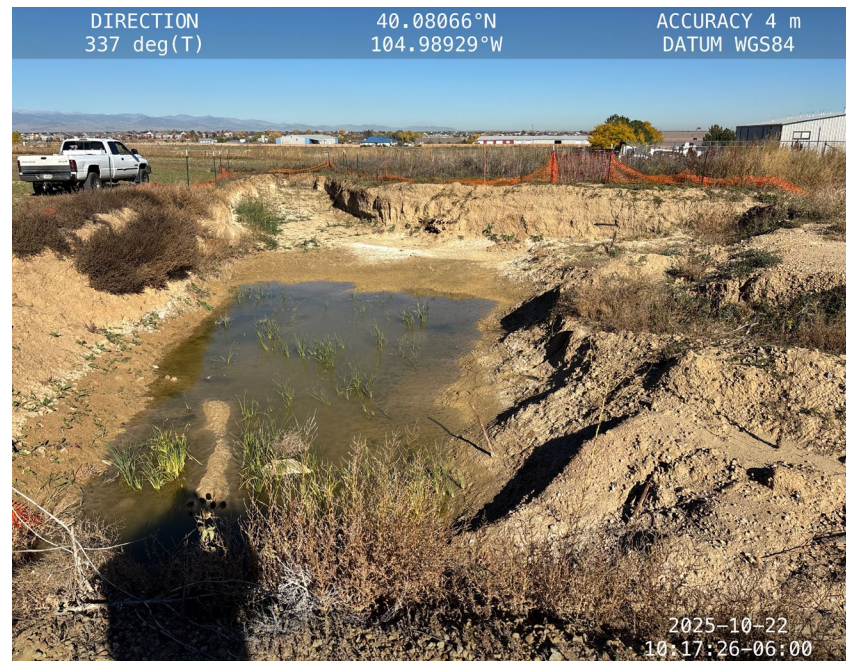
Open excavation and fallen fencing

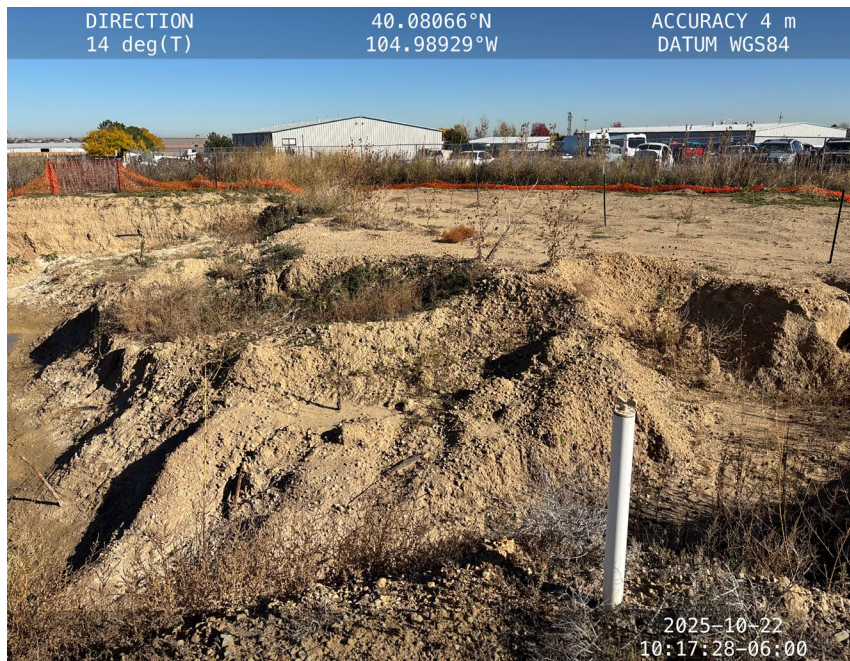
Stockpile left onsite

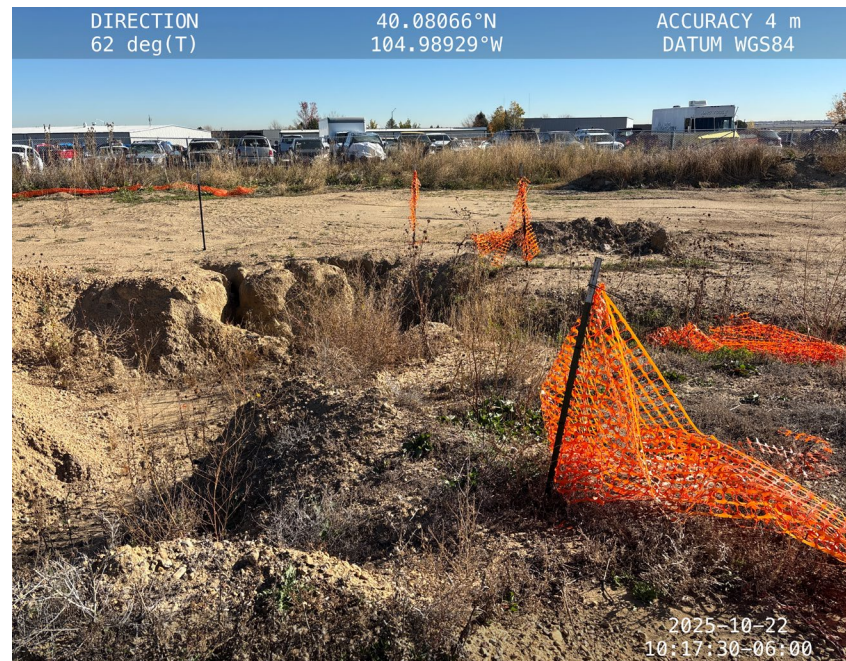
Open excavation and fallen fencing

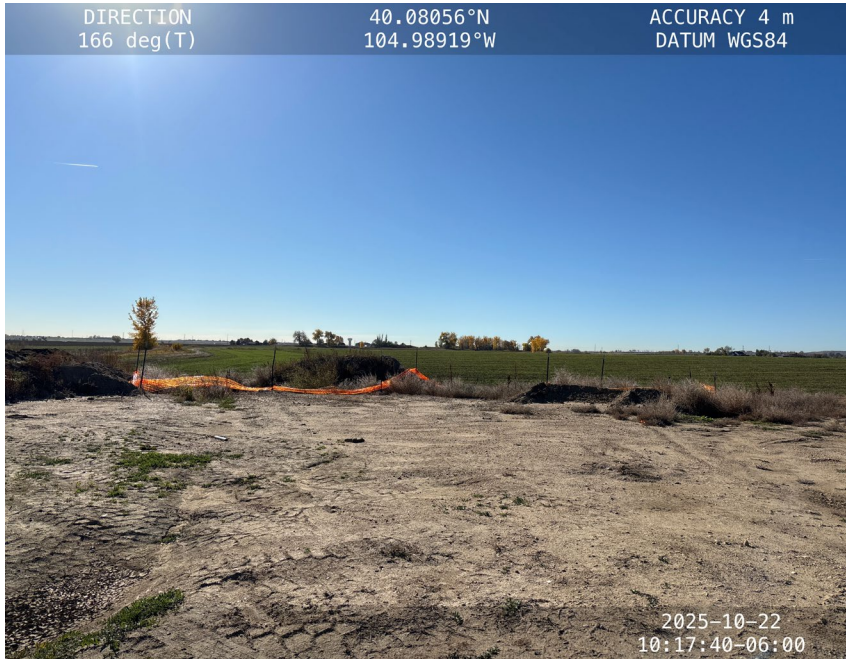
Large stockpile location that was removed

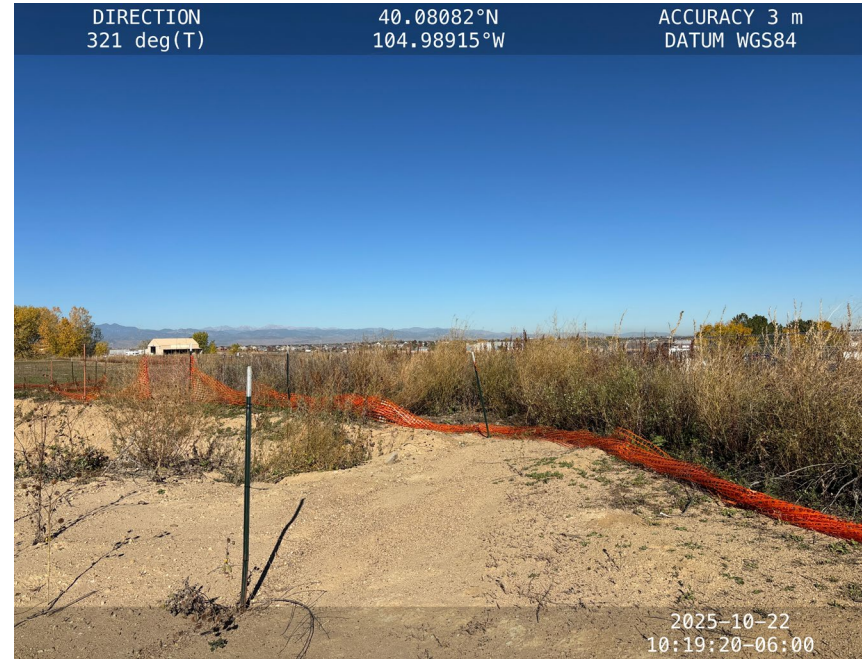
Large stockpile location that was removed

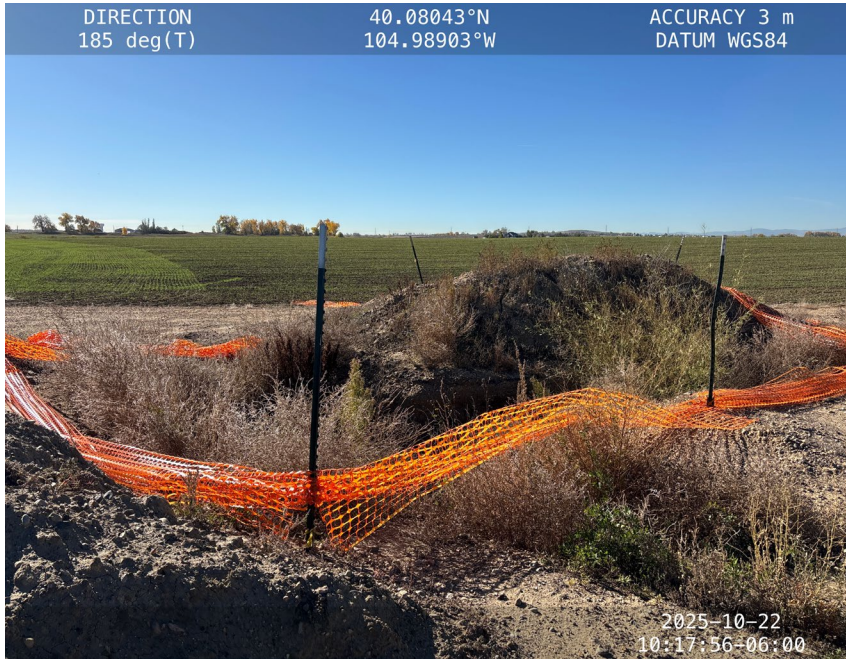
Stockpile left onsite. Weeds

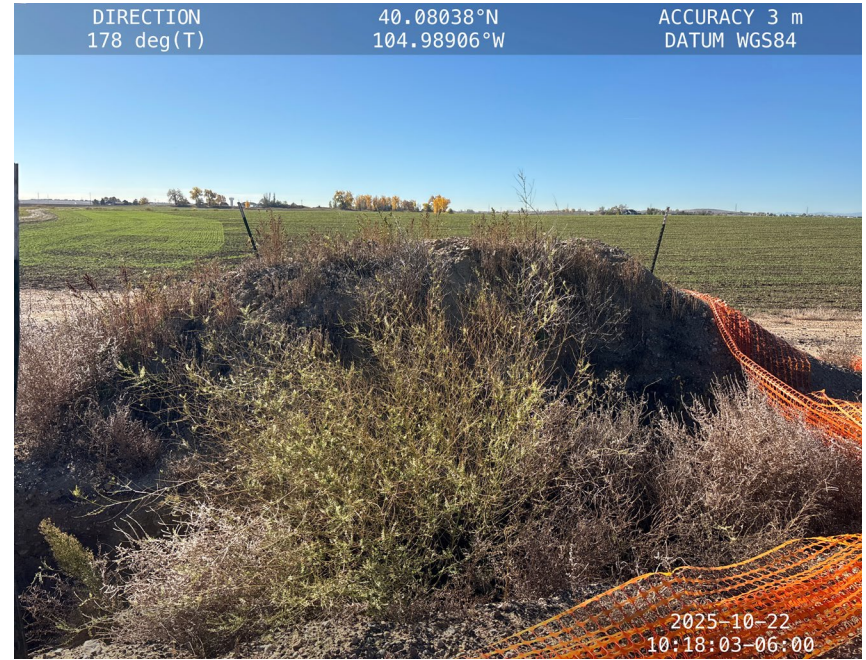
Stockpile left onsite. Weeds

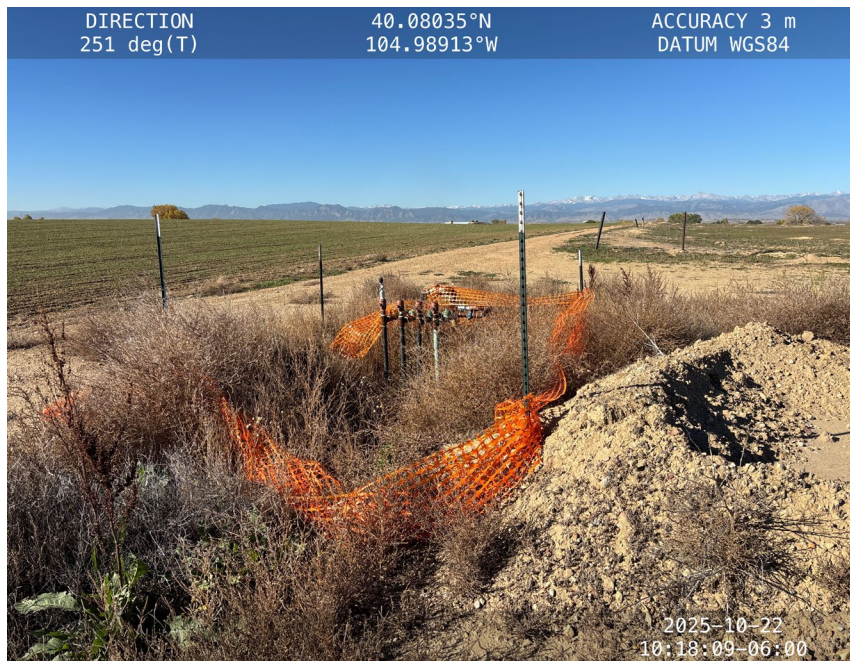
Stockpile left onsite. Weeds

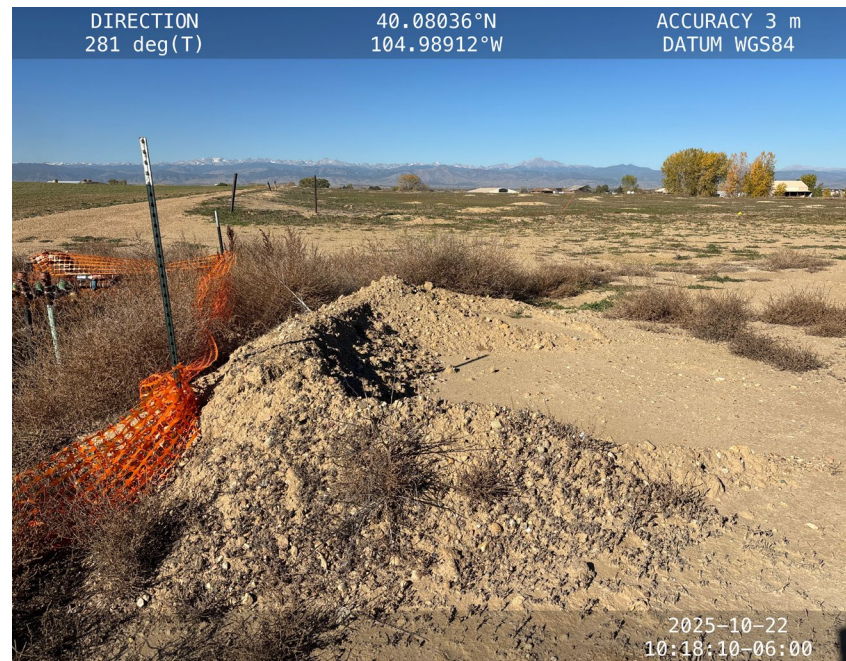
Stockpile left onsite. Weeds

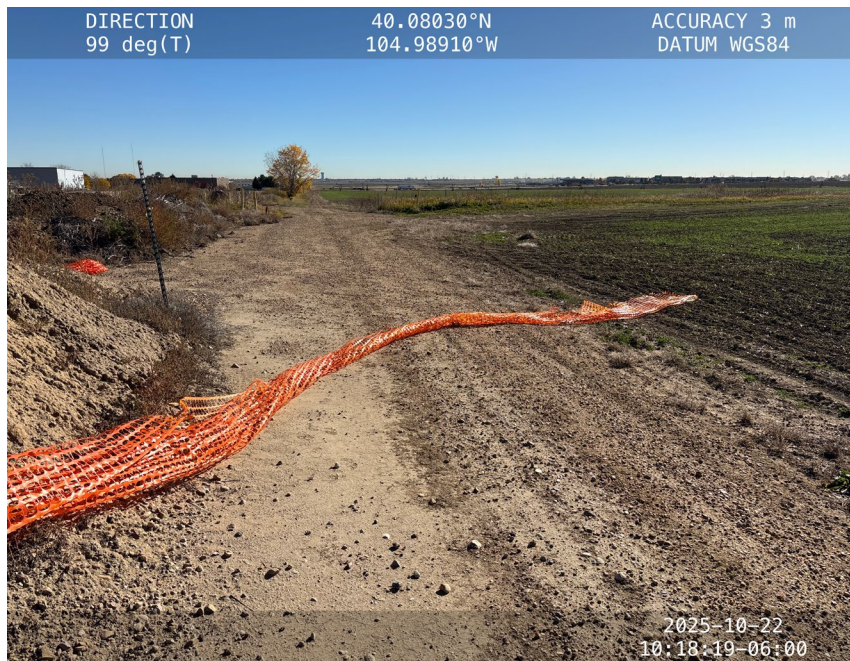
Torn excavation fencing

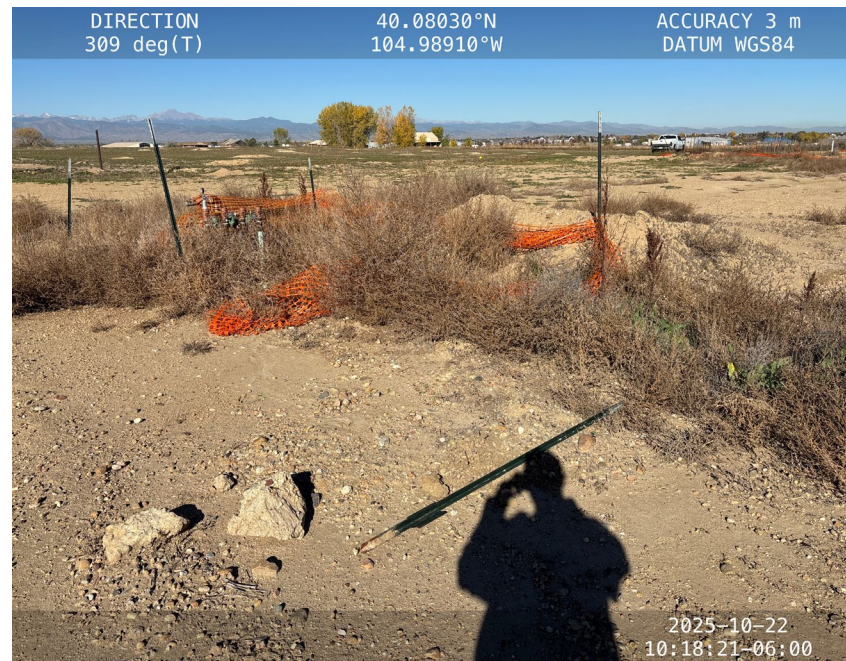
Weeds. Torn excavation fencing

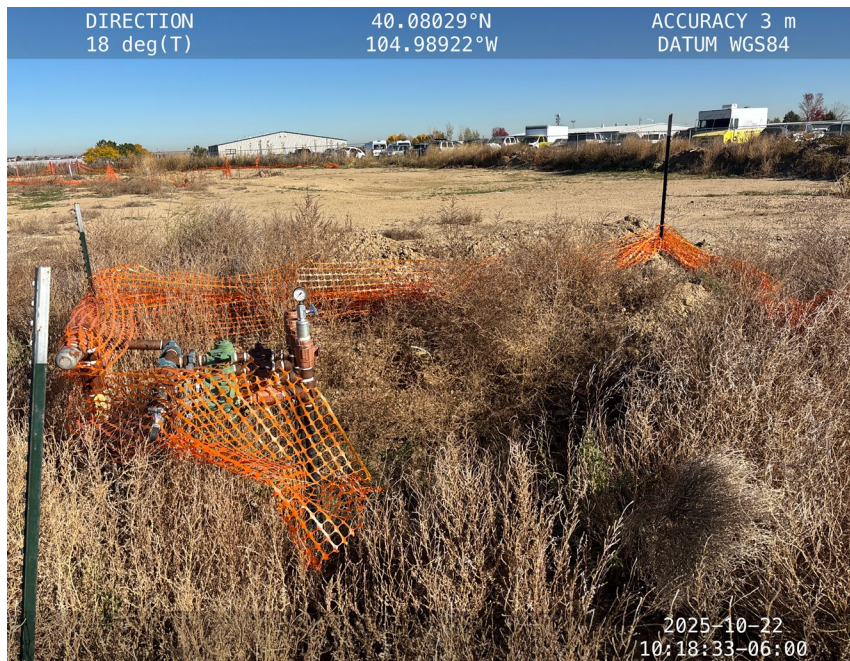
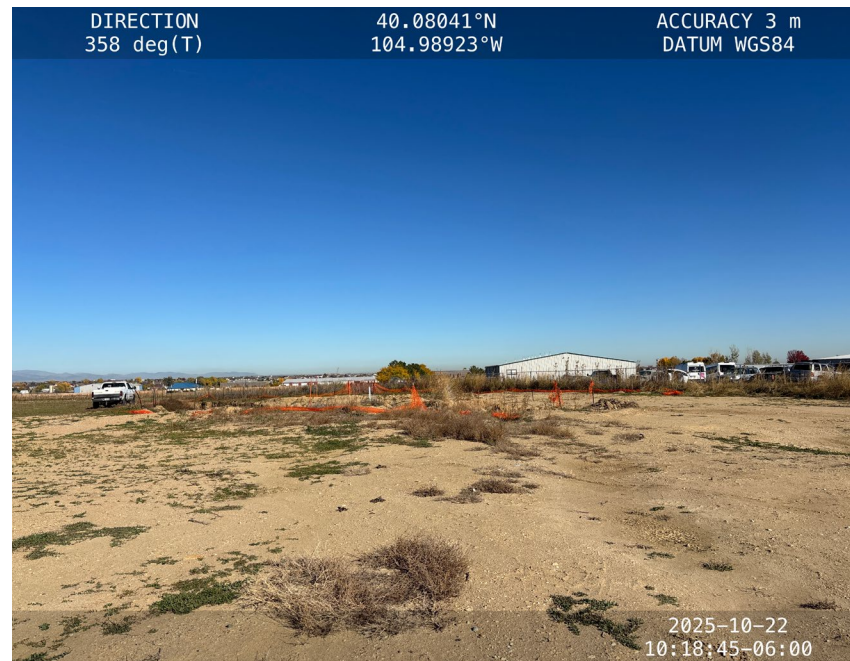
Weeds

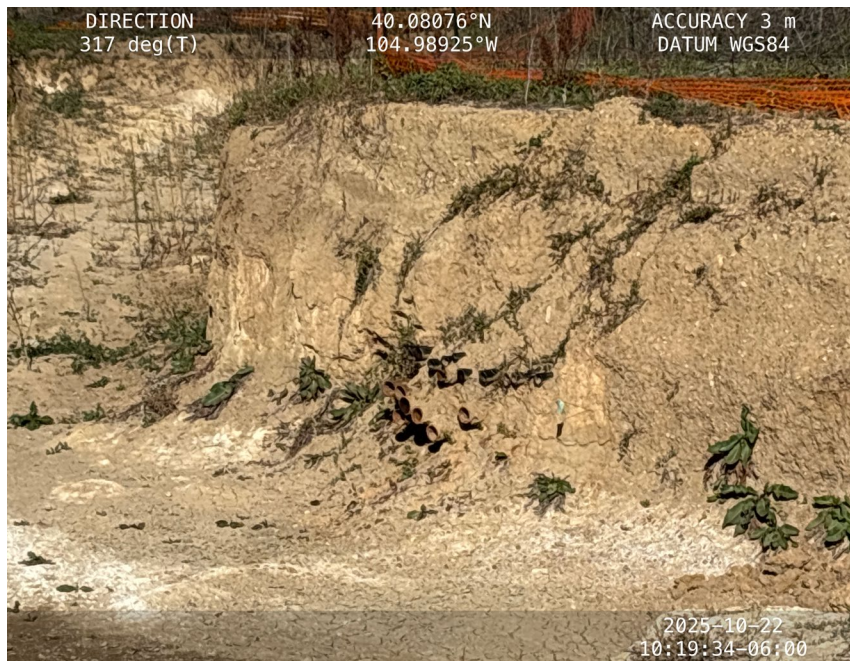
Open, exposed flowlines

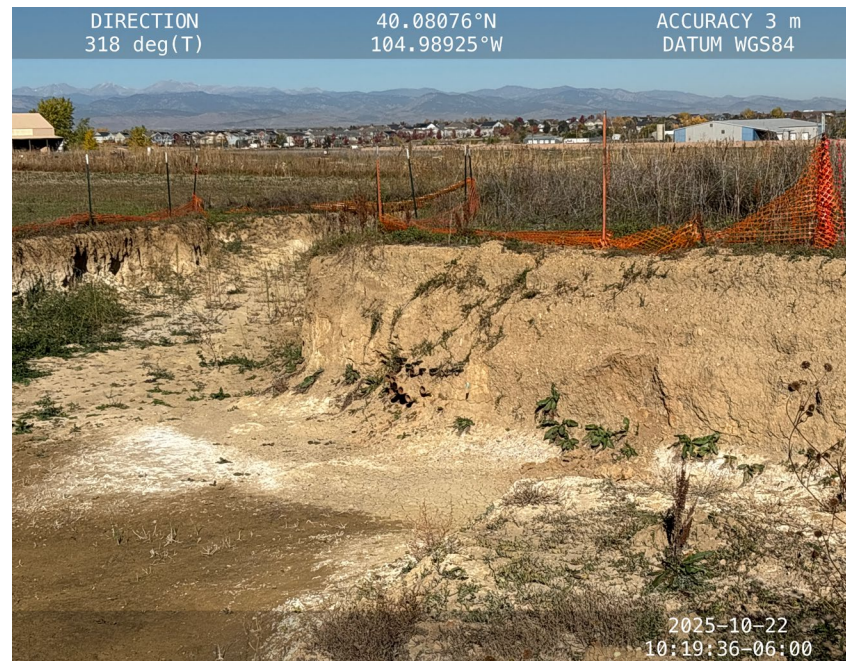
Open, exposed flowlines

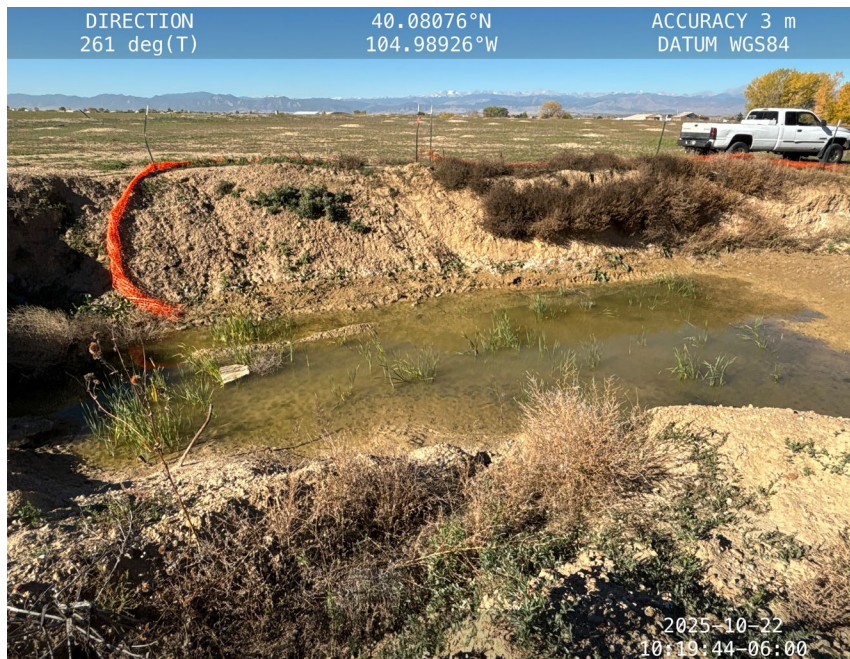
Groundwater within excavation

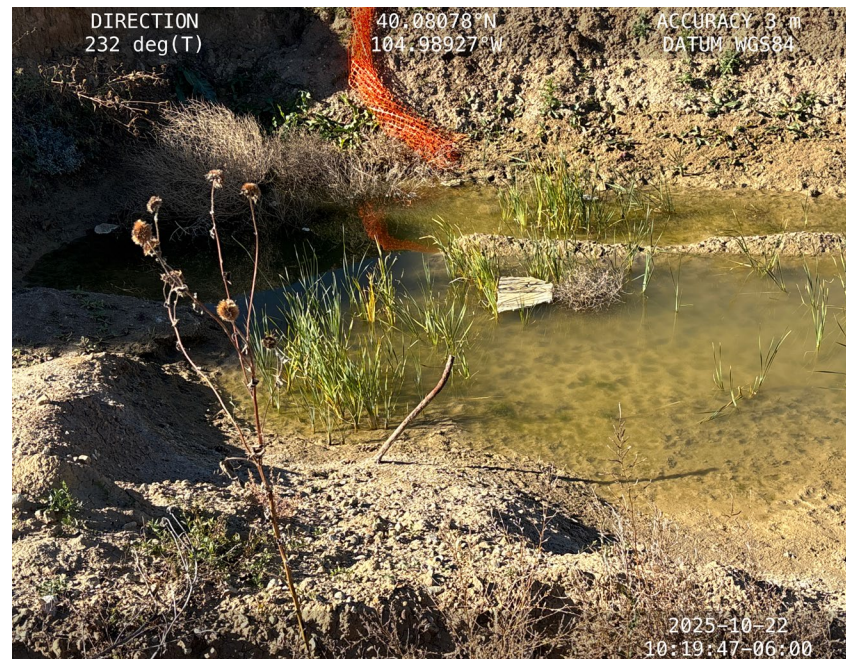
Groundwater within excavation
