Final Reclamation and Stormwater Inspection

Location ID: 316929

Well Name: LINKER #1

Inspection Document #: 718601099

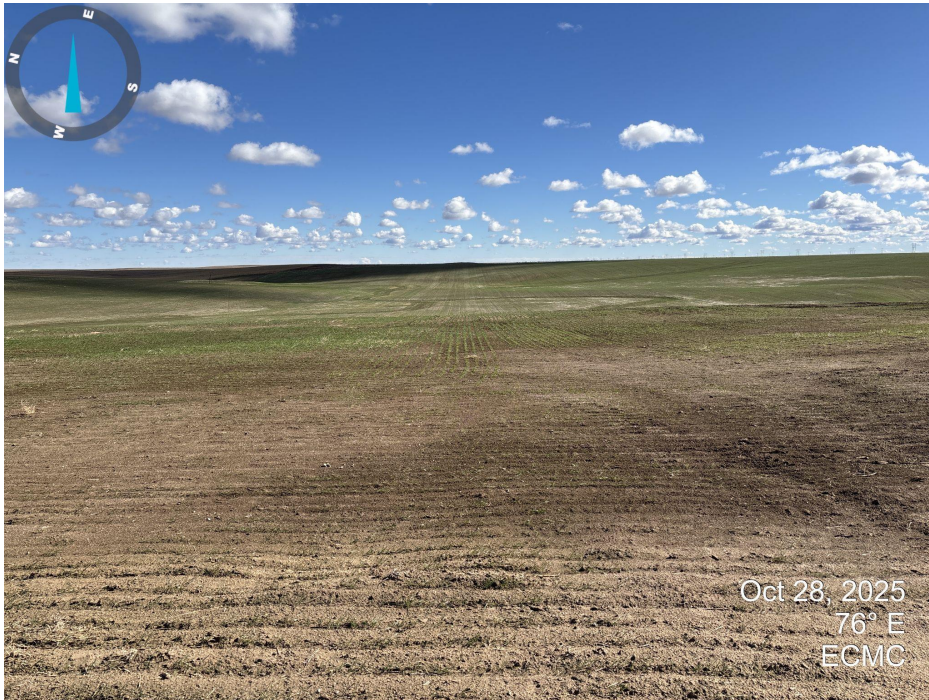
Photo 1. Looking east across the entrance of the access road and tank battery. No oil and gas equipment remains on the location. This area appears to have less crop germination than surrounding area.

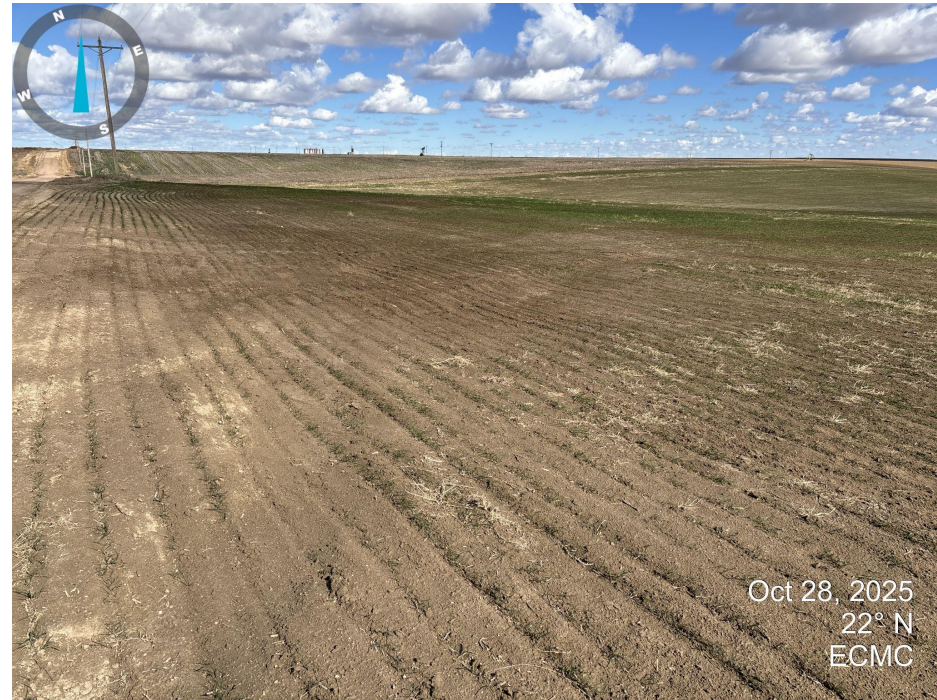
Photo 2. Looking north across the west side of the tank battery including entrance area. See photo 1 comments.

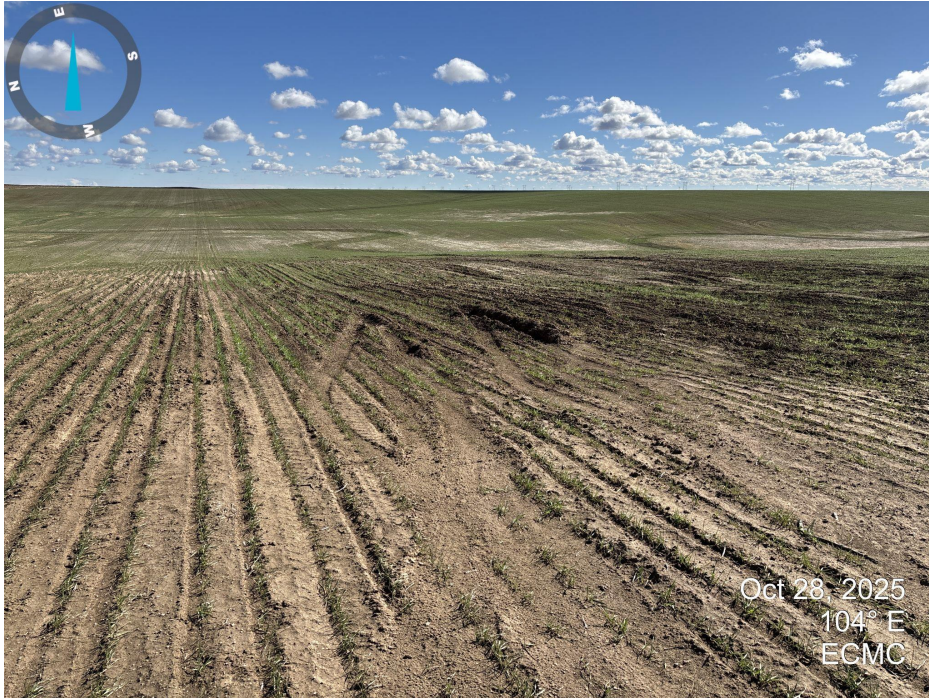
Photo 3. Looking east across the former pit/ evaporation pond area. This area does not appear to be contoured to surrounding terrain. Depressions, peaks and berms are visible in the pit area and it appears that farming equipment may have had trouble navigating this area.

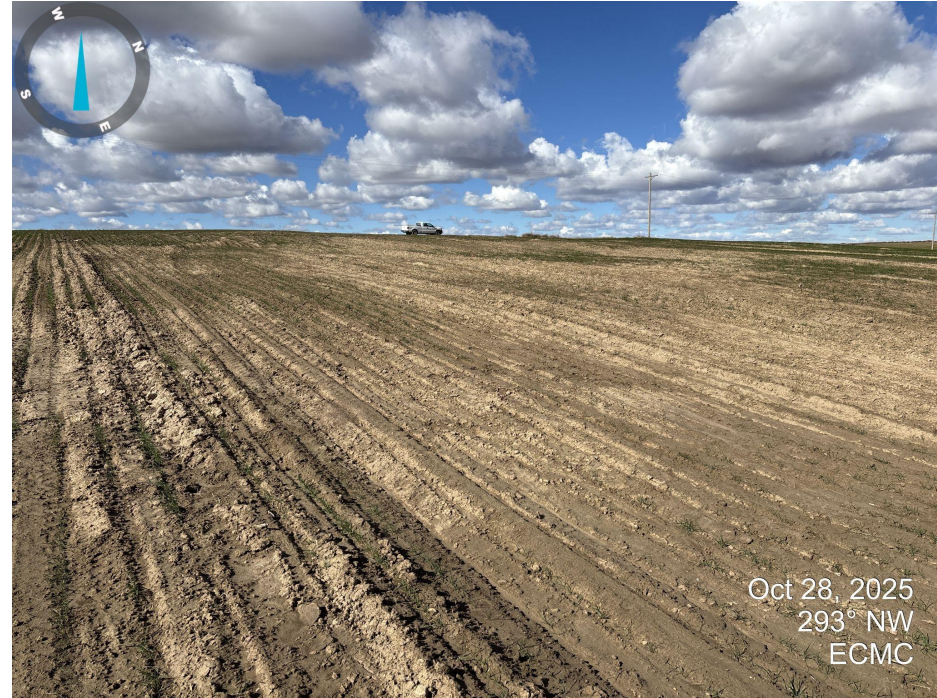
Photo 4. west across the pit area from the southeast corner. Uneven terrain and lower germination than the surrounding cropland.

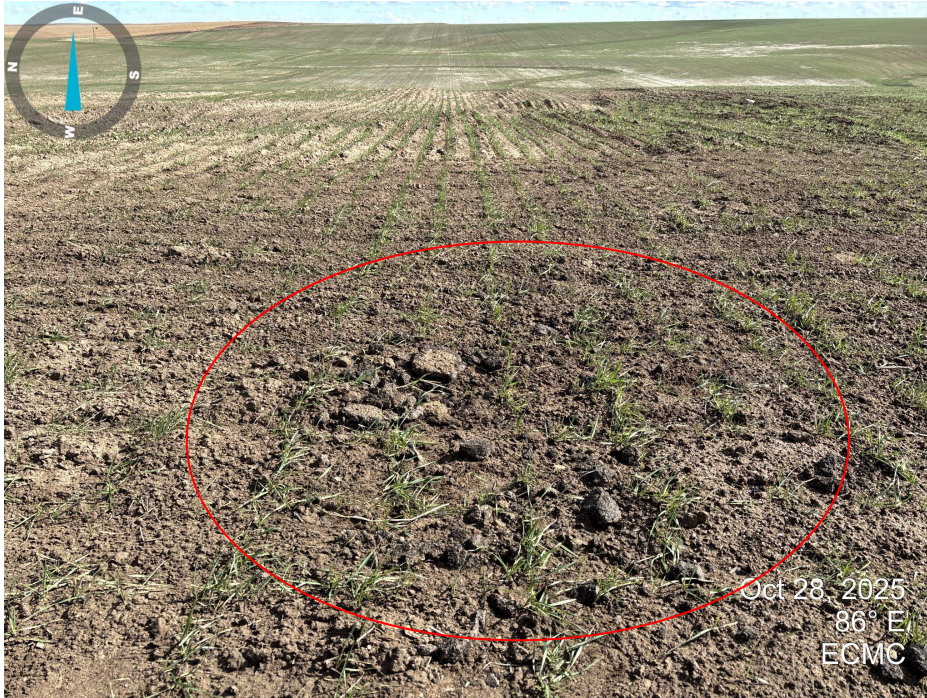
Photo 5. Picture taken west of the evaporation pond area looking east across the pit area. There appears to be black stained soil chunks (red circle). This area also had a strong hydrocarbon smell.

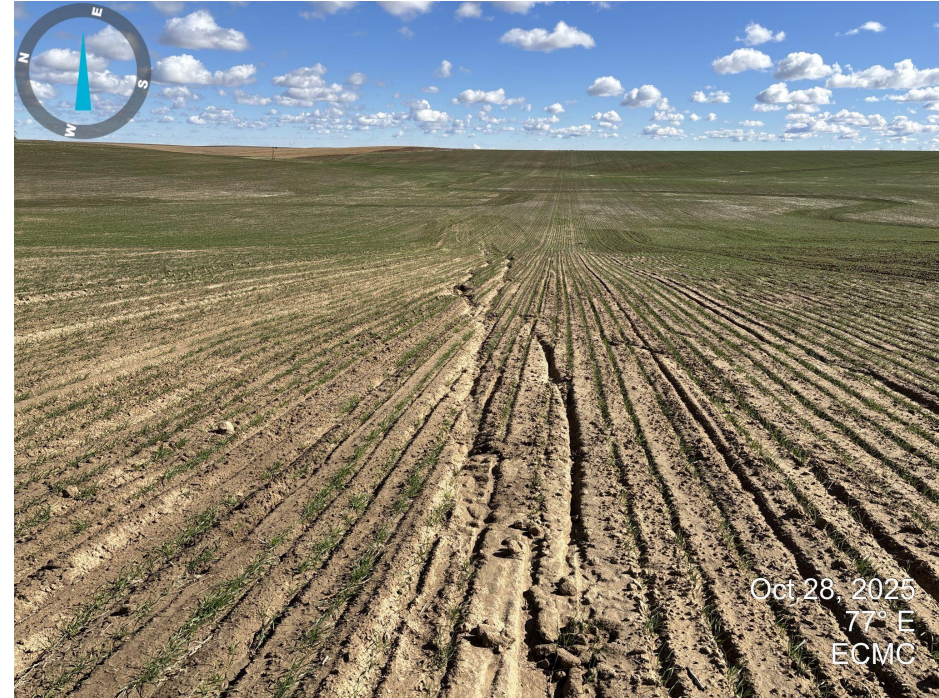
Photo 6. Looking east down the former access road towards the wellhead. Stormwater erosion is present along the former path of the access road.

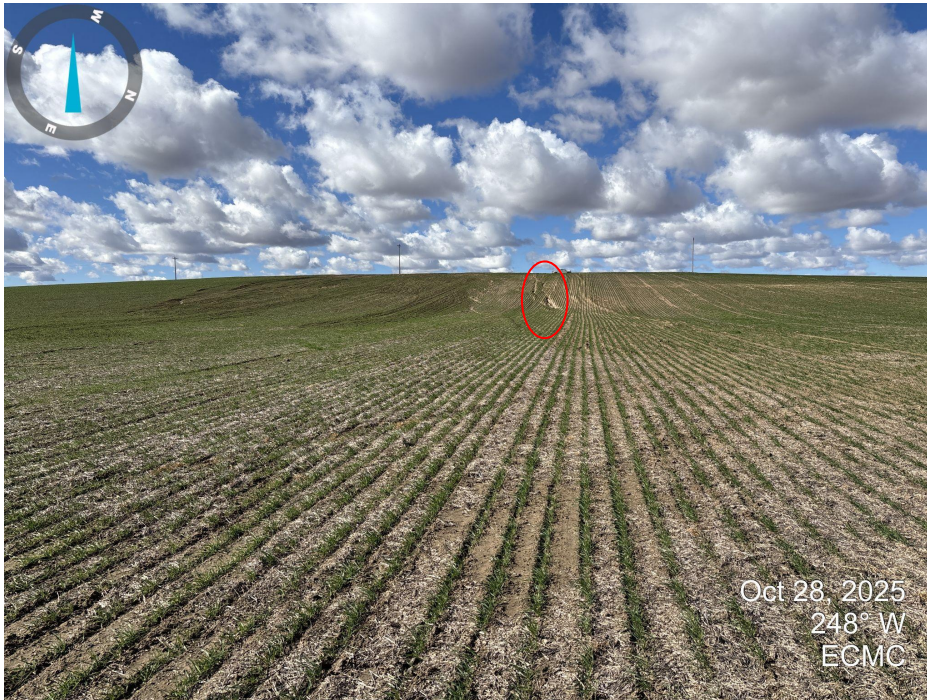
Photo 7. Looking west along the access road from the former wellhead area. Stormwater erosion is only present on the former access road portion of the slope (red circle).

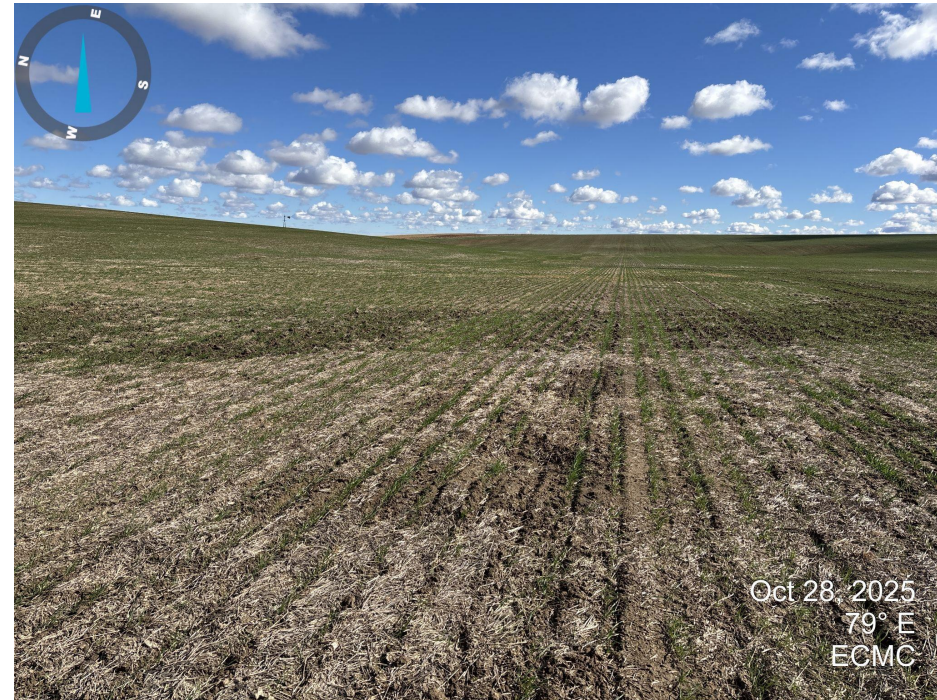
Photo 8. Looking east across the wellbore area. No oil and gas equipment remains. The well bore area appears reflective of the surrounding crop area.

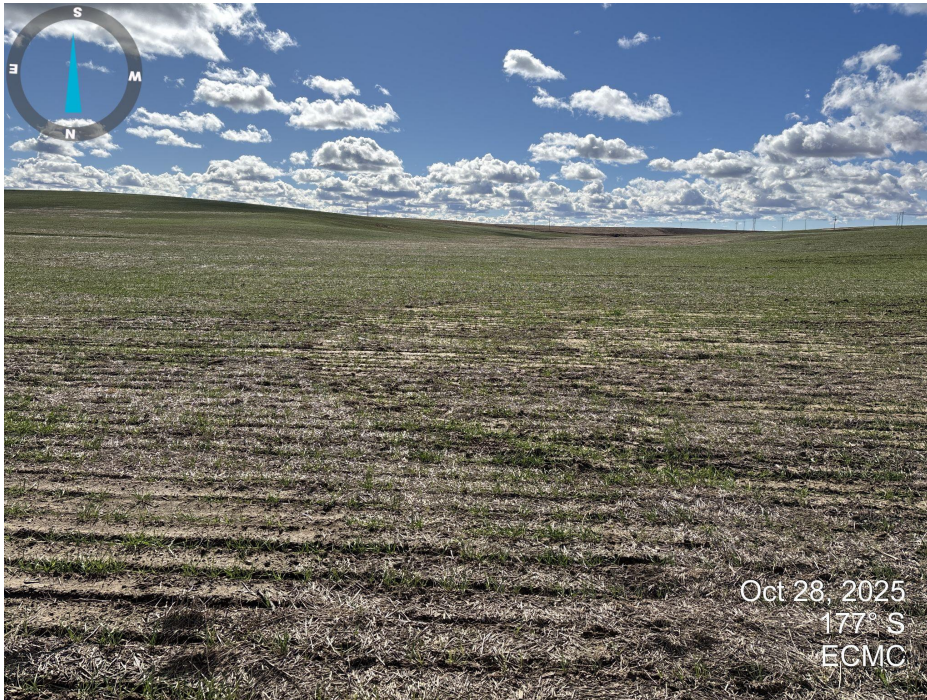
Photo 9. Looking south from the wellbore. See photo 8 comments.

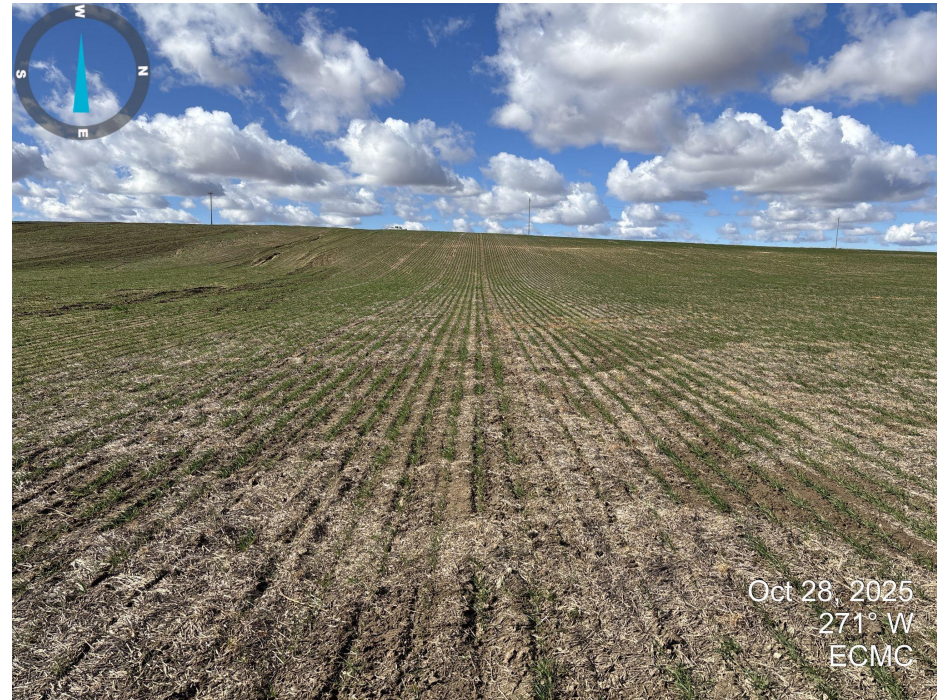
Photo 10. Looking west from the wellbore. See photo 8 comments.

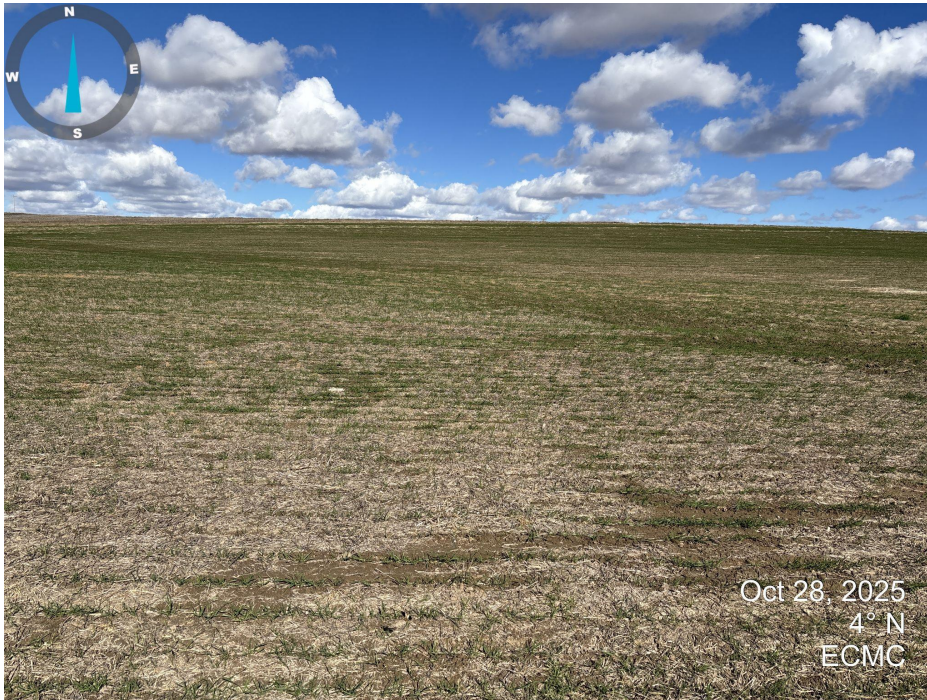
Photo 11. Looking north from the wellbore. See photo 8 comments.
