# Inspection Photos

ID: 321591

Operator: **CITATION OIL & GAS CORP**

Inspection Date: 10/21/2025

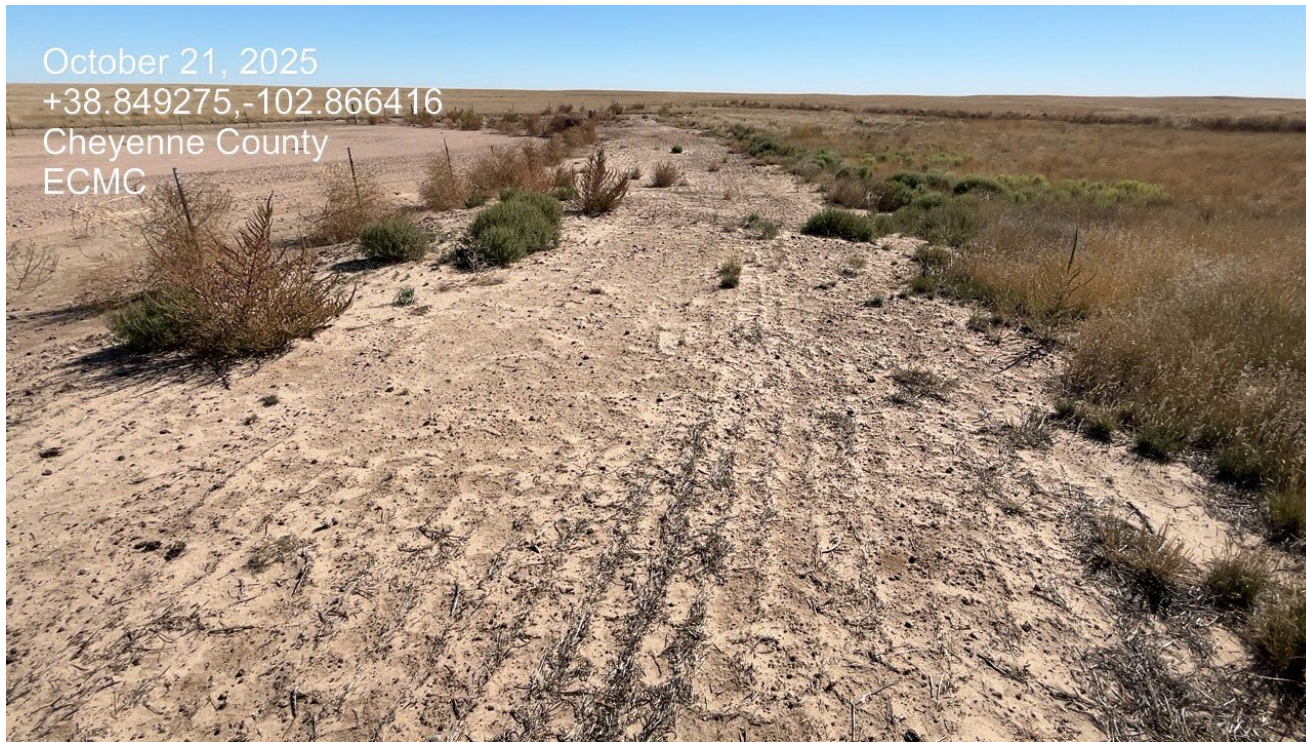
**Photo 1.** Facing southeast at the location. There is insufficient vegetation germination and additional reclamation will need to be completed.

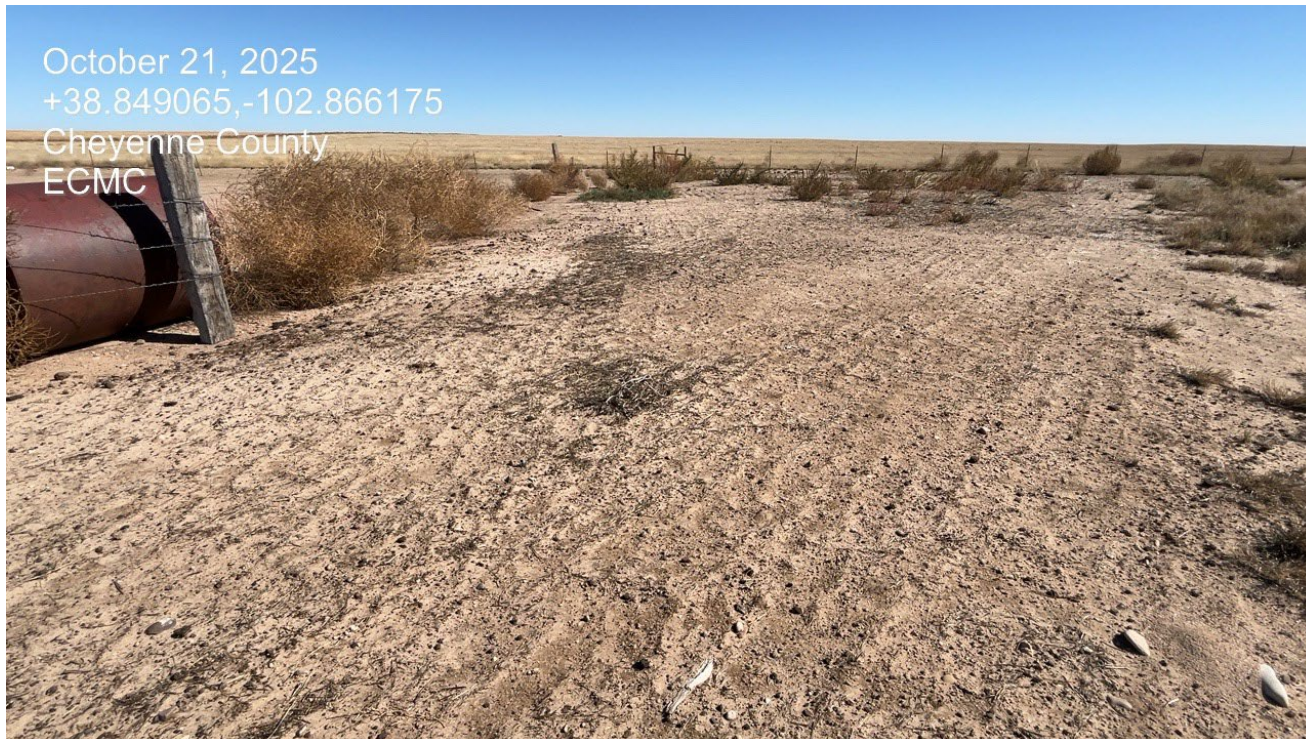
**Photo 2.** Facing southeast at the location. There is insufficient vegetation germination and additional reclamation will need to be completed. There is undesirable weeds (debris) along the fence line that needs to be removed.

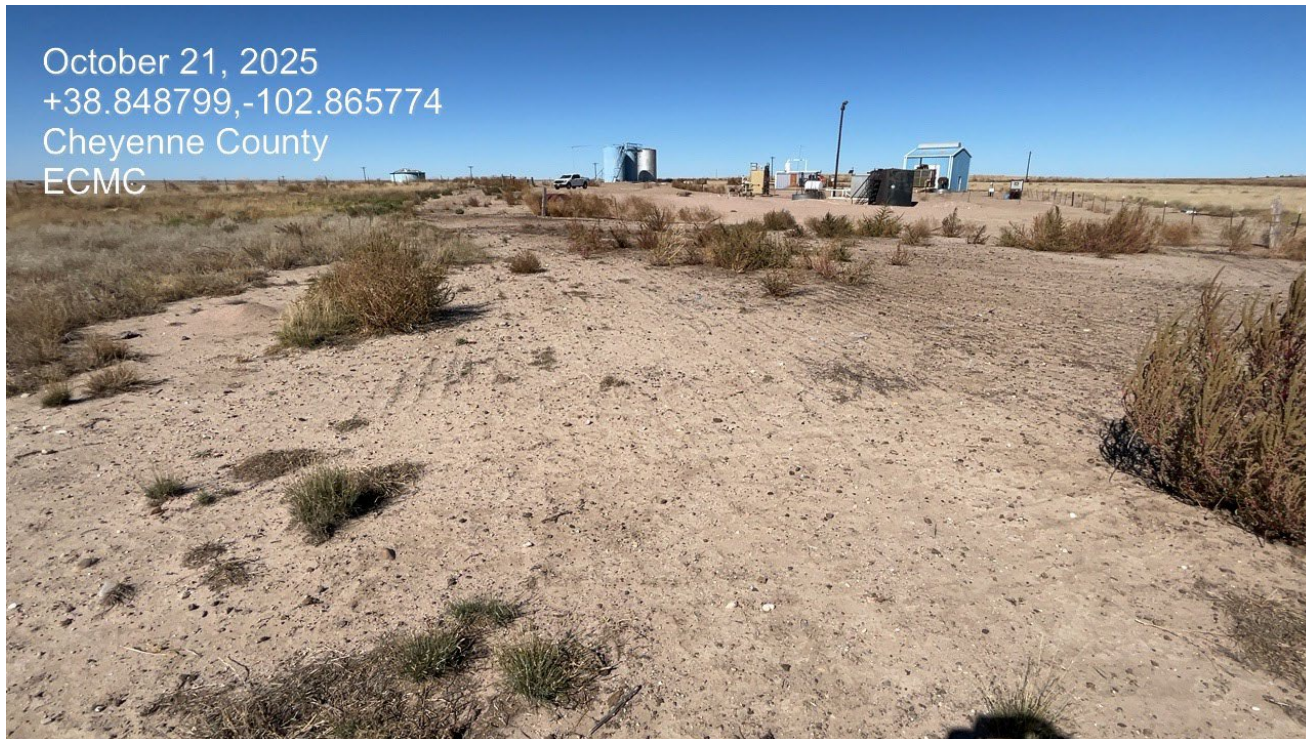
**Photo 3.** Facing northwest at the location. There is insufficient vegetation germination and additional reclamation will need to be completed.

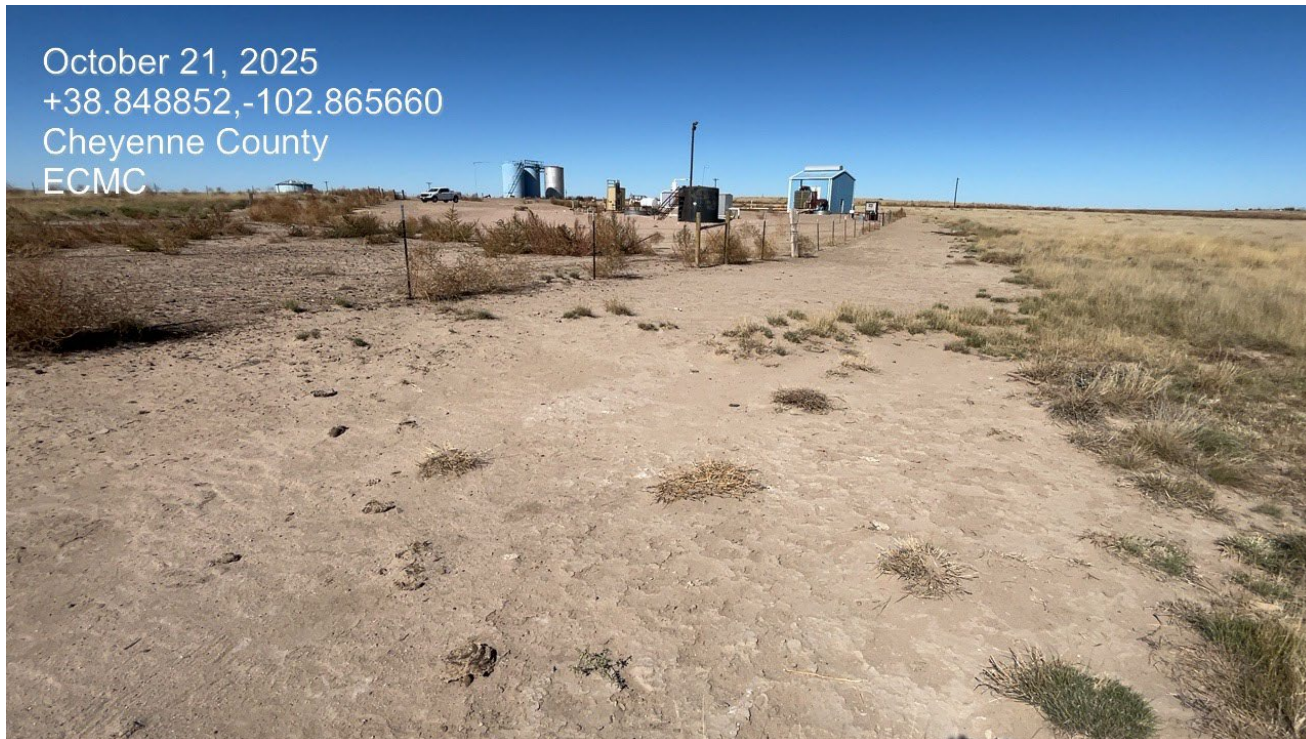
**Photo 4.** Facing northwest at the east side of the location. This area outside of the fence is bare of vegetation and needs to be reclaimed.

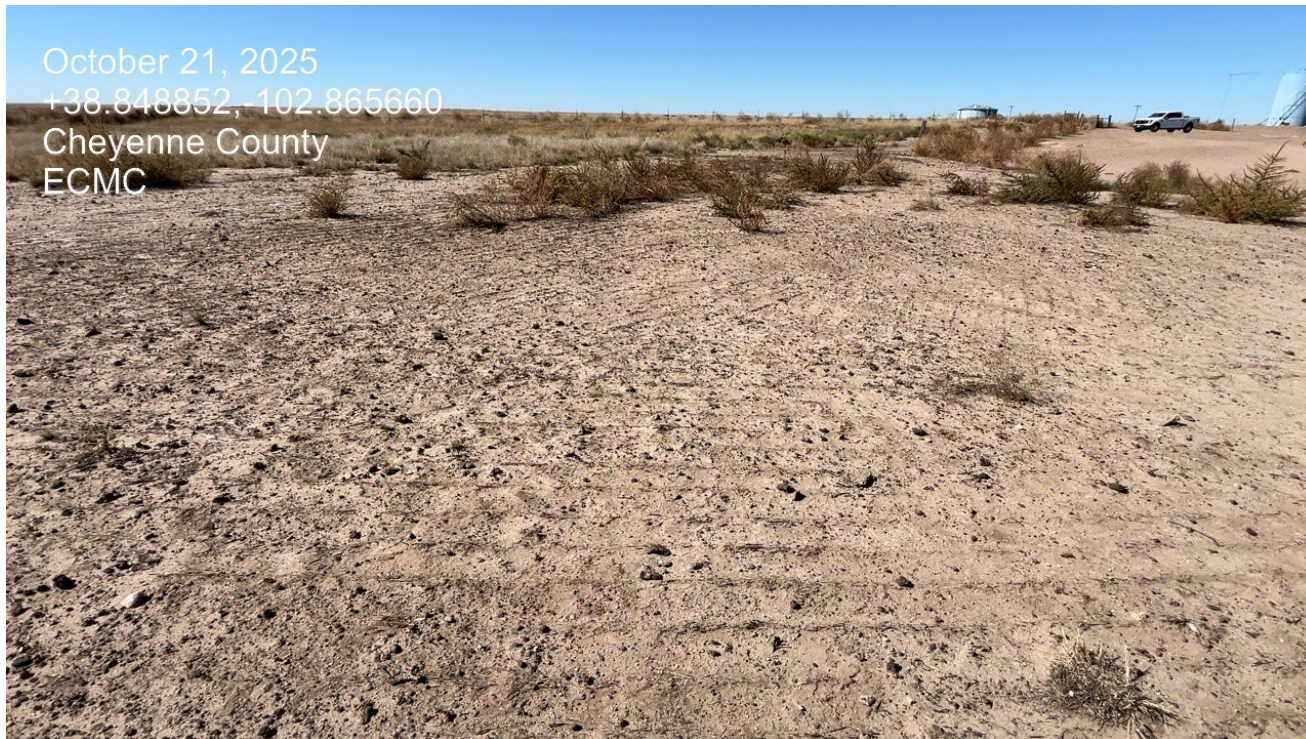
**Photo 5.** Facing west at the location. There is insufficient vegetation germination and additional reclamation will need to be completed.

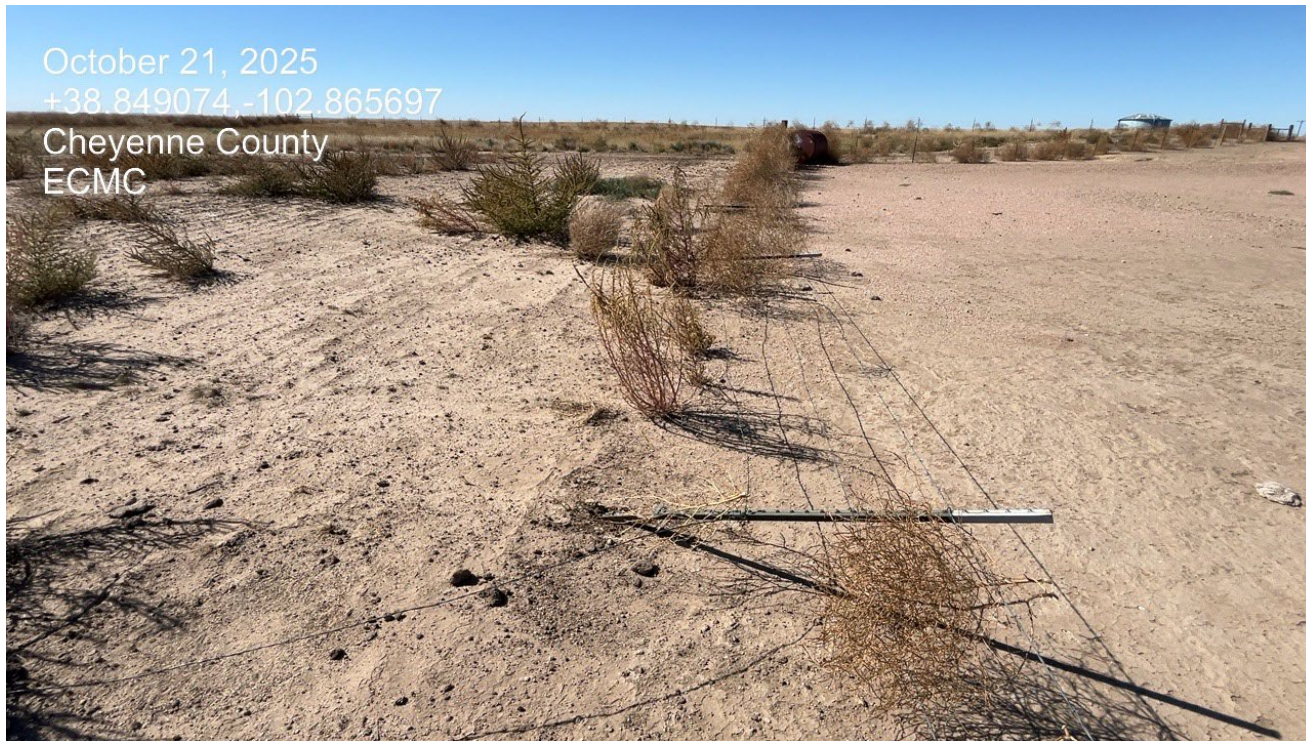
**Photo 6.** Facing west. The fence has fallen over and needs maintenance.
