# Final Reclamation Inspection

Operator: Kerr McGee Oil & Gas Onshore - 47120

Location ID: 329455

Inspection Photos  
Location Name: LDS T 13-5  
Location ID: 329455

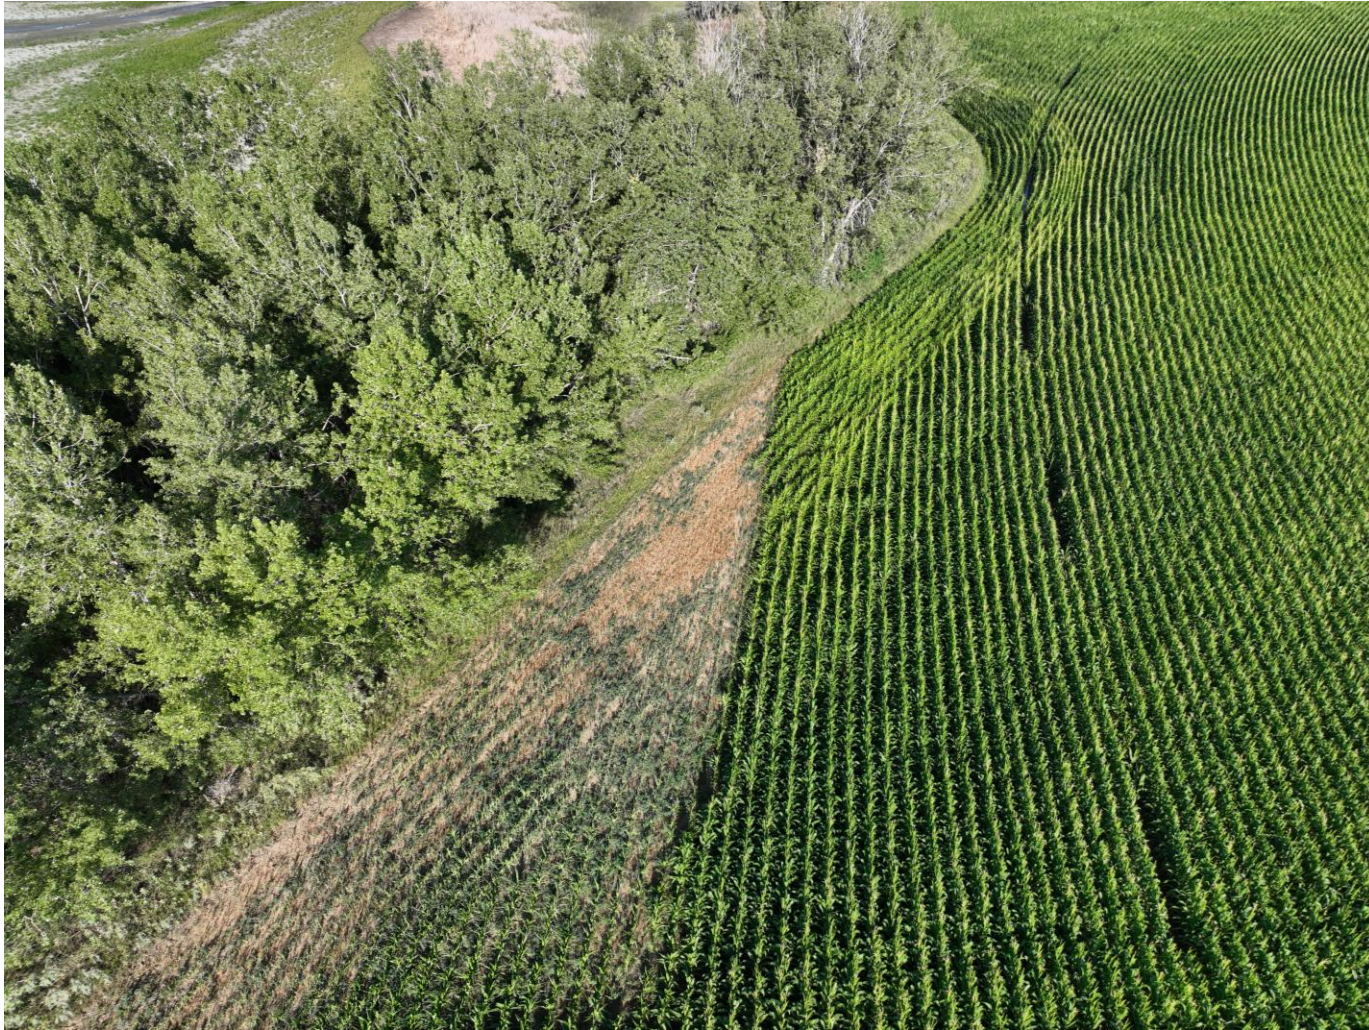
**Photo 3.** Drone aerial imagery taken at the well location, looking downward (displaying the well). No photo south of the well looking north was taken due to trees blocking the line of sight.

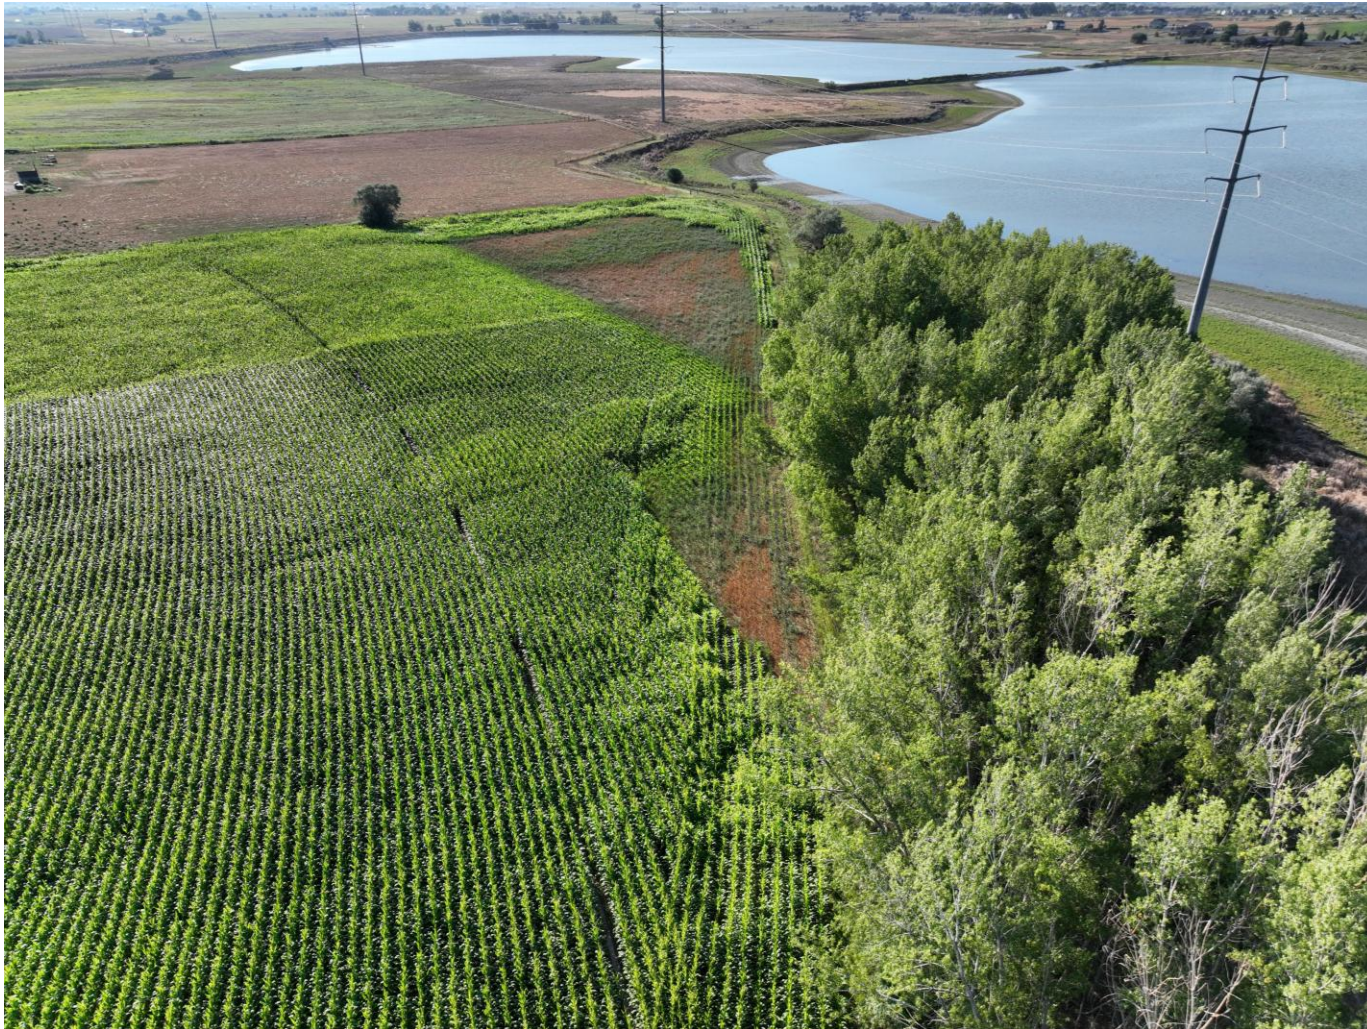
**Photo 4.** Drone aerial imagery taken west of well location, facing east (displaying the well).

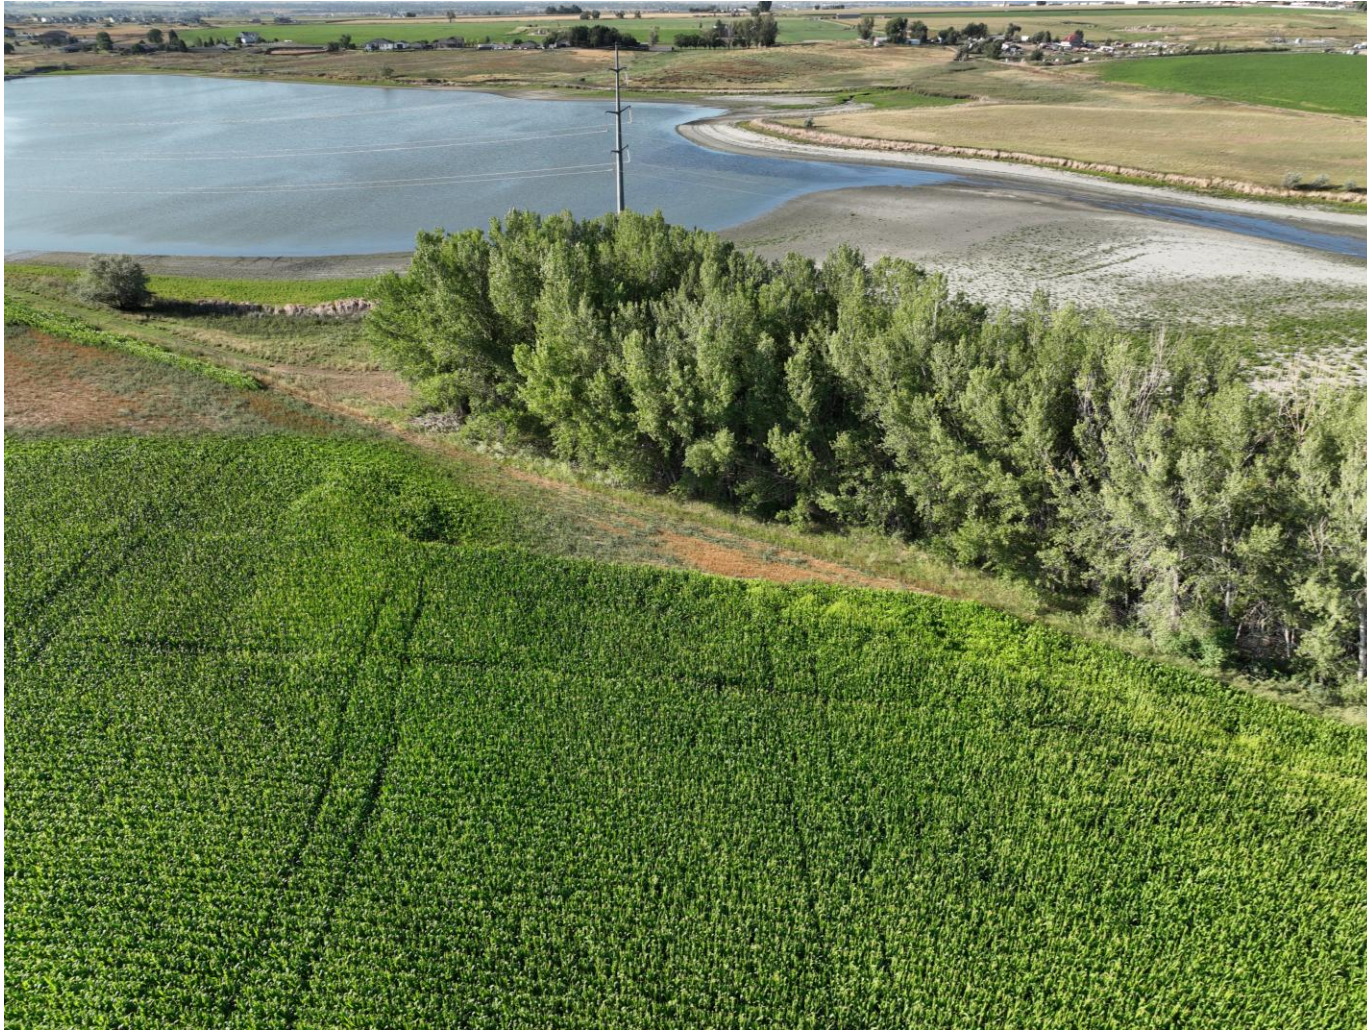
**Photo 5.** Drone aerial imagery taken north of well location, facing south (displaying the well and access road).

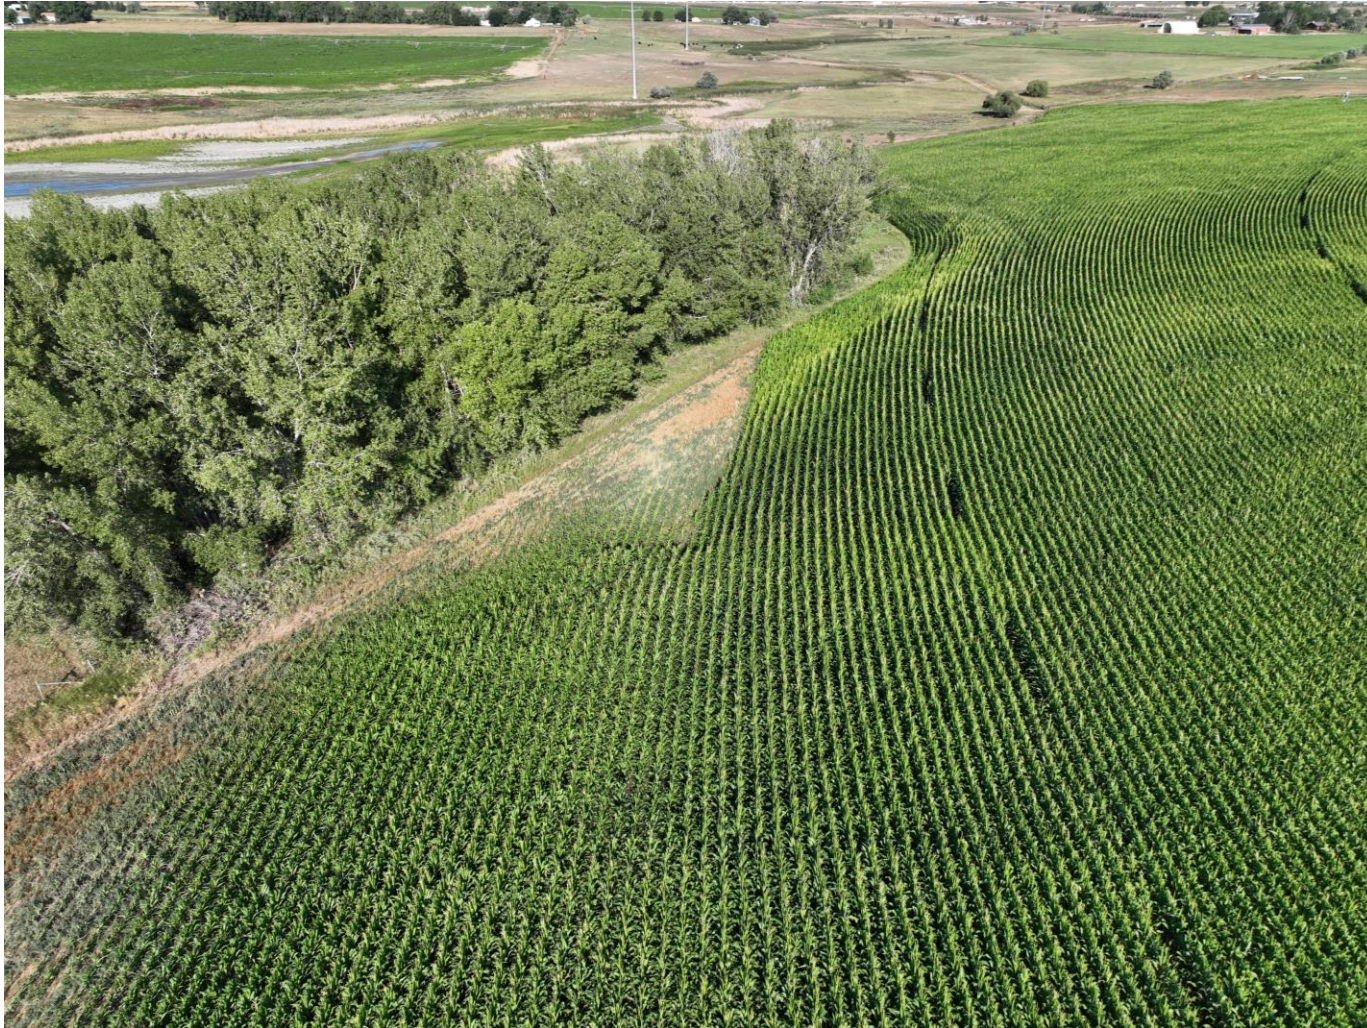
**Photo 6.** Drone aerial imagery taken east of well location, facing west (displaying the well).

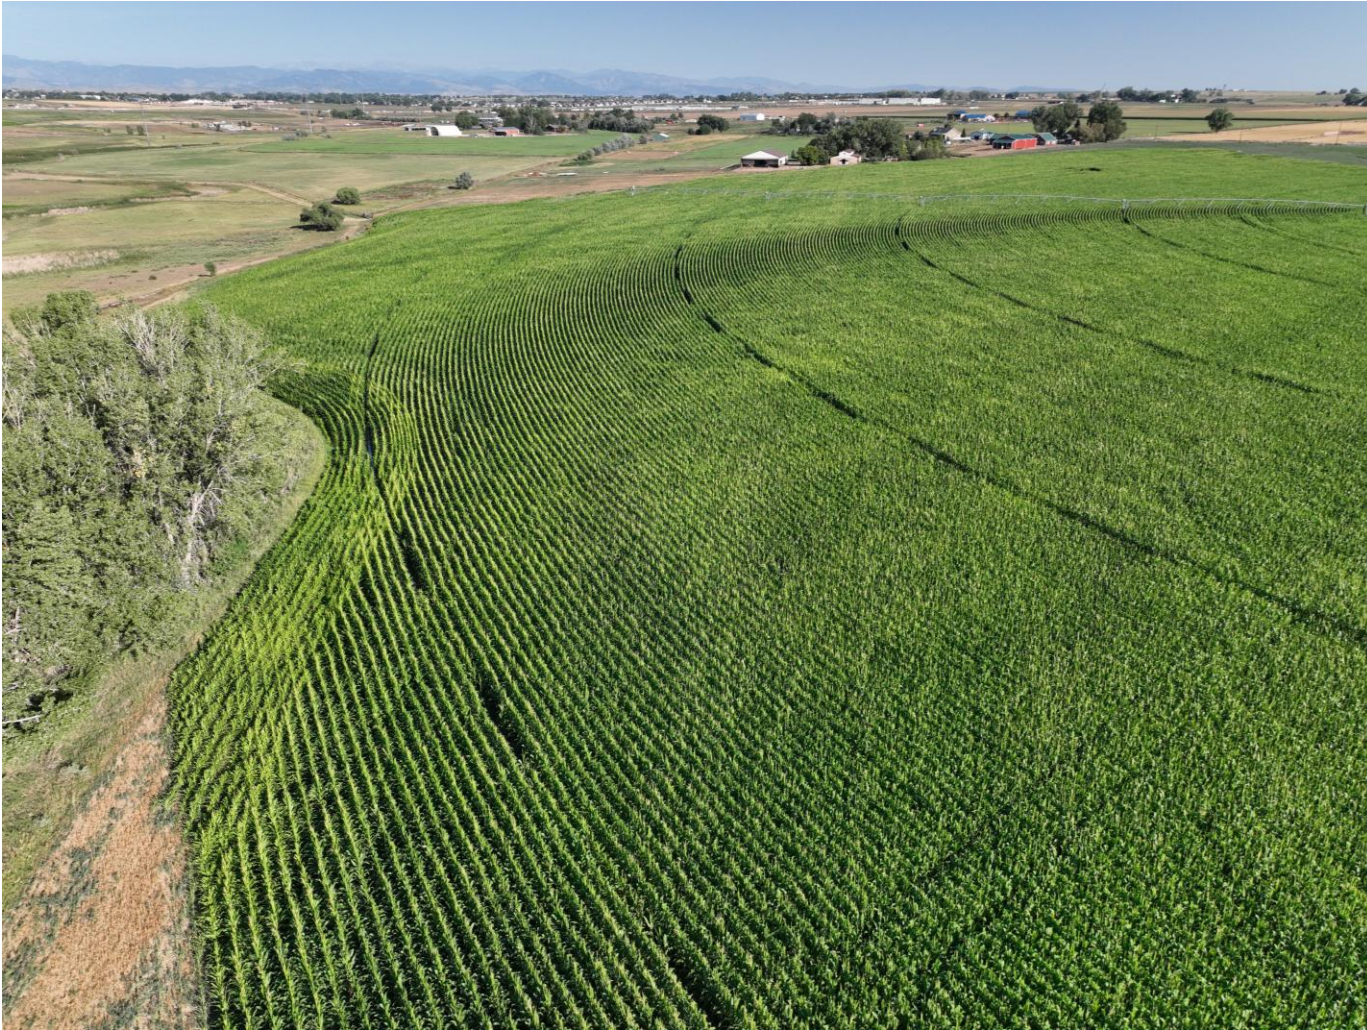
**Photo 7.** Drone aerial imagery east of the well and access road facing west (displaying the well access road and well).

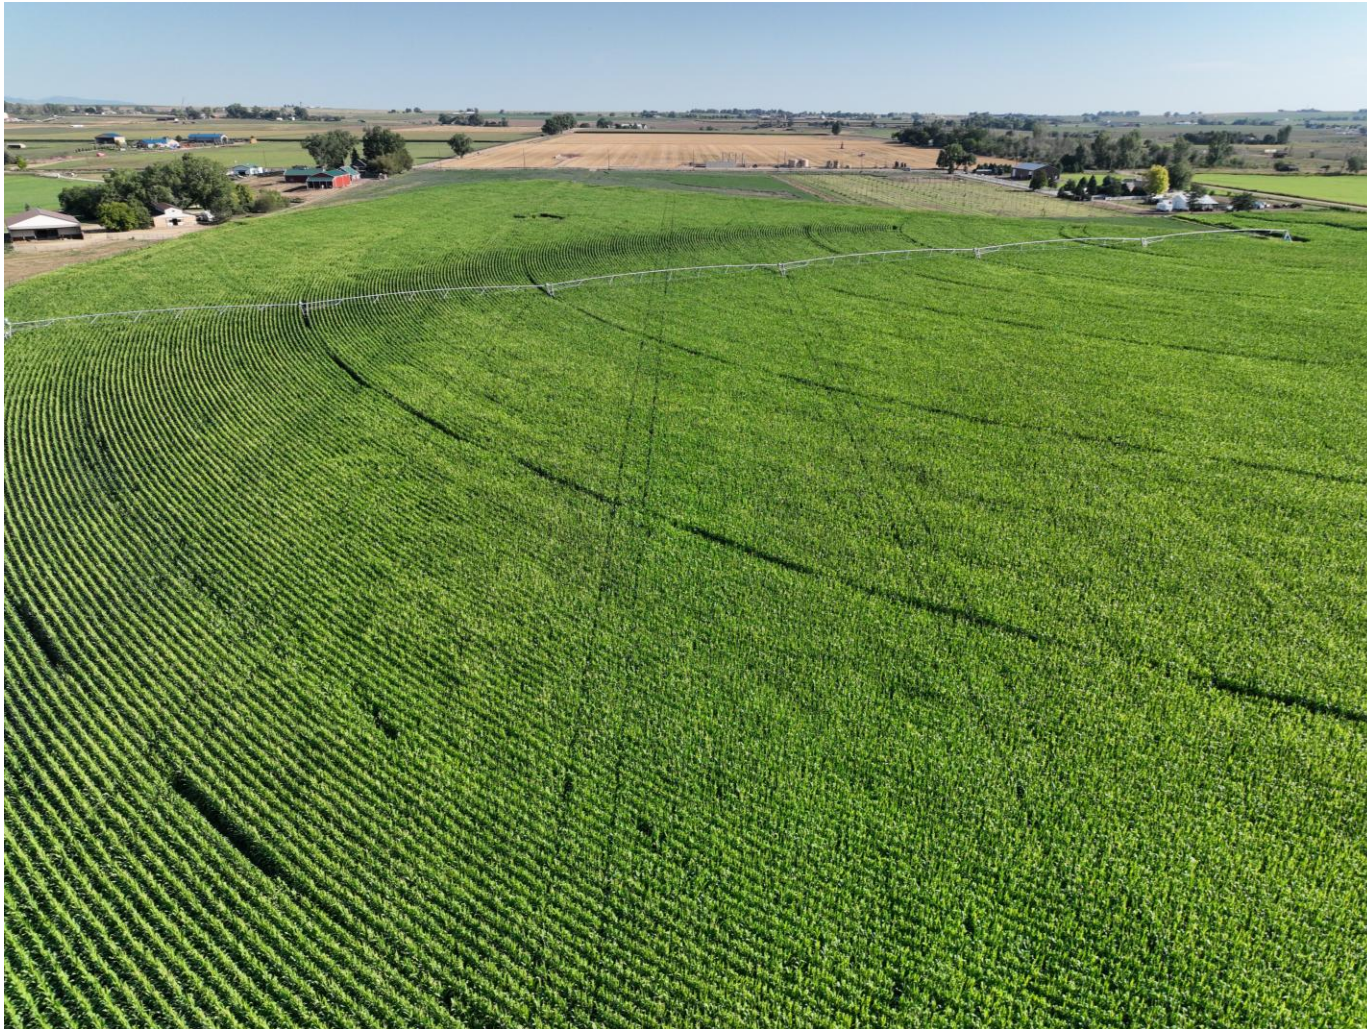
**Photo 8.** Drone aerial imagery south of the access road facing north (displaying the well access road).

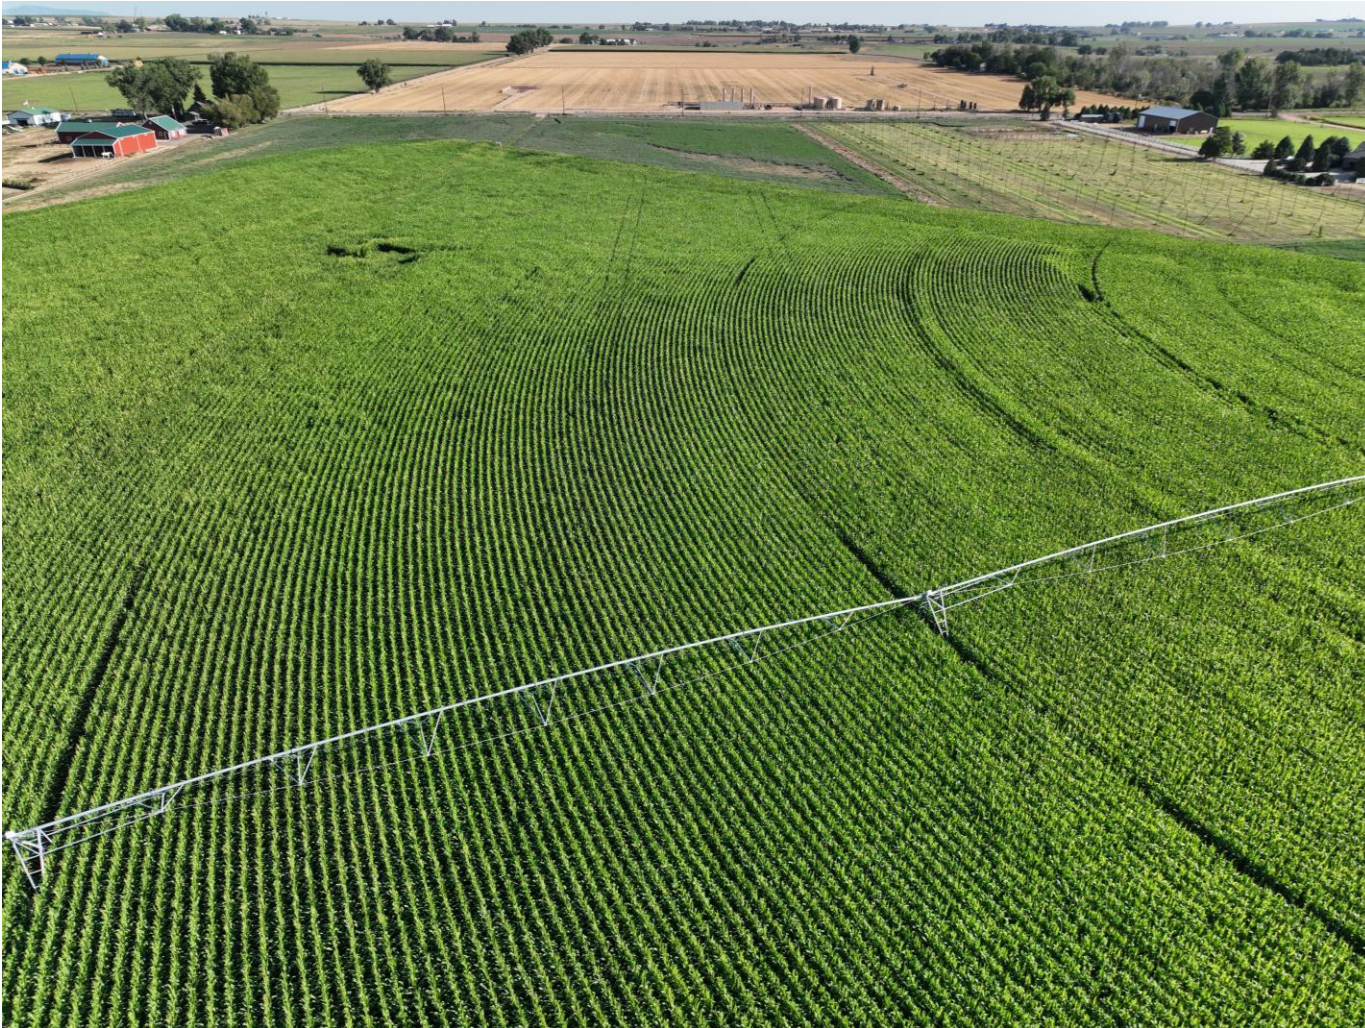
**Photo 9.** Drone aerial imagery mid access road facing north (displaying the well access road).  
Note: Crop vegetation at the well pad and access road appears consistent with adjacent reference areas.
