Inspection Photos

Operator: SWN Production Company LLC

Location ID: 313134

Inspection Doc: 719200383

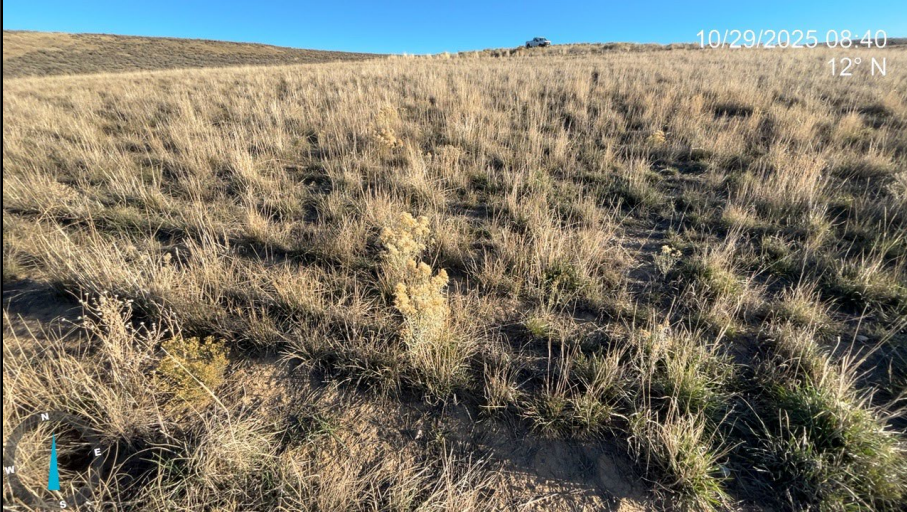
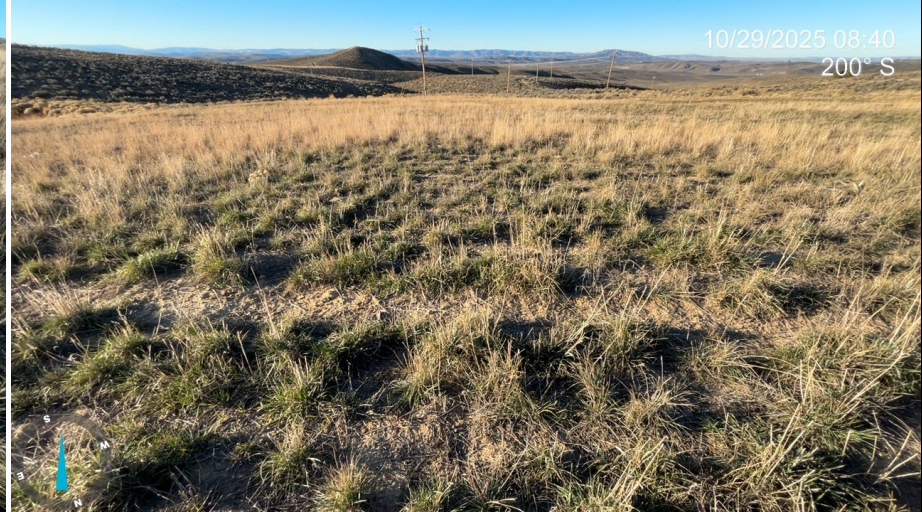
Photo 1: Photos showing an overview of the location looking north and south, respectively.

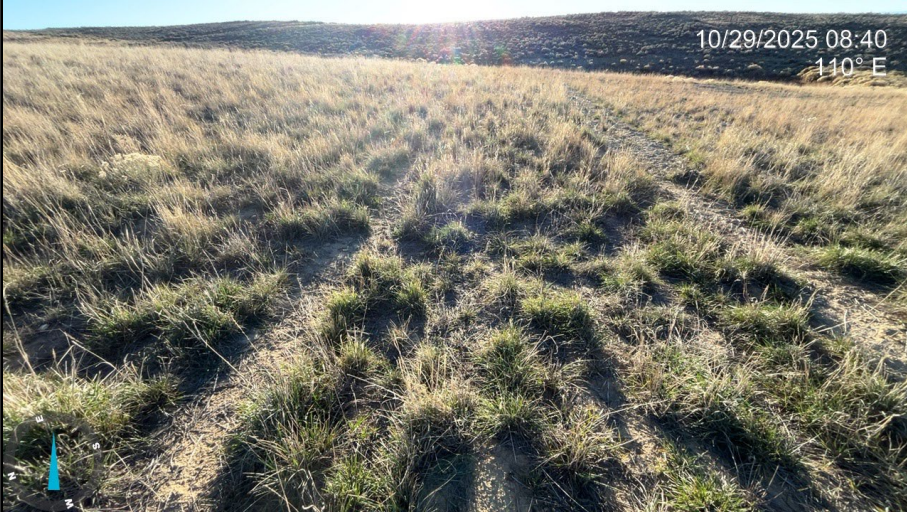
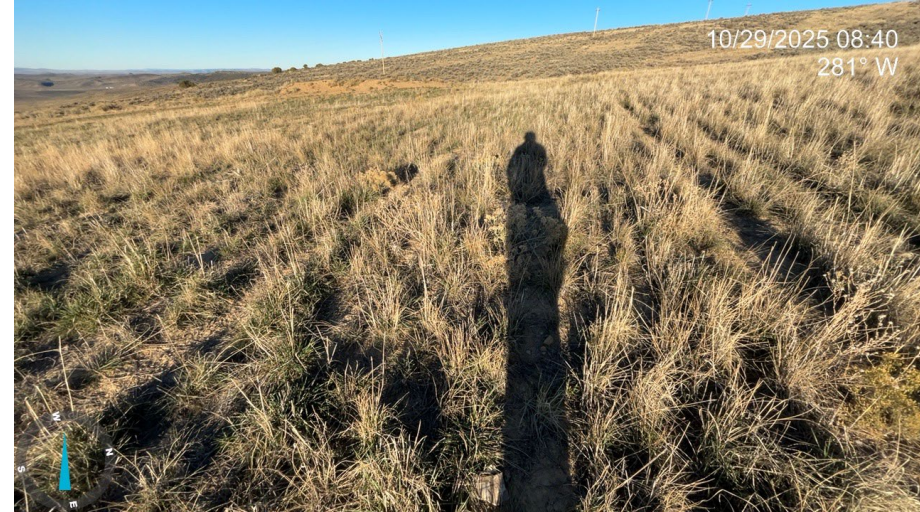
Photo 2: Photos showing an overview of the location looking east and west, respectively.

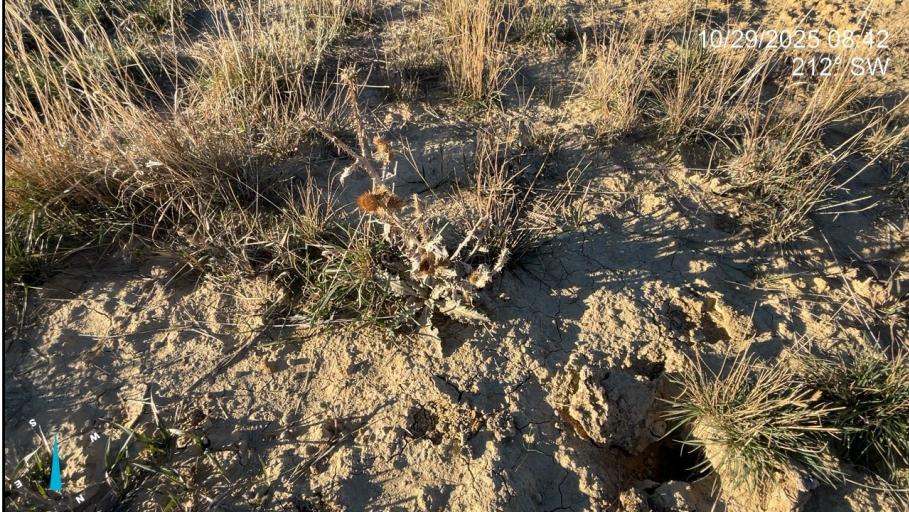
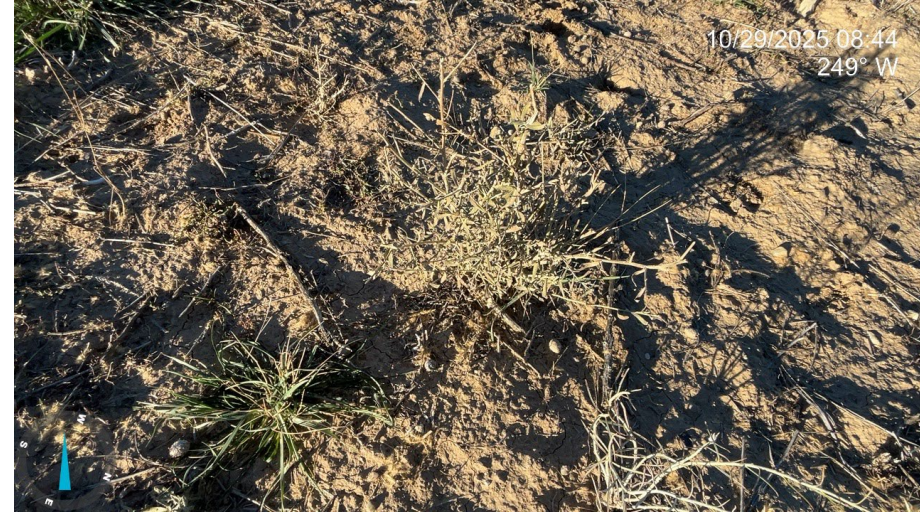
Photo 3: Photos showing an example of Scotch thistle (left), a List B noxious weed and knapweed, also a noxious weed, that is present throughout the location. It does not appear as though weeds have been managed in 2025.

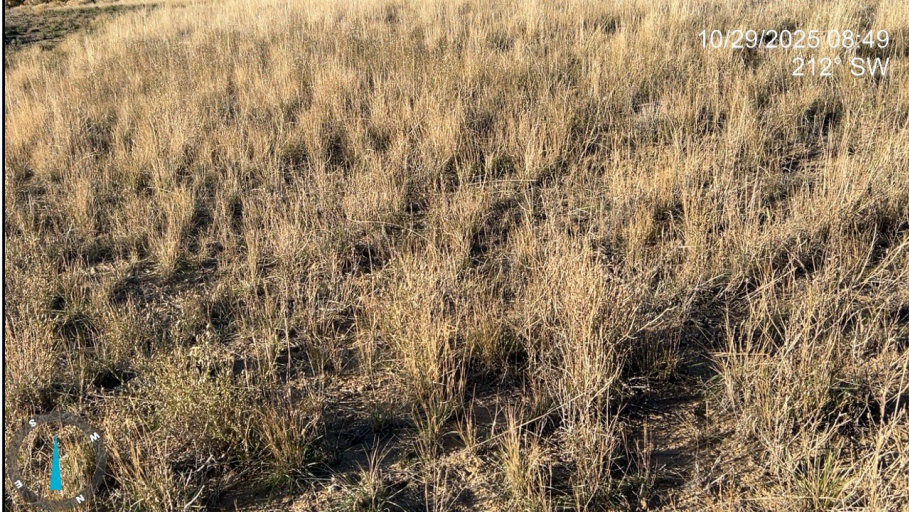
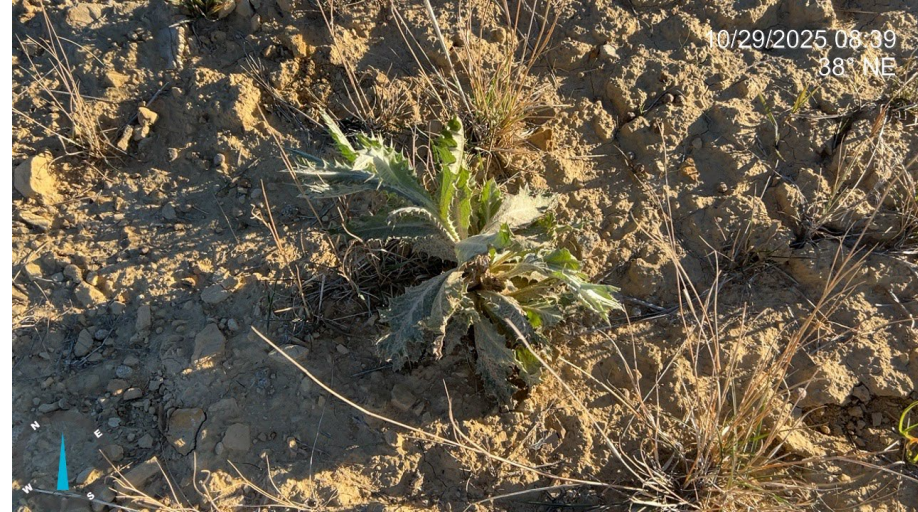
Photo 4: Photo left showing an infestation of knapweed, occurring on the northeastern portion of the location. Photo right showing new Scotch thistle growth at the location. It does not appear as though weeds have been managed in 2025.

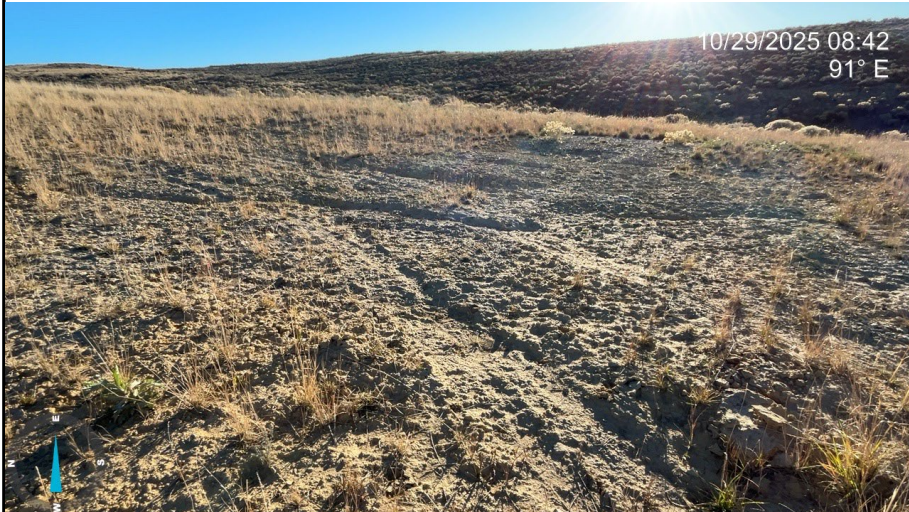
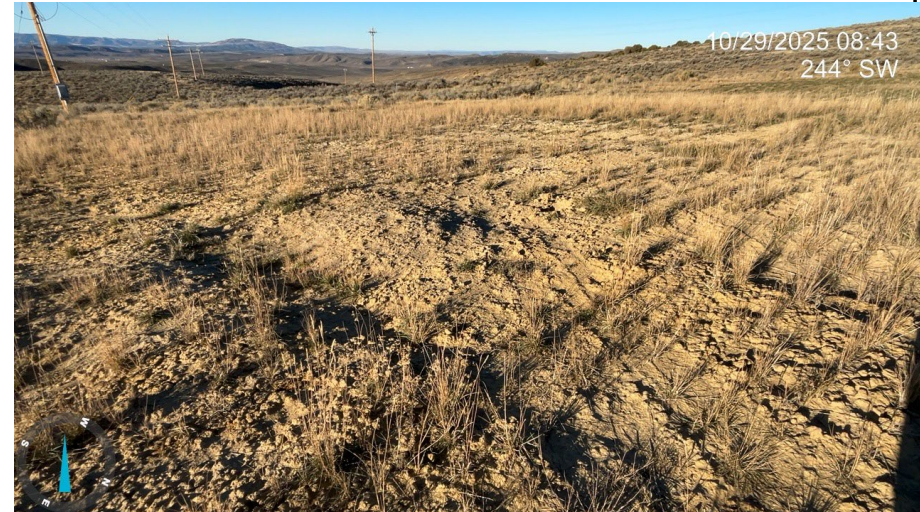
Photo 5: Photos showing examples of the southern portion of the location. Areas remain predominantly bare and uniform vegetation is not evident. Erosion and rilling is occurring.

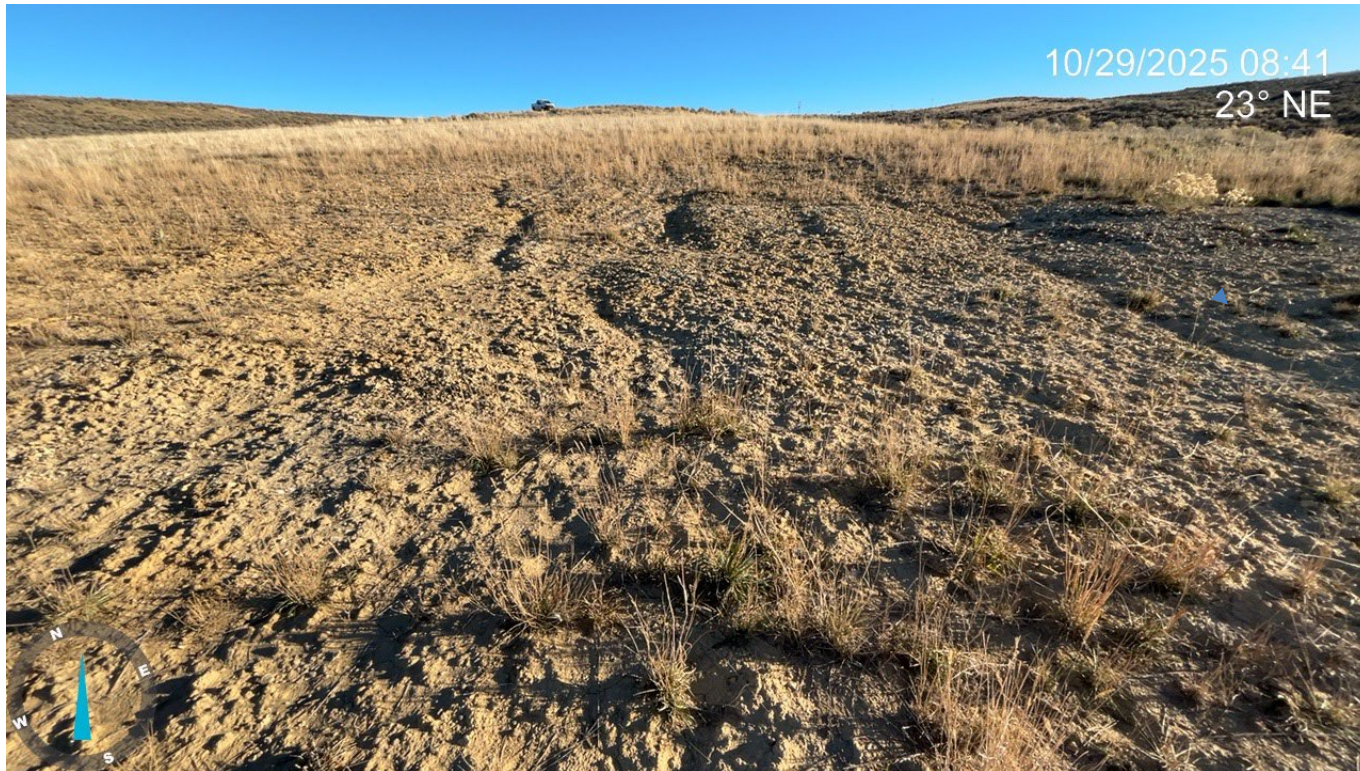
Photo 6: Photos showing examples of the southern portion of the location. Areas remain predominantly bare and uniform vegetation is not evident. Erosion and rilling is occurring.

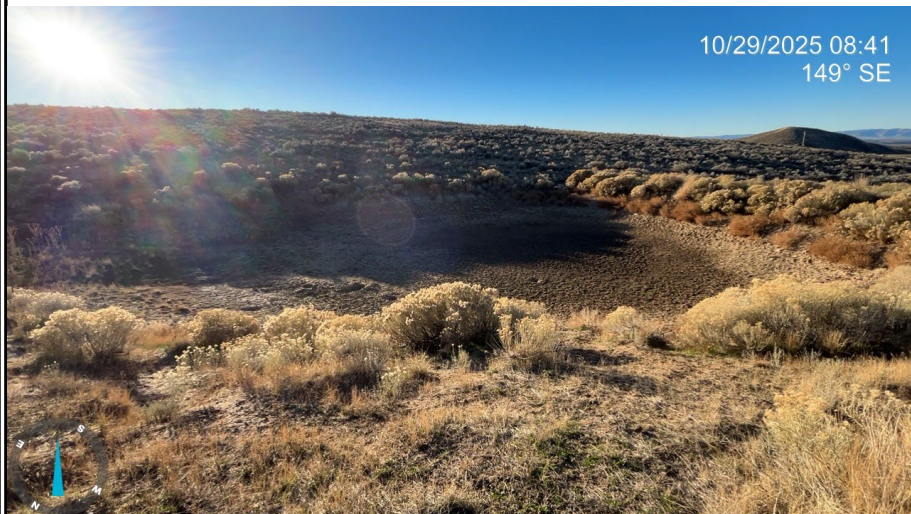
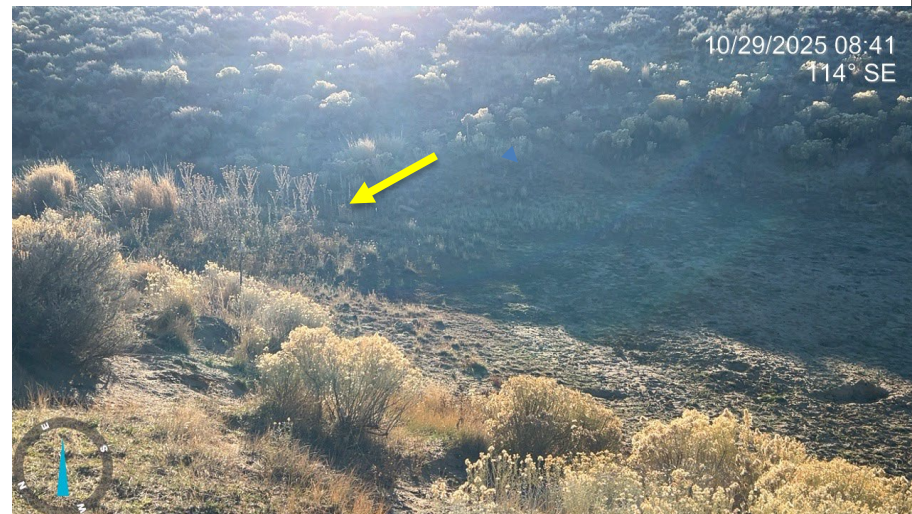
Photo 7: Photos showing a sediment trap on the southeastern end of the location has not been recontoured or reclaimed. An infestation of Scotch thistle is present (yellow arrow).

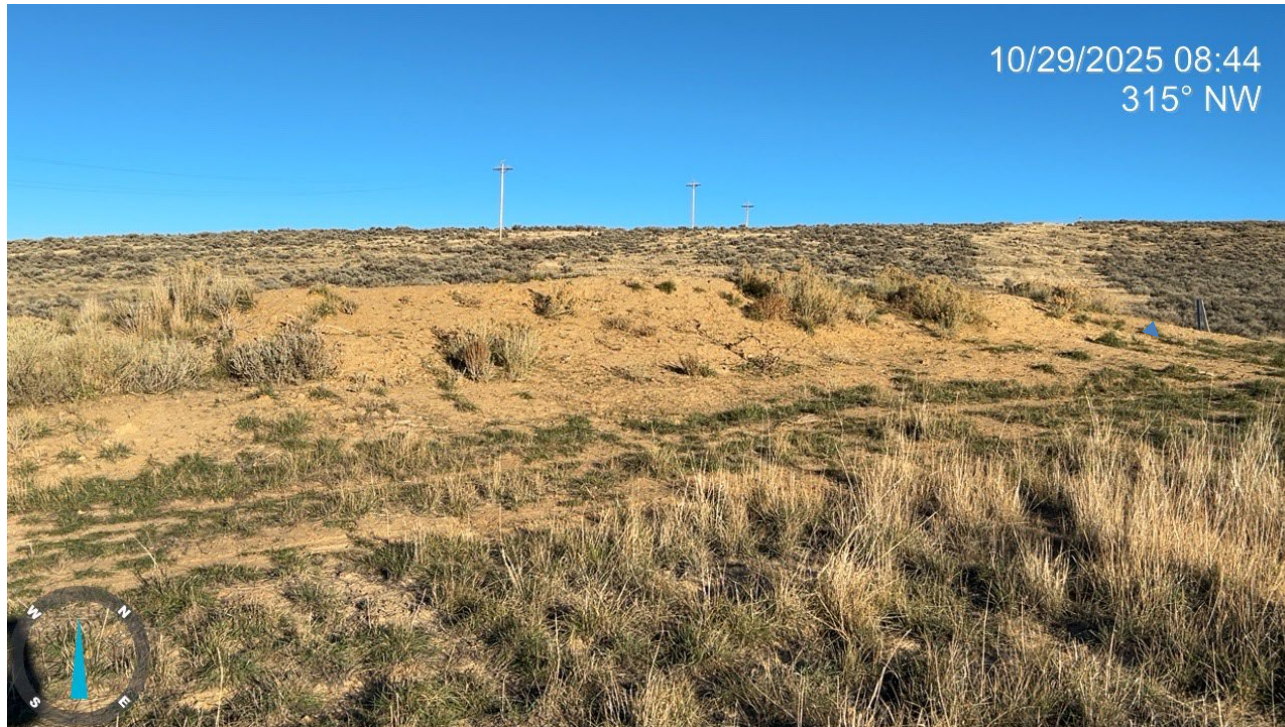
Photo 8: Photo showing a soil stockpile/berm remaining on the location. Location has not been properly contoured, and soils replaced. Soils are predominantly bare; BMPs to protect the stockpiled soils from erosion, degradation, weed establishment, as well as BMPs to minimize sediment transport are missing or insufficient.

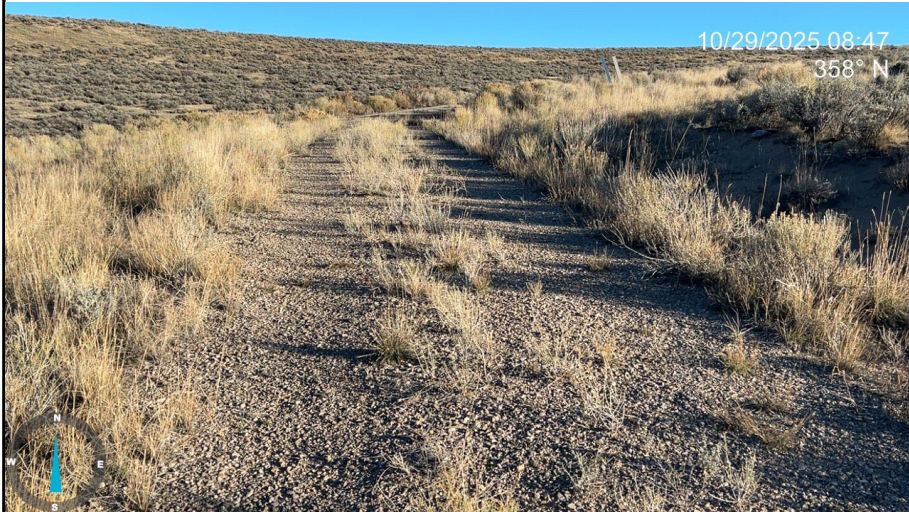
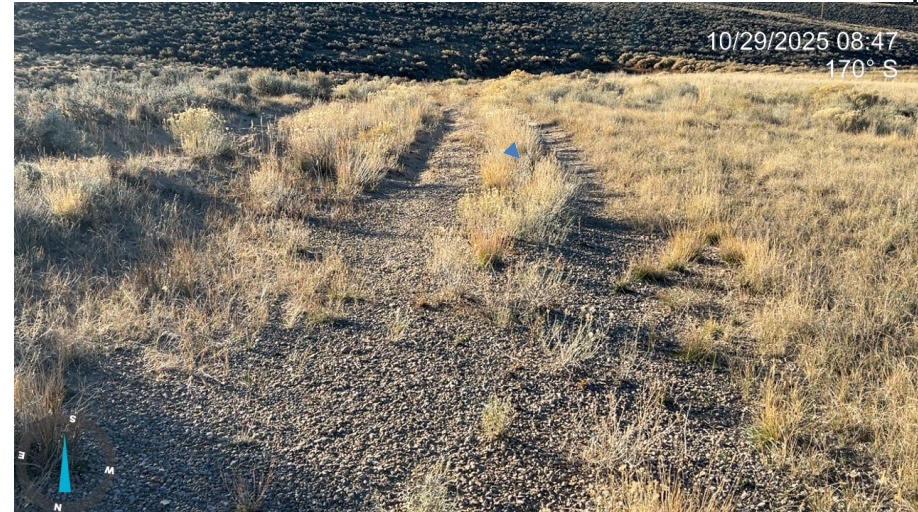
Photo 9: Photos showing the northeastern access road to the location remains unreclaimed. Gravel and compaction is evident.

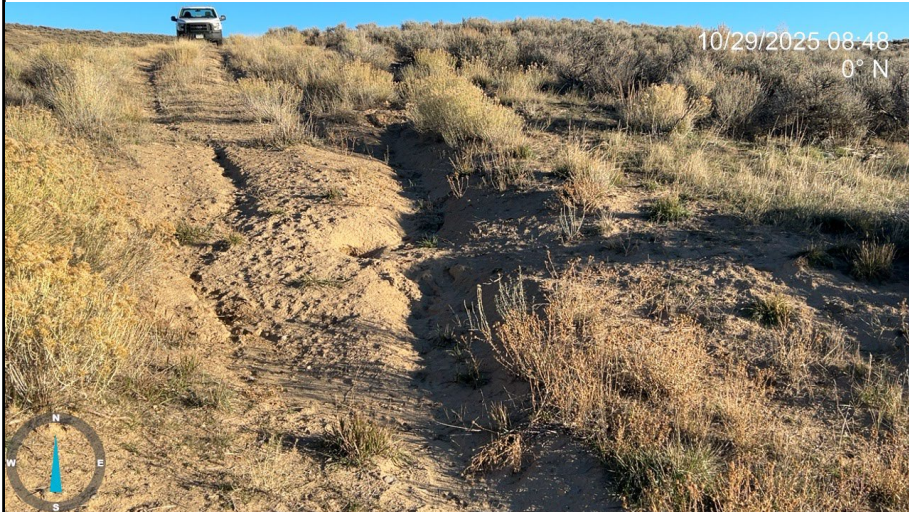
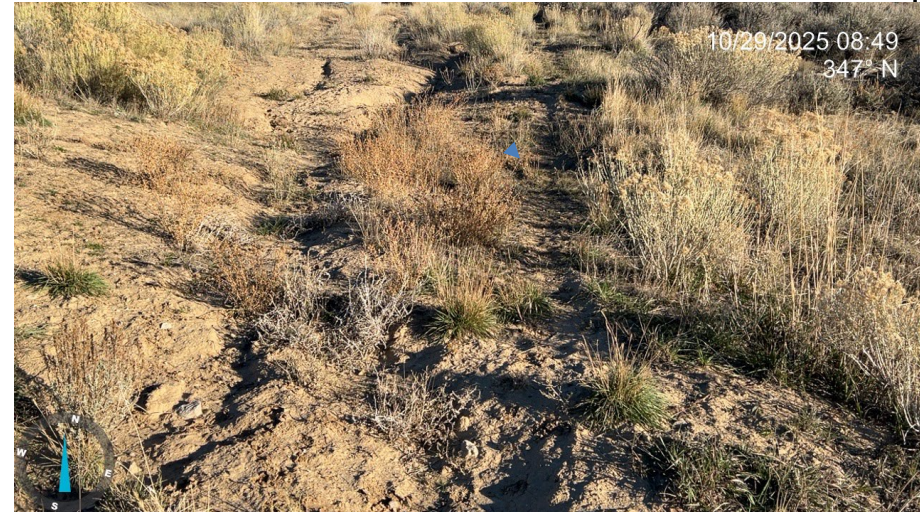
Photo 10: Photos showing erosion, rilling and sediment migration occurring on the northeastern access road. Ongoing stormwater maintenance is necessary until the location receives a passing final reclamation inspection.

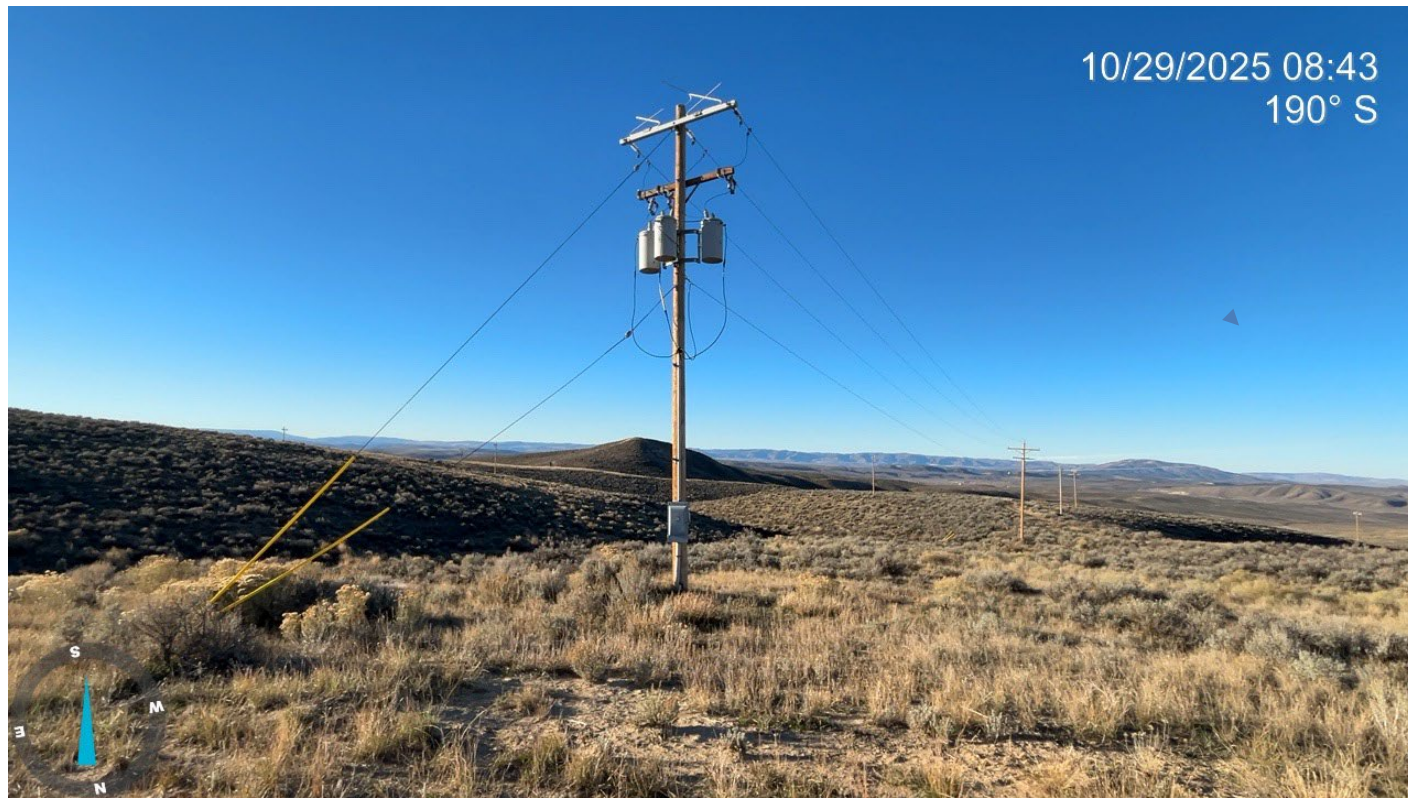
Photo 11: Photo showing utility equipment remains at the location and requires removal.

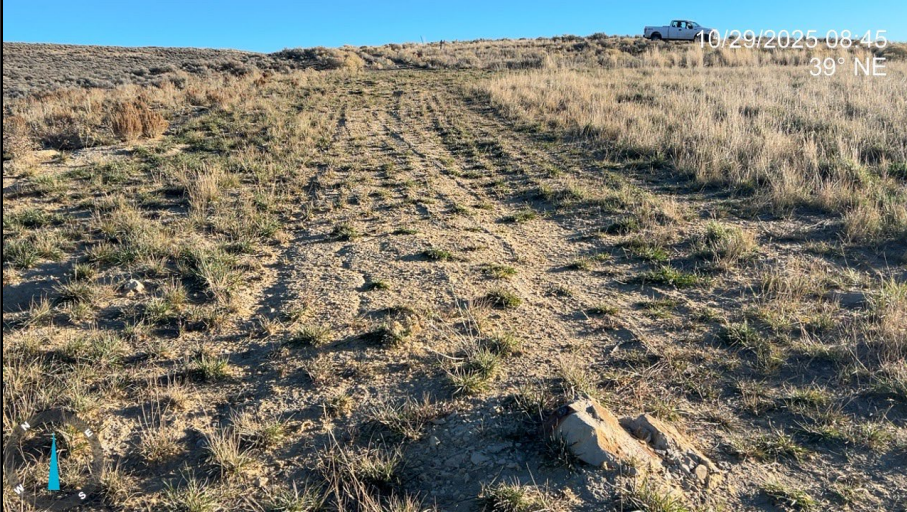
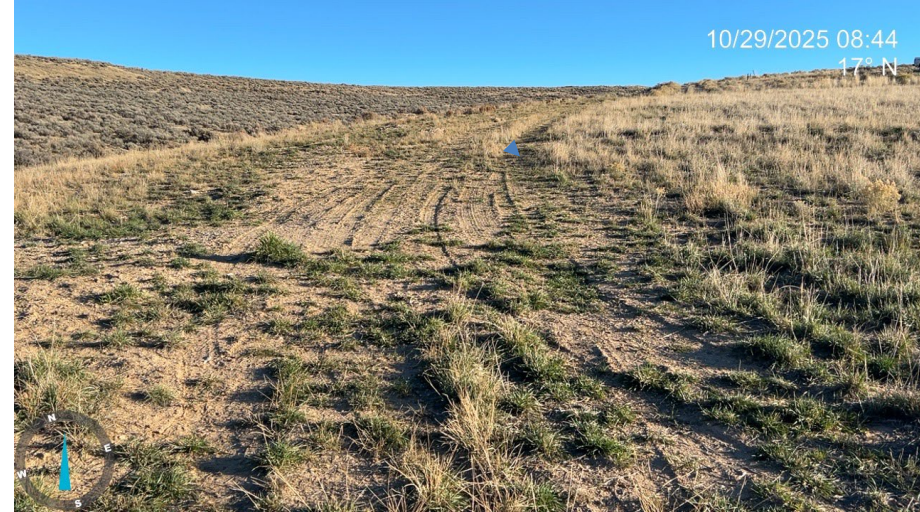
Photo 12: Photos showing the western access road that remains unreclaimed. Gravel and compaction is evident.

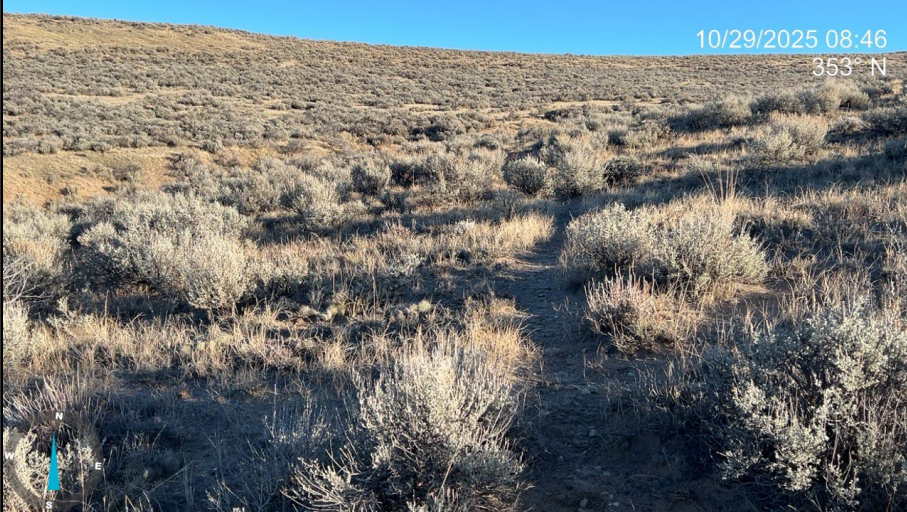
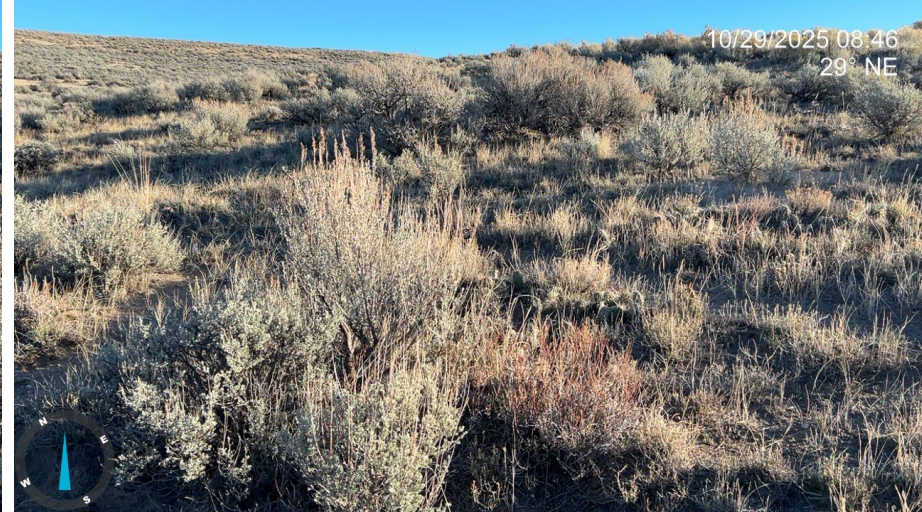
Photo 13: Photos showing an example of the reference area, located to the south of the location. Reference areas are characterized by big sagebrush shrublands, and big sagebrush is dominant.

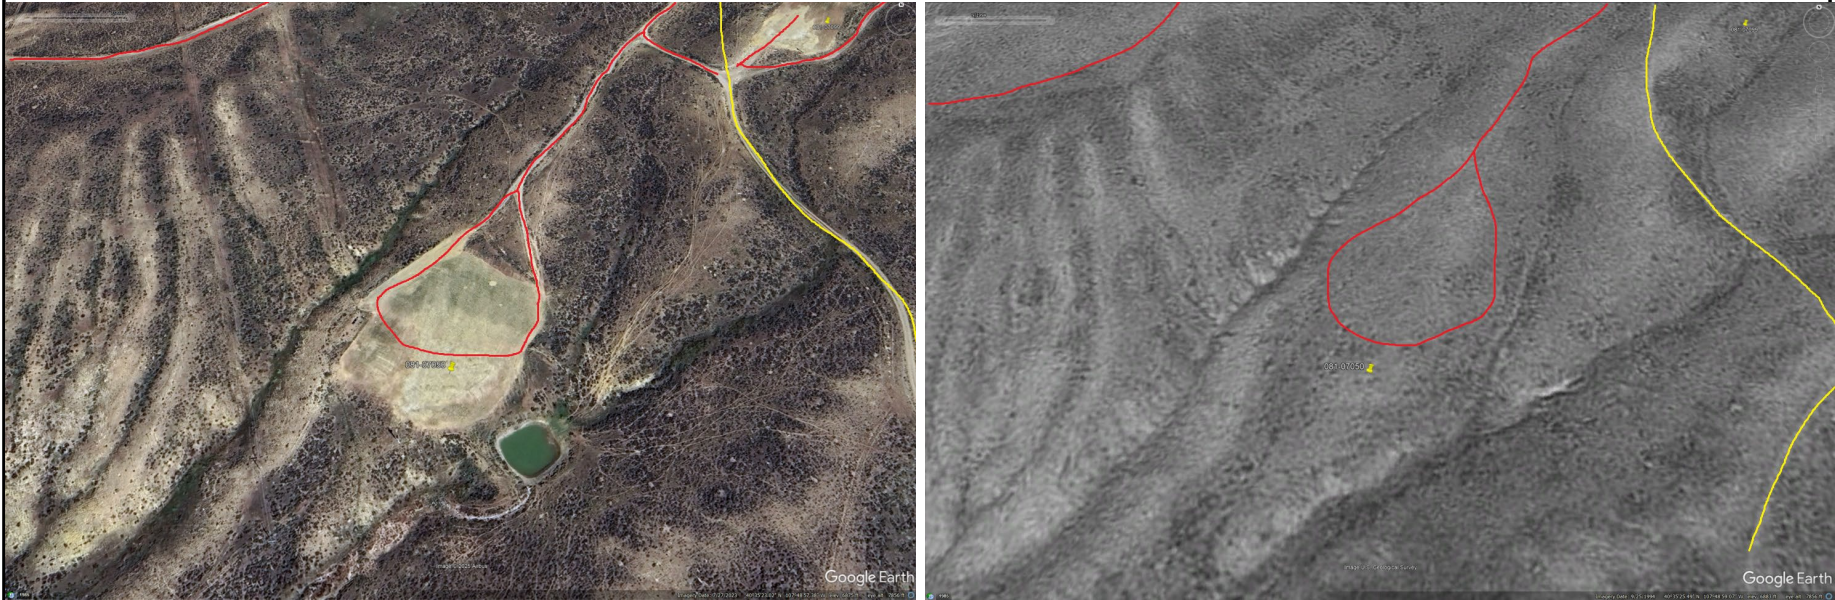
Photo 14: Google Earth aerial imagery. Top photo dated 2023; bottom 1994. Yellow lines represent access roads that existed prior to Oil and Gas disturbances. Red lines represent access roads constructed to Oil and Gas Locations subject to 1004 final reclamation requirements. Access road to the Walker 3-1 did not pre-exist the location.
