Aristocrat PC H11-19D  
© 30-Oct-25 13:22:18  
ECMC Environmental Inspection

**ECMC**  
**Environmental**  
**Field Inspection**

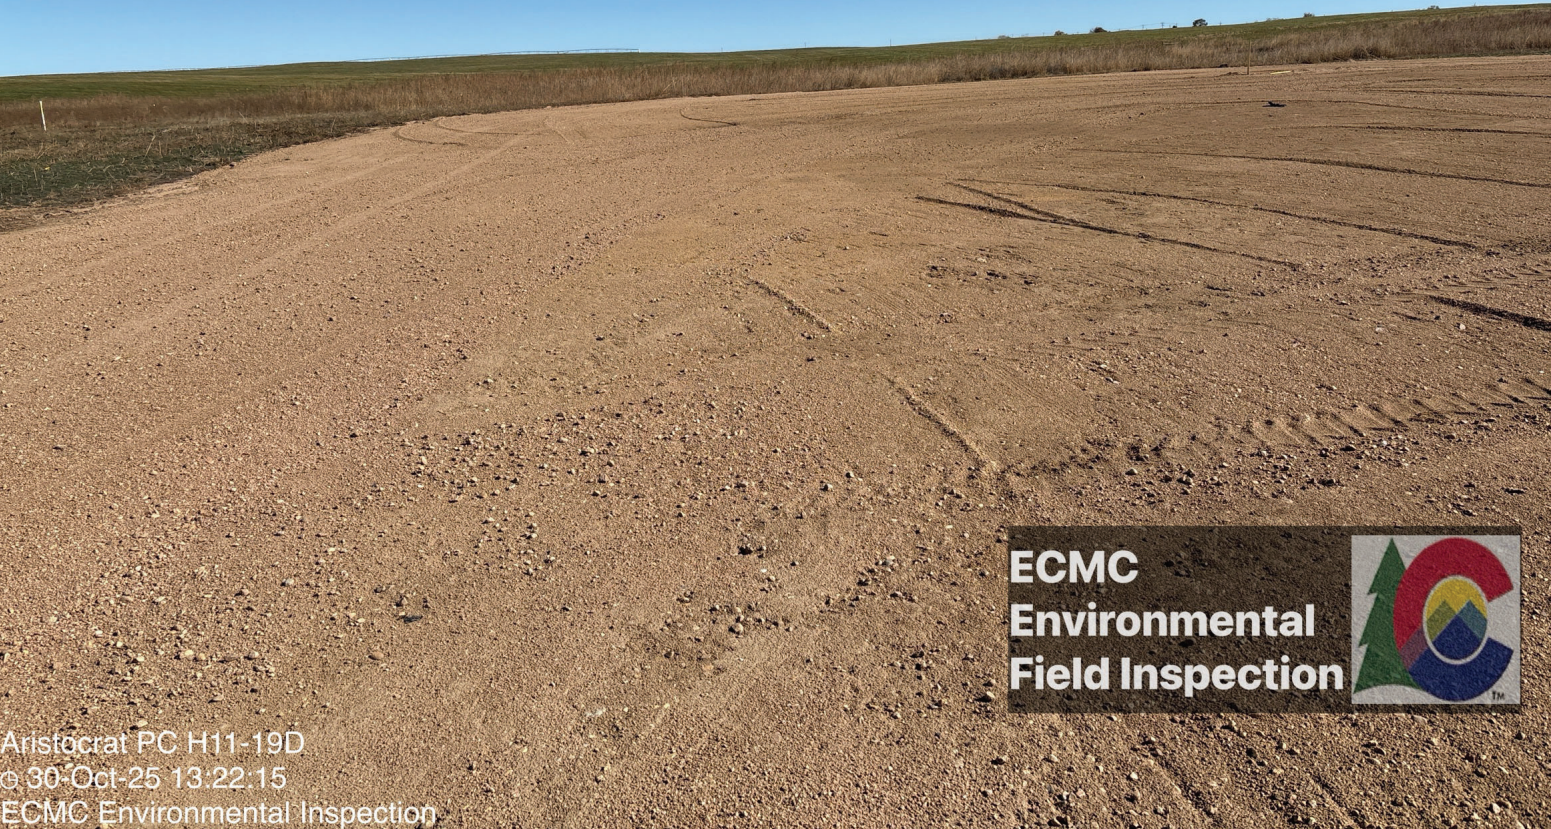
Former Aristocrat PC H11-19D Tank Battery. Surface appears to have been re-scraped/levelled recently.

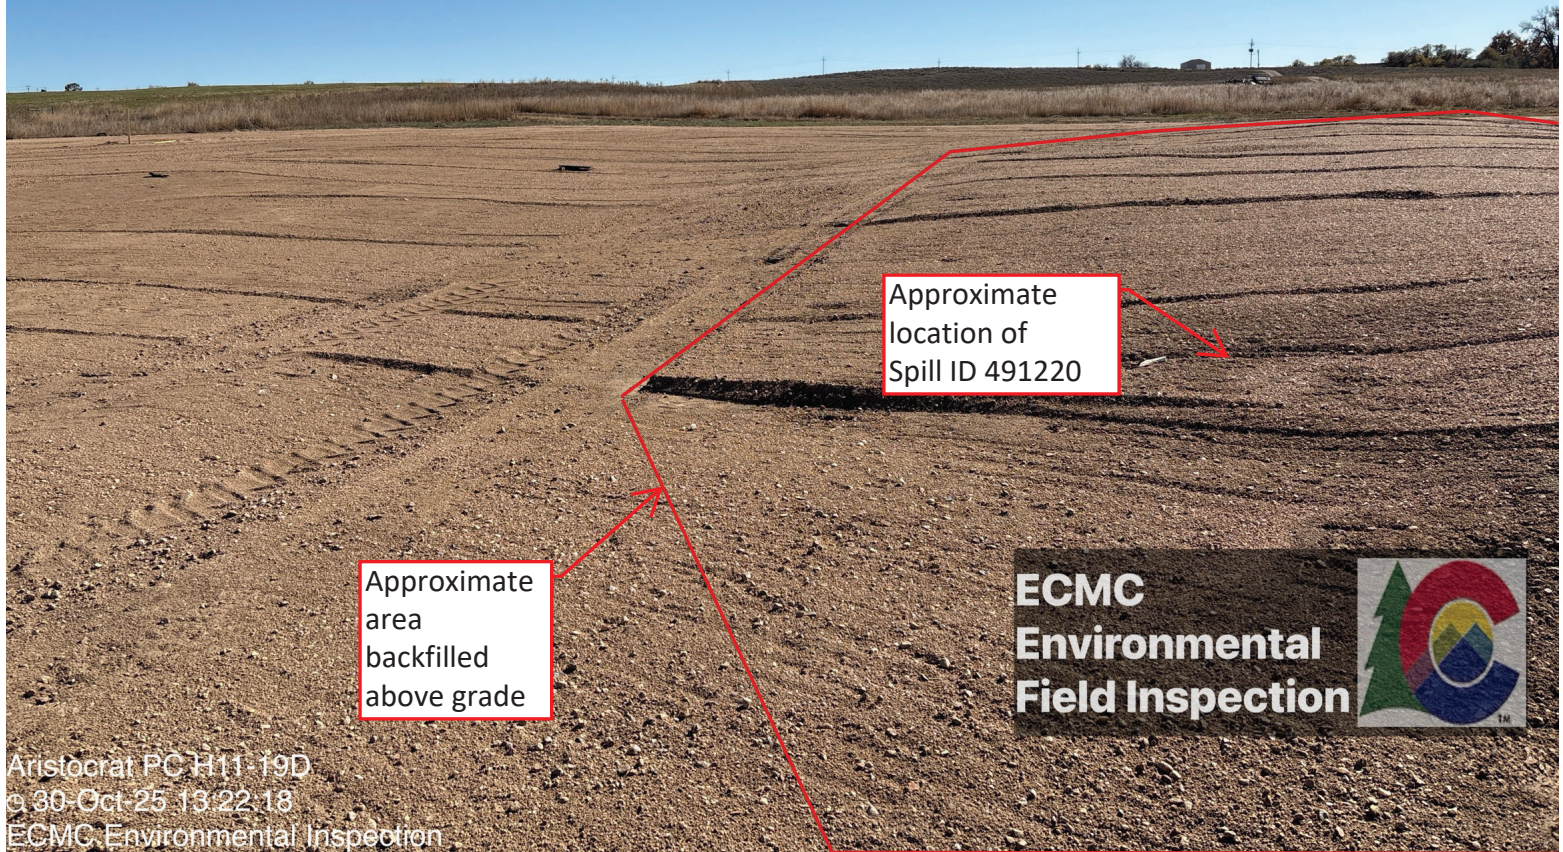
Looking at the Former Aristocrat PC H11-19D Tank Battery and approximate location of Spill ID 491220. Surface appears to have been re-scraped/levelled recently; however, the excavation at the spill location remains backfilled to a grade above that of the surrounding location.

Pump at the adjacent irrigation pond southwest of the spill location.

Irrigation pond

Approximate area backfilled above grade

Approximate location of Spill ID 491220

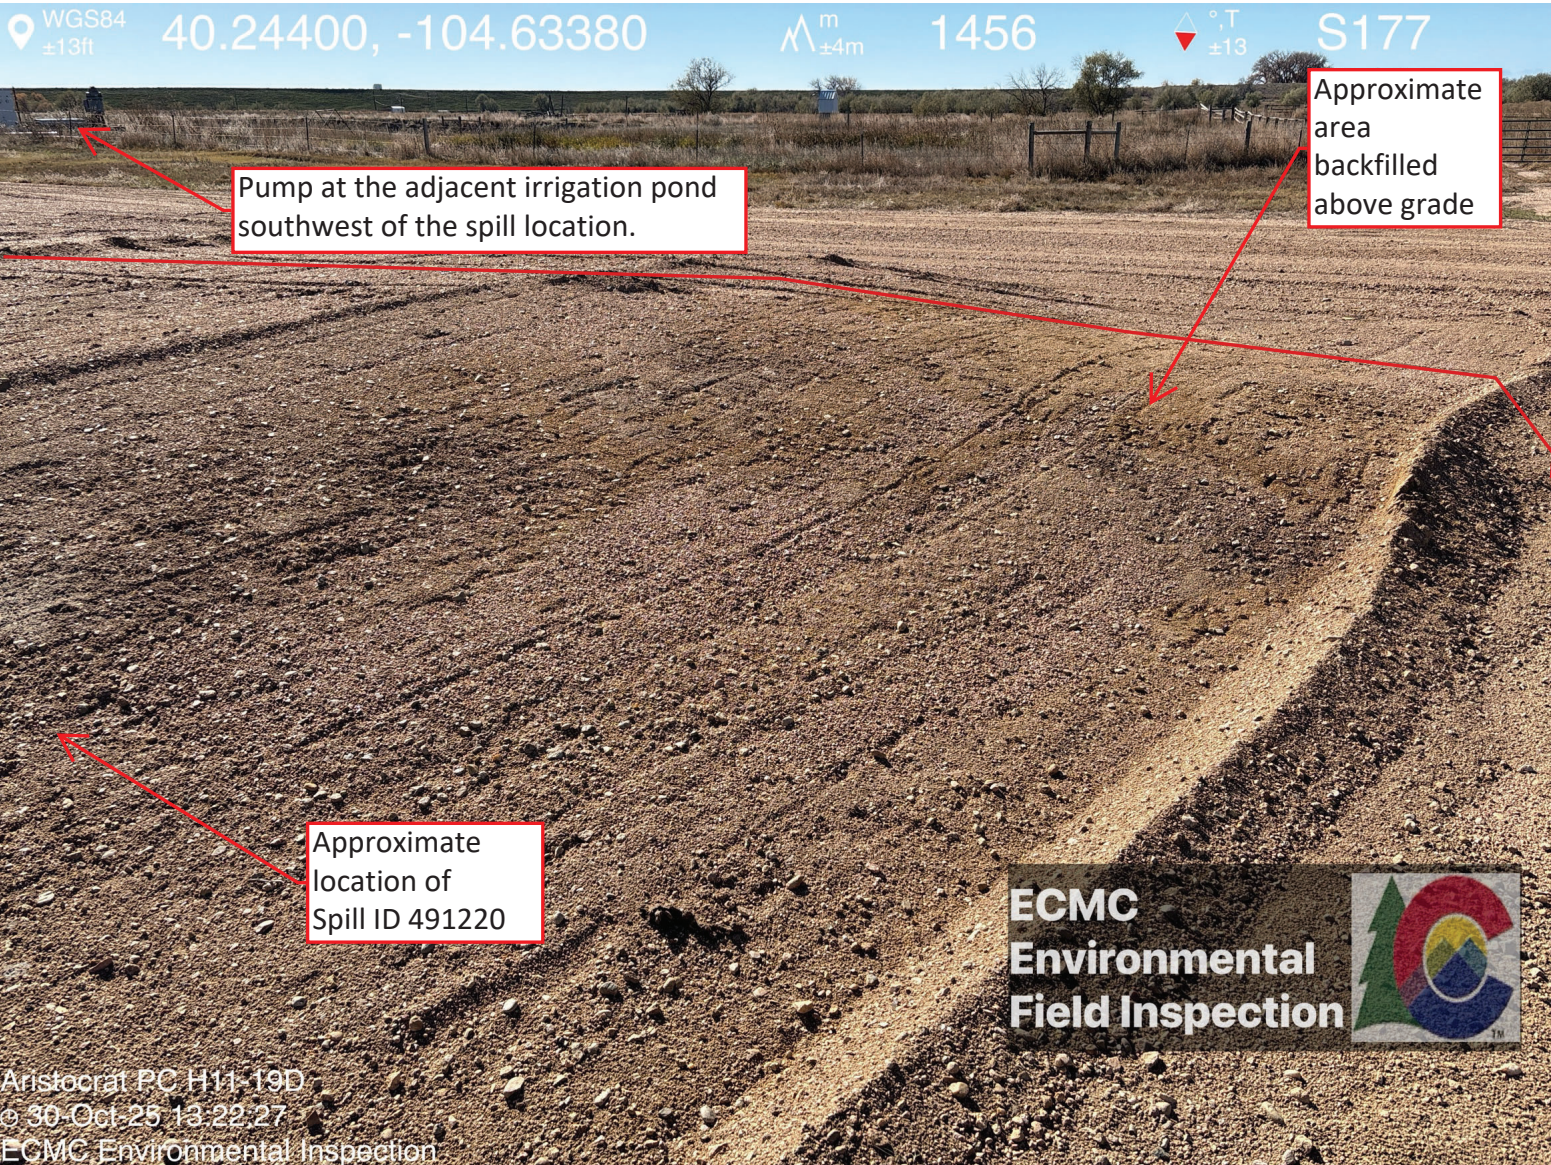
Aristocrat PC H11-19D  
e 30-Oct-25 13:22:22  
ECMC Environmental Inspection

Looking at the Former Aristocrat PC H11-19D Tank Battery and approximate location of Spill ID 491220. Surface appears to have been re-scraped/levelled recently; however, the excavation at the spill location remains backfilled to a grade above that of the surrounding location.

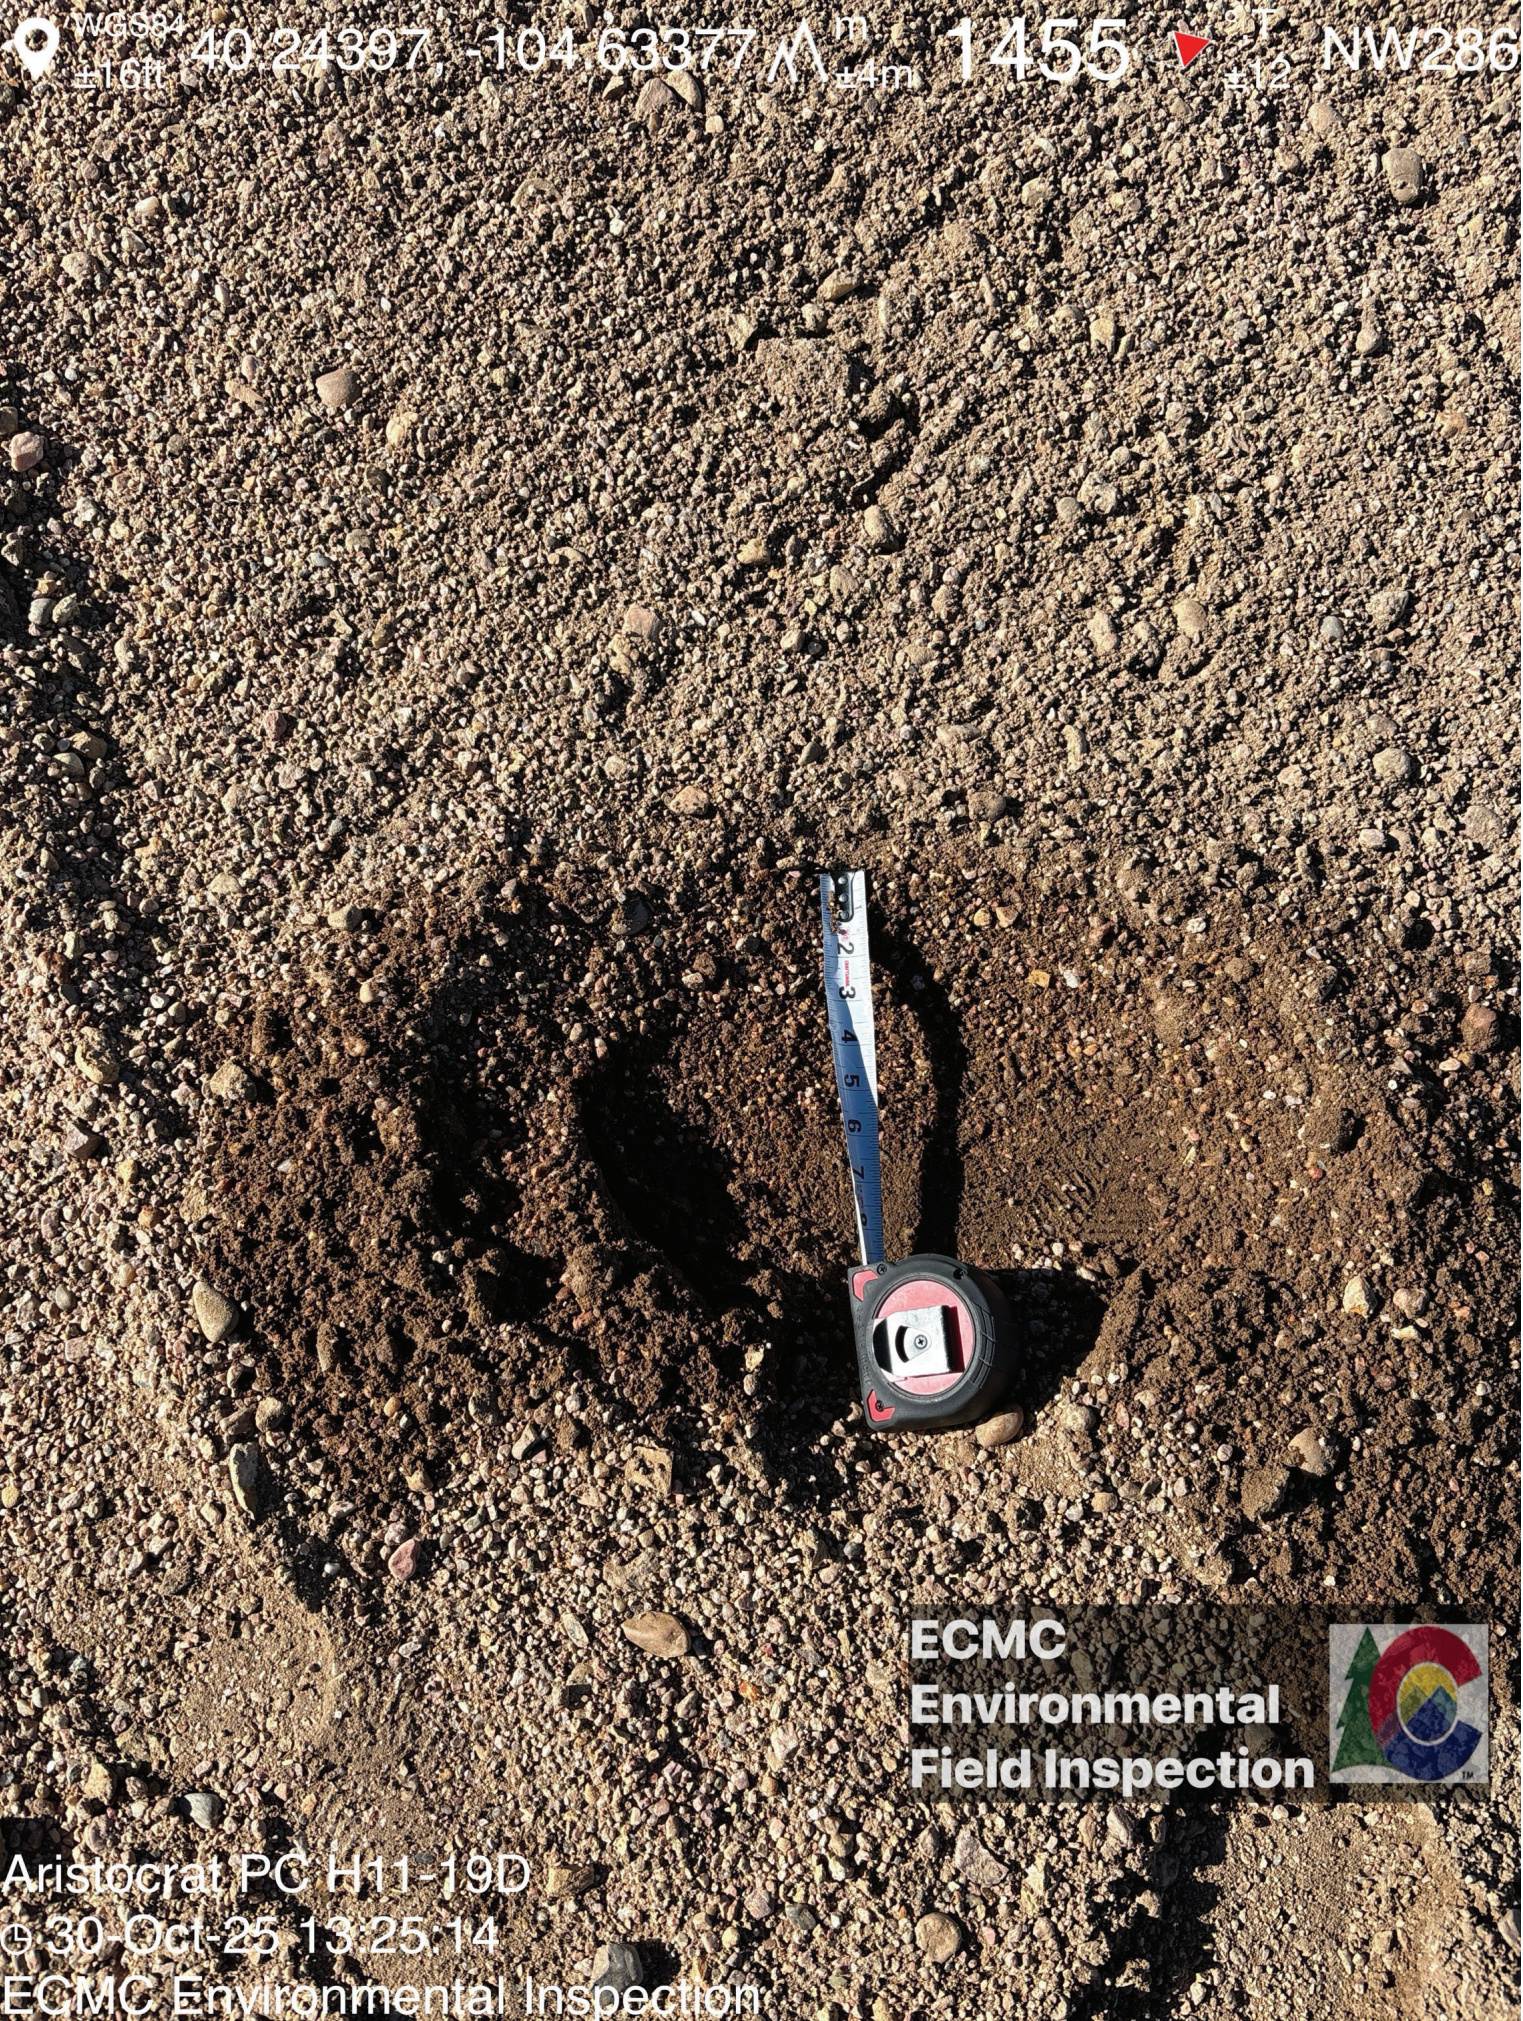
Aristocrat PC H11-19D  
© 30-Oct-25 13:25:14  
ECMC Environmental Inspection

Pea gravel and soil used as backfill.
