Final Reclamation and Stormwater Inspection

Operator: IMPETRO RESOURCES LLC - 10690

Location ID: 316923

Well Name: STATE #1

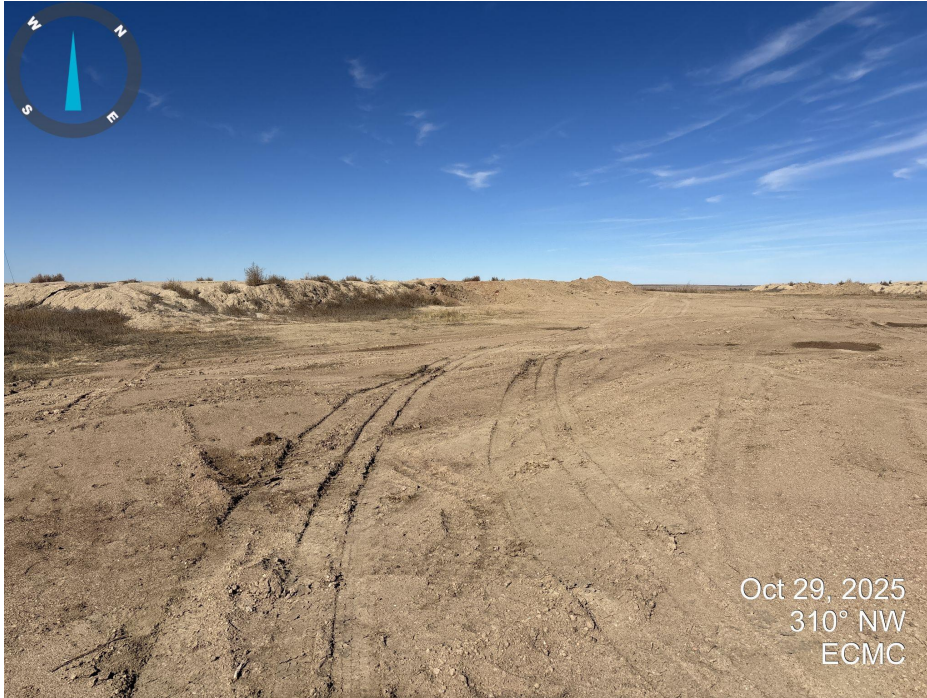
Photo 1. Looking northwest across the former tank battery and equipment area. Equipment and tanks have been removed.

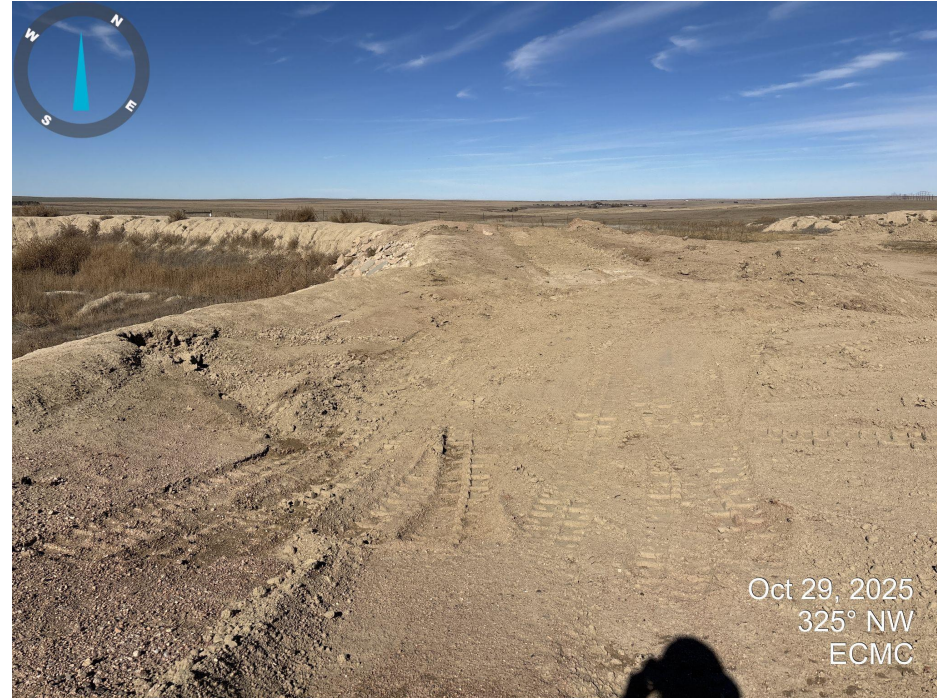
Photo 2. Looking northwest across the former storage tank area. Tanks have been removed. Wooden or cement foundation remains where the former blue open top tank was located.

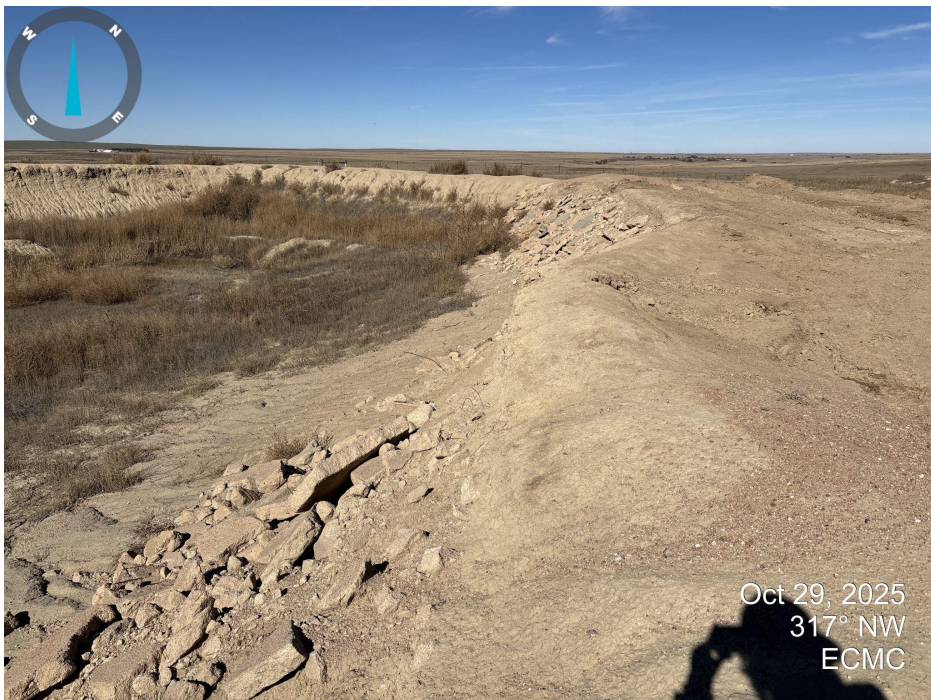
Photo 3. Looking northwest across the storage tank area along the east side of the pit. Concrete rubble is present.

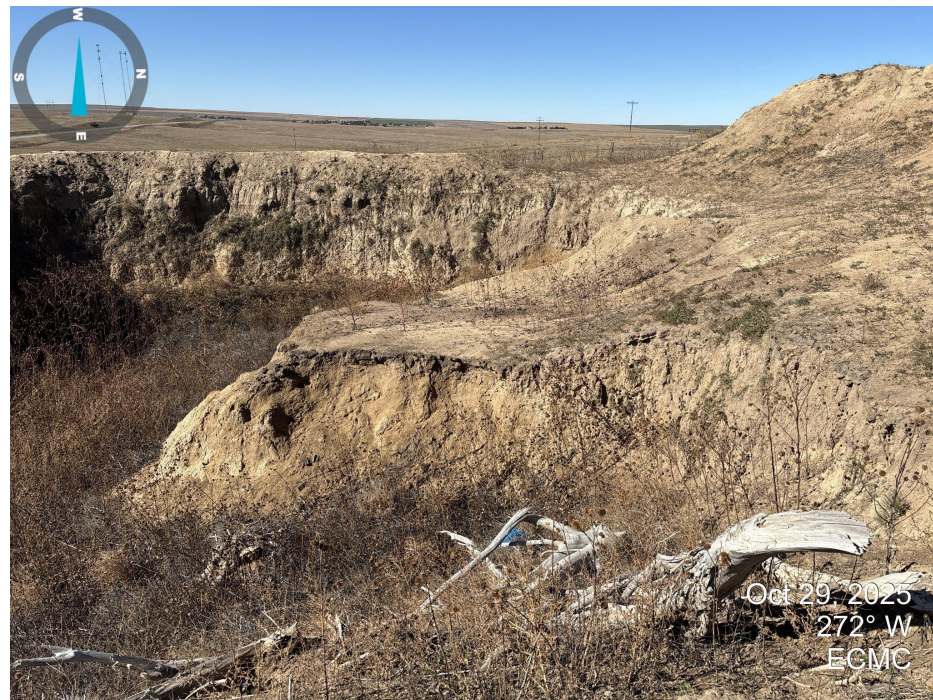
Photo 4. Looking west across the southernmost pit (ID 440212).

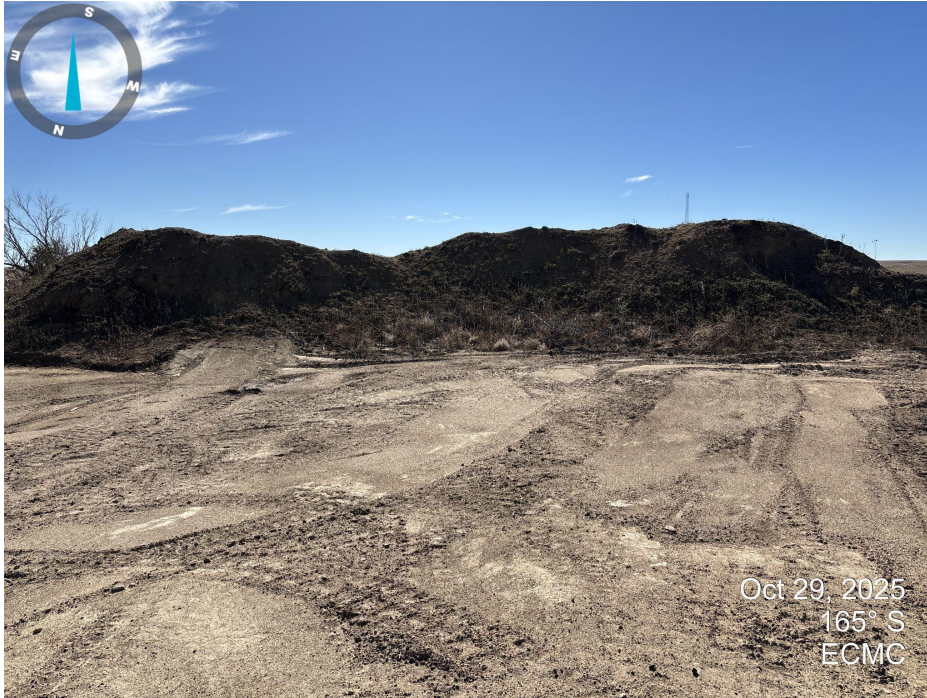
Photo 5. Soil pile near pit ID 440212 does not have stormwater protection BMPs.

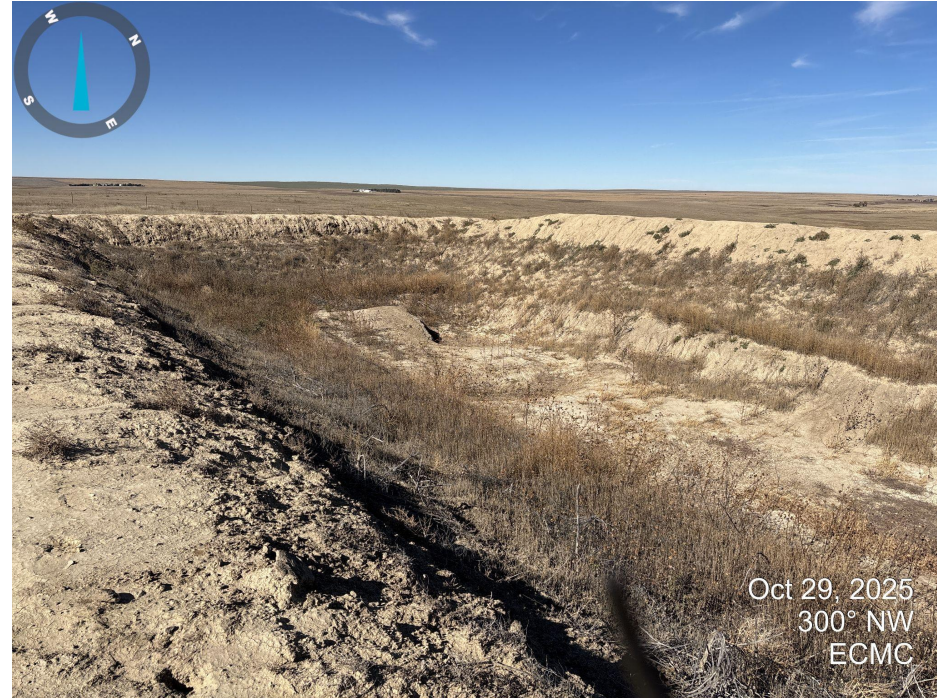
Photo 6. Looking west across pit #107648. It appears that equipment was removed from the south wall of this pit.

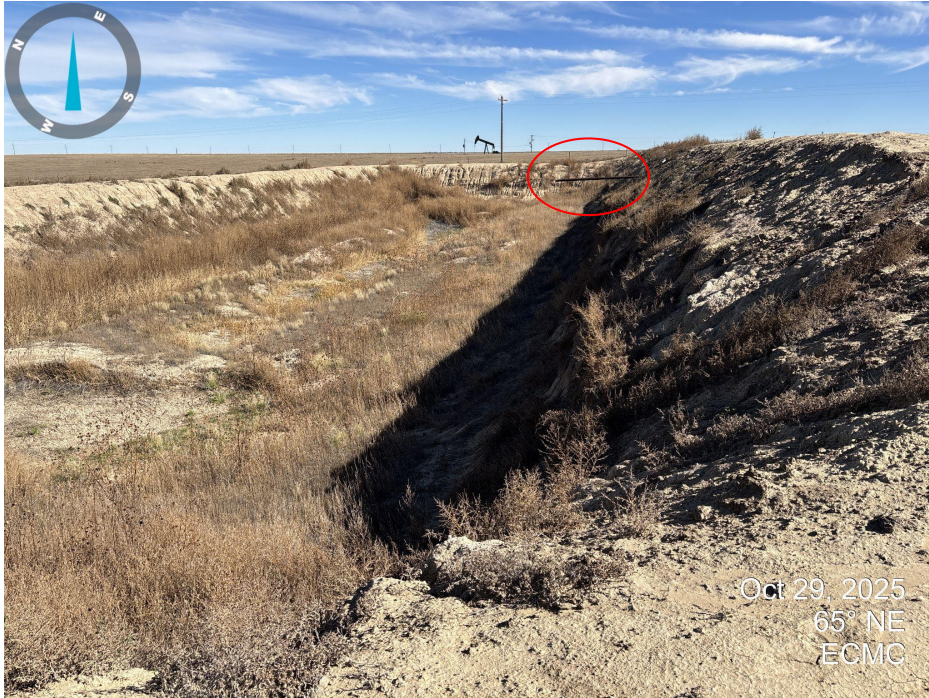
Photo 7. Looking east across pit #117577. Overflow pipe remains (red circle).

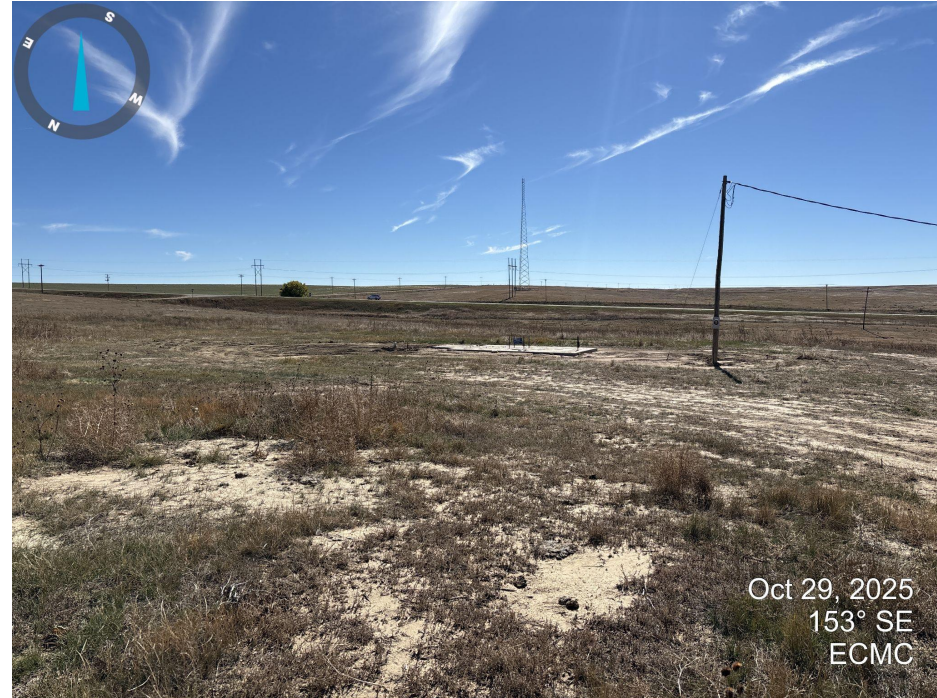
Photo 8. Looking south across the well location. Fence, spool and debris have been removed.

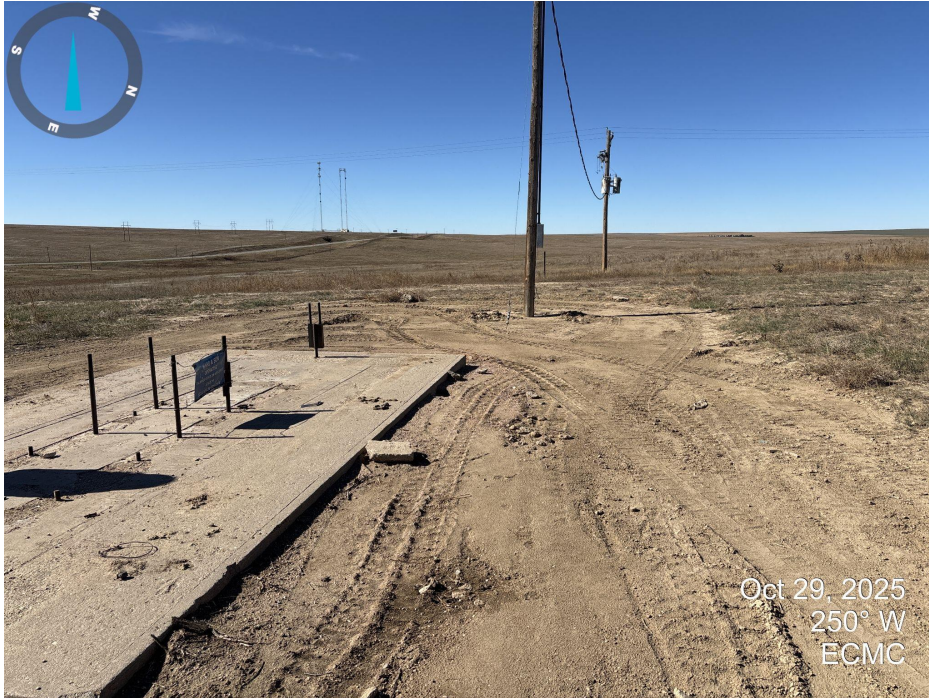
Photo 9. Looking west across the well area. Cement pad and electric poles remain.

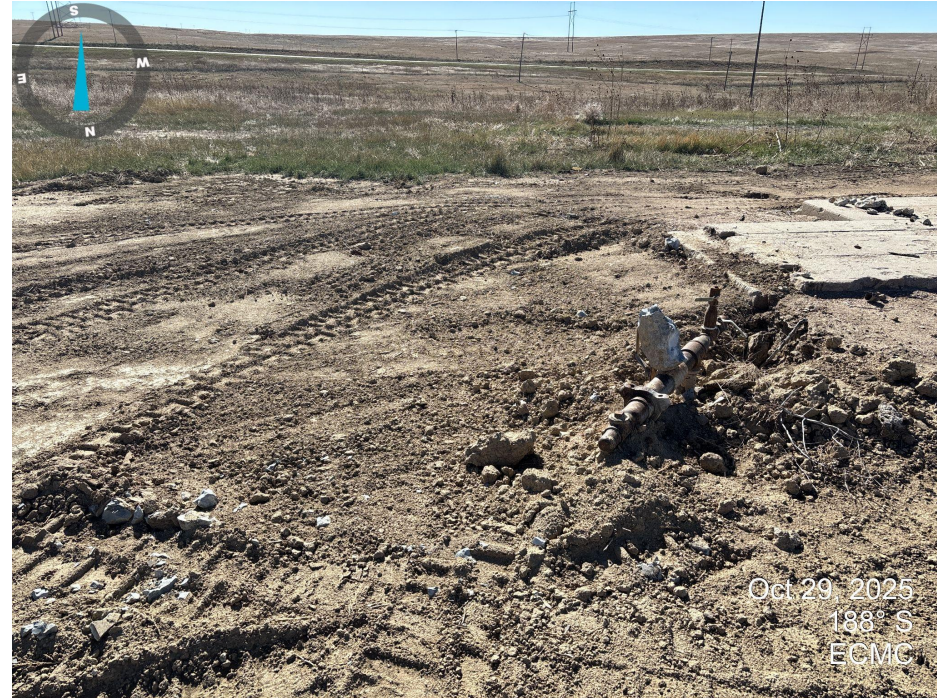
Photo 10. Excavation around the wellhead is filled in. A pipe riser remains.
