Inspection Photos

API: 011-05055

Loc: 321208

Operator: RENEGADE OIL & GAS COMPANY LLC

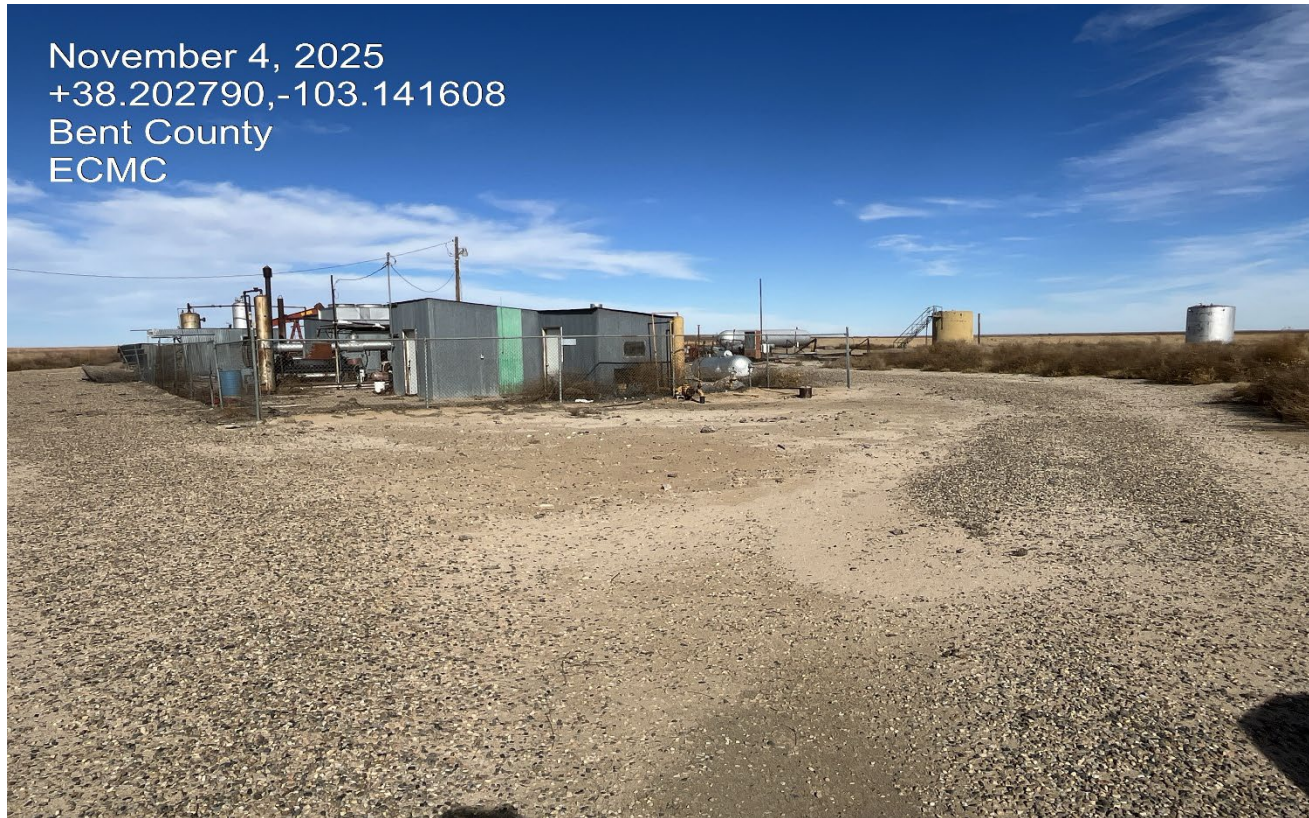
Photo 1. Facing northeast toward the GAS PROCESSING PLANT and Wellsite.

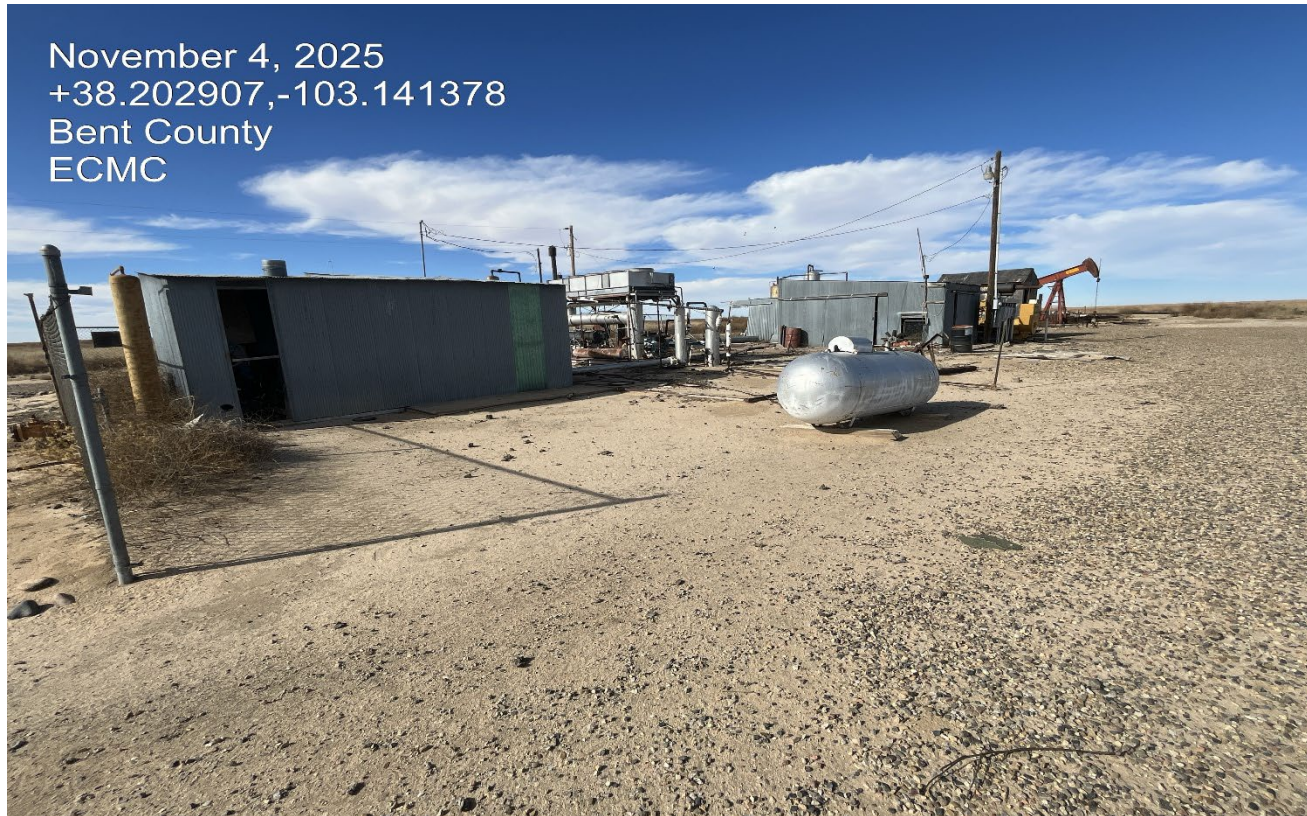
Photo 2. Facing northwest toward the GAS PROCESSING PLANT and Wellsite.

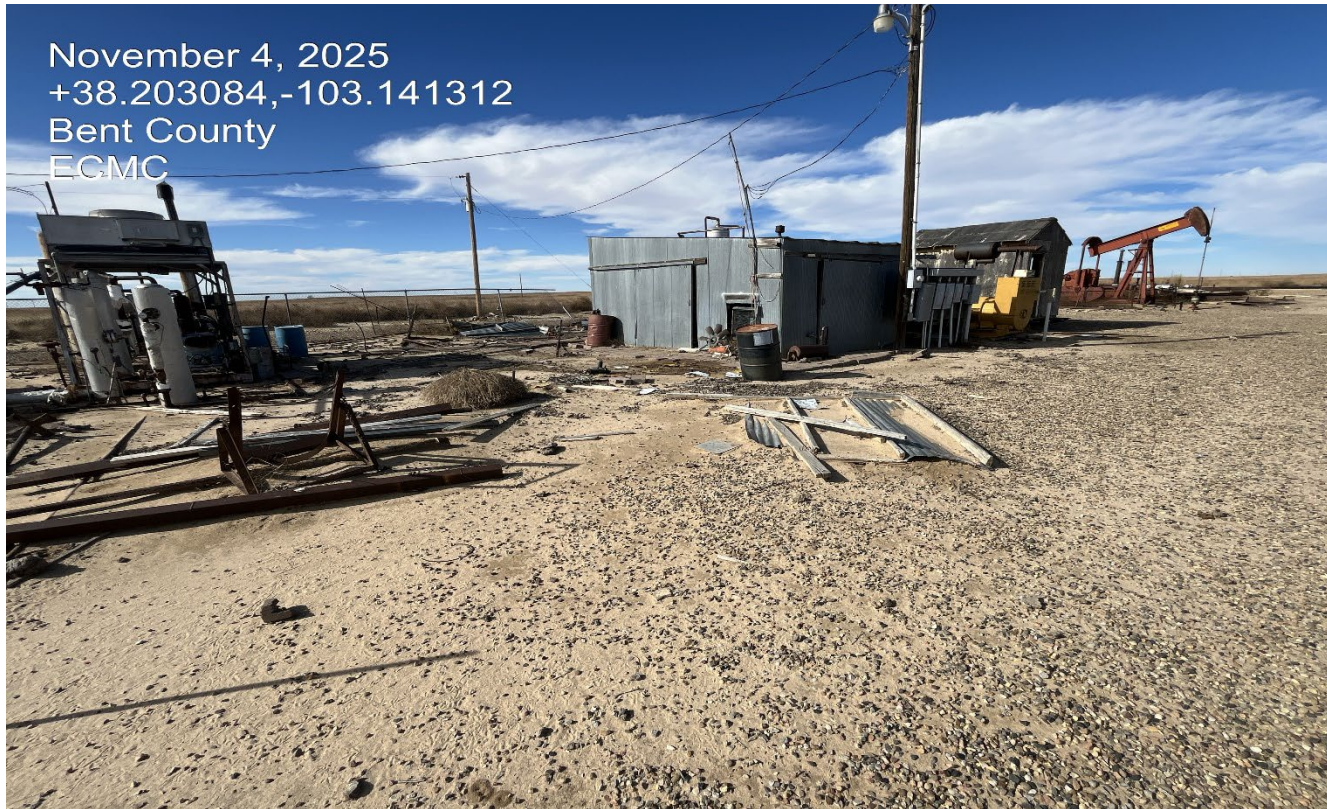
Photo 3. Facing northwest toward the GAS PROCESSING PLANT and Wellsite. There is various supplies and debris scattered throughout the location.

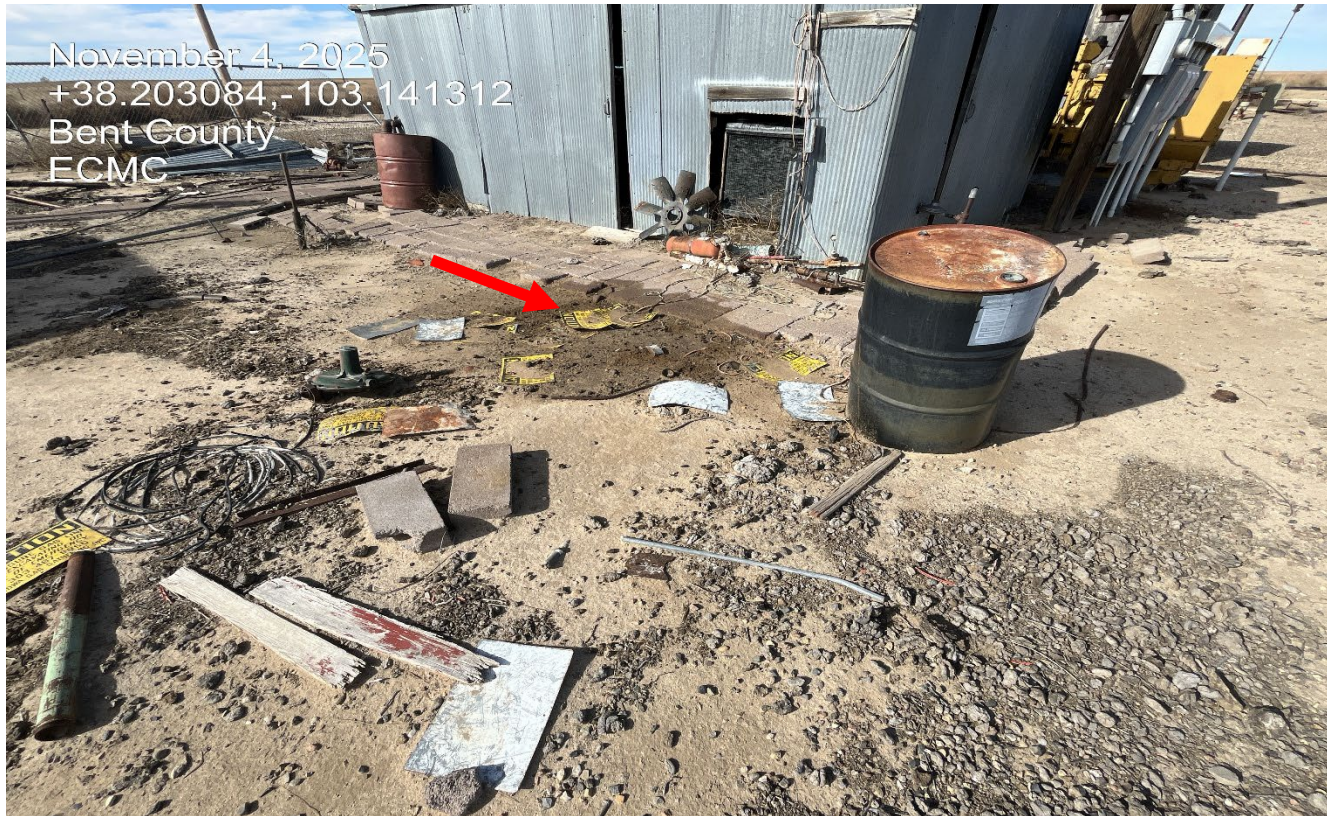
Photo 4. Facing northwest at the sheds and various equipment which are in disrepair. There is still oil stained soils from the barrel that leaked out shown at red arrow.

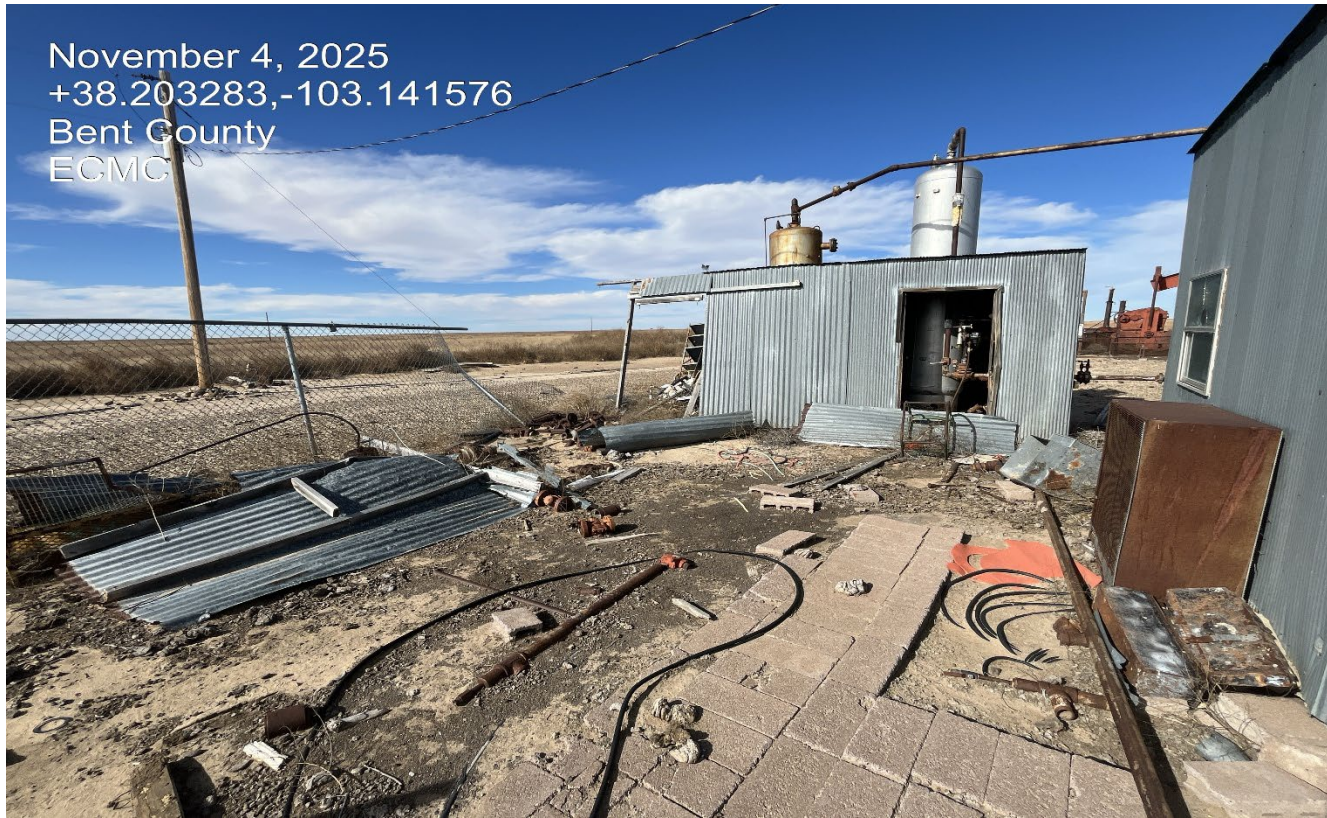
Photo 5. Facing northwest at the sheds and equipment which are in disrepair.

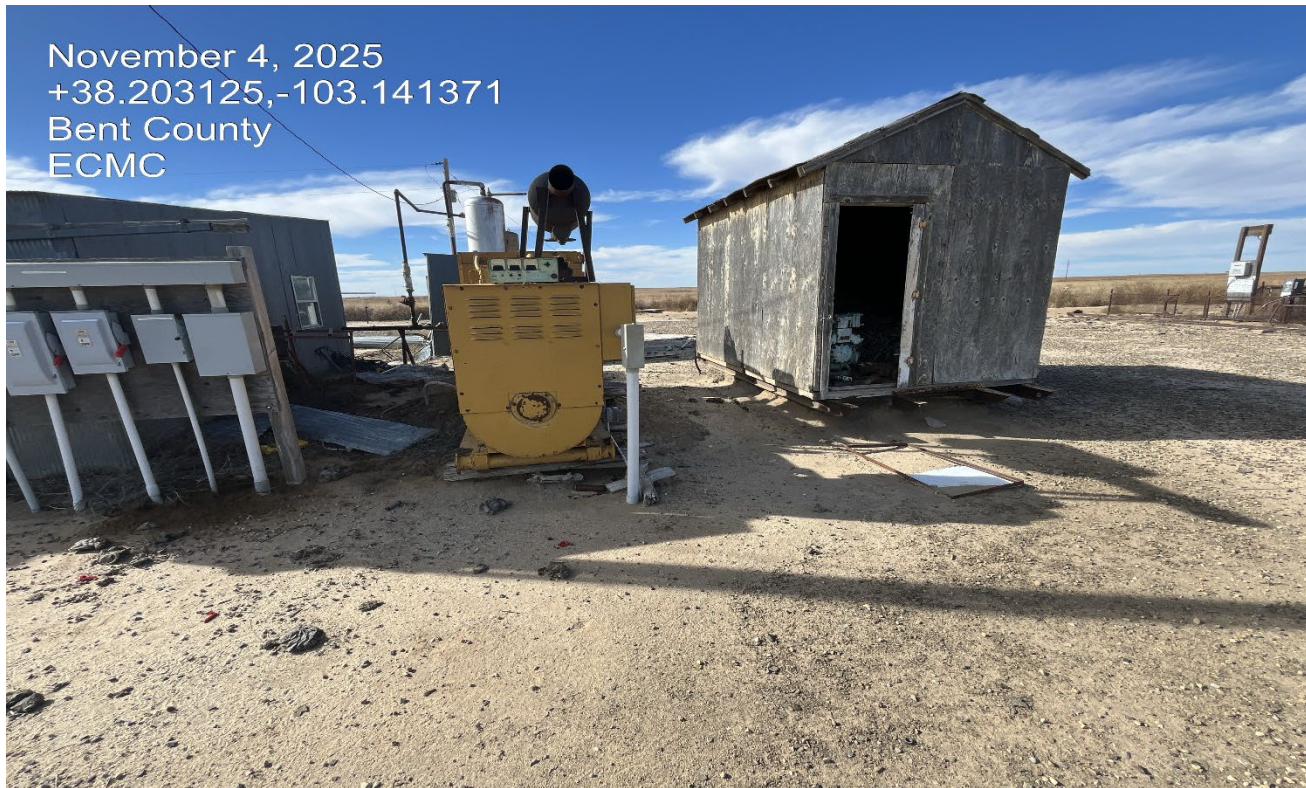
Photo 6. Facing west at center of location. There is a birds nest inside the sheds which are in disrepair.

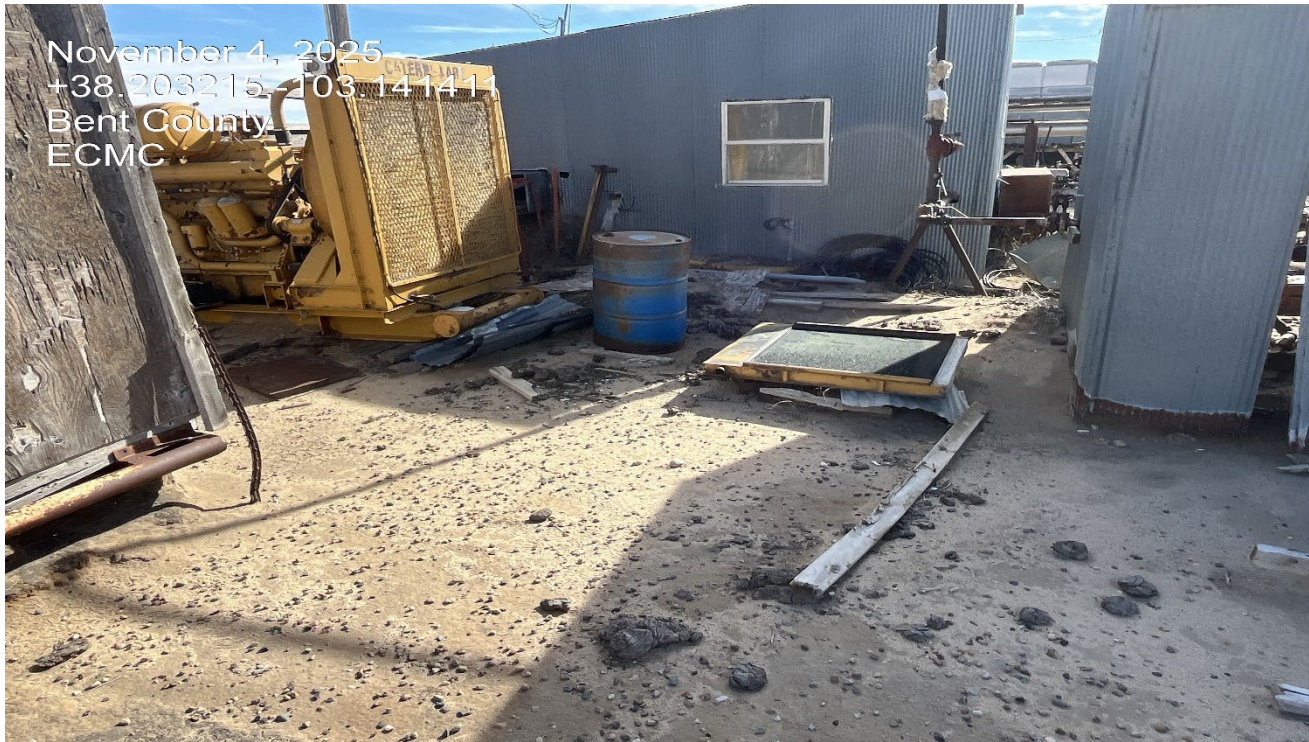
Photo 7. There is panels, boards, and a blue barrel laying on the ground which has leaked out fluids onto the ground.

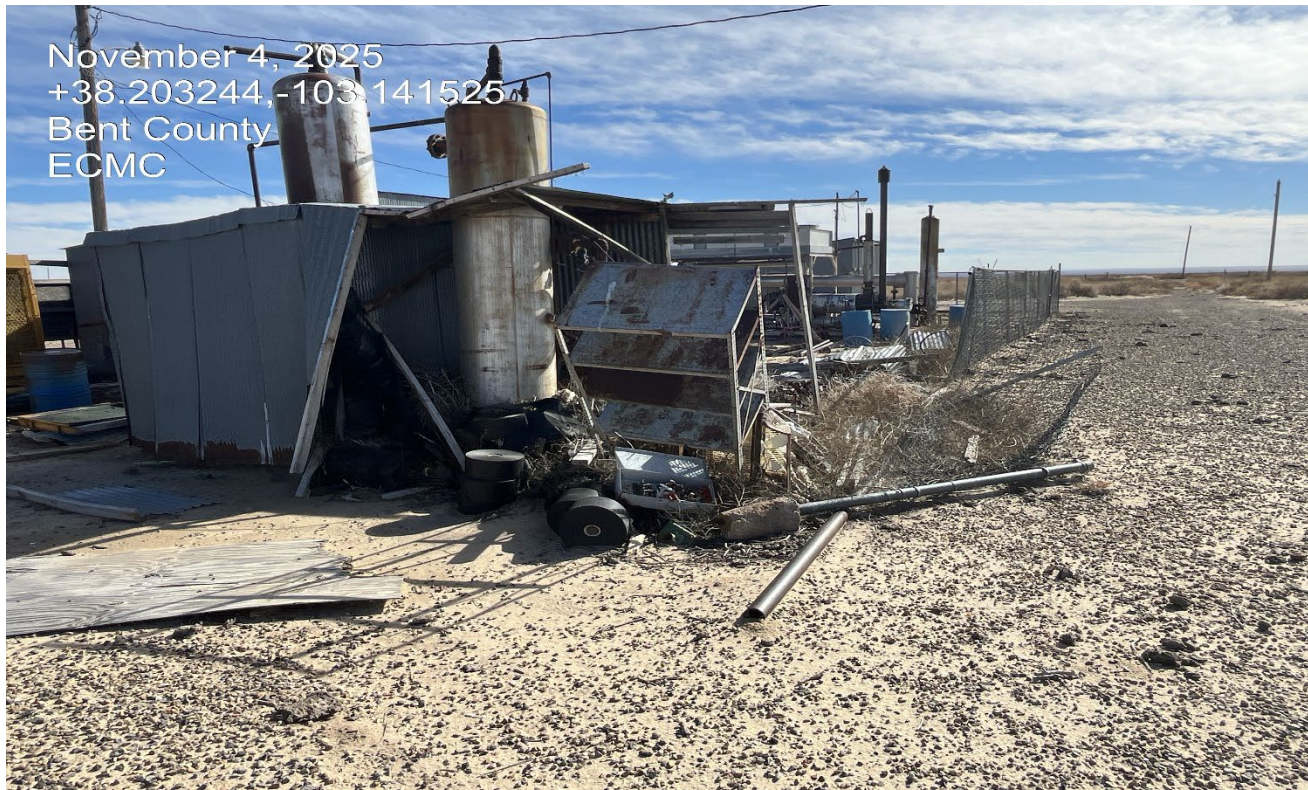
Photo 8. Facing southeast at the west side of the location. This shed and fence are in disrepair with supplies have fallen out of the dilapidated shed.

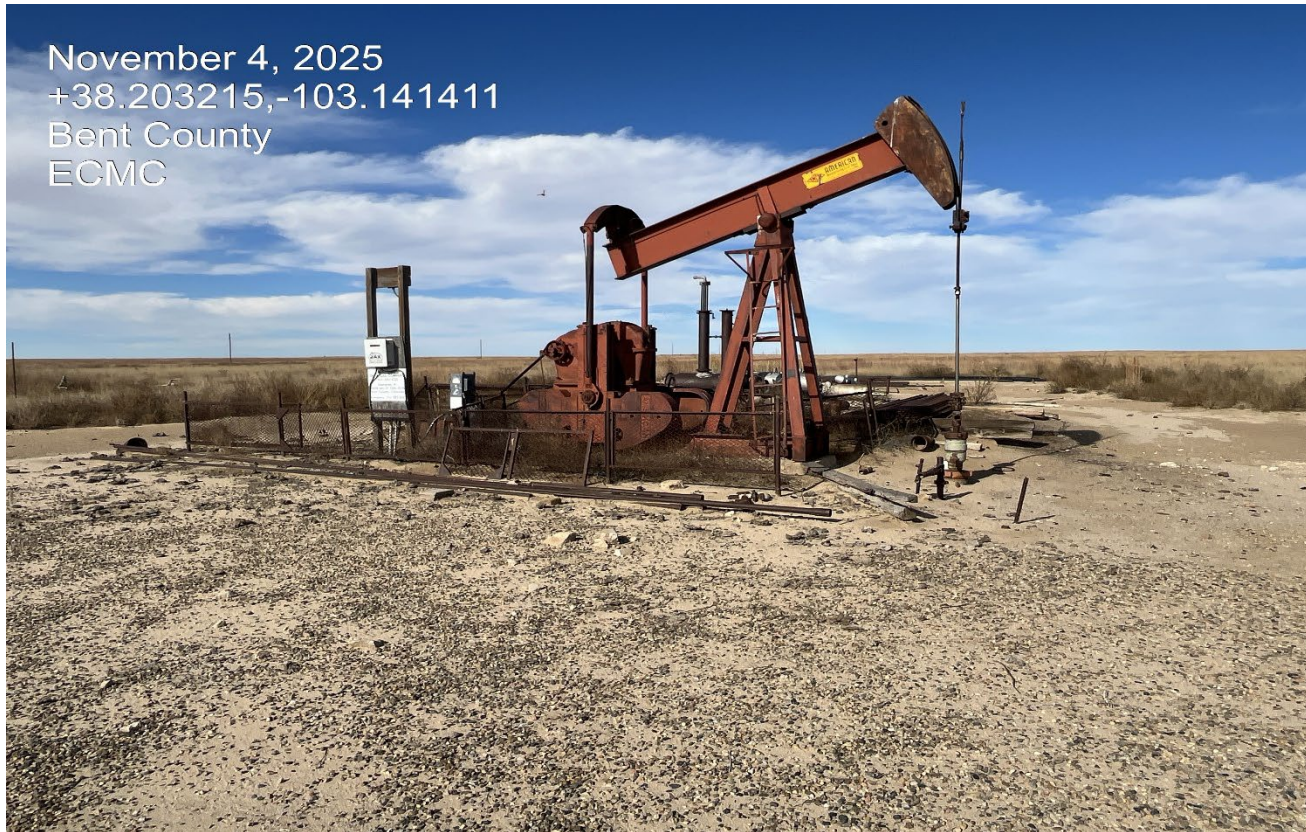
Photo 9. Facing northeast toward the well. The fence around the pumpjack is in disrepair and there is unused equipment stored near the well.

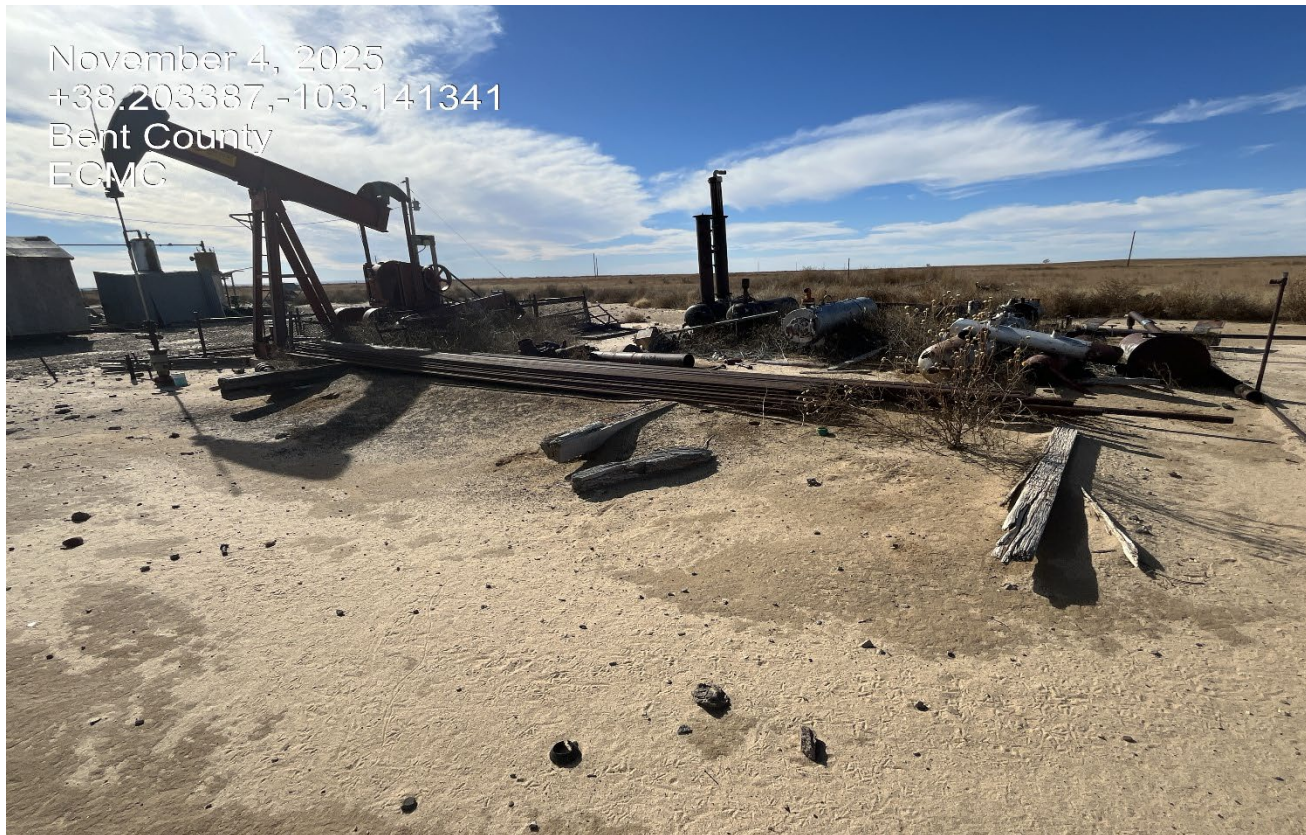
Photo 10. Facing southwest at the wellsite. There are various unused equipment, pipe, and debris stored on location that needs to be removed.

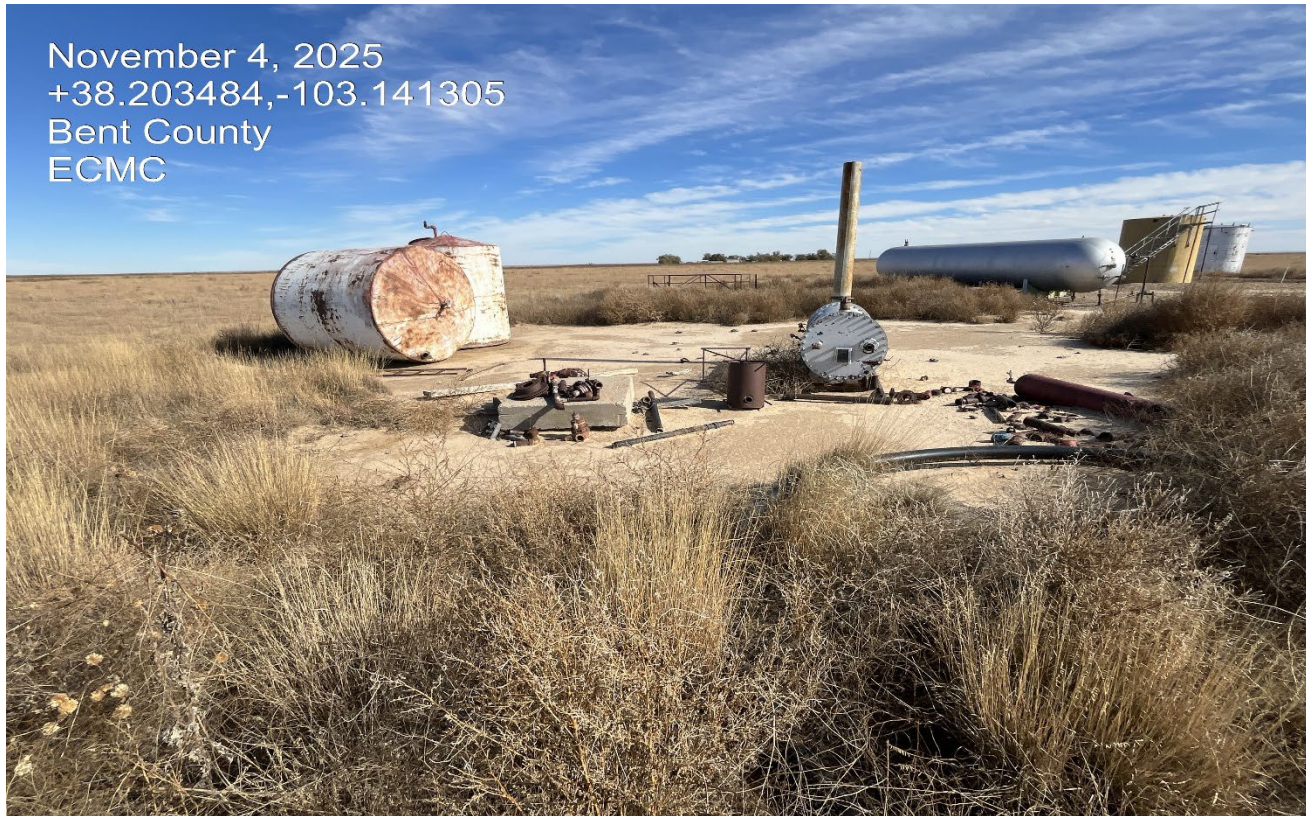
Photo 11. Facing east at the location. There is various unused equipment, supplies and tanks stored at the location that will need to be removed.

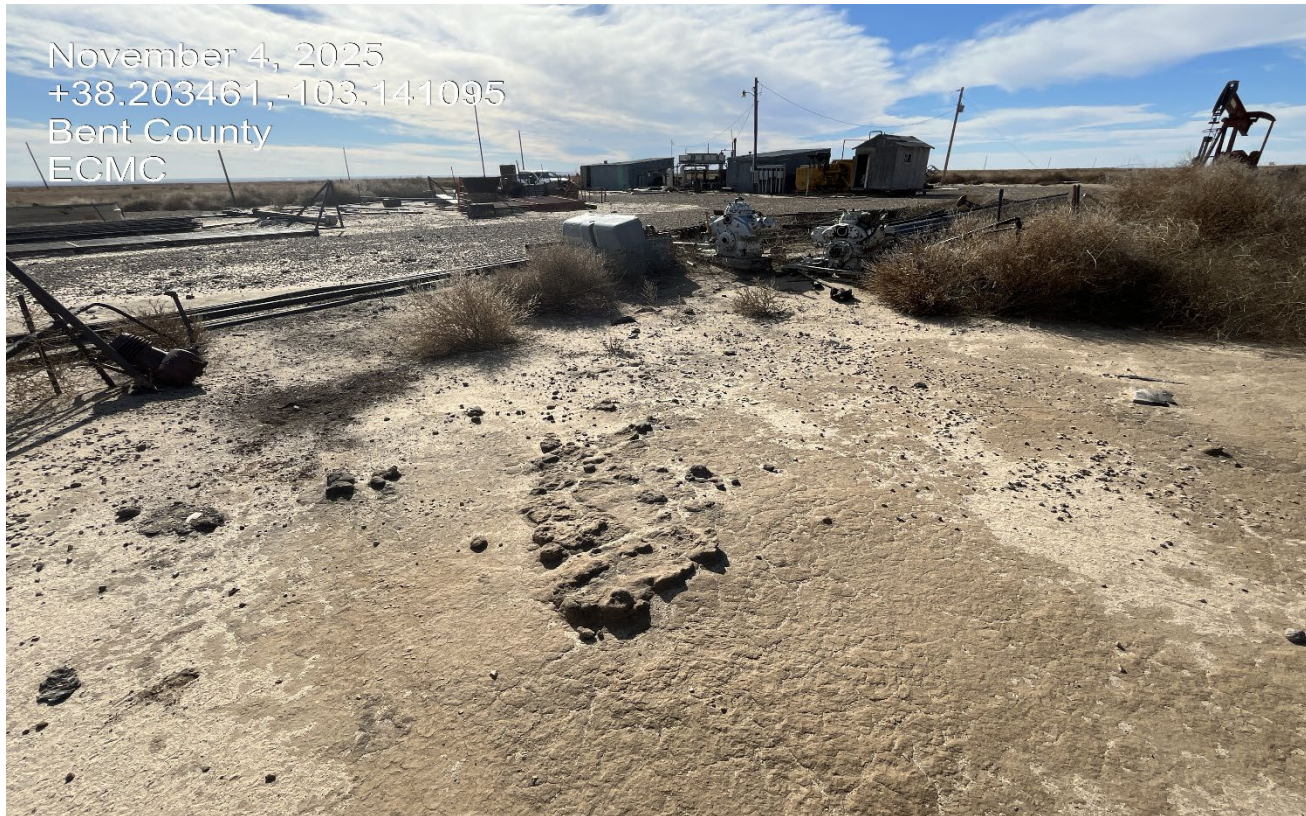
Photo 12. Facing southwest at the location. There is various unused equipment, supplies and tanks stored at the location that will need to be removed. The soils in this area are stained with hydrocarbon impacts from historic spill.

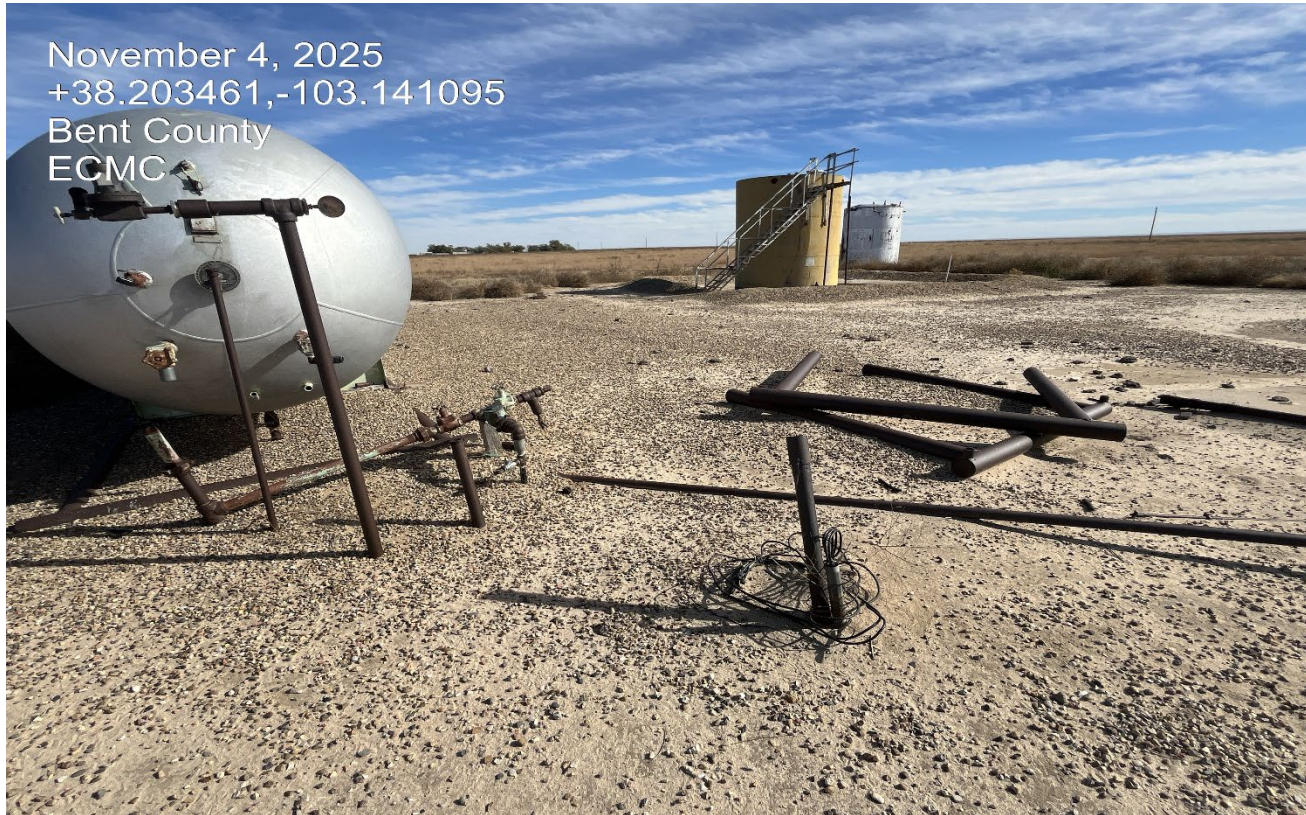
Photo 13. Facing southeast at the location. There is various unused equipment, supplies and tanks stored at the location that will need to be removed.

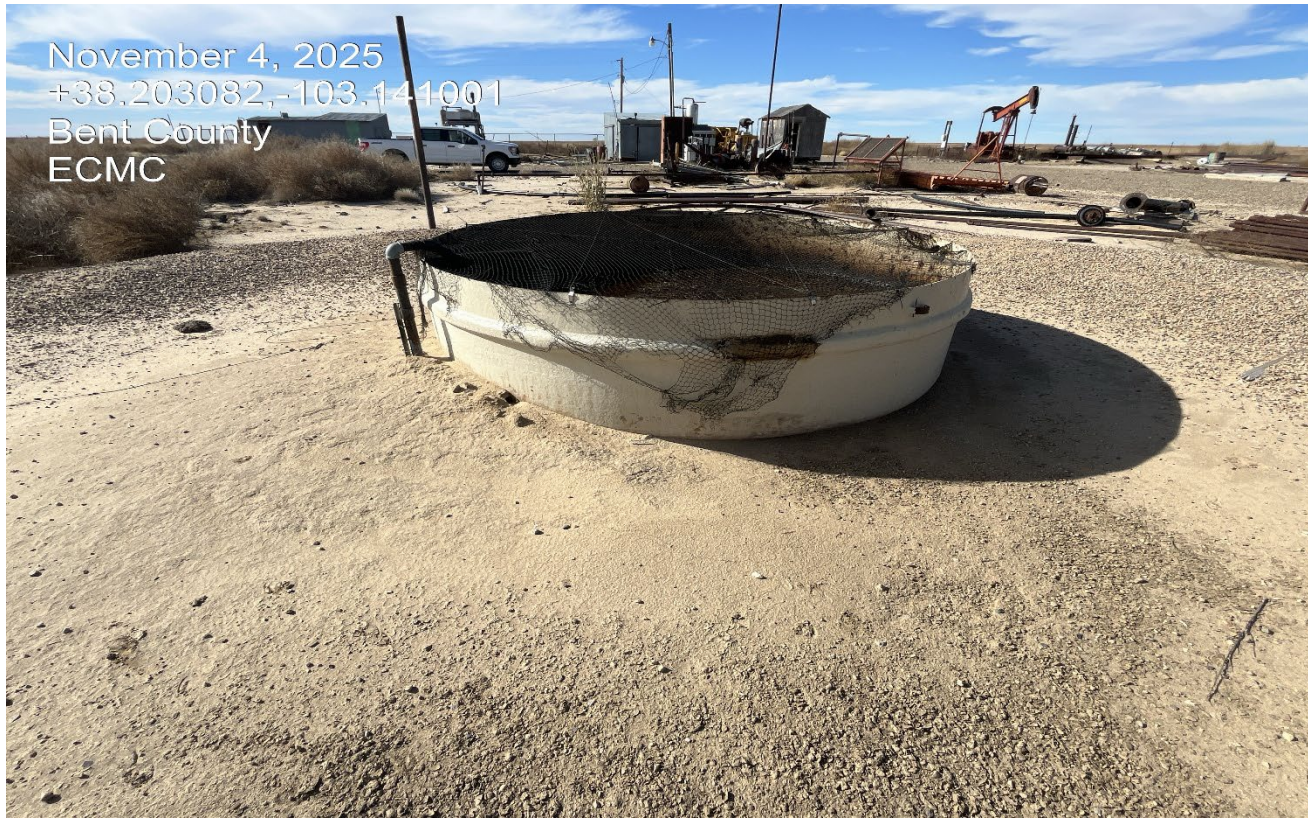
Photo 14. Facing east at the south side of the location. This open top tank remains with oily fluids. Wildlife netting is installed.

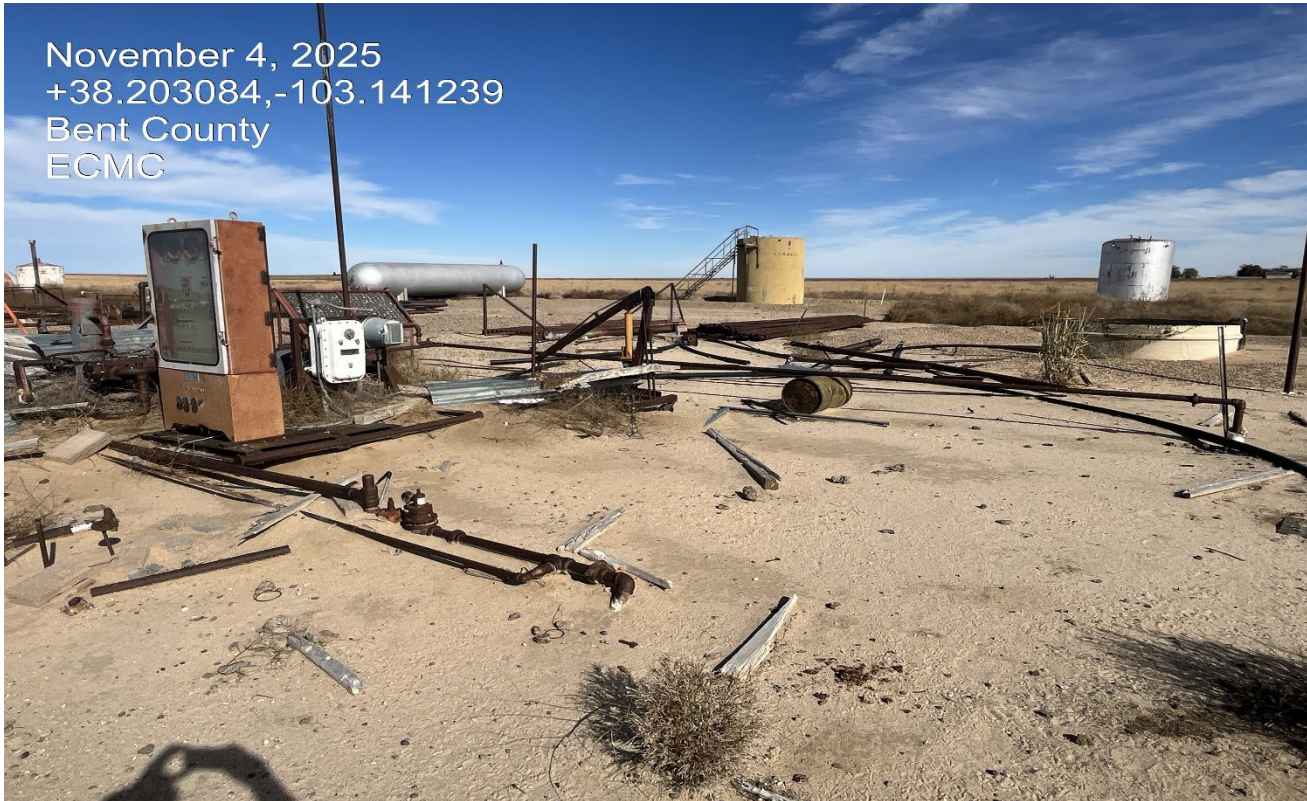
Photo 15. Facing northeast the location with various unused equipment, supplies and debris laying on the ground.

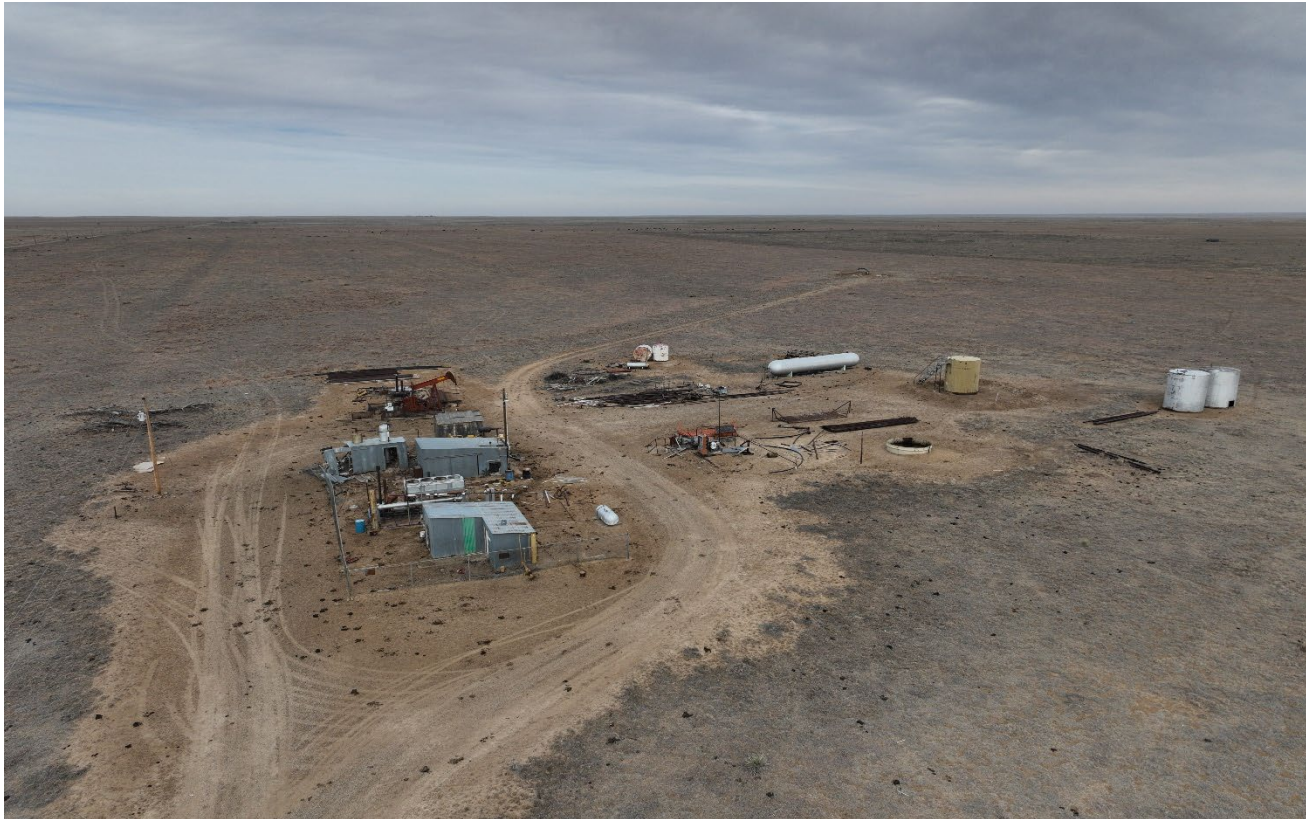
Photo 16. Drone aerial photo taken on 2/4/2025. Facing northeast toward the GAS PROCESSING PLANT and Wellsite.

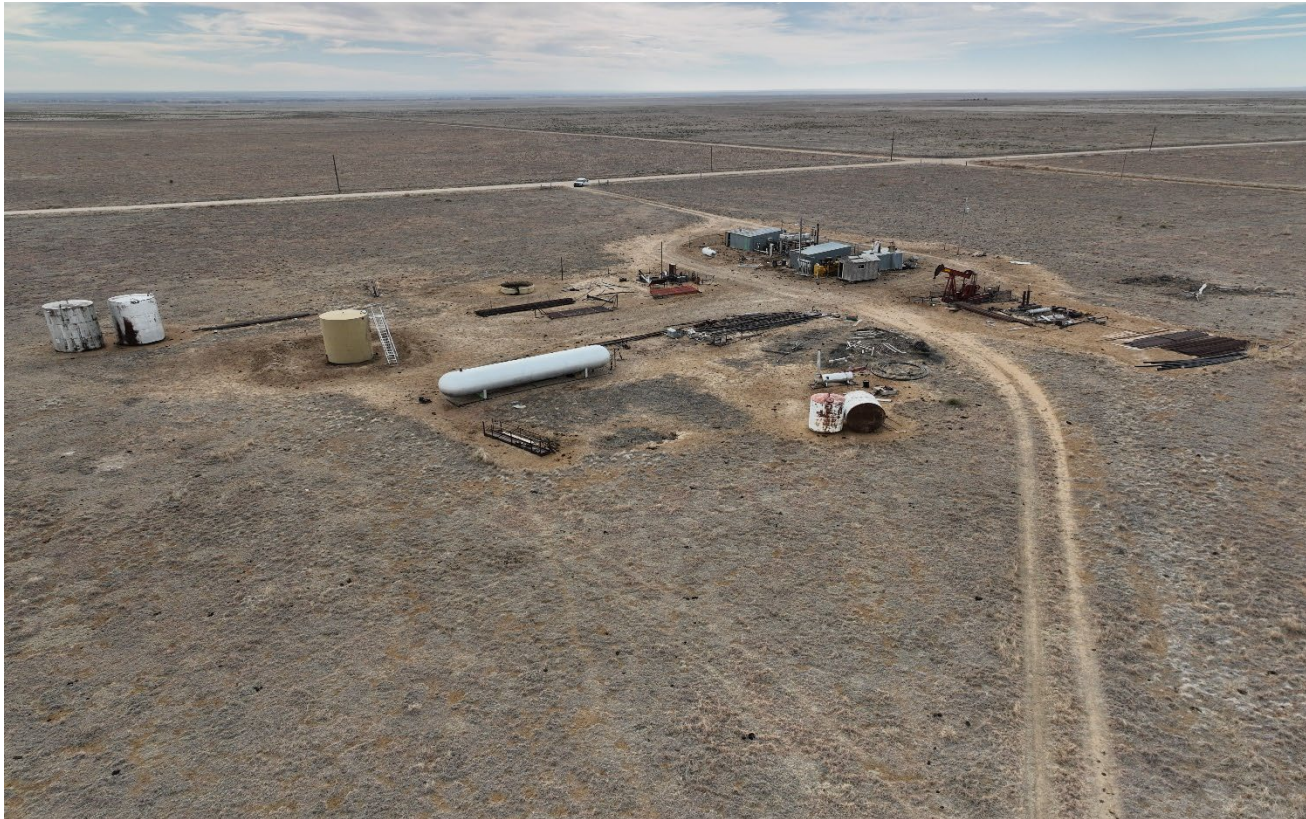
Photo 17. Drone aerial photo taken on 2/4/2025. Facing southwest toward the GAS PROCESSING PLANT and Wellsite.
