Inspection Photos

11/10/2025

Operator: TEP Rocky Mountain LLC #96850

Location ID: 335271

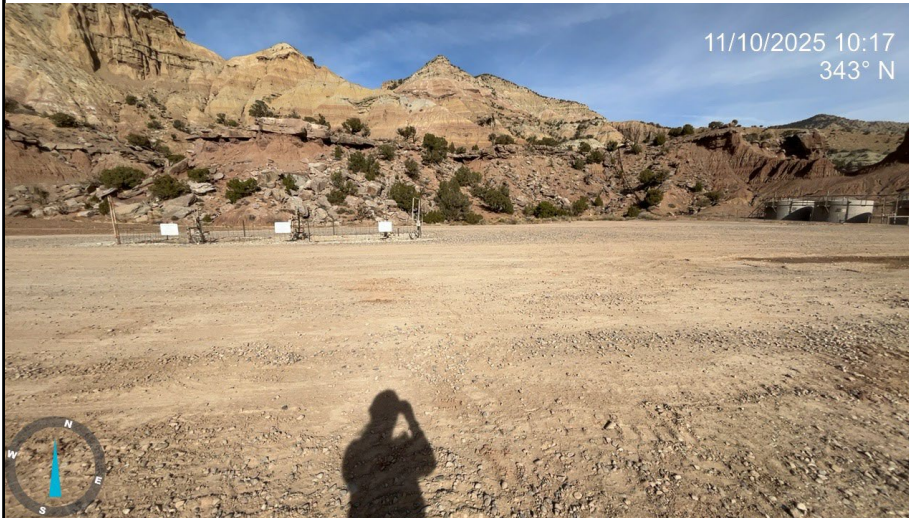
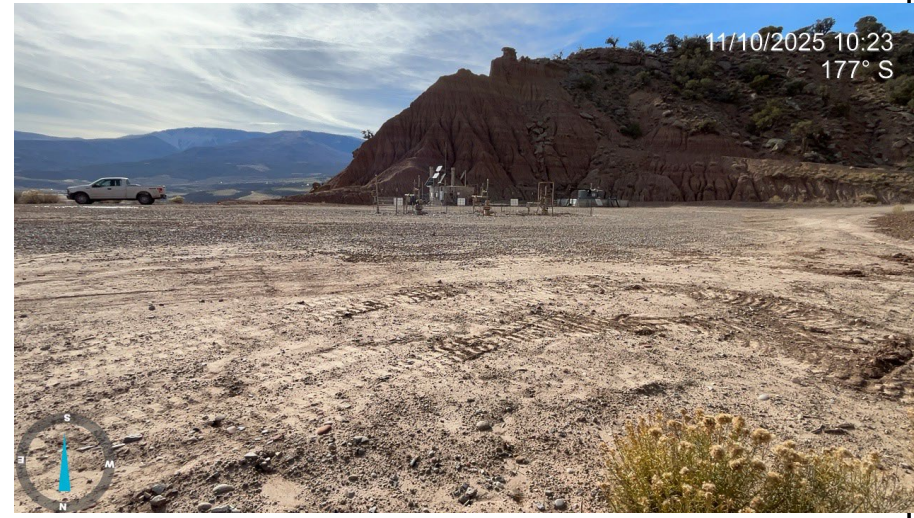
Photo 1: Photos showing an overview of the location looking north and south, respectively.

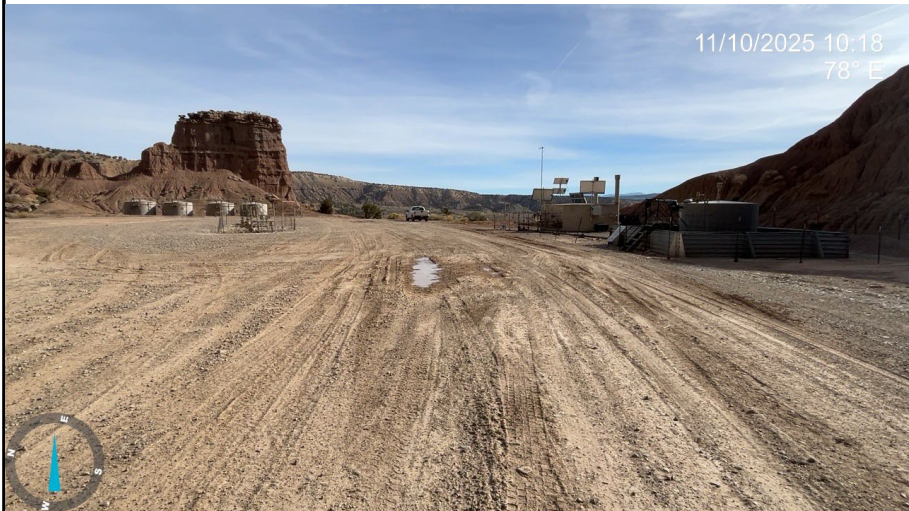
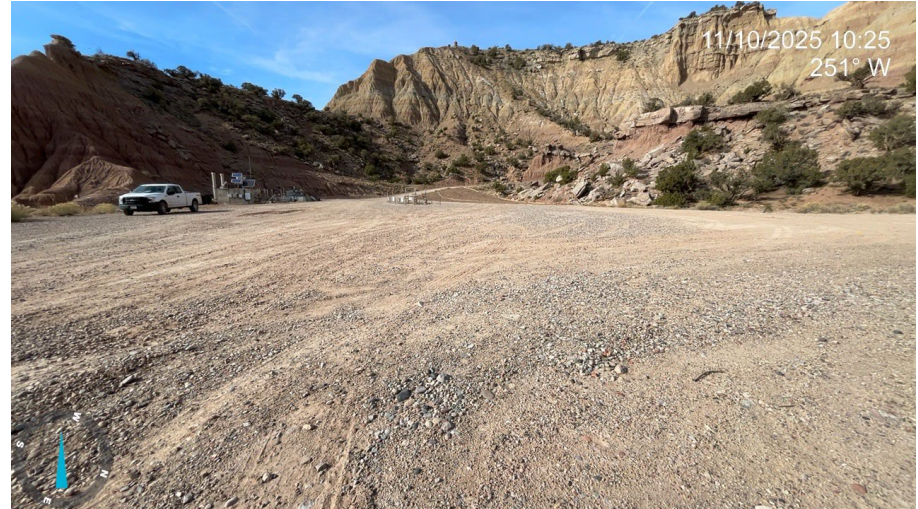
Photo 2: Photos showing an overview of the location looking east and west, respectively.

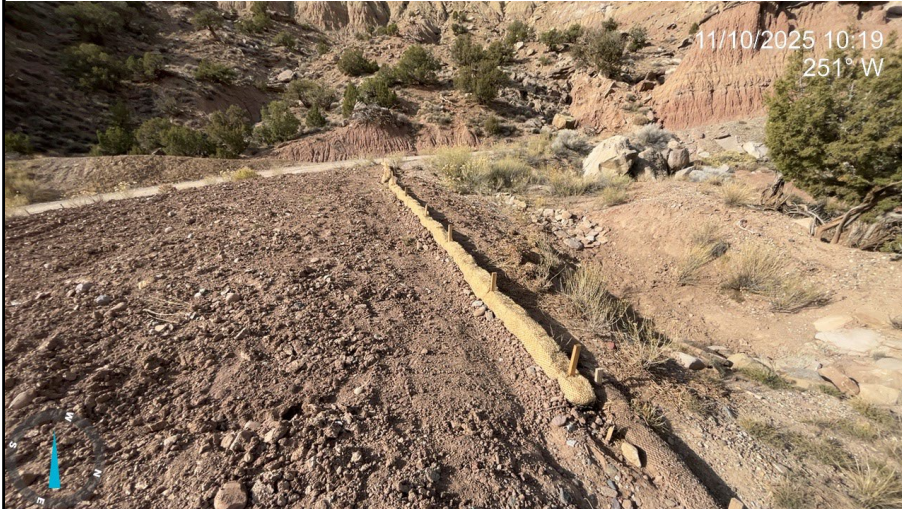
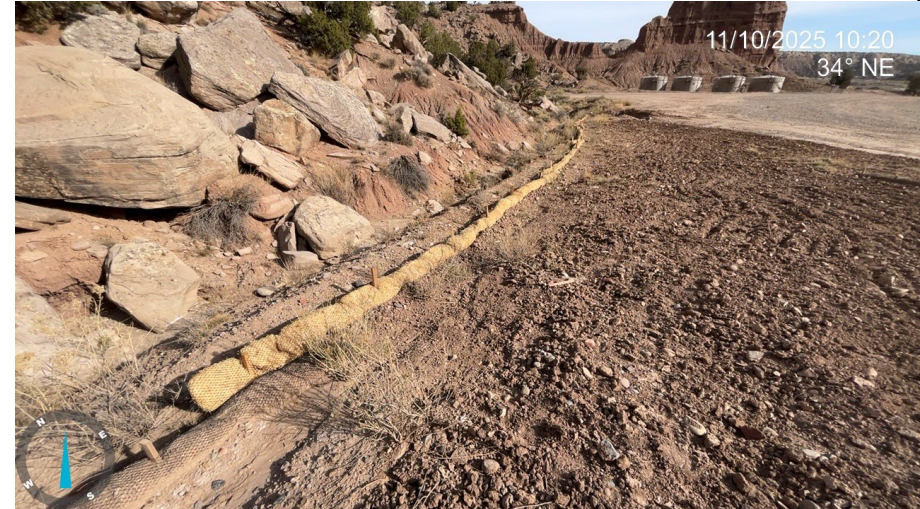
Photo 3: Photos showing stormwater controls on the northeastern portion of the location have been replaced or maintained. The Corrective Action from inspection #719200201 has been resolved.

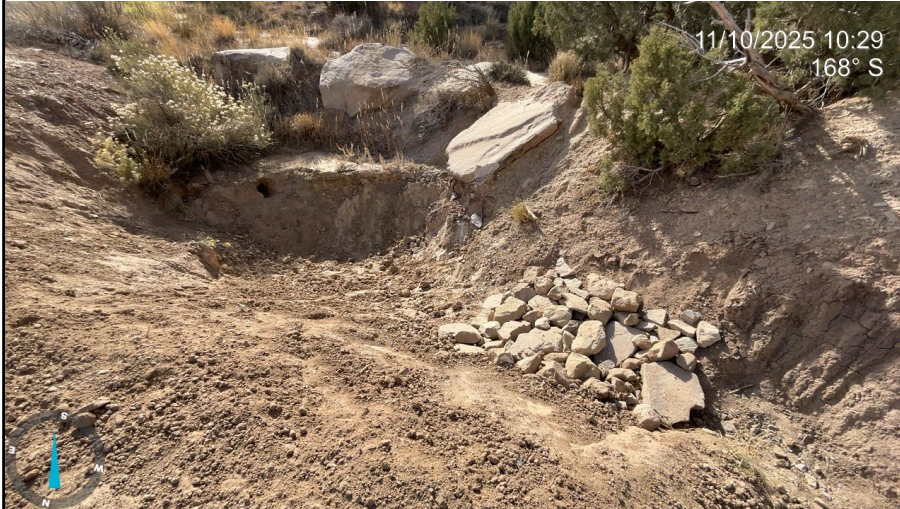
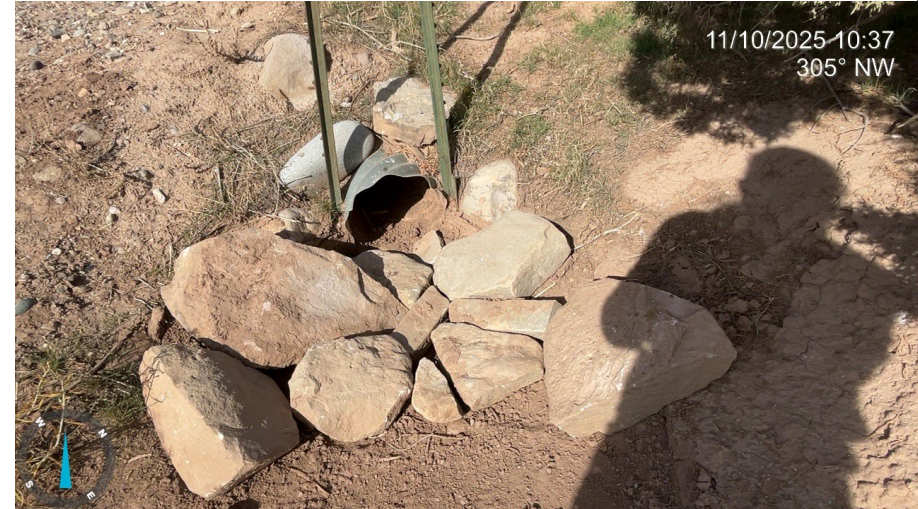
Photo 4: Photos showing stormwater controls (sediment traps and culverts) throughout the location have been maintained. The Corrective Actions from inspection #719200201 has been resolved.

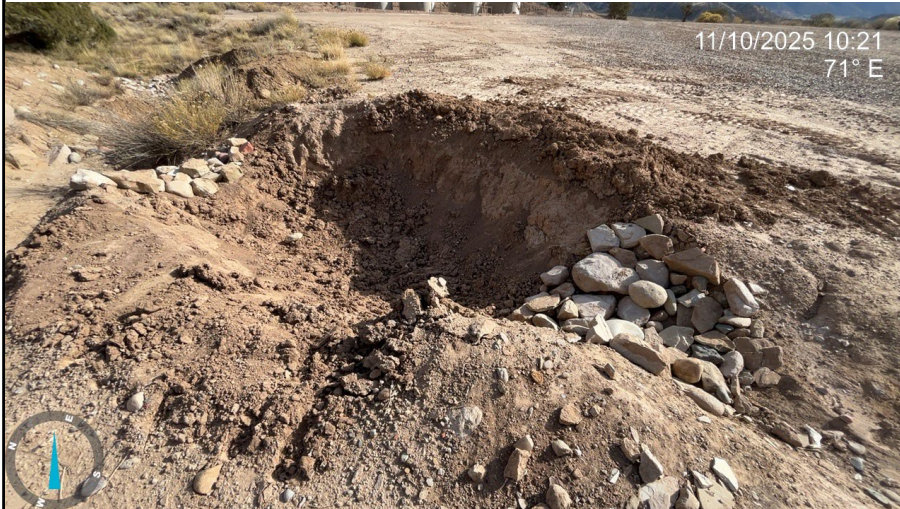
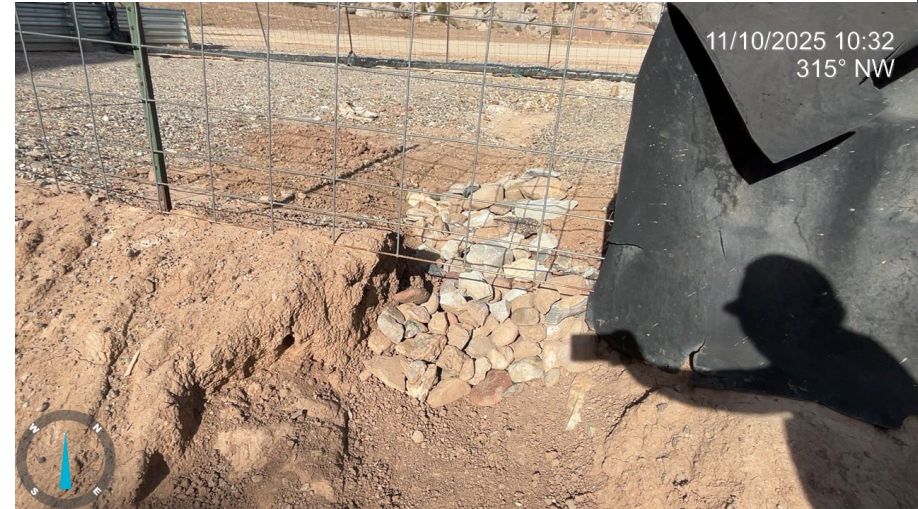
Photo 5: Photos showing stormwater controls (sediment traps and culverts) throughout the location have been maintained. The Corrective Actions from inspection #719200201 has been resolved.

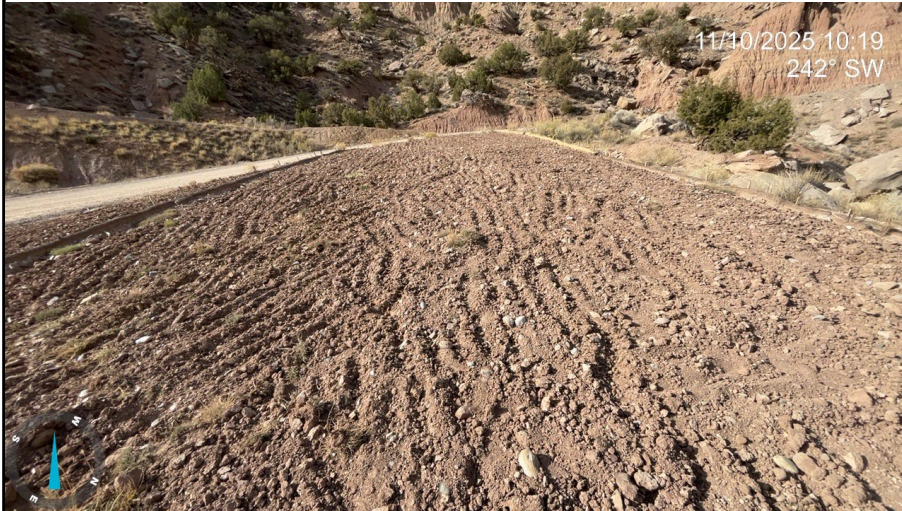
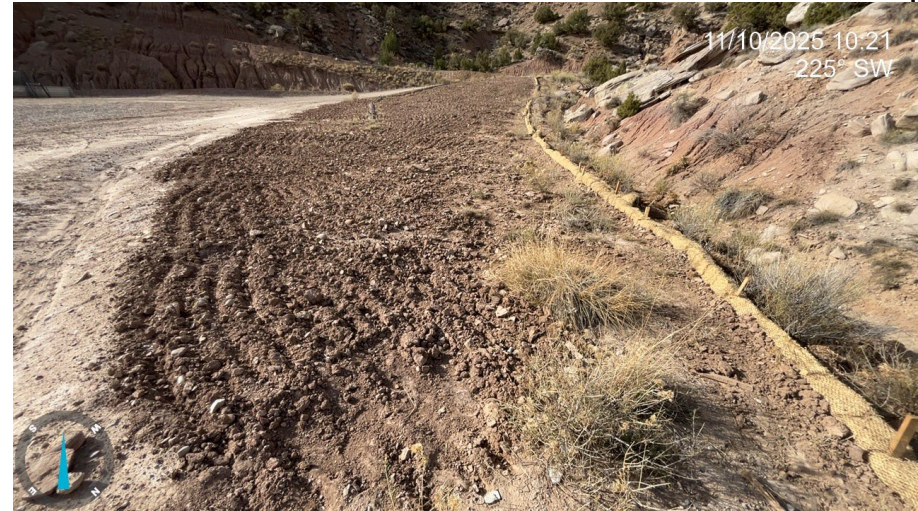
Photo 6: Photos showing the northeastern interim area. The area appears to have been recently decompacted; however, the area does not appear to have been cross-rippled to a depth of 18 inches and reseeding efforts are not apparent. Additionally, a Resolution has not been submitted summarizing work performed. A follow-up inspection will be conducted in future growing seasons to determine progression towards 1003 reclamation requirements.

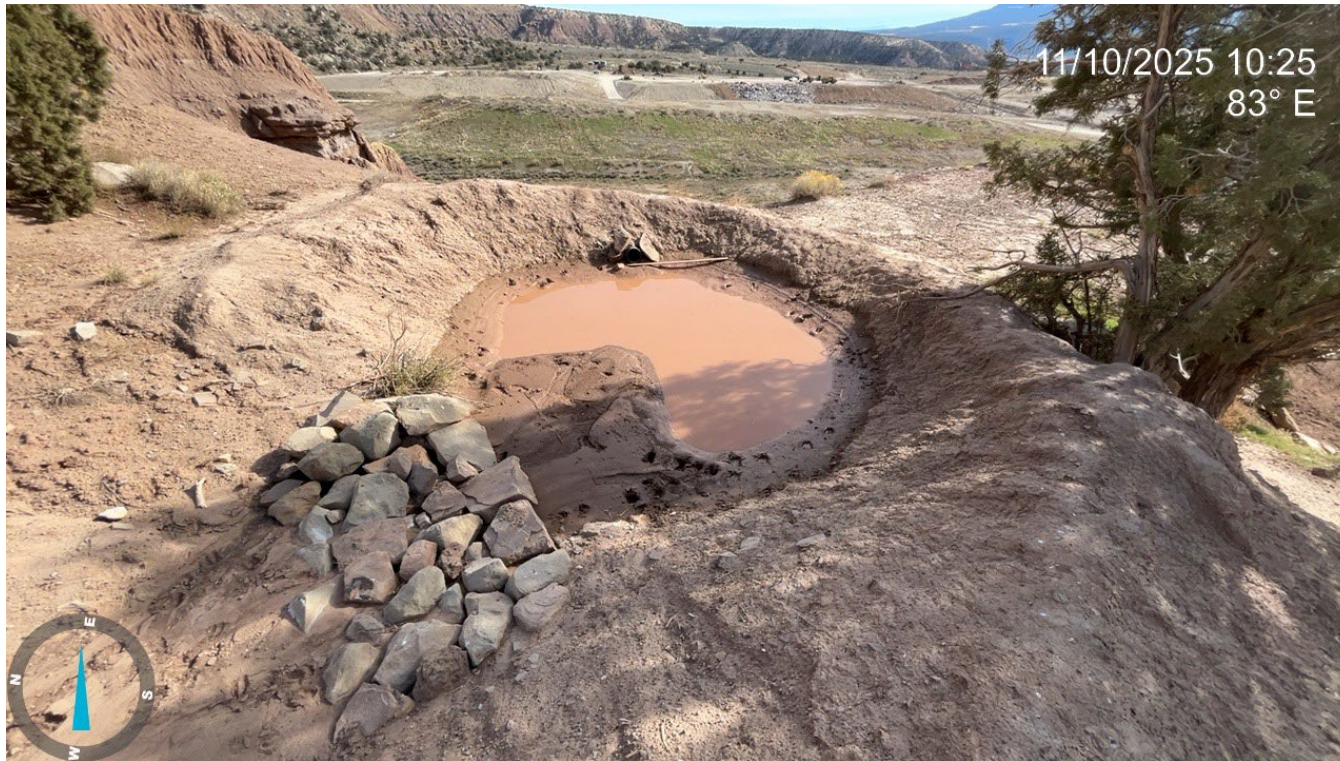
Photo 7: Photo showing a sediment trap on the eastern end of the location is laden with sediment, reducing capacity. Comply with 1002.f. and maintain stormwater BMPs.
