Inspection Photos

Operator: QB ENERGY OPERATING LLC

Location ID: 335577

Inspection Doc: 718100962

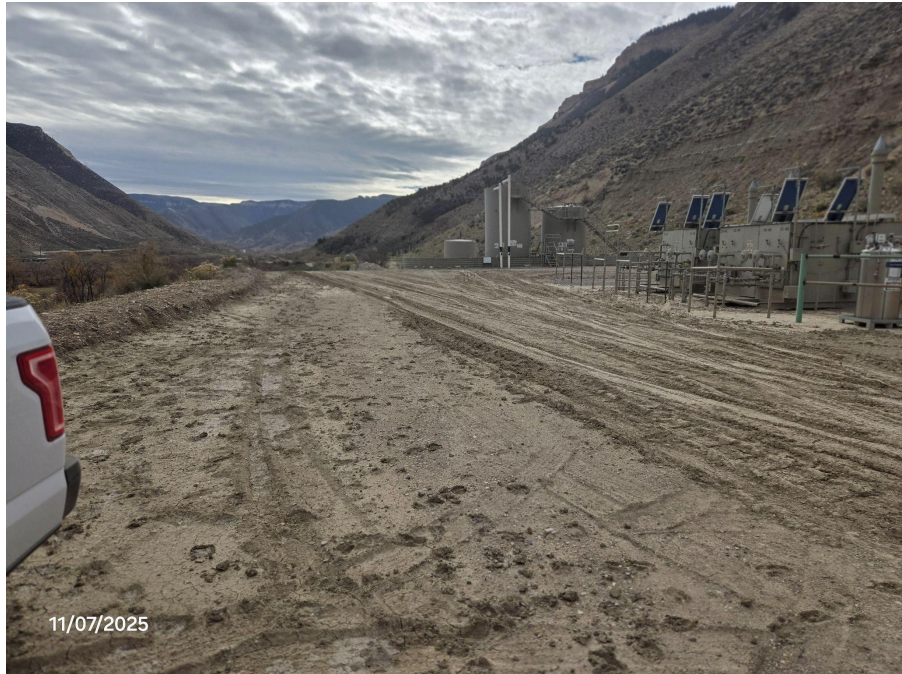
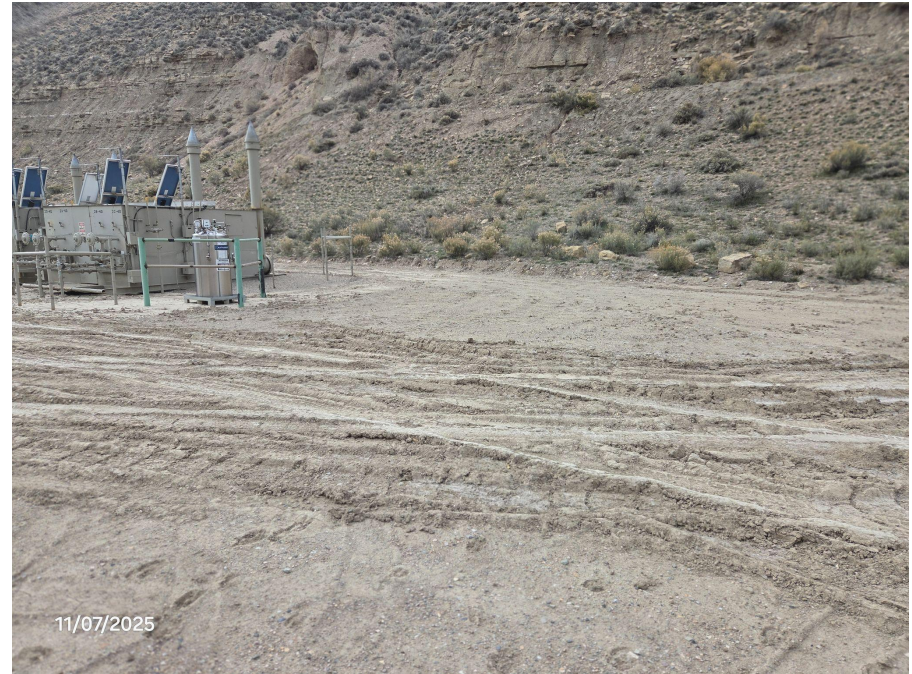
Photo 1: Photos 1-2 taken from the east end of the Location. Photos provide an overview of the Location from south, southwest, northwest to north. Photos also show degradation to the working pad surface, including vehicle tracking. Stormwater appears to be ponding on the Location resulting in degradation and destabilization. BMPs to allow for controlled and proper management of stormwater runoff, as well as stabilization and tracking control measures are missing or insufficient.

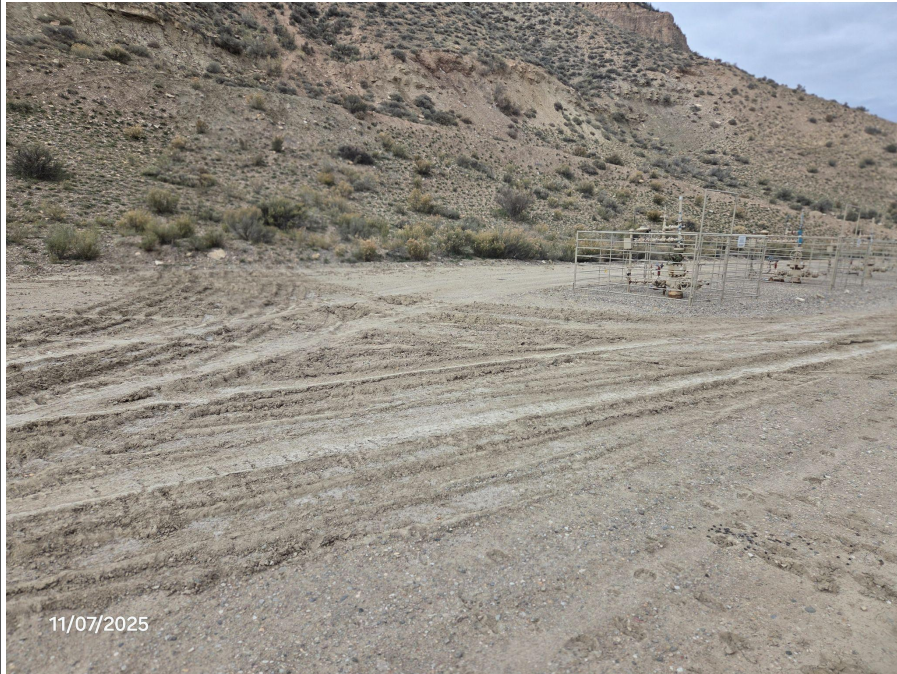
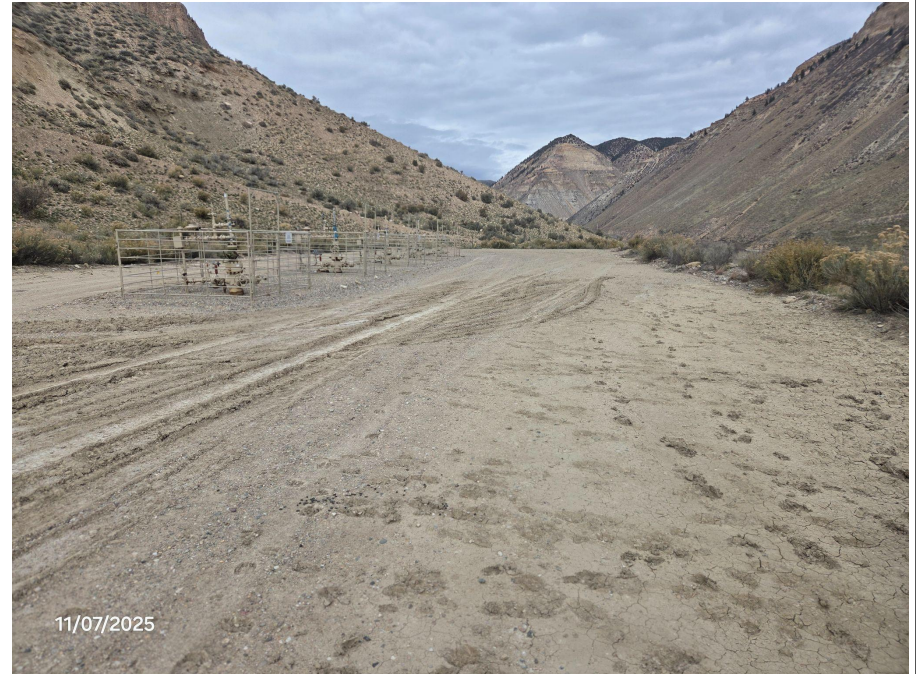
Photo 2: See comments under photo 1.

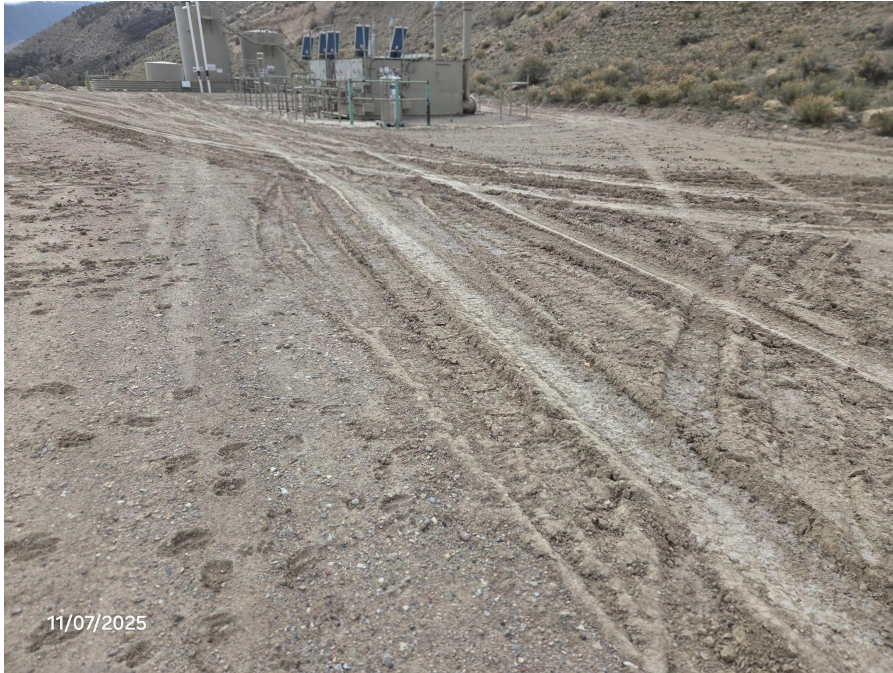
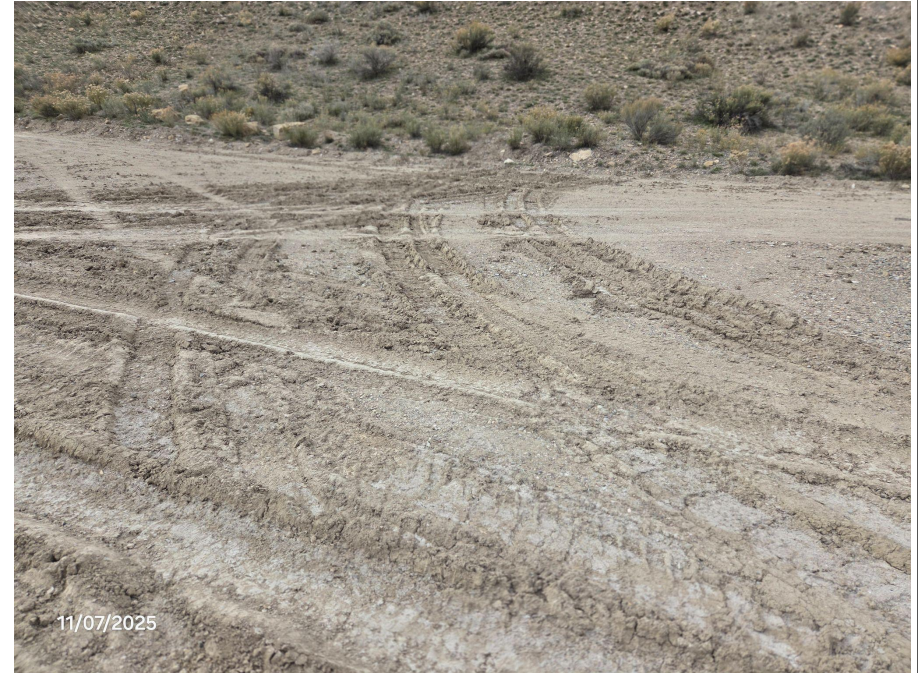
Photo 3: Photos show vehicle tracking/degradation on the working pad surface. See comments under photo 1.

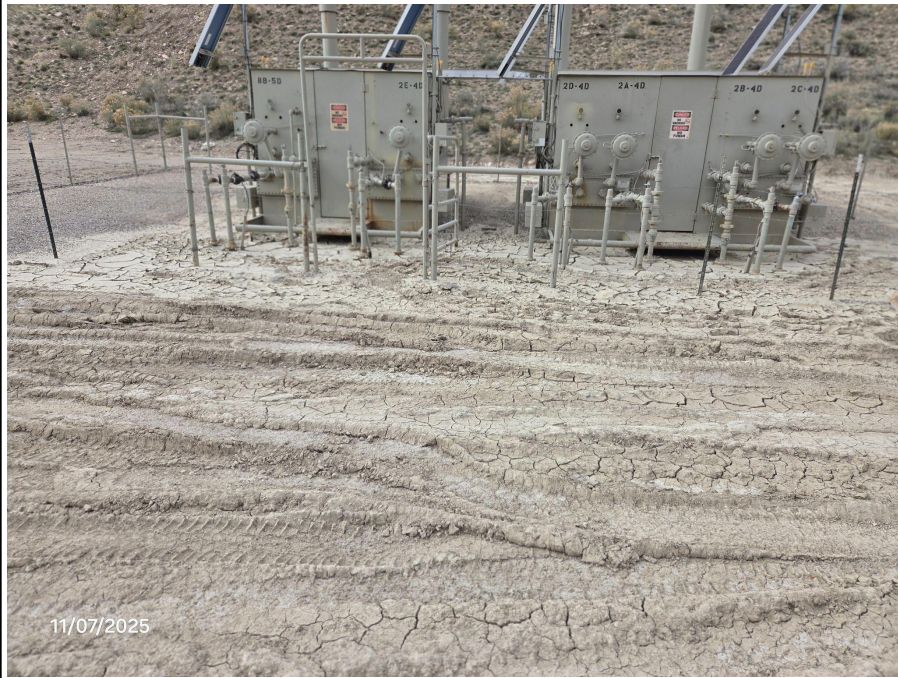
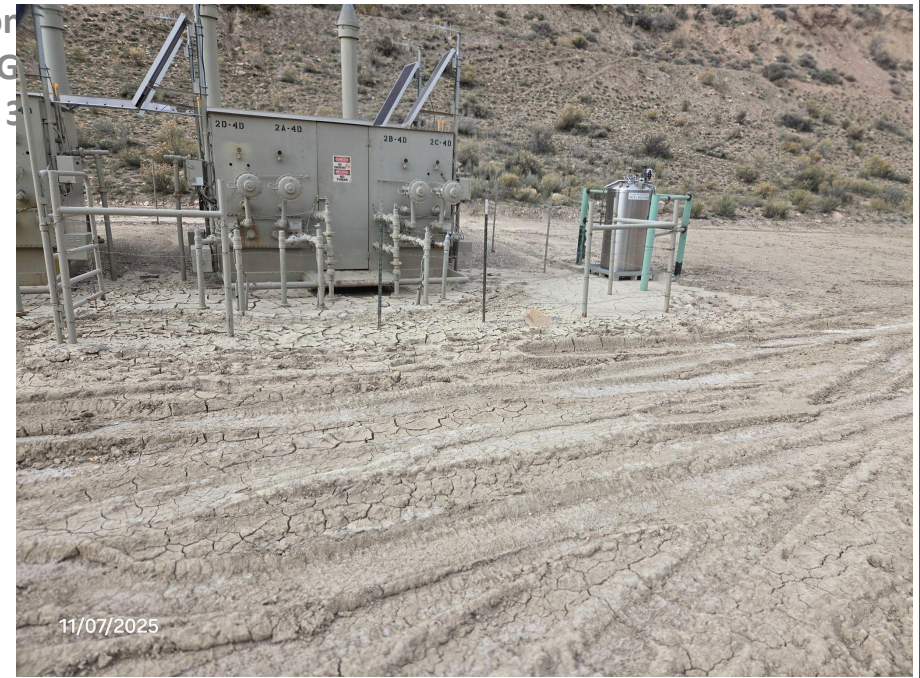
Photo 4: Photos taken from the separator equipment on the Location. See comments under photo 1. Photos also show evidence of ponding and comingling of stormwater with production equipment on the Location.

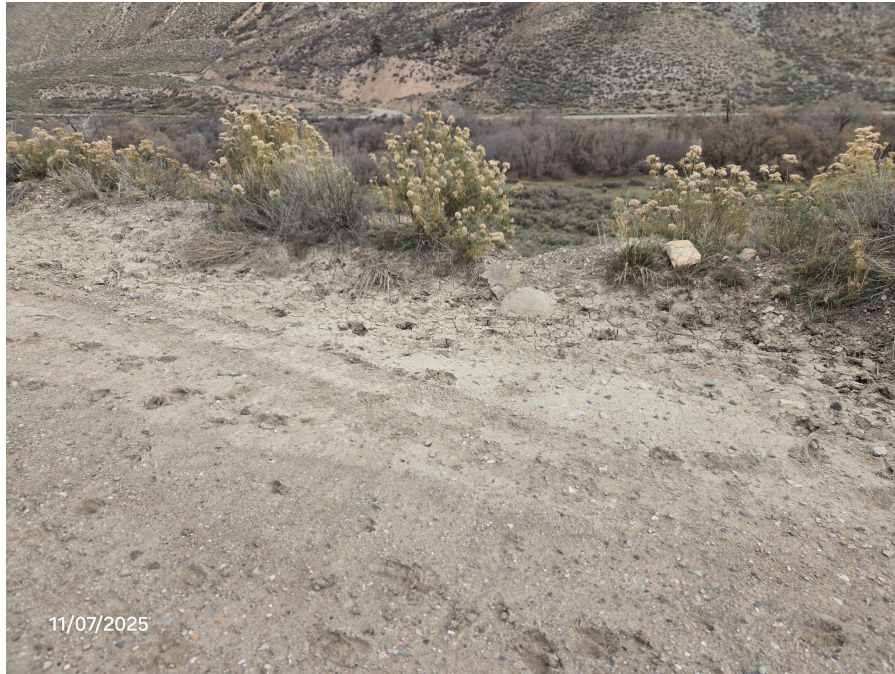
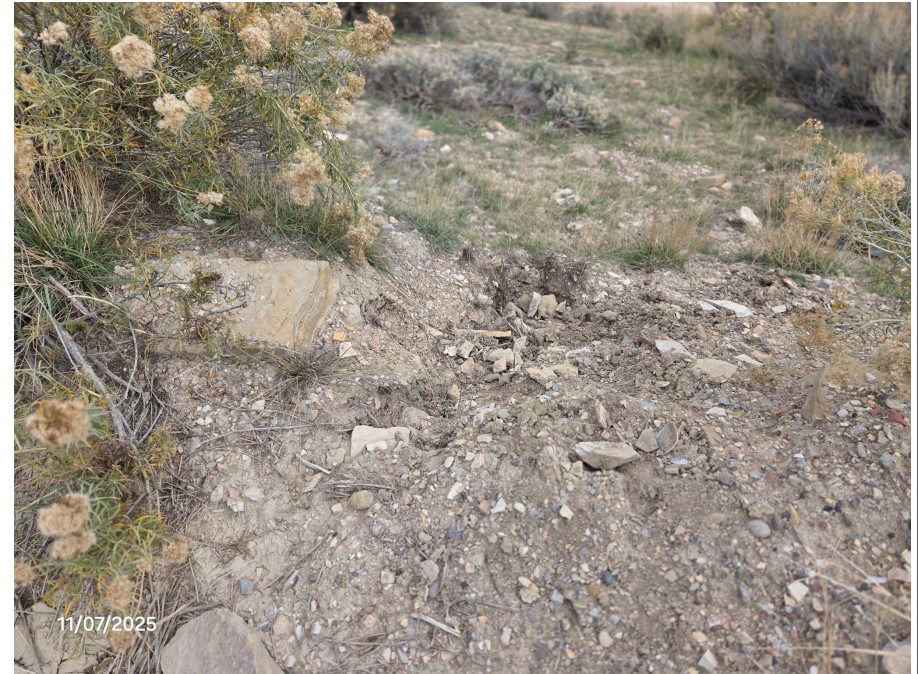
Photo 5: Photos taken from the east end of the Location. Photo shows point where stormwater runoff is discharging from the Location. No engineered outlet or other BMPs to allow for proper and controlled stormwater discharge observed.

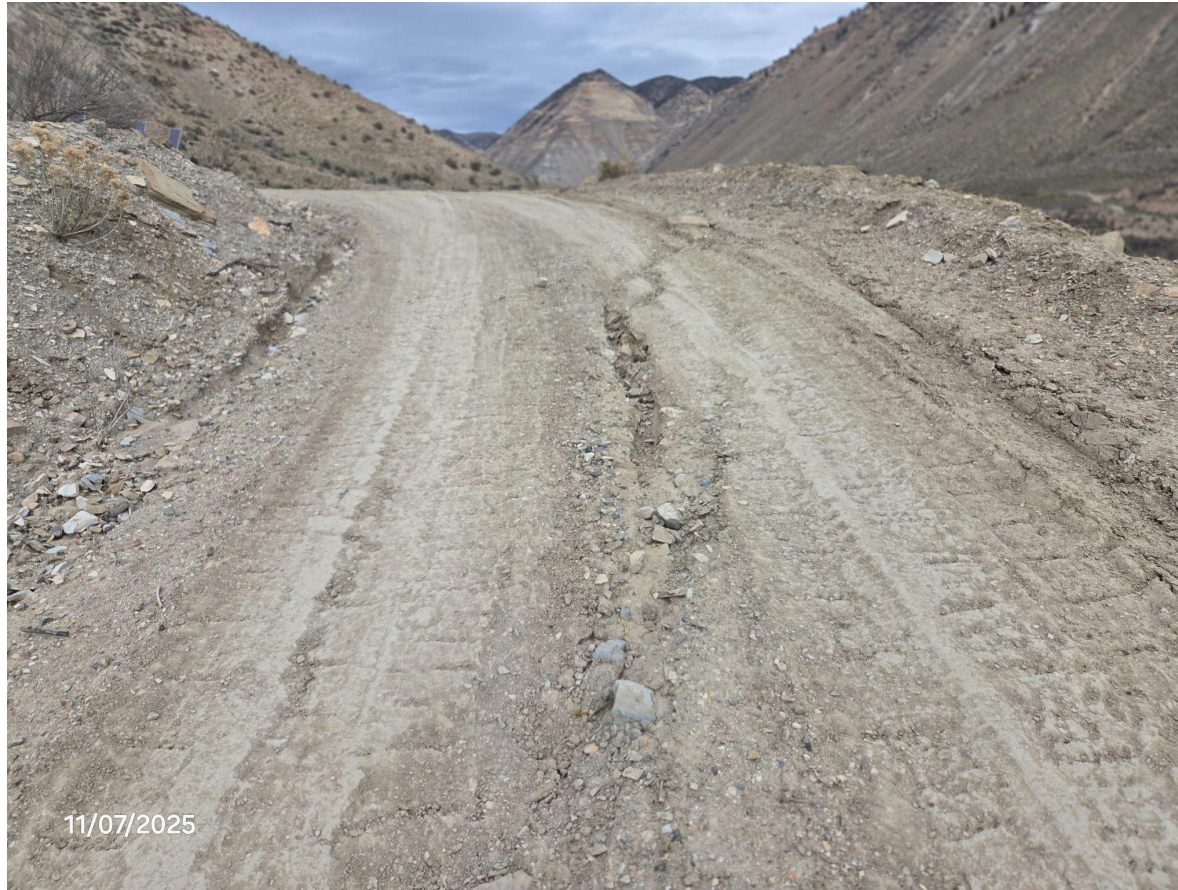
Photo 6: Photo taken from the access road facing north. Photo shows erosion degradation due to runoff. Runoff from these areas discharge to the CHEVRON-66S96W/4SWNW location immediately south, and is contributing to stormwater issues observed there. Refer to inspection #718100960 for additional details.

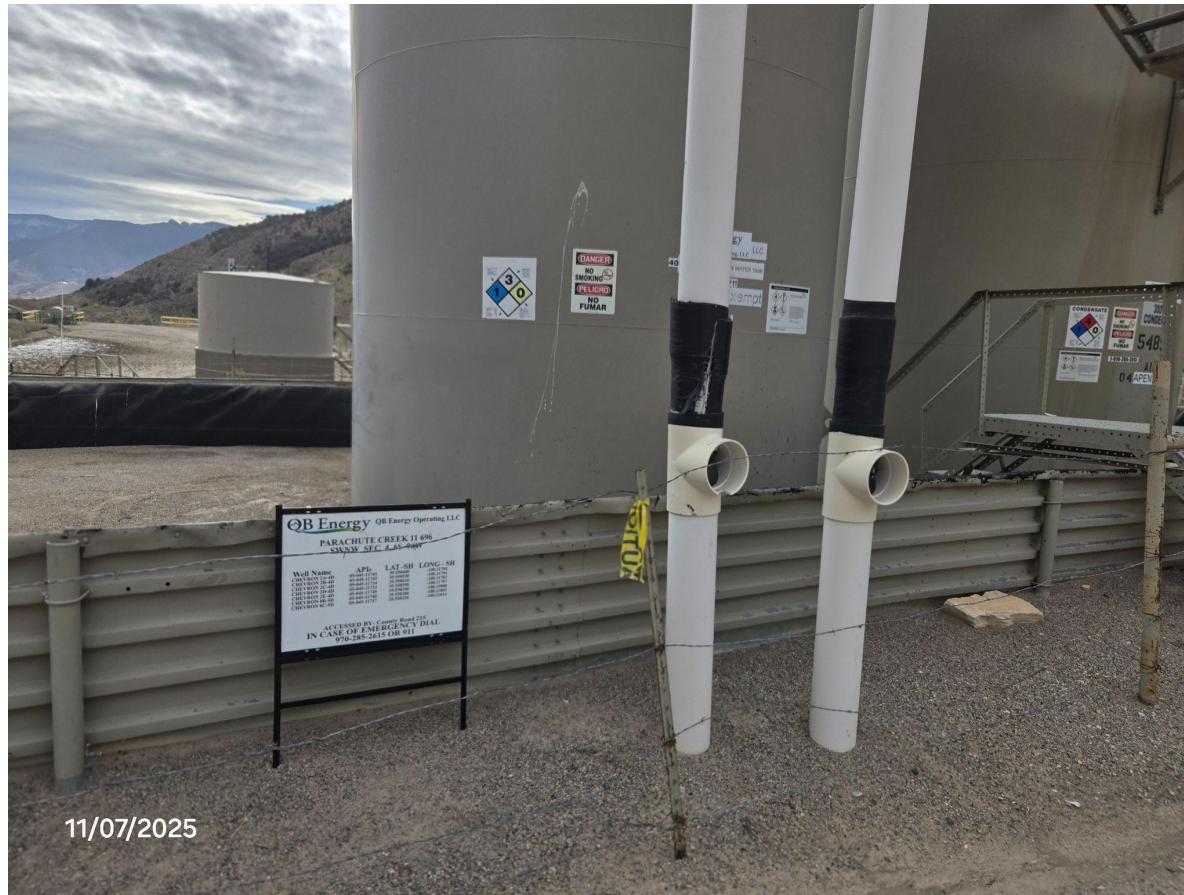
Photo 7: Photo shows tank battery facility on the south end of the Location.

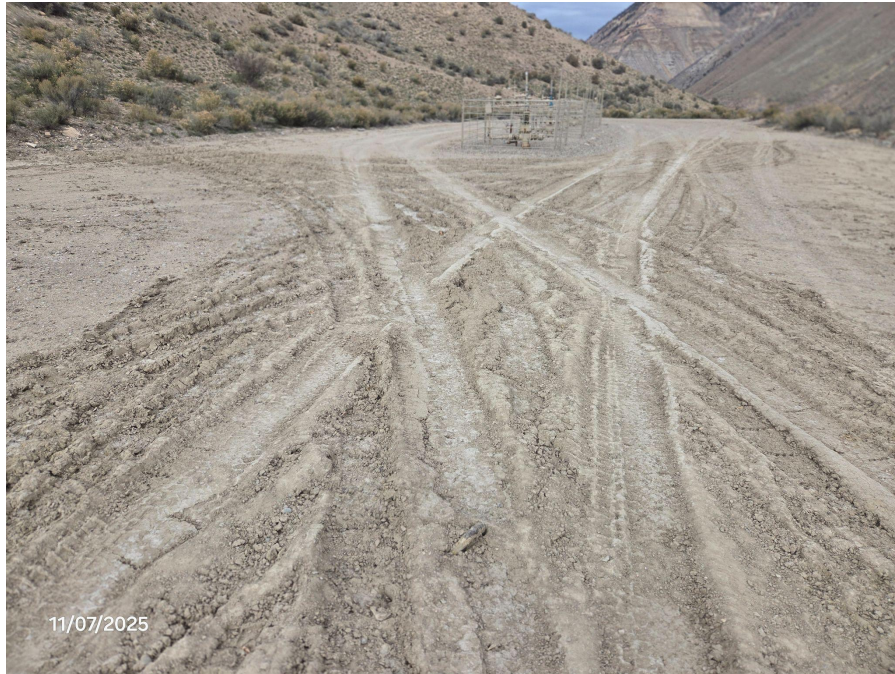
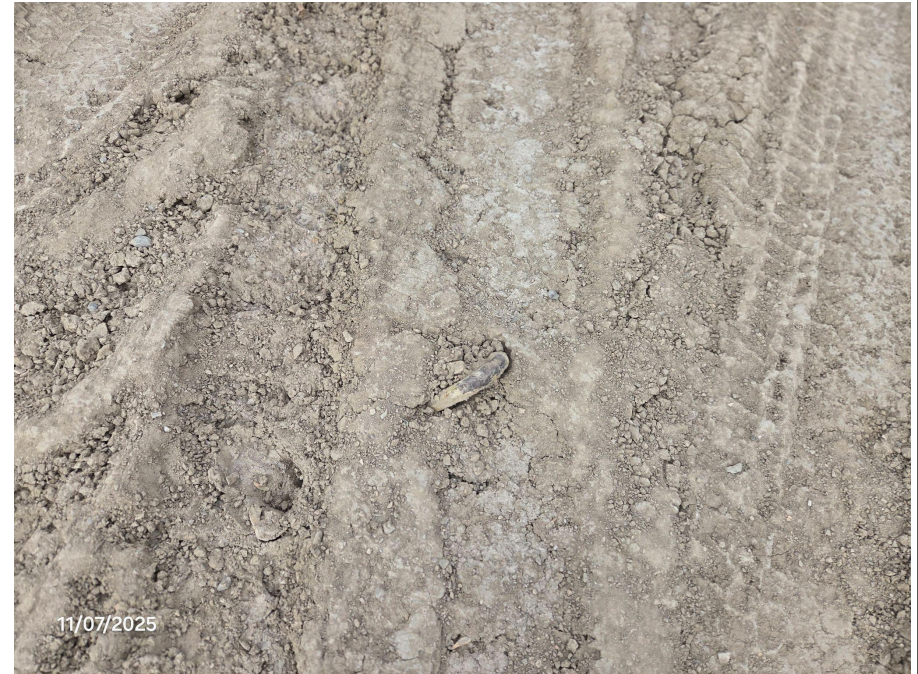
Photo 8: Photos taken from the south of the well, facing north. Photo shows unmarked anchor on Location. Operator appears to have only marked anchors along the west end of the Location. Unsure if anchors along the east end of the Location have been removed, or have been buried. Anchors require marking pursuant to Rules 1003.a and 603.j. If anchors on the Location are no longer necessary, they are considered unused equipment and should be removed pursuant to Rule 606.
