Inspection/Audit Photos

Location: QB ENERGY OPERATING LLC ELU J14/FED-496 PAD

Location ID: 467272

Date: 11/6/2025

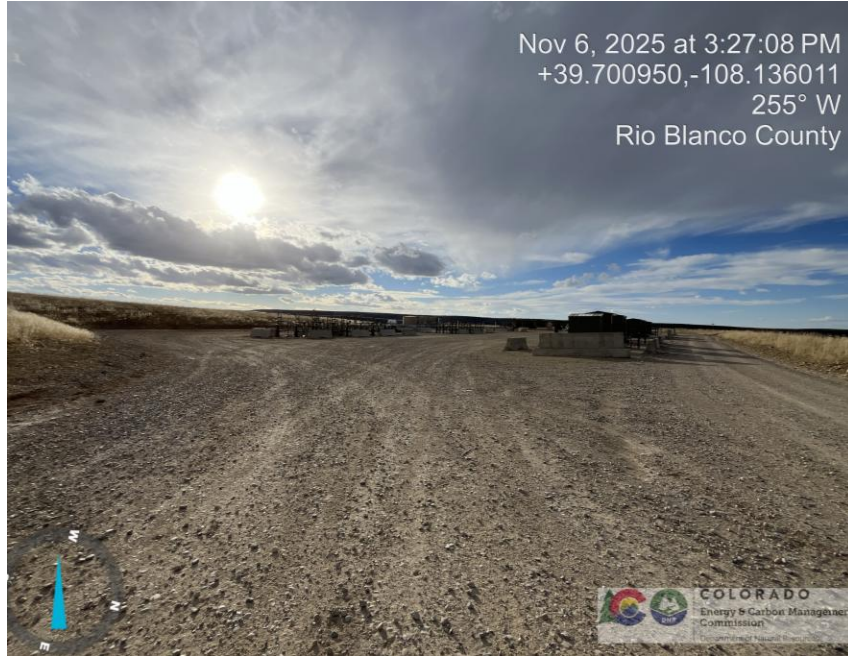
Photo # 3832 Entrance to location

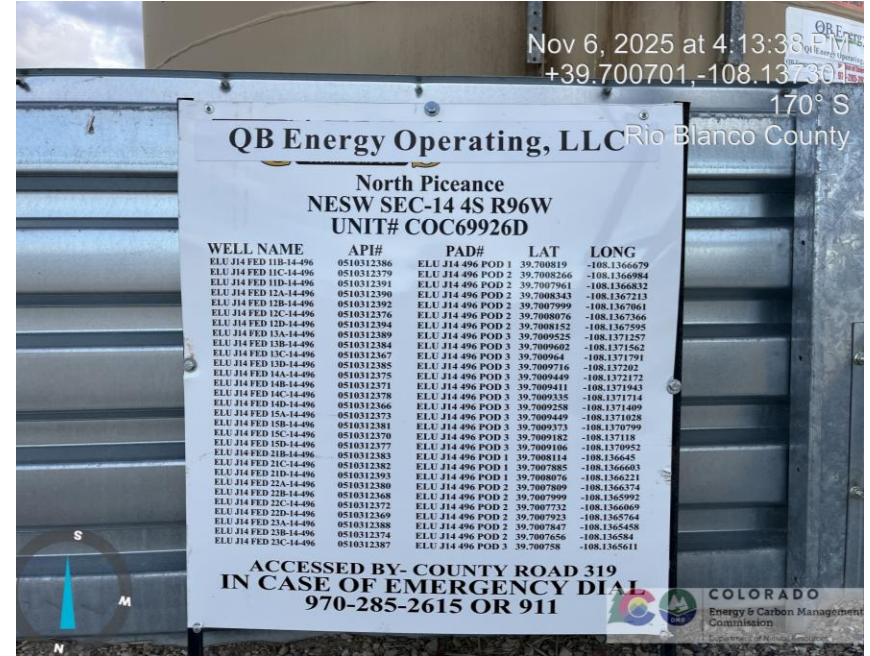
Photo # 3879 Location

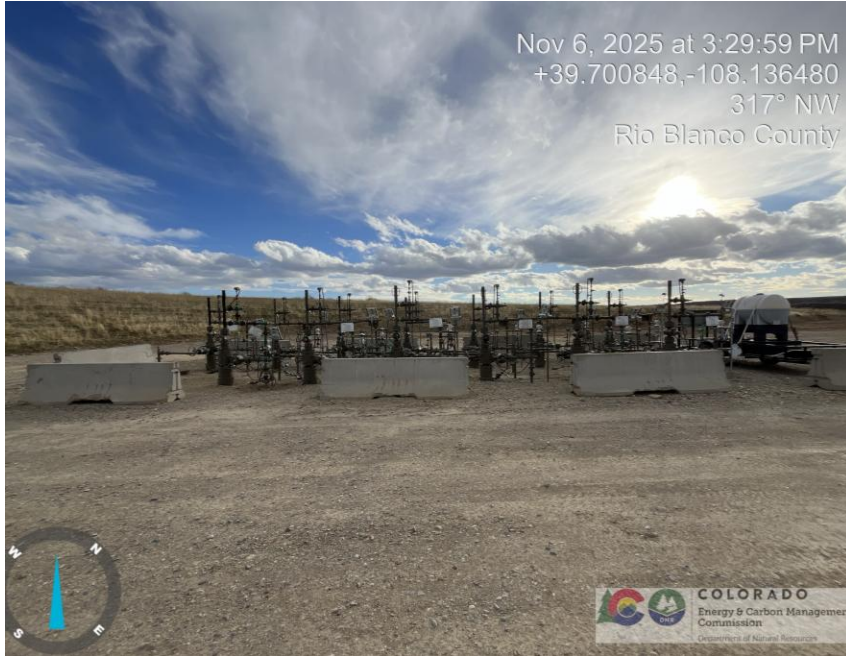
Photo # 3833 Location

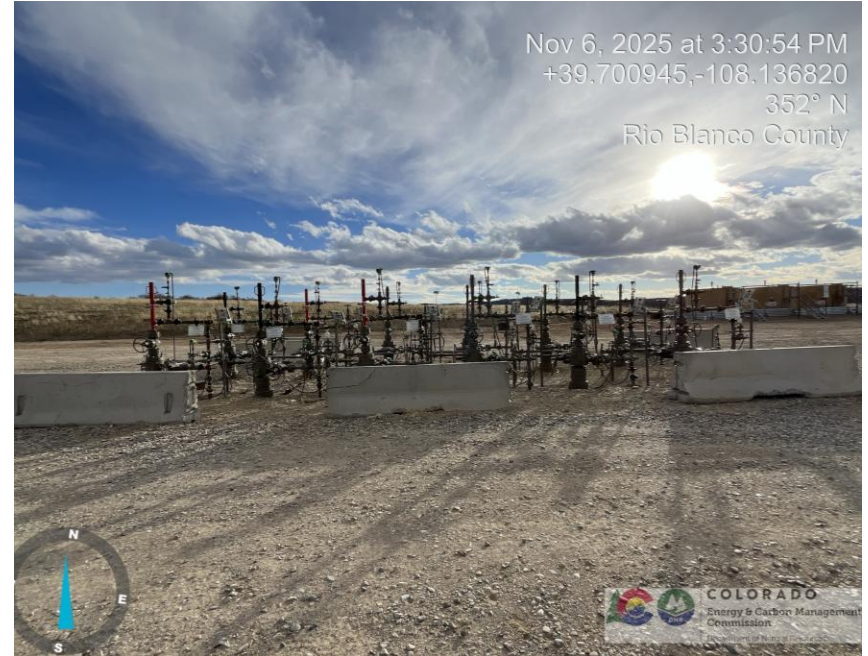
Photo # 3834 Location

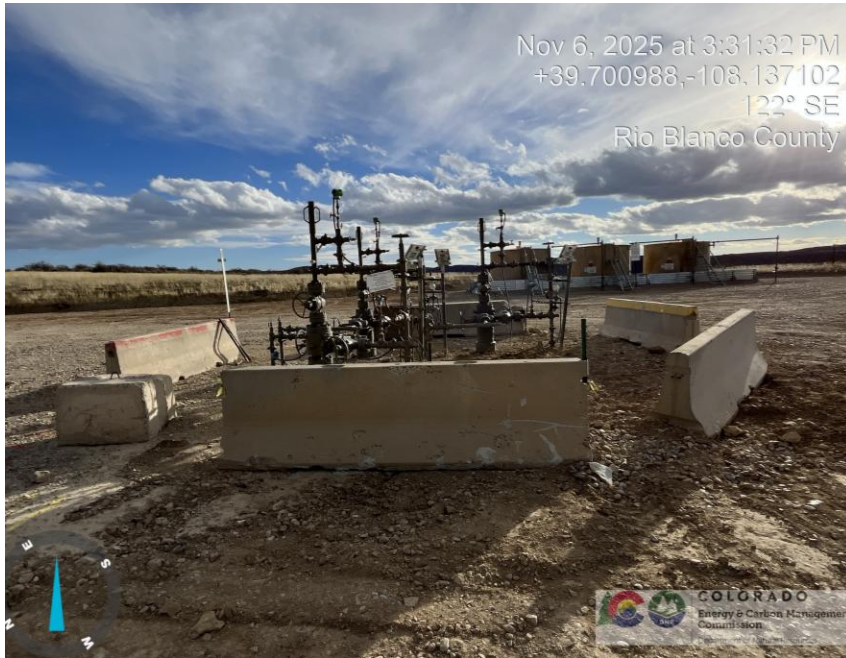
Photo # 3835 Location

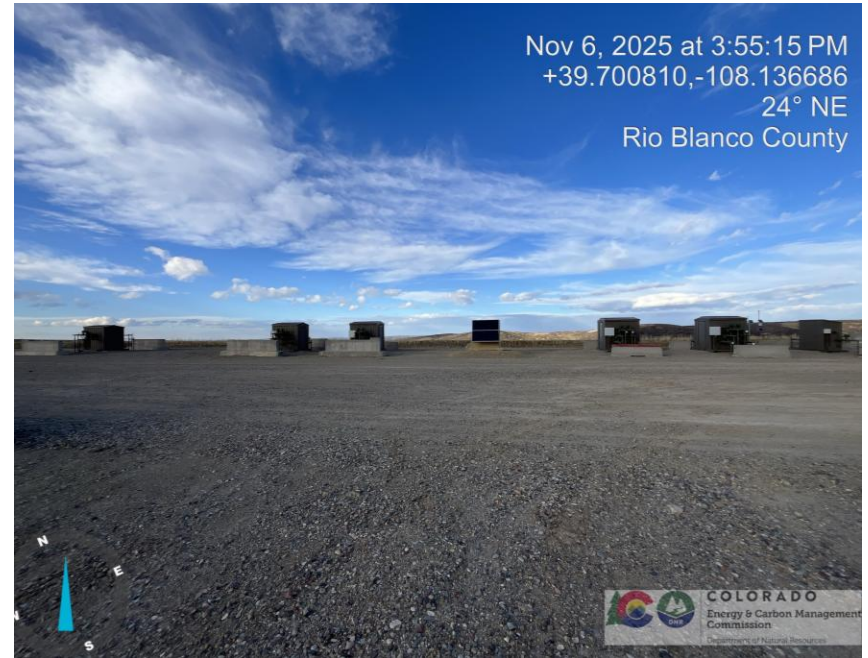
Photo # 3868 Location

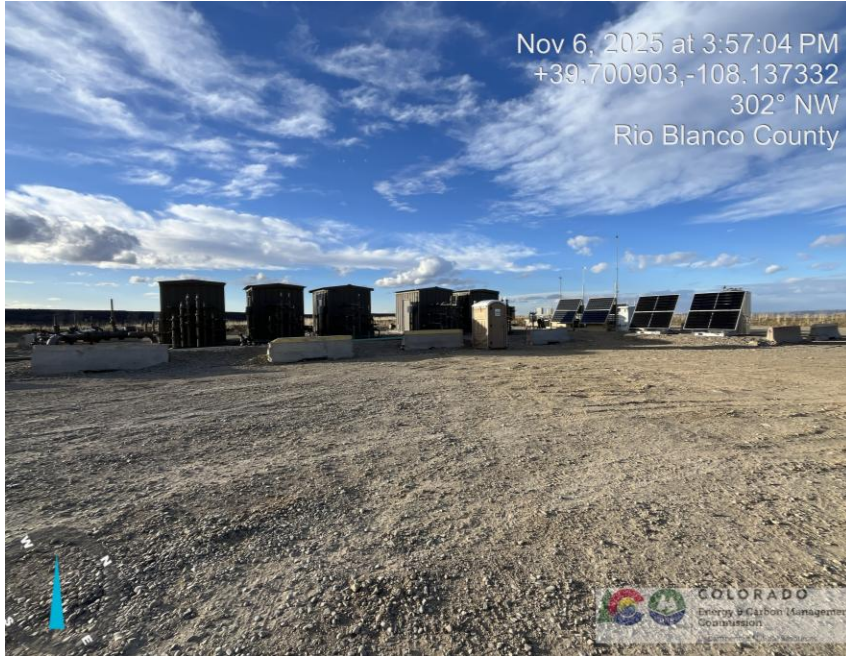
Photo # 3869 Location

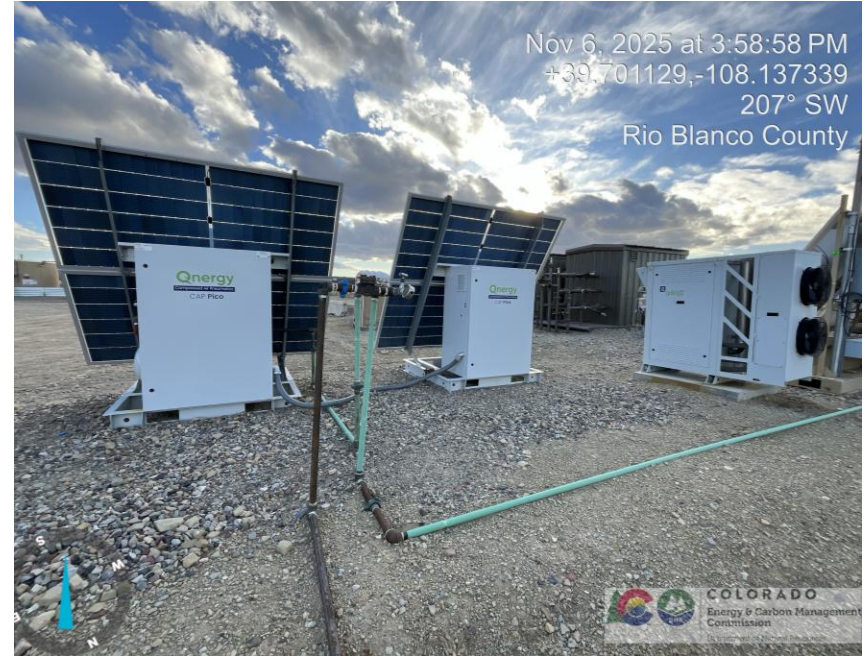
Photo # 3870 Location

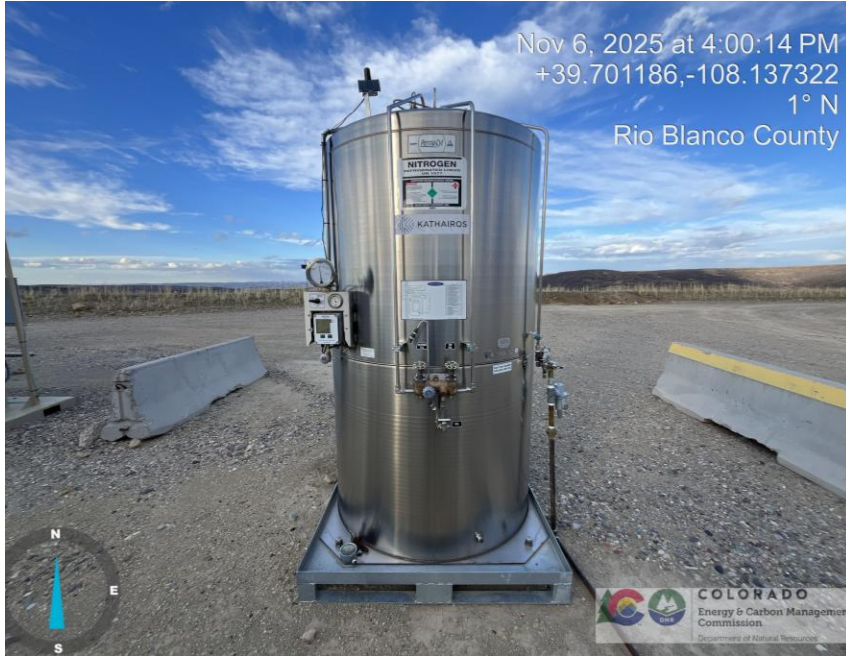
Photo # 3871 Location

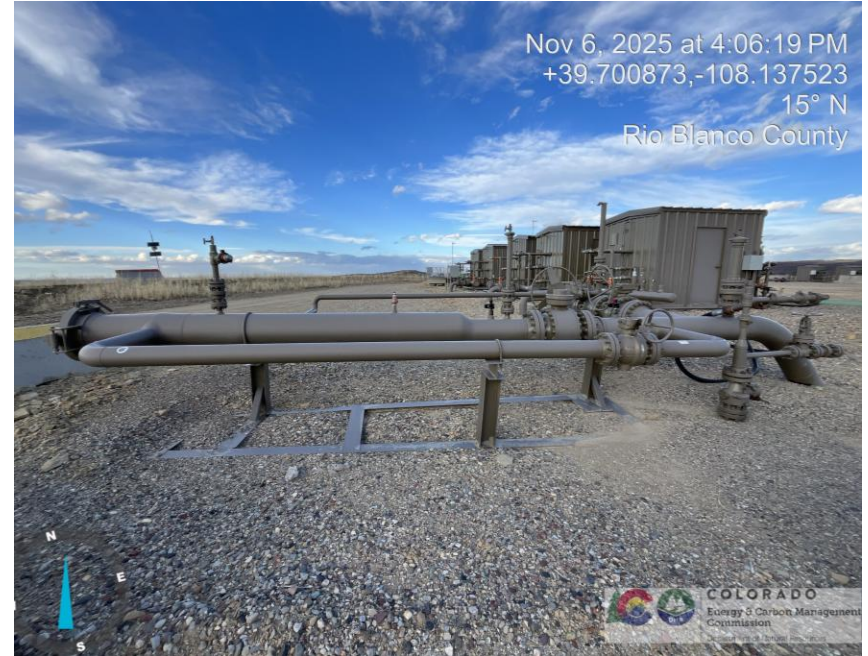
Photo # 3874 Location

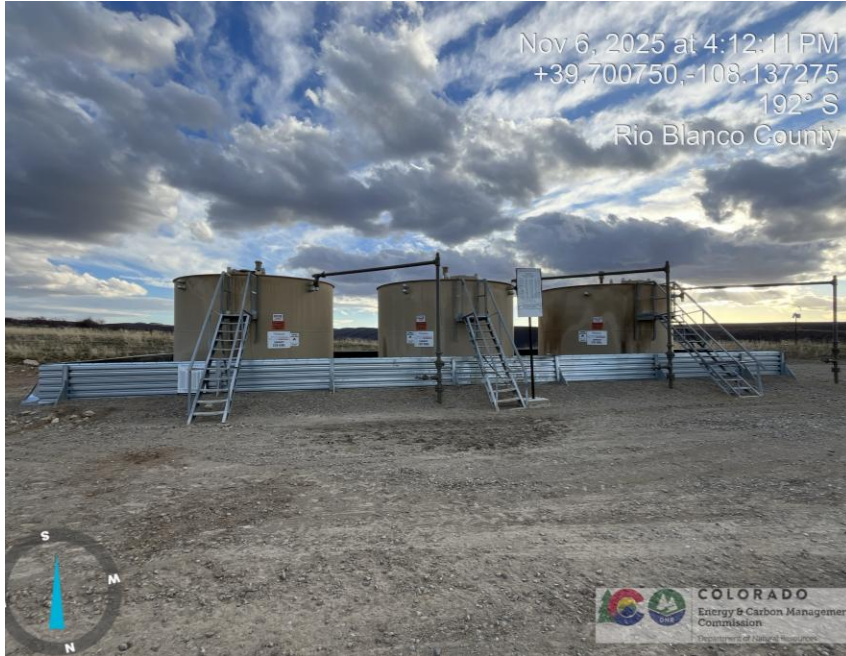
Photo # 3876 Location

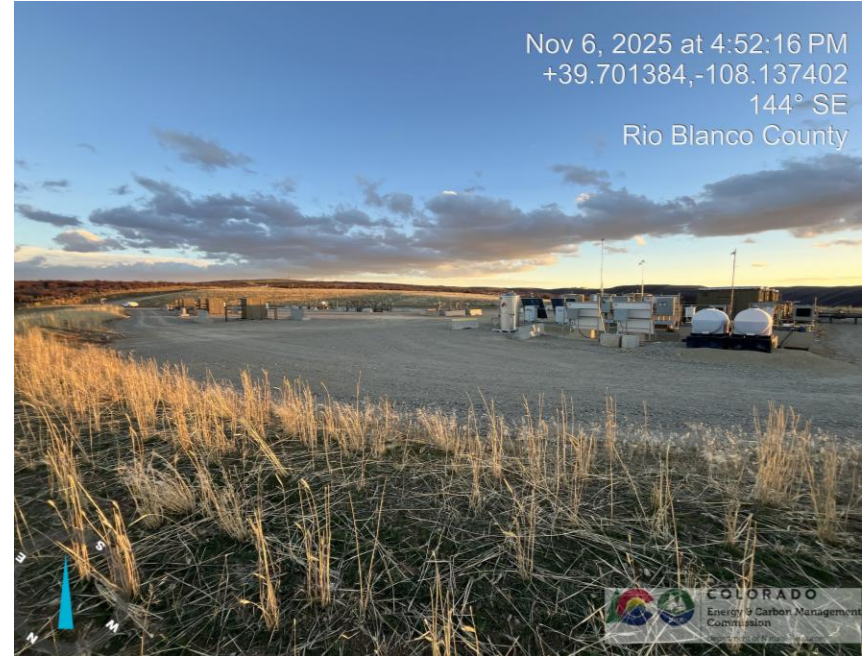
Photo #3901 NW corner of location

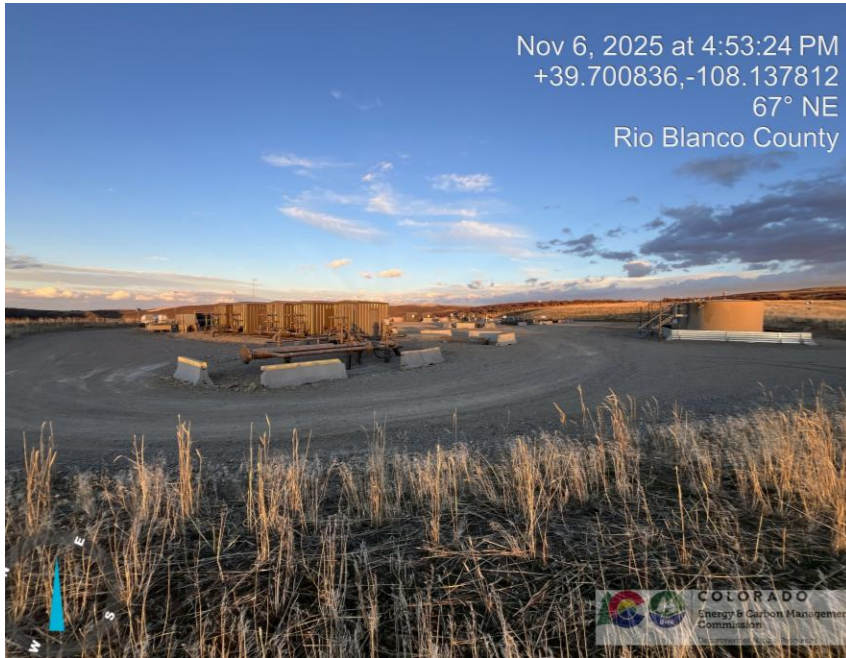
Photo # 3902 SW corner of location

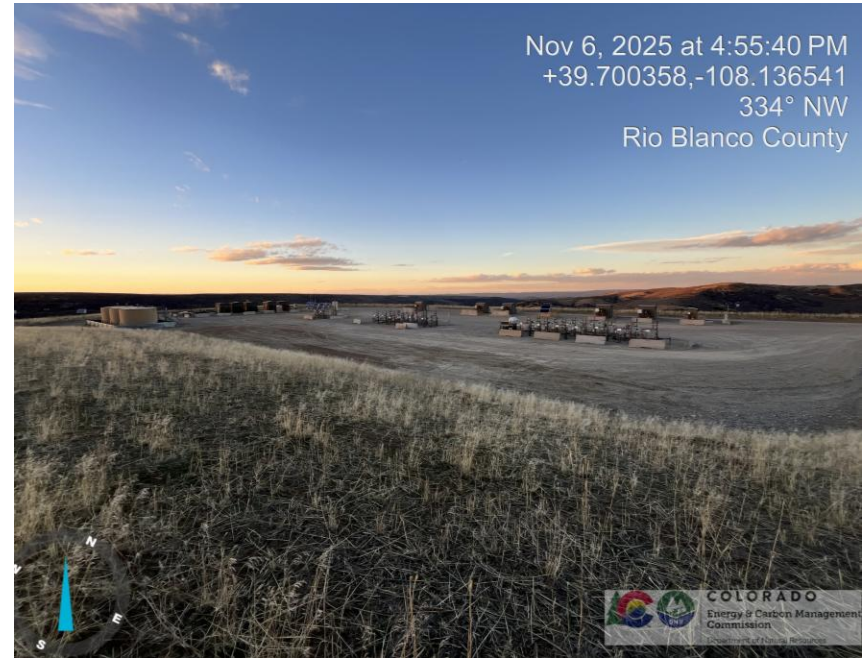
Photo # 3903 SE corner of location

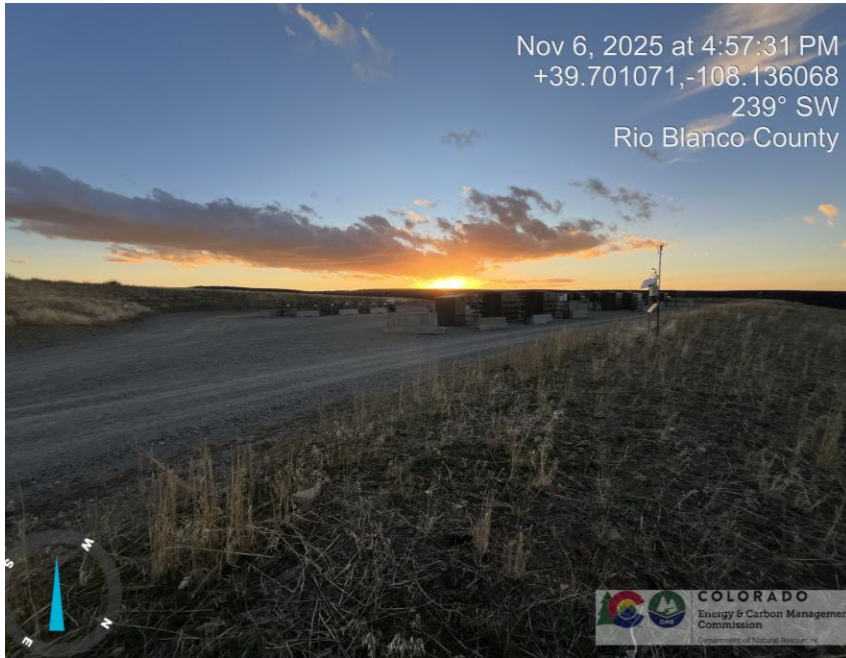
Photo # 3904 NE corner of location

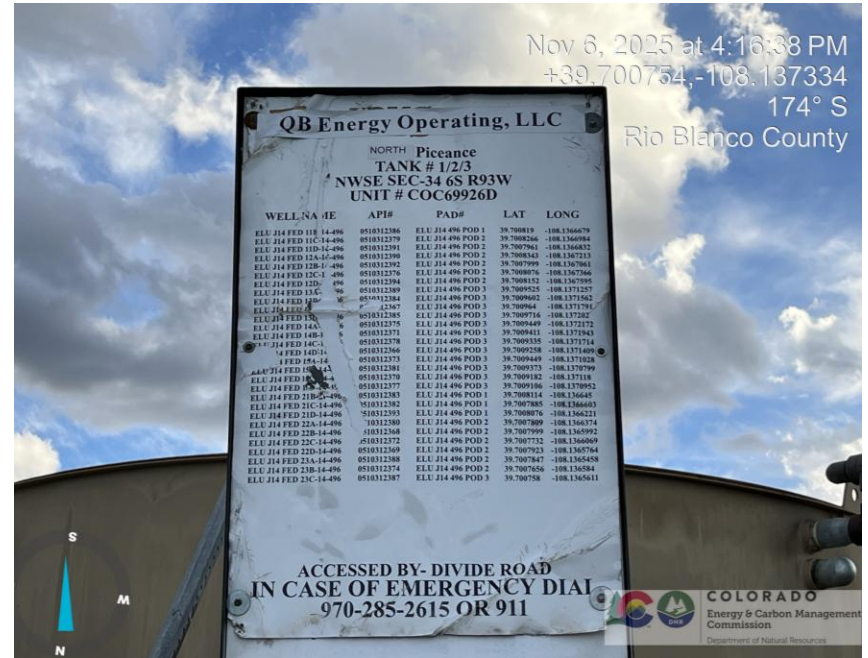
Photo # 3881 Damaged sign contains inaccurate information

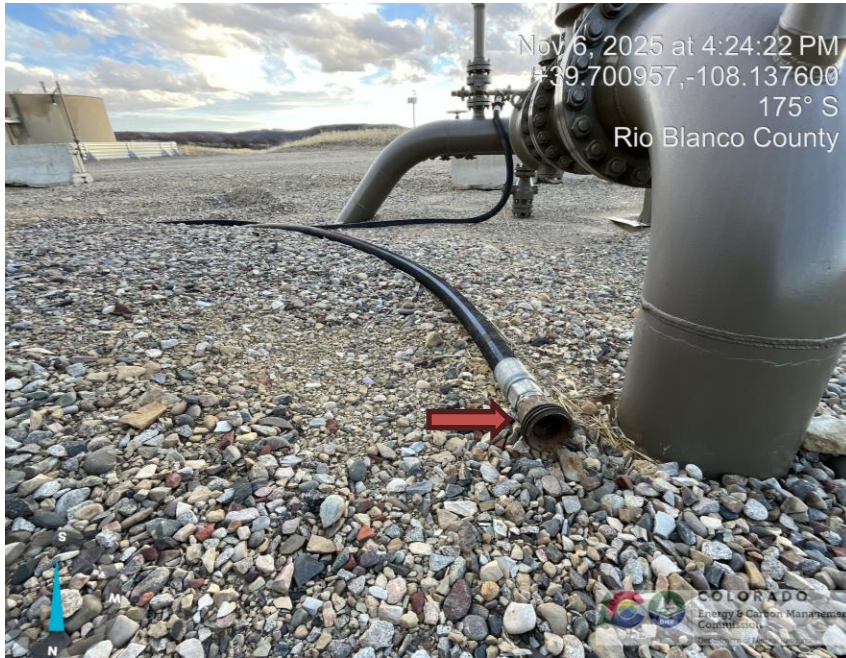
Photo # 3889 Open ended pressure hose/wildlife hazard/available for entry by wildlife

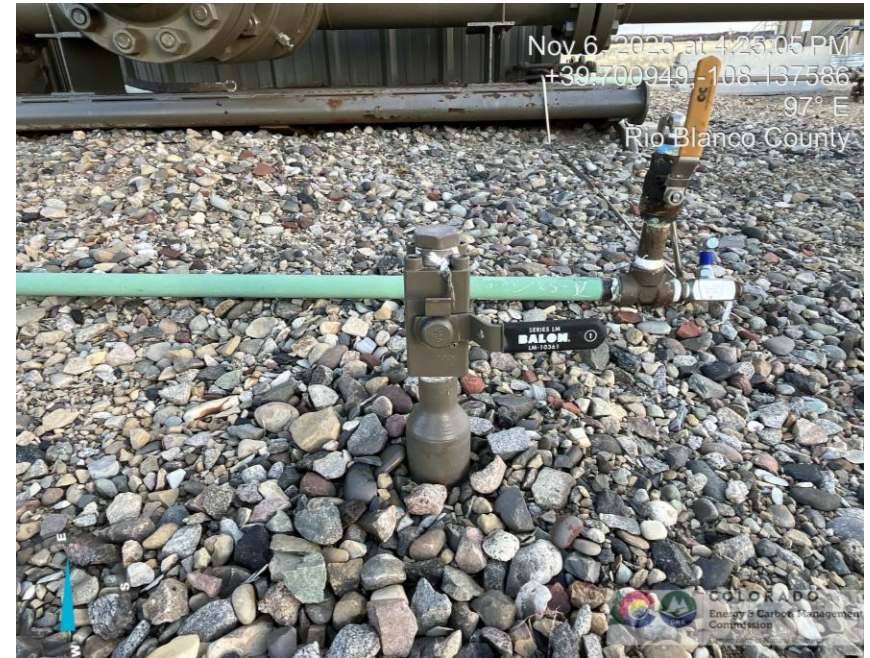
Photo # 3890 Unused flowline lacks lockout tagout (OOSLAT)

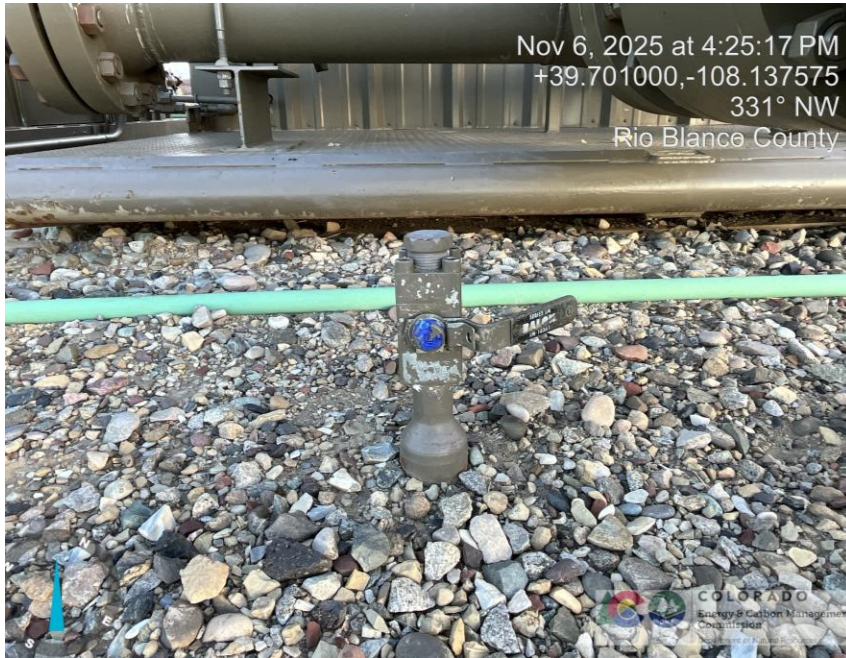
Photo # 3891 Unused flowline lacks lockout tagout (OOSLAT)

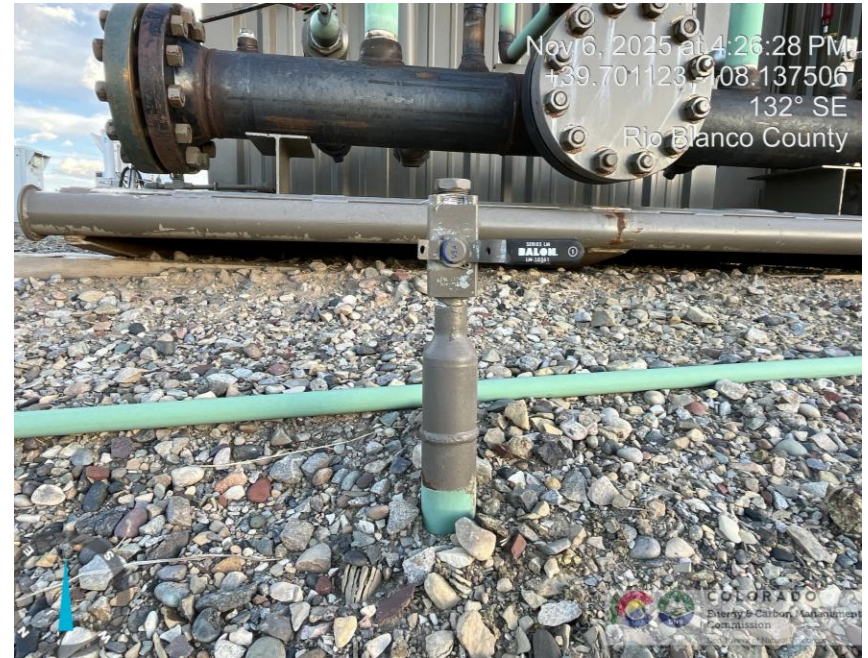
Photo # 3893 Unused flowline lacks lockout tagout (OOSLAT)

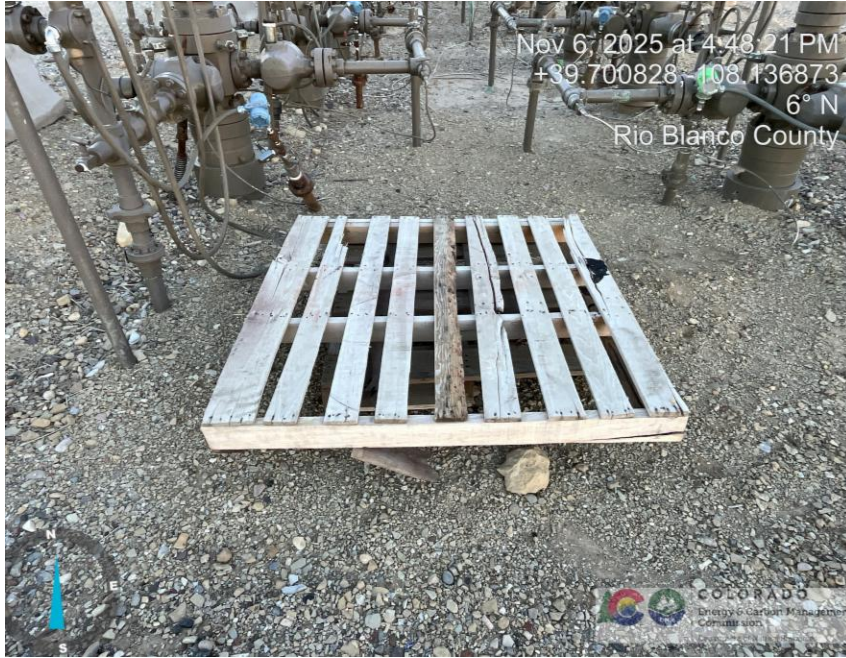
Photo # 3897 Debris

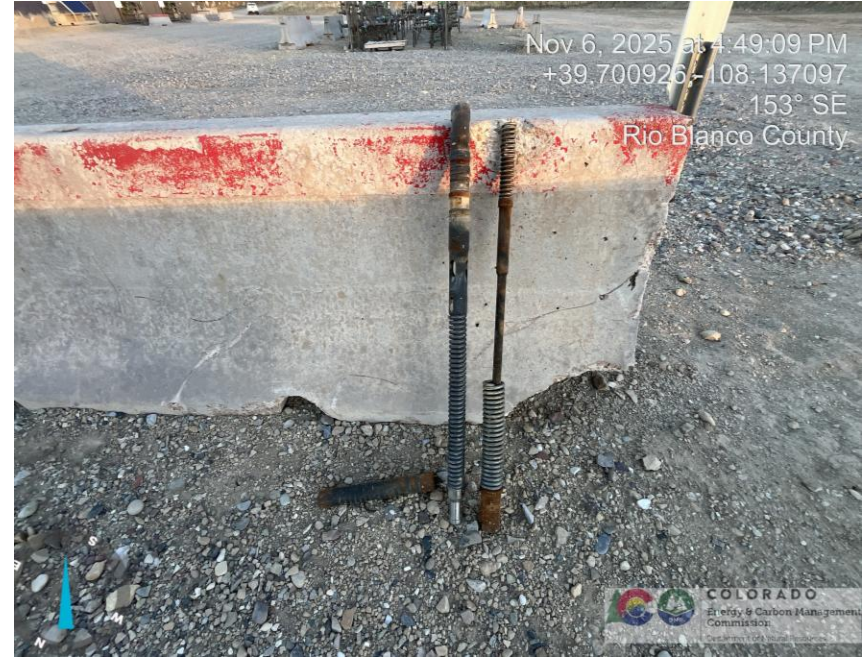
Photo # 3898 Debris

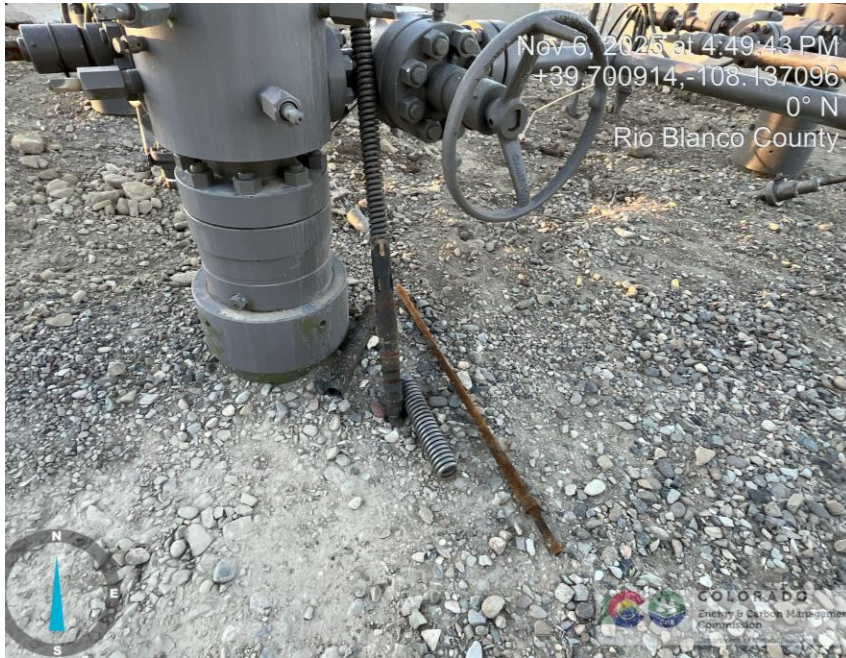
Photo # 3899 Debris

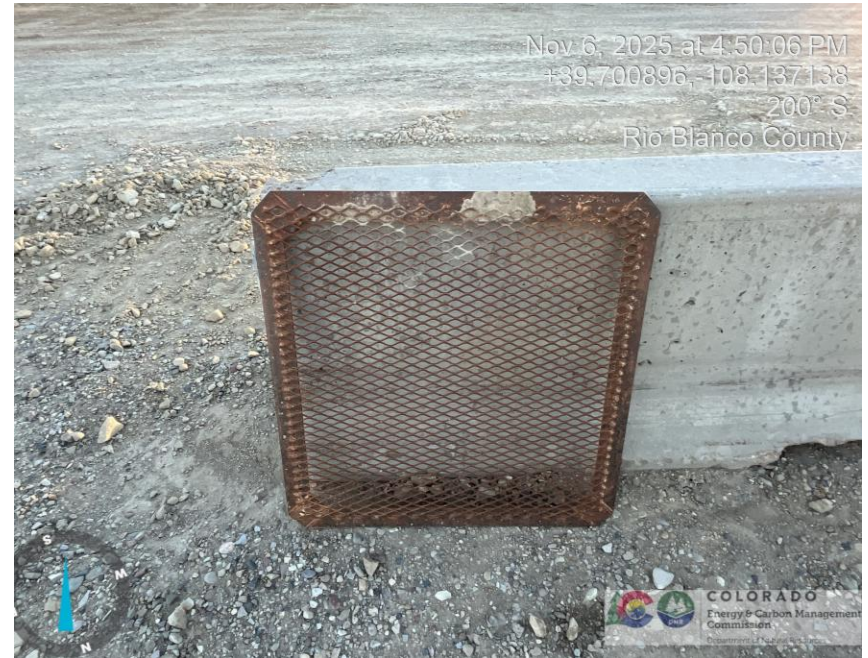
Photo # 3900 Debris
