Final Reclamation and Stormwater Inspection

Location ID: 306078

Well Name: SEVCIK V #27-23

Inspection Document #: 718601162

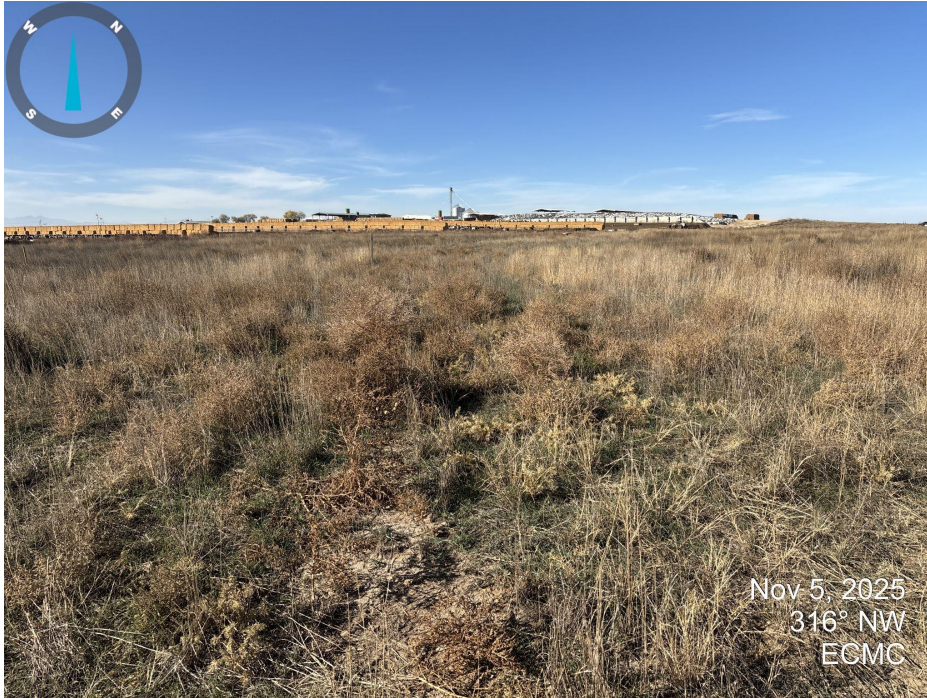
Photo 1. Looking northwest down the former access road. Some undesirable weeds such as russian thistle are present on the access road. Desirable vegetation that is reflective of the surrounding reference area is present on the access road.

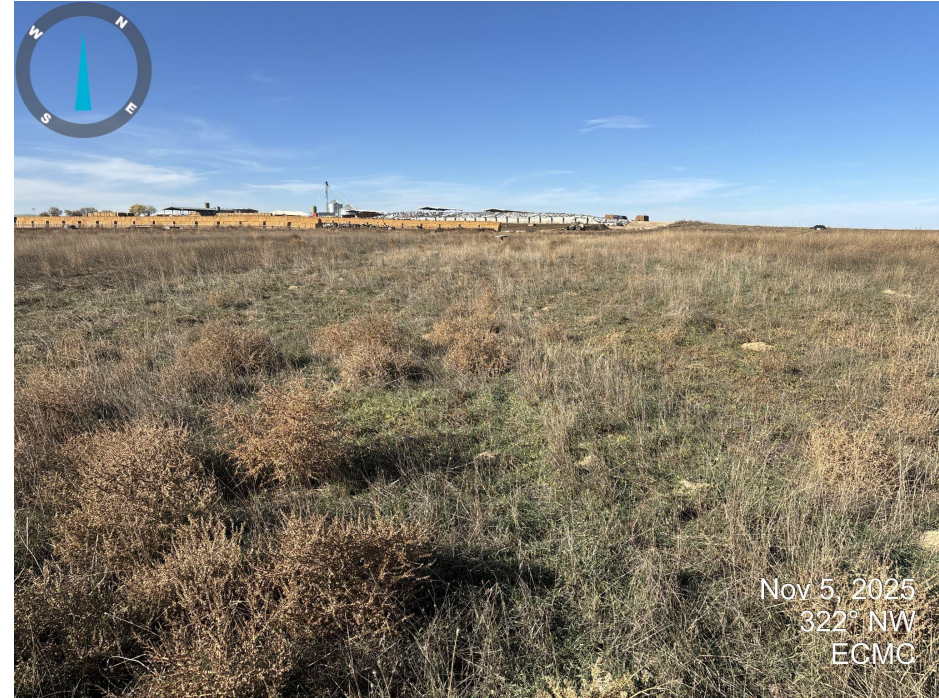
Photo 2. Looking north across the location. No oil and gas equipment remains on location. Vegetation on location is primarily cereal rye. Vegetation appears reflective of the surrounding area.

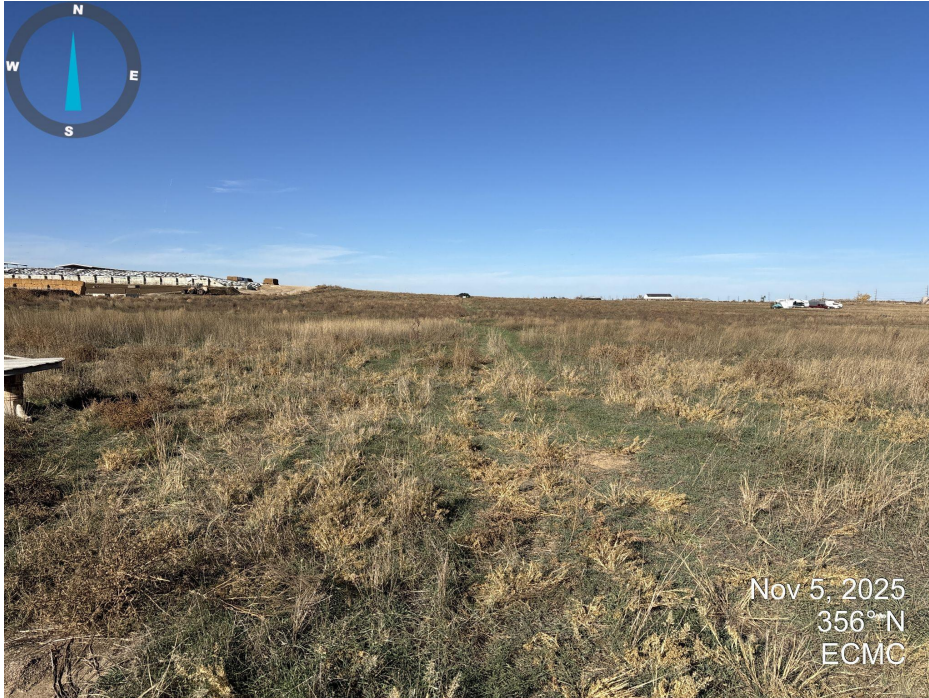
Photo 3. Looking north from the wellhead. Desirable vegetation coverage appears to have reached 80% of the surrounding reference area. Vegetation on location is reflective of the reference area. The table pictured does not appear to be related to oil and gas.

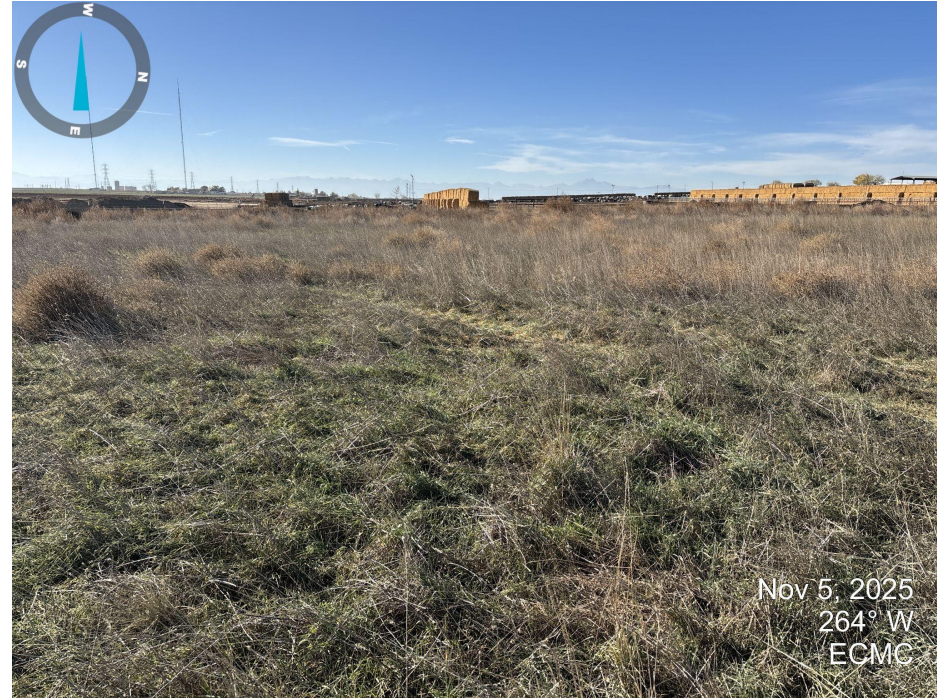
Photo 4. Looking west from the well location. See photo 3 comments.

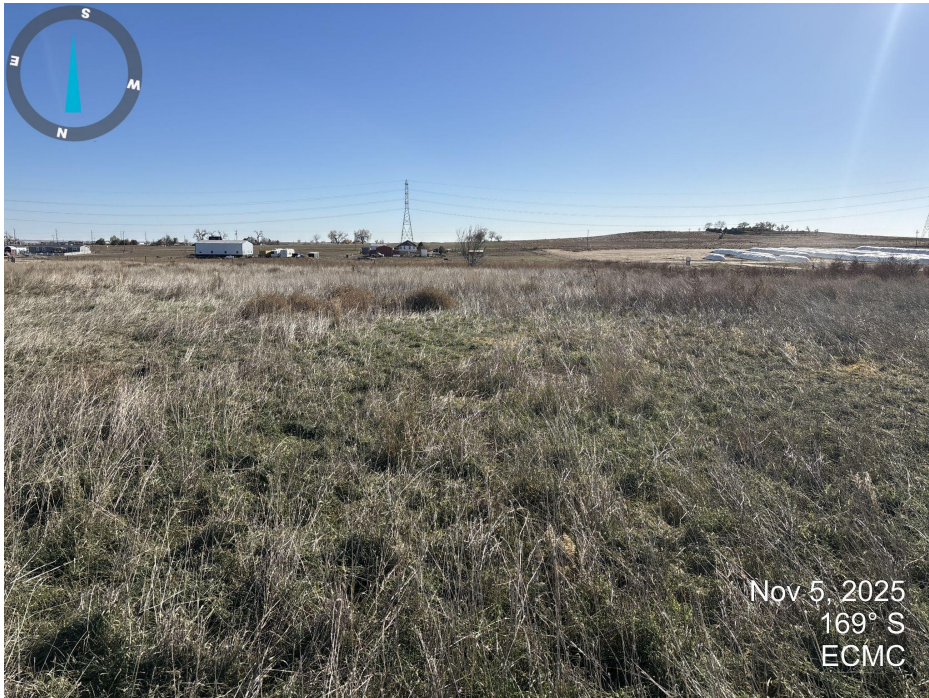
Photo 5. Looking south from the well location. See photo 3 comments.

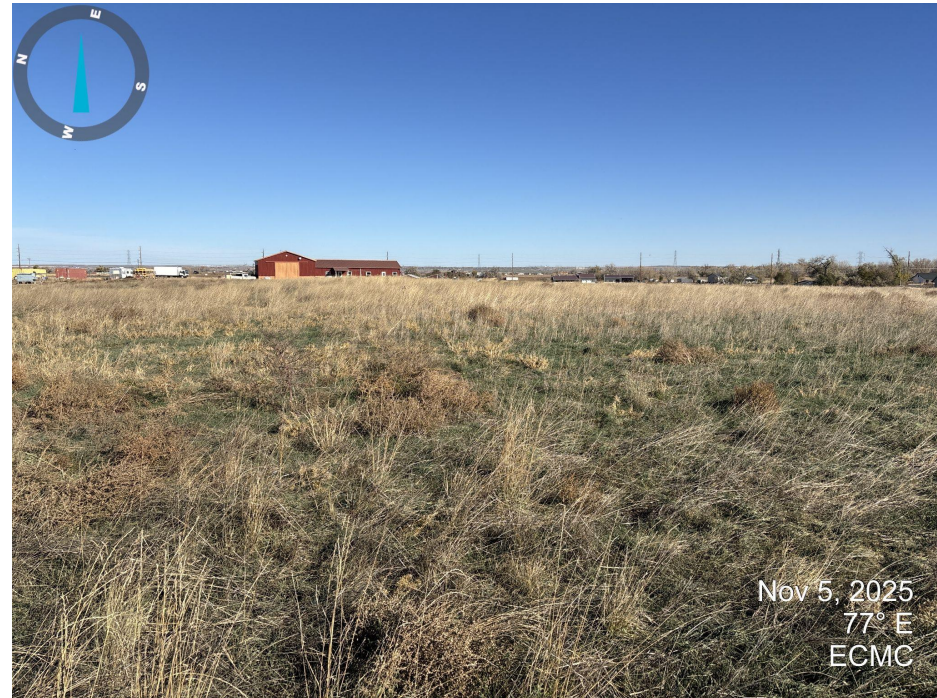
Photo 6. Looking east from the well location. See photo 3 comments.

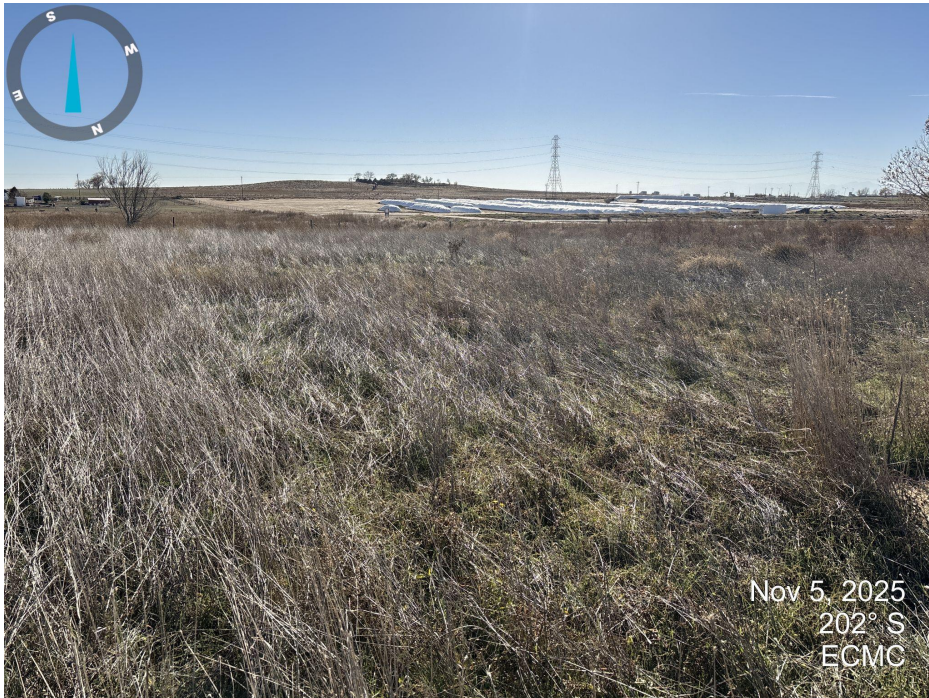
Photo 7. Reference area to the southwest of the location.

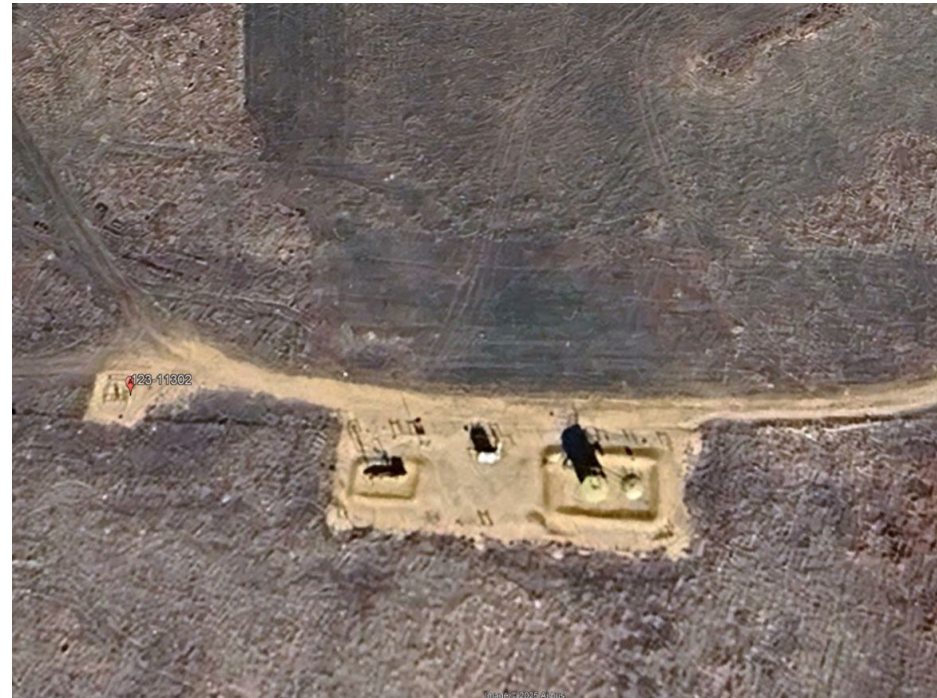
Photo 8. The tank battery to the southeast was reduced when several surrounding wells were plugged. No equipment remains on the closed portion and reclamation has been conducted. The tank battery does not have a separate location ID but is associated with active well API 123-11302.
