# Site Specific Final Reclamation Completion Notice – Cropland Drone Imagery

## Permit Closure Report – Cropland

**Location Name:** ANDERSON-64N65W/27SWNW

9/22/2025

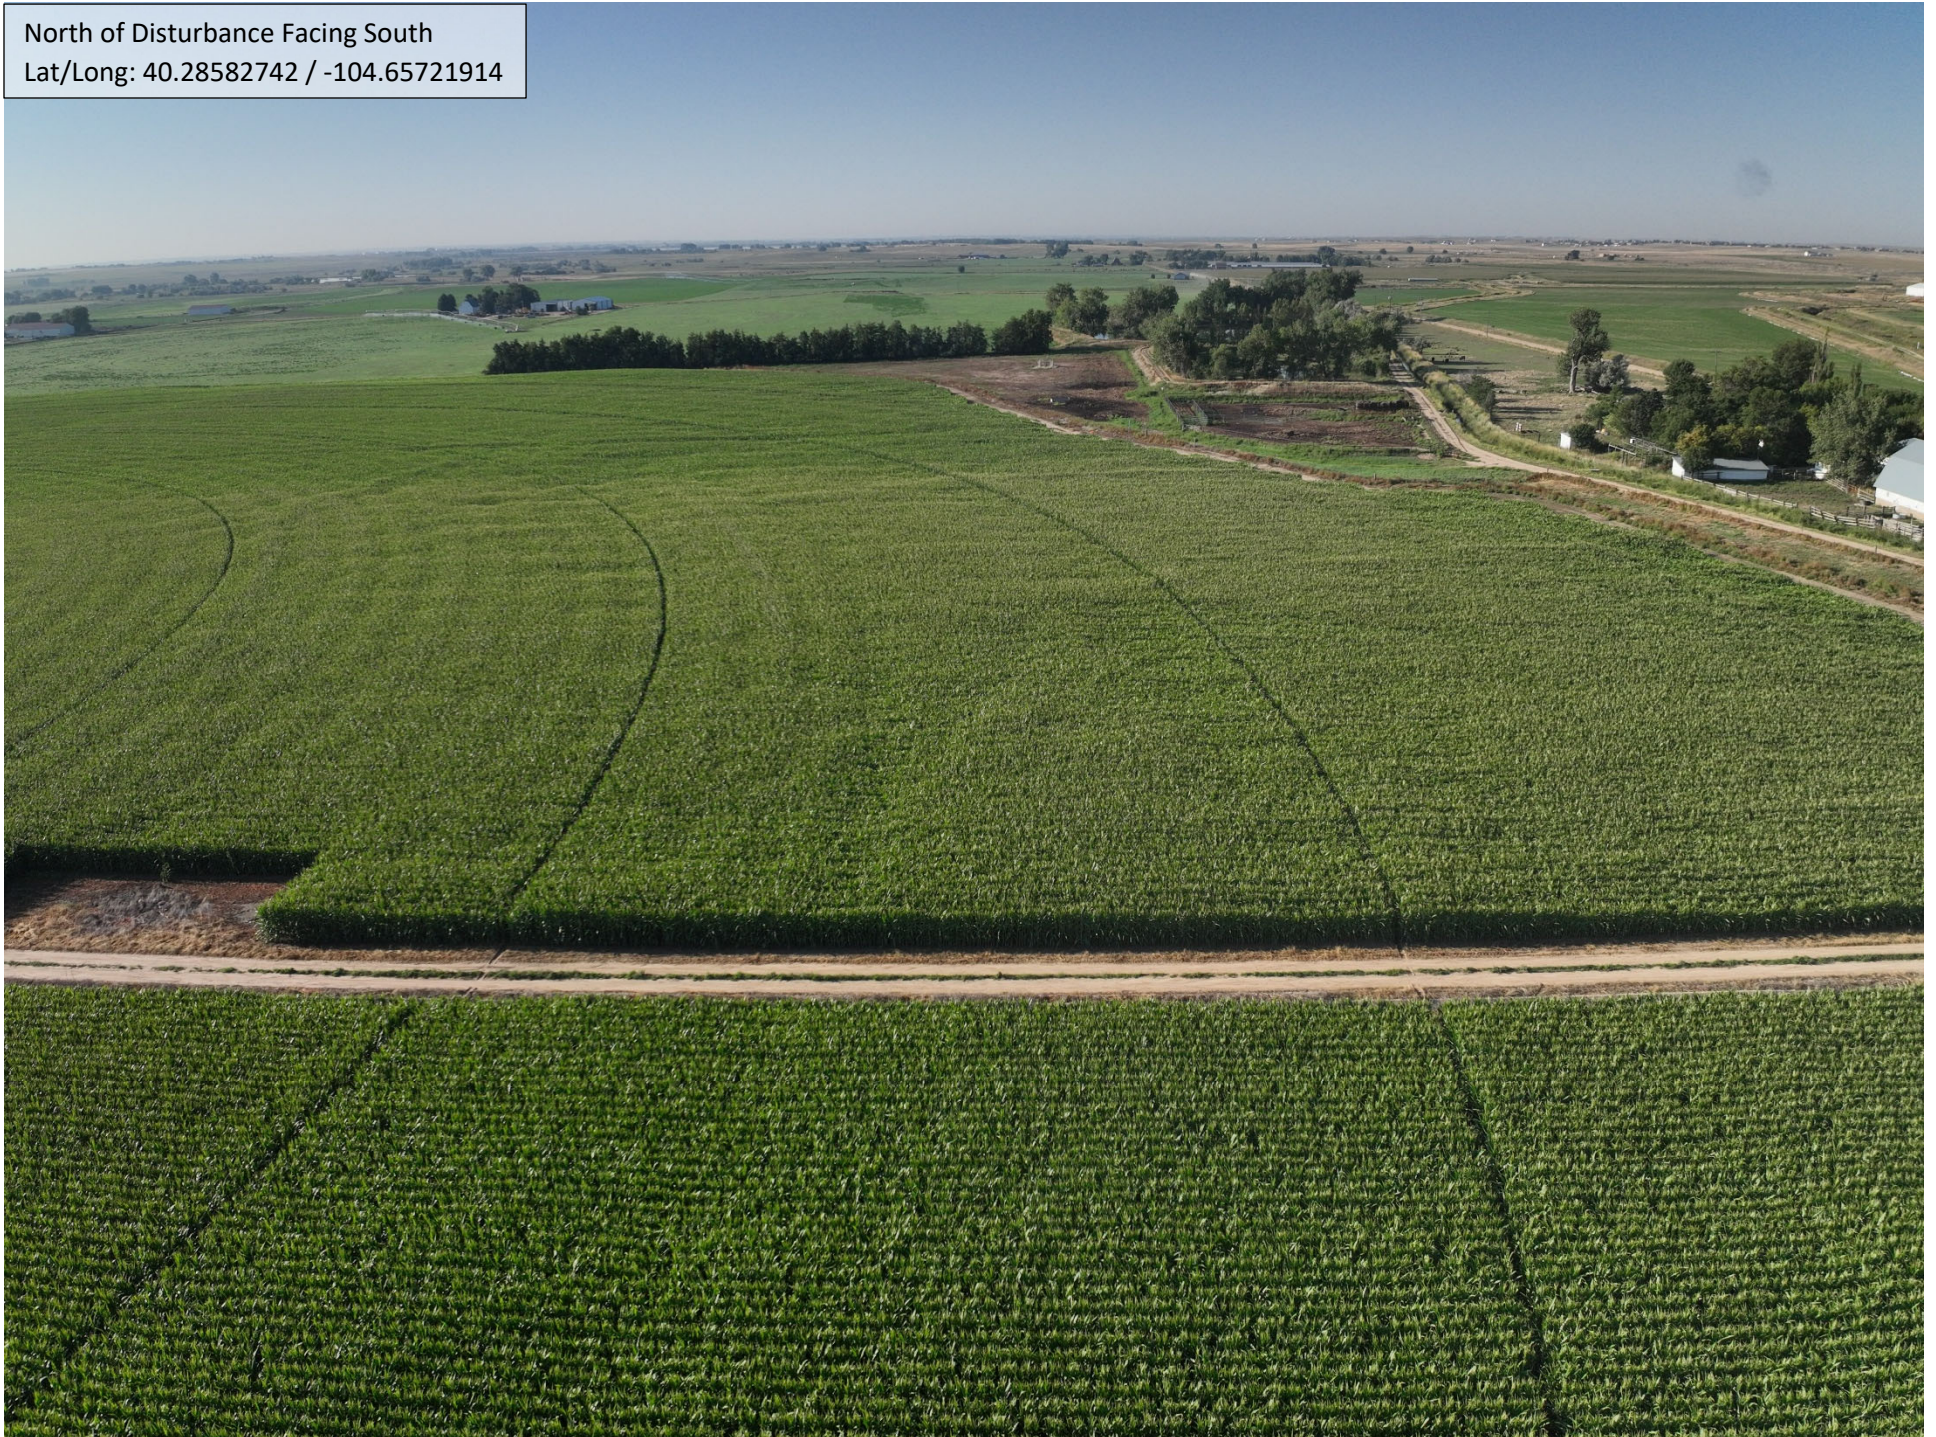
North of Disturbance Facing South  
Lat/Long: 40.28582742 / -104.65721914

Drone imagery confirms that no equipment was left on site at this location after reclamation activities occurred.
