Site Specific Final Reclamation Completion Notice – Cropland Drone Imagery

Permit Closure Report – Cropland

Location Name: ANDERSON-66N66W/10SENE

Report Date:

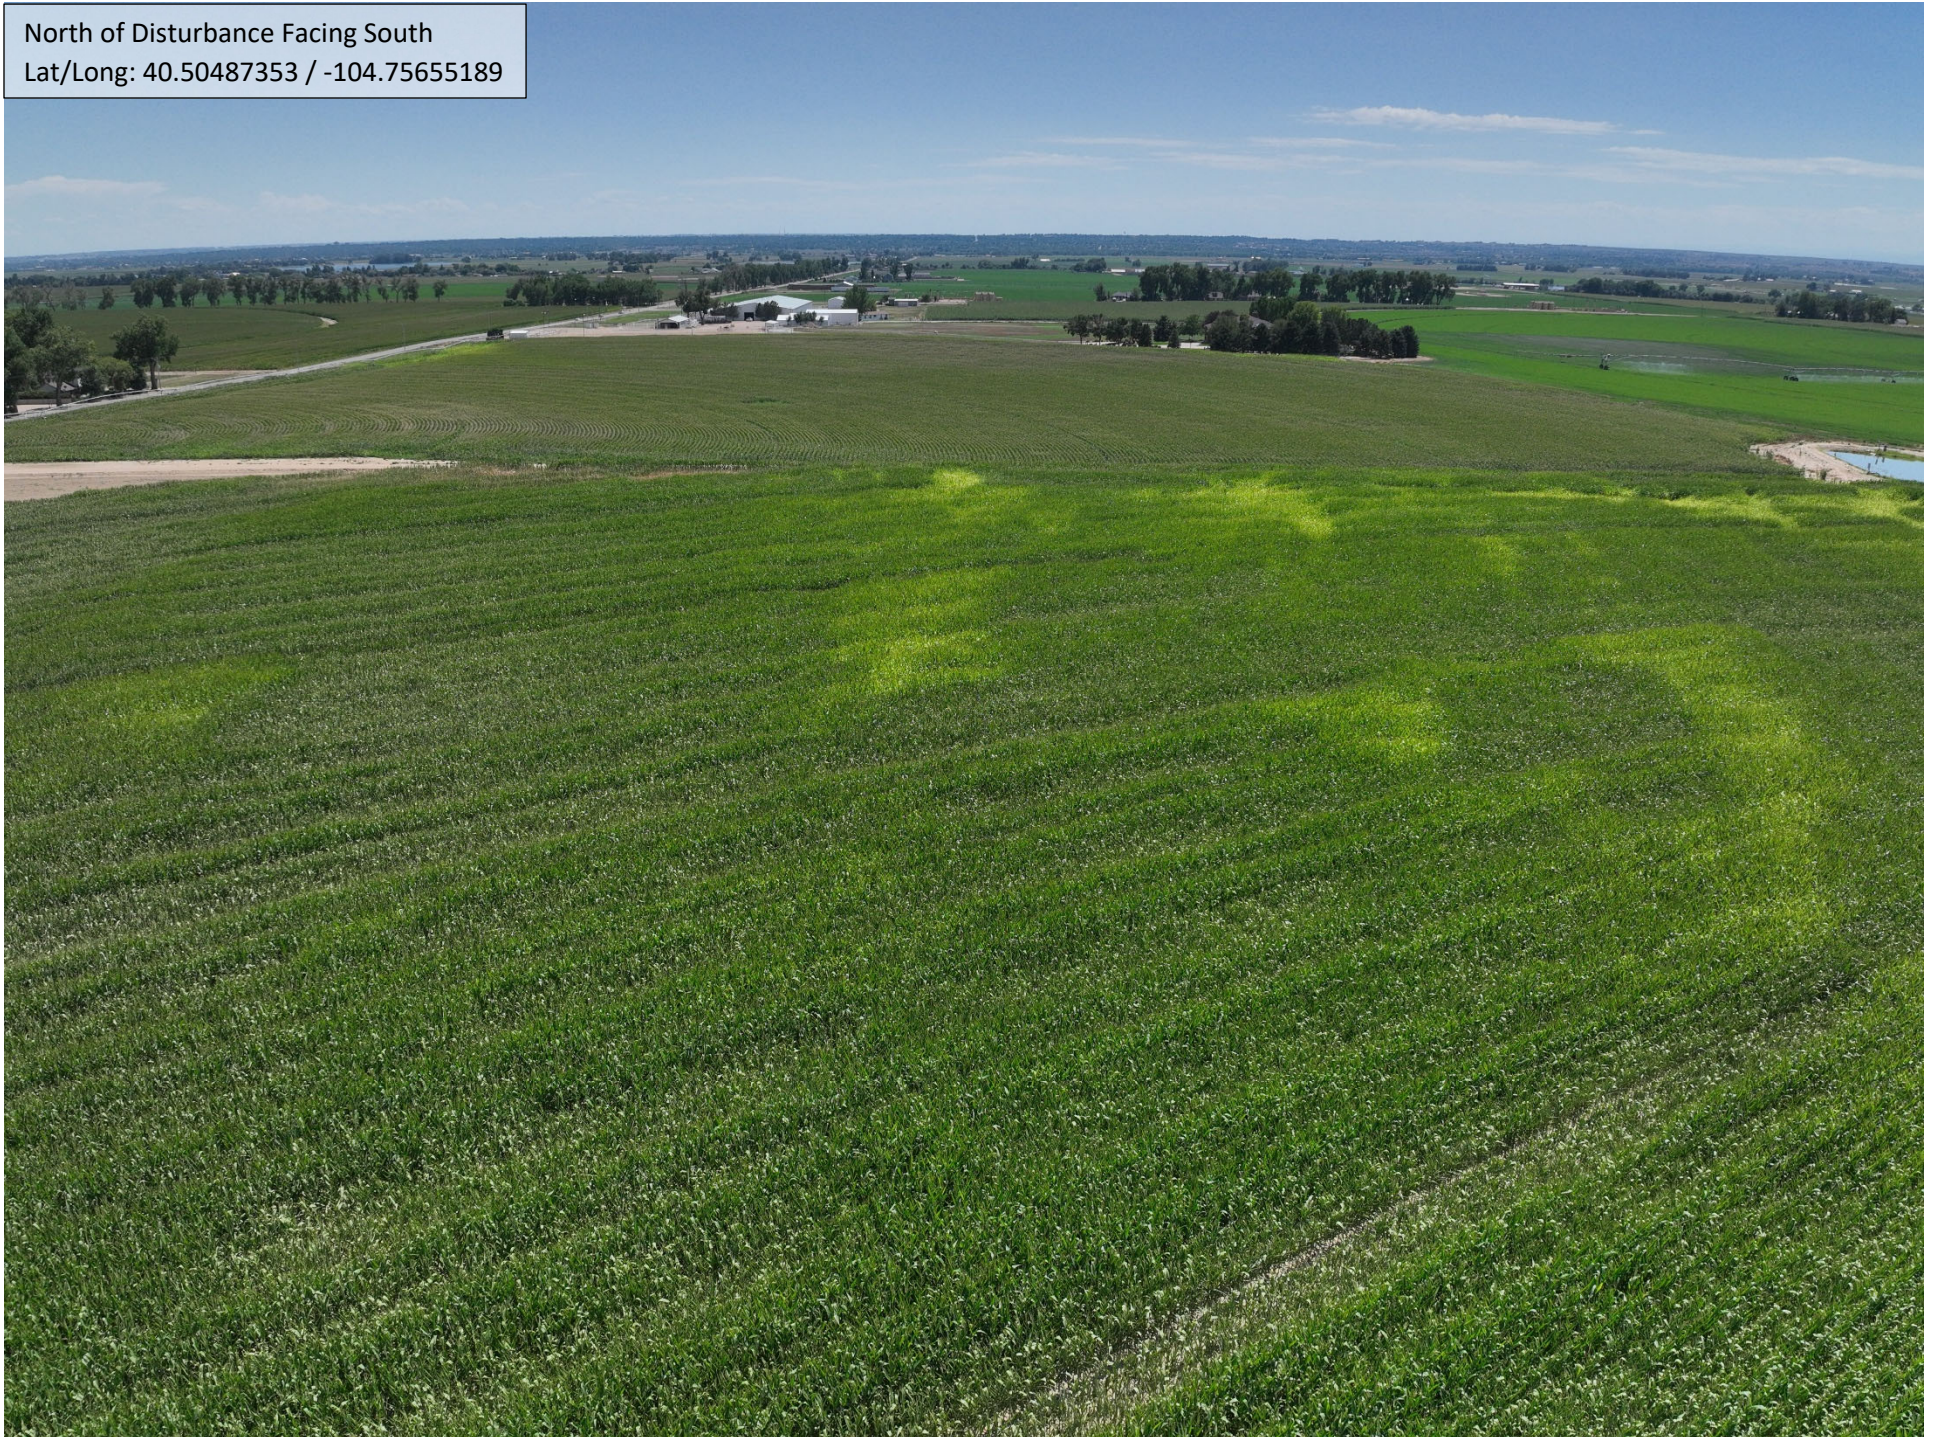
North of Disturbance Facing South
Lat/Long: 40.50487353 / -104.75655189

Drone imagery confirms that no equipment was left on site at this location after reclamation activities occurred.

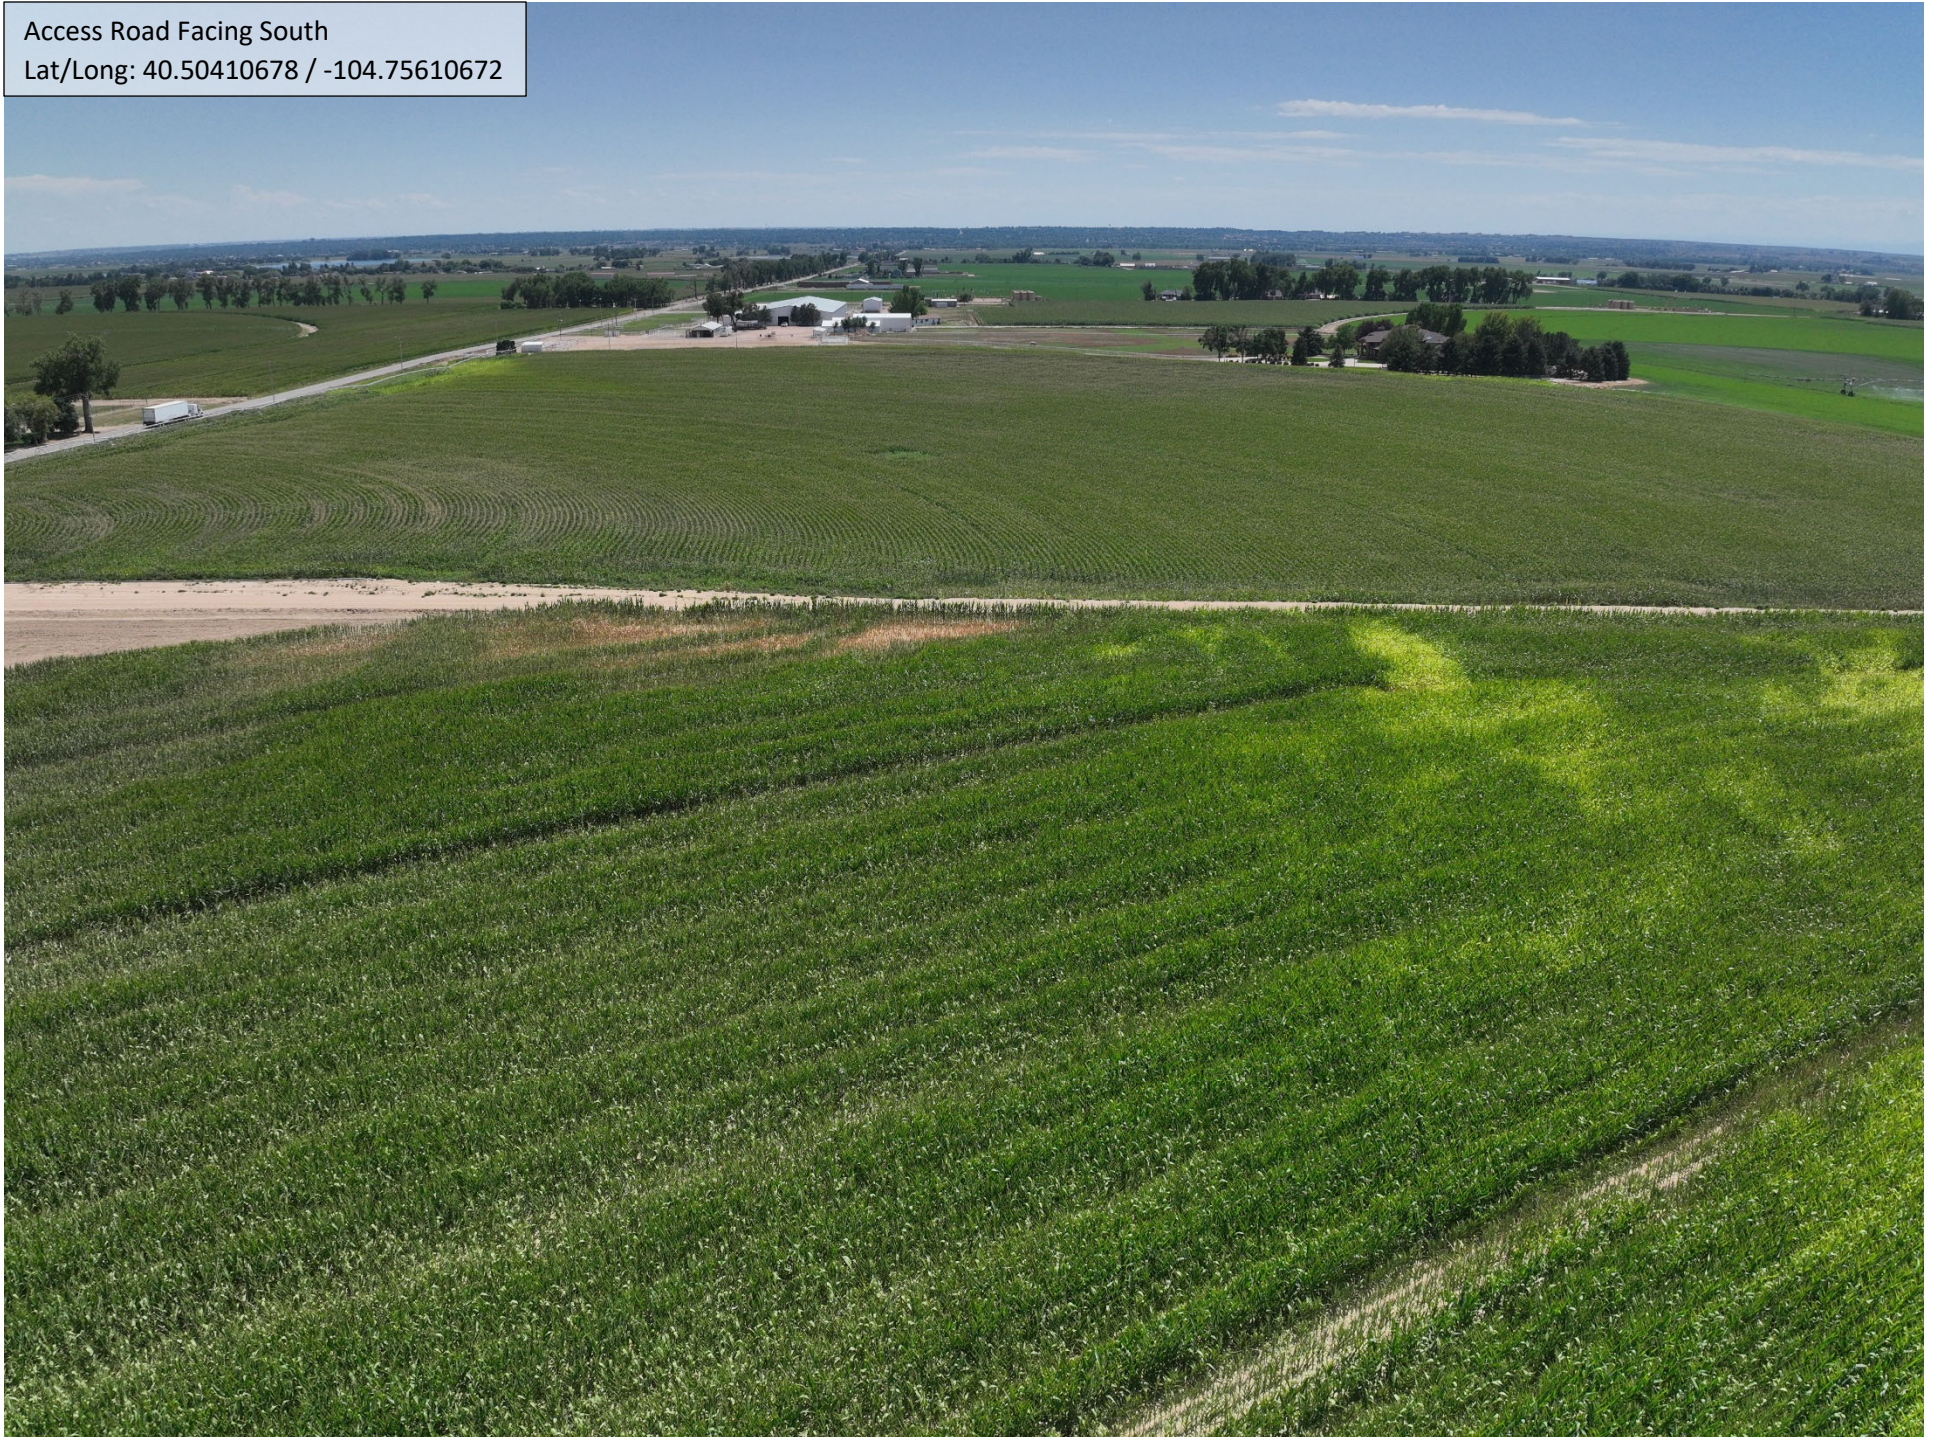
Access Road Facing South

ANDERSON #42-10 was reclaimed and returned to the landowner for agricultural use in 2021. The wellhead was accessed from an unpaved access road that originated at an existing agricultural service road off of County Road 33. The access road was reclaimed and returned to agriculture in conjunction with the reclamation of the well location.
