Inspection Photos

Operator: QB ENERGY OPERATING LLC

Location ID: 335799

Inspection Doc: 718100972

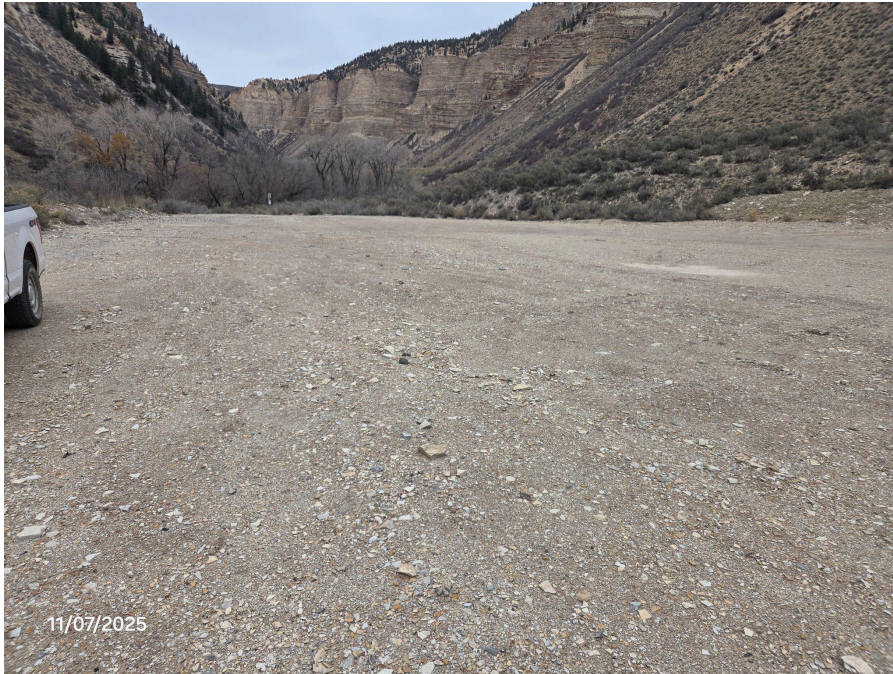
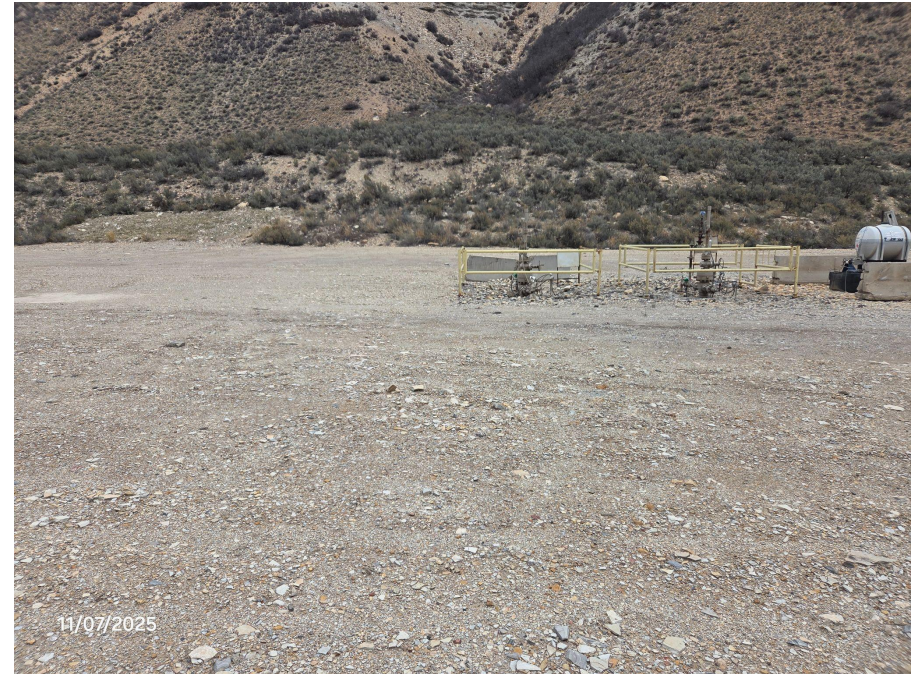
Photo 1: Photos taken from the west end of the Location; photos provide an overview of the working pad surface from north, northeast, southeast to south.

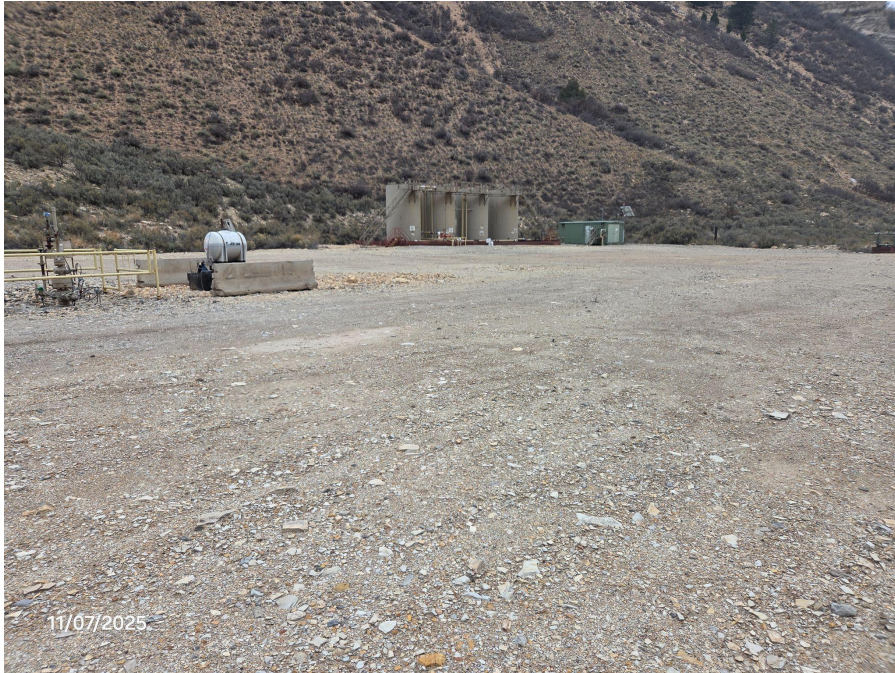
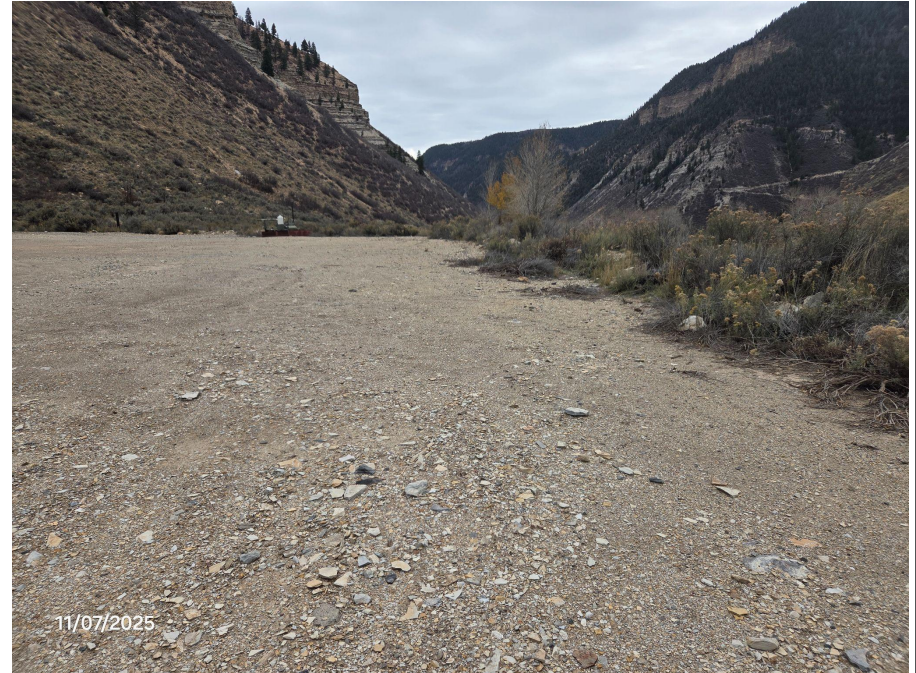
Photo 2: See comments under photo 1.

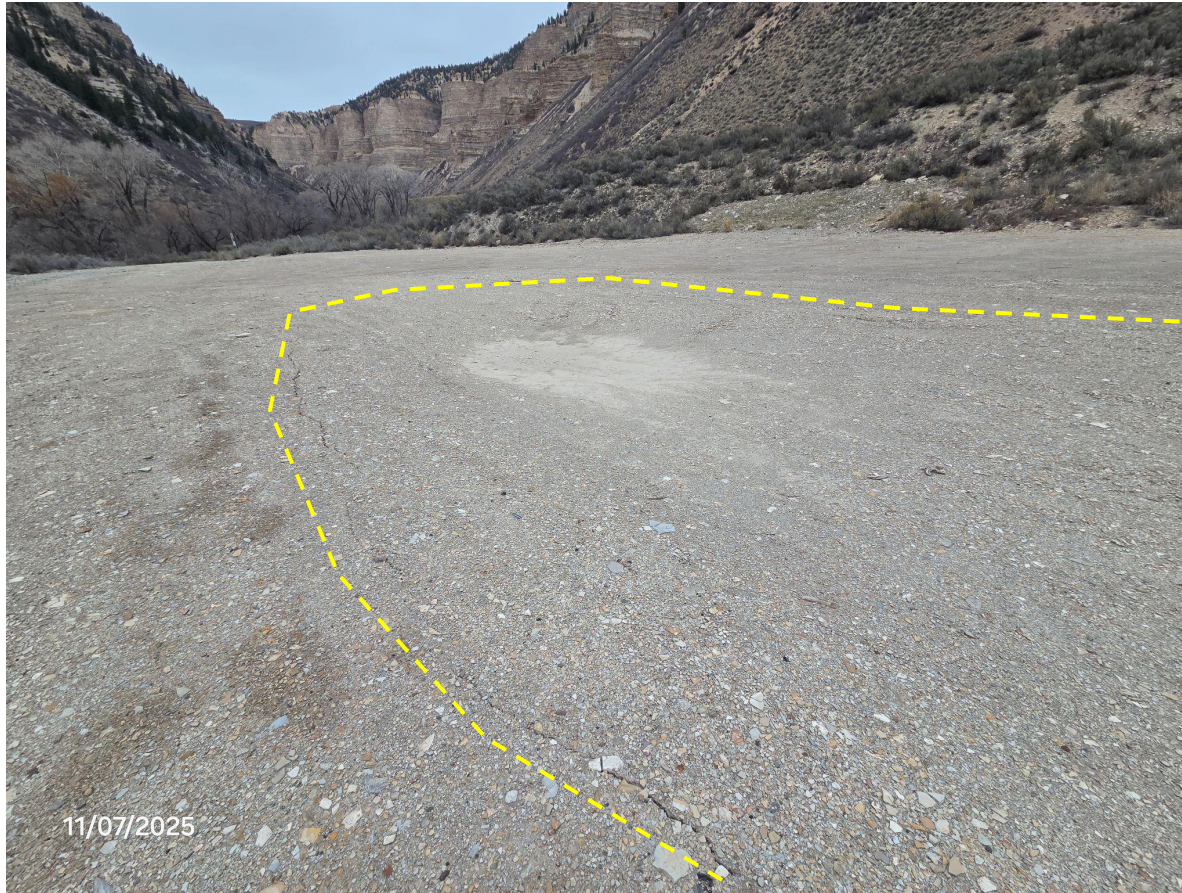
Photo 3: Photo taken next to the wells on the north end of the Location, facing north. Dotted yellow line shows the area where subsidence is developing on the Location and cracking is evident. Stormwater ponding is also apparent within these areas; unclear if stormwater is the source of the subsidence/sinking, or if ponding is facilitating the degradation.

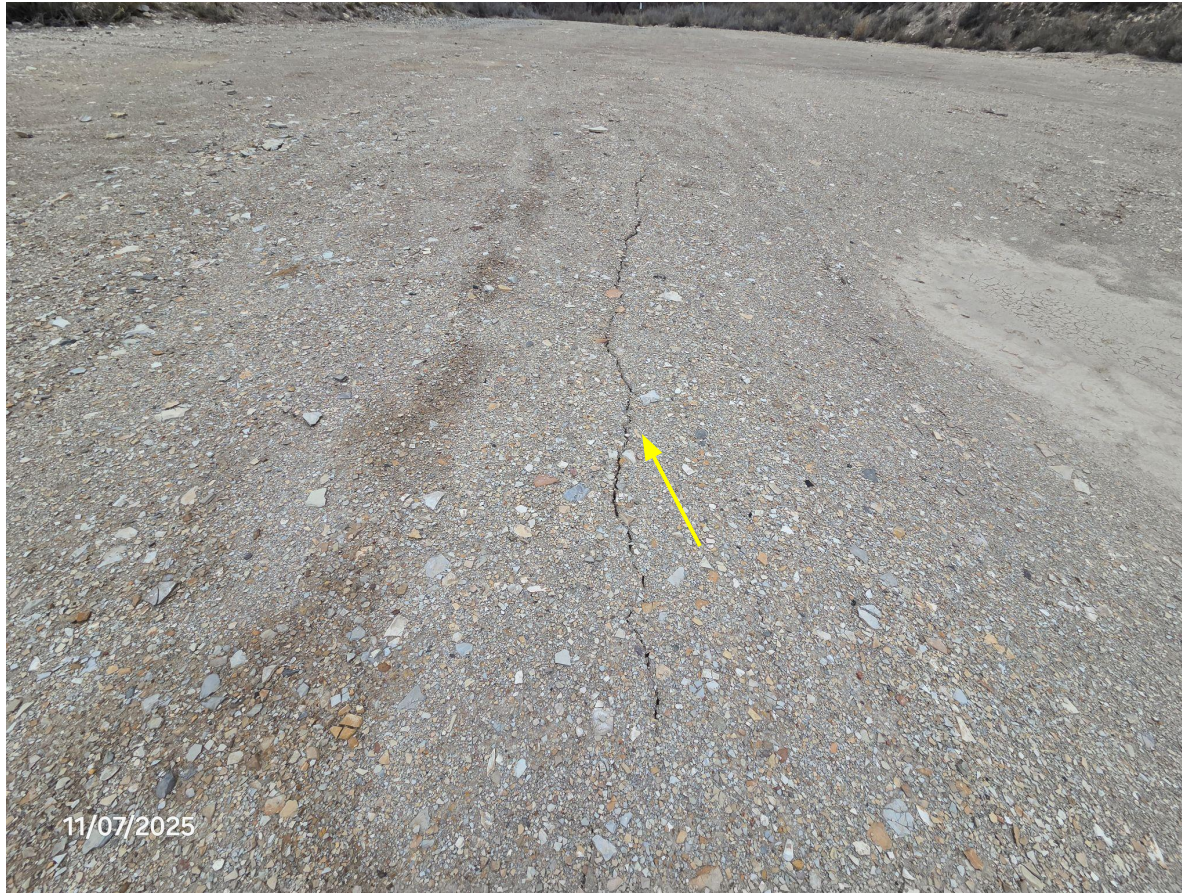
Photo 4: Continued from photo 3. Arrow shows cracks developing around areas of observed subsidence.

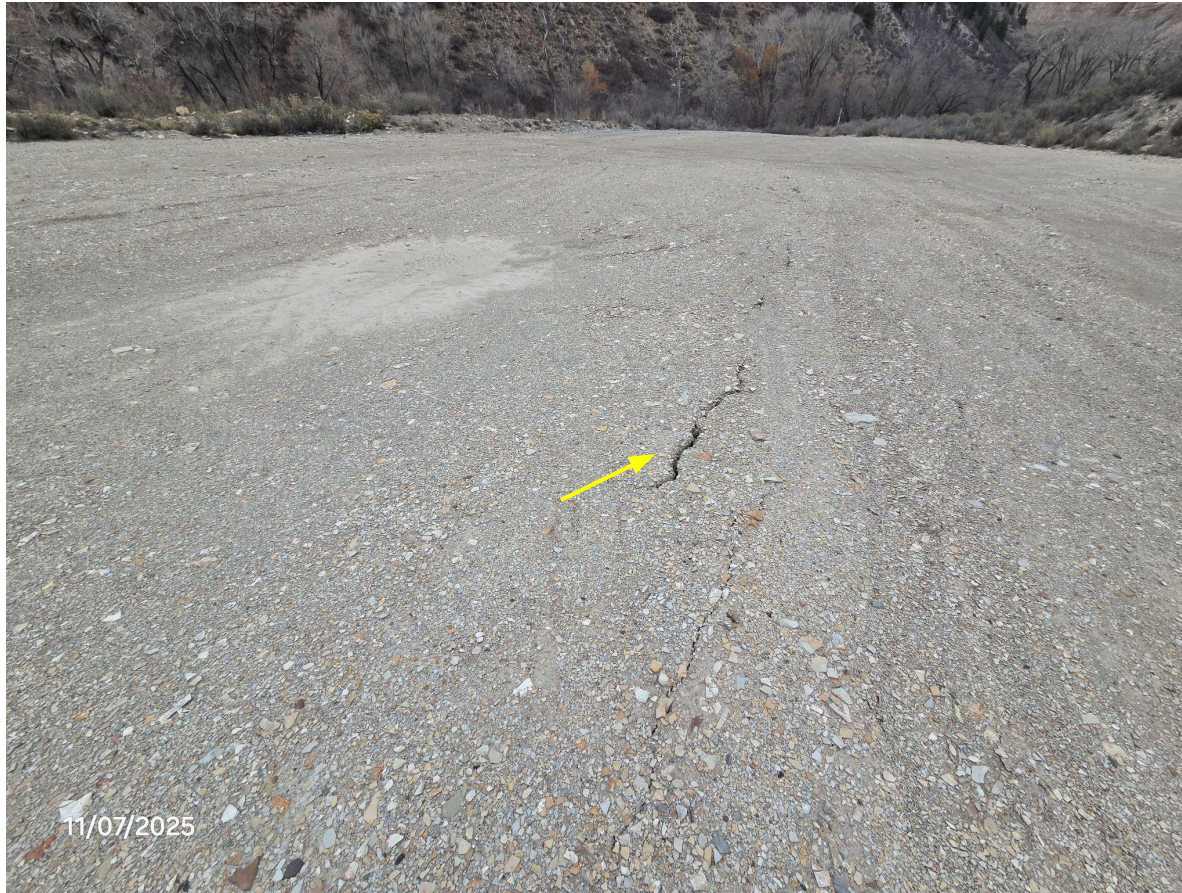
Photo 5: Continued from photo 3. Arrow shows cracks developing around areas of observed subsidence.

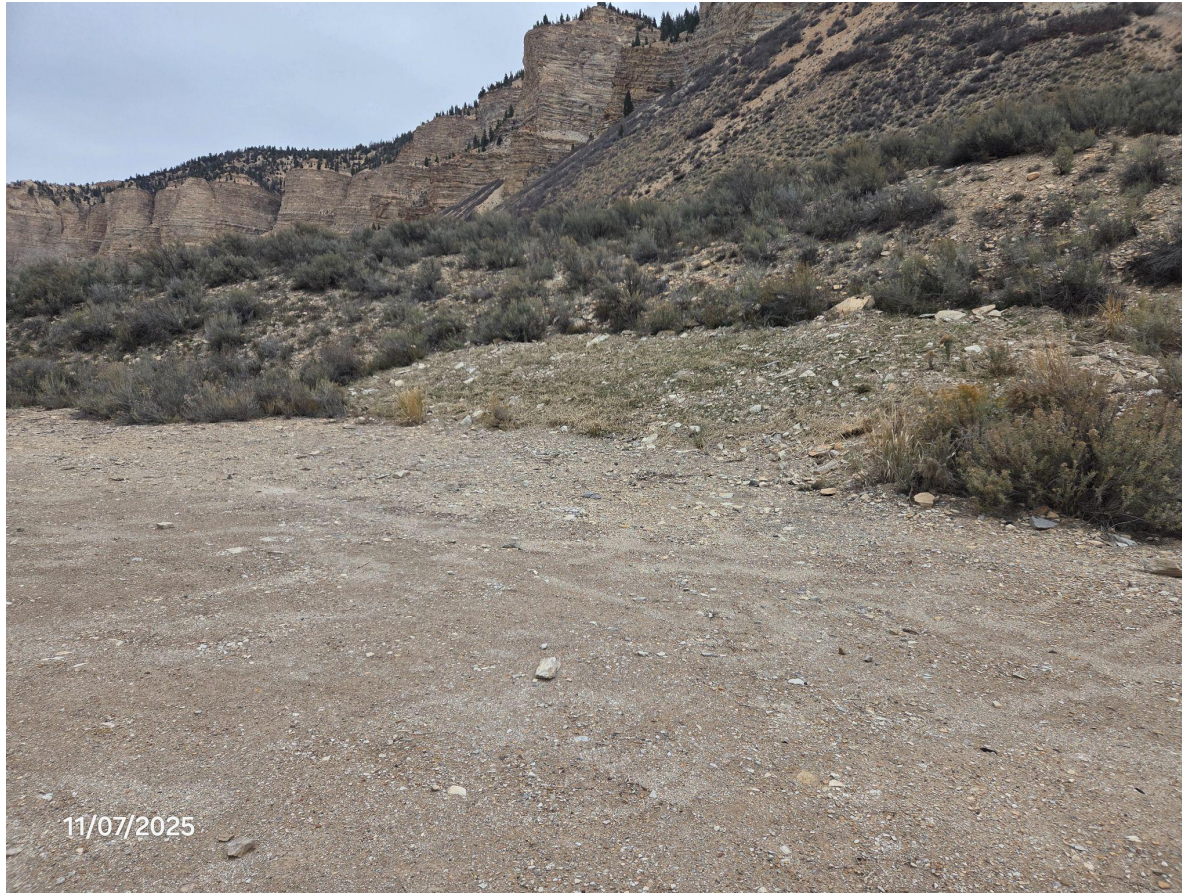
Photo 6: Photo taken from the northeast end of the Location, facing northeast. Photo shows additional reclamation efforts have been taken by Operator. Areas appear to be progressing towards 1003 standards.

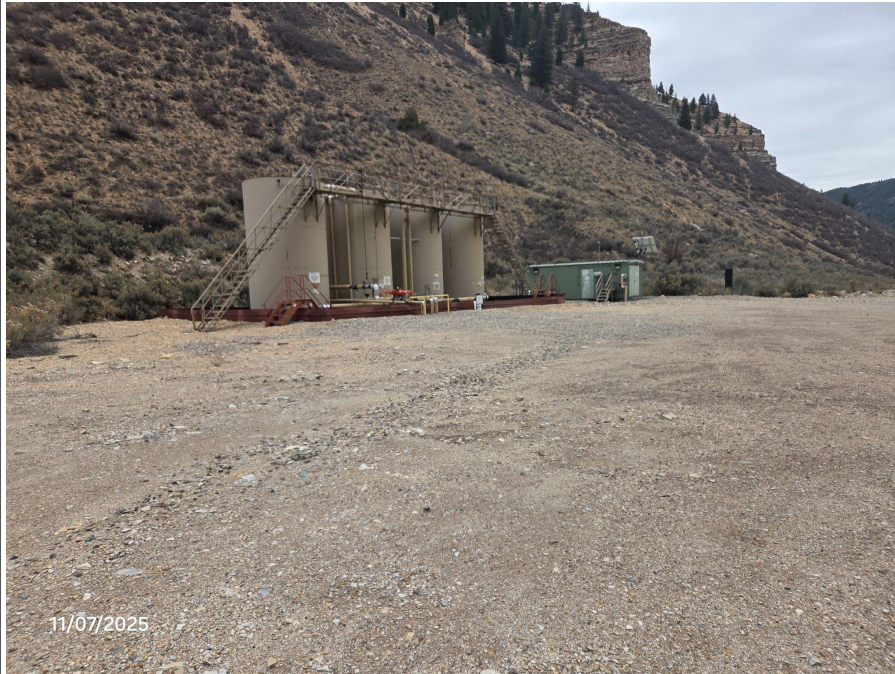
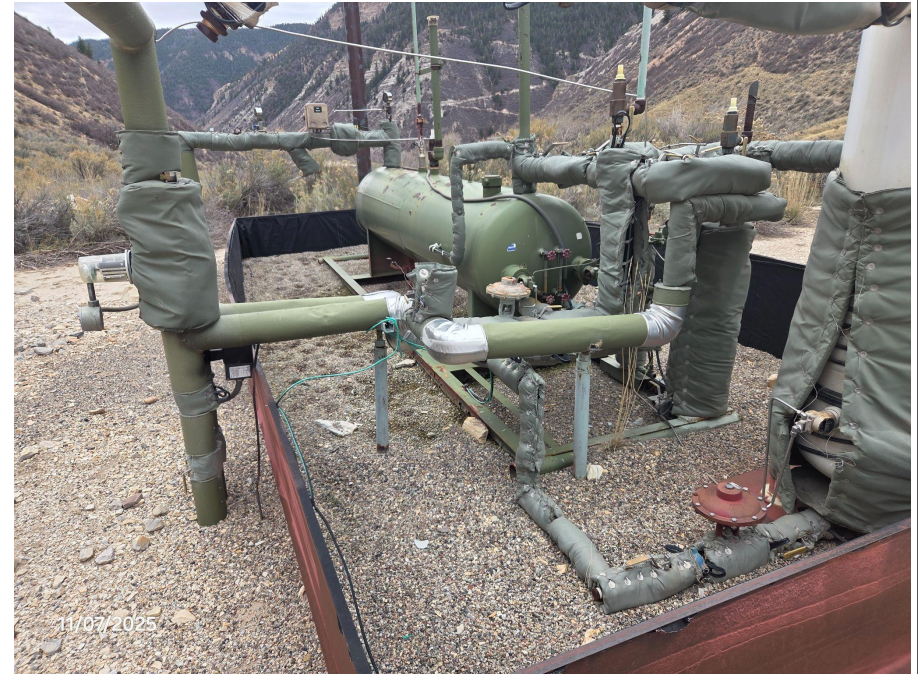
Photo 7: Photo shows the tank battery and separator facility on the southern areas of the Location. Secondary containment has been maintained and appears to be in proper functioning condition.

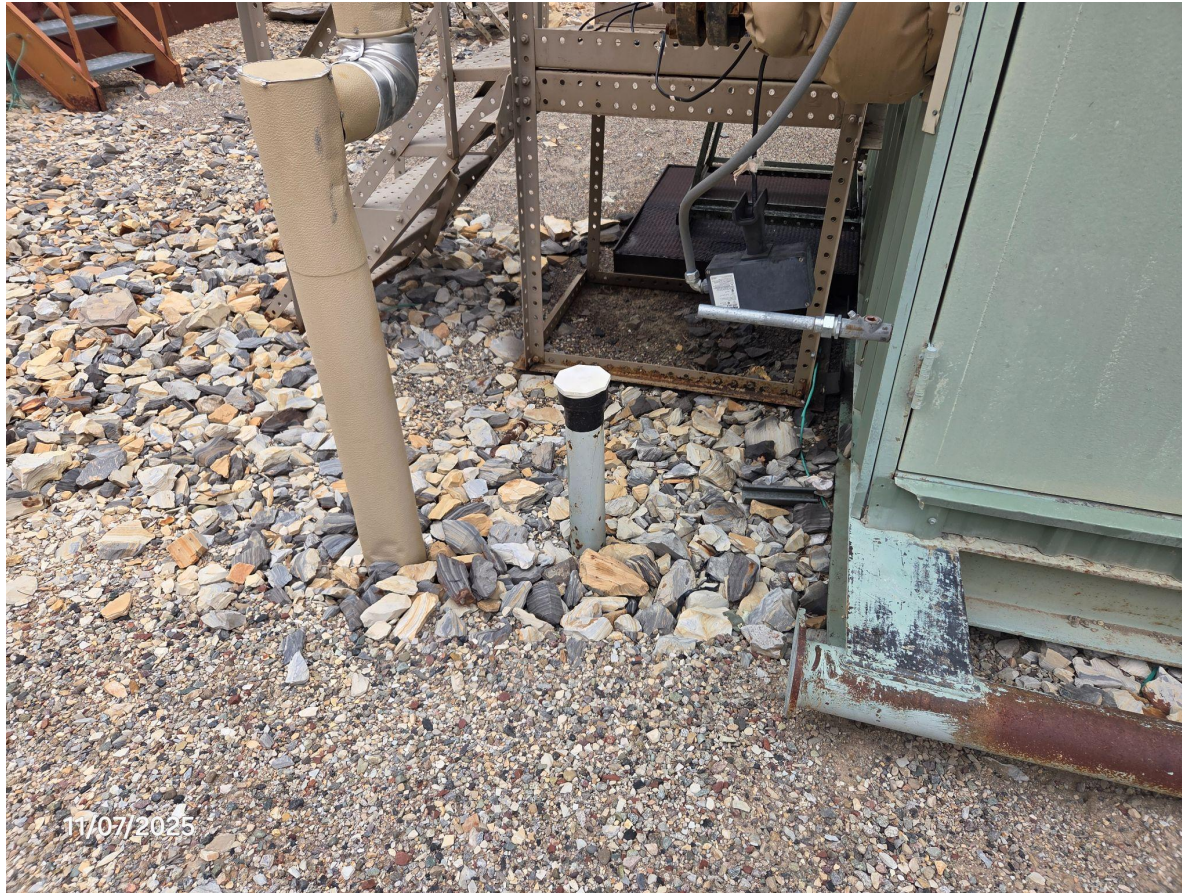
Photo 8: Photo taken from the housing unit on the southeast end of the Location. Pipe next to housing has been capped to prevent wildlife access.
