Inspection Photos

11/07/2025

Operator: QB ENERGY OPERATING LLC

Location ID: 335656

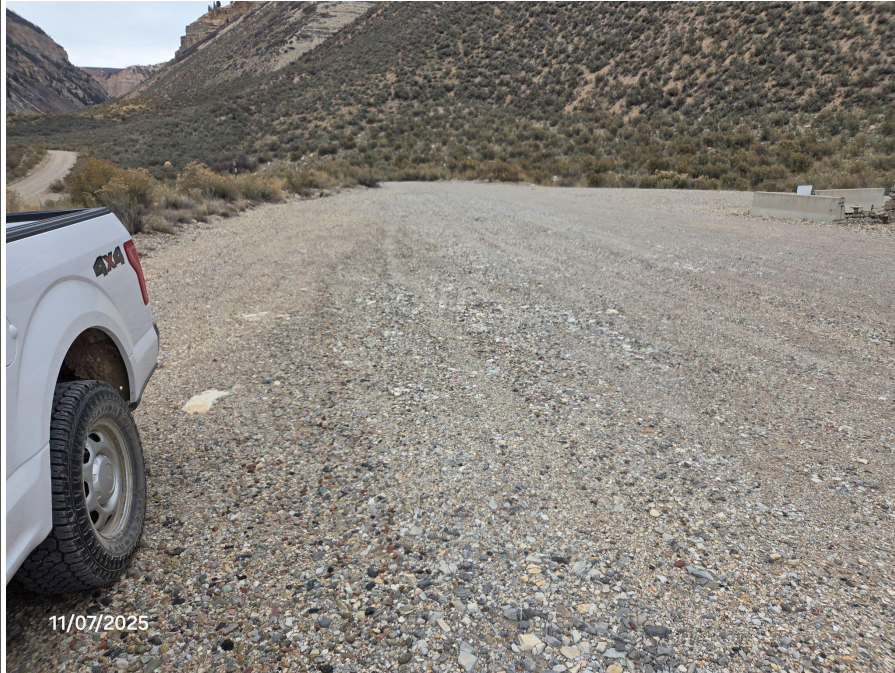
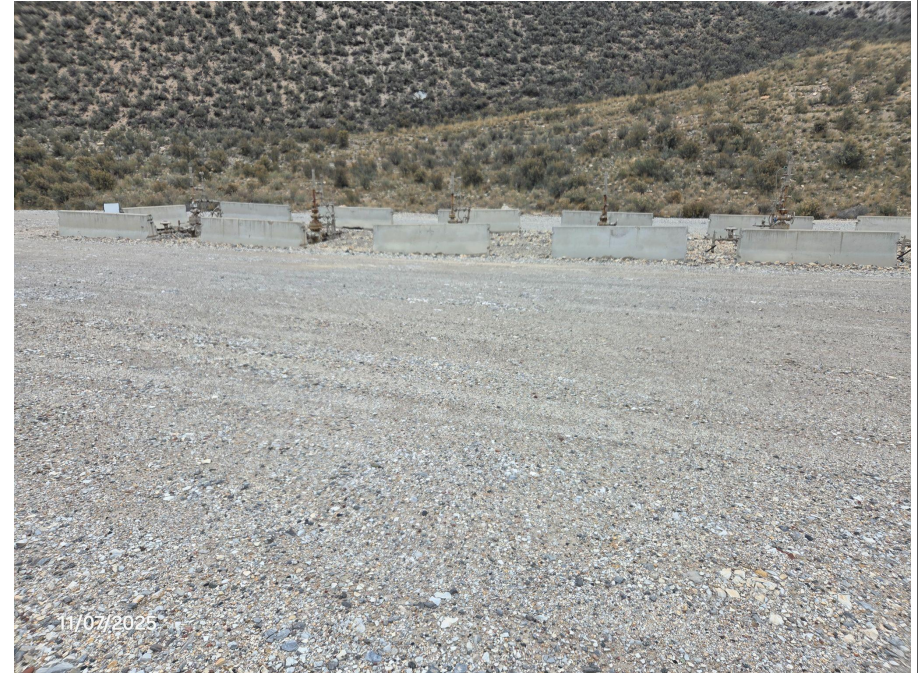
Photo 1: Photos taken from the west end of the Location; photos provide an overview of the working pad surface from north, northeast, southeast to south.

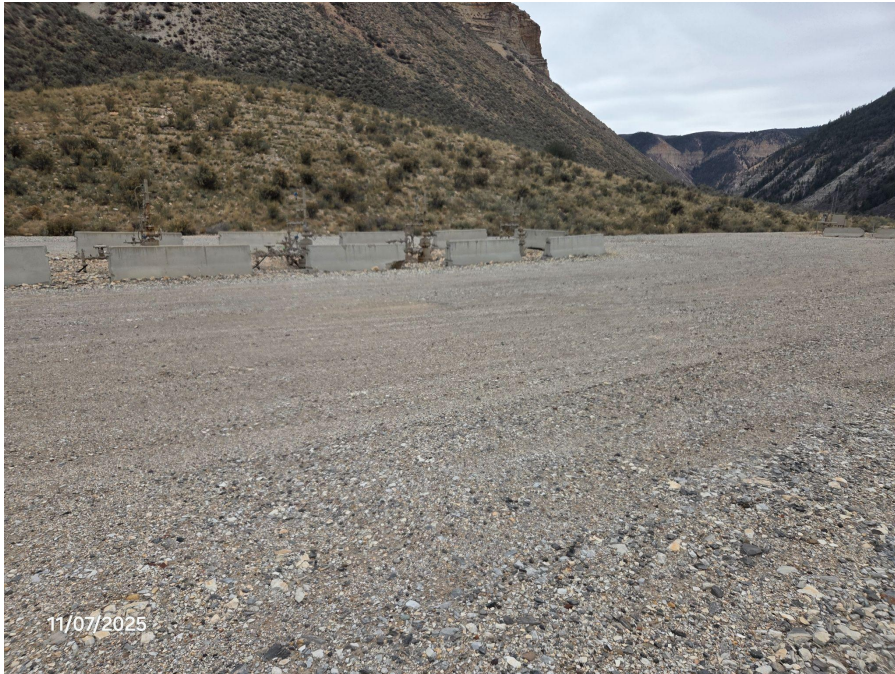
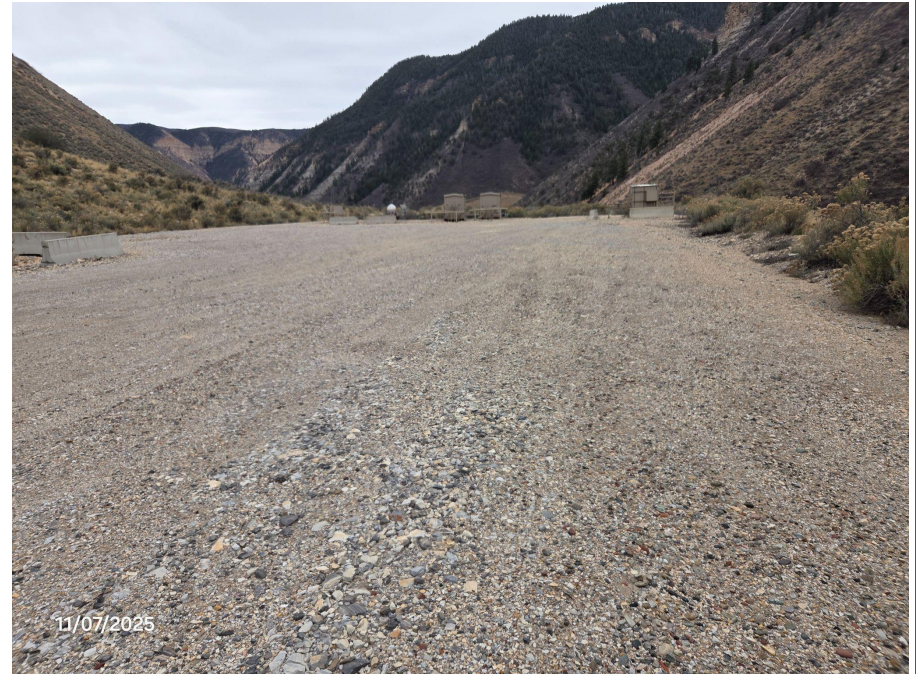
Photo 2: See comments under photo 1.

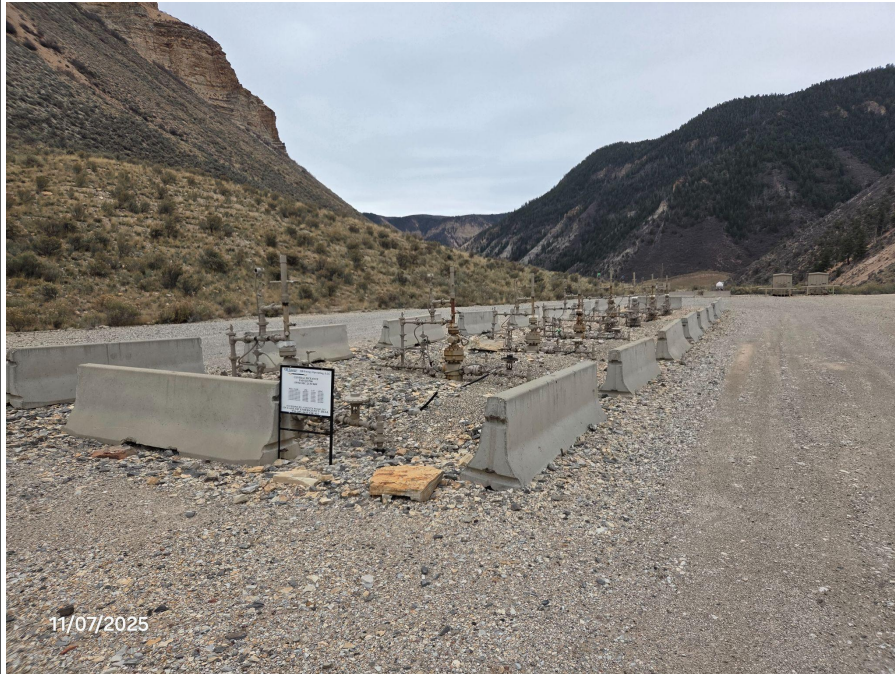
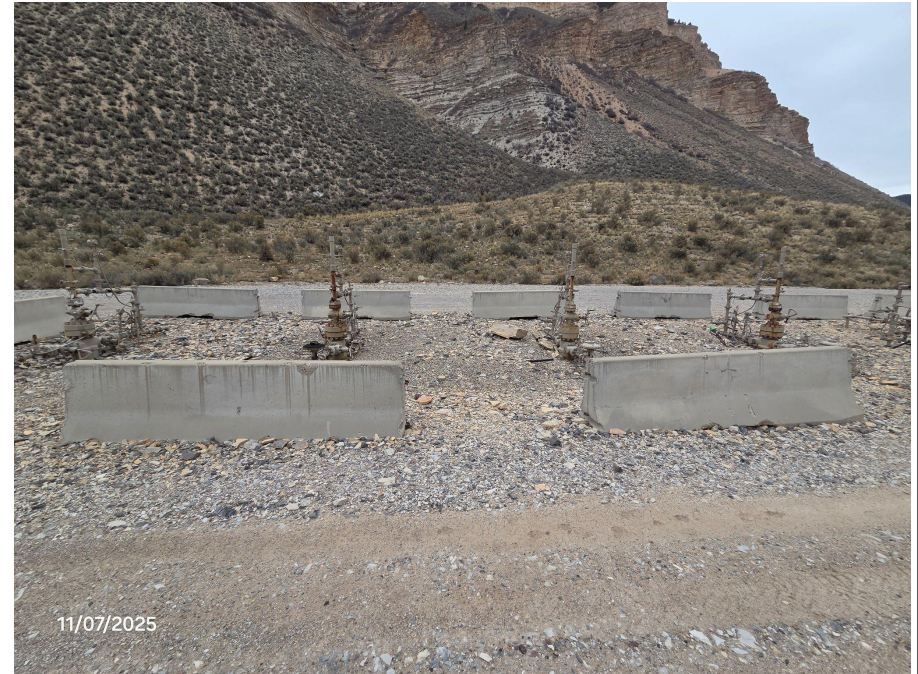
Photo 3: Photos taken from the wells. Operator has placed a single sign on the north end of the wells. Signage has not been posted at each wellhead pursuant to Rule 605.d.

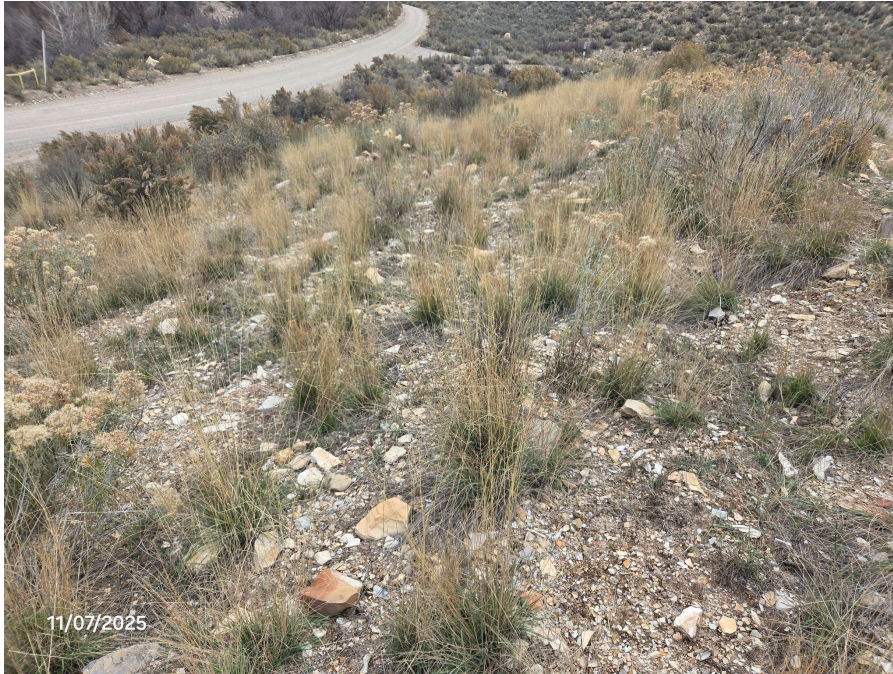
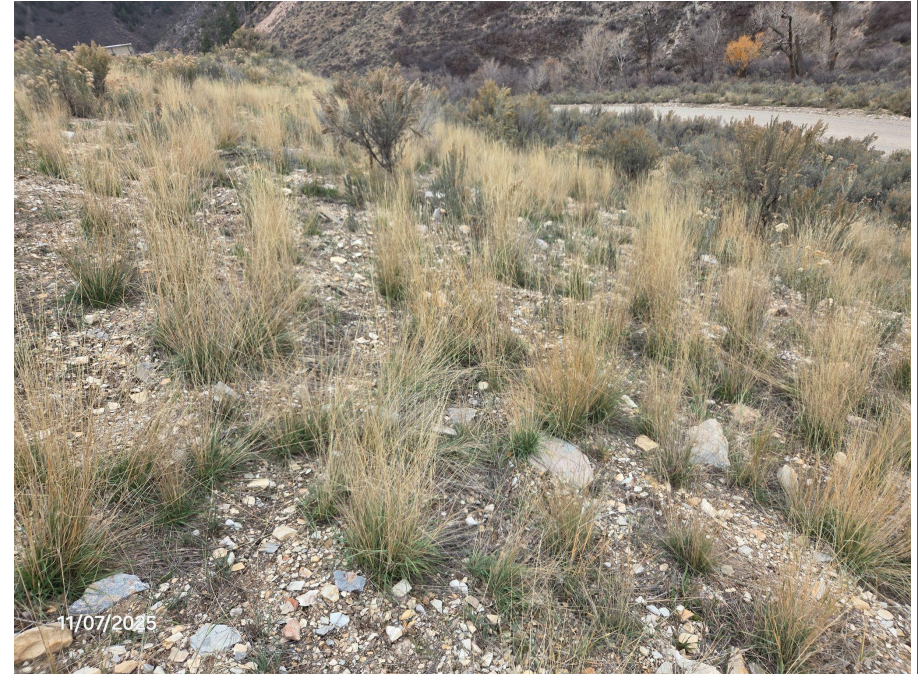
Photo 4: Photo shows taken from the interim areas on the west end of the Location, facing north and south respectively. Vegetation appears to be progressing towards 1003.e standards.

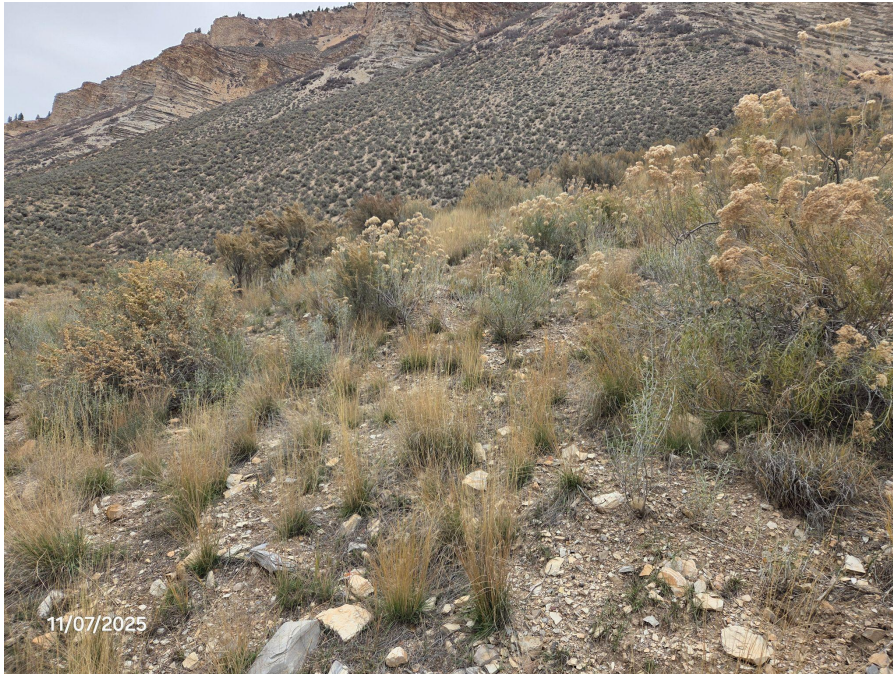
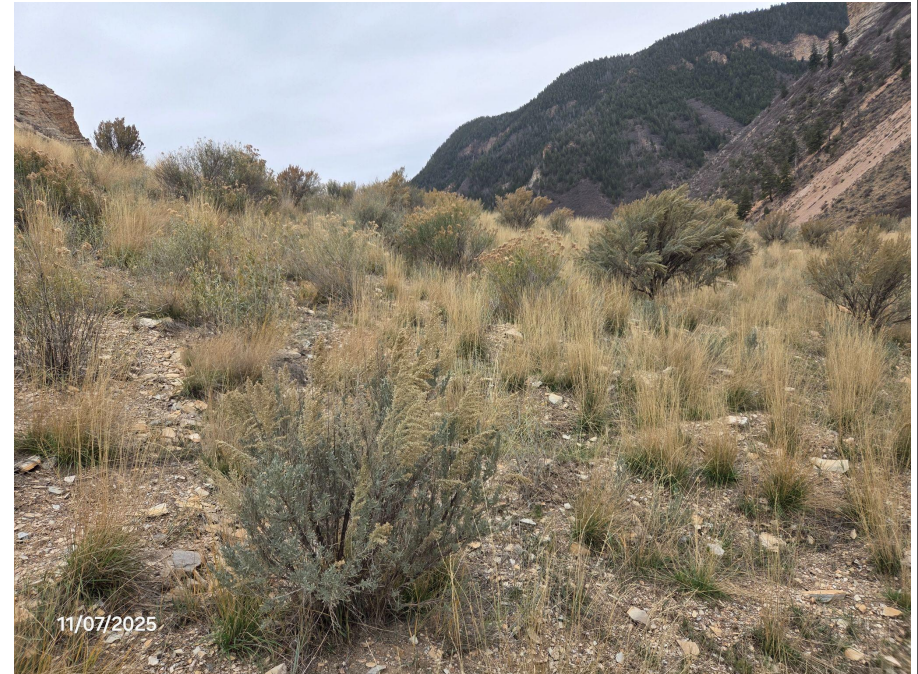
Photo 5: Photo shows taken from the interim areas on the east end of the Location, facing north and south respectively. Vegetation appears to be progressing towards 1003.e standards.

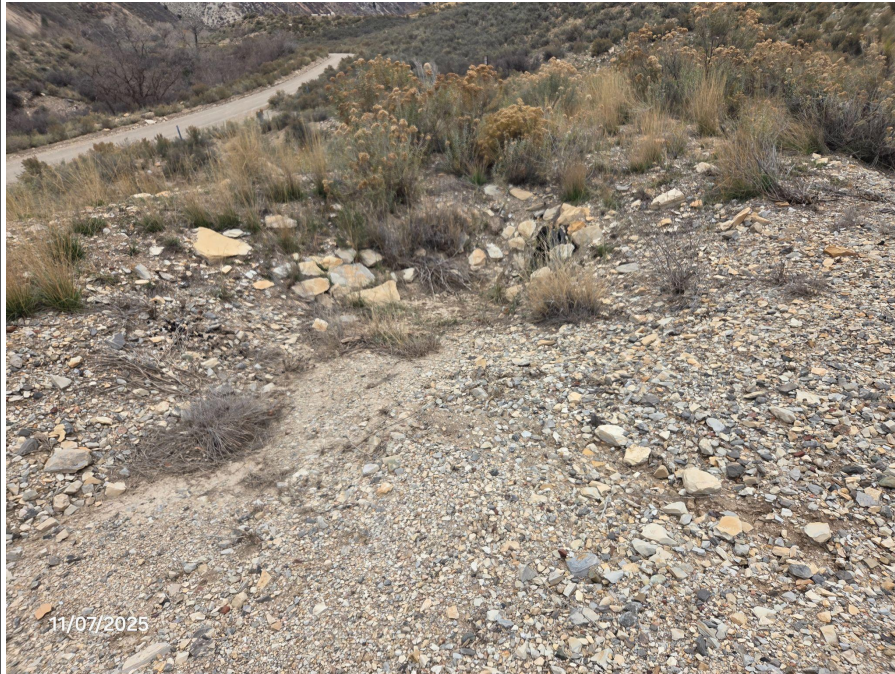
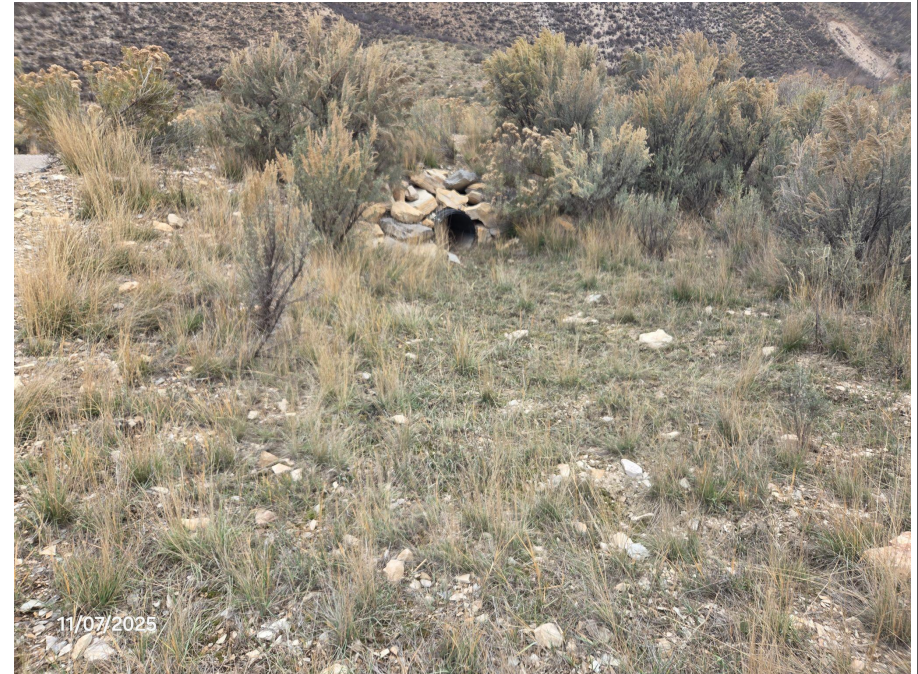
Photo 6: Photo shows culvert and sediment traps at the Location entrance on the north end of the Location.

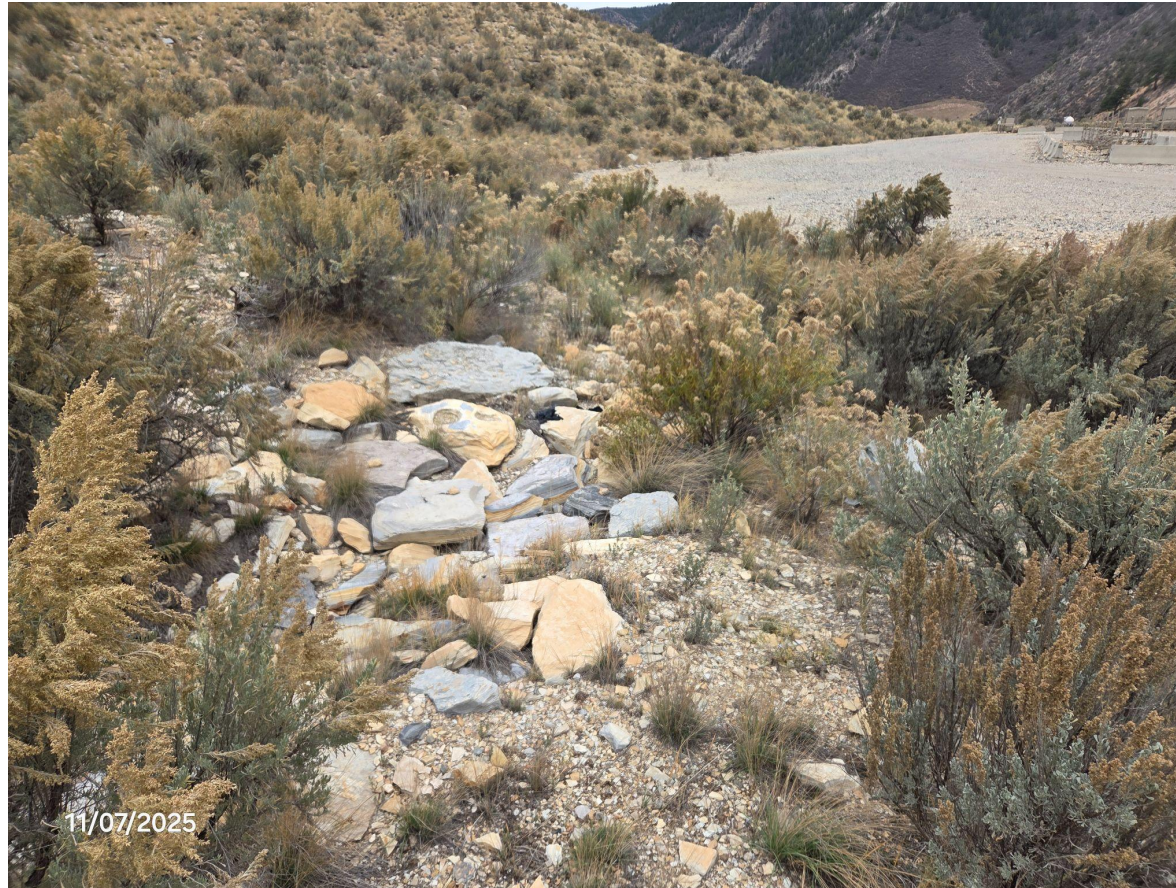
Photo 7: Photo shows the outlet point for the sediment trap on the north end of the Location (east side of road/culvert) appears to be higher in elevation than the inlet and WPS; additional investigation and review of the BMP advised to ensure outlets are functioning as intended.

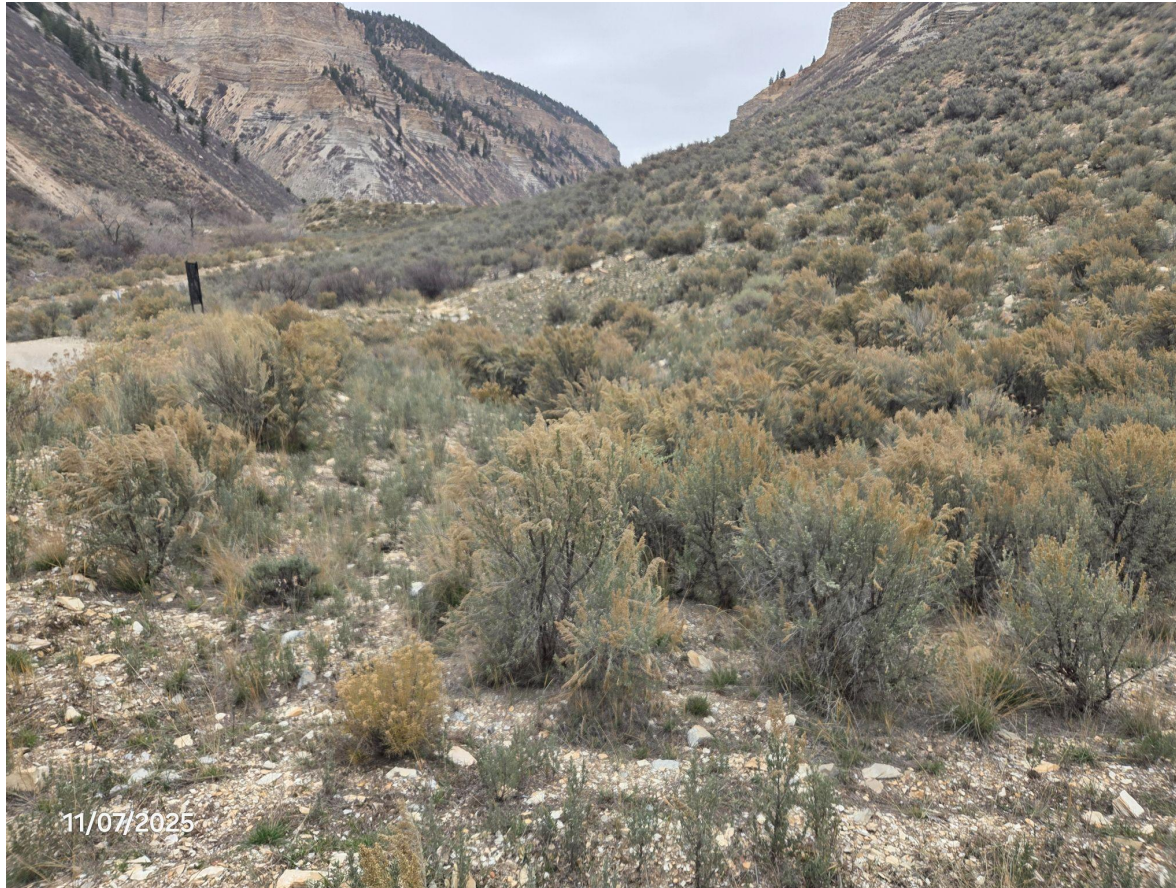
Photo 8: Photo shows the multiple retention basins observed on the north/northeast end of the Location.

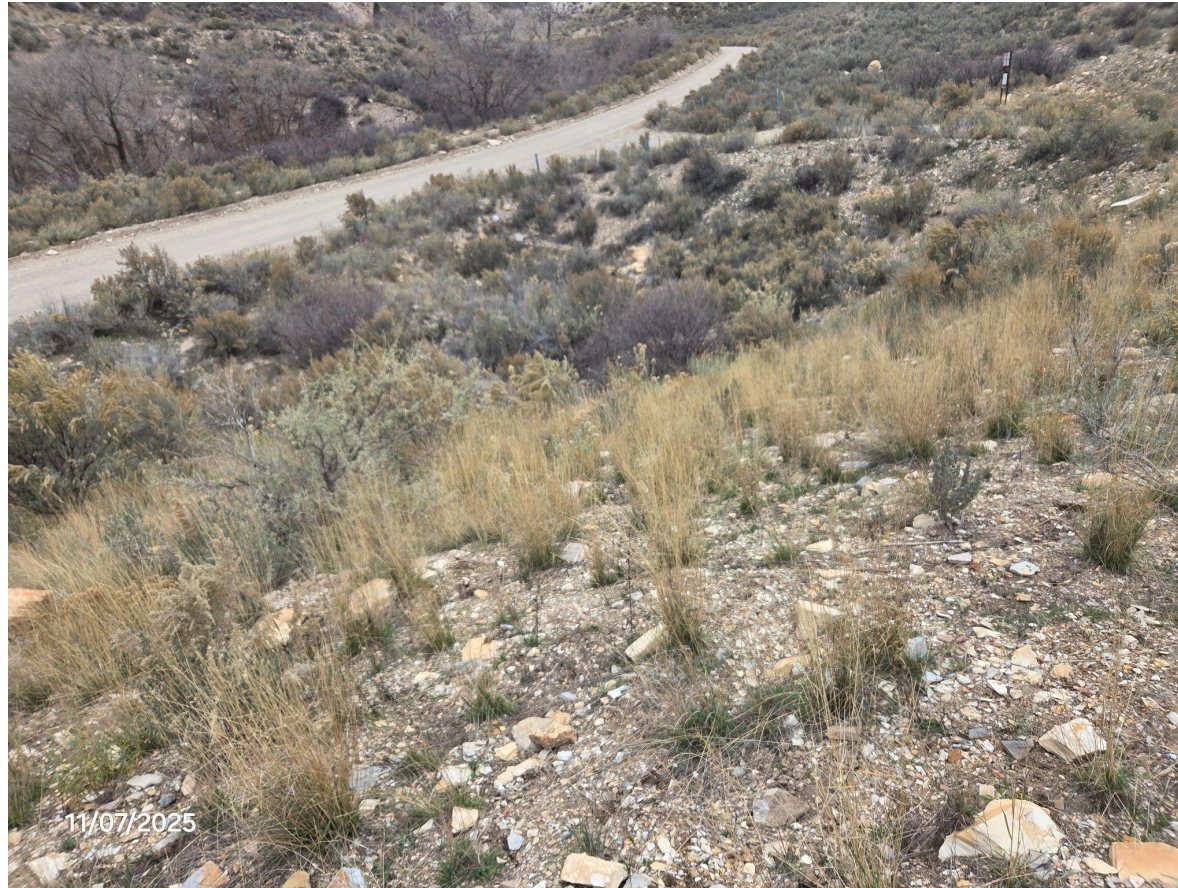
Photo 9: Photo shows the retention basin observed on the northwest end of the Location.
