# Inspection Photos

**Operator:** QB ENERGY OPERATING LLC

**Location ID:** 335668

**Inspection Doc:** 718100978

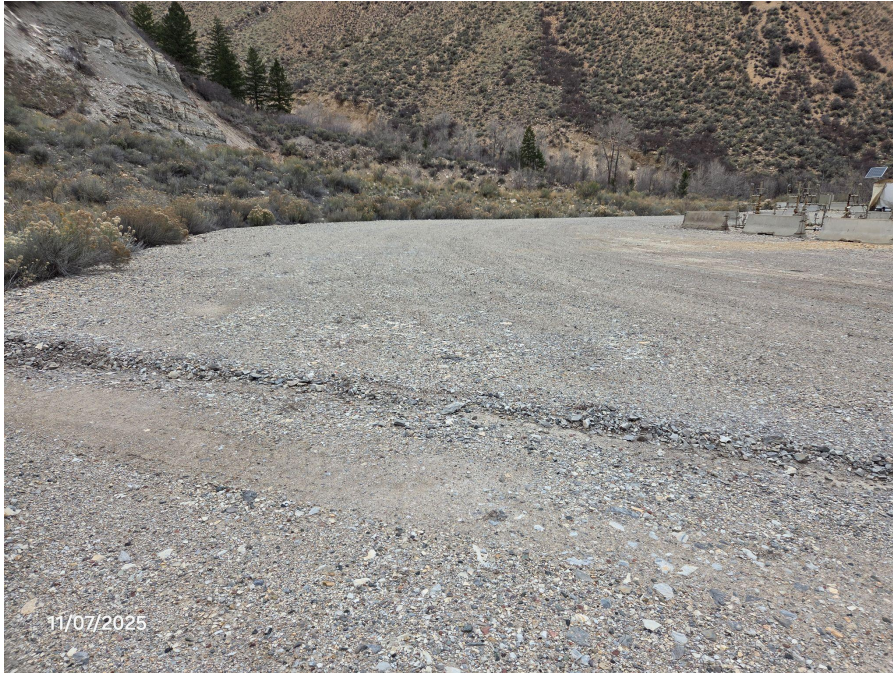
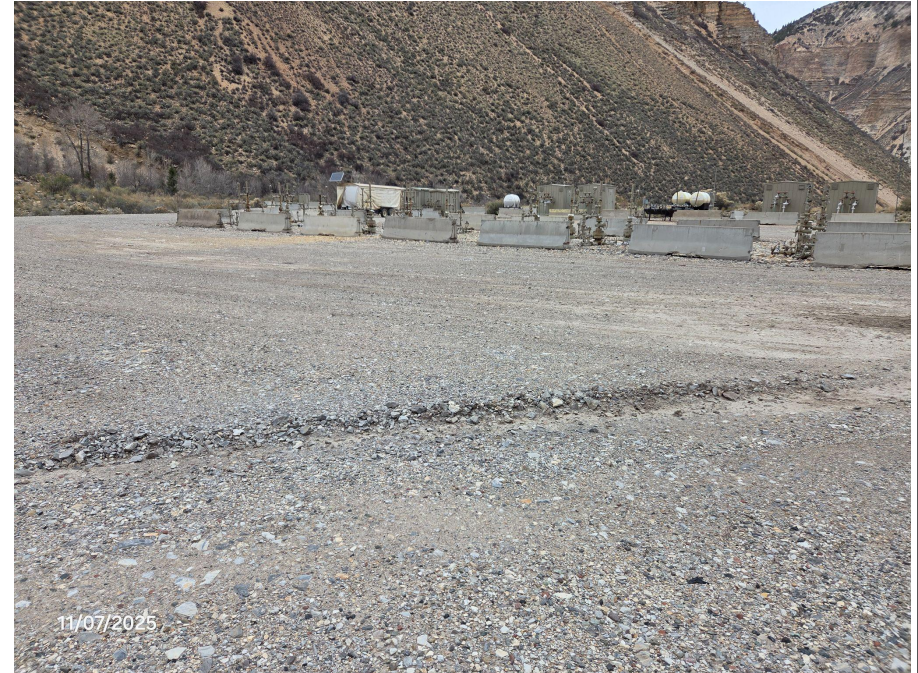
**Photo 1:** Photos taken from the south end of the Location; photos provide an overview of the working pad surface from west, northwest, northeast to east.

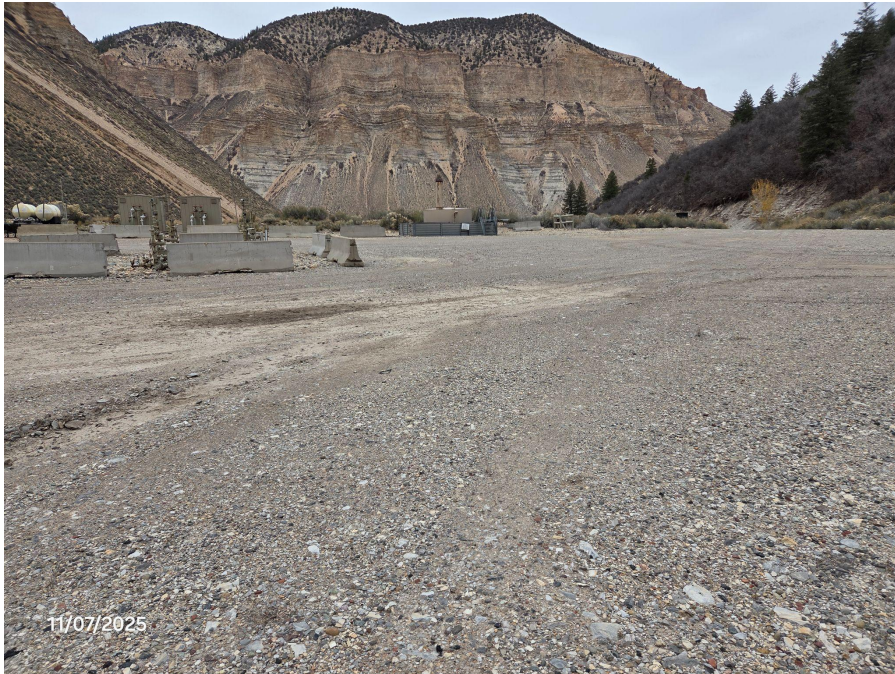
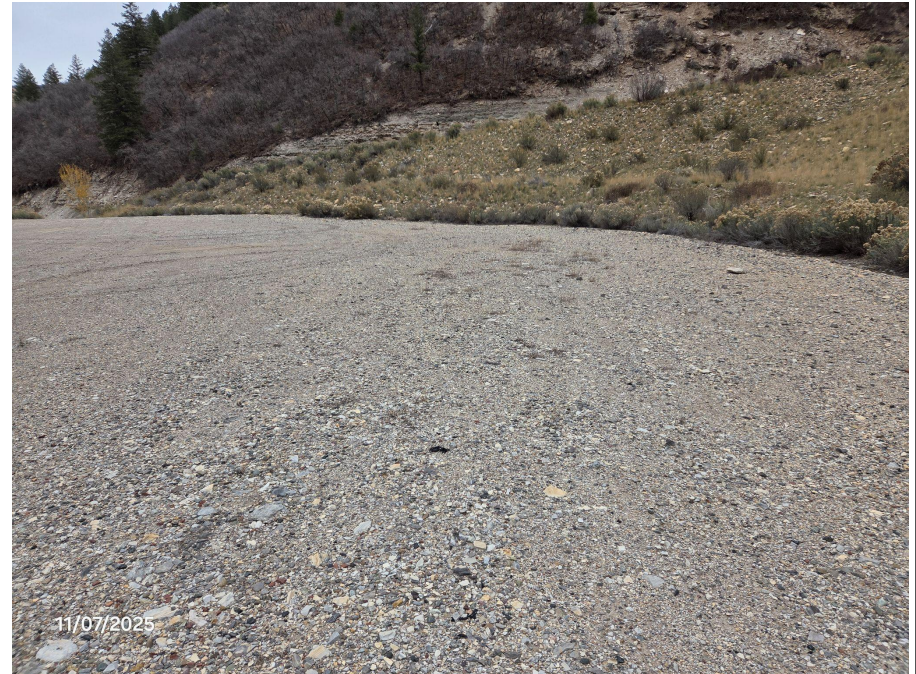
**Photo 2:** See comments under photo 1.

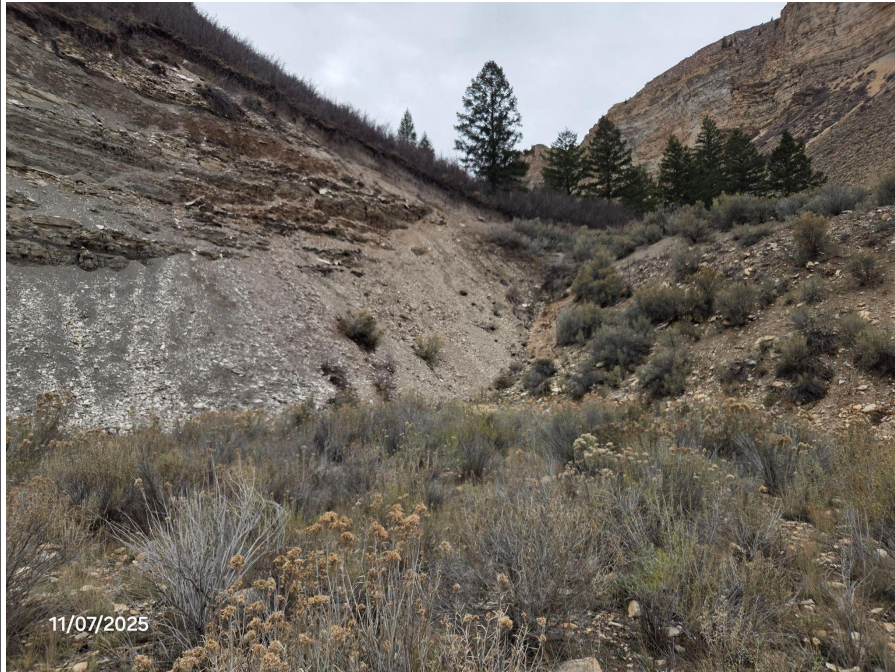
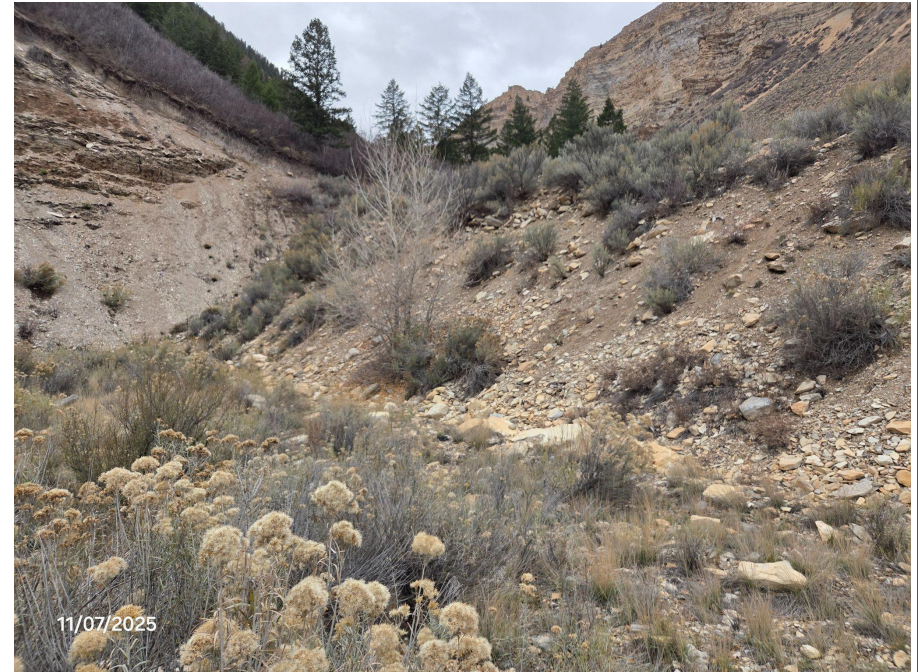
**Photo 3:** Photos taken from the western interim areas of the Location. Areas are not progressing towards 1003.e standards; slopes remain predominantly bare and exposed soils, and lack stabilization; cuts remain evident and soils do not appear to have been replaced to their original relative grade. Areas appear to be the former K26 pit site.

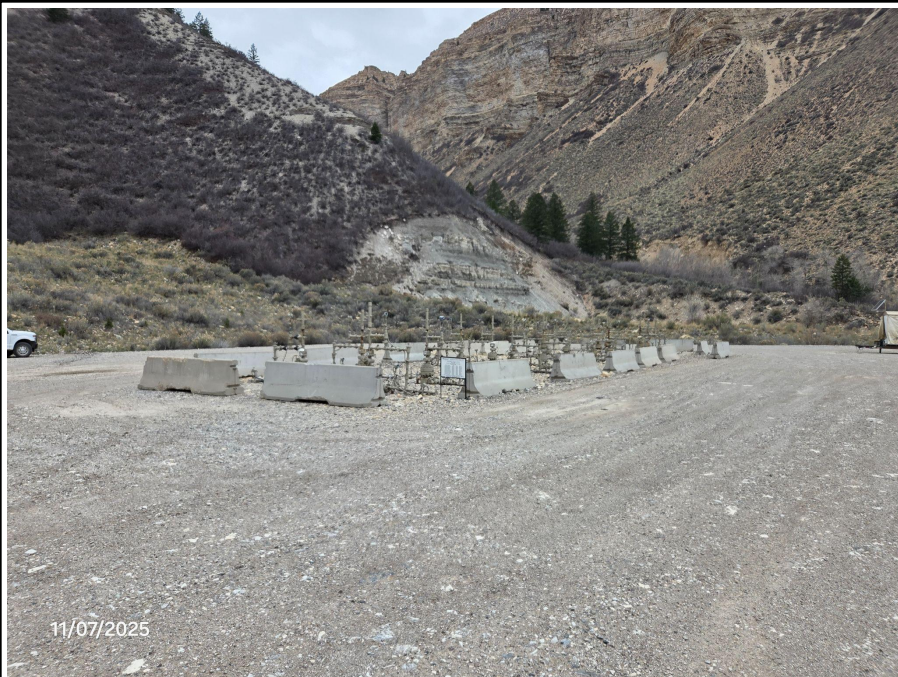
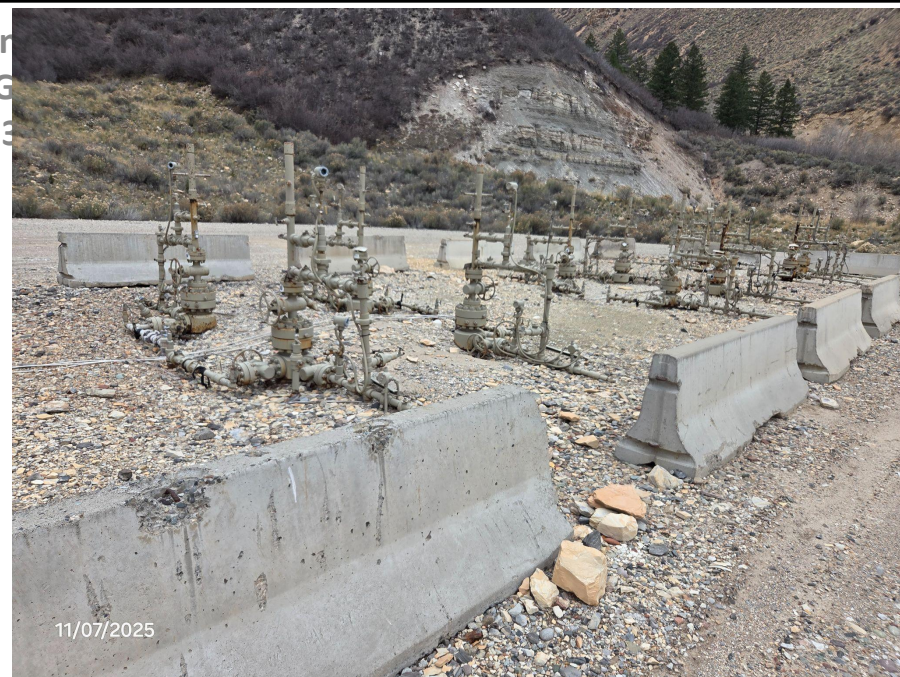
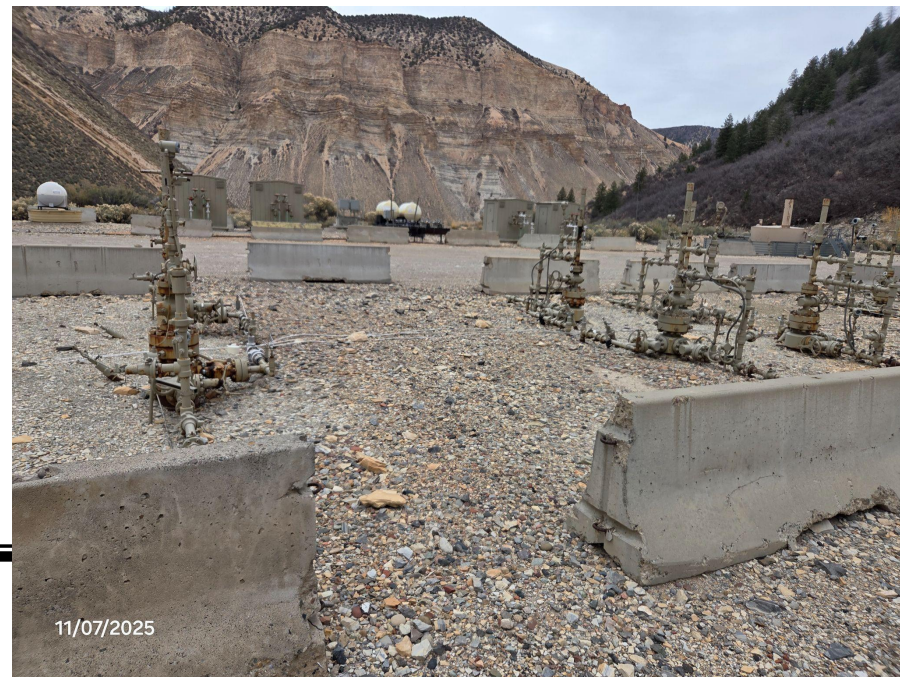
**Photo 4:** Photos taken from the wells. Operator has placed a single sign on the north end of the wells. Signage has not been posted at each wellhead pursuant to Rule 605.d.

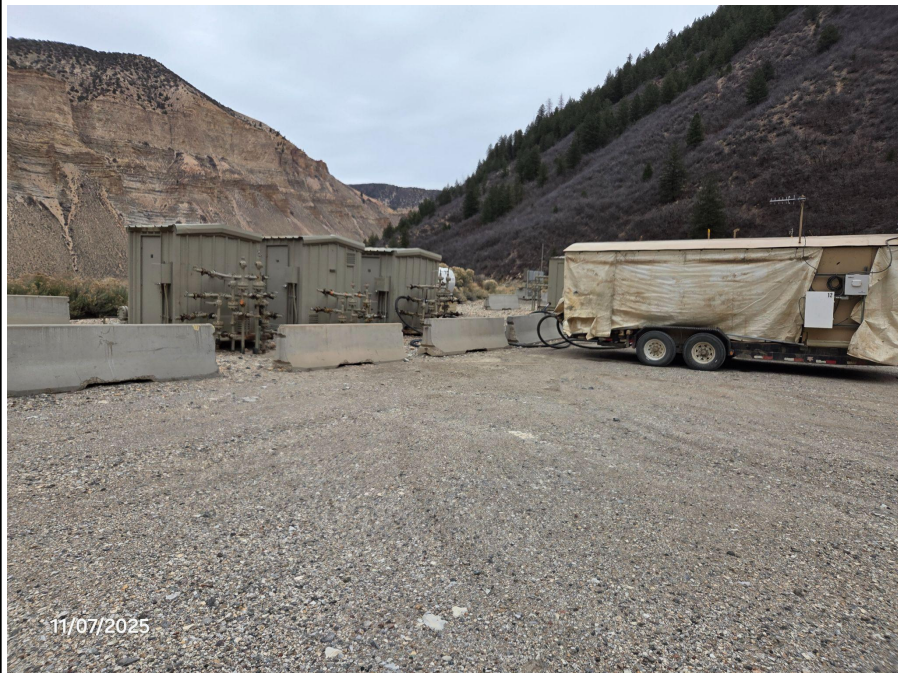
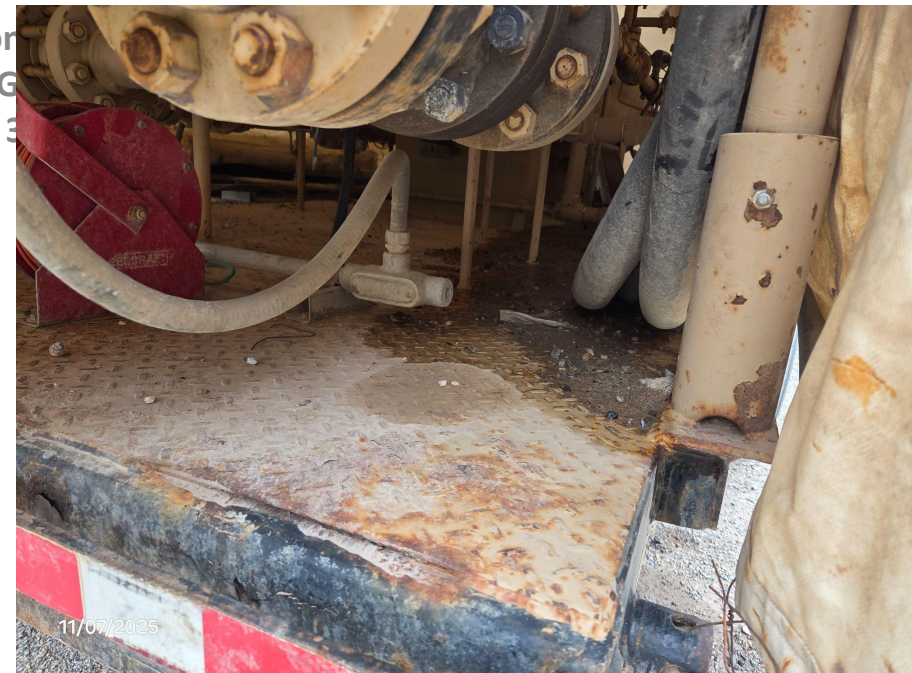
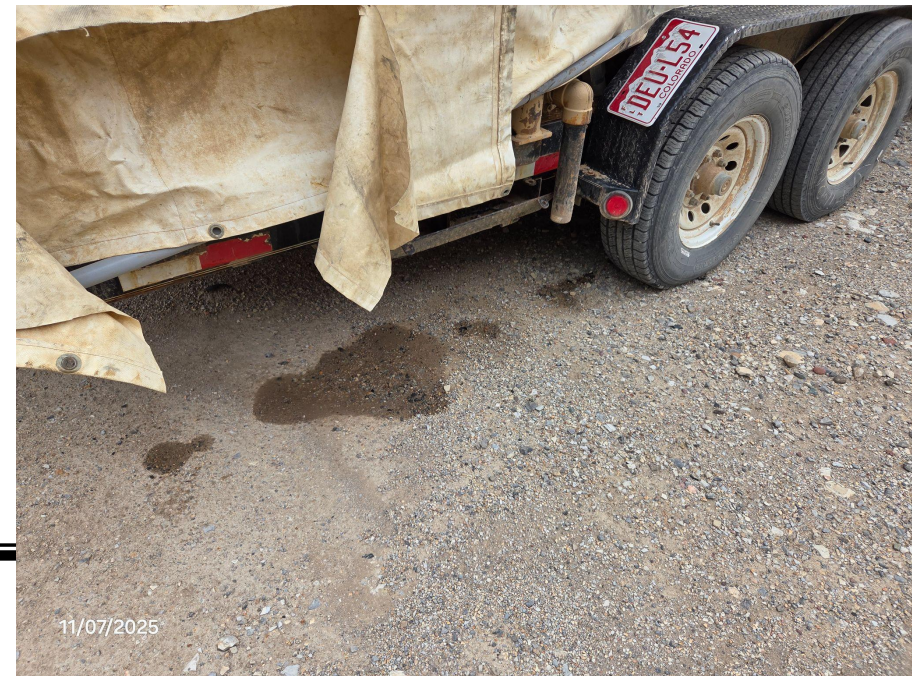
**Photo 5:** Photos show trailered equipment next to separators/gas lifts. Equipment appears to be leaking resulting in spills onto the WPS.

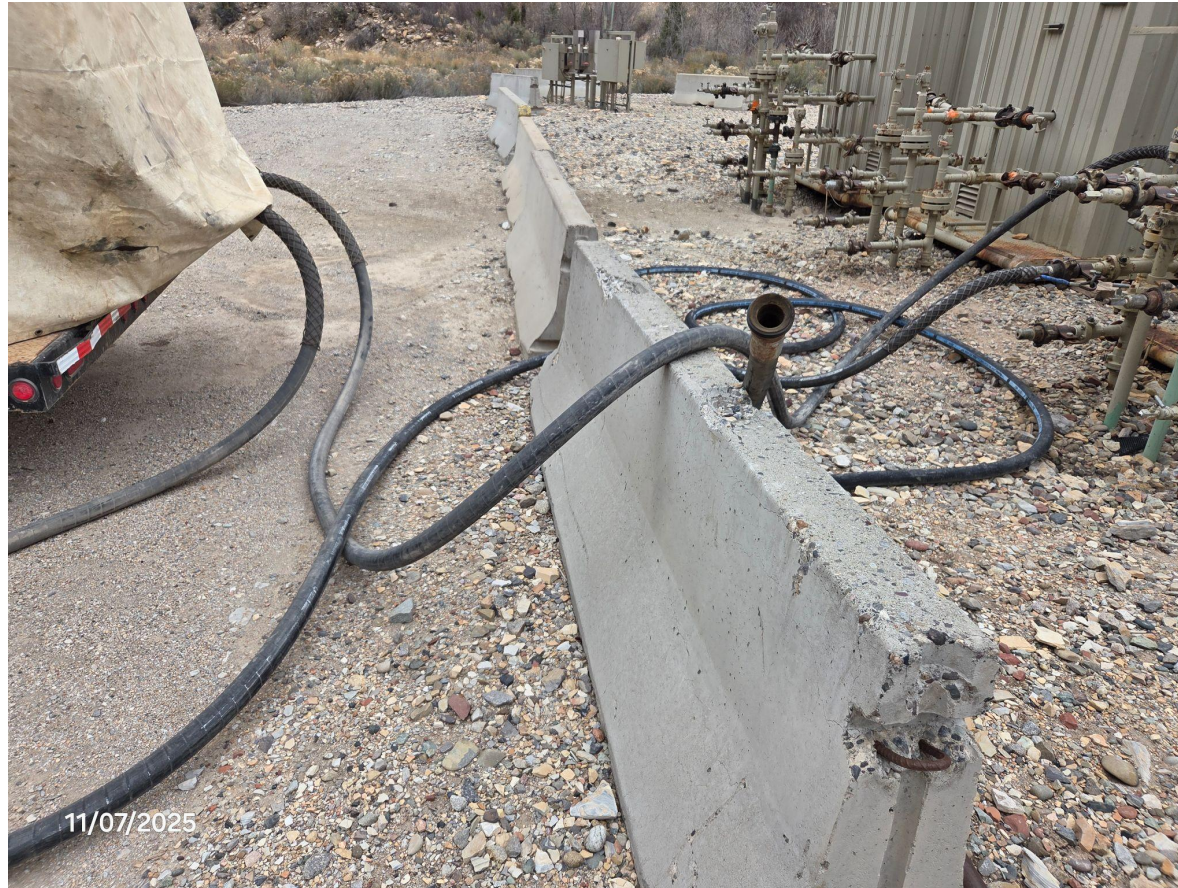
**Photo 6:** Continued from photo 5. Photo shows open ended hose equipment.

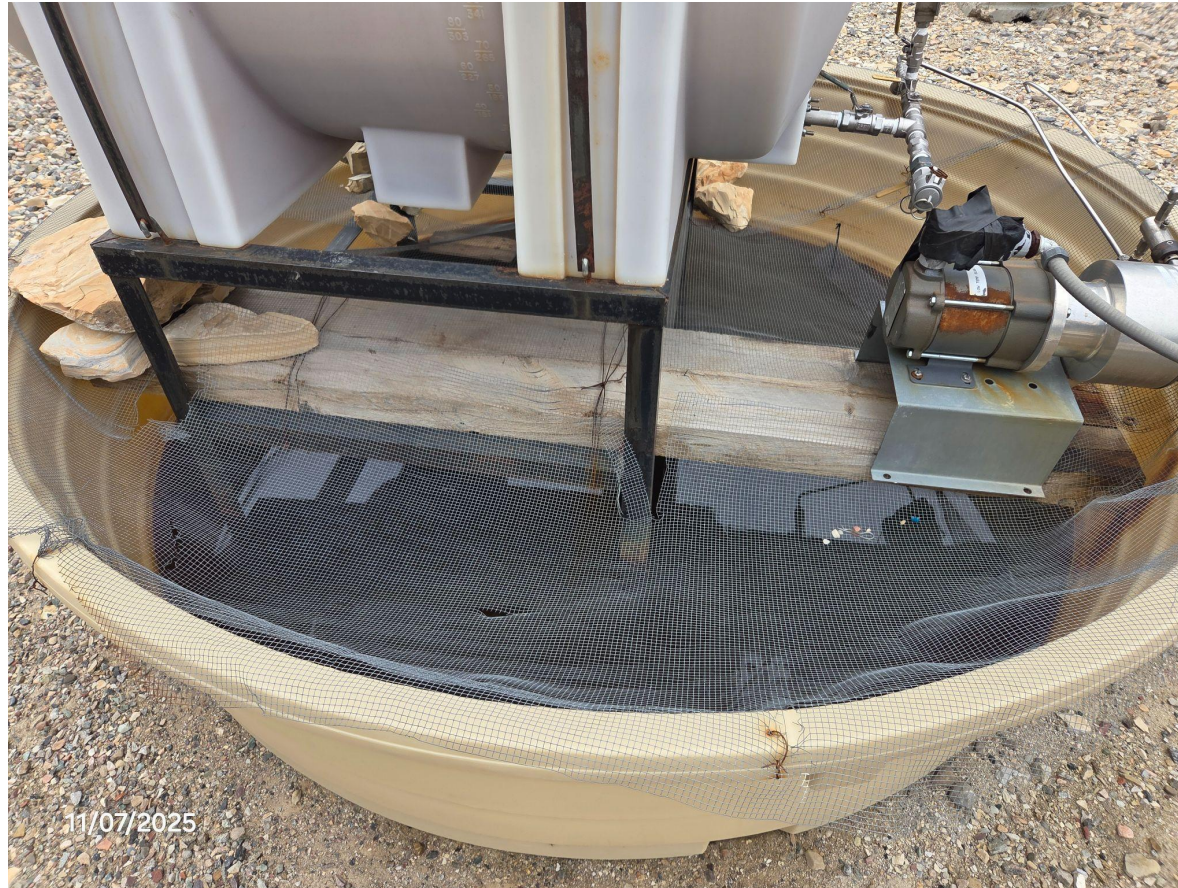
**Photo 7:** Photo shows fluids spilled within containment.

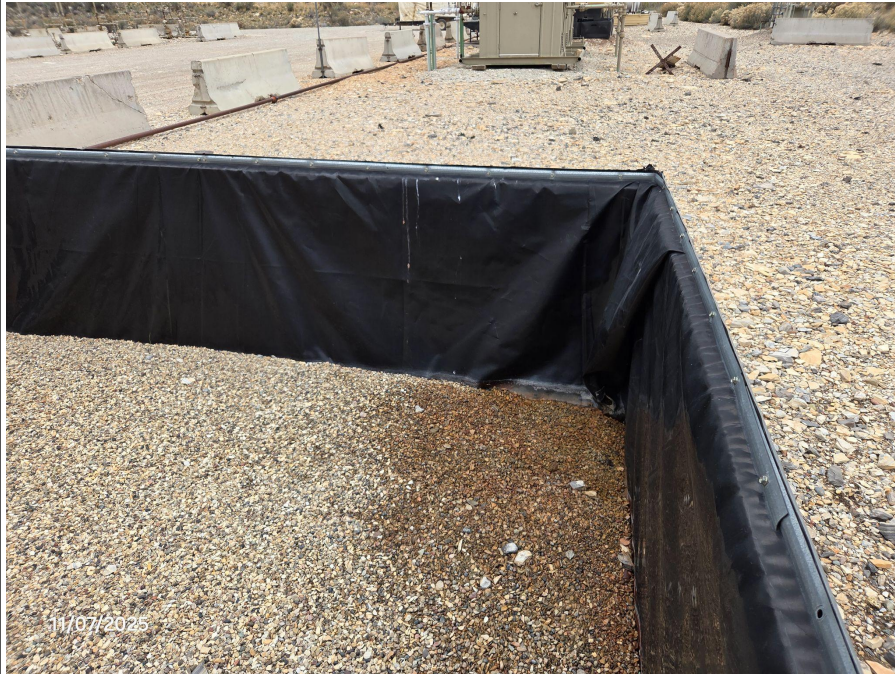
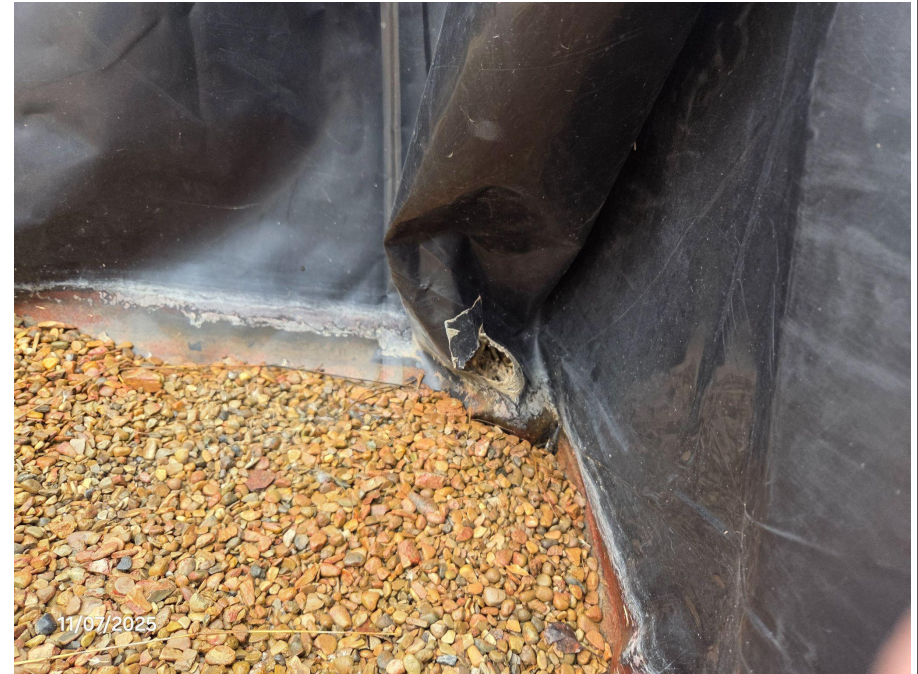
**Photo 8:** Photo taken from the tank facility on the northeast end of the Location. Hole/tear observed within the northwest corner of the liner.

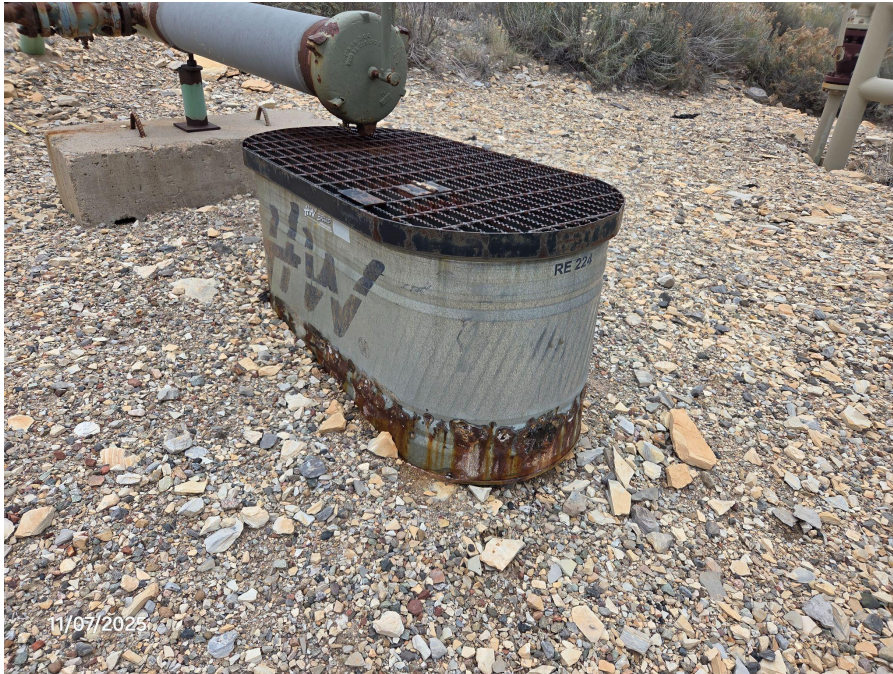
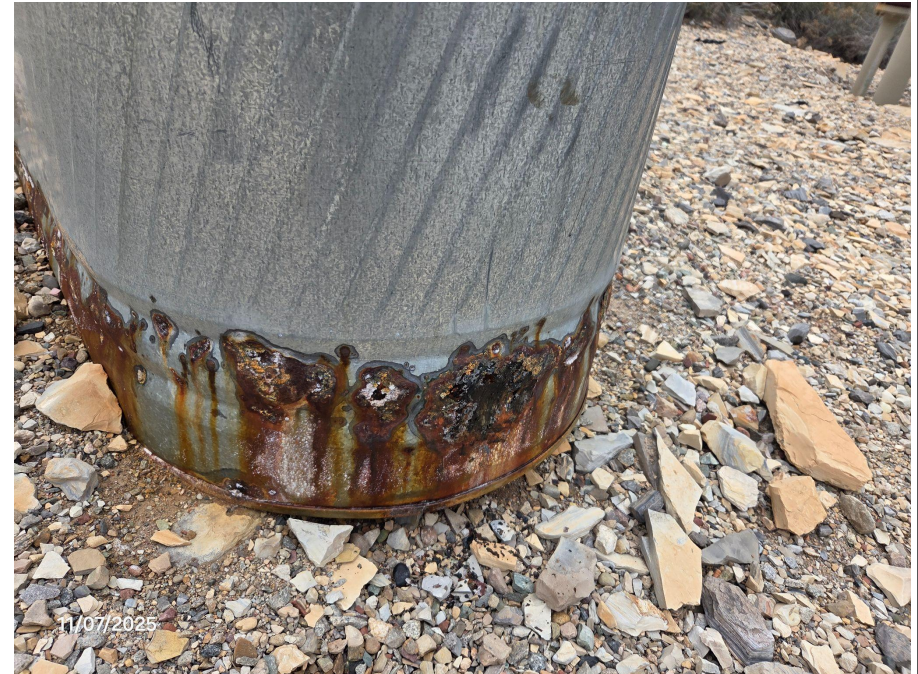
**Photo 9:** Photo taken from the pipeline equipment on the northeast end of the Location. Corrosion evident at the base of the secondary containment BMP. ECMC staff have concerns regarding the integrity and imperviousness of the containment measure.
