# Inspection Photos

Operator: Catamount Energy Partners

Location ID: 311991

Inspection Photos  
Location Name: Outpost 33-8  
Location ID: 311991

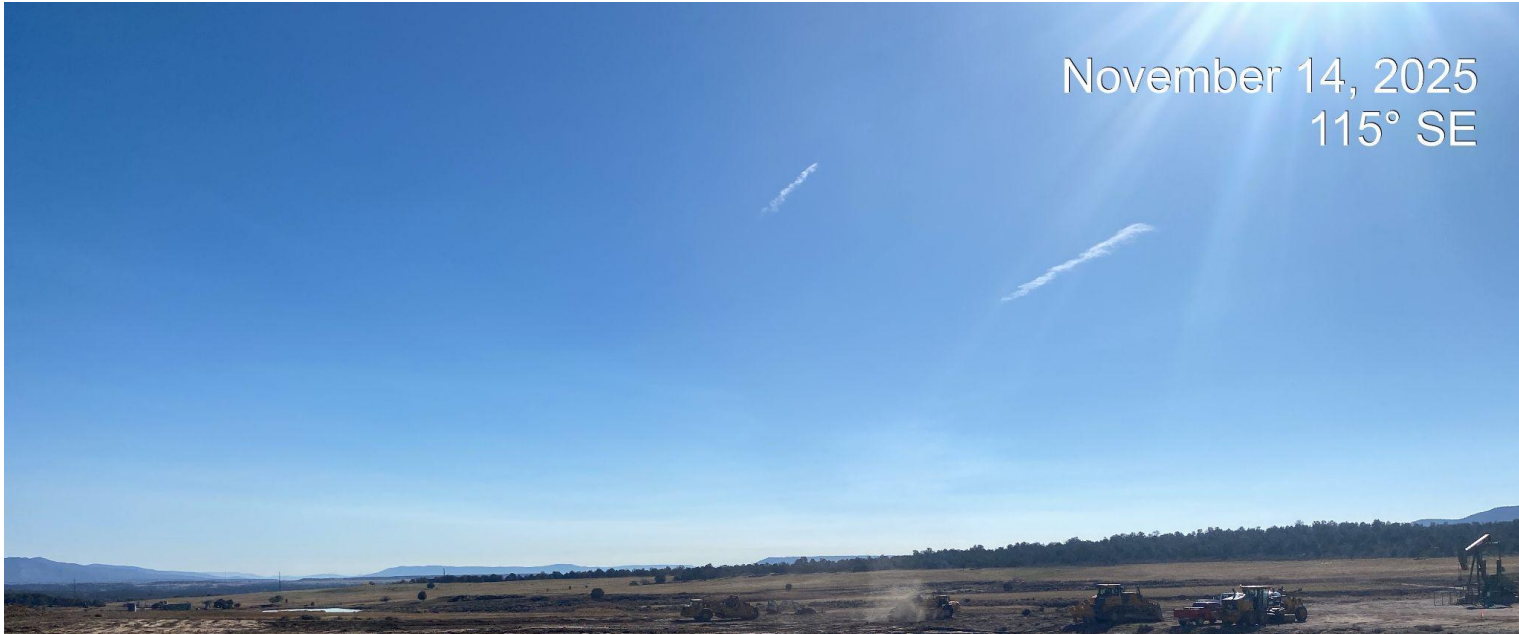
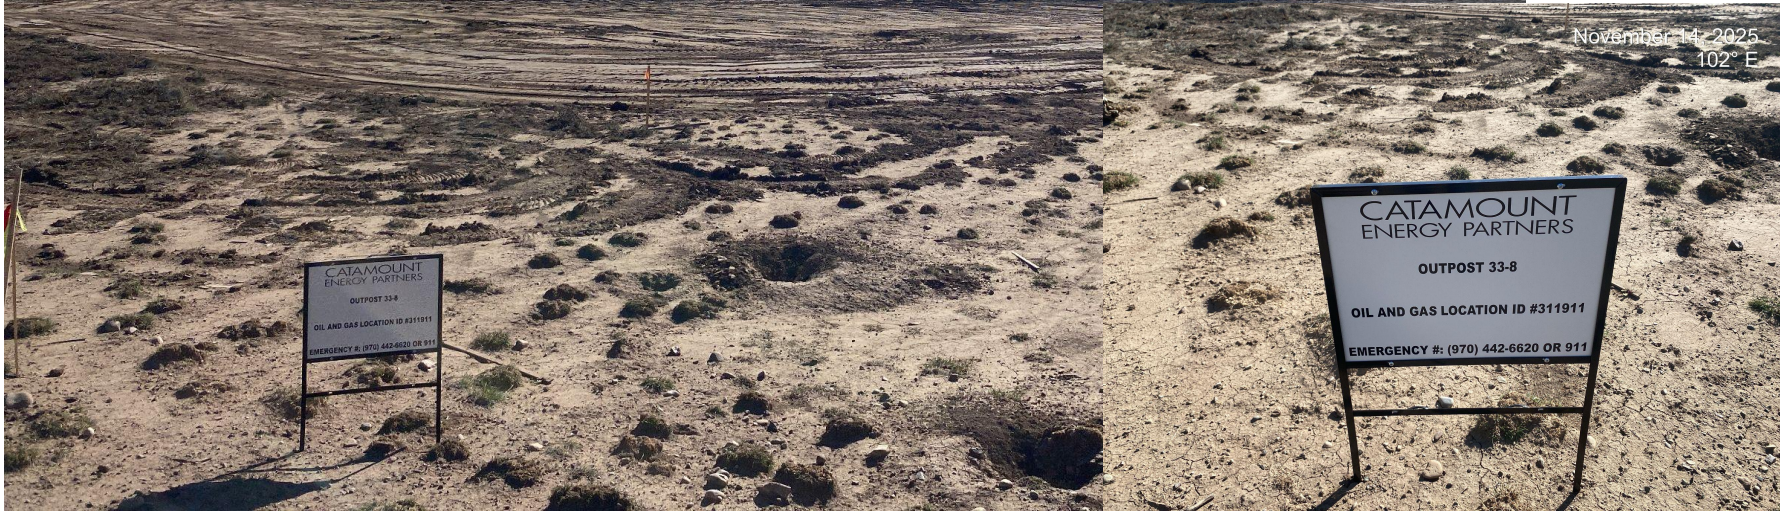
**Photo 1.** Overview photo of the well pad construction operations and location sign taken from the northwest corner facing center. Scraping and salvaging operations were on going during the time of the inspection.

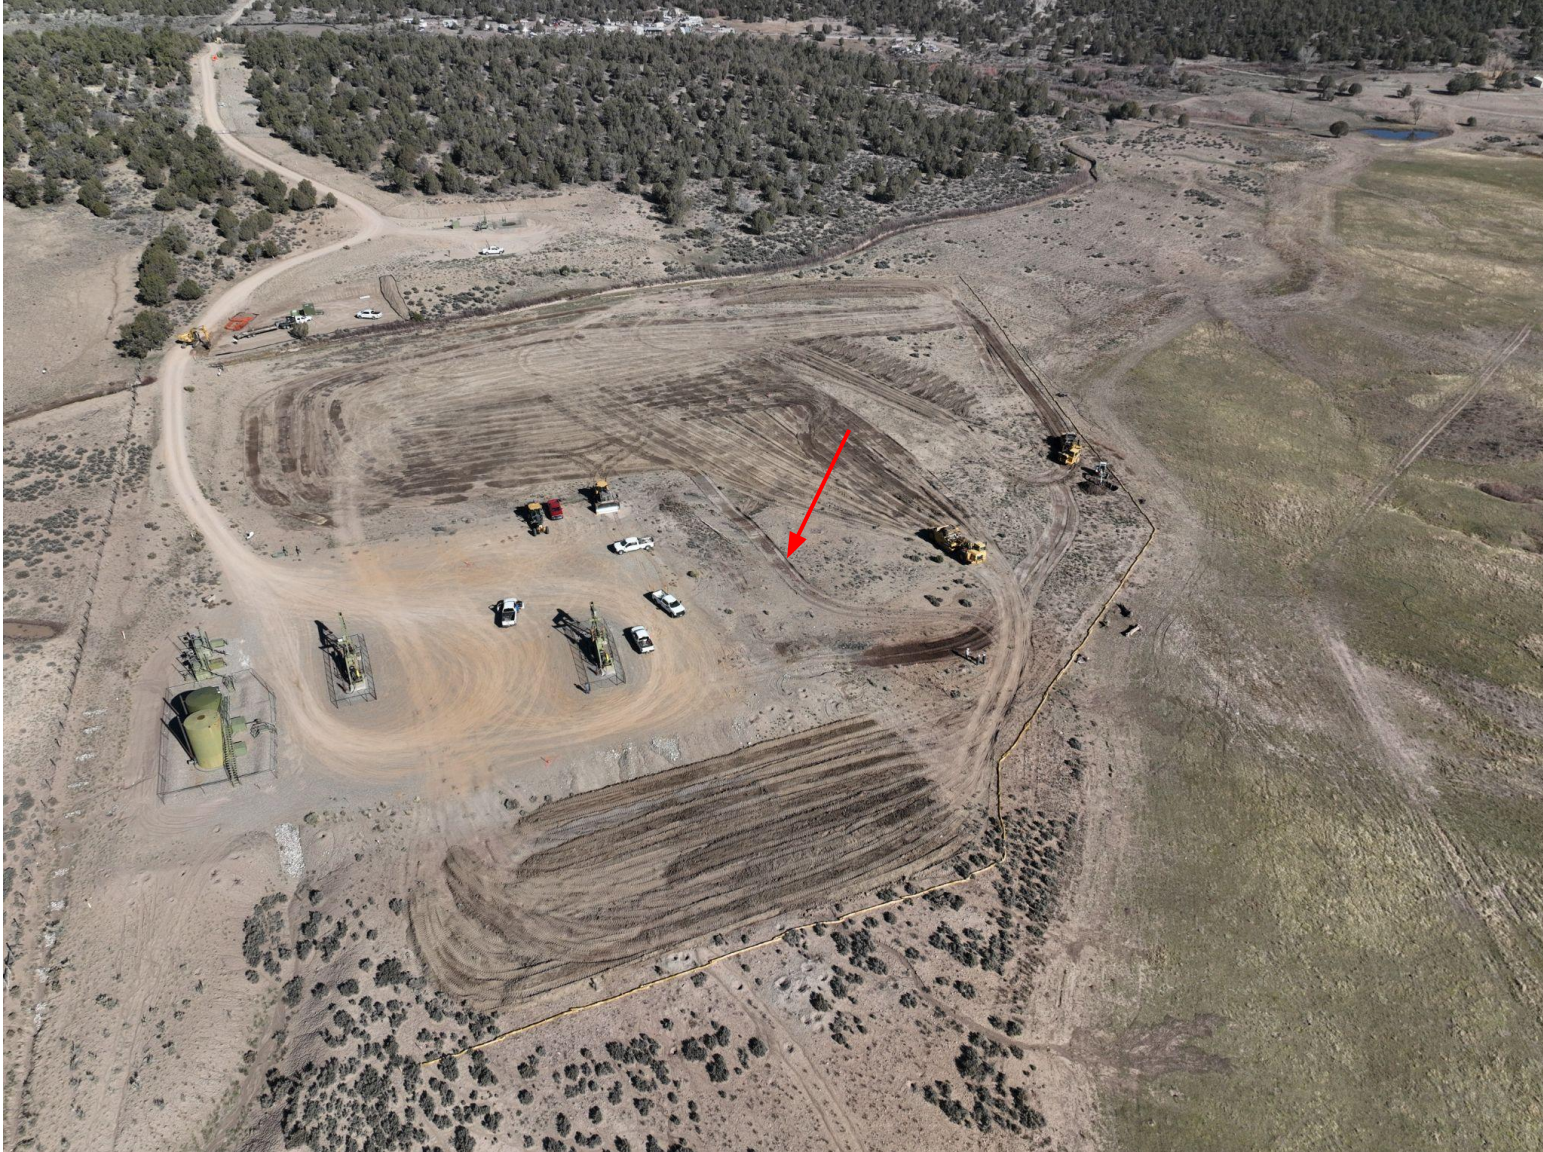
**Photo 2.** Overview photo of the well pad construction area taken with a drone from the southern edge facing north. It was noted that area (highlighted with red area) immediately east of the existing active pad had not yet been salvaged.

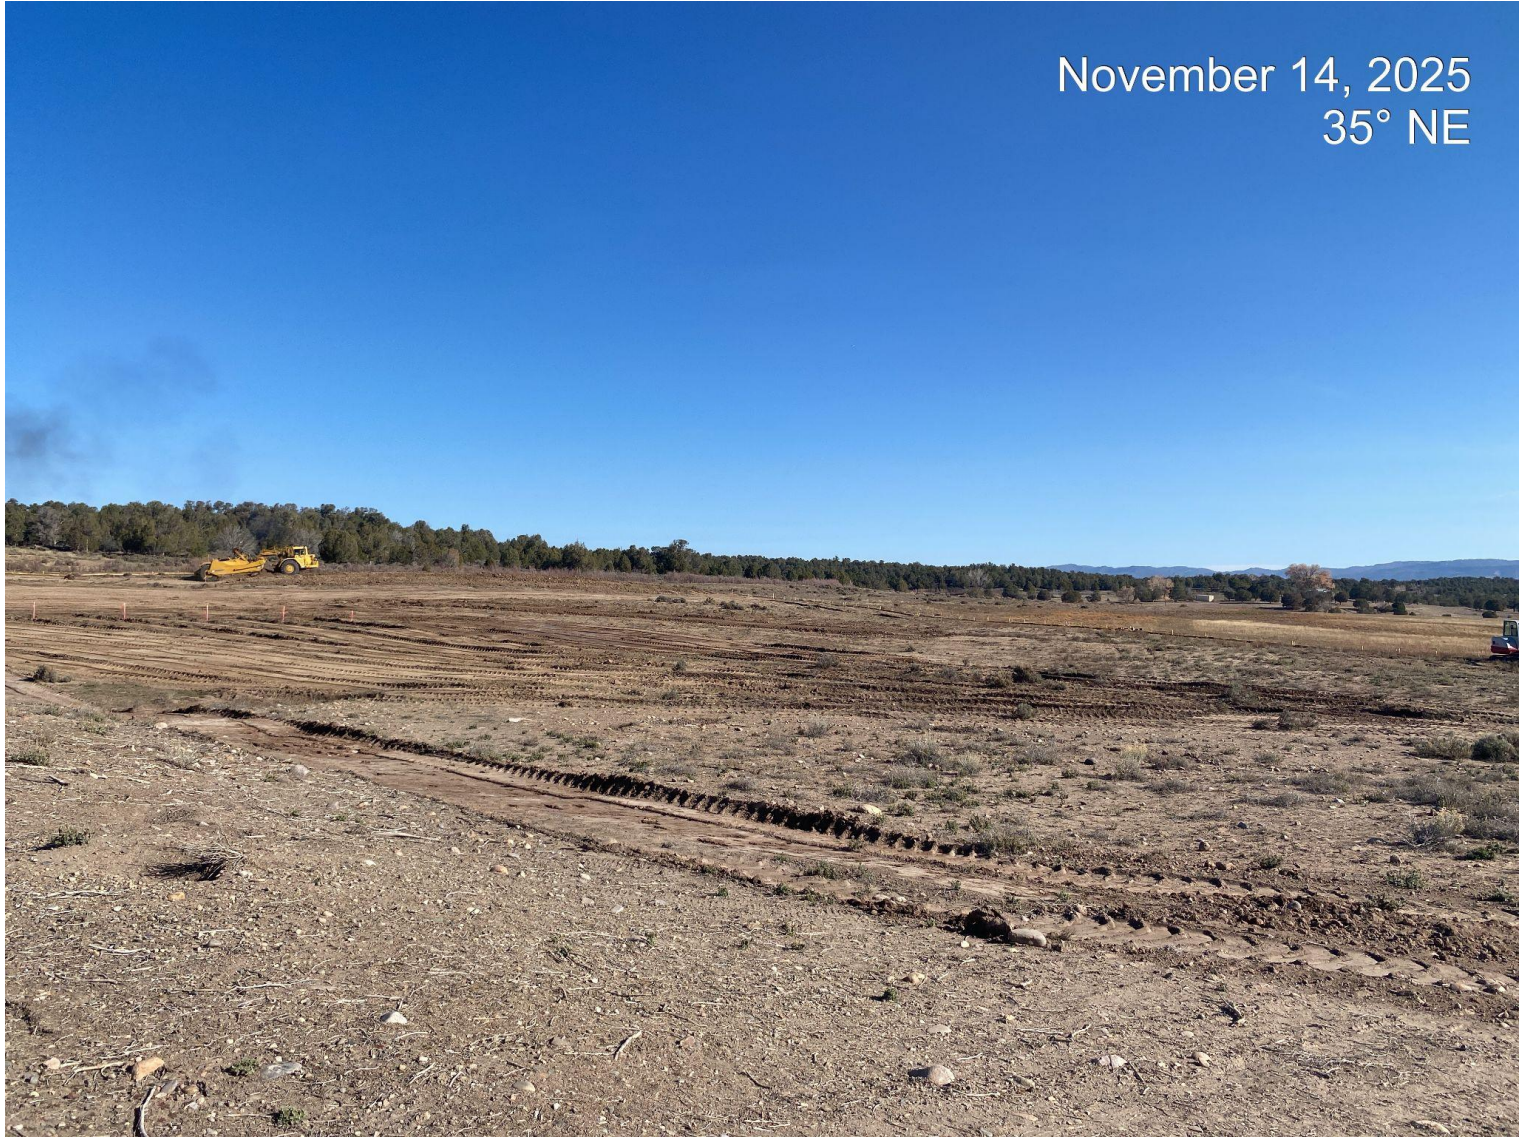
**Photo 3.** View of the well pad disturbance taken from the eastern edge of the existing red will pad facing center.

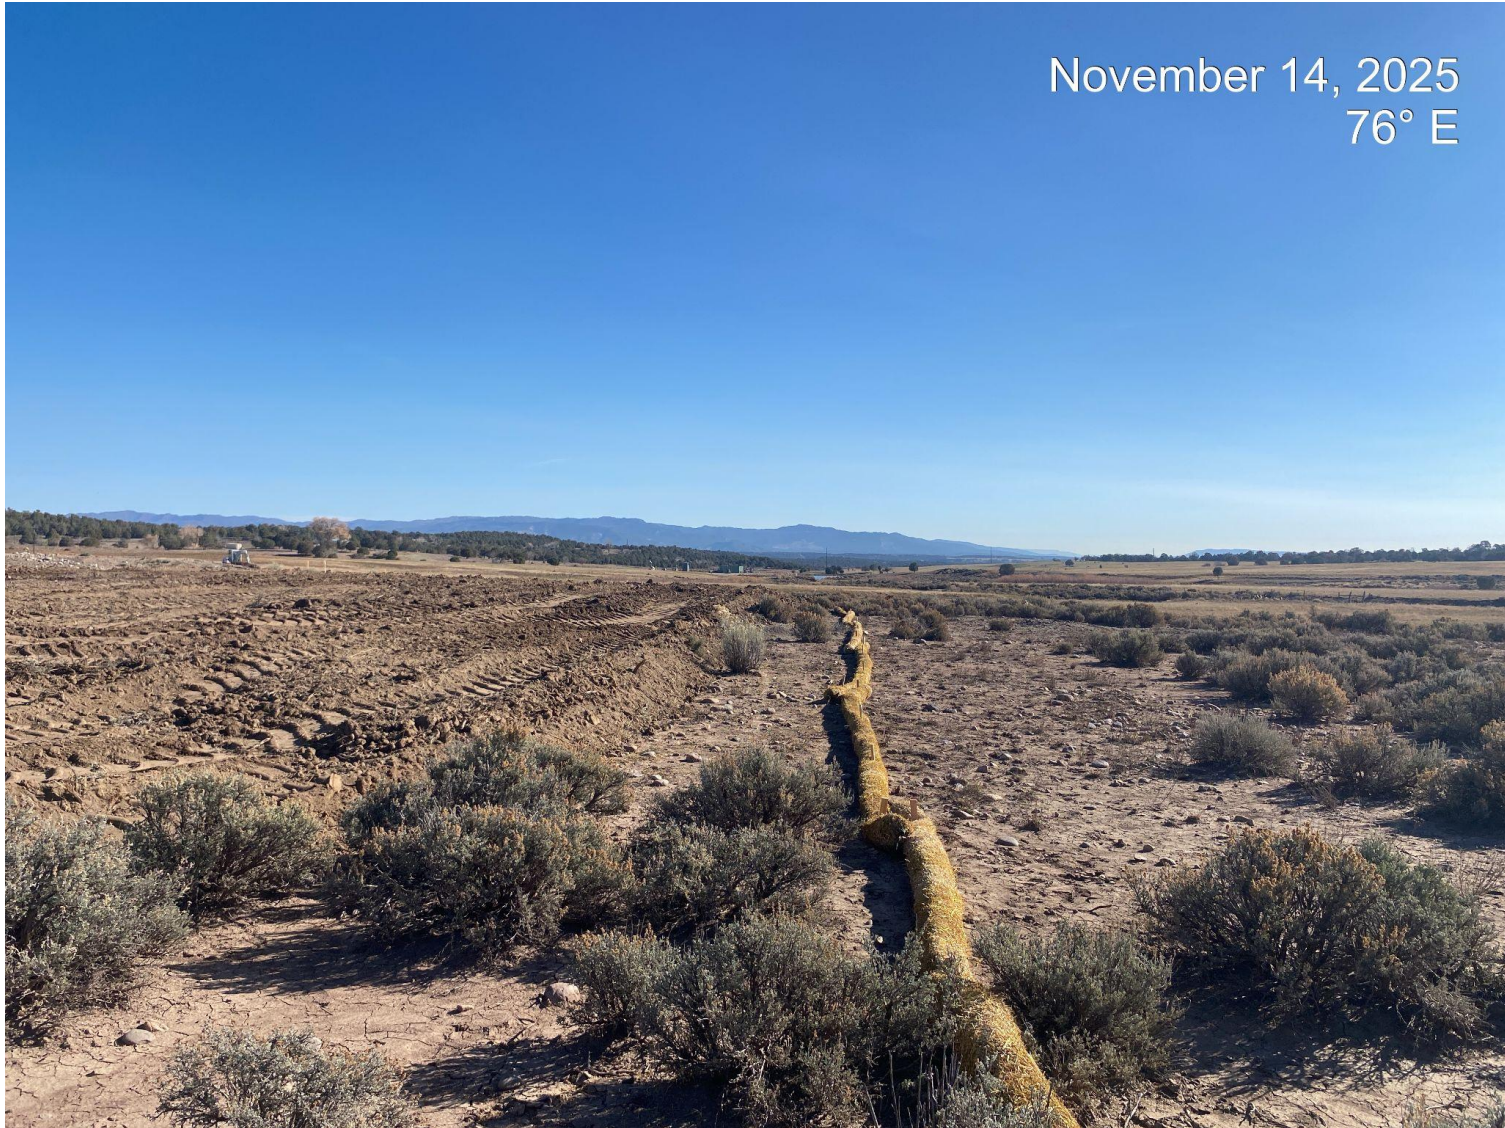
**Photo 4.** View of the southern edge of the well pad and perimeter BMP wattles. Note: wattles have not been installed per good engineering practices (trenched) in these areas.

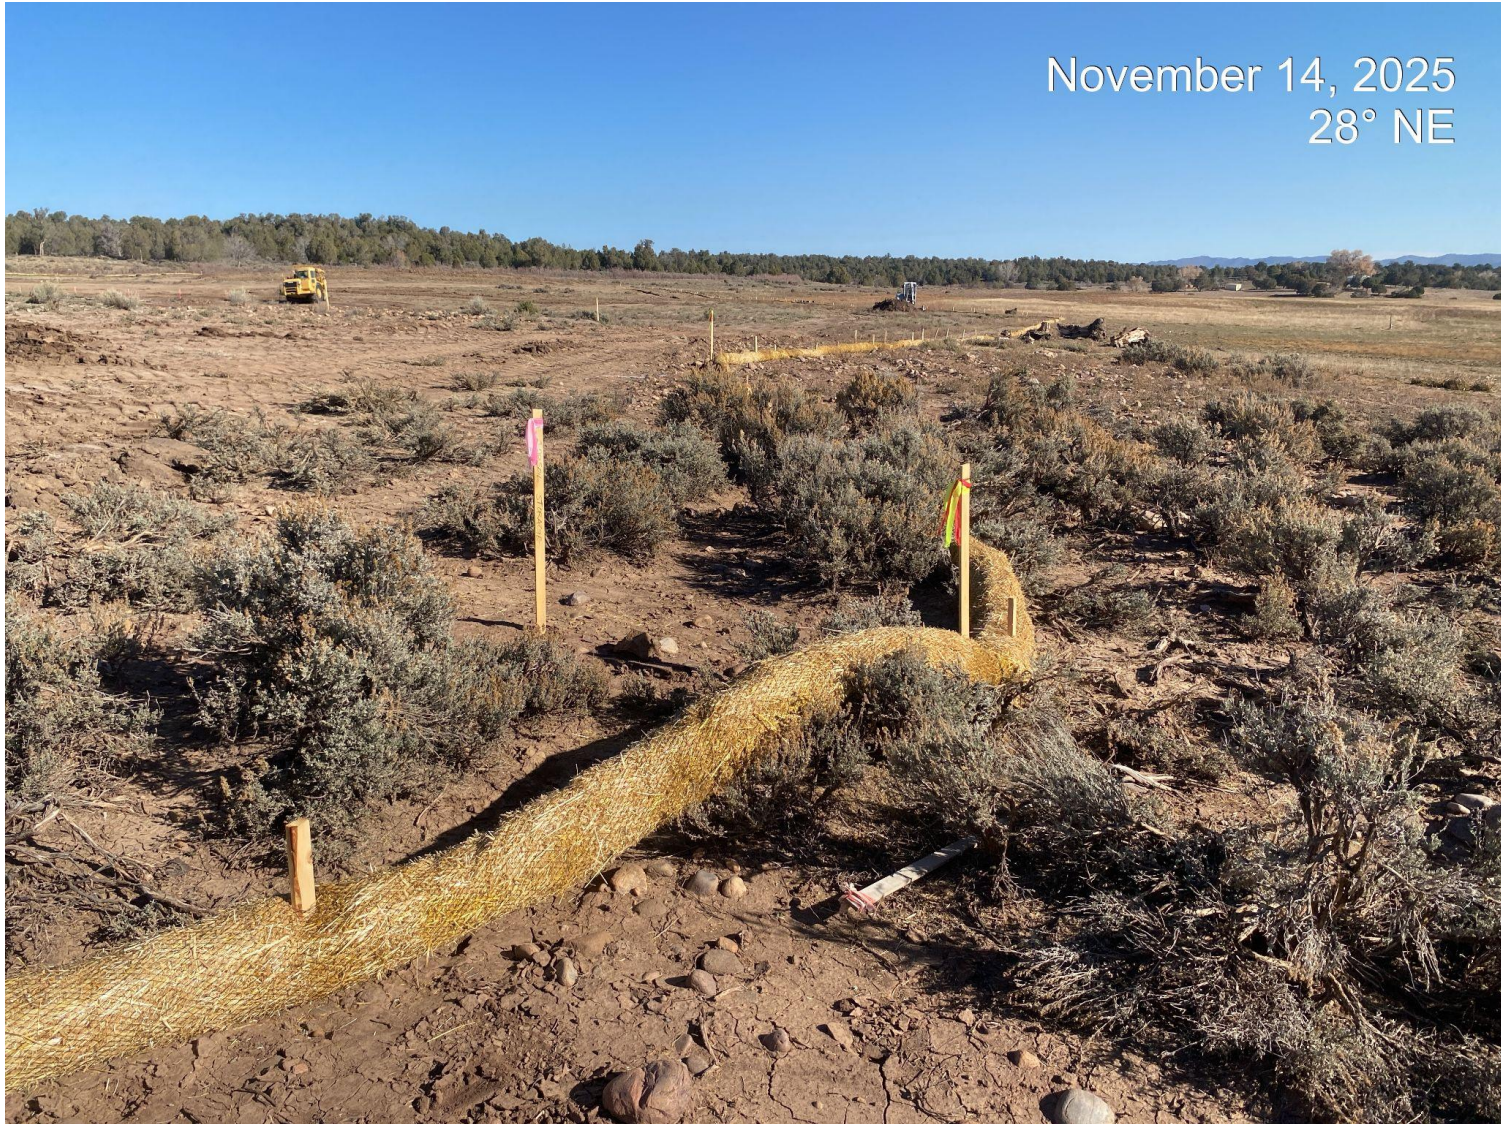
**Photo 5.** Additional view of perimeter BMP wattles on the southern and eastern edges of the disturbance which have not been installed per good engineering practices (trenched).

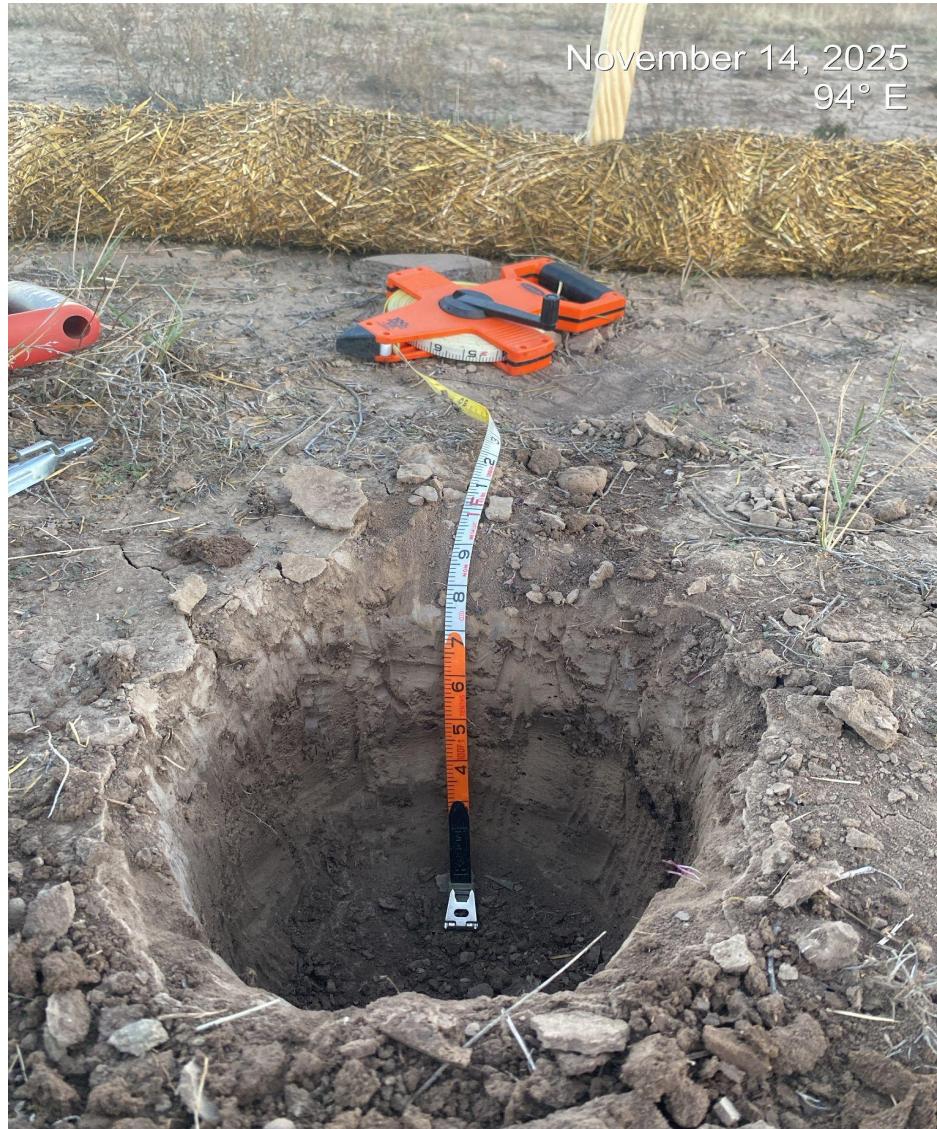
**Photo 6.** View of soil pit taken in the eastern portion of the disturbance. It was noted that no more than 6 inches of topsoil were observed on site.

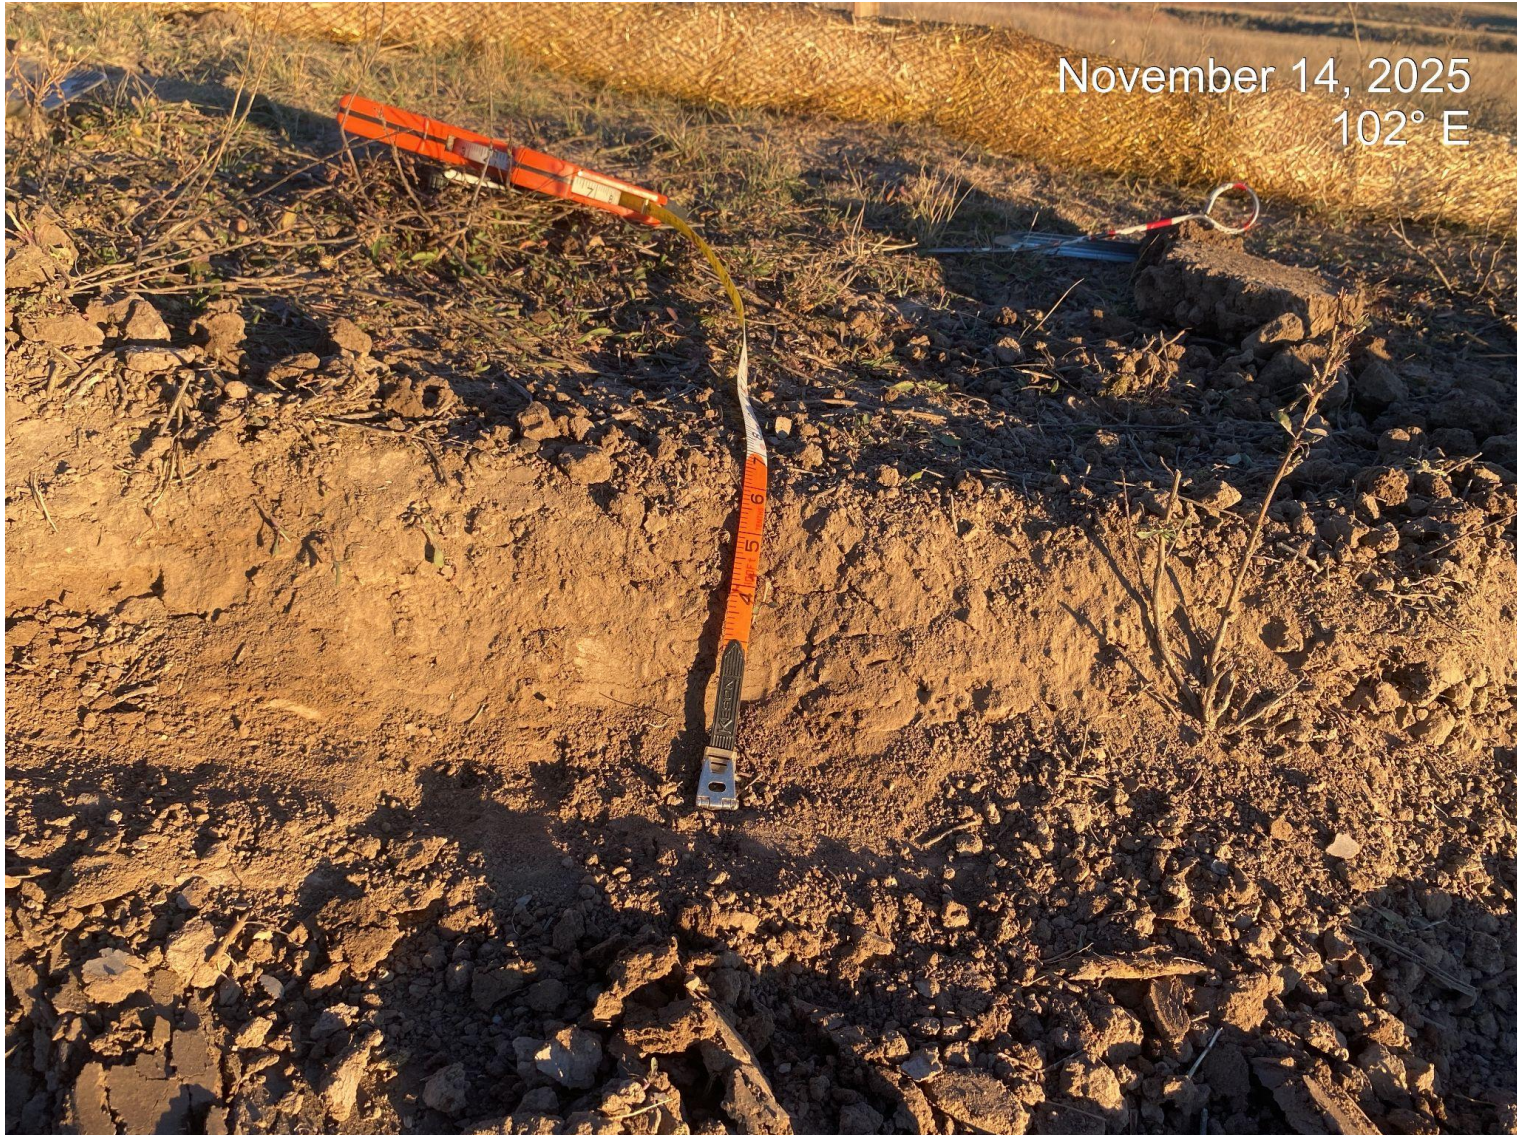
**Photo 6.** View of cut for topsoil salvage on the location. It appears that the operator is salvaging the 6 inch minimum requirement of topsoil
