WELL NAME: CENTAUR 24-36, API #: 071-08349, INSP. # 716301711

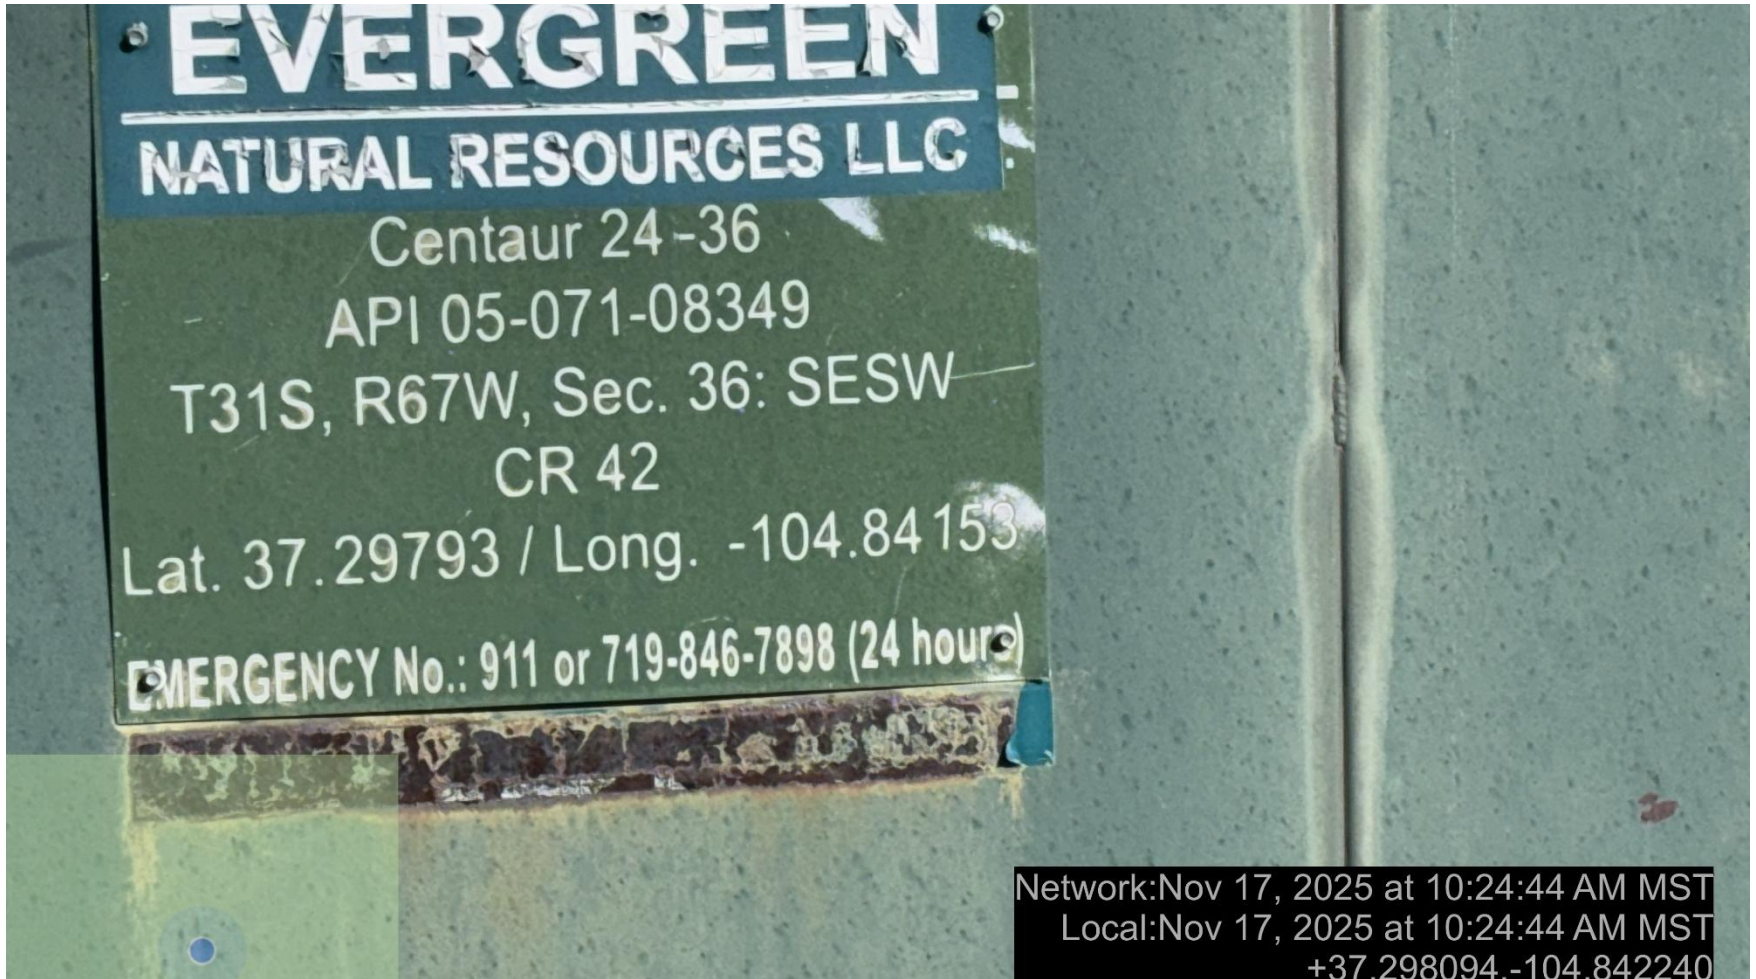
PHOTO 1: WELL SIGN

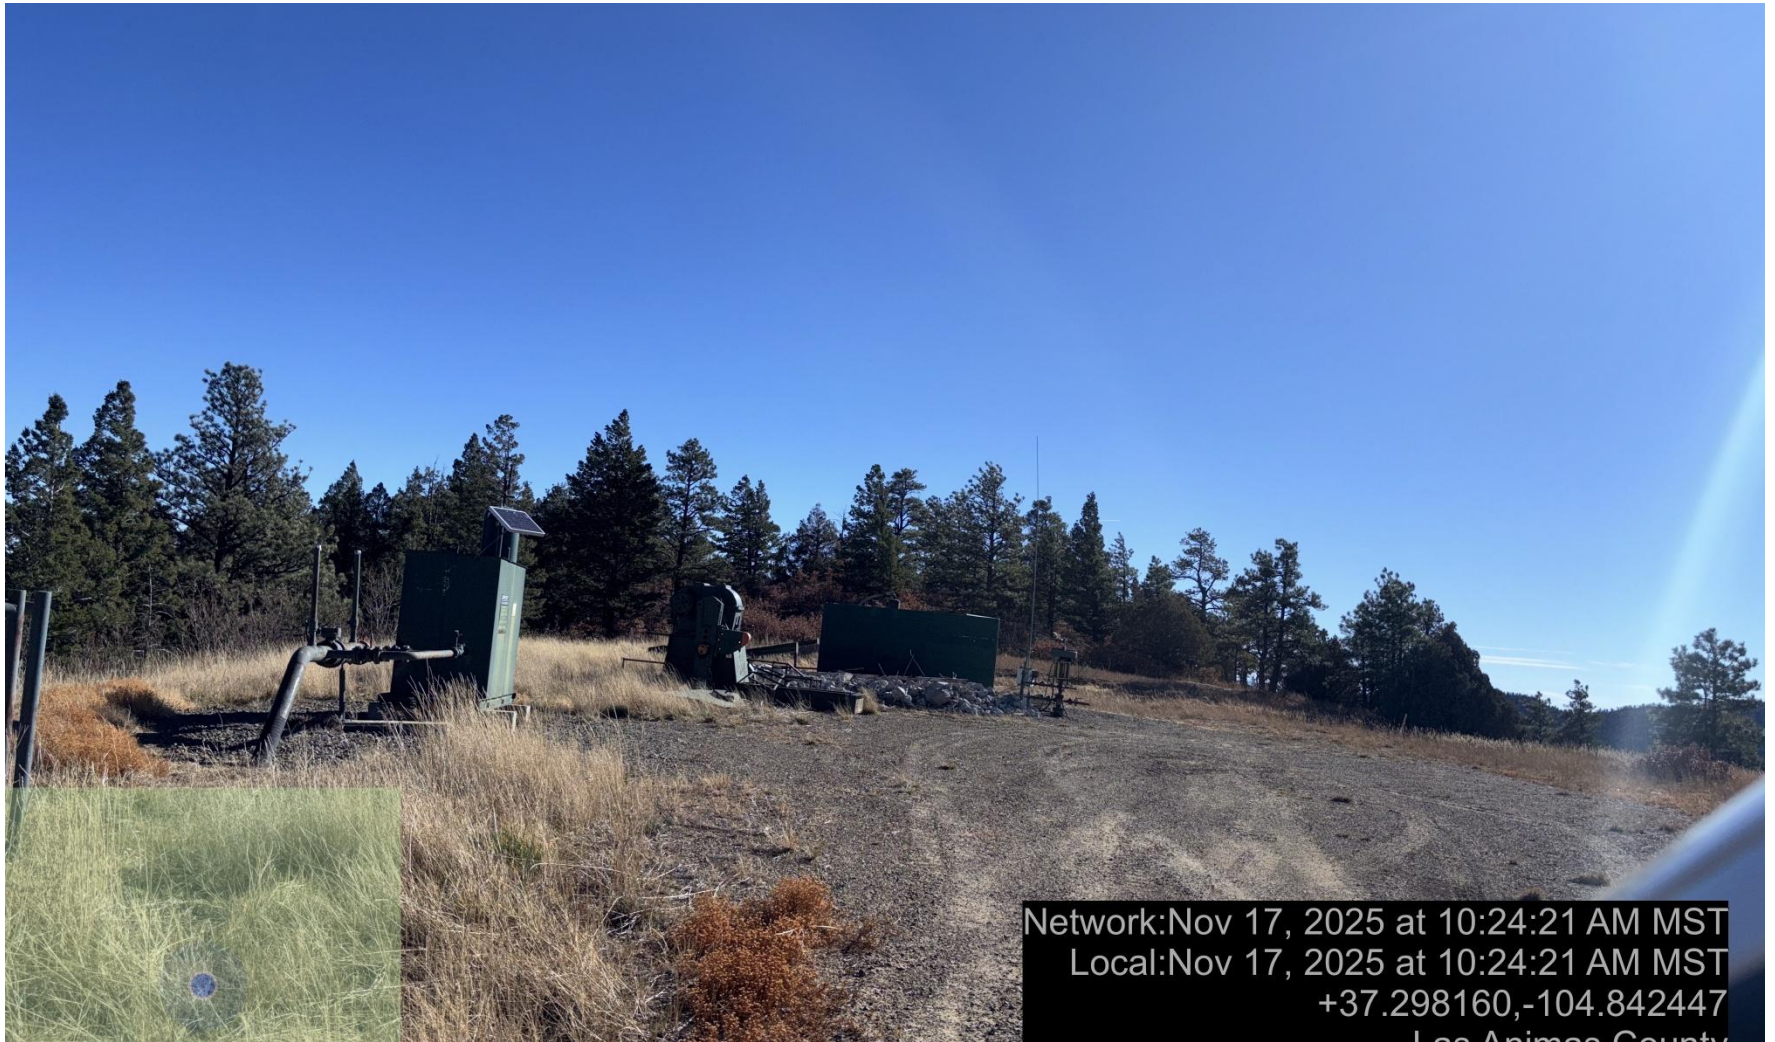
PHOTO 2: LOCATION.

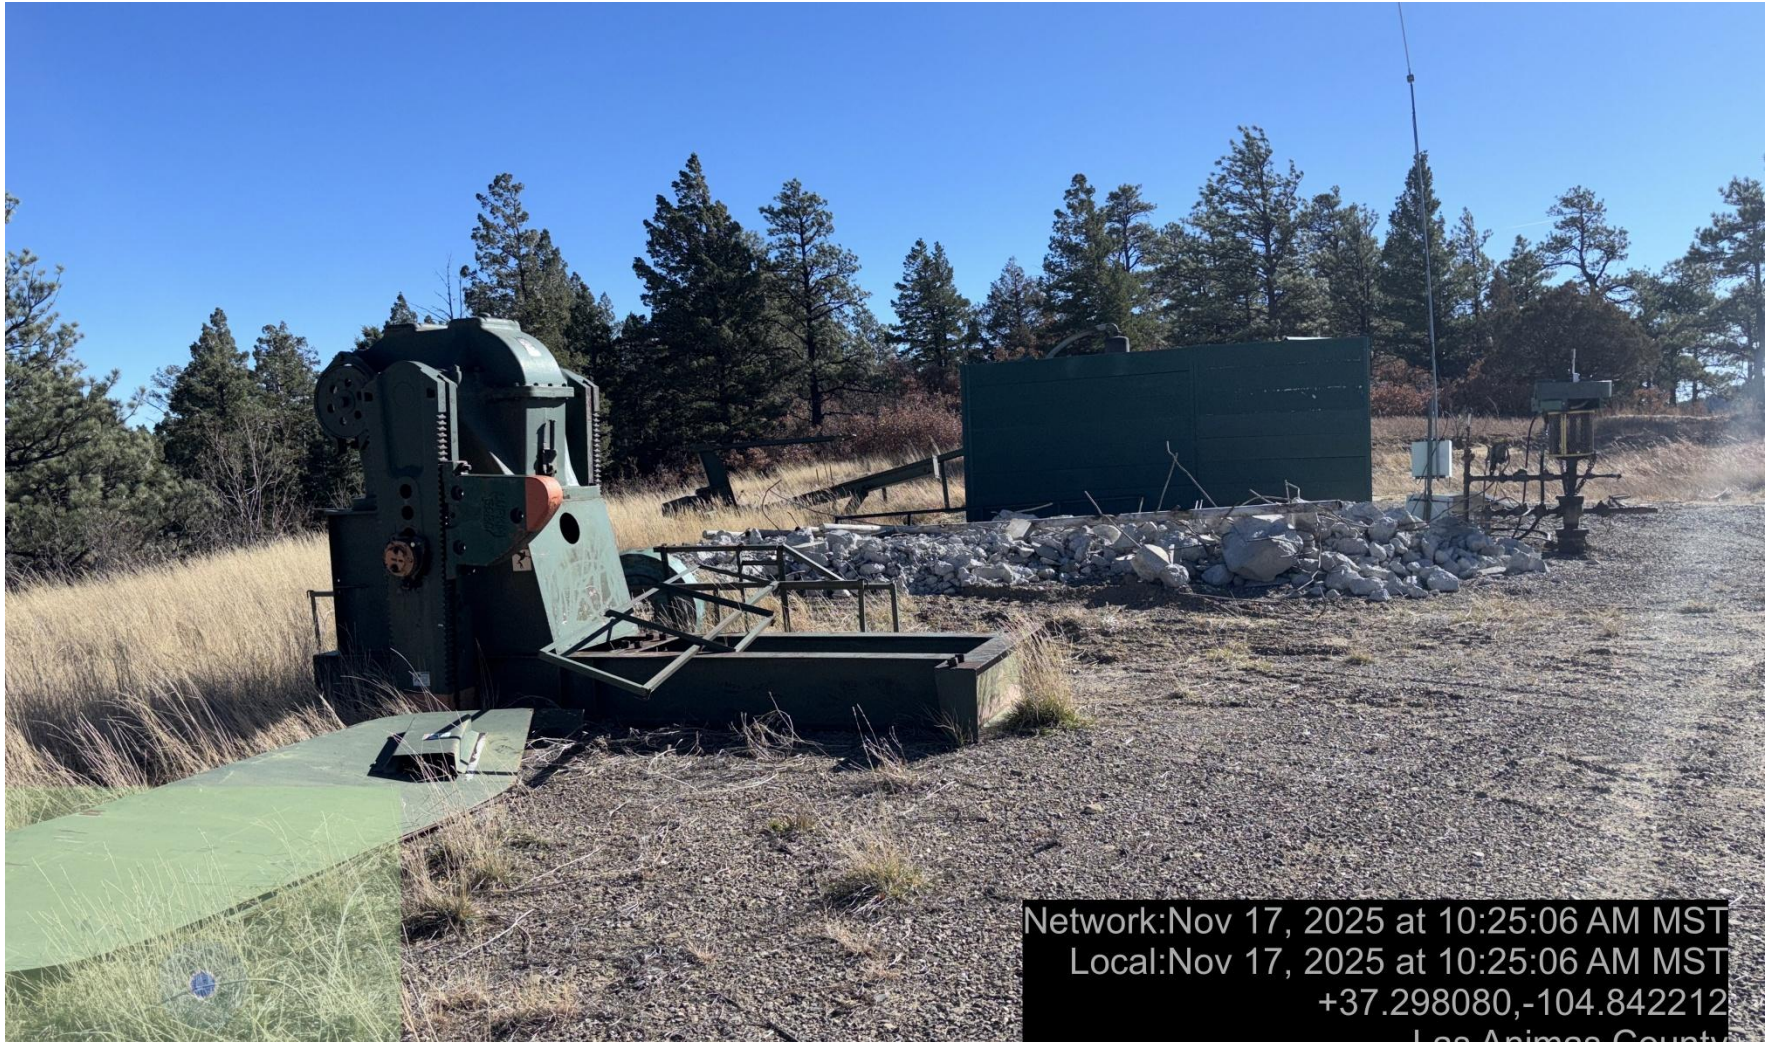
PHOTO 3: UNUSED EQUIPMENT (PUMPJACK AND ALL ITS COMPONENTS INCLUDING CEMENT PAD). REMOVE UNUSED EQUIPMENT PER RULE 606. THIS IS THE 2ND NOTICE FOR THIS CA IMMEDIATE ACTION IS REQUIRED.

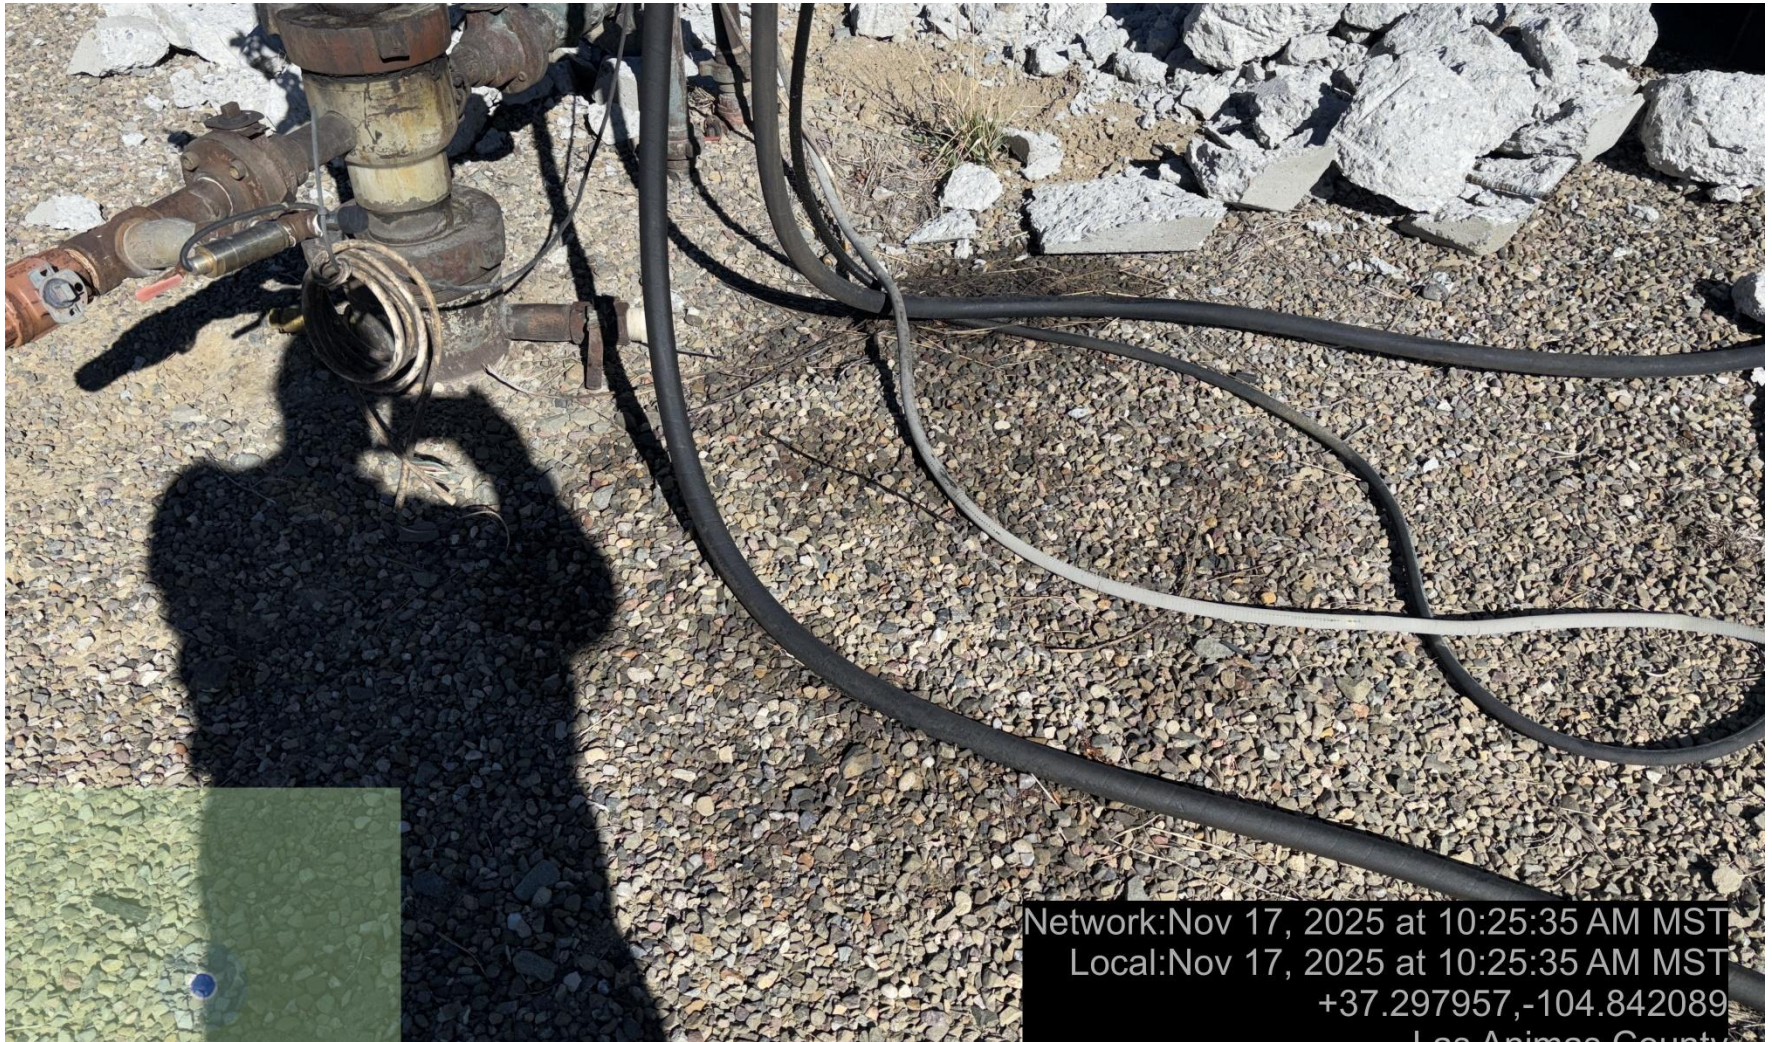
PHOTO 4: AREA OF IMPACTED SOIL NEAR WELLHEAD. Conduct maintenance on equipment, cleanup stained material and review self inspection processes. COMPLY WITH RULE 1002, (2).D. THIS IS THE 2ND NOTICE FOR THIS CA IMMEDIATE ACTION IS REQUIRED.

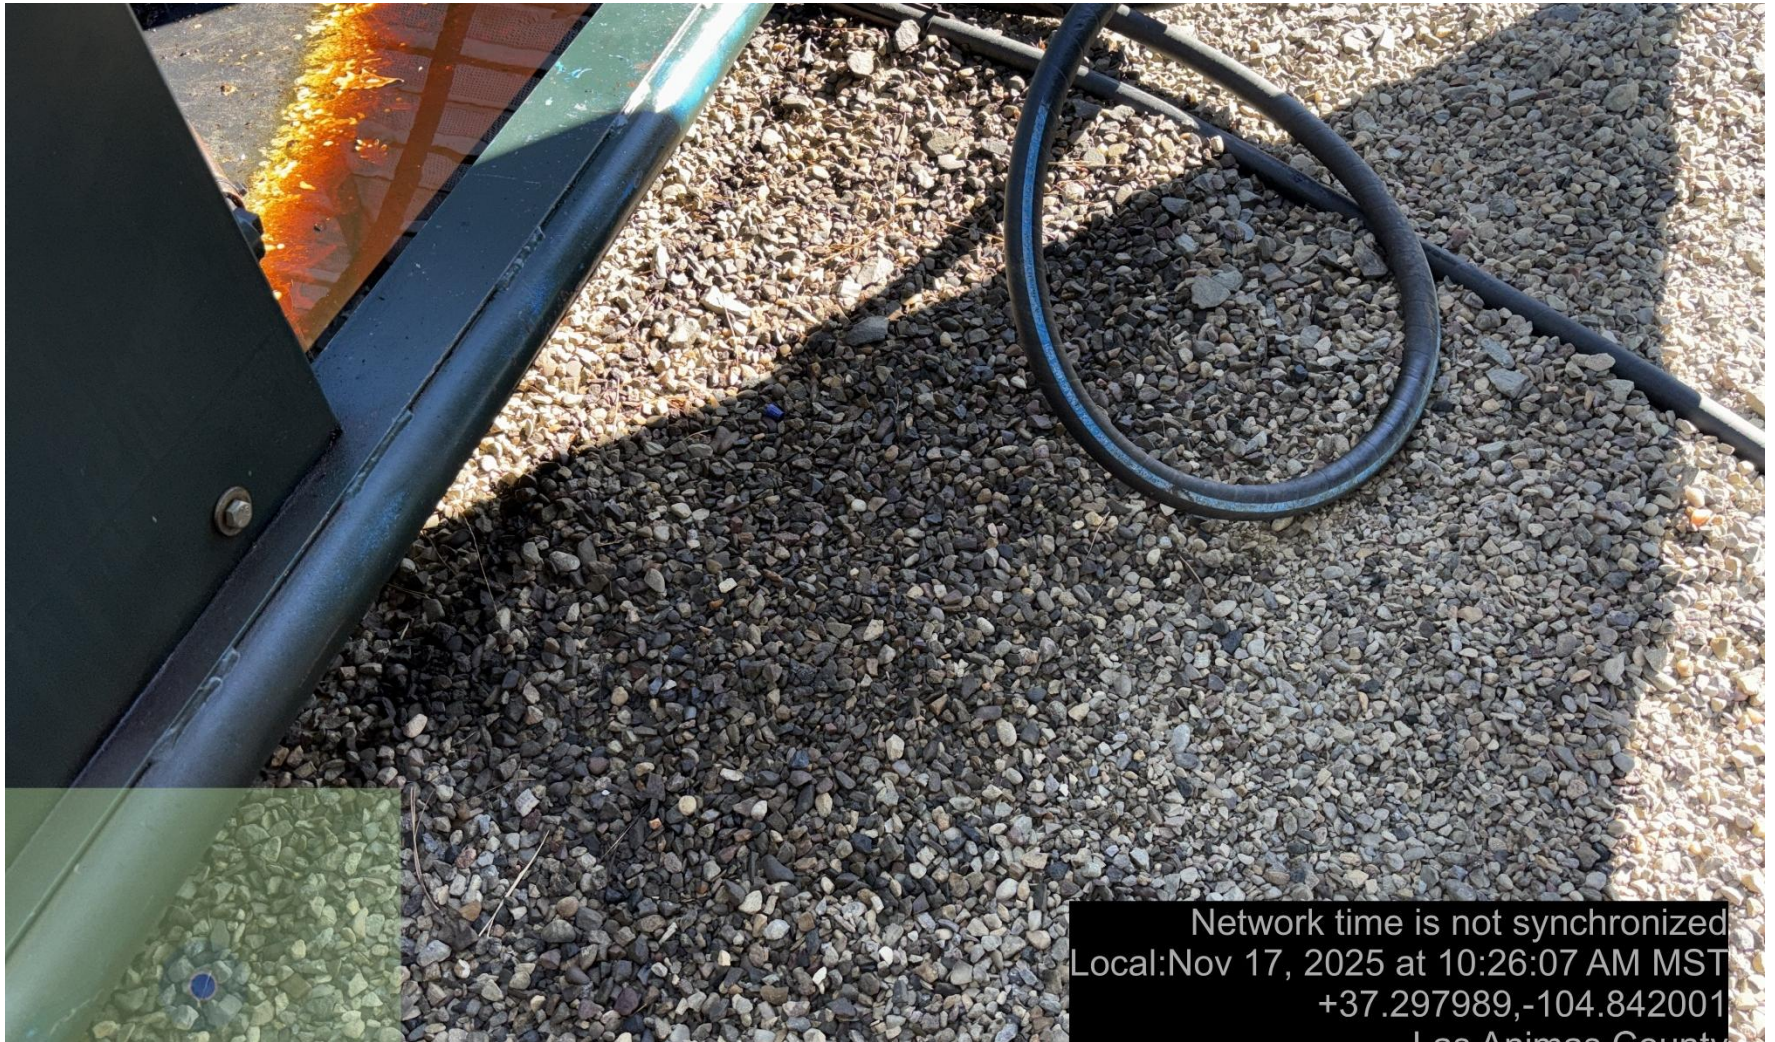
PHOTO 5: AREA OF IMPACTED SOIL NEAR COMPRESSOR. Conduct maintenance on equipment, cleanup stained material and review self inspection processes. COMPLY WITH RULE 1002,,(2).D.

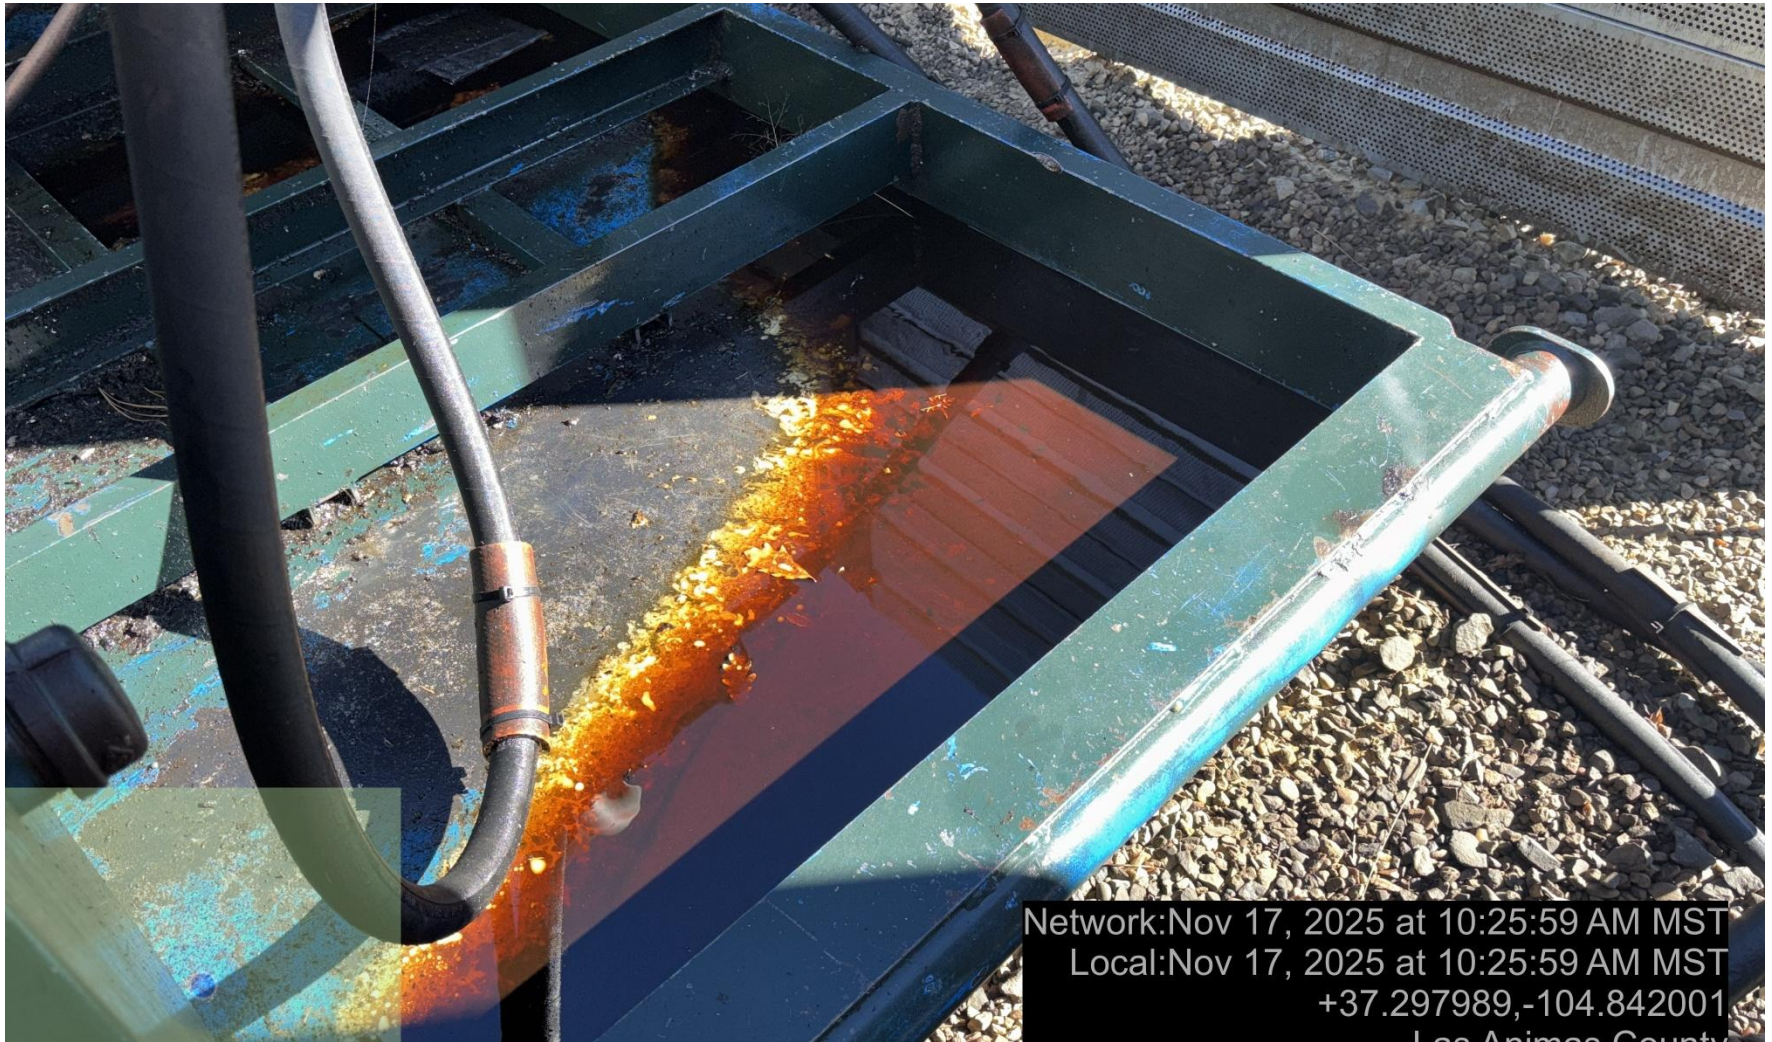
PHOTO 6: OILY WASTE IN PRIME MOVER SKID. DRAIN OILY WASTE REPAIR ALL LEAKS AND REMOVE IMPACTED SOIL PER RULE 1002.(2), D & 1002.f.(2)B, Comply with general provisions of the oil and gas act for wildlife protection AND SB-181 CA DATE 11-18-2025.
