Inspection Photos

Operator: TEP ROCKY MOUNTAIN LLC #96850

Location ID: 335096

Inspection Doc: 718101000

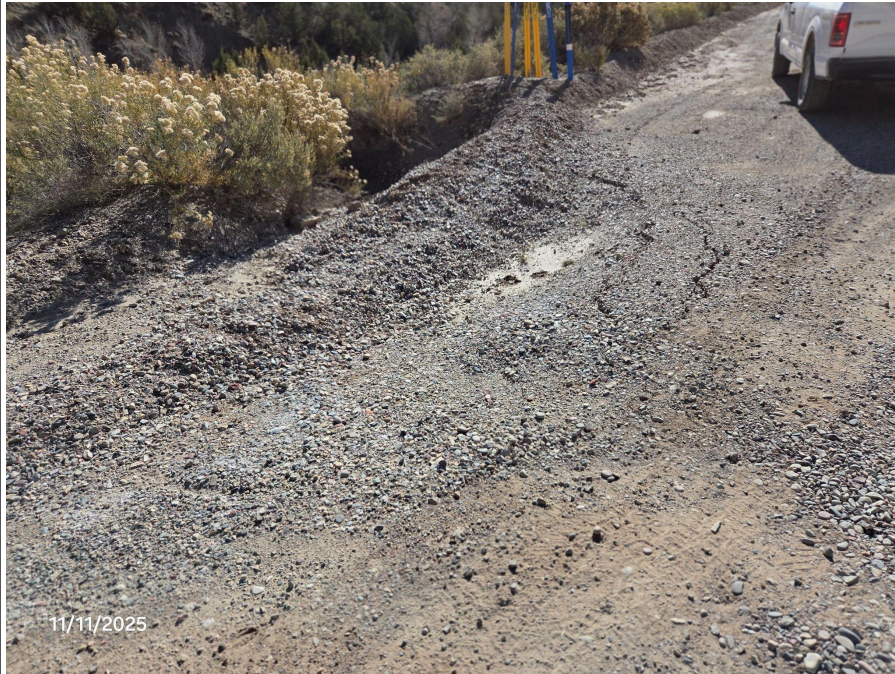
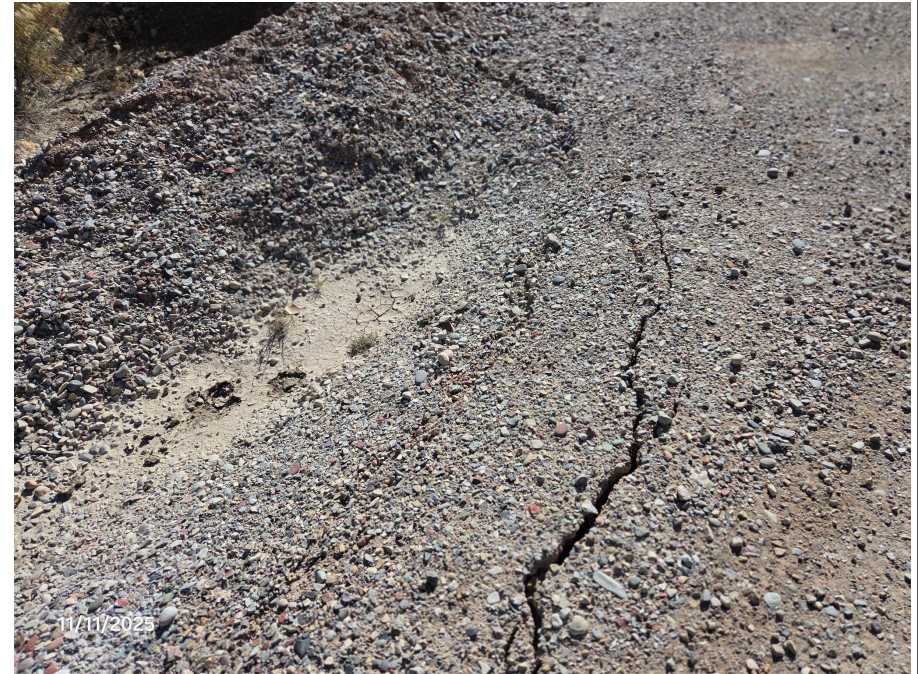
Photo 1: Photos taken from the northeast end of the Location. Photo shows subsidence/stabilization issues.

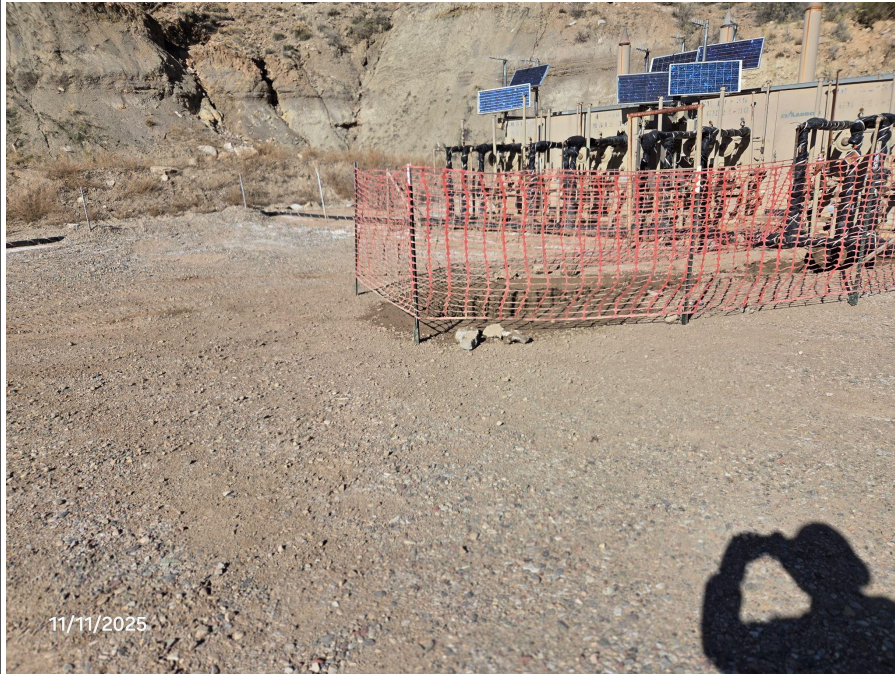
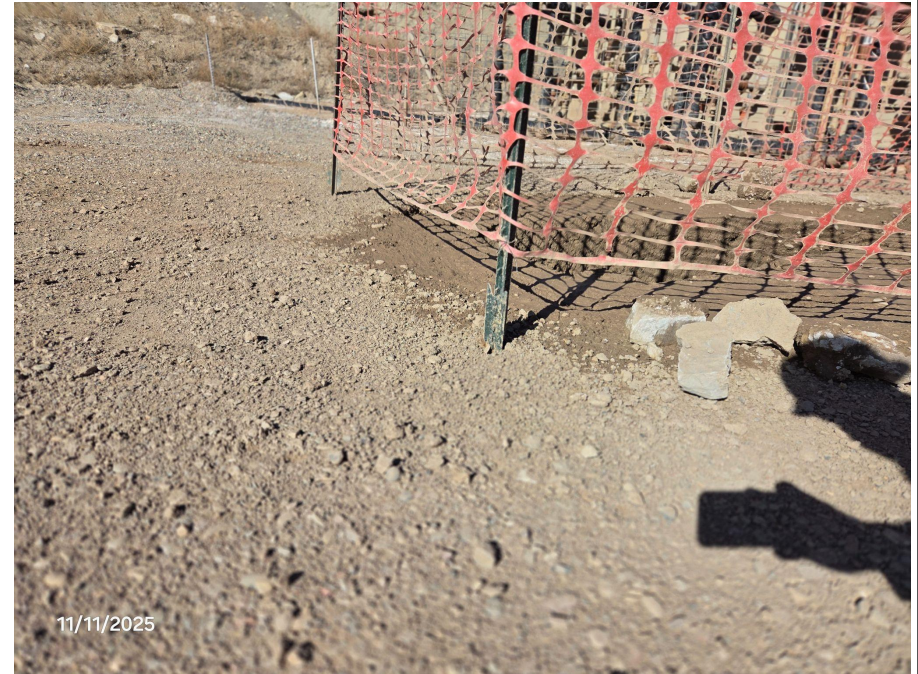
Photo 2: Photos show safety fencing inadequate to prevent wildlife access to the excavated areas. No other BMPs to prevent wildlife access to, or allow wildlife egress from, the excavated areas observed.

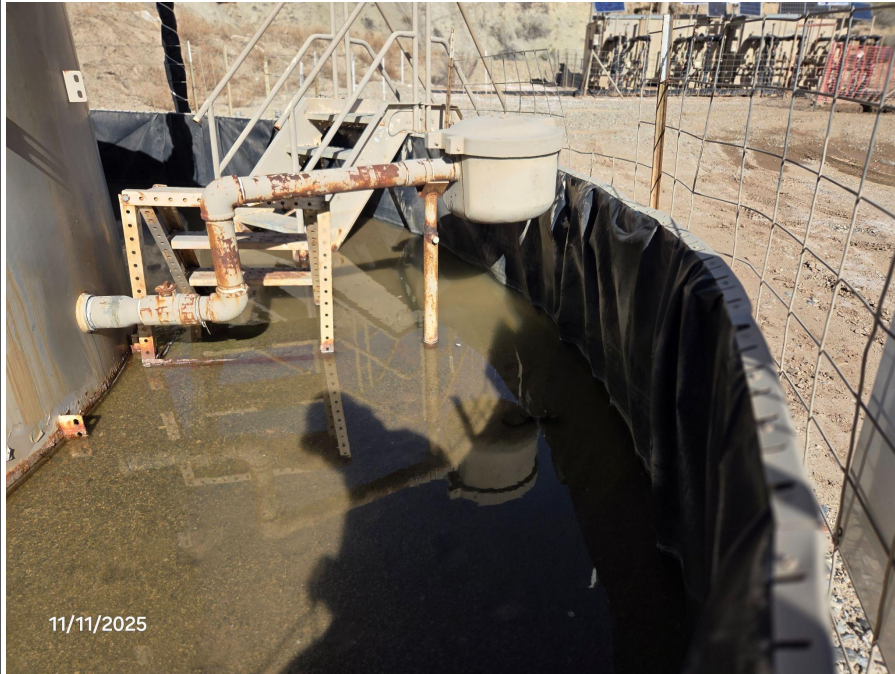
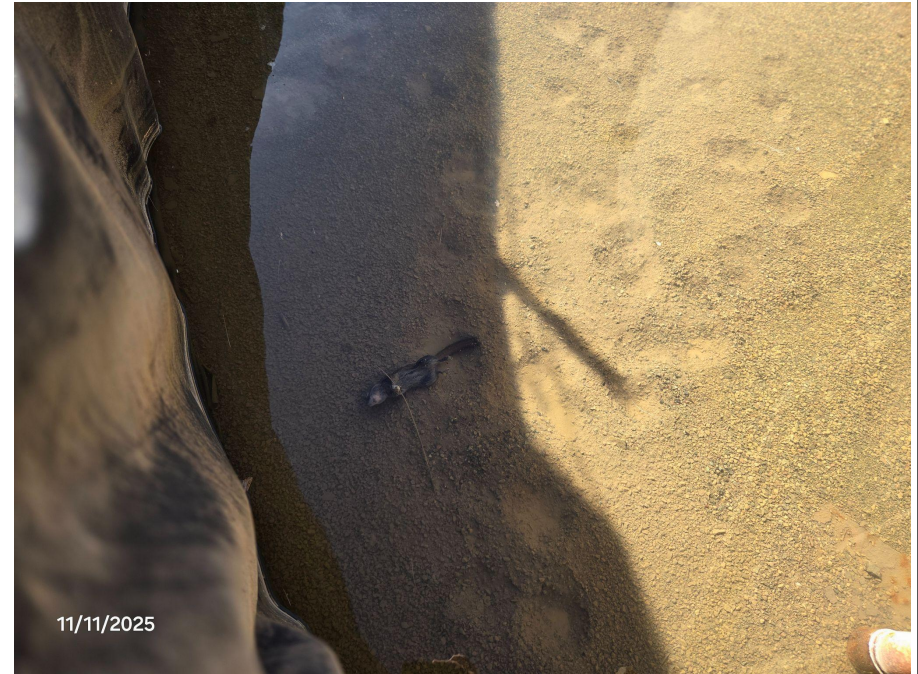
Photo 3: Photos taken from the tank battery. Photos show fluid accumulation and wildlife mortality observed within containment.

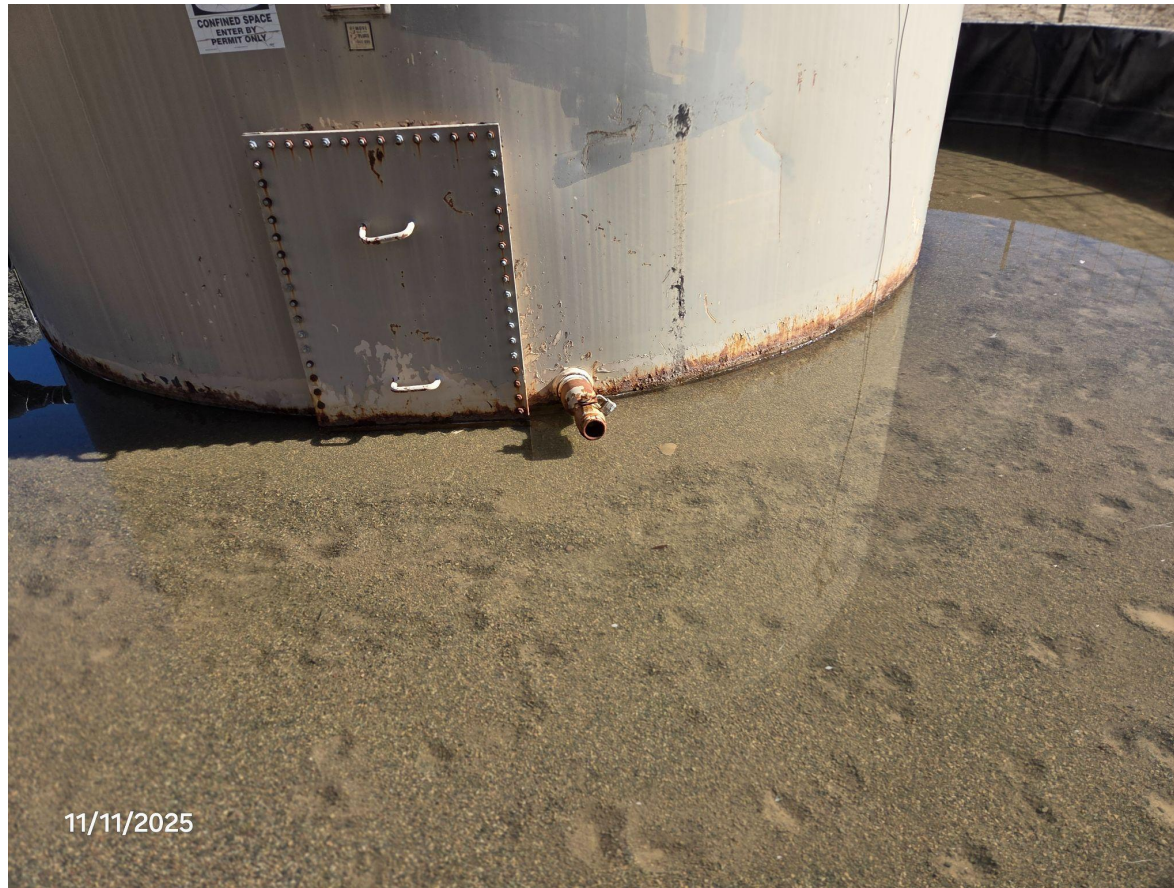
Photo 4: Lines at tank have not been capped or plugged.

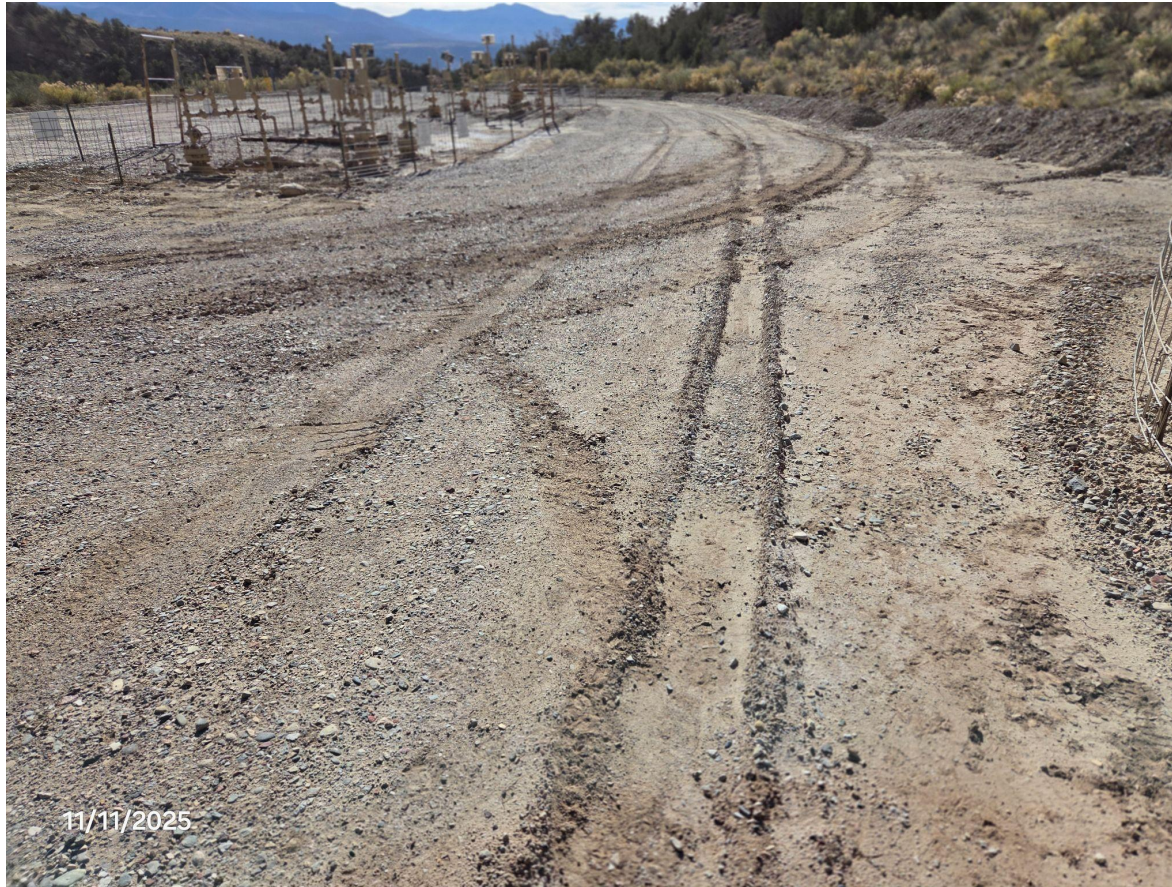
Photo 5: Photo shows BMPs to stabilize the working pad surface, as well as to minimize vehicle tracking and sediment transport show signs of disrepair, and do not appear to be sufficient. Maintenance advised to ensure BMPs remain in proper functioning condition.

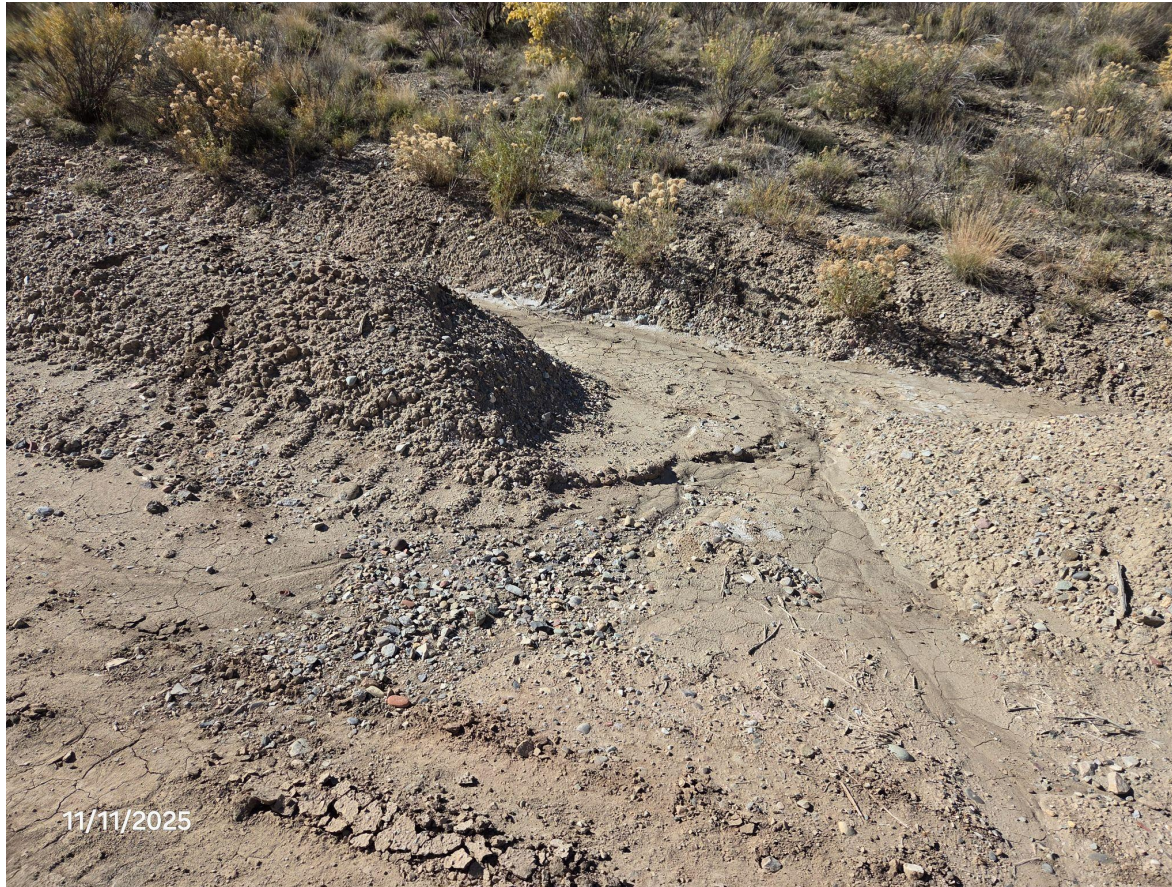
Photo 6: Photo taken from ditch/berm on the west end of the Location. Sediment accumulation within the ditch is apparent. Maintenance advised to ensure stormwater discharge can continue, and ponding on the pad is prevented.
