Inspection Photos

API: 017-06410

Operator: **WILLIFORD ENERGY COMPANY**

Inspection Date: 11/18/2025

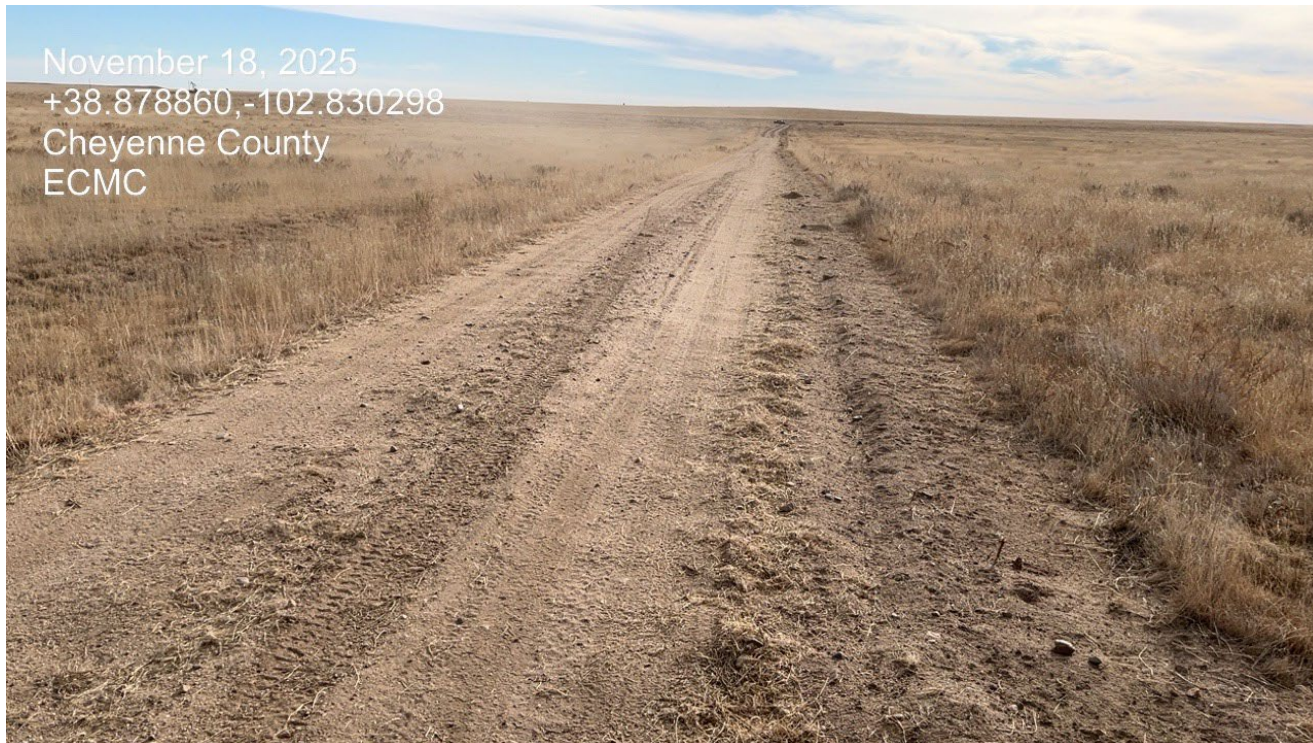
Photo 1. Facing south along the access road. This area was graded with loose soil material from the roadside. The adjacent roadside soils should not be graded, causing the road to widen with additional disturbance.

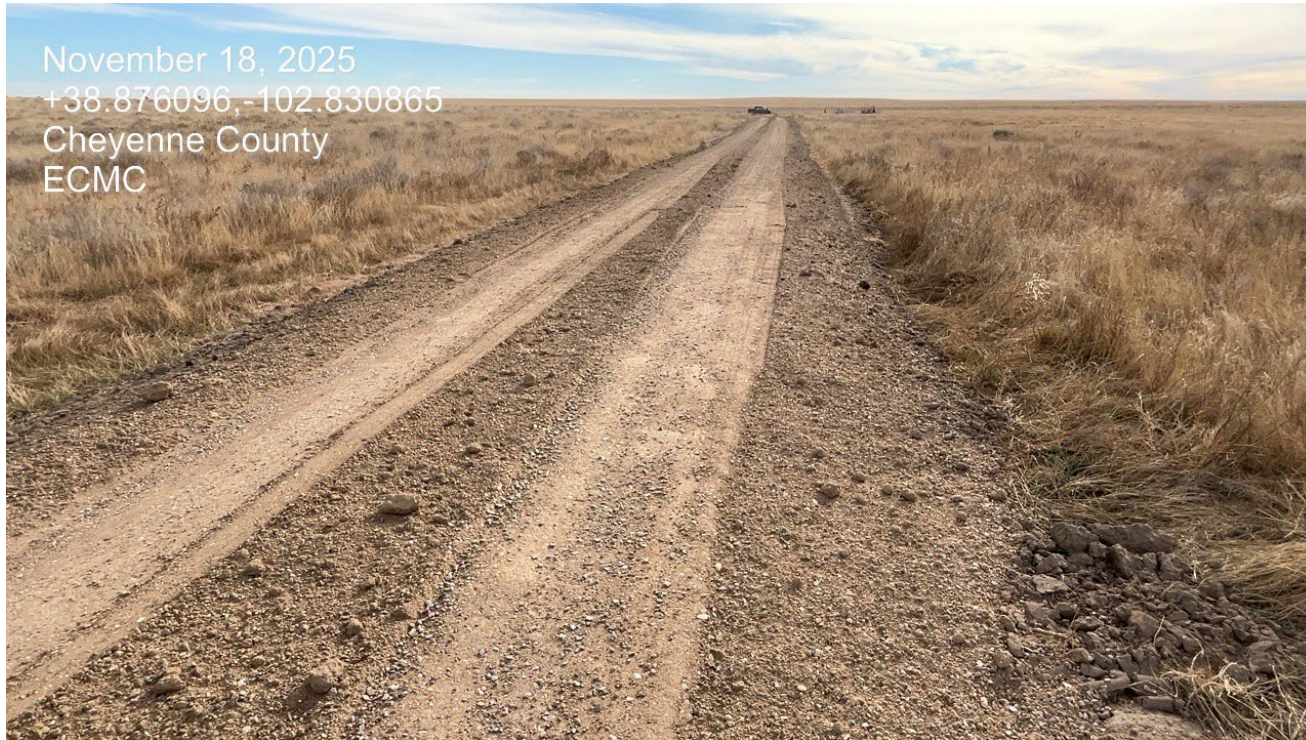
Photo 2. Facing south along the access road. There has been road base material spread along the road where road degradation had occurred.

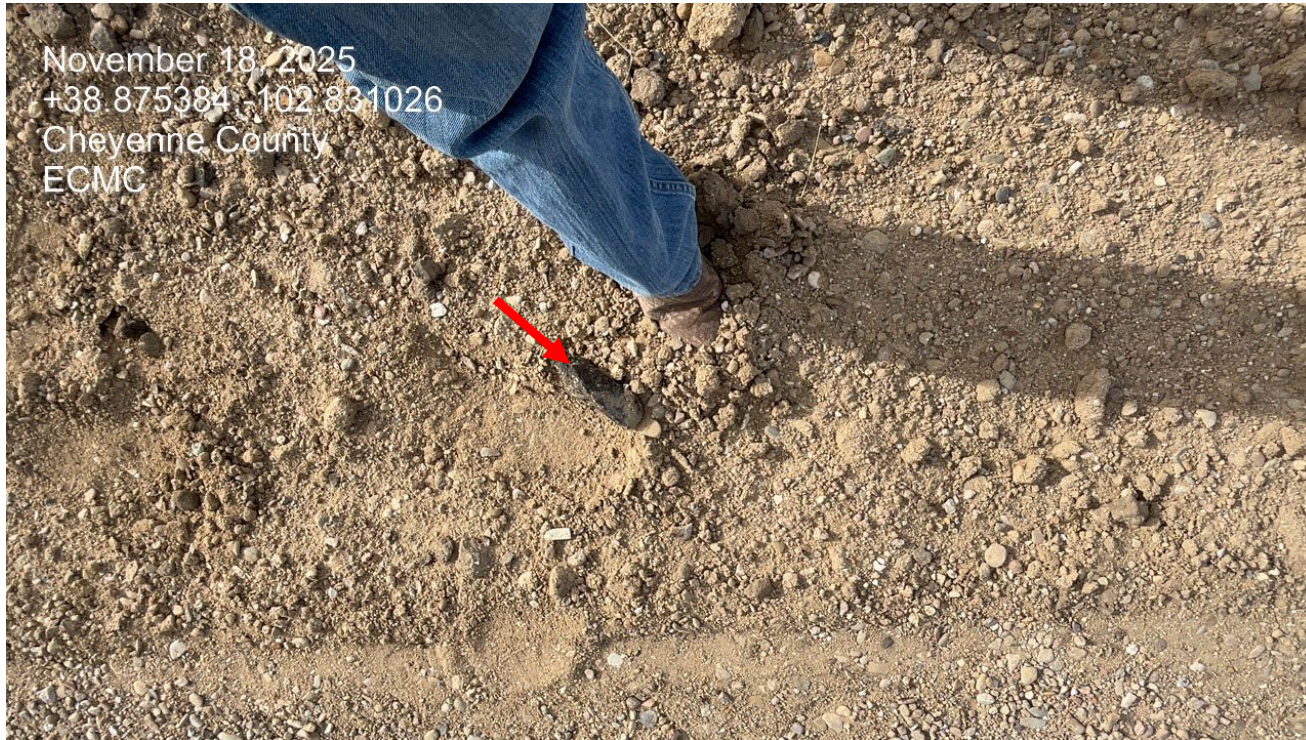
Photo 3. There are chunks of asphalt from material brought in to build up the road. Also material where inspectors foot is placed is loose and needs to be graded and compacted.

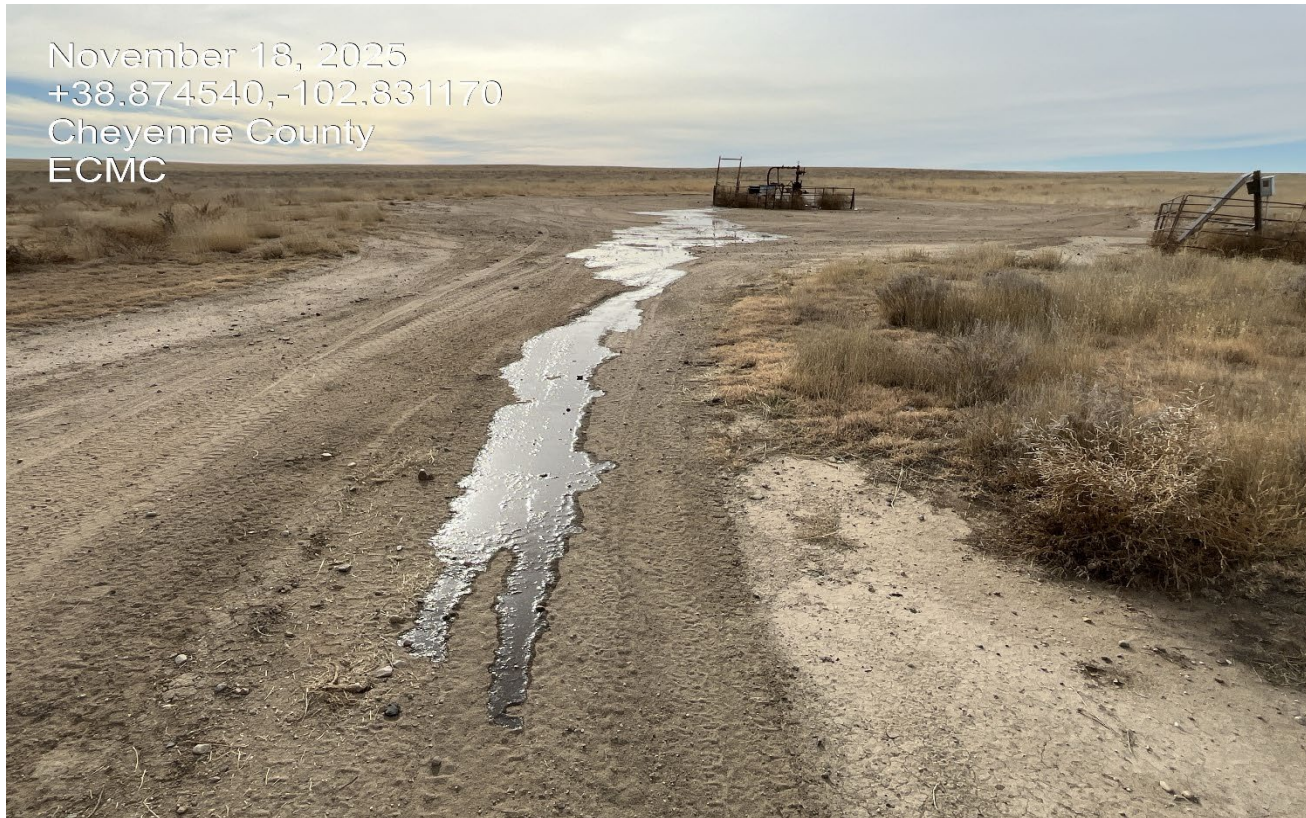
Photo 4. Facing southwest toward the wellsite. There was an active leak observed at the well which had flowed approximately 120' down to this point from the wellhead.

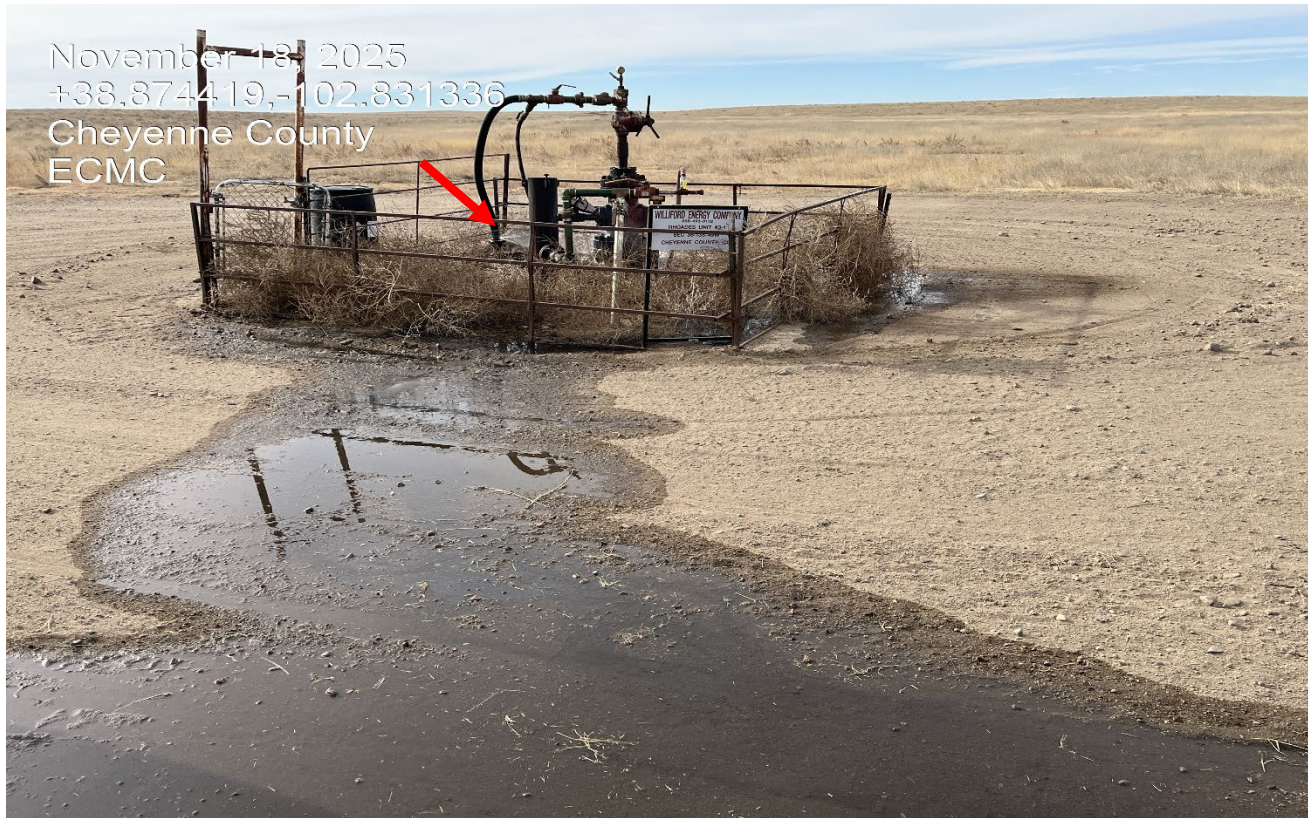
Photo 5. The source of the leak can be seen at red arrow..

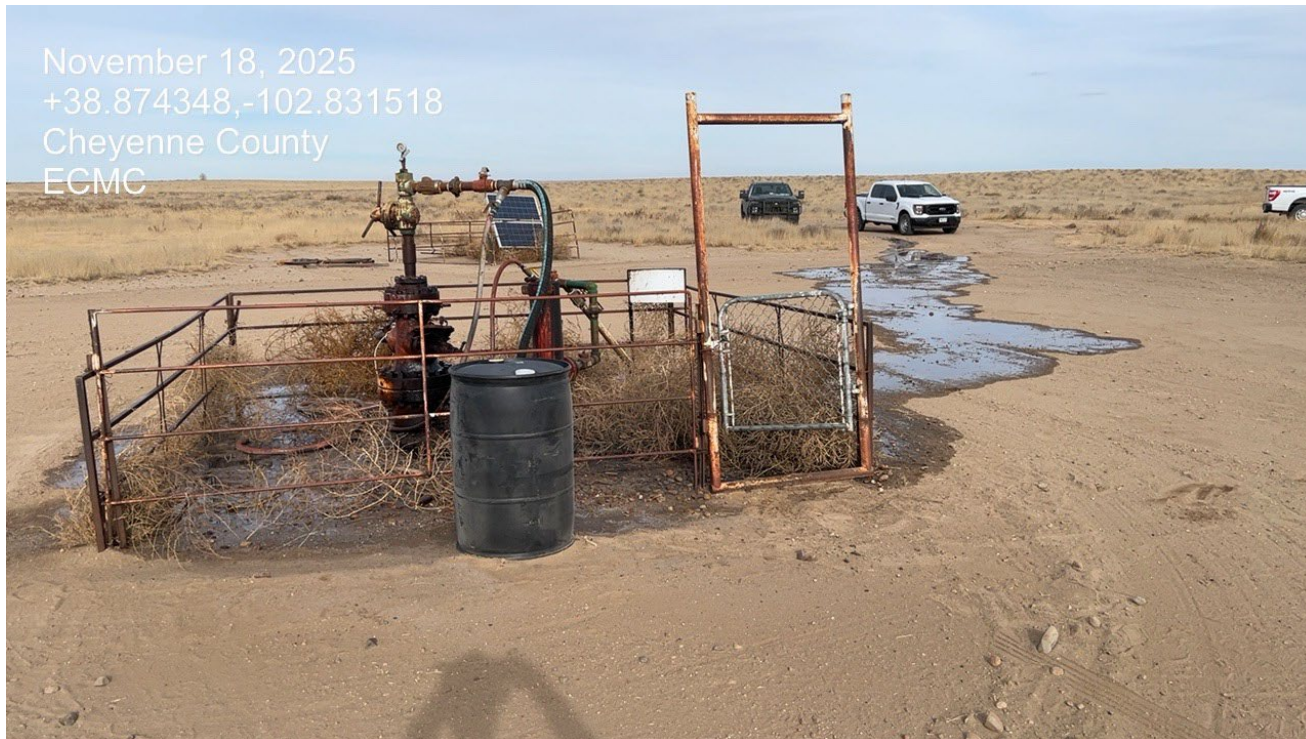
Photo 6. Facing to the northeast at the wellhead. The pumper arrived onsite to turn the valve and stop the leak.

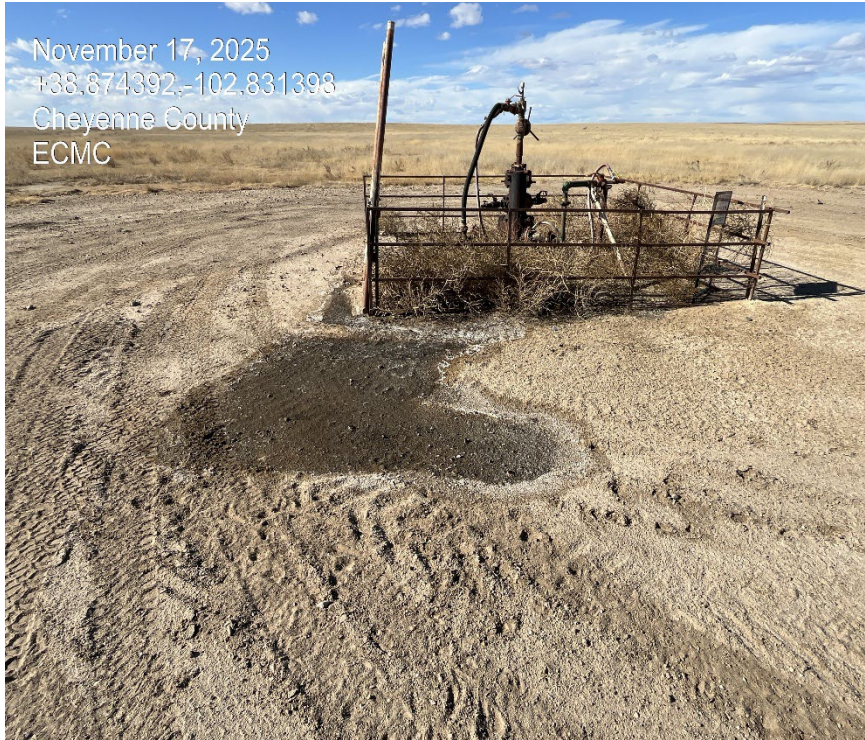
Photo 7. Inspection the day before observed a small spill had occurred at the wellhead.

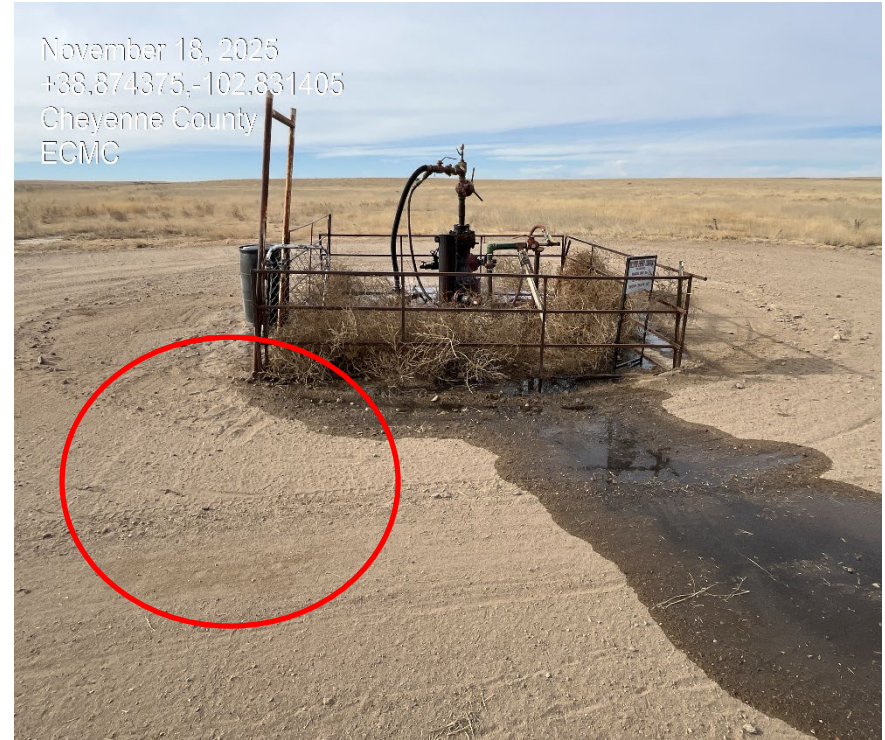
Photo 8. The next day when active sill was occurring, it was observed that the previous spill at area of red circle had been covered up with a drag harrow.
