Site Specific Final Reclamation Completion Notice – Cropland Drone Imagery

Permit Closure Report – Cropland

Location ID: 328430

Location Name: BAILEY-65N64W/33SWNW

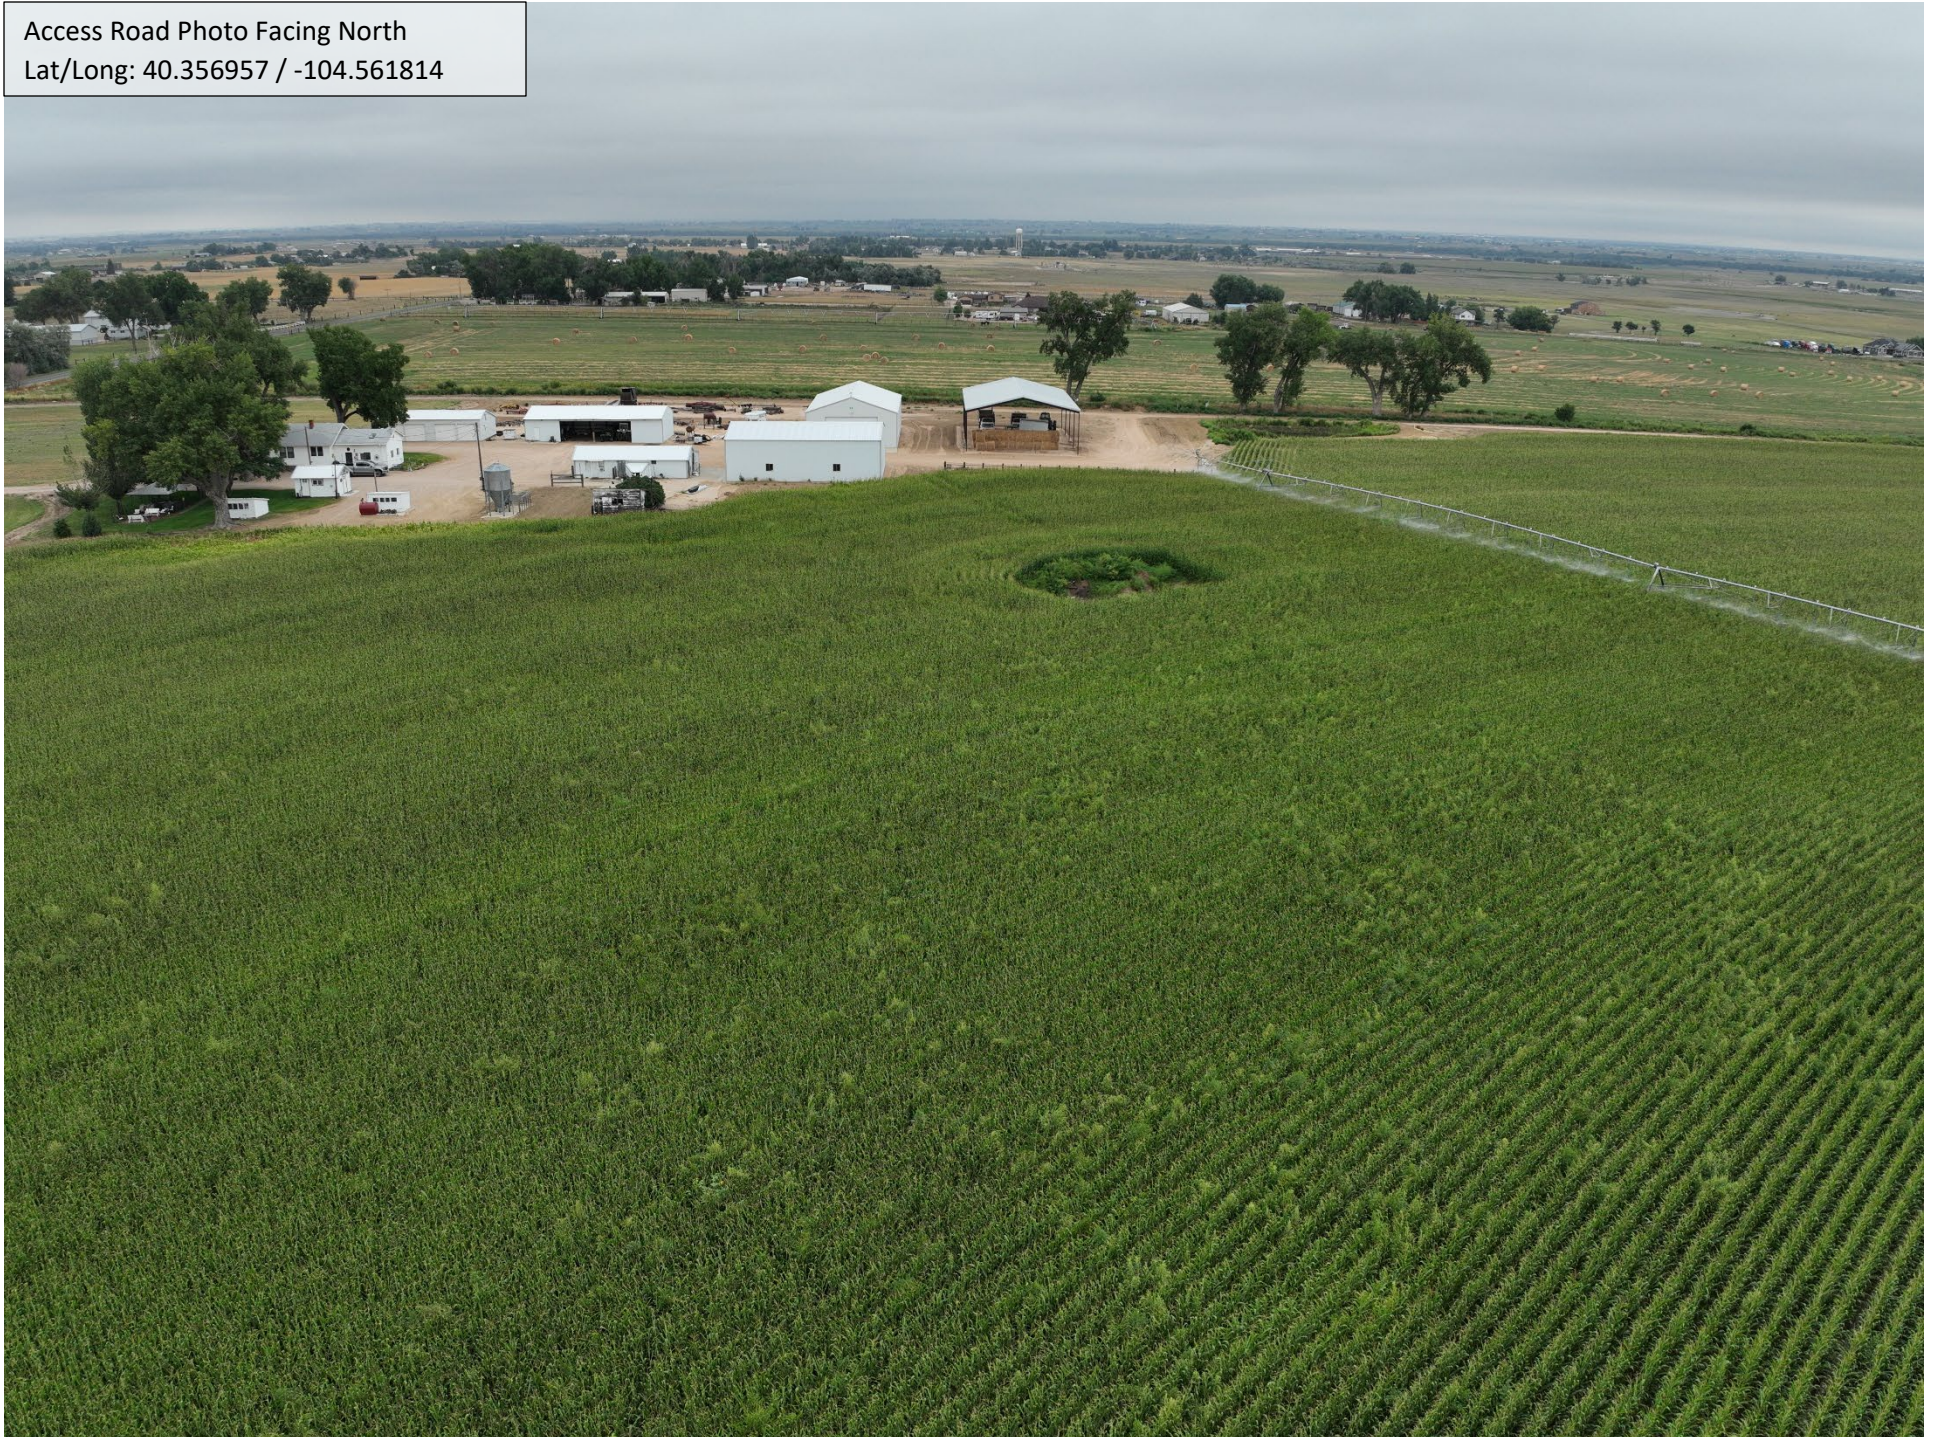
Access Road Photo Facing North
Lat/Long: 40.356957 / -104.561814

BAILEY #33-2 was reclaimed and returned to the landowner for agricultural use in 2019. The wellhead was accessed from an unpaved access road that originated at an existing agricultural service road off of County Road 53. The access road was reclaimed and returned to agriculture in conjunction with the reclamation of the well location.
