Site Specific Final Reclamation Completion Notice – Cropland Drone Imagery

Permit Closure Report – Cropland

Location ID: 323264

Location Name: BUDERUS-65N65W/23NENE

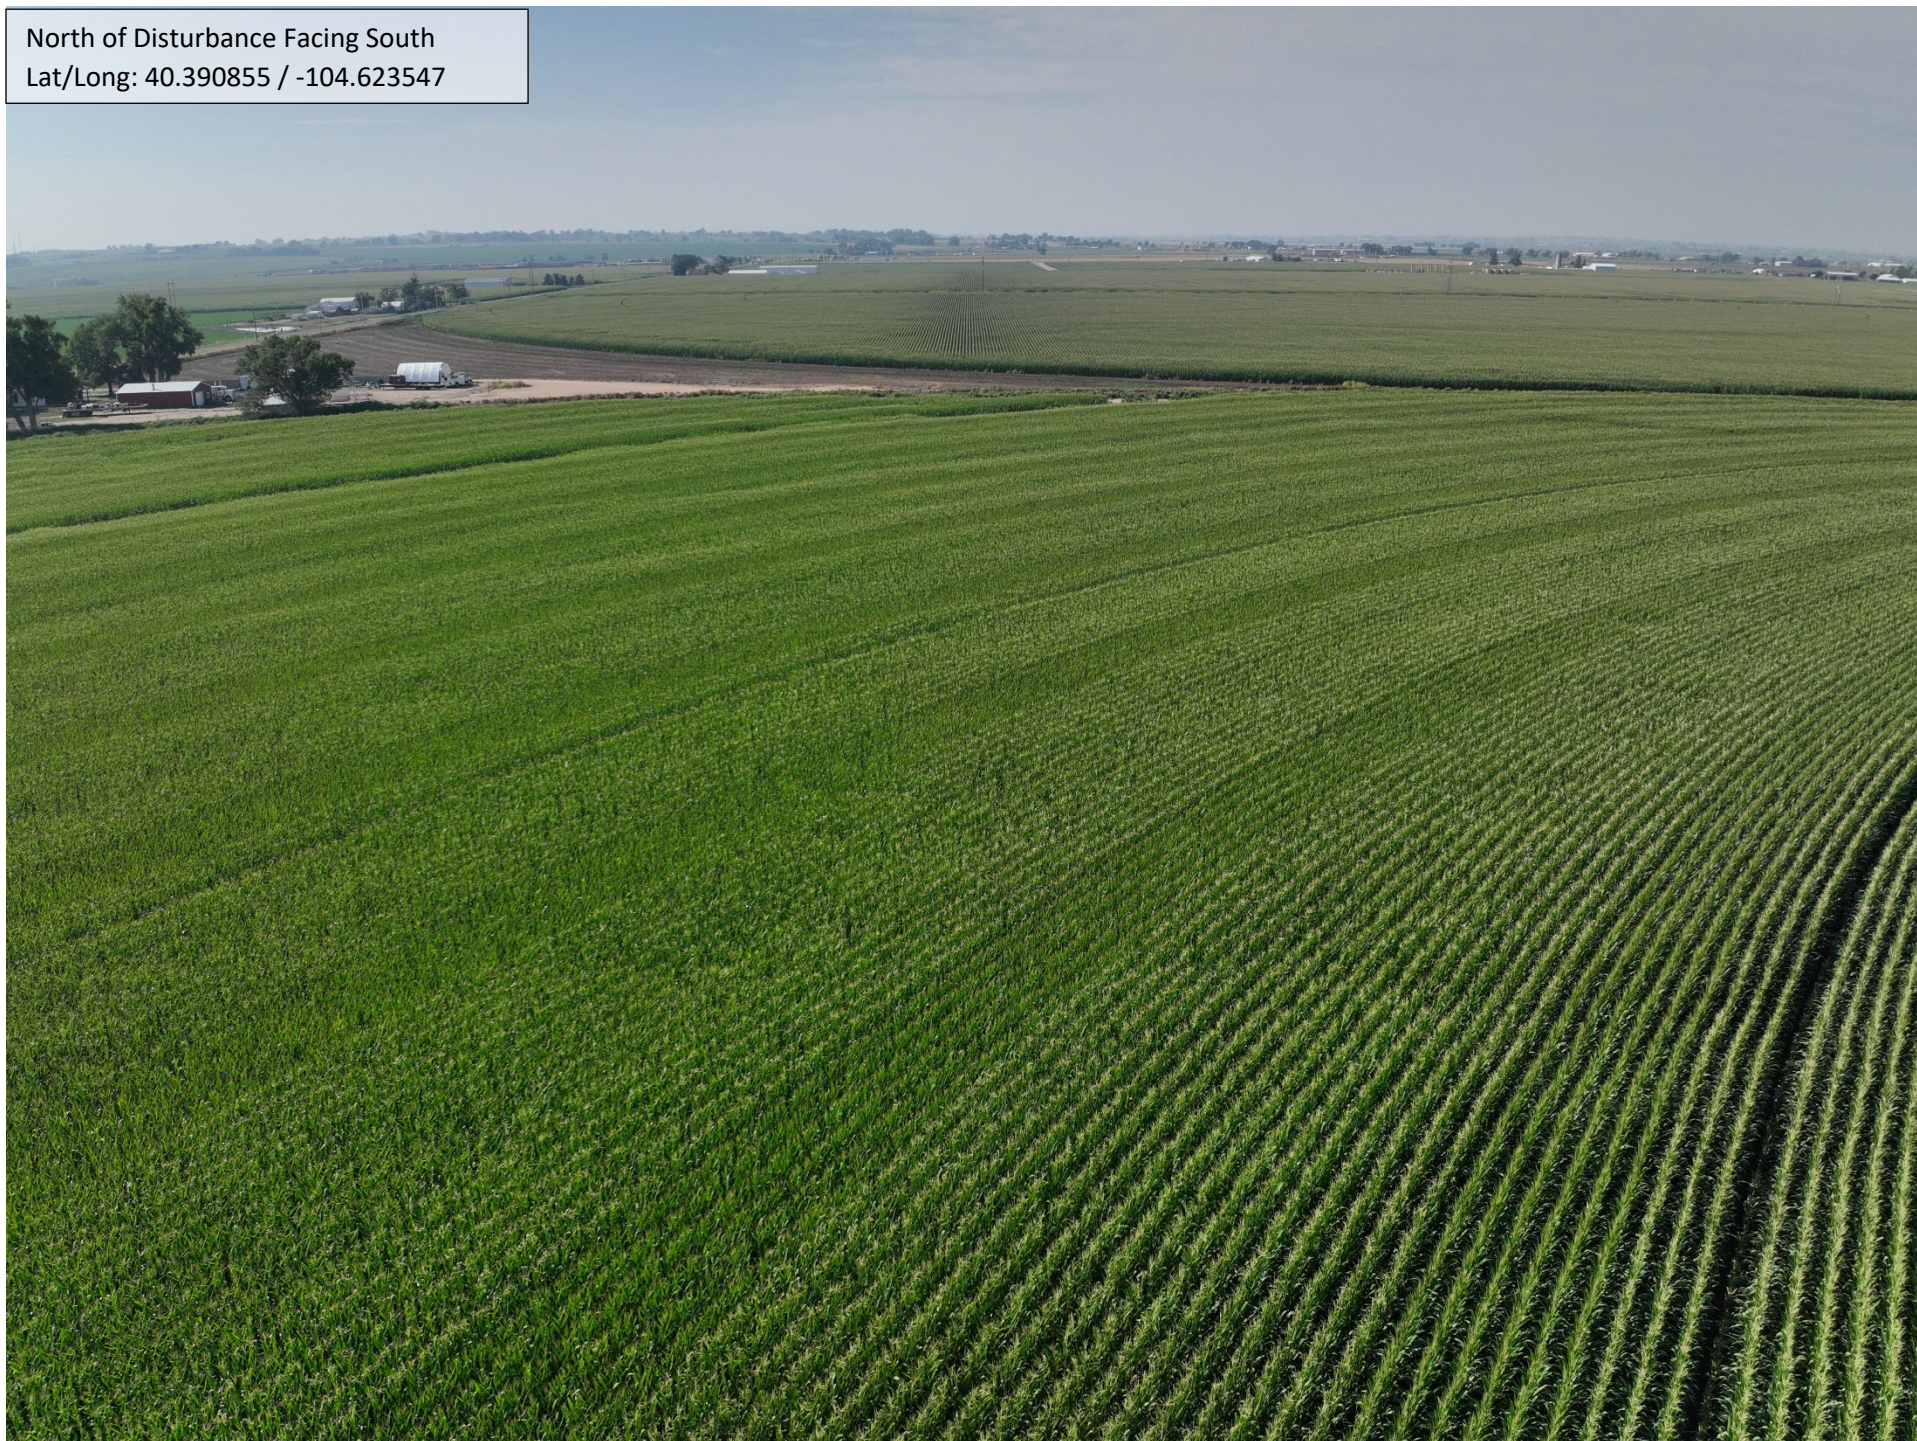
North of Disturbance Facing South
Lat/Long: 40.390855 / -104.623547

Drone imagery confirms that no equipment was left on site at this location after reclamation activities occurred.

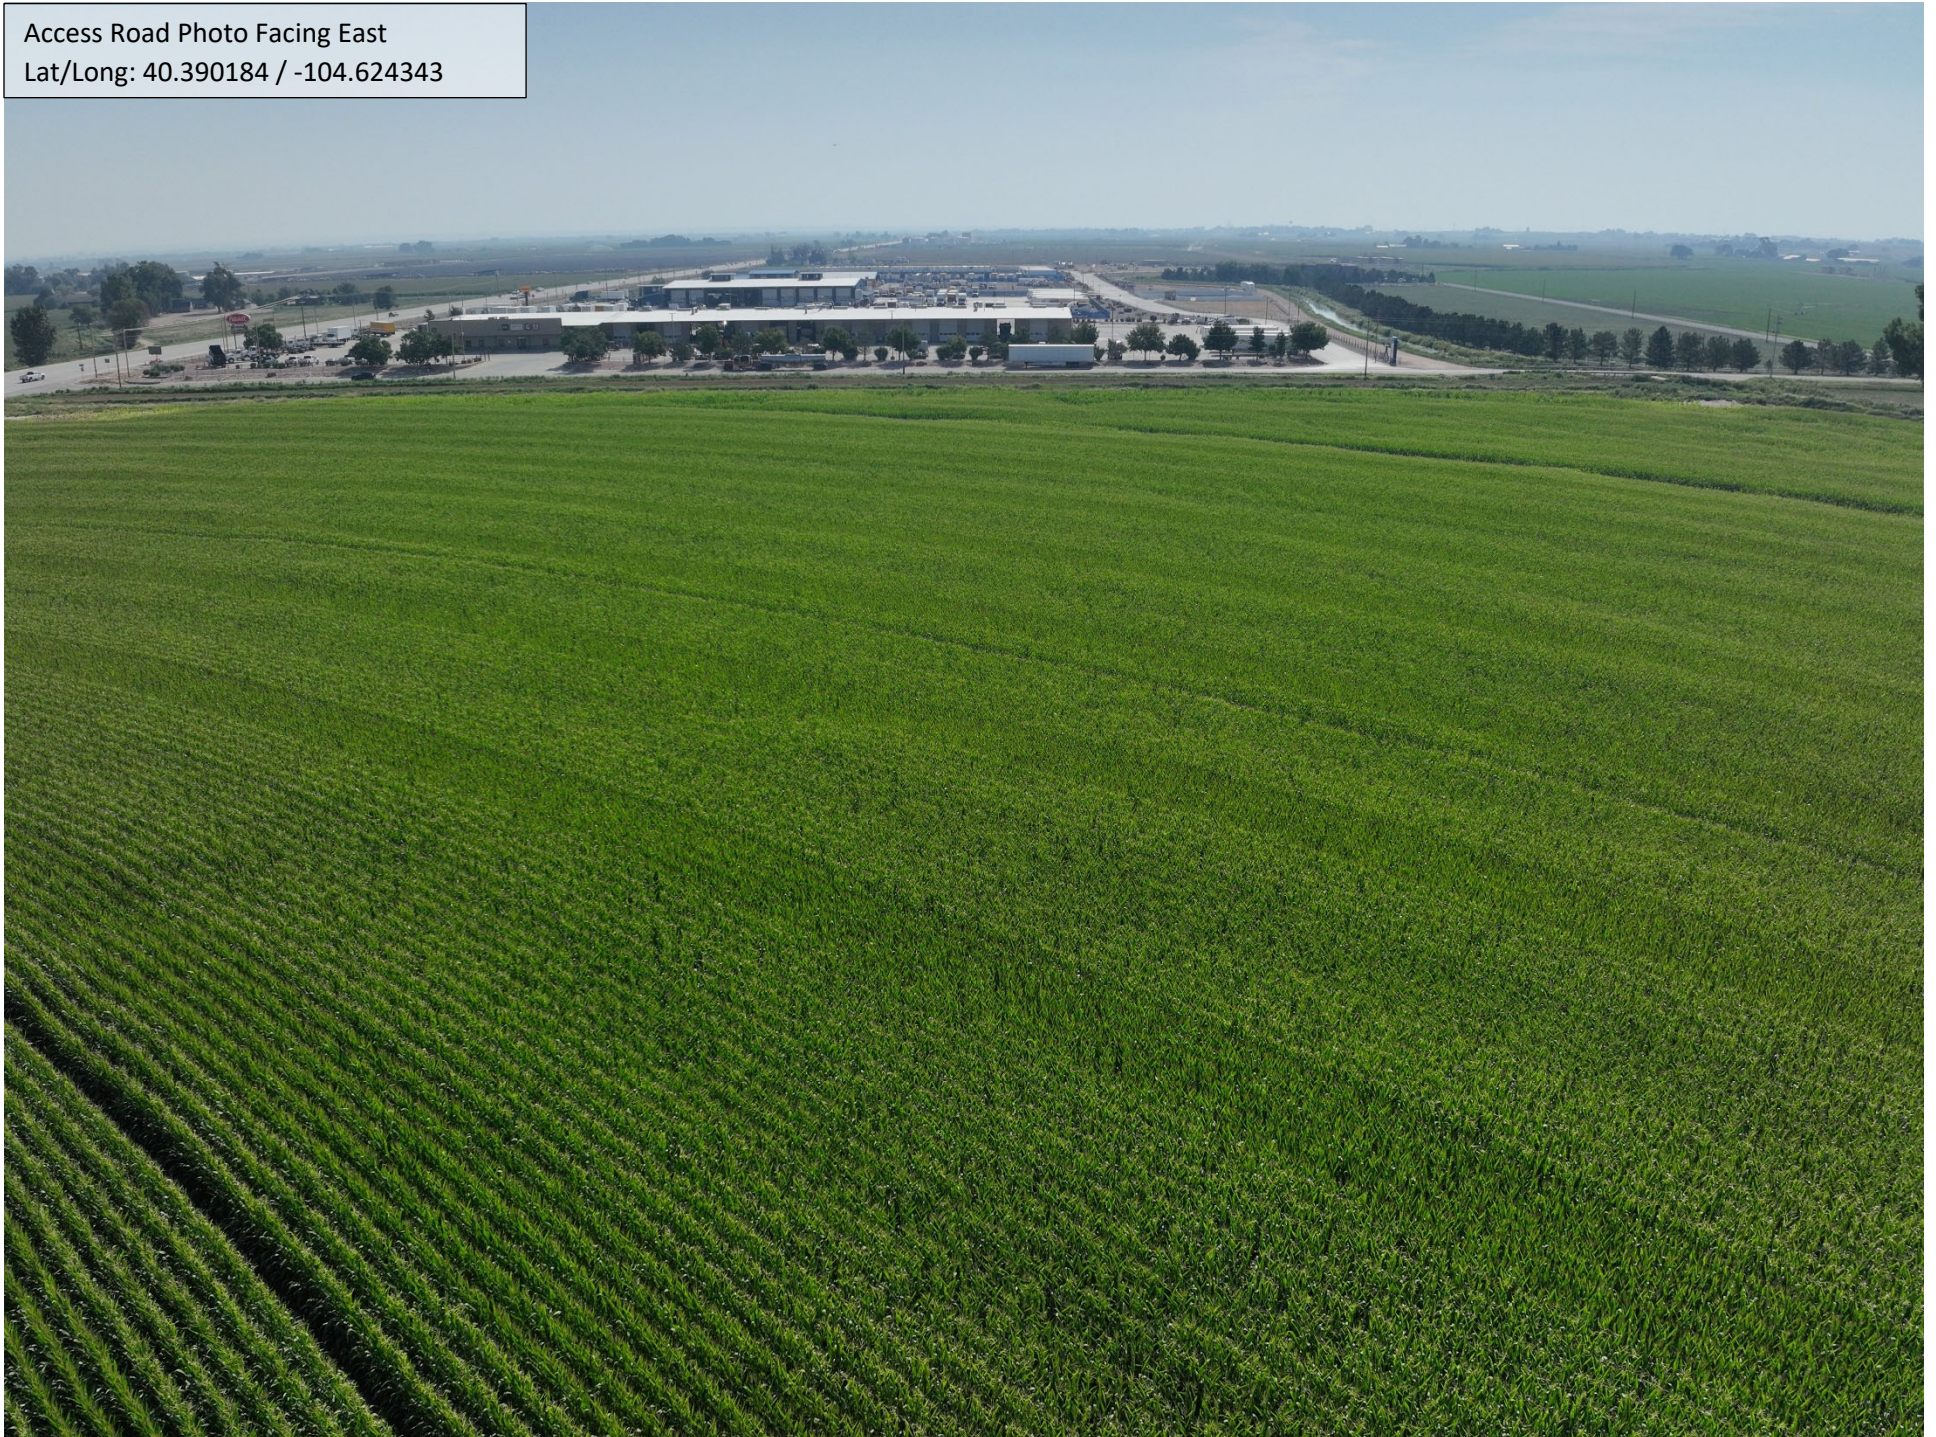
Access Road Photo Facing East
Lat/Long: 40.390184 / -104.624343

BUDERUS #1-23 was reclaimed and returned to the landowner for agricultural use in 2018. The wellhead was accessed from a pre-existing agricultural service road with entrances off US HWY 34 and County Road 45 ½. The access roads to the BUDERUS #1-23 wellhead from the agricultural service road were reclaimed and returned to agriculture in conjunction with the reclamation of the well location.

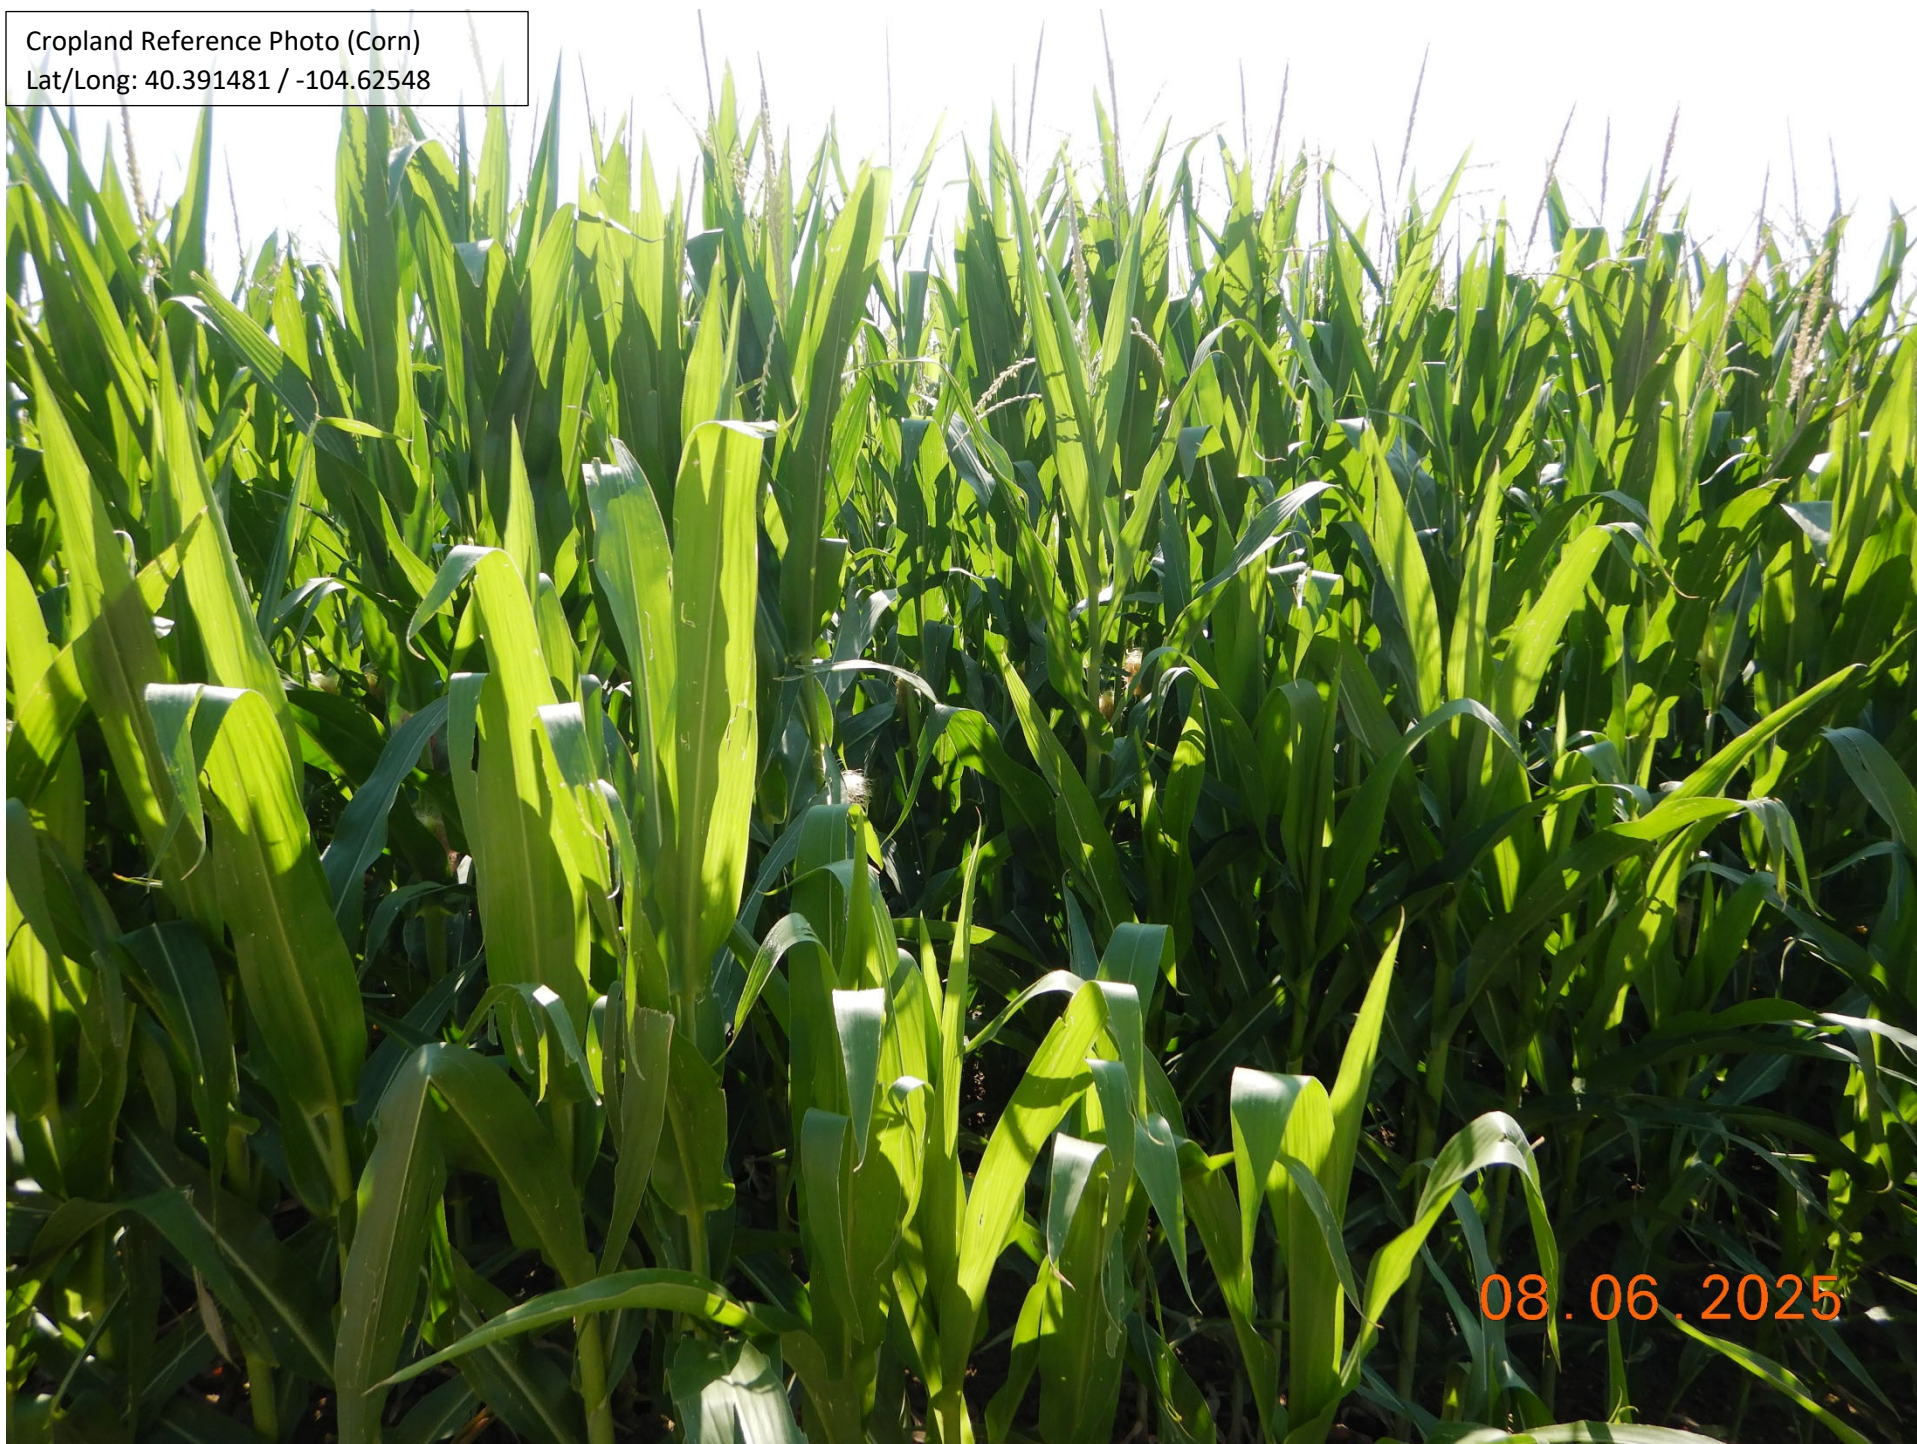
Cropland Reference Photo (Corn)
Lat/Long: 40.391481 / -104.62548

Crop 2025 – Corn
