KPK
Central tank battery
Location ID: 450391

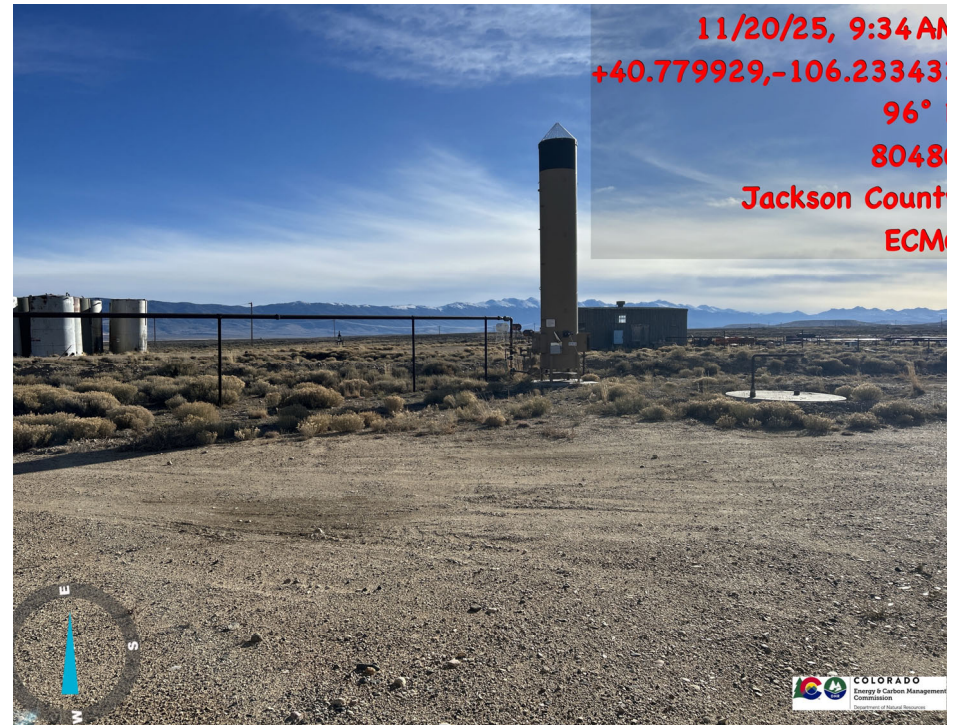
ECD not metered

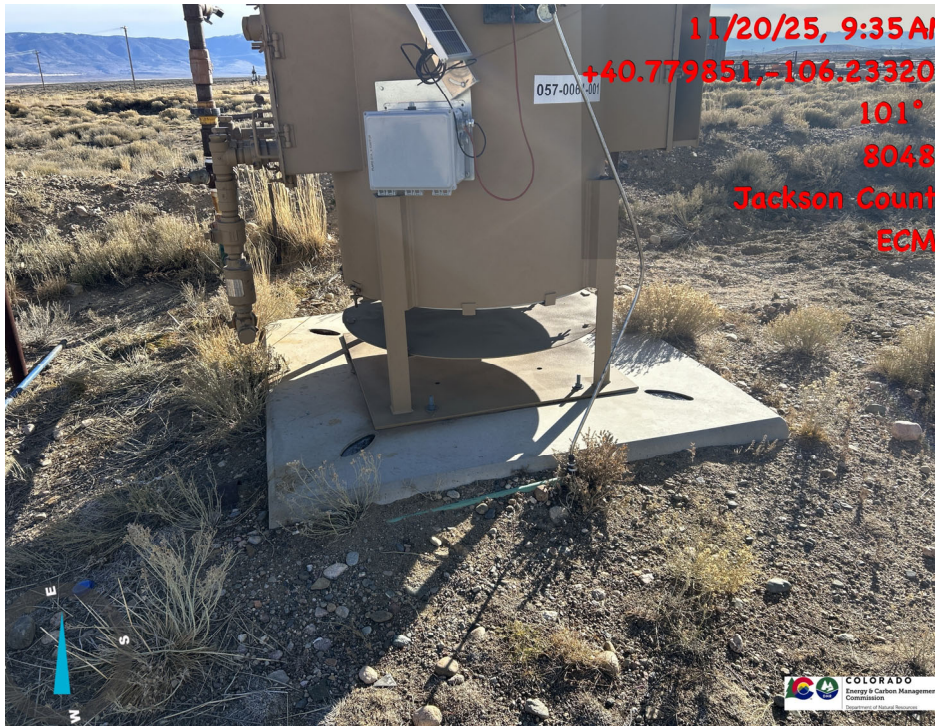
Weeds around running ECD

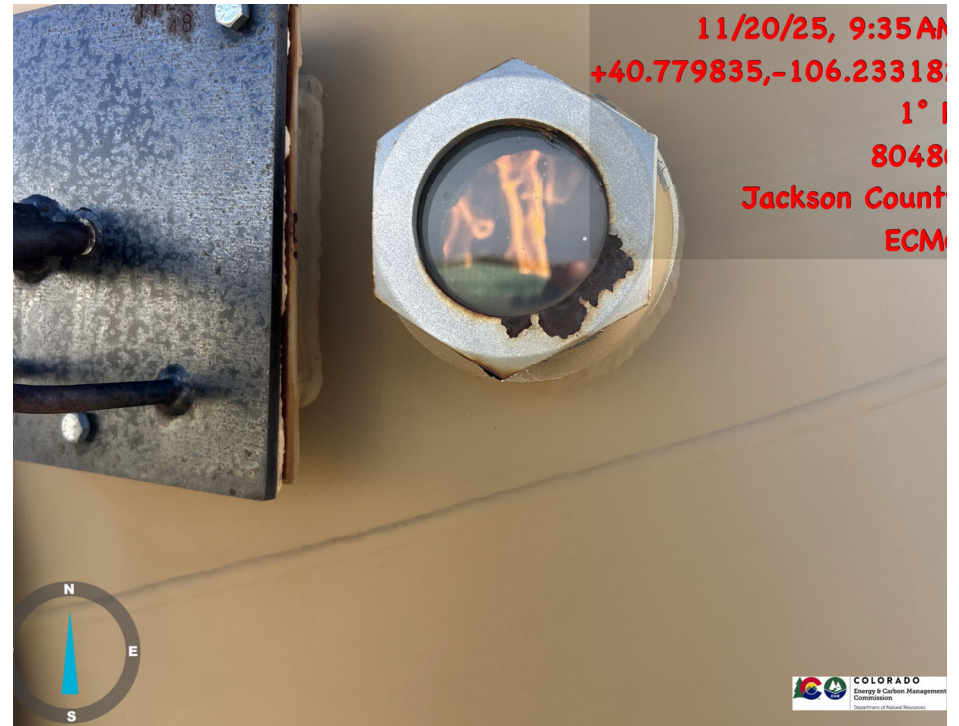
ECD running

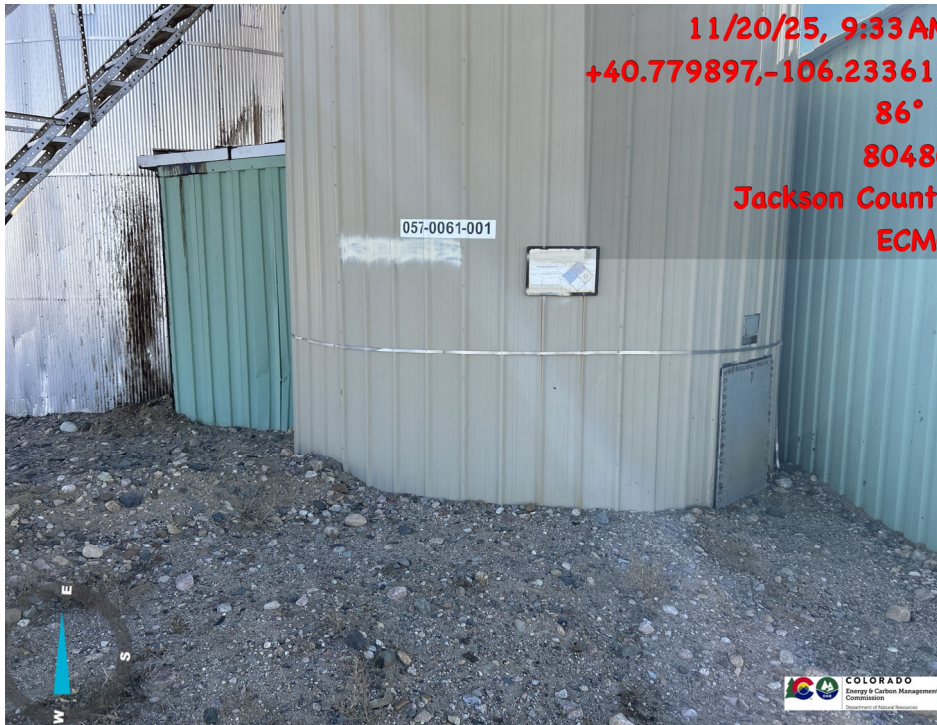
Tank lacks legible labeling and debris

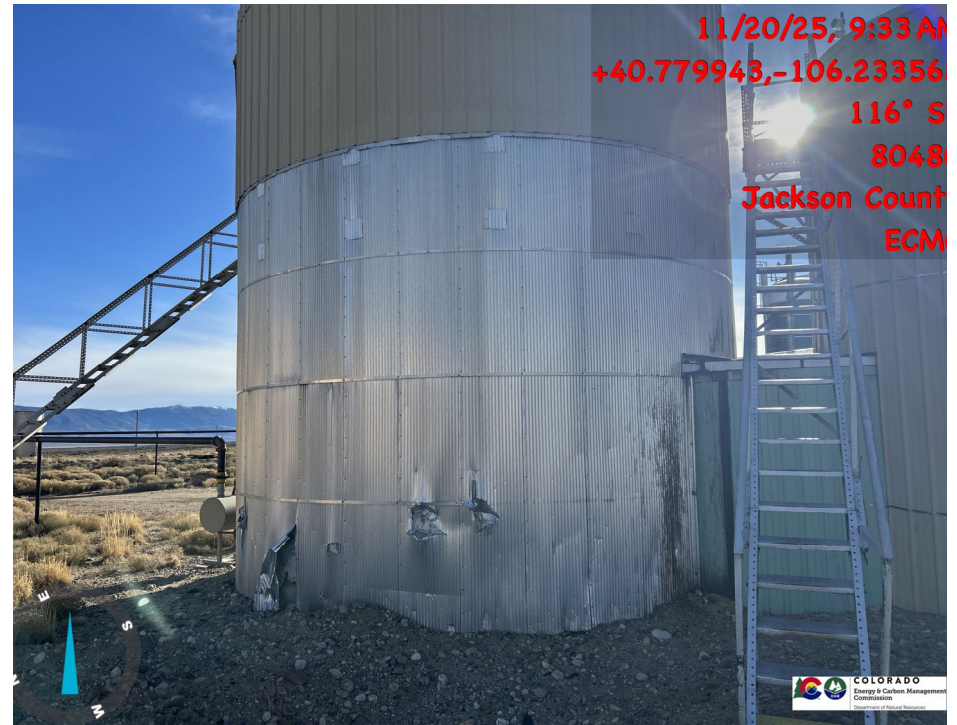
Tank lacks legible labeling and debris

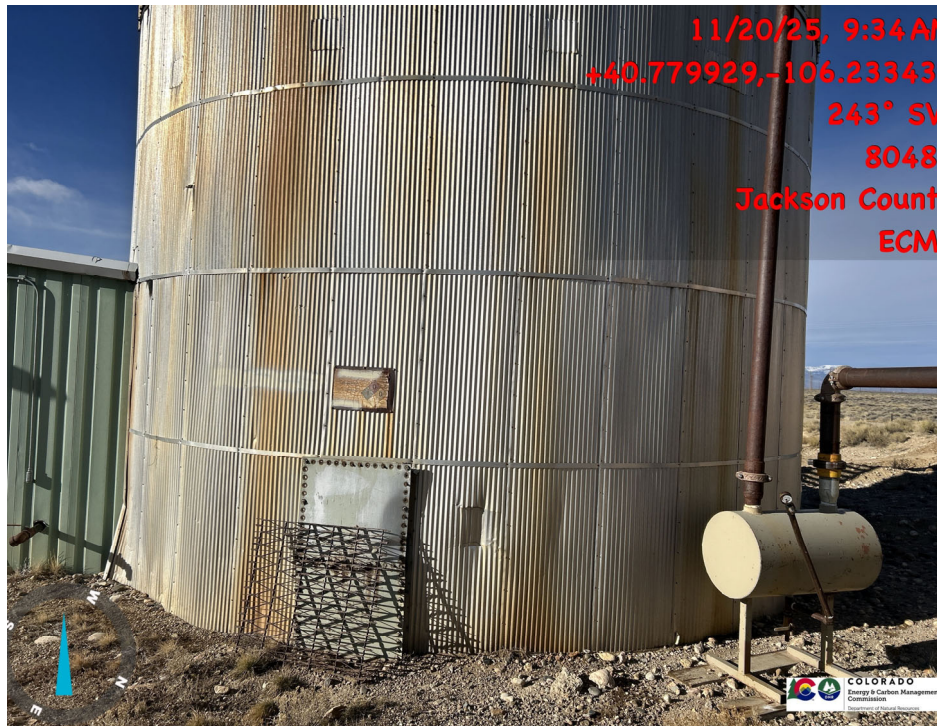
Tank lacks legible labeling and debris

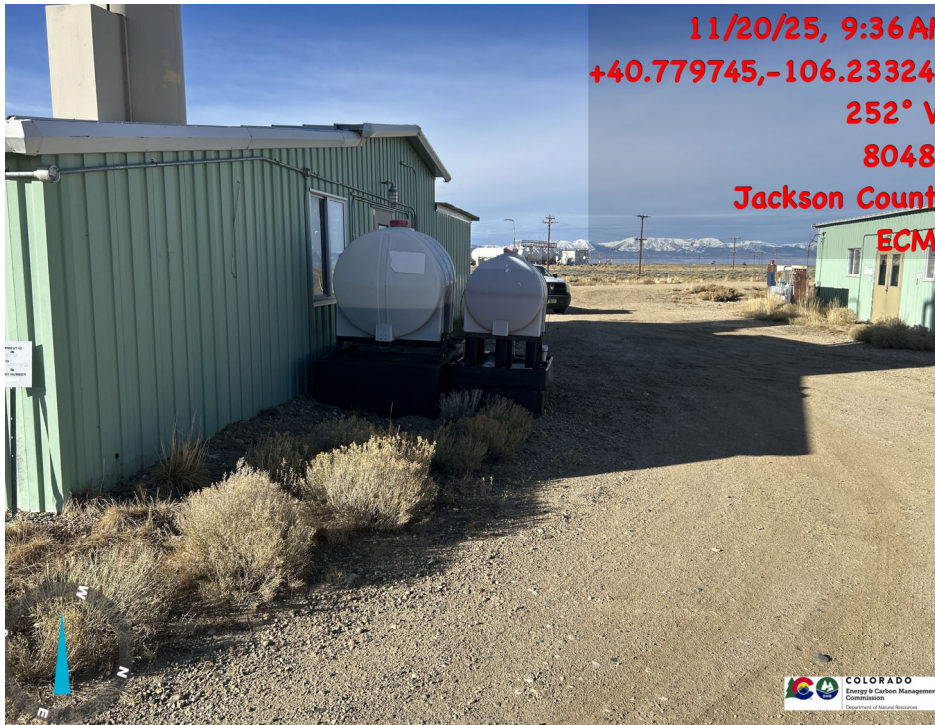
Chemical tanks lacking legible labeling

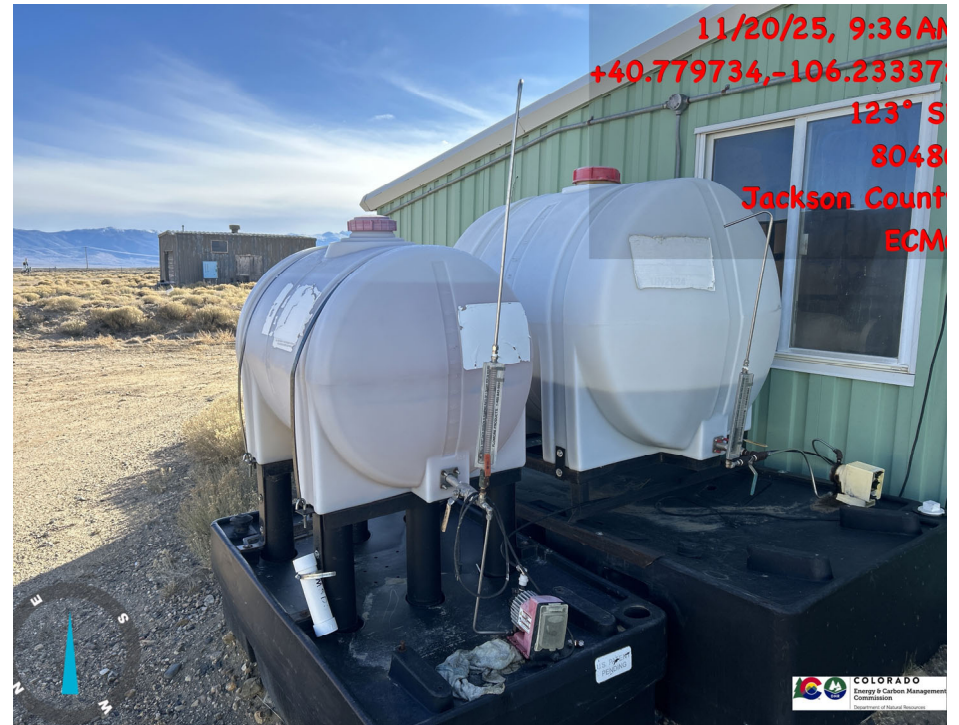
Chemical tanks lacking legible labeling

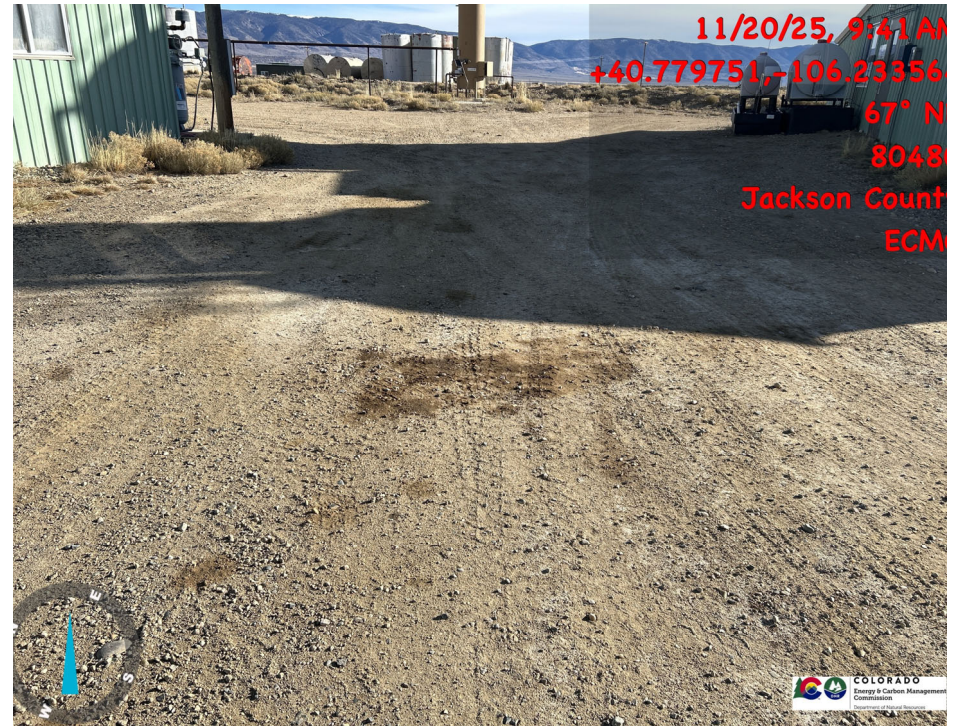
Staining

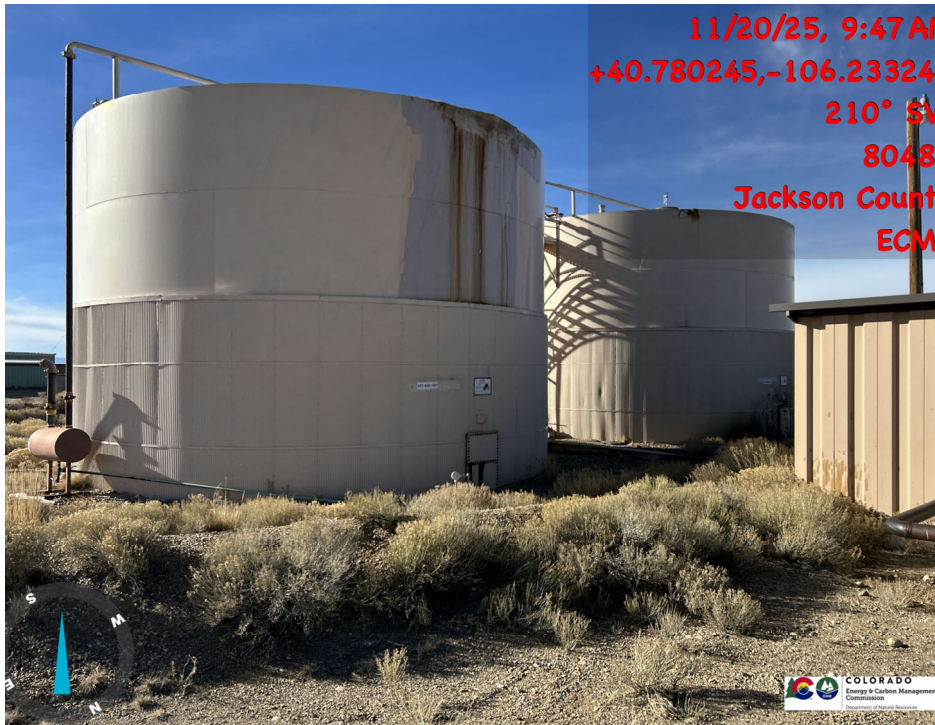
Tank that was leaking emissions

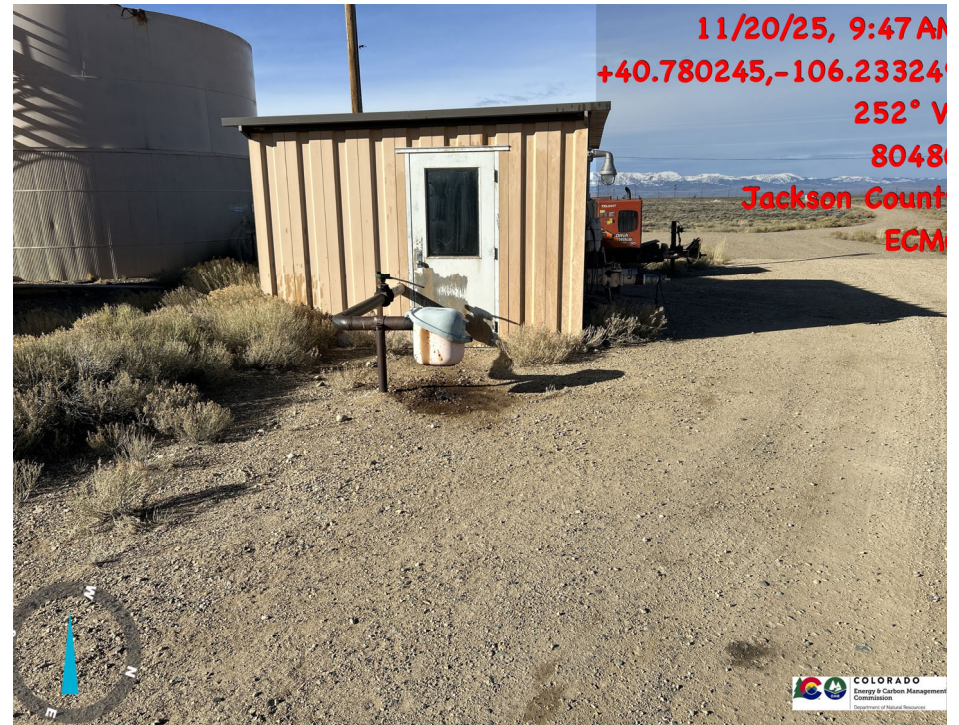
Staining

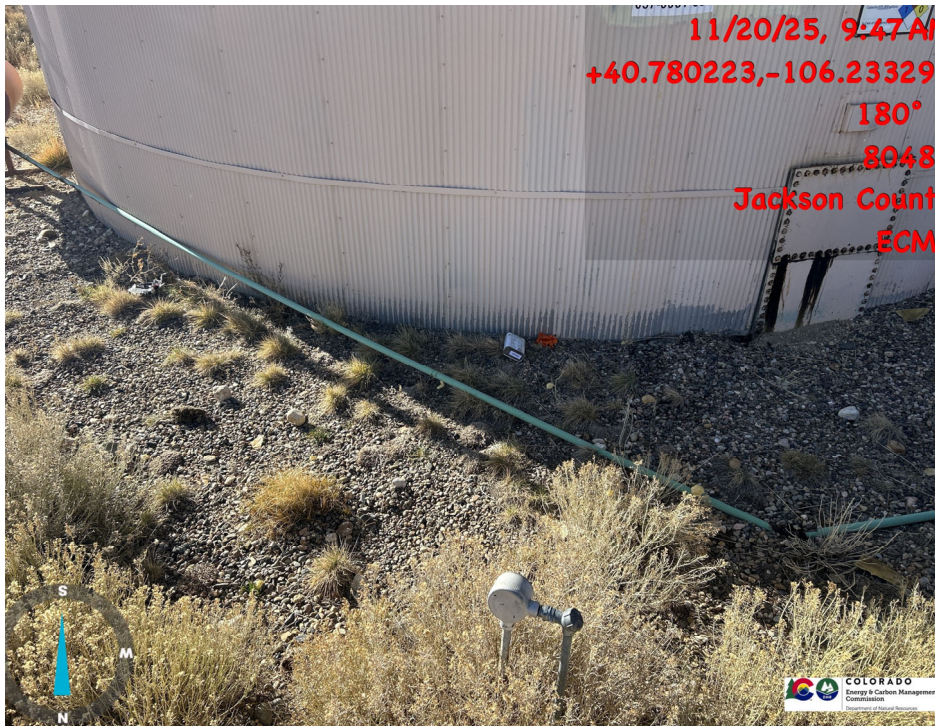
Debris

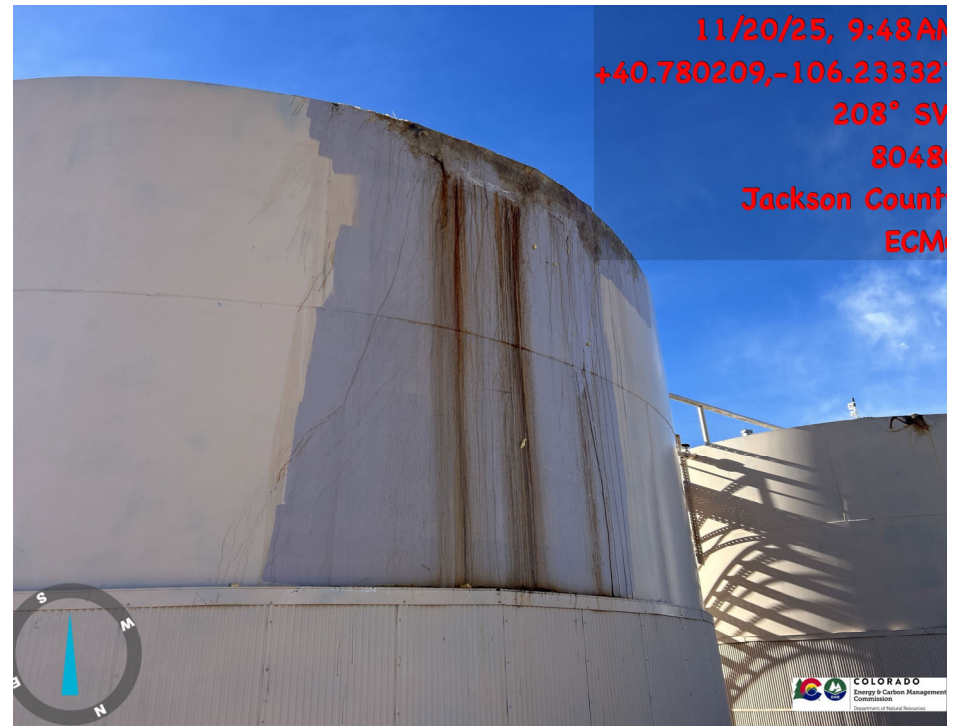
Crack in tank sealed with fiberglass patch

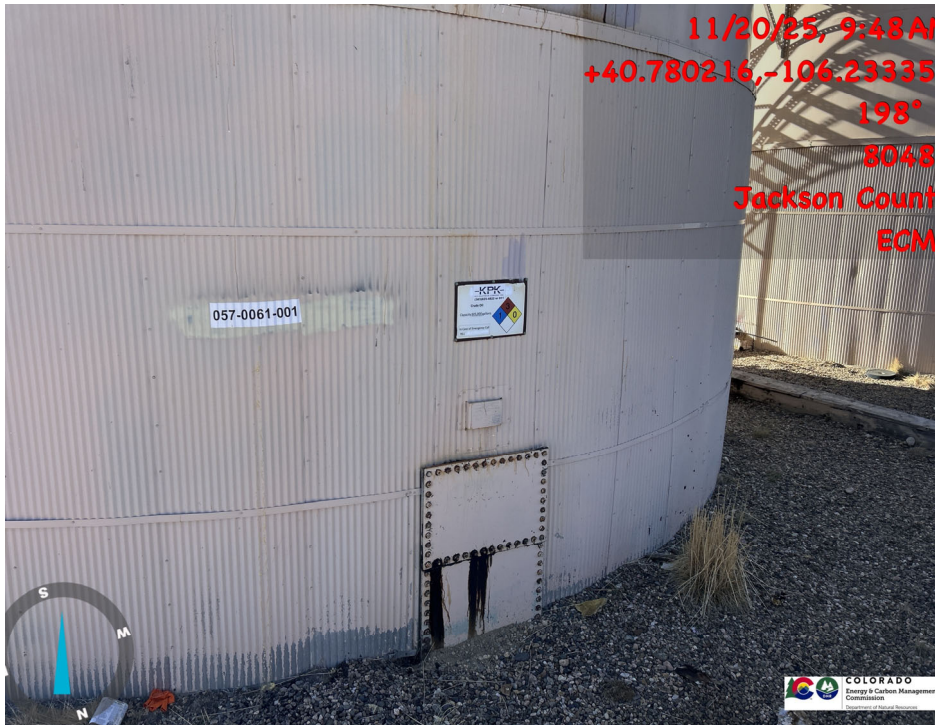
Manway leaking

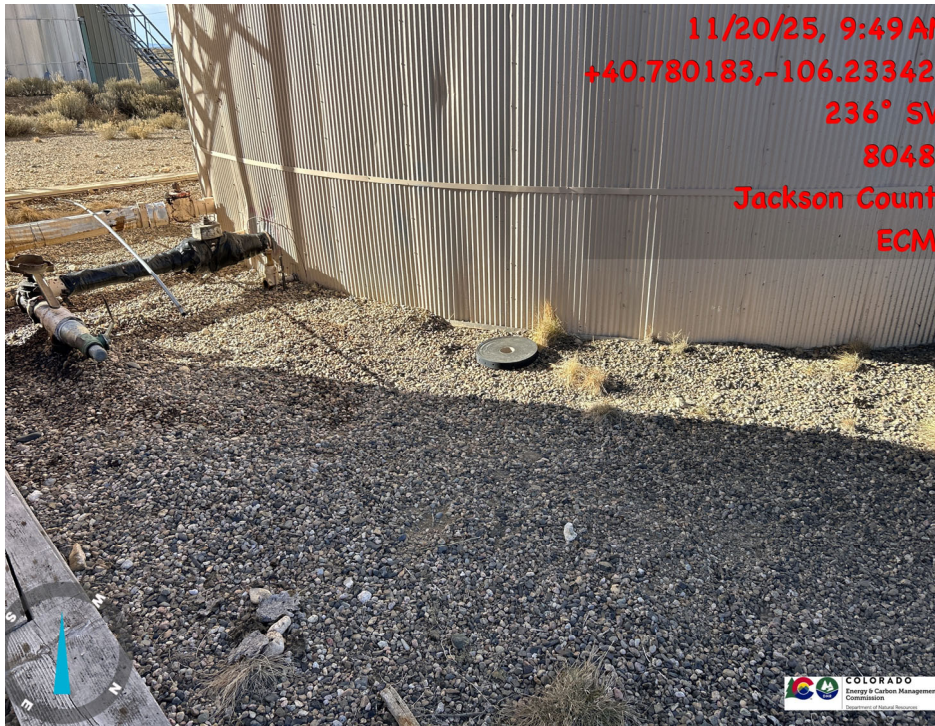
Debris

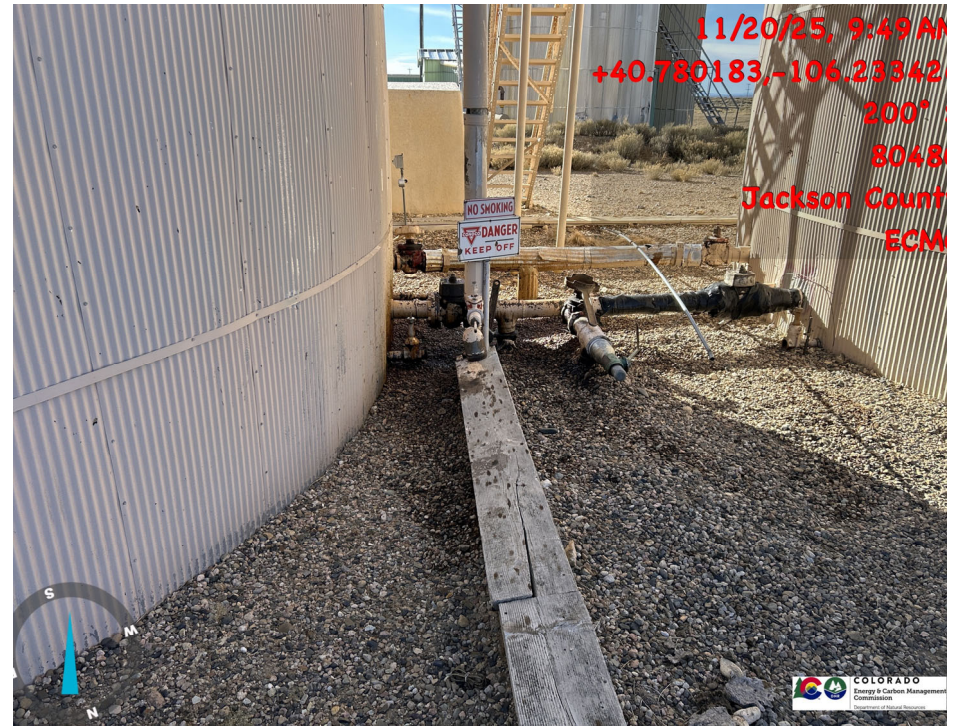
Debris

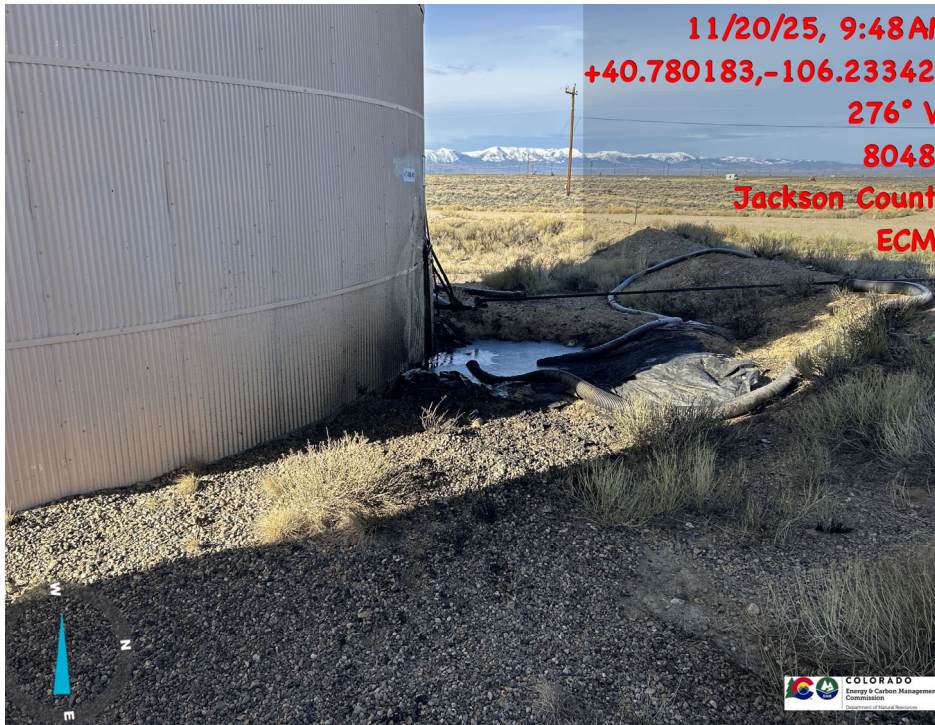
Staining and debris

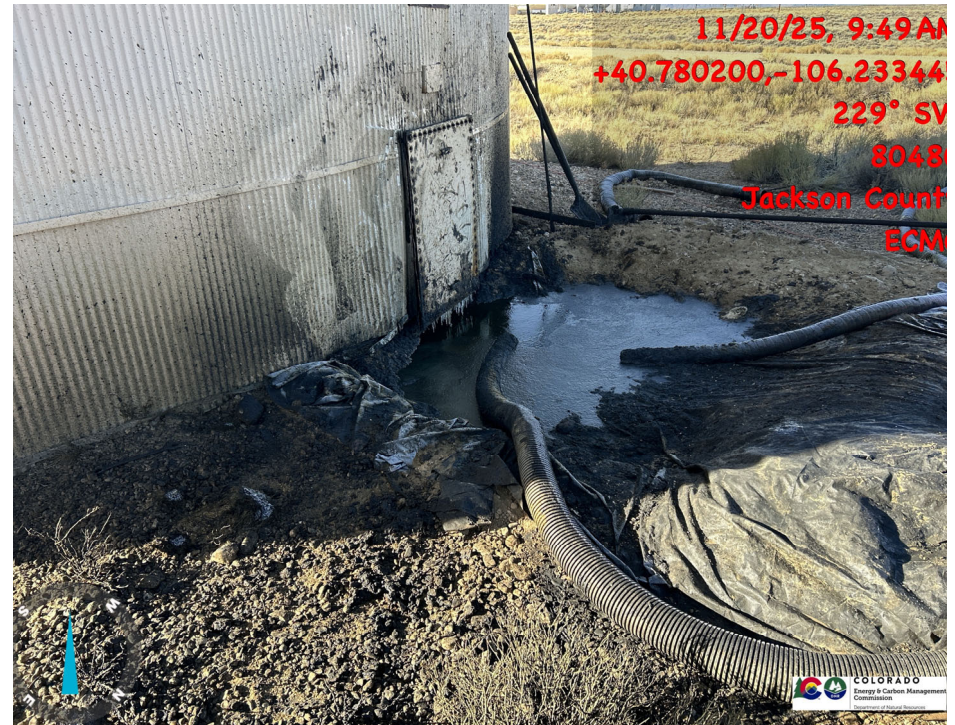
Leaking tank and staining

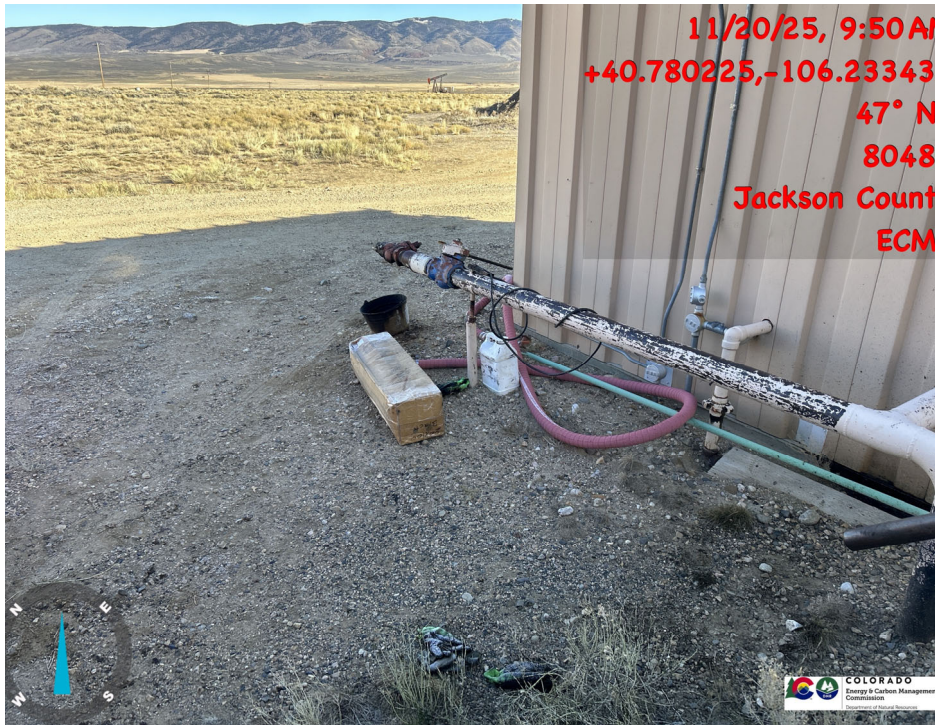
Debris

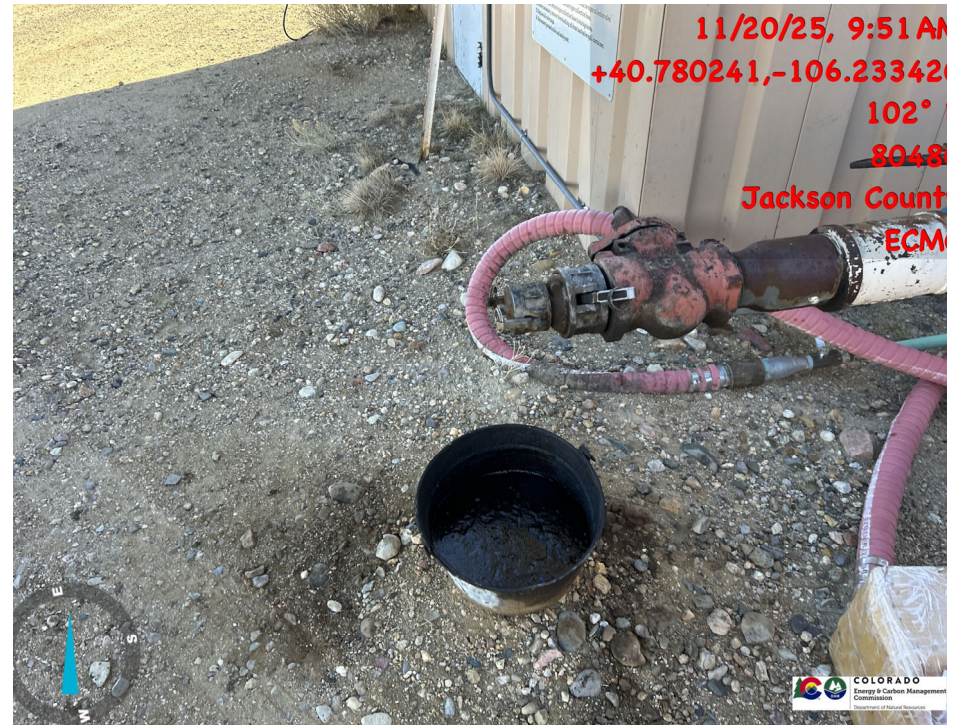
Open bucket with oil

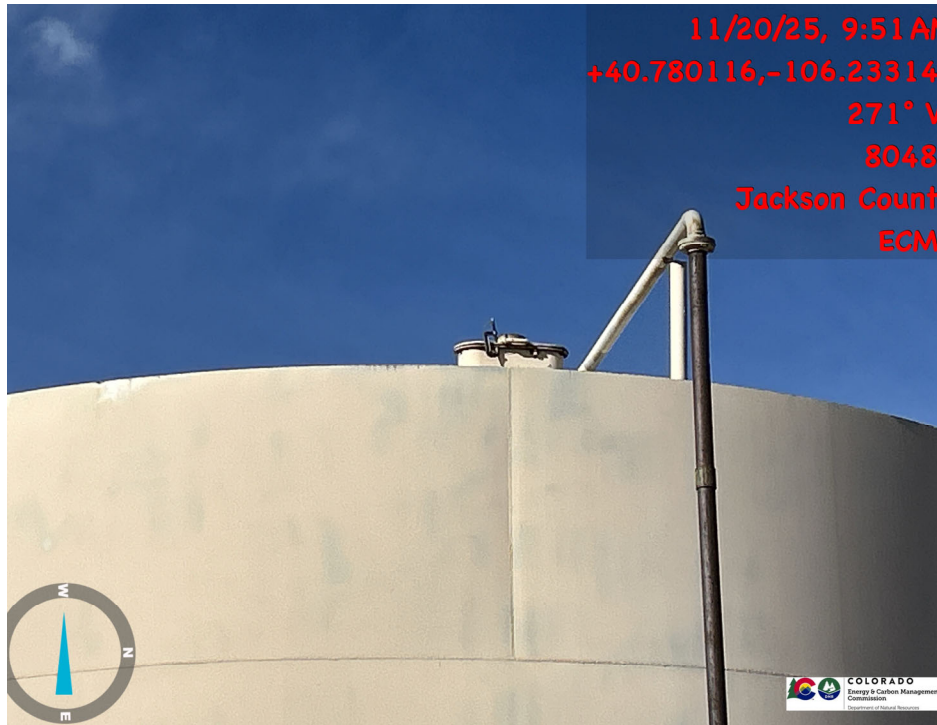
Thief hatch closed with plyers
