Inspection Photos

API: 017-06632

Operator: **WILLIFORD ENERGY COMPANY**

Inspection Date: 11/17/2025

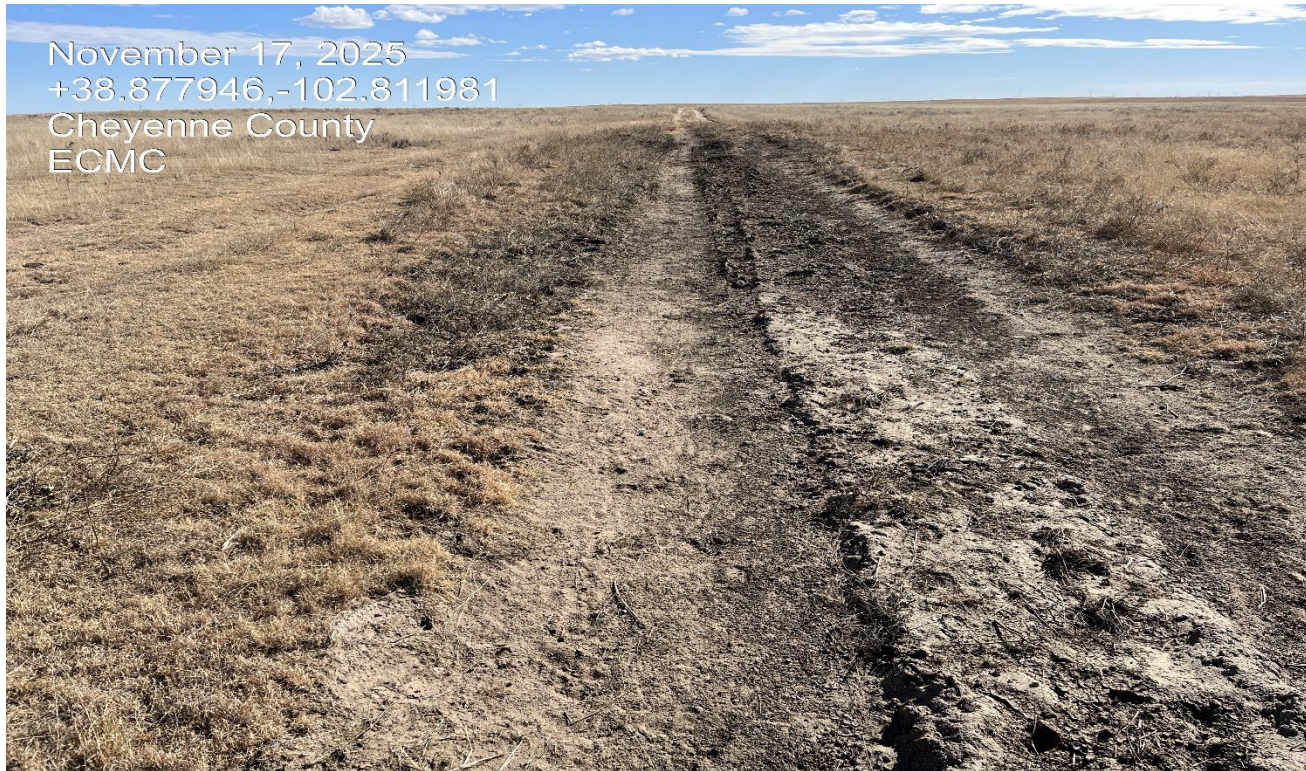
Photo 1. Facing southeast toward the access road. The access road is impassible due to stormwater accumulating along the road. Since the well has been PA'd the road will need to be decompacted, regraded, and reclaimed.

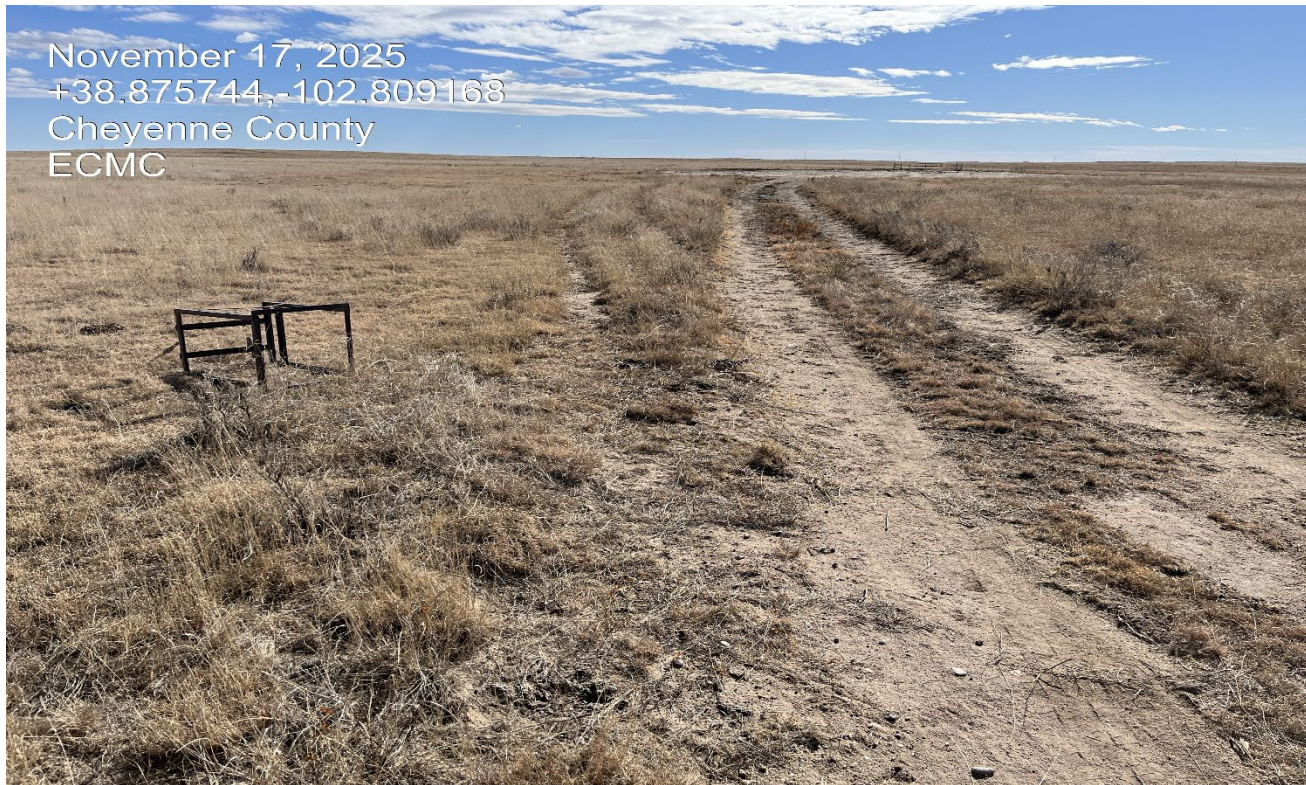
Photo 2. Facing southeast along the access road. There is a metal stand that was left on the roadside.

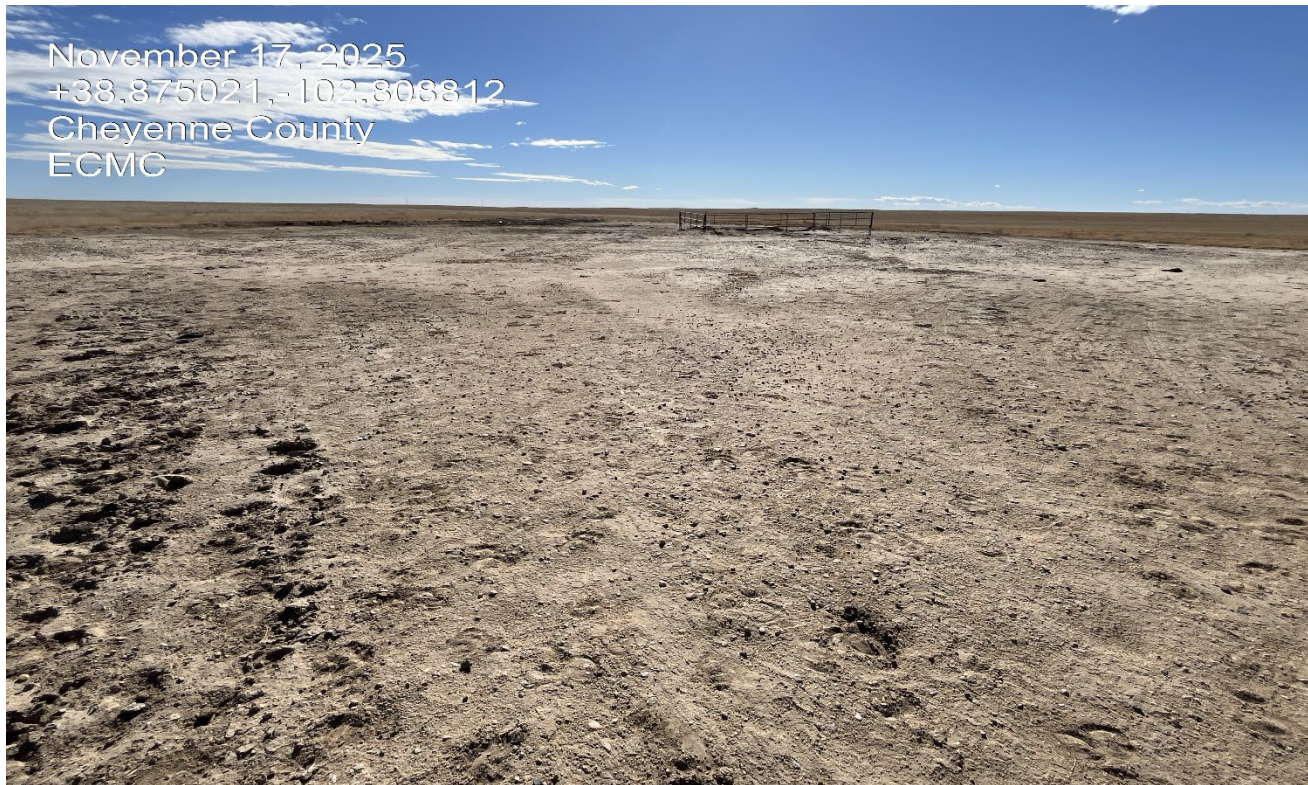
Photo 3. Facing southeast toward the location.

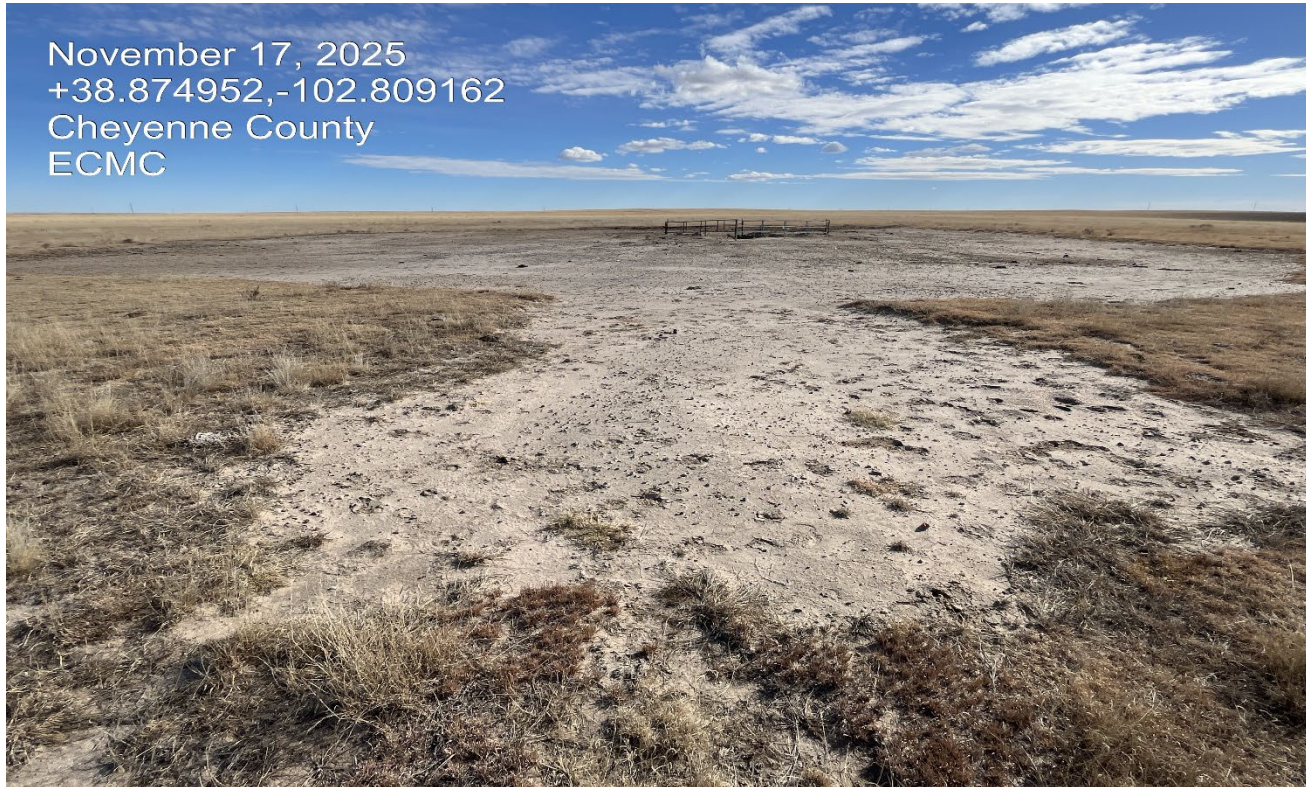
Photo 4. Northwest corner of the location facing southeast. It is suspected that there are impacted soils further out from the plugged well.

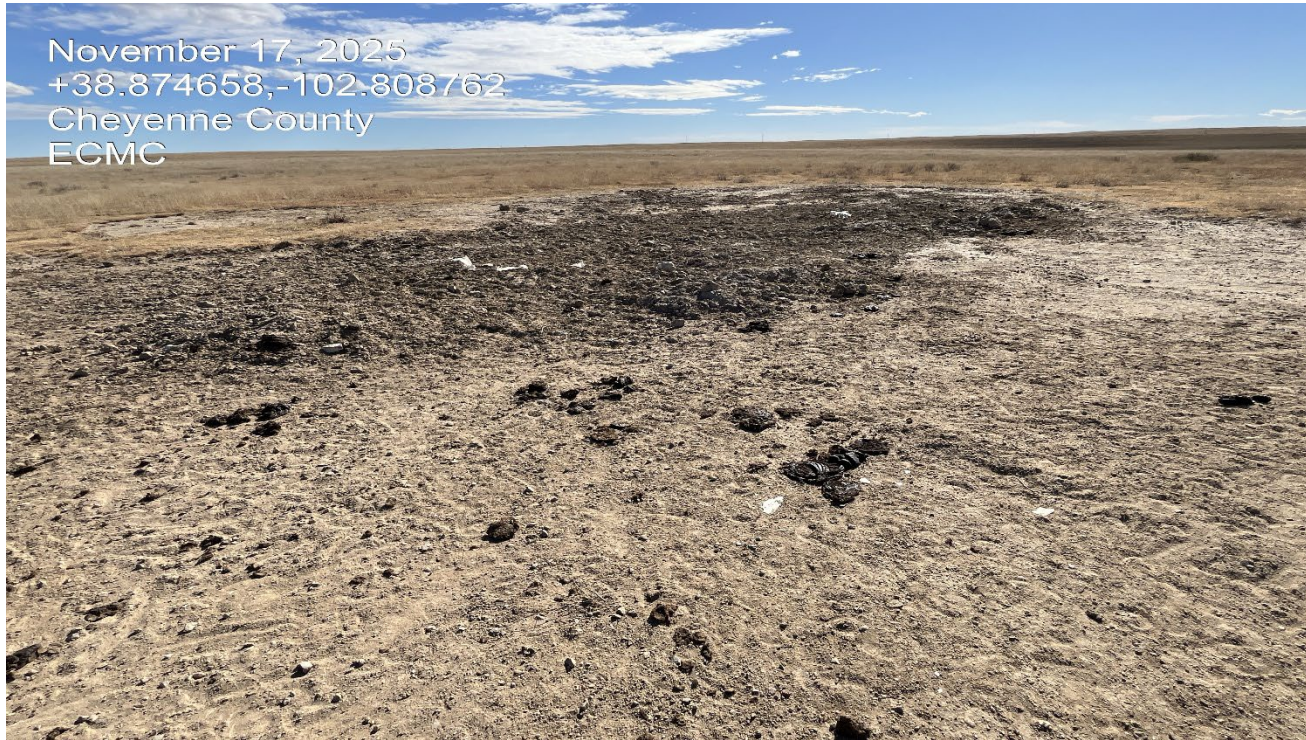
Photo 5. Facing toward southeast side of the location. The excavated impacted material was placed on a piece of plastic with no containment and some of the material has fallen outside of the liner. The pile was removed but it does appear some impacted soil remains in this area.

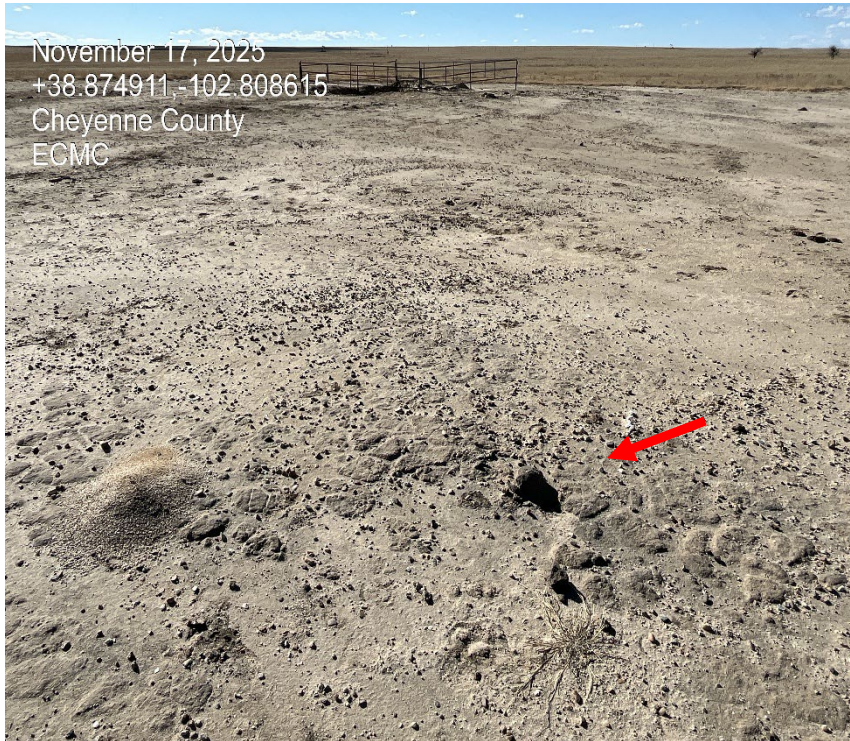
Photo 6. East side of the location facing southwest. There are blacked stained soils at the east side of the location. This does not appear to be suitable soil for reclamation.

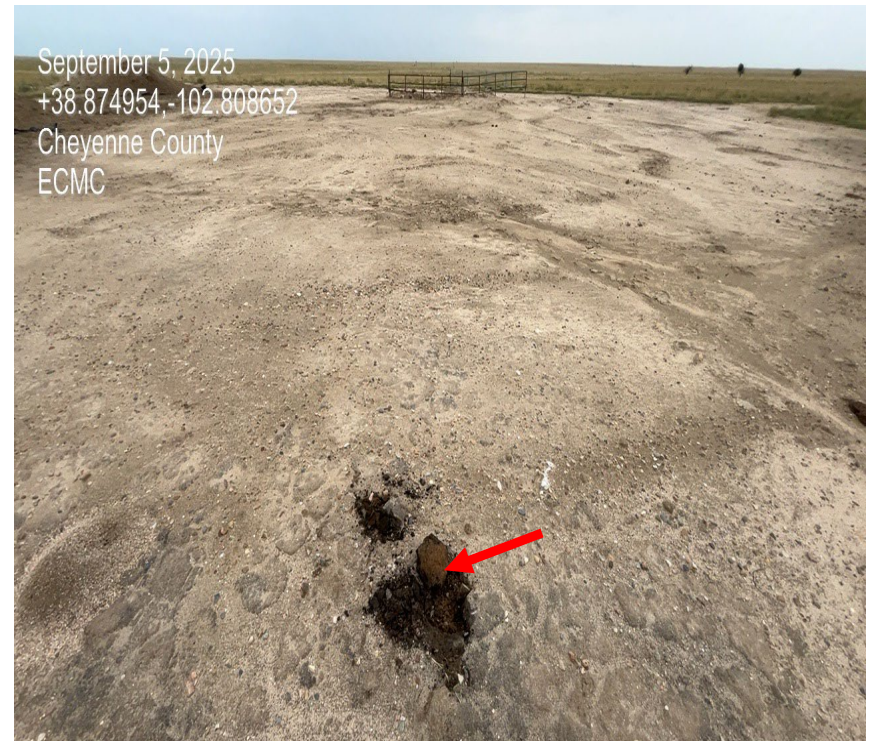
Photo 7. East side of the location facing southwest. There are blacked stained soils at the east side of the location. This does not appear to be suitable soil for reclamation.
