Interim Reclamation and Stormwater Inspection

Location ID: 475084

Location Name: LINNEBUR-MANIFOLD/13NWSE

Inspection Document #: 718601193

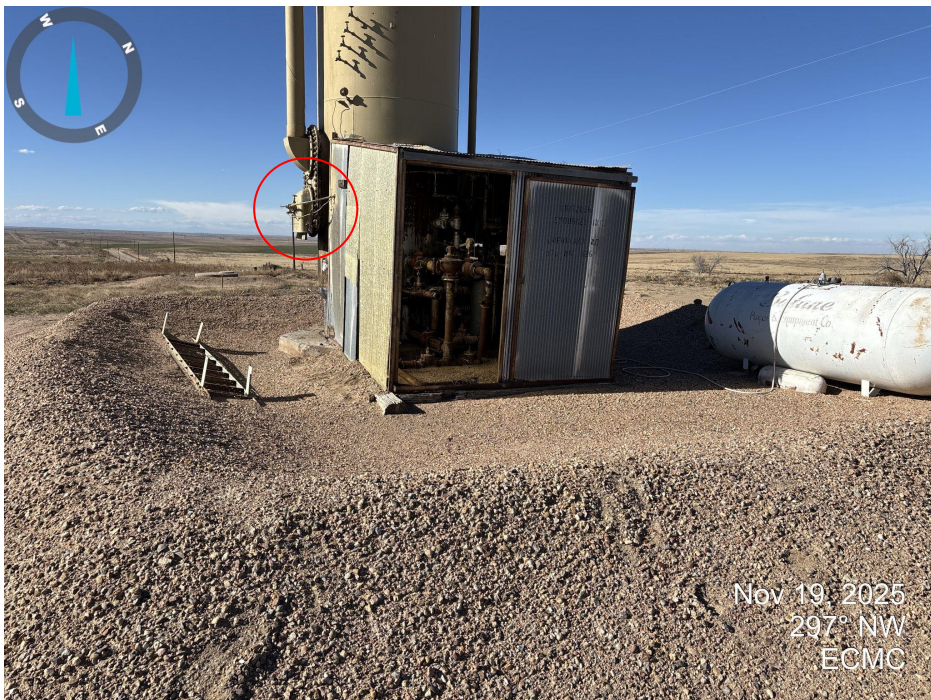
Photo 1. Looking west at the separator shed. Separator opening (red circle).

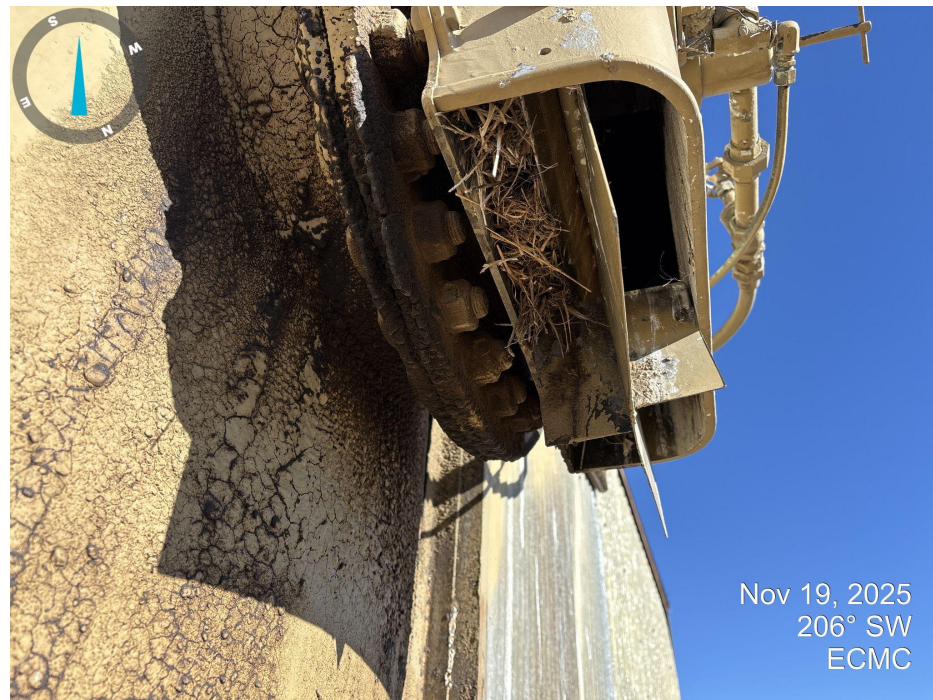
Photo 2. Appears that nest material/ debris is present in a separator opening.

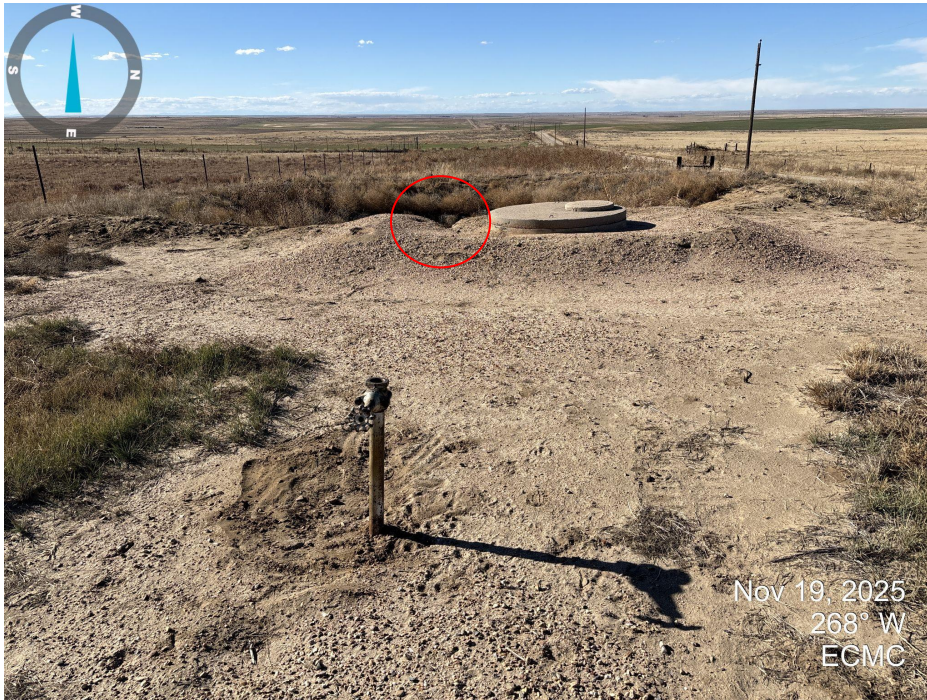
Photo 3. Looking west across the east side of the location near the evaporation pit. Secondary containment berm around partially buried concrete vessel appears to be compromised and shows signs of stormwater erosion (red circle).

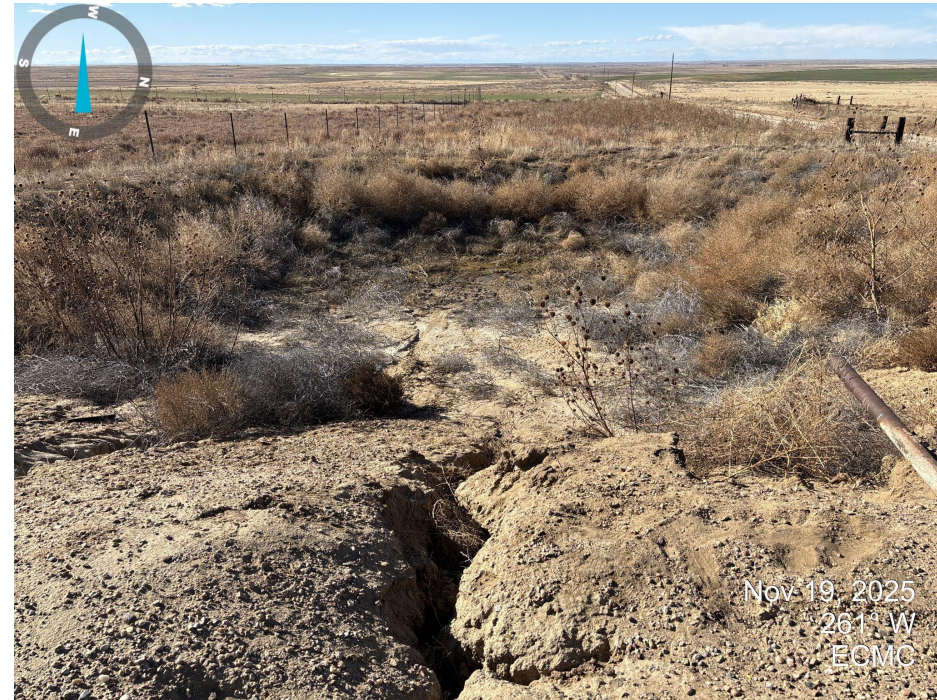
Photo 4. Picture taken looking across the evaporation pit. Stormwater erosion is present in the secondary containment berm near the partially buried vessel. Undesirable weeds such as kochia and russian thistle are present in and around the pit.

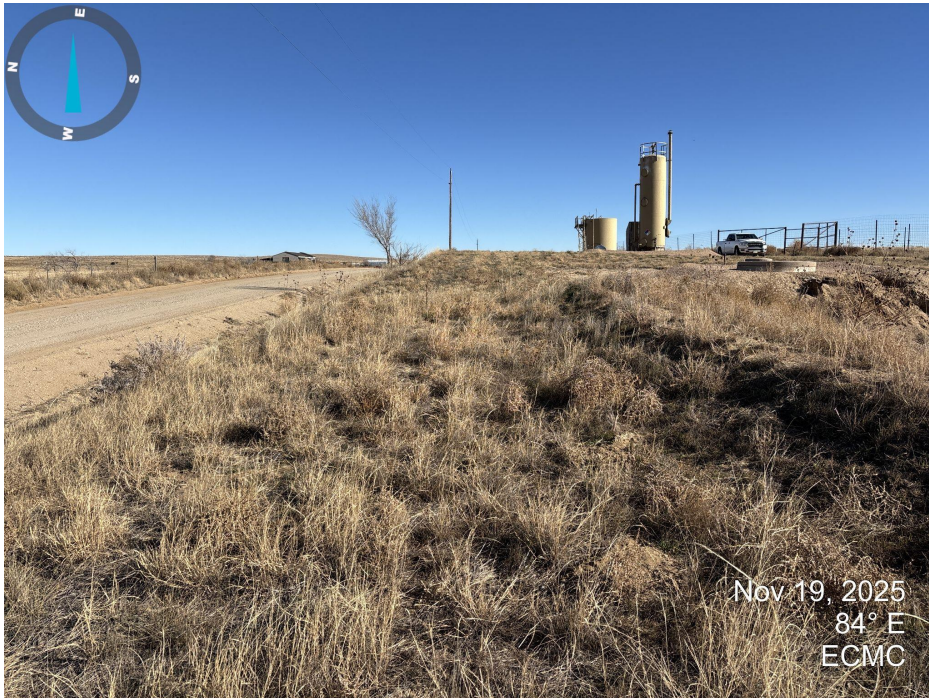
Photo 5. Looking east across the north side of the tank battery location. Vegetation on the location is mowed at the time of location. Some desirable perennial vegetation is present in the interim area. Undesirable weeds such as kochia and russian thistle are also present in the interim area.

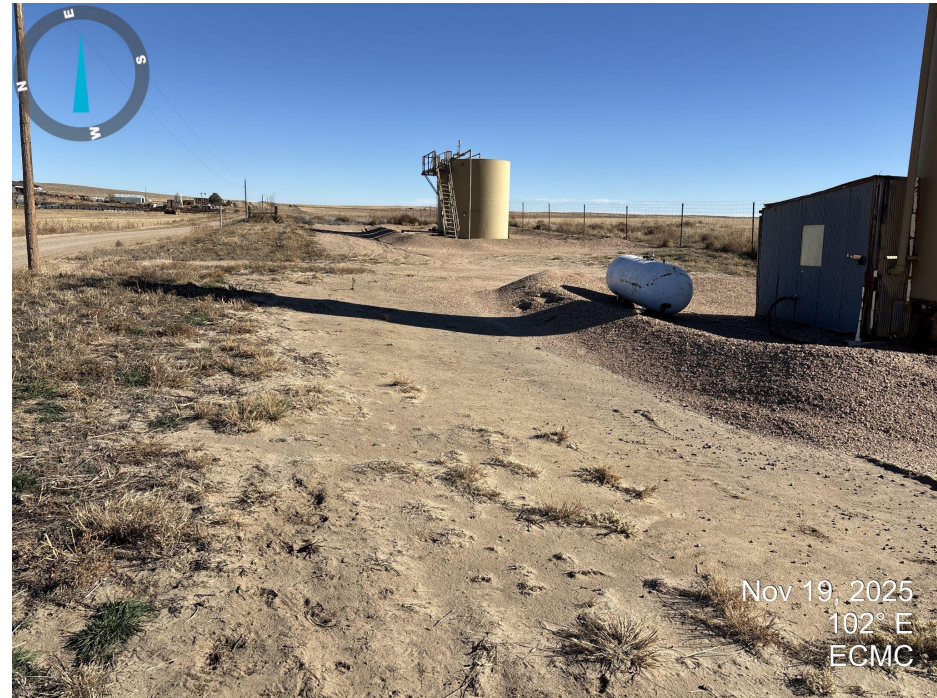
Photo 6. Looking east across the north side of the tank battery location. See photo 5 comments.

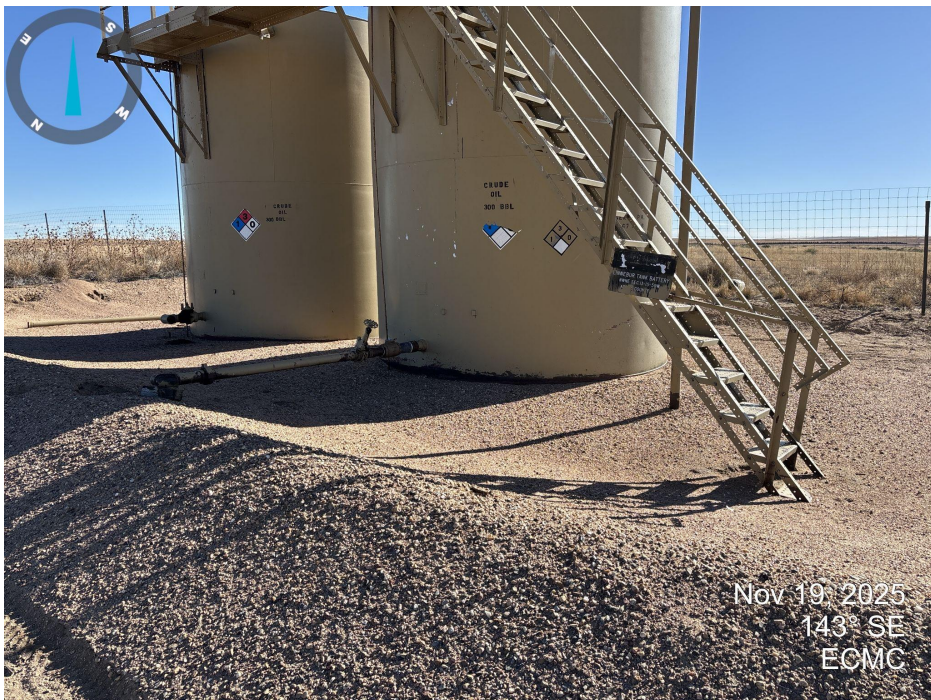
Photo 7. Looking south at the tank battery. Tank battery sign is inadequate.

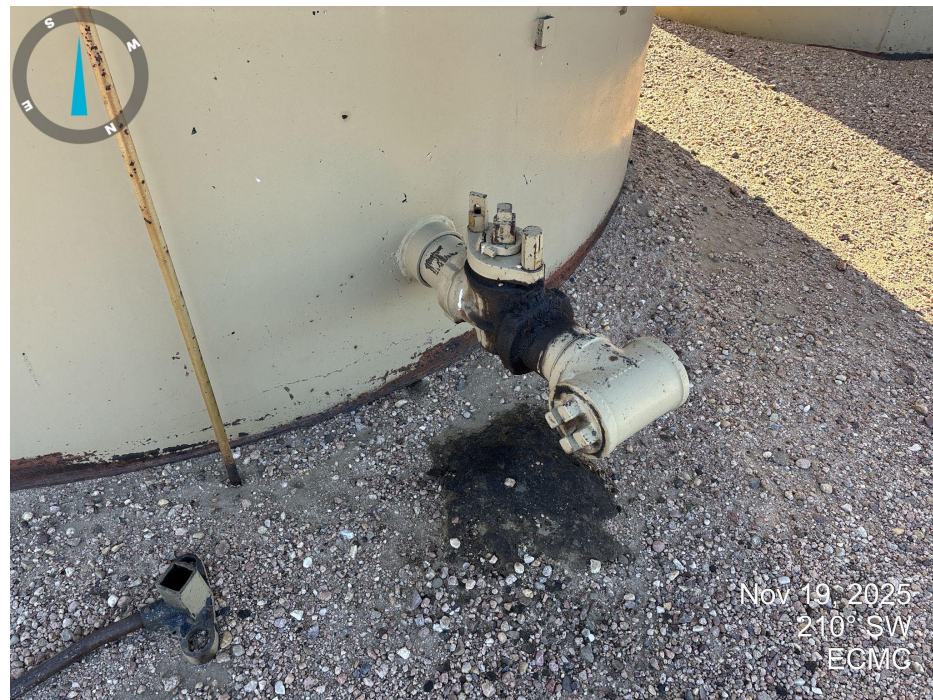
Photo 8. Fitting on the eastern tank appears to be leaking. Stained soil is present beneath the valve.
